MEADOWBANK MINE WATER MANAGEMENT AND
GEOTECHNICAL INFRASTRUCTURES

COLLECTION POND 23 – PHASE 1

CONSTRUCTION SUMMARY REPORT

March 23, 2026

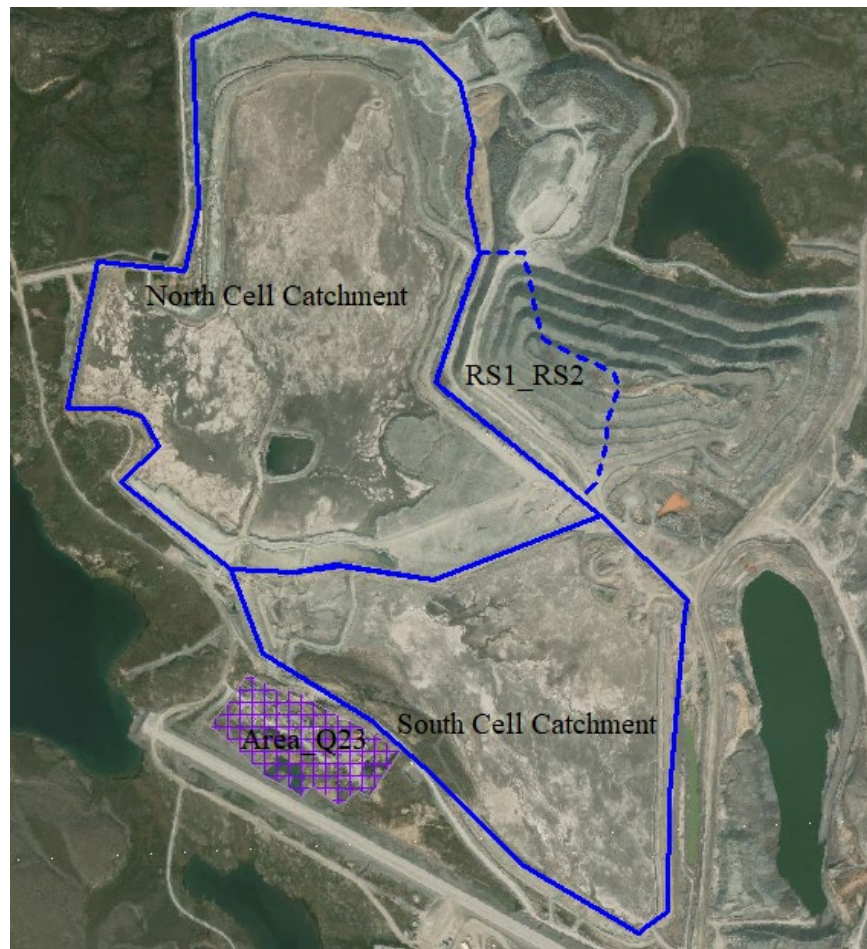
Figure 2: TSF Catchment boundaries

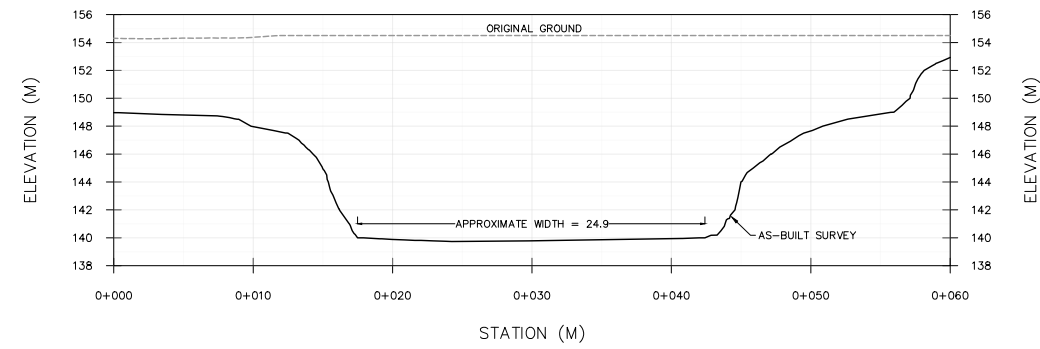
SECTION C - SOUTH CELL TO CP23 CHANNEL - 0+150

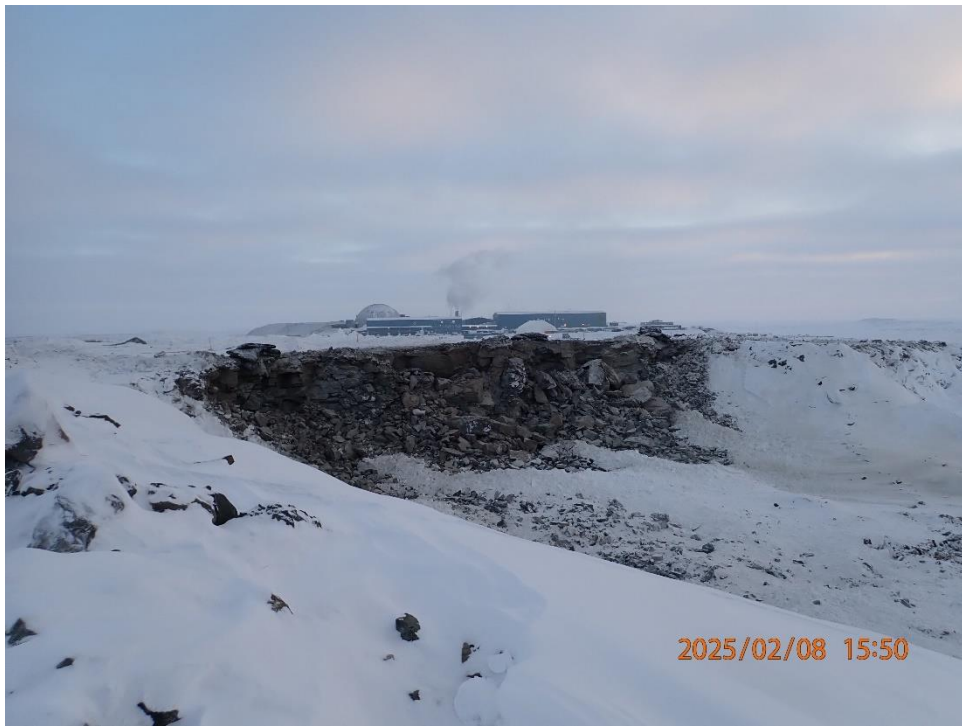
Photo 1.1

East wall of collection pond; signature blast

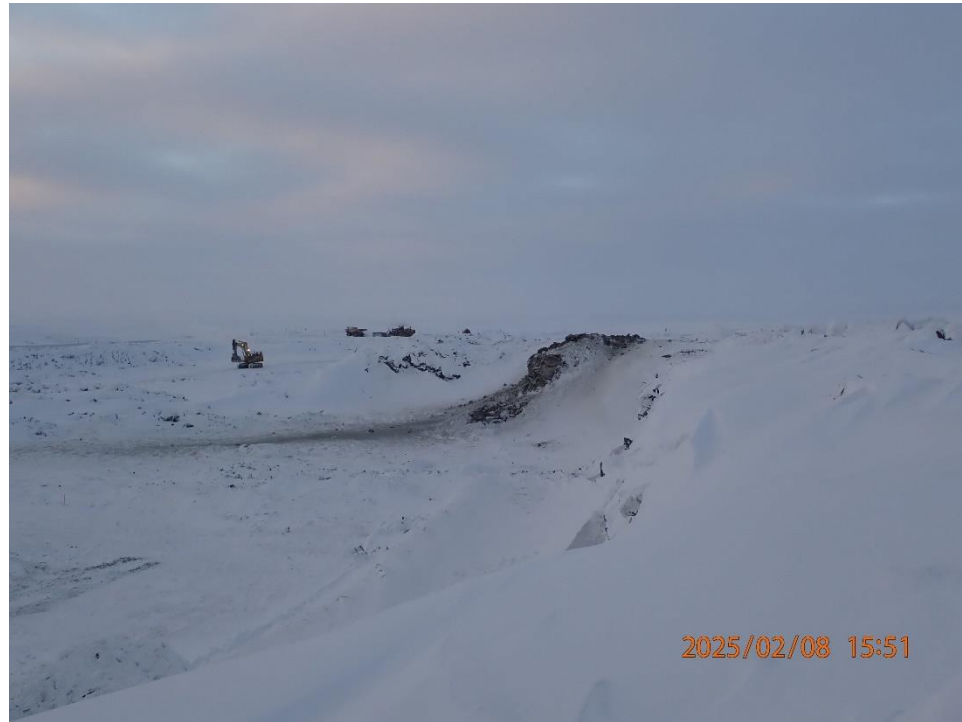
Photo 1.2

West wall of collection pond; signature blast

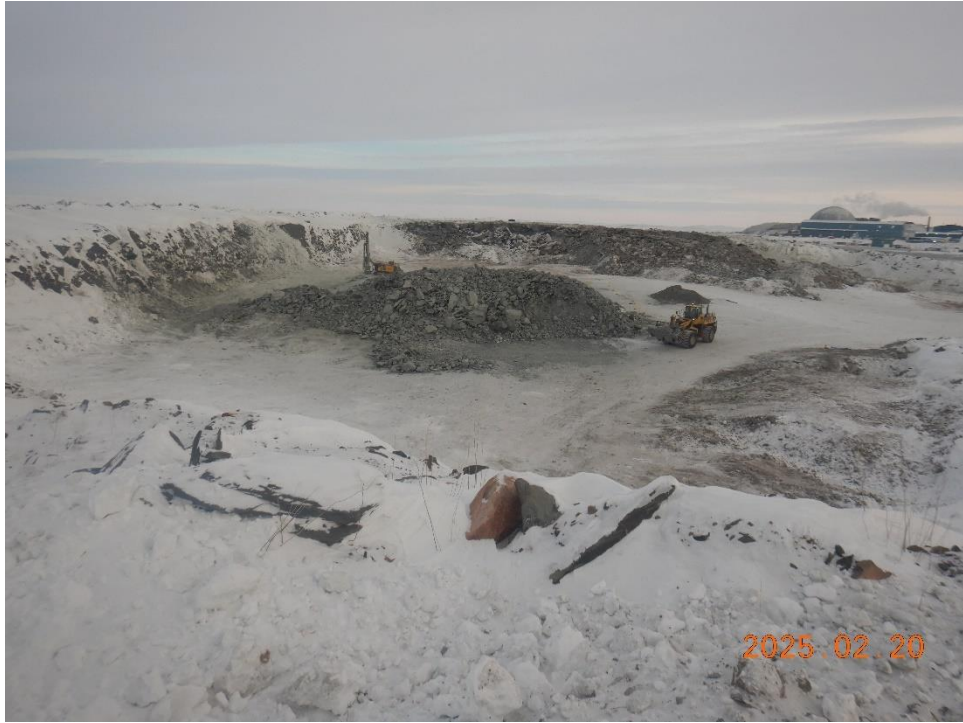
Photo 1.3

Mucking of 5142 blast material

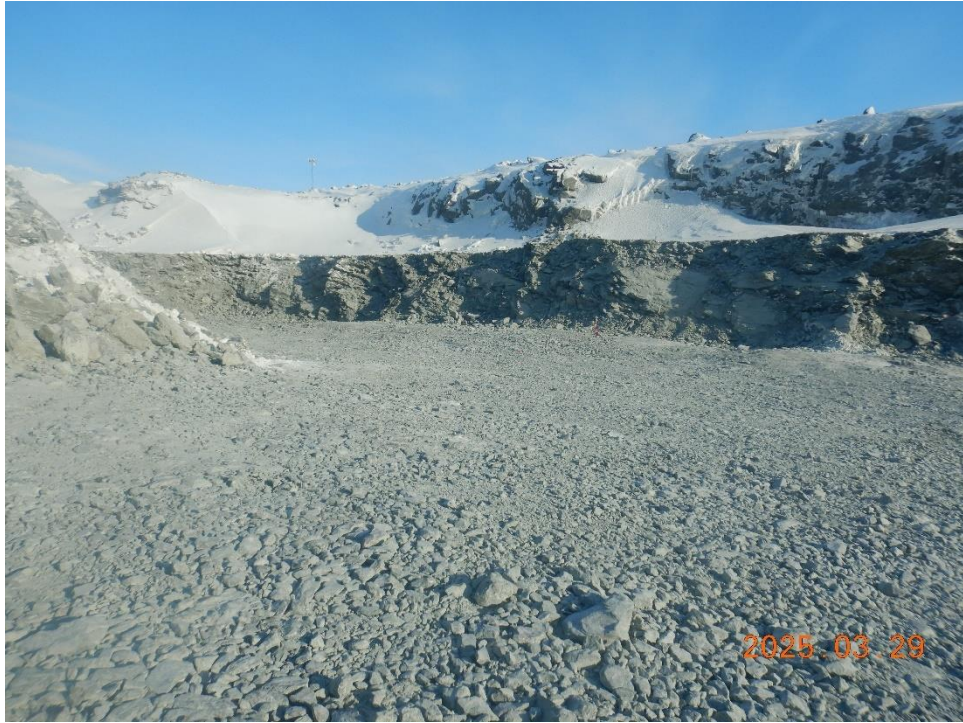
Photo 1.5

Clean floor of 5142 prior to blasting to 5135

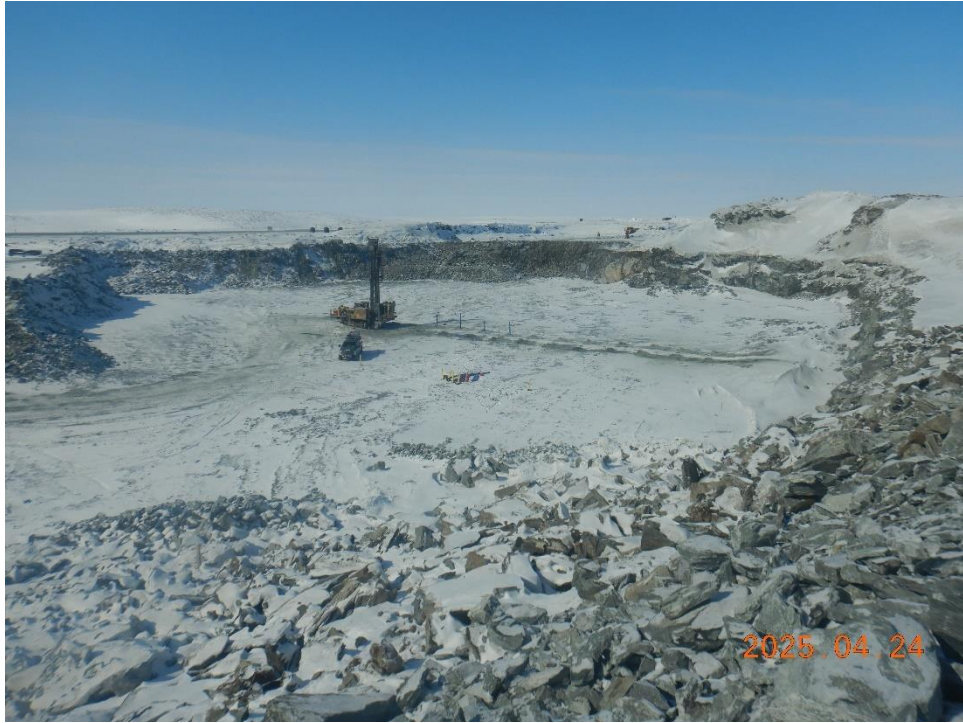
Photo 1.9

Drilling of 5128 temporary sump

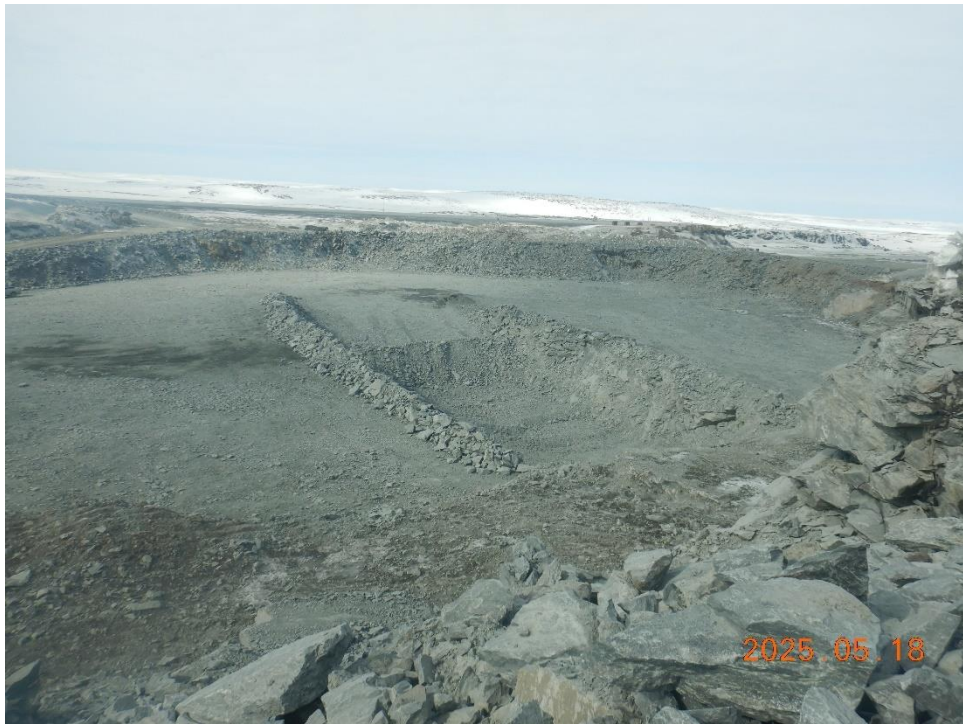
Photo 1.10

Completed 5128 sump with safety berms in place

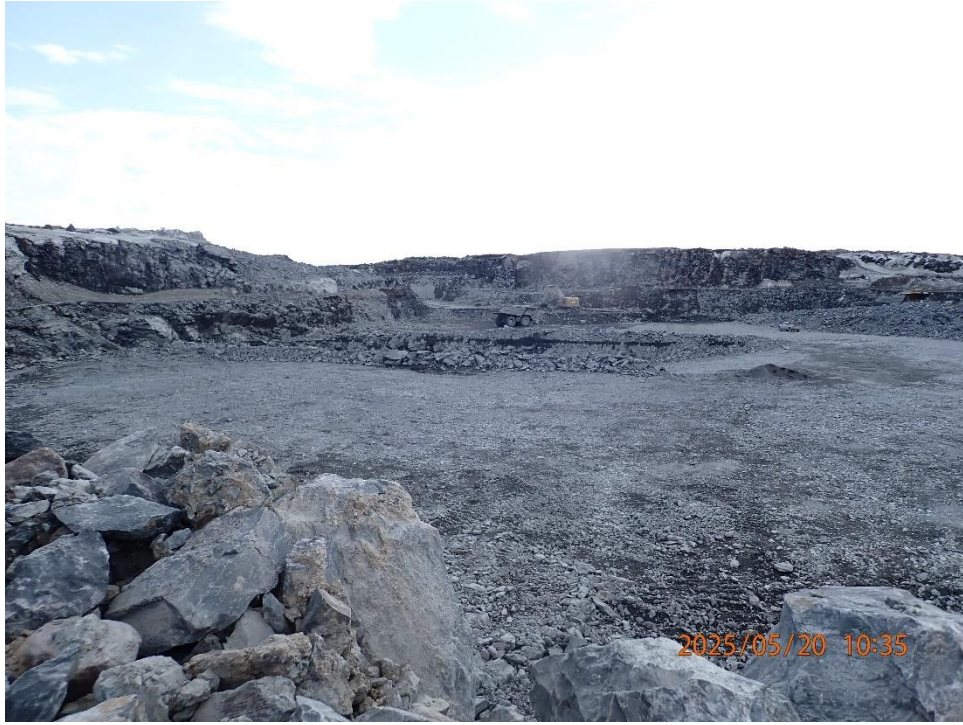
Photo 1.13

Completed Phase 1, looking northeast and 5135 floor

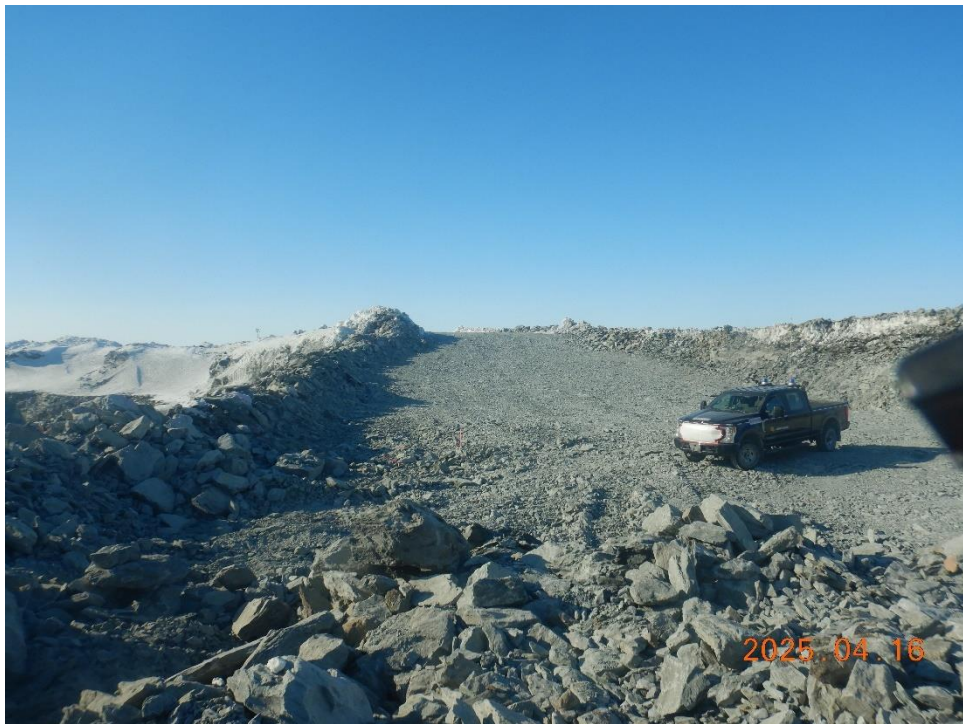
Photo 2.1

Ramp from west created to 5149 to access spillway footprint

The spillway was blasted in two stages, to floor 5149 and then final floor of 5140. Material was hauled via the Collection Pond 23 elevation 5135 floor, as well as a ramp created at the western side of the spillway. The final spillway is approximately 135 m at an overall grade of 4%, with an average width of 24.5 m. The spillway invert and outlet are 141.0 m and 138.0 m, respectively. The walls remain as a free face up to about 14 m at its maximum, with no catch benches.

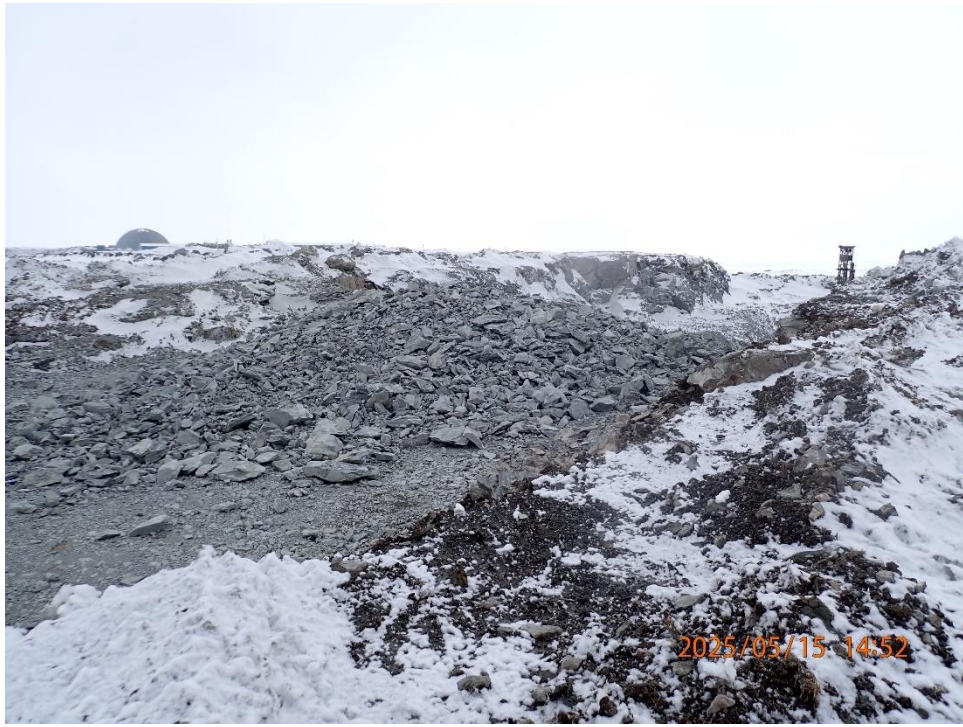
Photo 2.3

Blast to 5140 floor

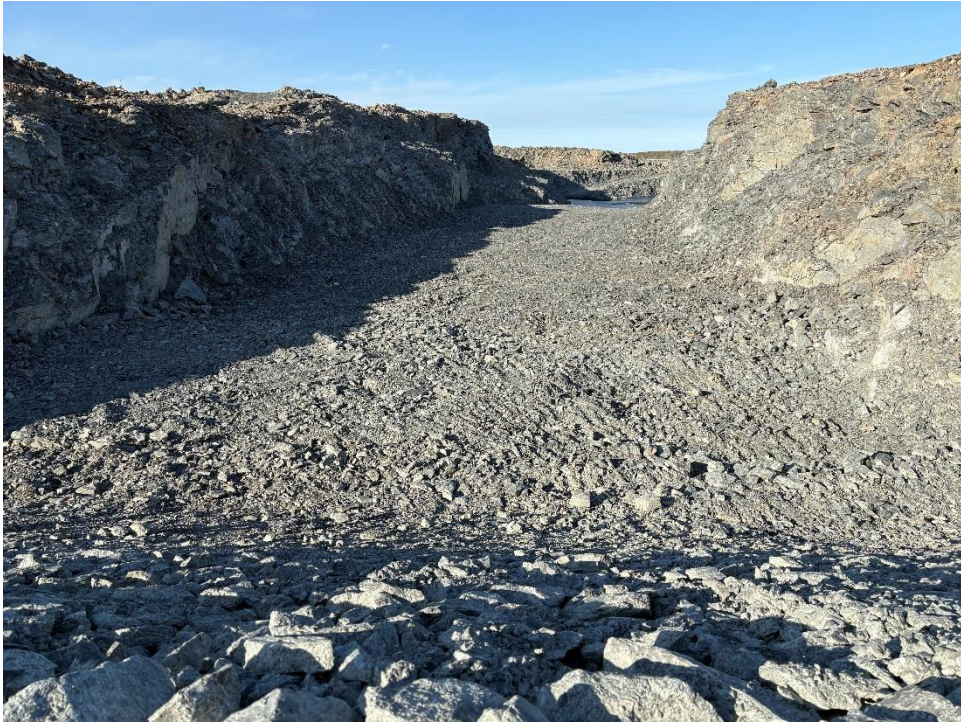
Photo 2.9

Completed spillway, looking south from temporary reclaim berm

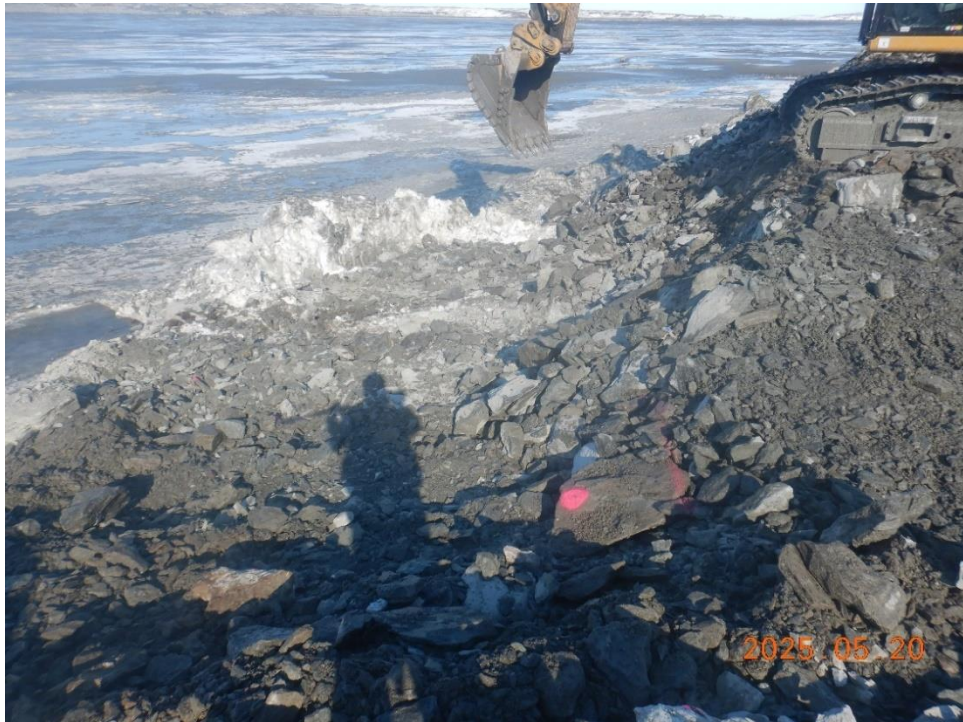
Photo 3.2

Exposure of natural ground for abutment tie-in and discovery of snow-rich material. Snow was removed prior to proceeding.

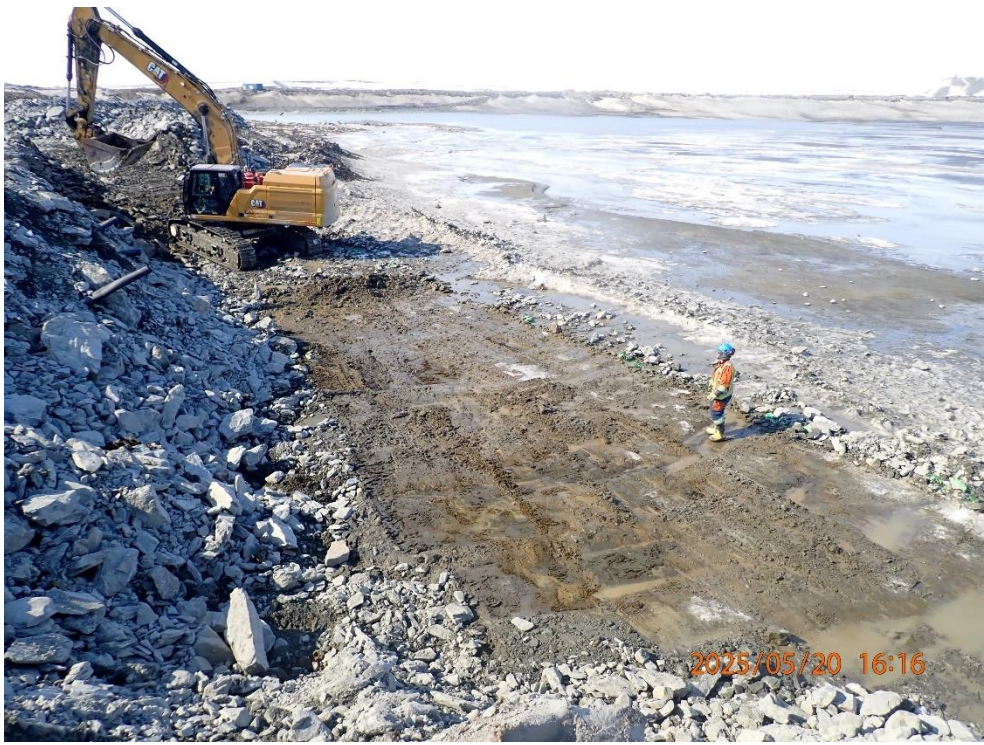
Photo 3.3

Preparation of upstream foundation in tailings

In the main body of the structure, the foundation was prepared similarly to the abutments. At the upstream, the foundation was scraped and the rockfill slopes were prepared to 2H:1V. The key-in trench, geotextile installation, and coarse filter placement followed the same procedure as the abutments. After these steps were complete to El. 143.8 m, the rockfill road was raised back to El. 145 masl to accommodate the reclaim pipe and eventual tailings pipe. The downstream slope was placed and bucket compacted rockfill at 2H:1V slopes.

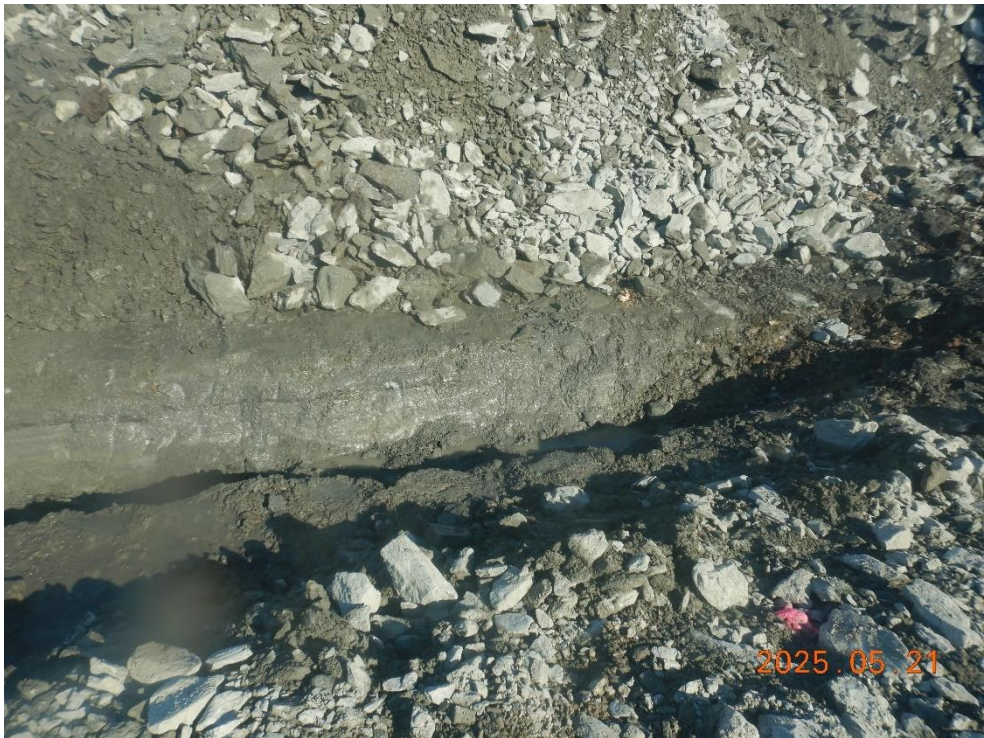
Photo 3.6

Condition of key trench excavation in tailings near east abutment

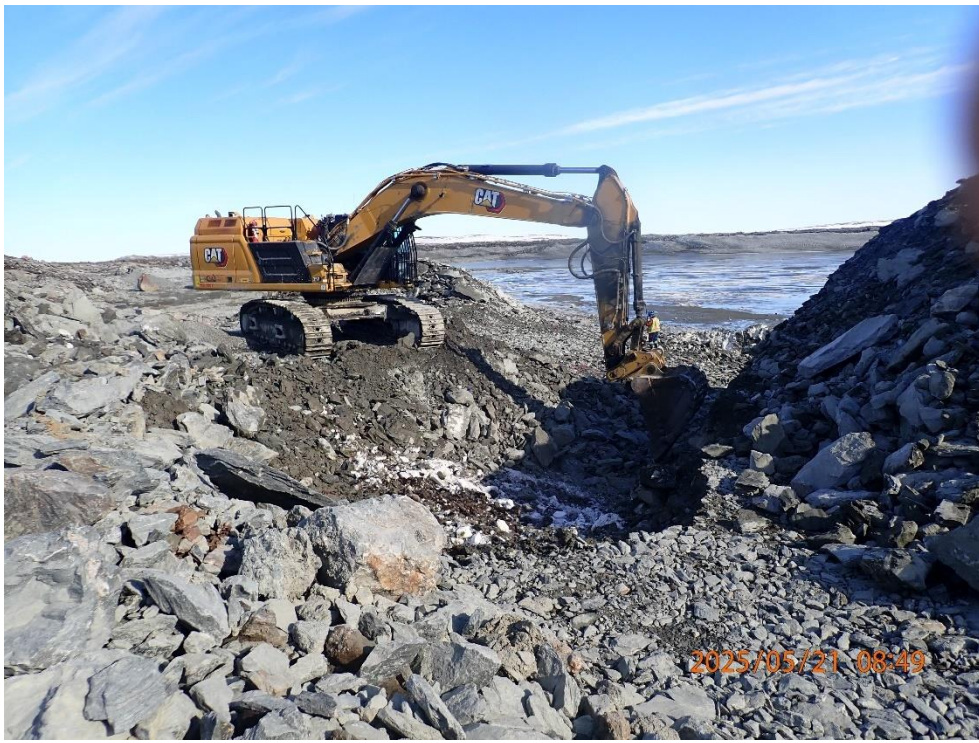
Photo 3.7

Preparation of east abutment tie-in to natural ground. Removal of snow.

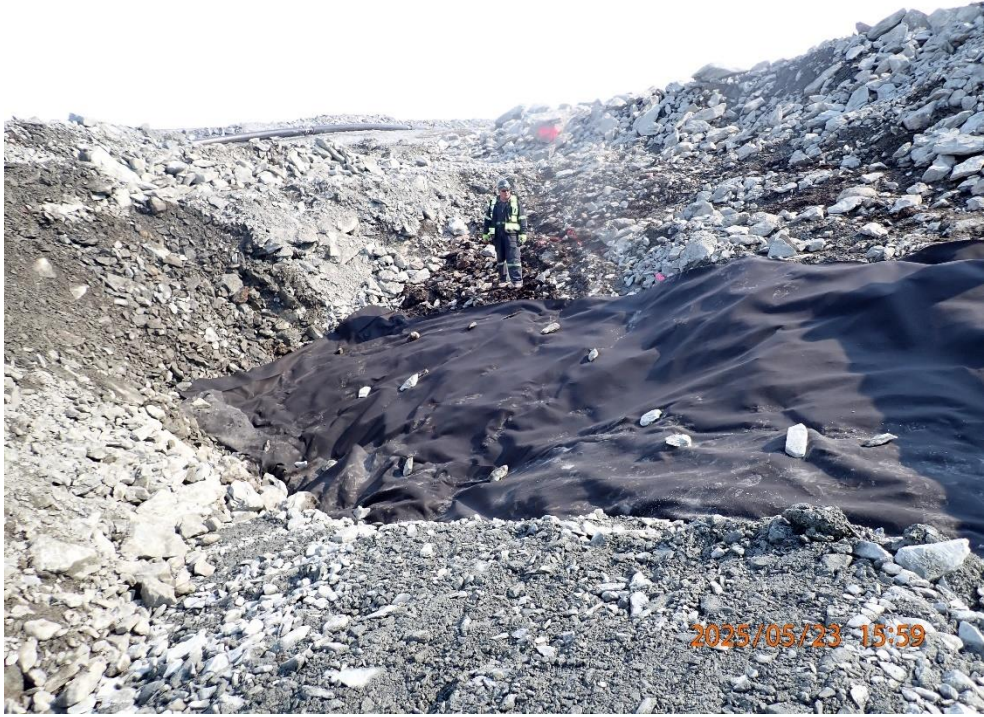
Photo 3.11

Geotextile placement on natural ground at east abutment

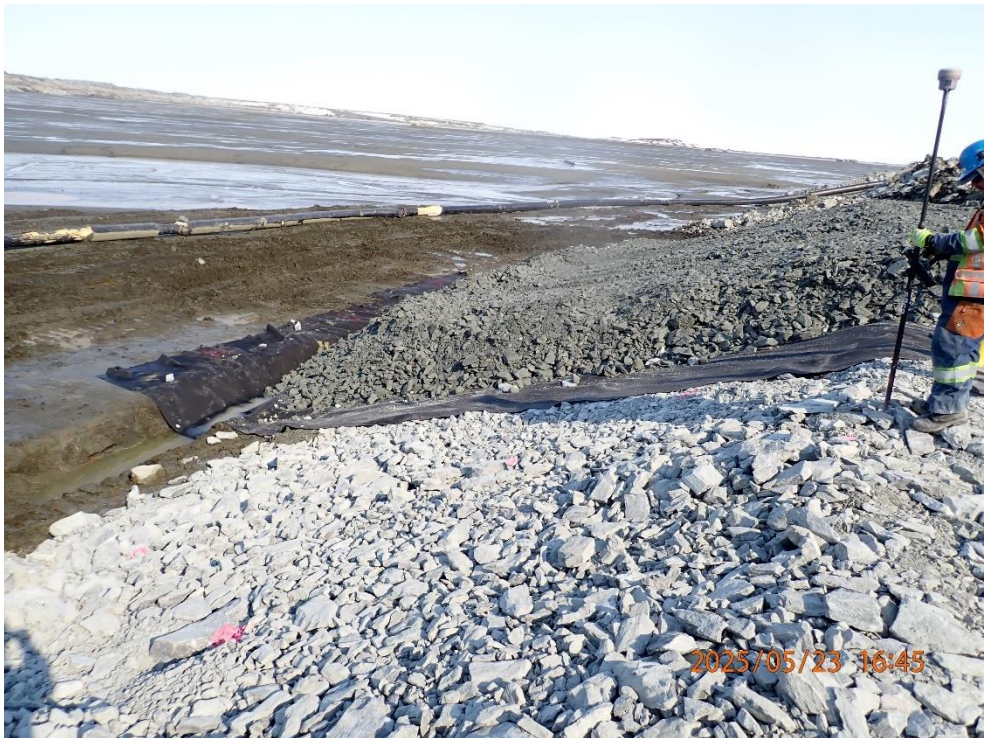
Photo 3.12

Coarse filter placed over geotextile near eastern slope

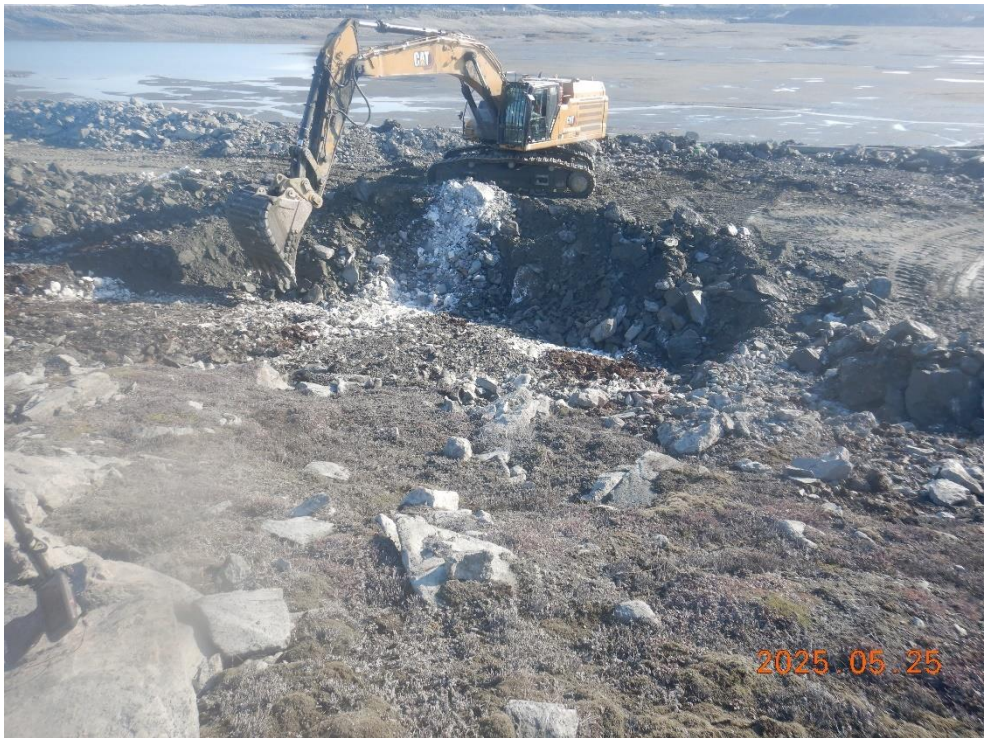
Photo 3.16

Non-compliant snow removal at west abutment

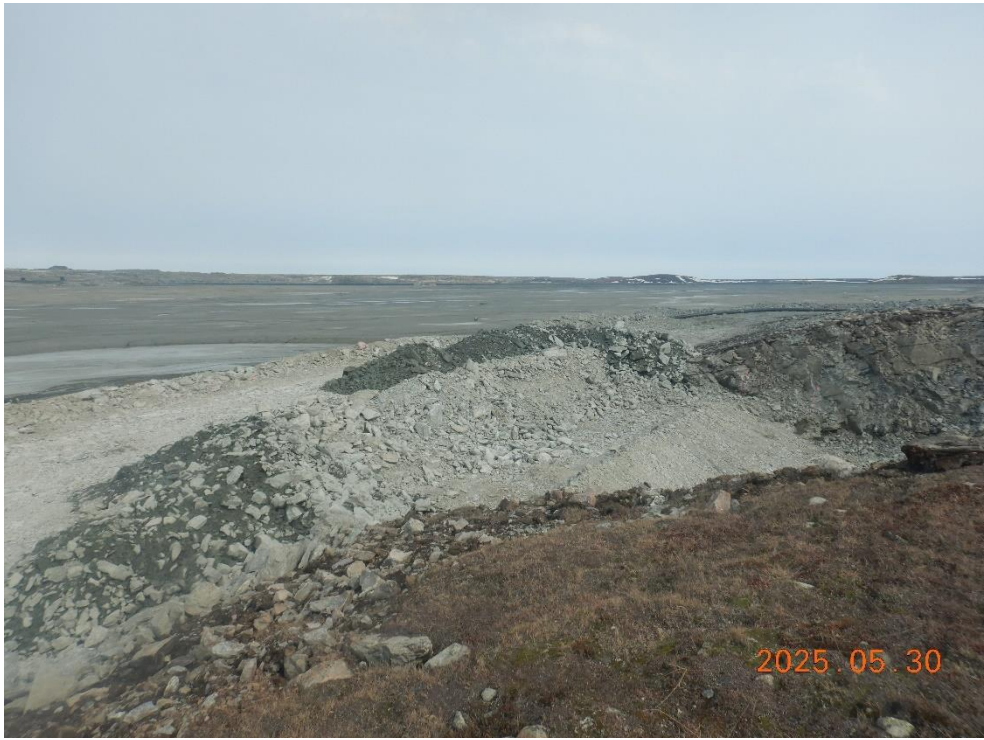
Photo 3.27

Progress of first lift of rockfill on downstream slope

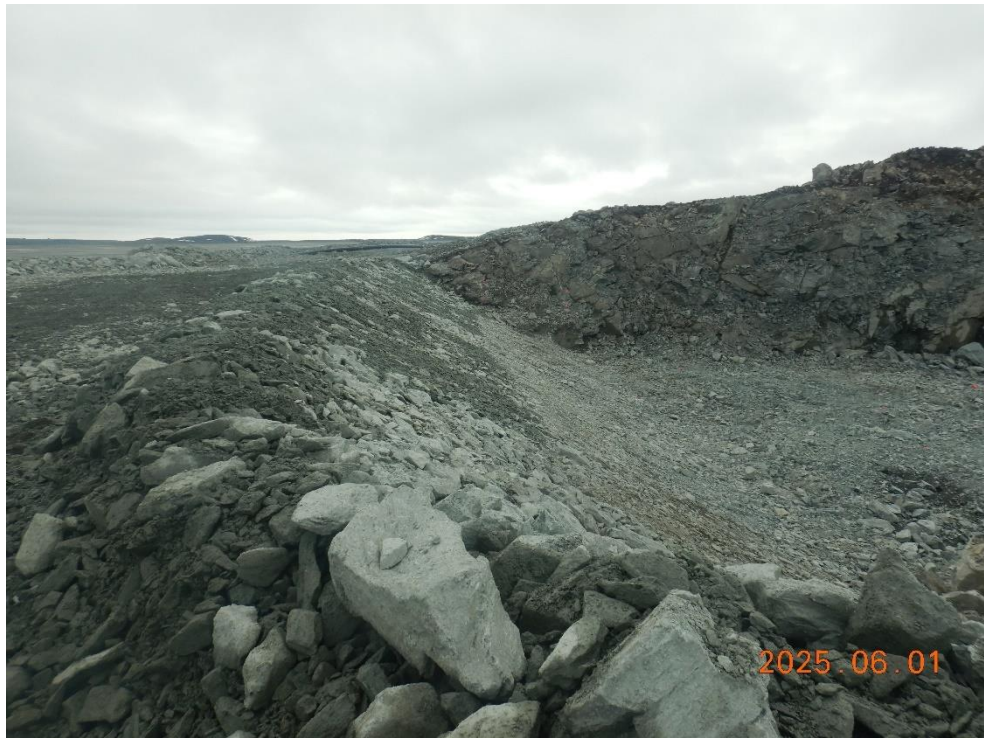
Photo 3.30

Completed downstream slope

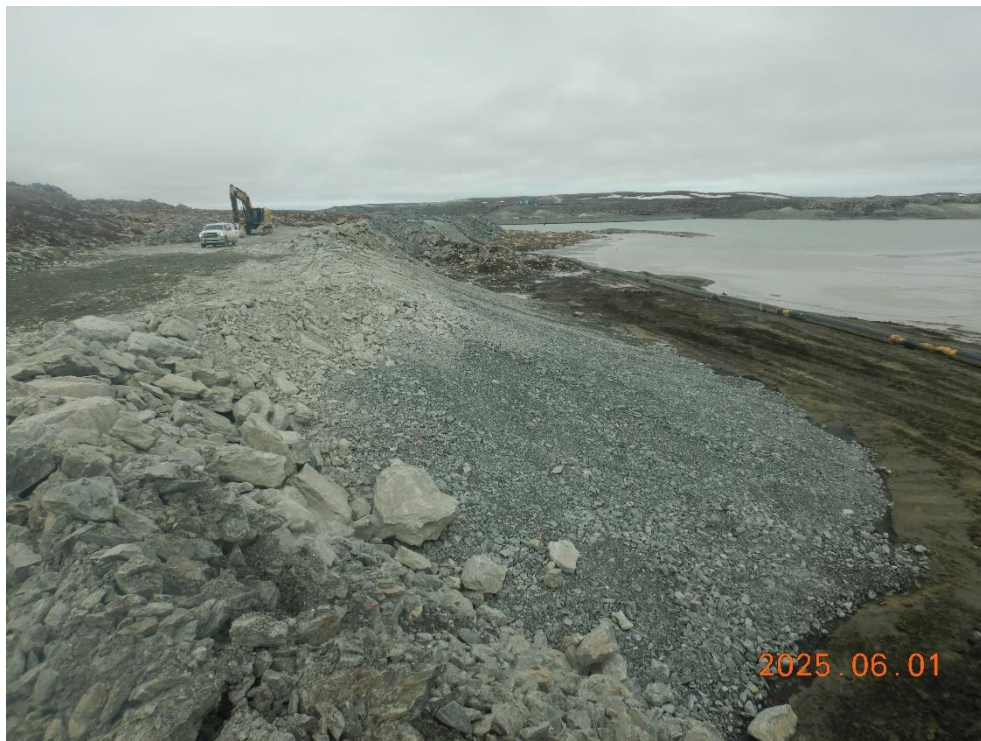
Photo 3.32

Completed upstream slope
