# **Meadowbank 2025 Habitat Compensation Monitoring Report**

**2025 HABITAT COMPENSATION MONITORING  
REPORT**

DFO Fisheries Authorizations NU-0190, NU-03-0191.3, NU-03-0191.4 and  
14-HCAA-01046

Agnico Eagle Mines Limited – Meadowbank Complex

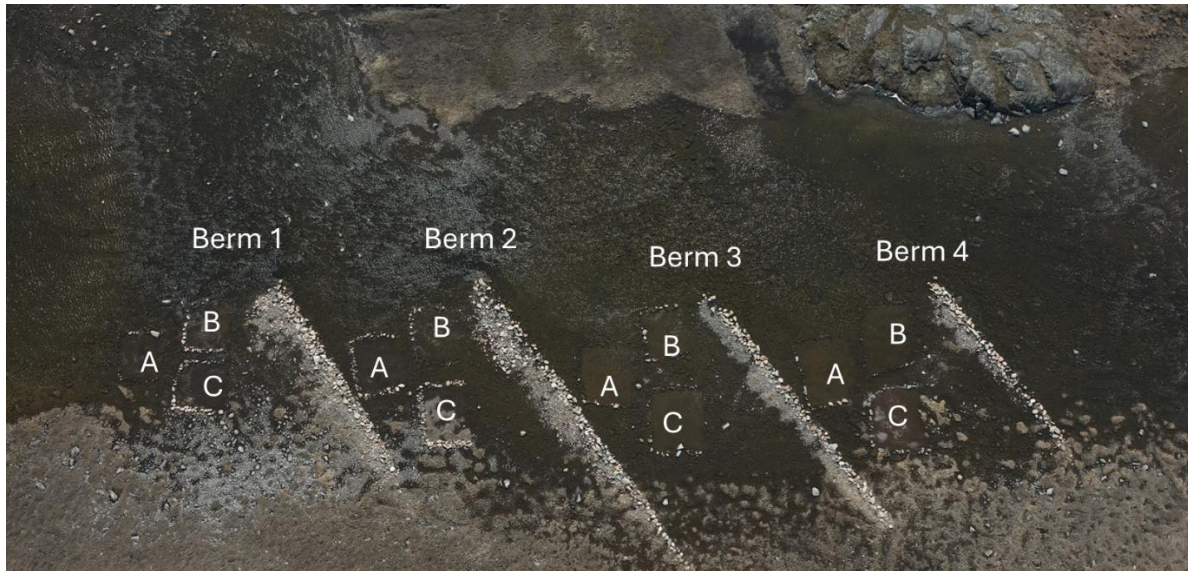
Figure 1. R02 spawning pads (aerial imagery collected by Agnico Eagle on June 23, 2025).

In 2009, a habitat compensation project consisting of four sets of gravel-cobble spawning pads (Figure 1) was constructed at crossing R02 according to design specifications that met biological criteria aimed at enhancing Arctic grayling (*Thymallus arcticus*) productivity. The construction focused on creating high value spawning and nursery habitat to compensate for the loss of the low and medium value habitat affected by bridge abutment construction at the four crossings.

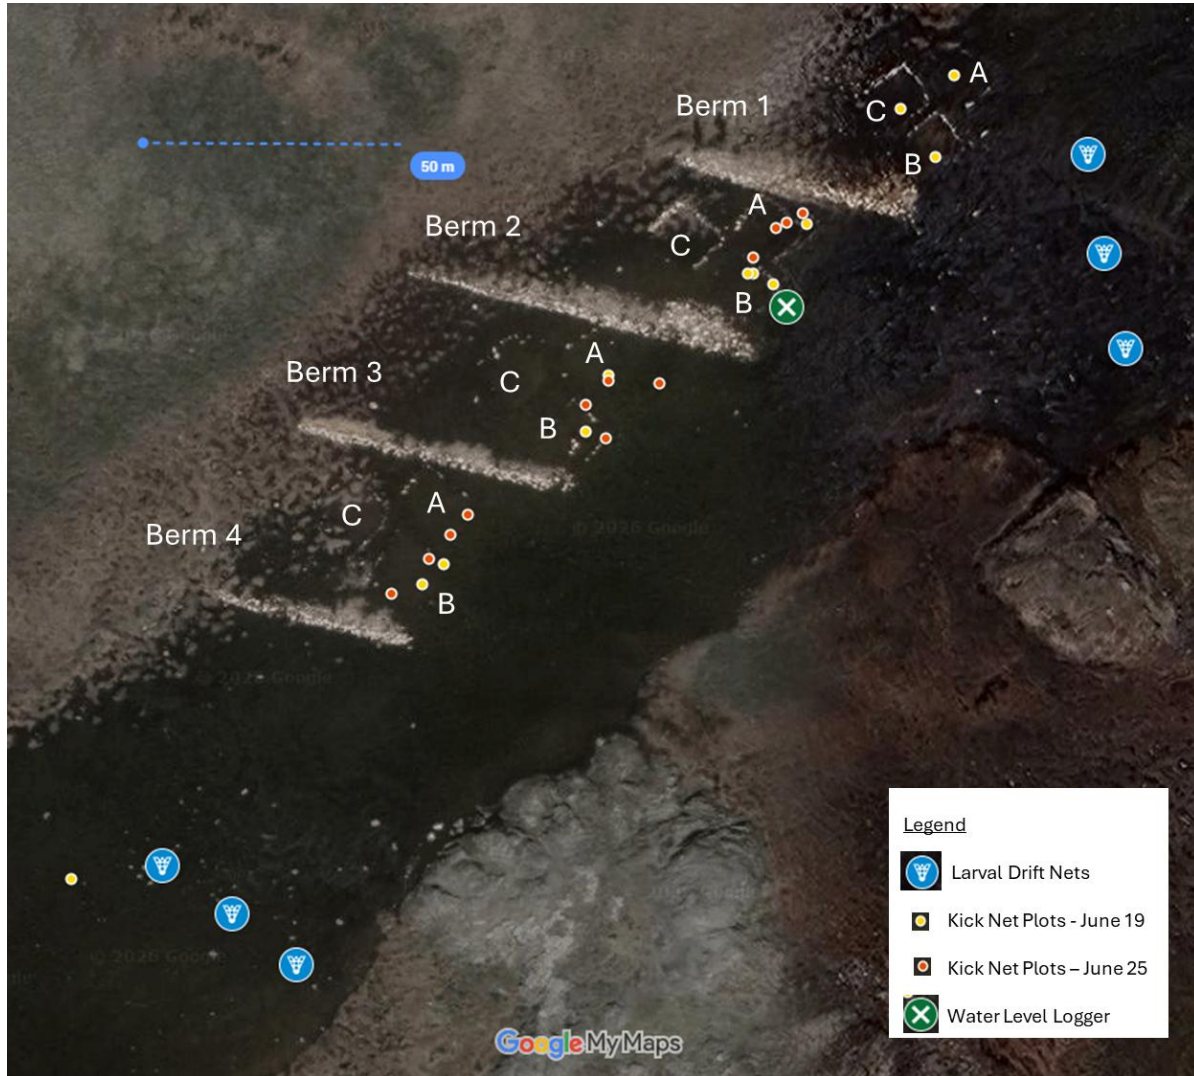
**Figure 3. Monitoring locations at the R02 spawning pads in 2025.**

*Notes: Water flow direction is left to right (west to east). Kick net locations shown in yellow were surveyed June 19, and locations shown in red were surveyed June 25. Satellite imagery is dated July 25, 2024 as published by Google Maps ©2025; accessed December 11, 2025.*

Monitoring locations in 2025 are shown in Figure 3 and described below.

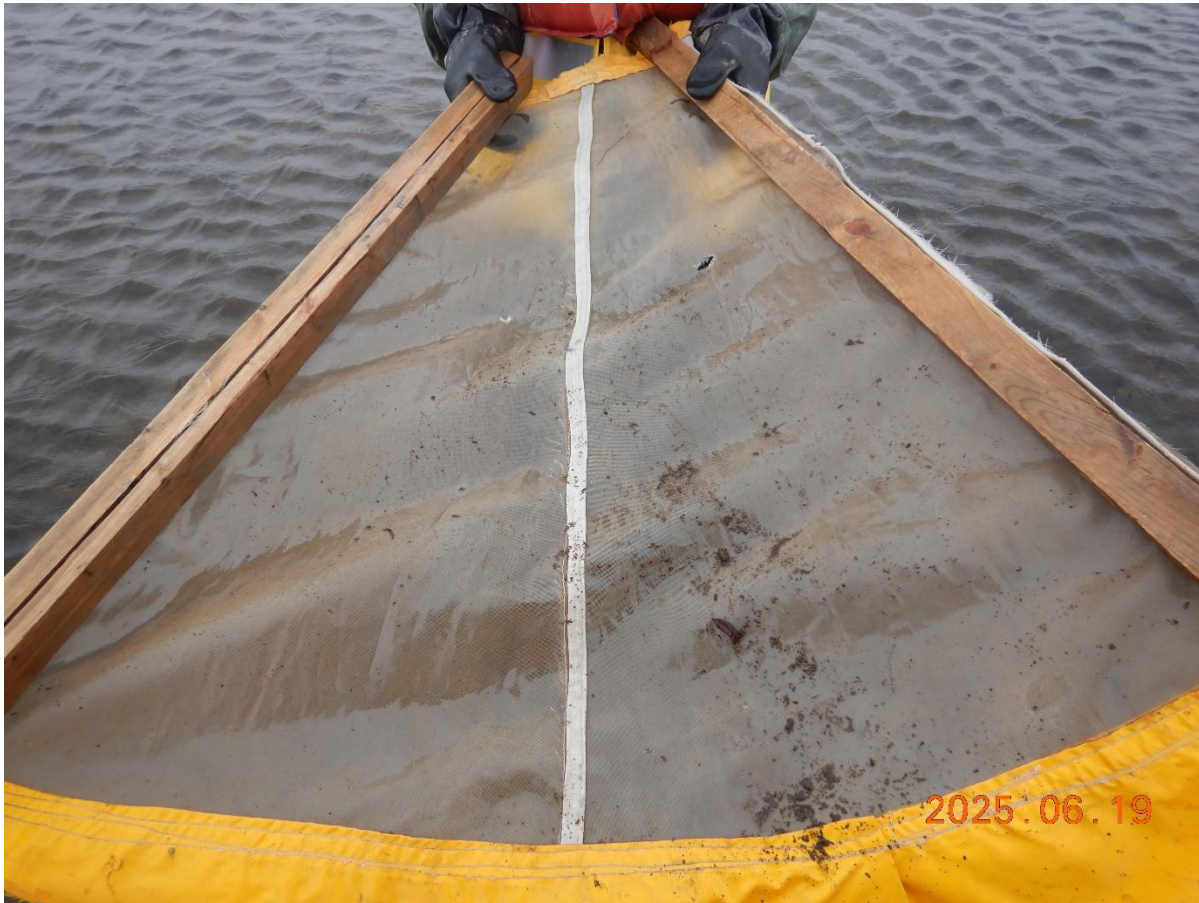
**Figure 4. Custom net made for egg kick sampling, used at the R02 location on the first sampling date (June 19, 2025).**

Water temperature is daily average from in-stream logger.  
<sup>^</sup>Eggs were found in spawning pad 1-C (Table 2 and Figure 3)  
<sup>\*</sup>A custom fan-style net was used on June 19, and a larval drift net was used on June 25 to collect material kicked up during surveys (Figures 4 and 5).

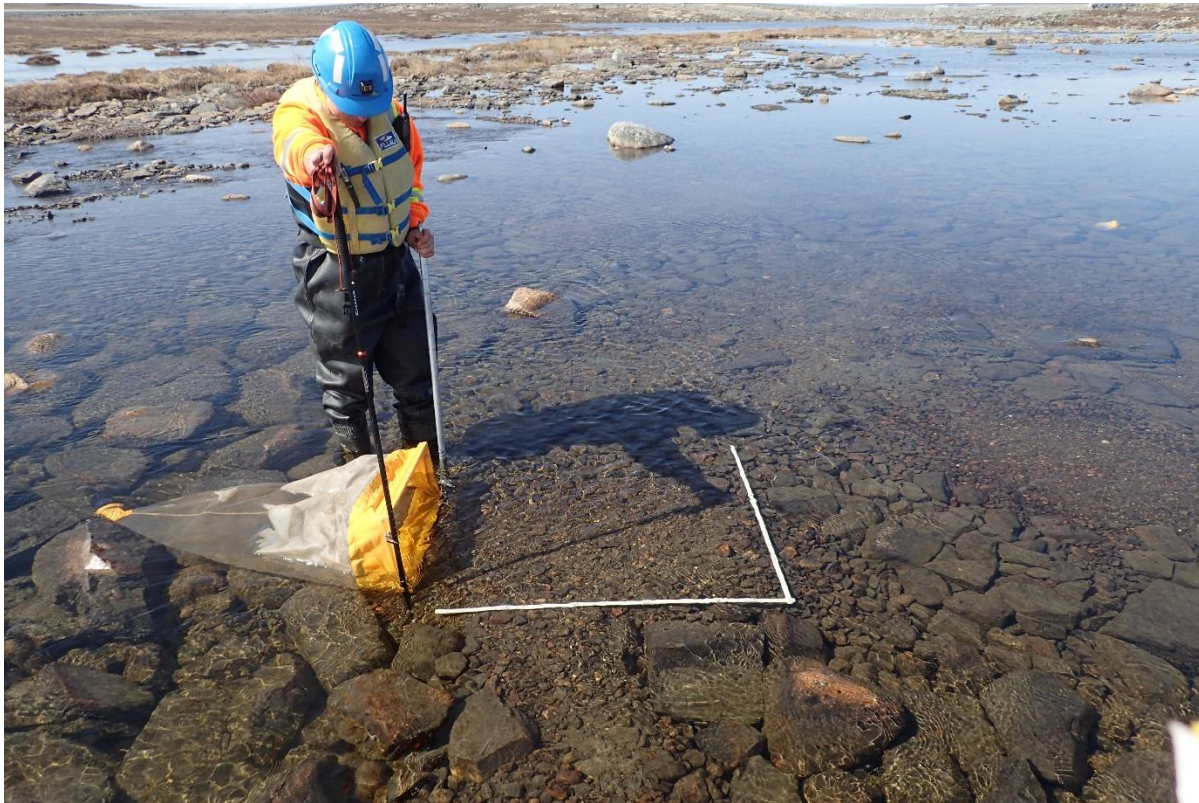
**Figure 5. Use of drift net for egg kick surveys conducted on June 25, 2025 (photo is not from the R02 location).**

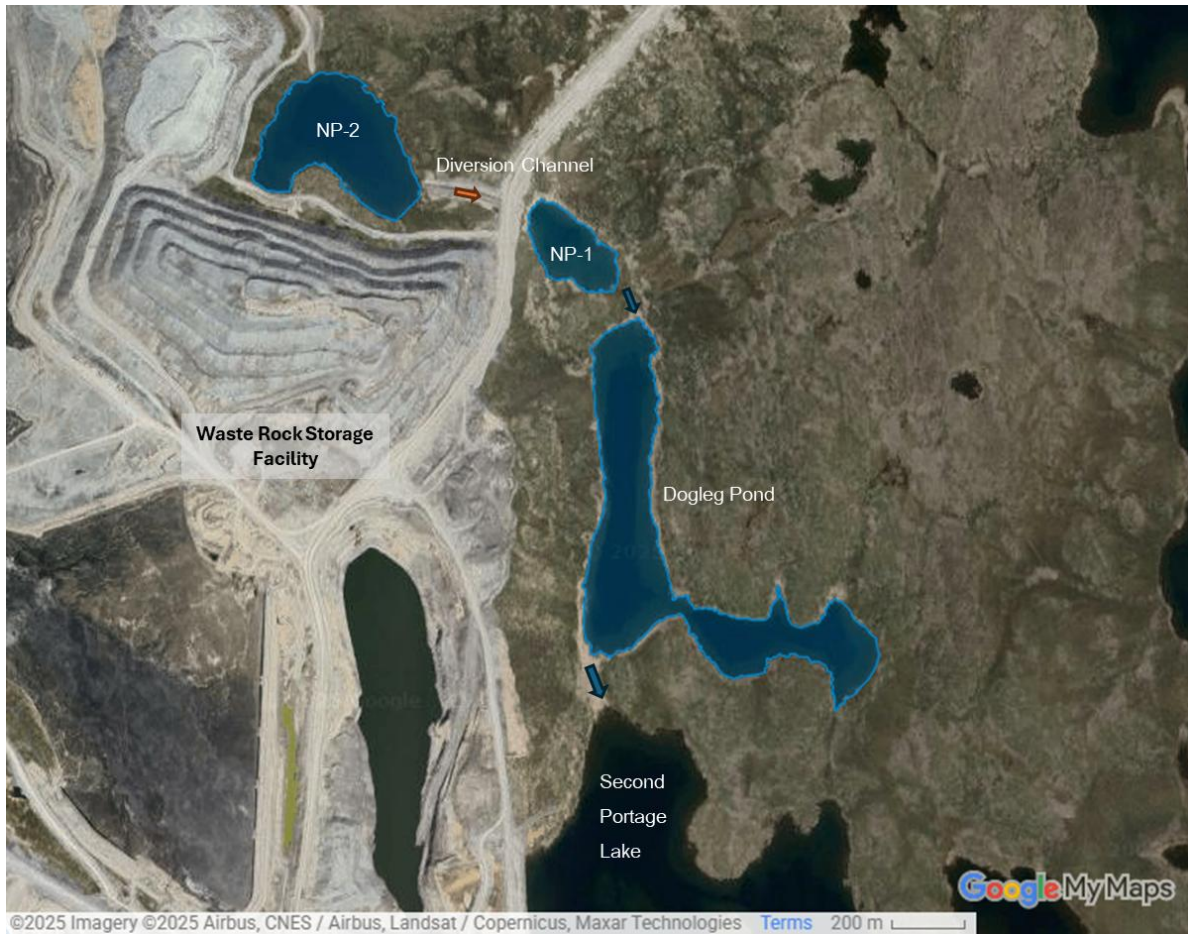
**Figure 6. Locations of surveyed connecting channels (arrows) and delineation of shorelines for the Dogleg Ponds.**

Locations of monitoring for the Dogleg Ponds are shown in Figure 6 and described below.

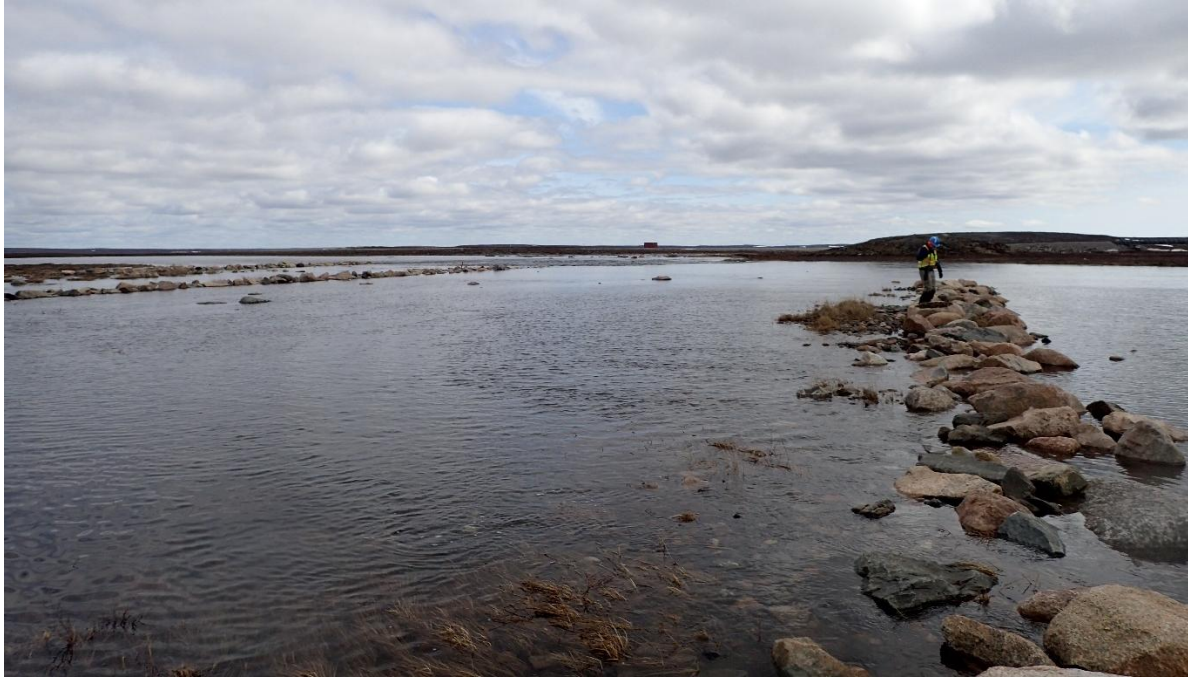
**Figure 7. Looking out from shore along one of the baffle berms at the R02 spawning pad area (June 10, 2025).**

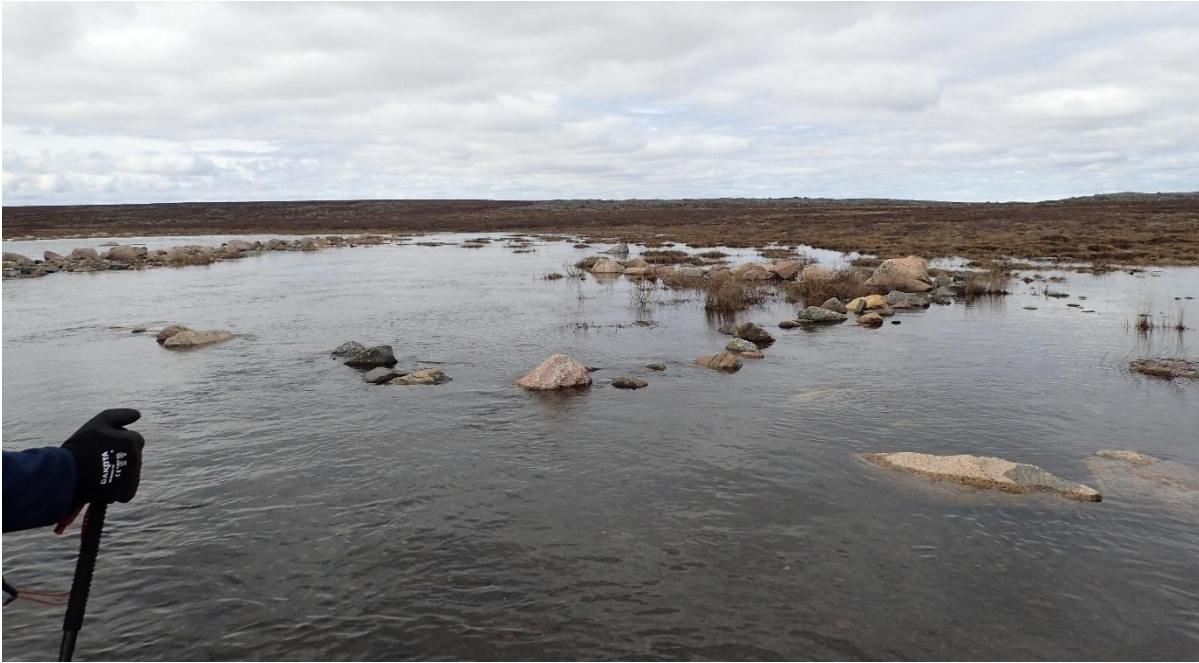
Berm 2: All 3 pads and berm are noted to be in good condition. Velocity good aside from shore side of farthest west pad, where vegetation growth was occurring.

**Figure 8. Looking towards shore at the R02 spawning pad area, showing vegetation growth within one of the spawning pad U-berms (June 10, 2025).**

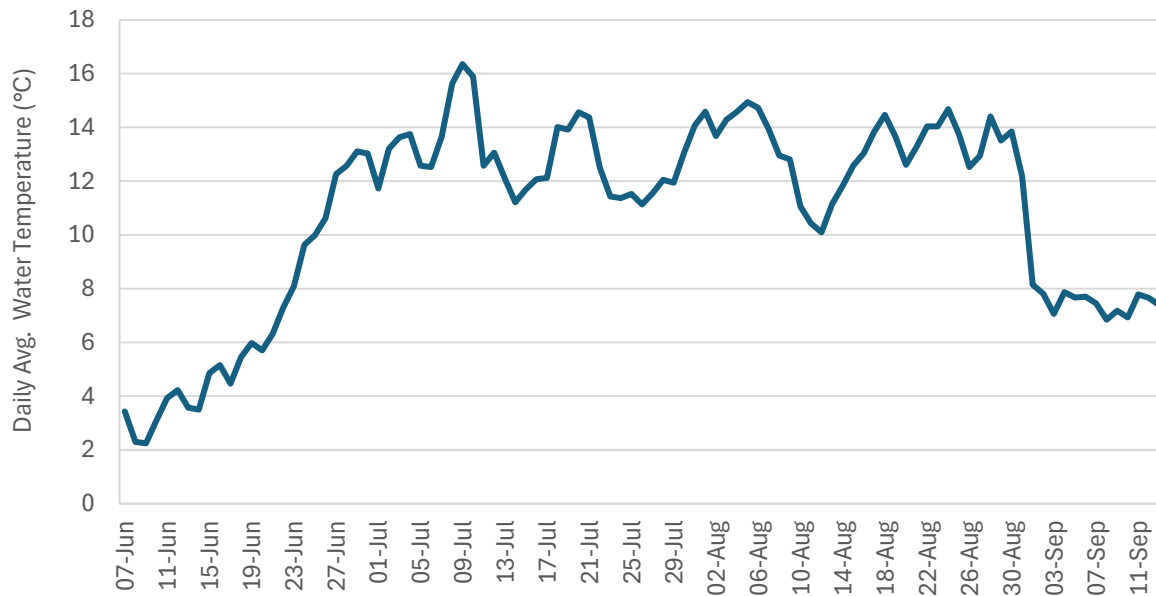
**Figure 9. 2025 daily average water temperature in stream R02, from hourly in-water temperature logger records.**

Water temperature was recorded hourly by temperature loggers, along with in-water and barometric pressure for calculation of water depth, as described in Section 2.1.2.1. Daily averages for the 2025 season are presented in Figures 9 and 10.

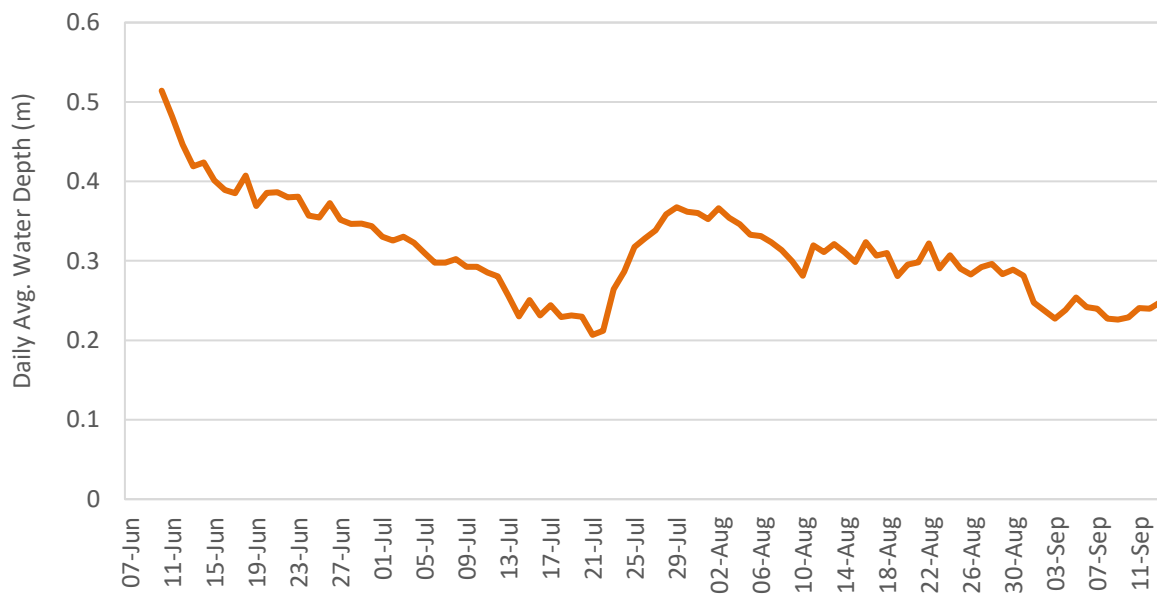
As discussed in Section 3.1.1, design recommendations for water depth were 0.2 – 0.4 m from ice-off until late July. The final design document (Golder, 2007) recognized that greater depths would occur at peak flow. Conditions in 2025 matched these indicators (Figure 10).

**Figure 10. 2025 daily average water depth in stream R02, from hourly data logger records.**

*Notes: Barometric pressure was measured to 0.1 psi, which translates to a margin of error of approximately 7 cm of water depth. A significant rainfall event occurred on July 22-23.*

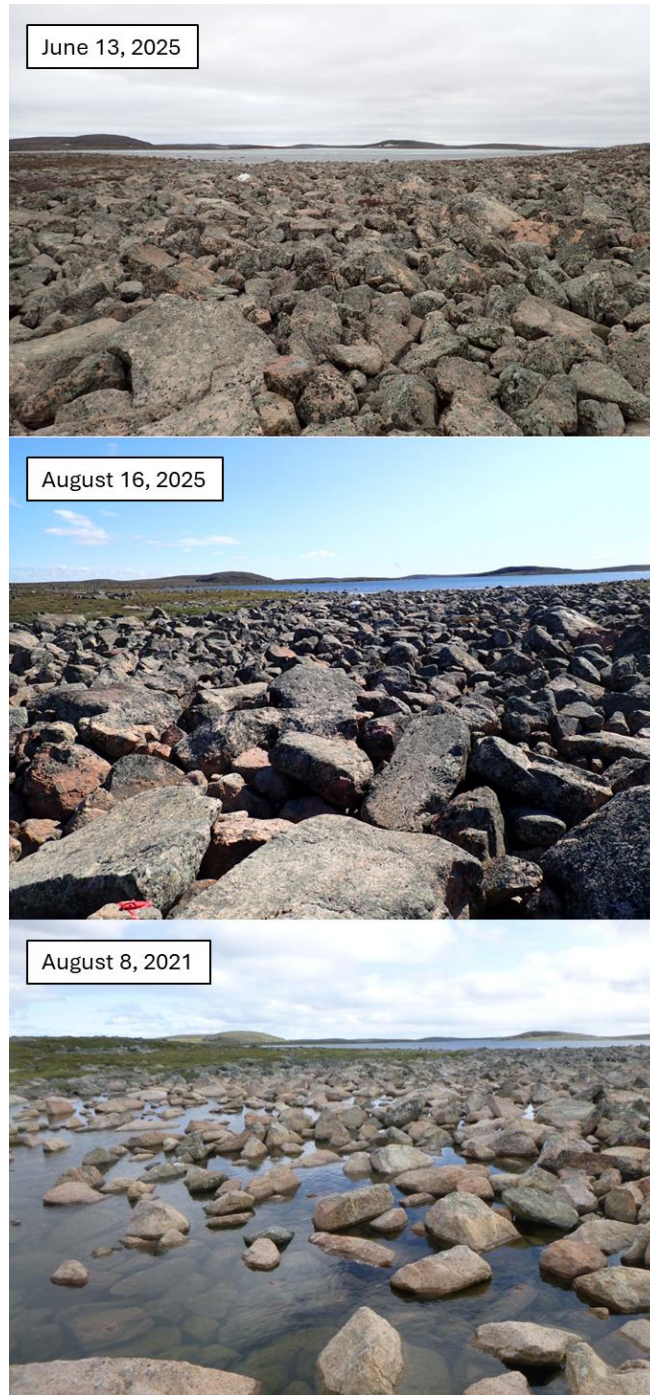
This differs from the previous evaluation in 2021 when water levels were higher and all three channels were considered likely passable to large-bodied fish at least during and post-freshet, with the connection remaining for small-bodied fish between Second Portage Lake, Dogleg Pond (Figure 11), and NP-1 throughout the open water season. These observations are likely due to interannual variability in precipitation and evaporation factors, as water levels were evidently higher during the 2021 season (Figure 11).

**Figure 11. Looking upstream from Second Portage Lake to Dogleg Pond in June and August, 2025 and August, 2021.**

*Note: No fish habitat value is assigned to this channel.*

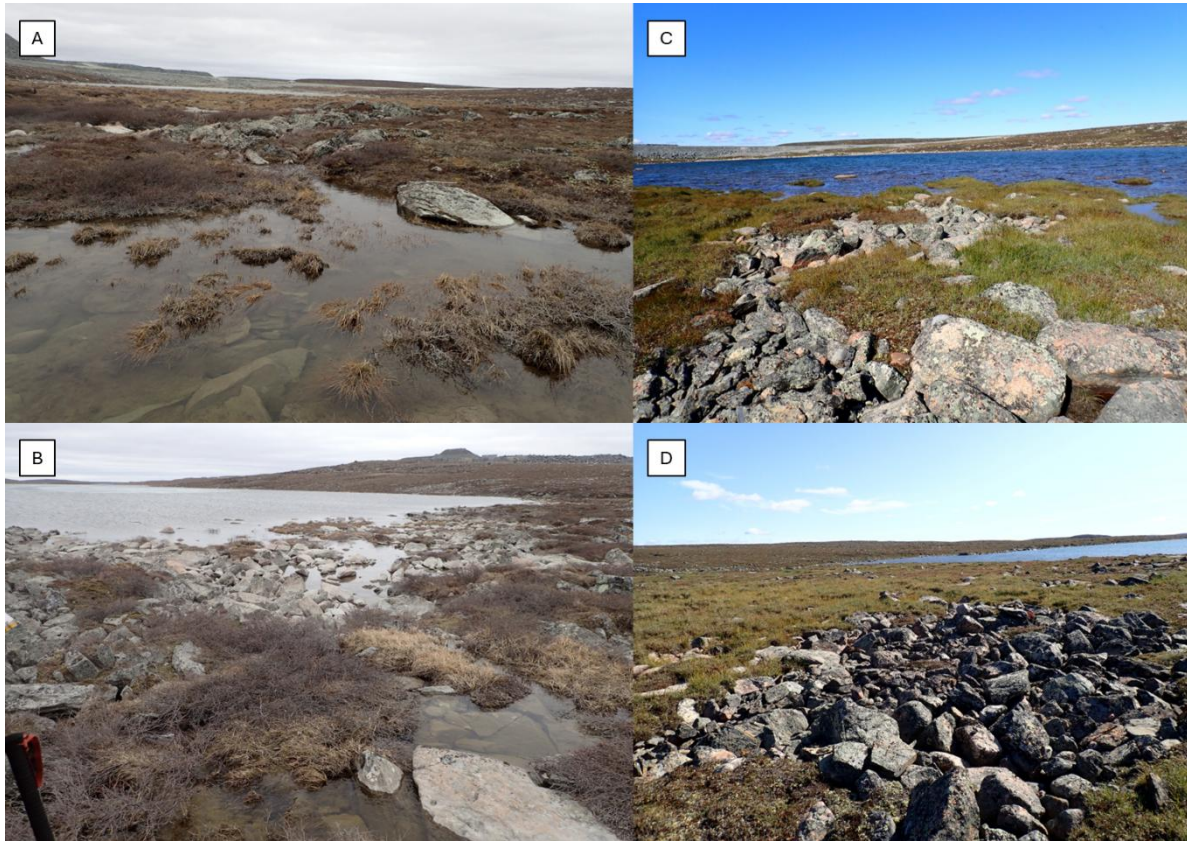
**Figure 12. NP-1 to Dogleg Pond channel on June 13 (left) and August 16 (right), 2025.**

*A&C) Looking upstream towards the Vault Haul Road, with NP-1 just in front of the road embankment. B) Channel outlet to Dogleg Pond where connectivity deteriorates. D) Looking downstream towards Dogleg Pond. Note: No fish habitat value is assigned to this channel.*

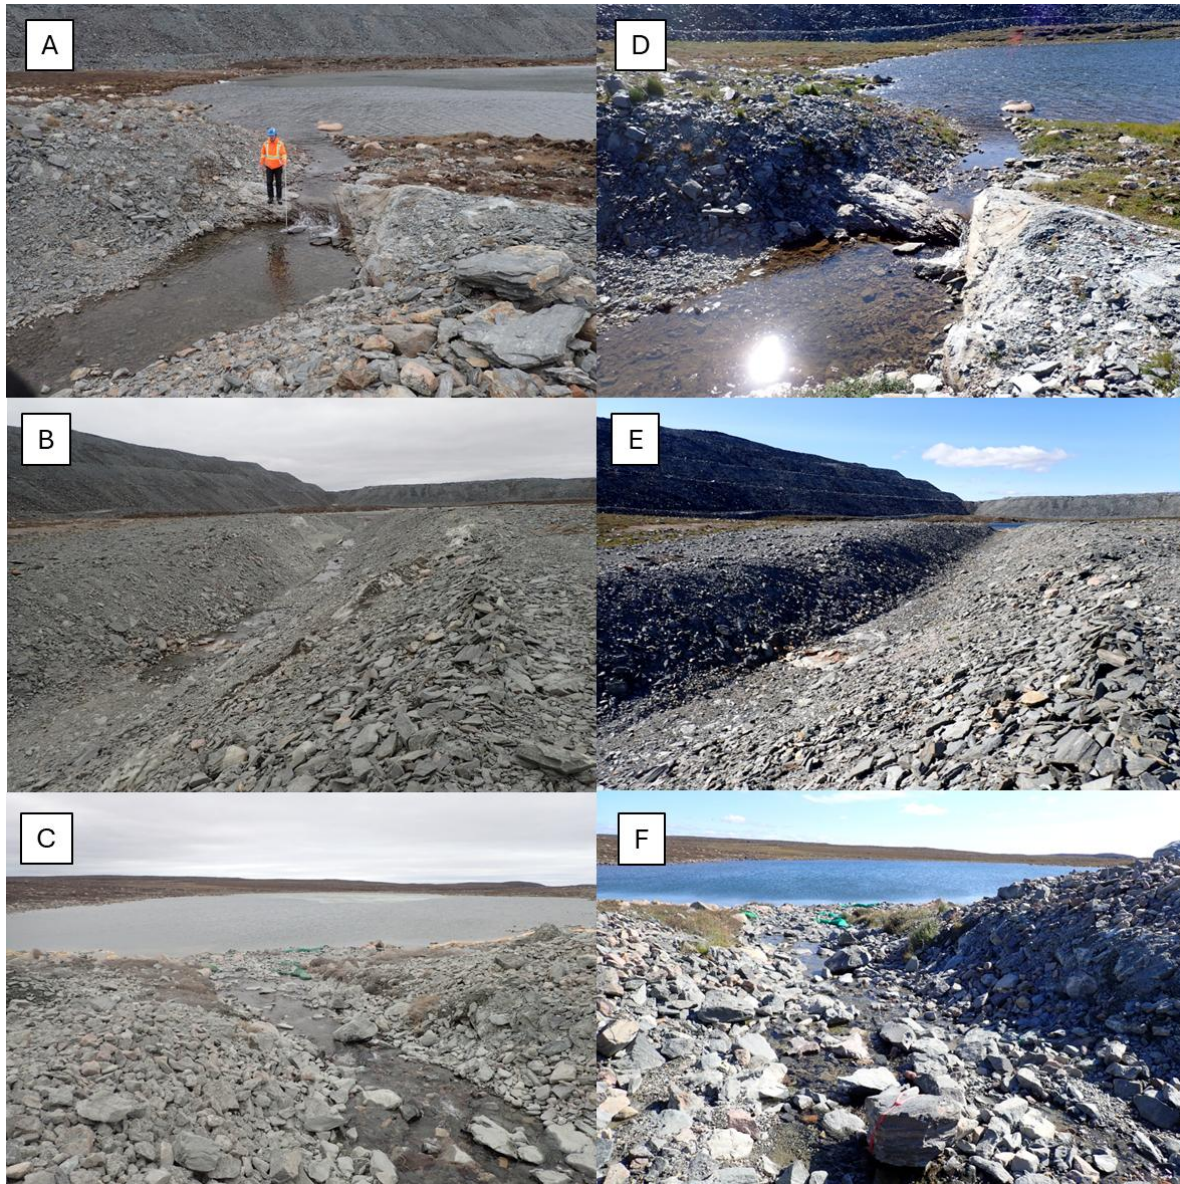
As part of the program to monitor this access enhancement, the three connecting channels between Second Portage Lake, Dogleg Pond, NP-1, and NP-2 were visually assessed for their suitability in permitting fish passage in 2021 and 2025. By the time of the first assessment in 2025 (June 13), all three channels had at least one section with limited or no connectivity for fish. Conditions were drier in late August. The connection between Second Portage Lake and Dogleg Pond was identified as a boulderfield with only interstitial flow on June 13, and limited to no connectivity for small-bodied fish (Figure 11). Dogleg Pond to NP-1 had good flow on June 13 except at the outlet, where there was limited to no connectivity for small-bodied fish (Figure 12). NP-1 to NP-2 was dry in sections, and not passable to fish (Figure 13).

**Figure 13. NP-1 to NP-2 channel on June 13 (left) and August 16 (right), 2025.**

*Note: No fish habitat value is assigned to this channel.*
