**MEADOWBANK GOLD MINE**

**SOUTH CELL PERMEABLE BERM AS-BUILT REPORT**

**AGNICO-EAGLE MINES LIMITED  
MEADOWBANK GOLD PROJECT**

**MAY 2019**

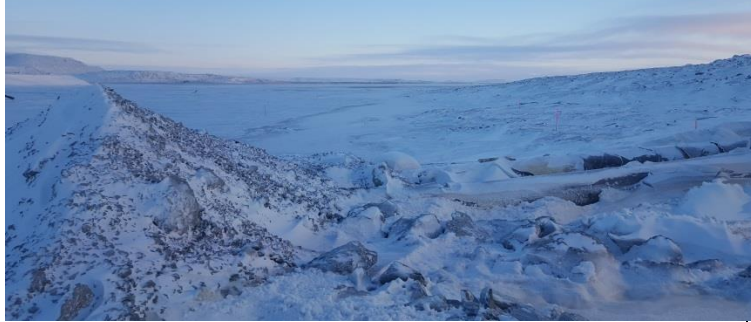
Photo 1: Placement of piquets to align the structure

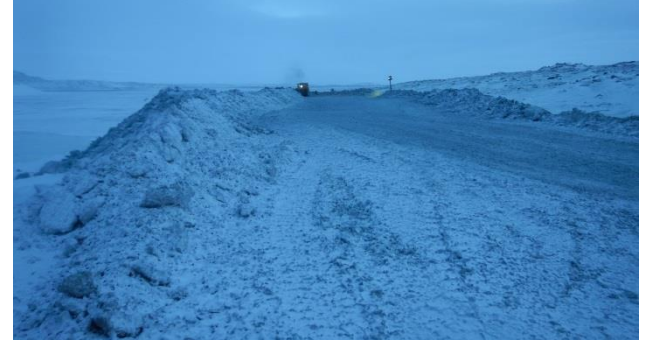
Photo 2: Construction of the access road

To access the area where the permeable berm need to be constructed a 110m access road was built on dry land within the South Cell using NAG material.

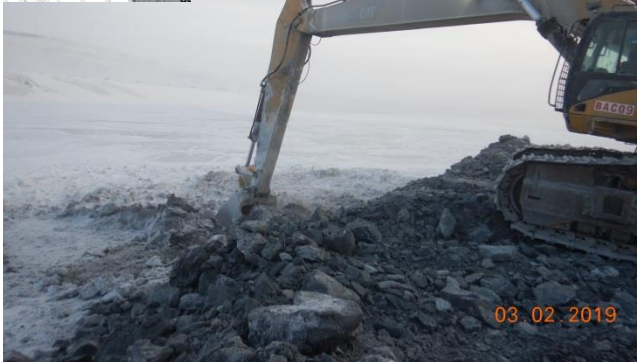
Photo 3: Removal of ice with an excavator

Construction of the internal structure was done with the placement of a single lift of rockfill to El. 142.5 m in the South Cell. Due to winter condition during construction, the ice was progressively broken and removed using a Caterpillar 345 excavator prior to rockfill placement.

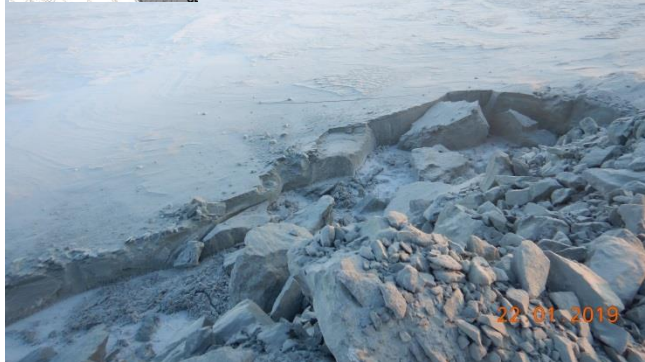
Photo 4: Broken ice

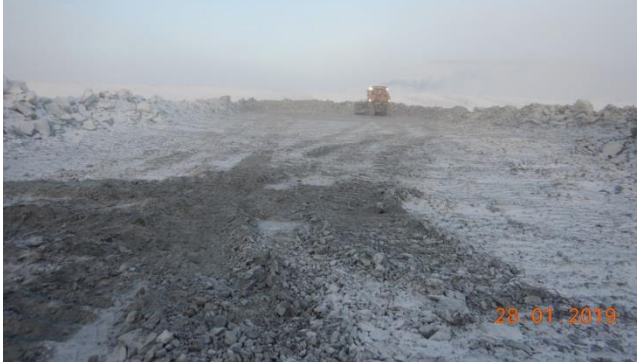
Photo 5: Permeable berm rockfill placement

The Permeable Berm was built using 100T haul trucks operated by the Mine Operations Department. PAG and NAG rockfill from the Portage Pit E was hauled to the construction area. The rockfill was dumped onto the surface of the internal structure and a dozer pushed the rockfill in the South Cell Pond to advance the internal structure. Compaction of the rockfill surface was achieved through heavy equipment passage. Construction of the permeable berm within the South Cell was conducted during both night and day shifts.

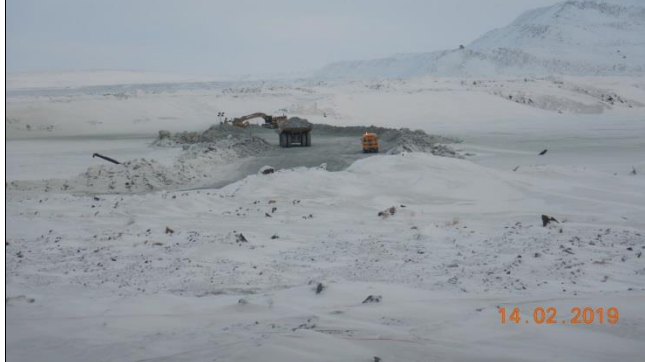
Photo 6: permeable berm construction. Excavator is broken the ice before the dozer advance the structure

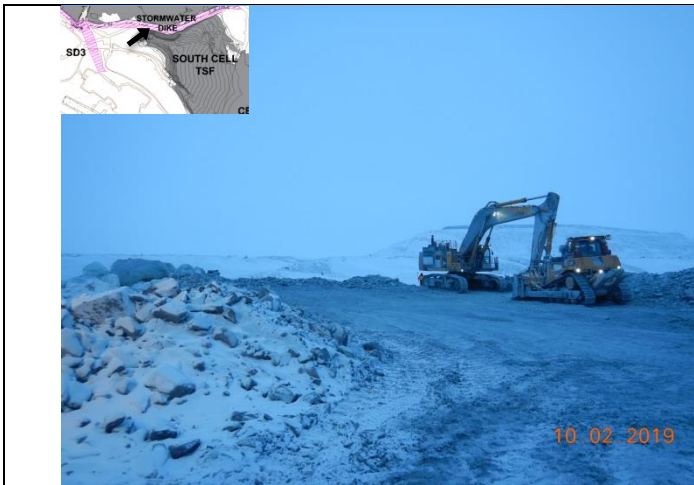
Photo 7: Equipment use for the construction

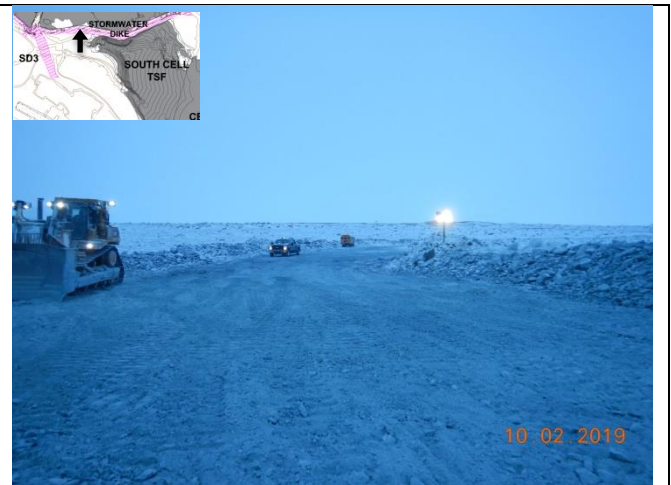
Photo 8: View of the berm

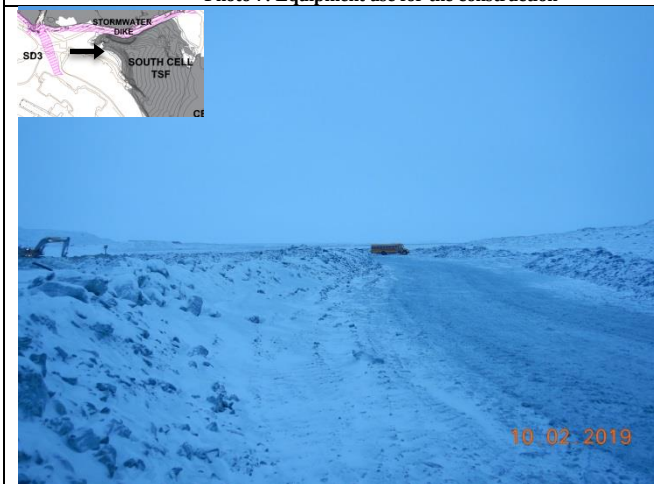
Photo 9: View of the access road
