CONSTRUCTION SUMMARY REPORT Baker Lake Fuel Storage Tank 7 and Containment Facilities

Agnico Eagle Mines Ltd

Report

653281-0004-40ER-0005_0 January 17, 2020

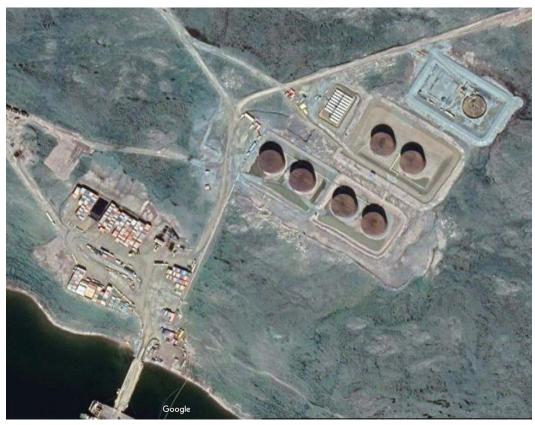
Figure 1 – Baker Lake Fuel Farm Site Overview (tank 7 in construction)

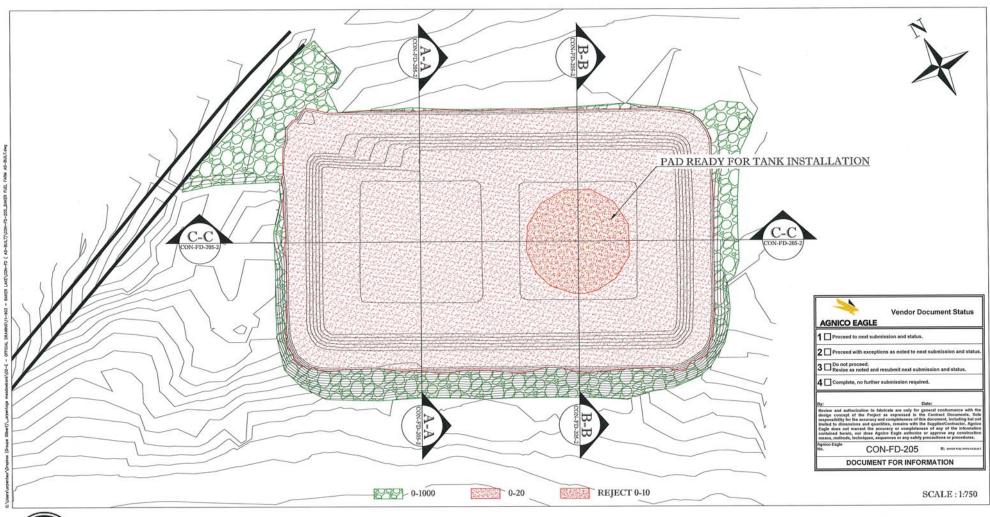
PREPARED BY : MIKAËL LÉVESQUE DATE : 10-07-2019 CON-FD-205-1

AS-BUILT BAKER LAKE FUEL FARM CONSTRUCTION CONTRACT # 11-903

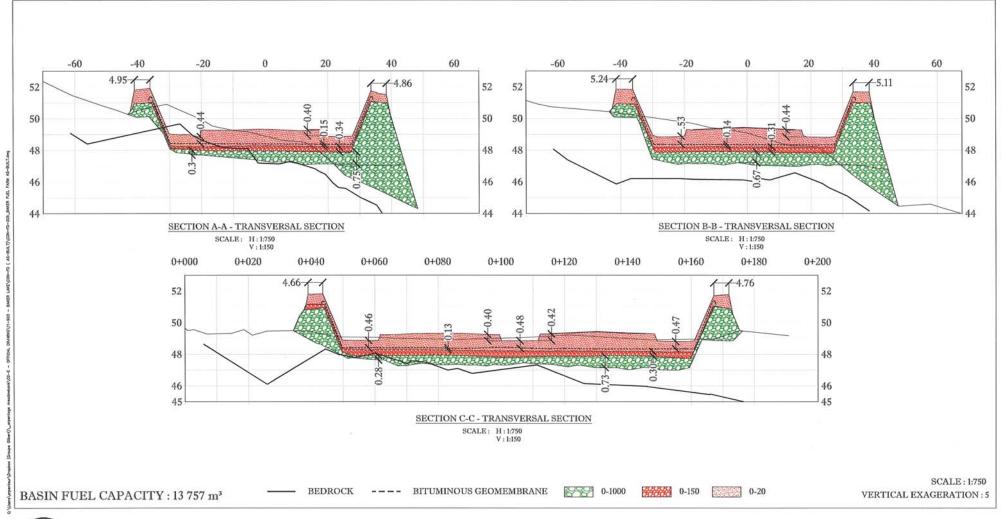
PREPARED BY : MIKAËL LÉVESQUE DATE : 10-07-2019 CON-FD-205-2

AS-BUILT BAKER LAKE FUEL FARM CONSTRUCTION CONTRACT # 11-903

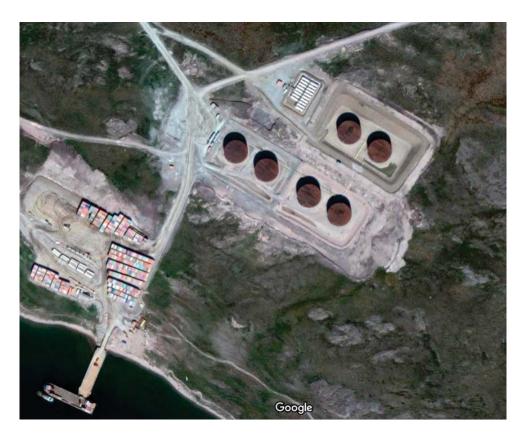
General site view before tank and containment construction

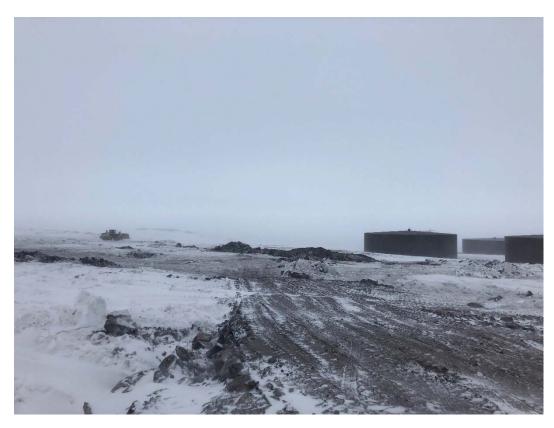
Overburden excavation

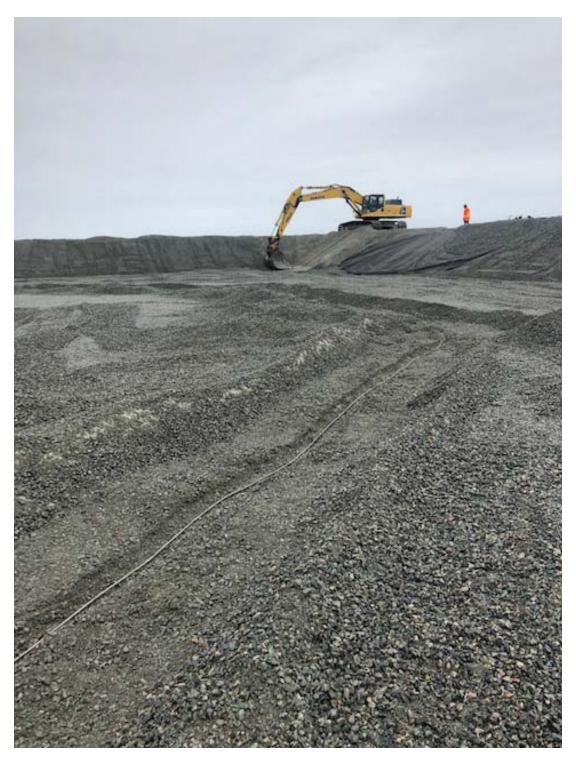
Pad and Berm construction

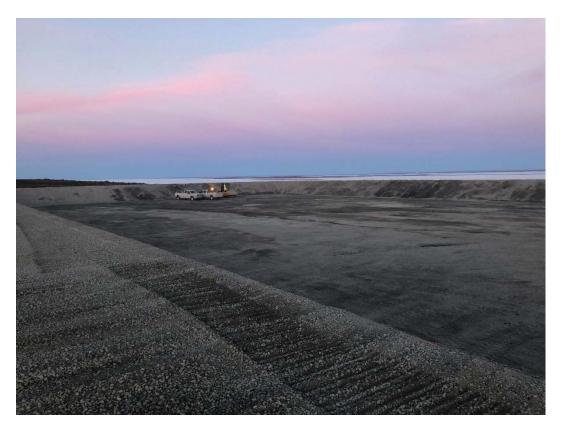
Containment overview

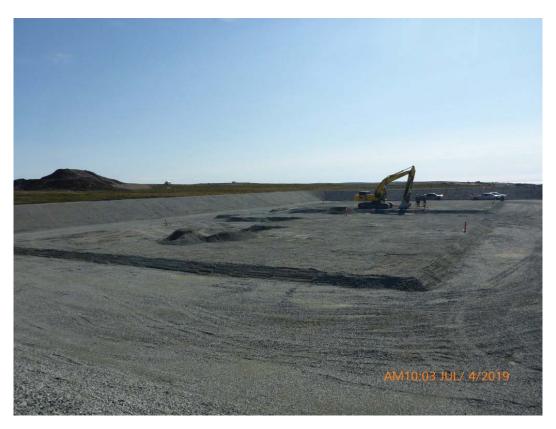
Tank pad construction

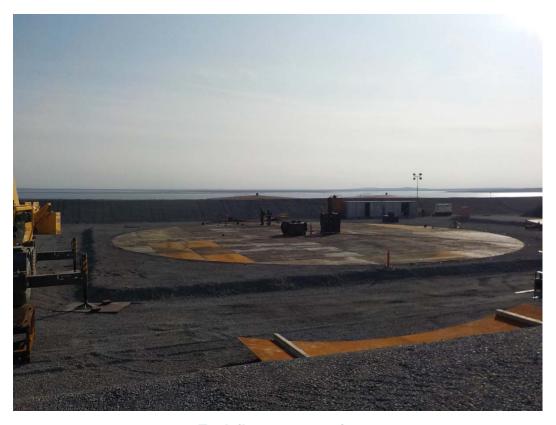
Tank floor construction

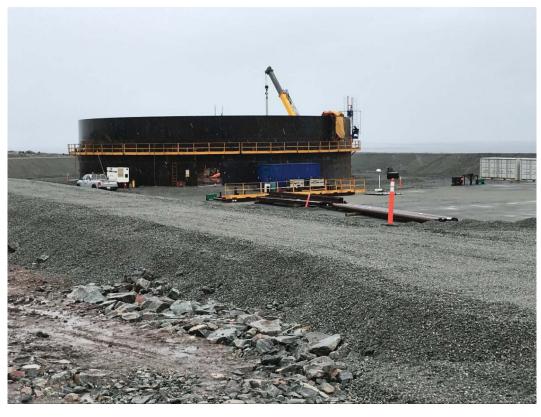
Tank wall welding

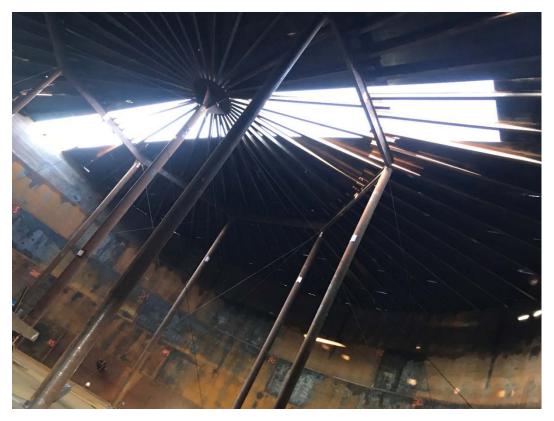
Tank roof structure

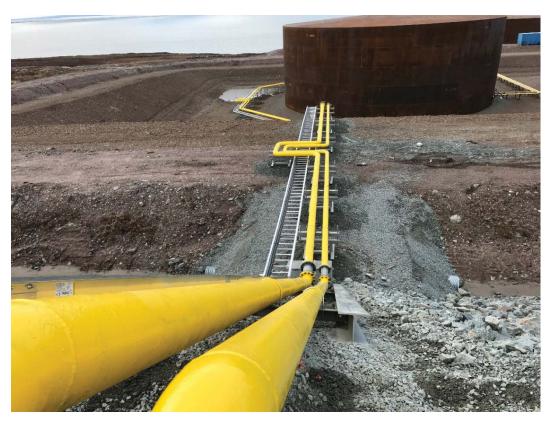
Piping to and from fuel tank

Piping between filling and distributing container and the fuel tank respect the point to point design. The piping isn't exactly as per drawing (can be seen on photos in Appendix C) but respect the P&ID. As built drawings can be consulted in Appendix B.

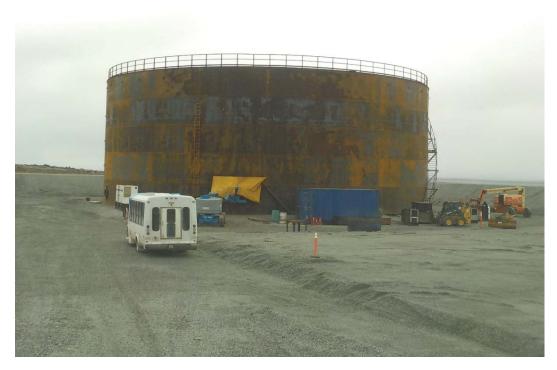
Tank general view
