## QA DAILY REPORT

1897439-1576-TM-Rev0

### QA DAILY REPORT FOR JUNE 1<sup>ST</sup>, 2018 – TSF NORTH CELL CONSTRUCTION - MEADOWBANK (1897439)

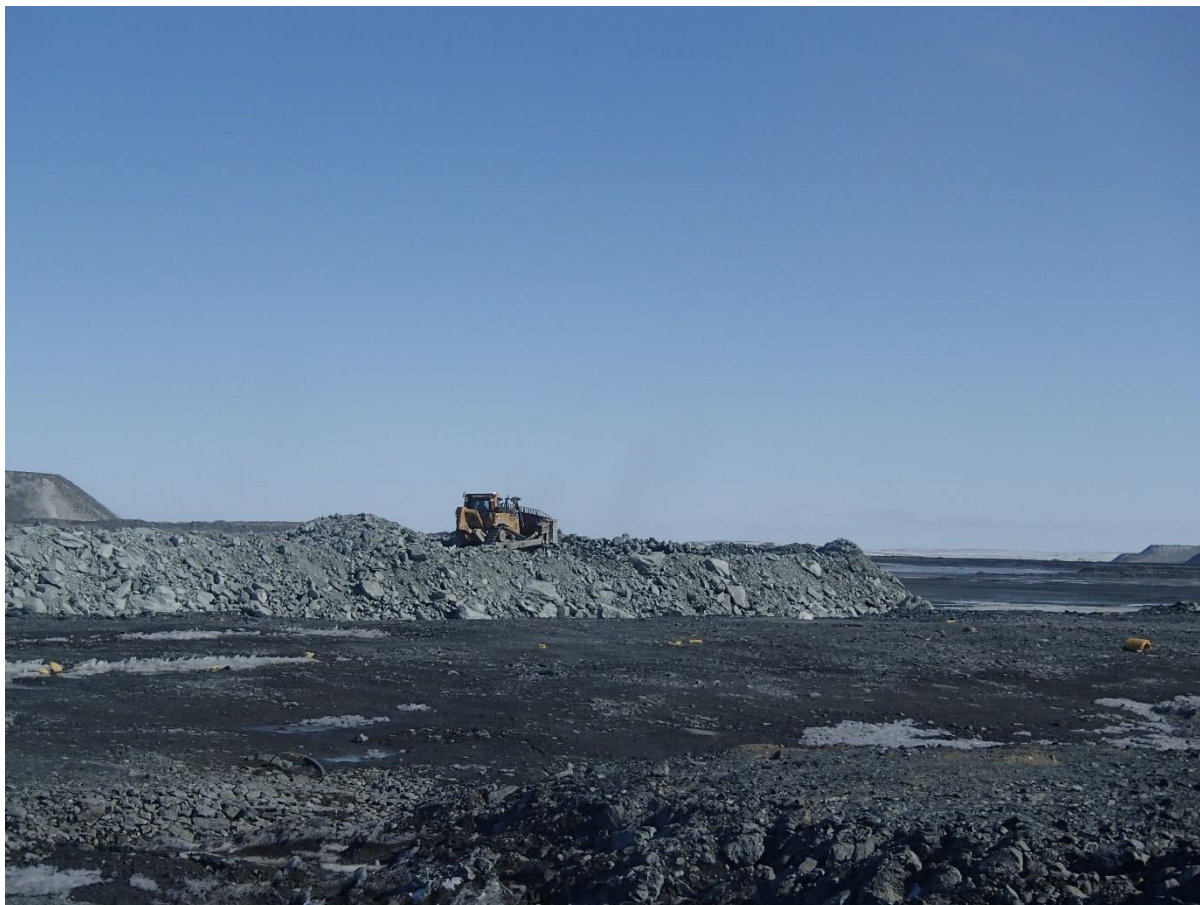
**Photograph NCIS-025: From Sta. 1+475 m (approx.), looking SE. Placement of a 2 m thick (approx.) lift of UM rockfill from El. 150 m to El. 152 m (approx.) with a dozer from Sta. 1+450 m to 1+390 m (o.s. unavailable). The material is of good quality and is well graded.**

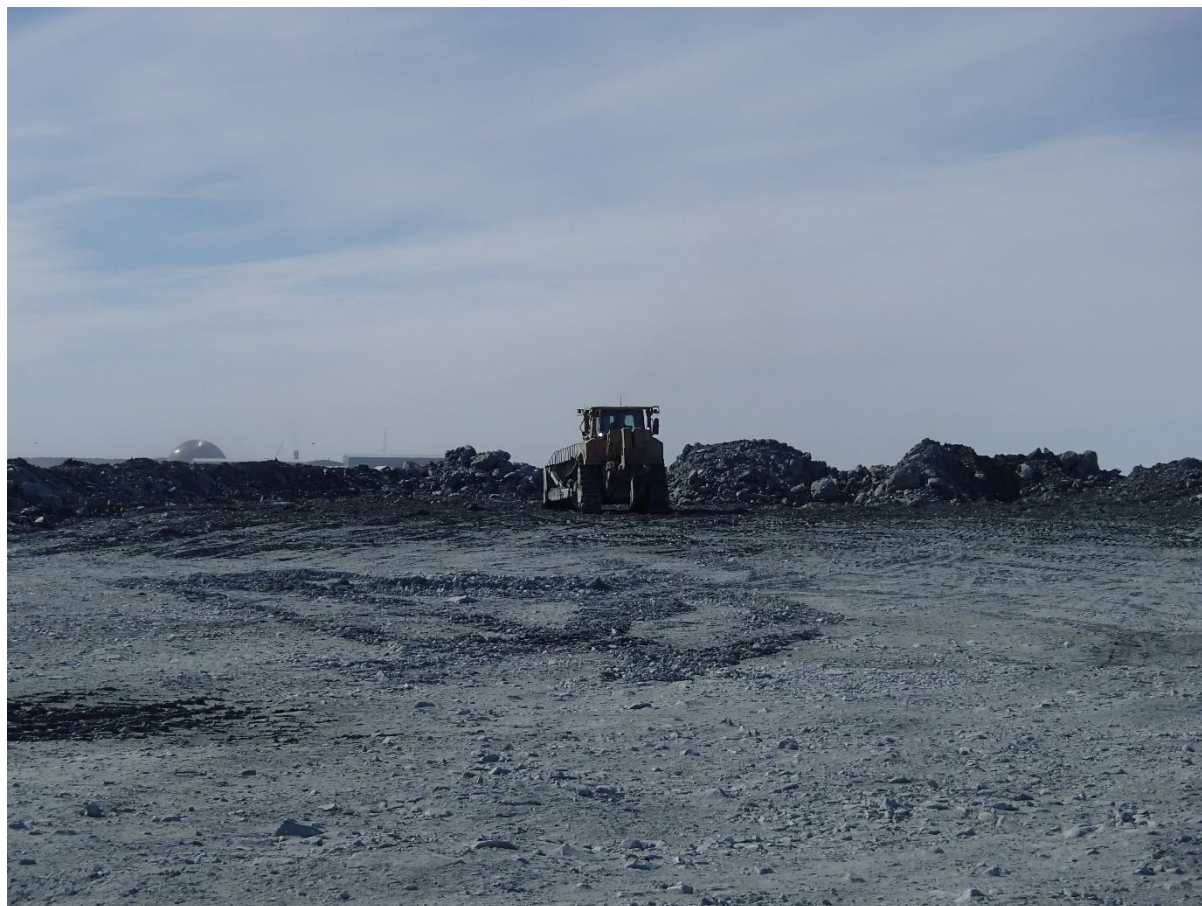
**Photograph NCIS-026: From Sta. 1+440/+2 m, looking S. Placement of a 2 m thick (approx.) lift of UM rockfill from El. 150 m to El. 152 m (approx.) with a dozer from Sta. 1+390 m to 1+365 m (o.s. +10 m to -29 m).**

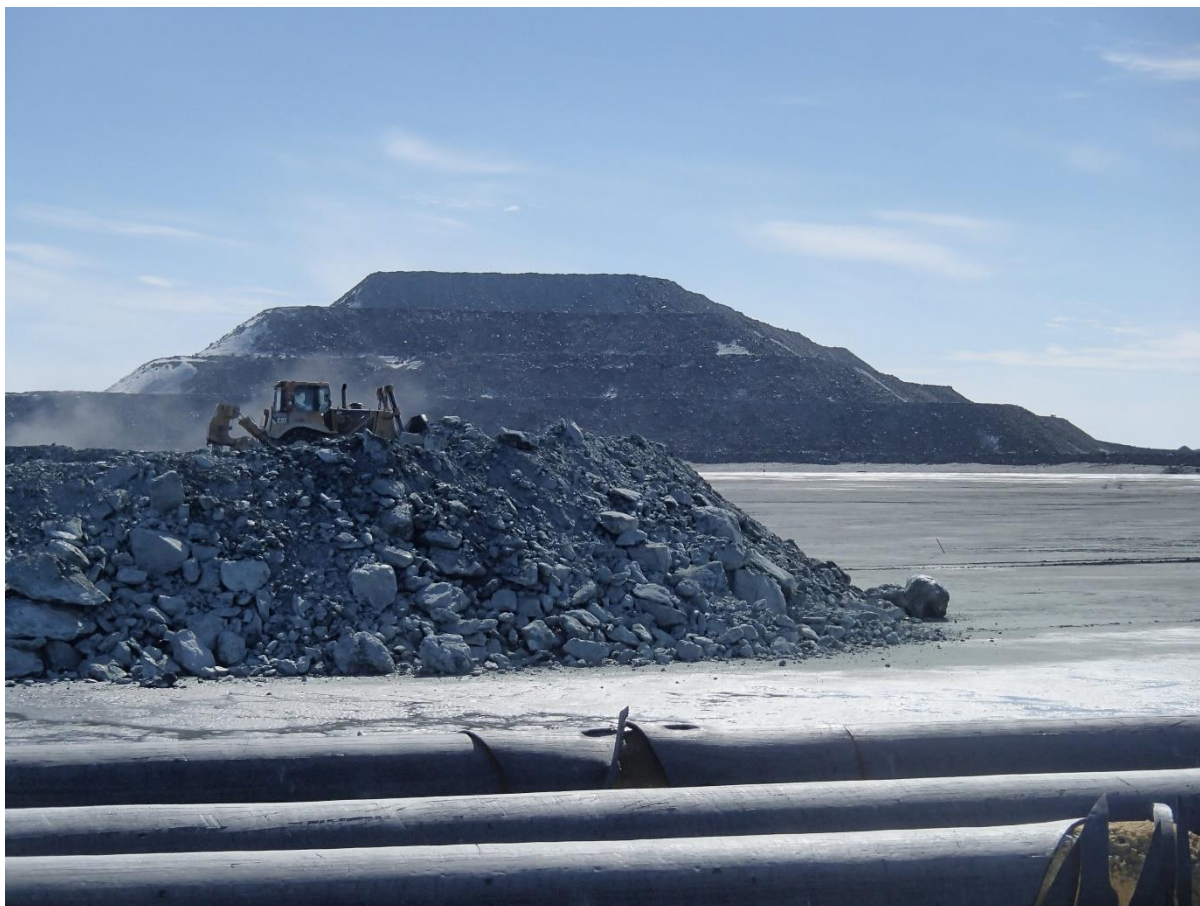
**Photograph NCIS-027: From Sta. 1+360/+67 m, looking S. Placement of a 2 m thick (approx.) lift of UM rockfill from El. 150 m to El. 152 m (approx.) with a dozer from Sta. 1+365 m to 1+360 m (o.s. +9 m to -28 m).**

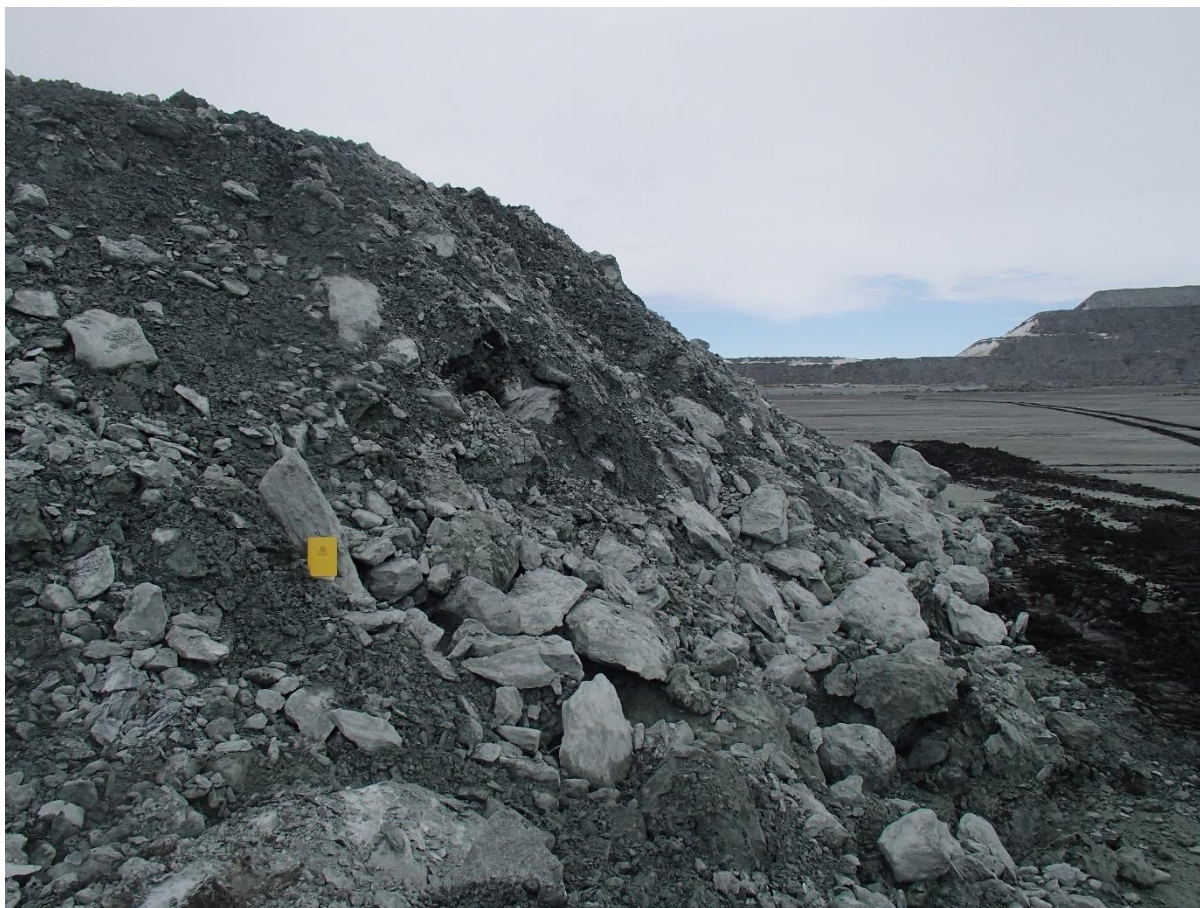
- The QA Manager observed that the UM rockfill lift was about 3.2 m thick around Sta. 1+340 m.
- The QA Manager asked for the elevation of the tailings ahead of the UM rockfill lift advancement front. AEM consulted the LIDAR survey and reported a 148.8 m elevation (approx.) that is declining towards the direction of the rockfill lift advancement and reaches 148 m around Sta. 1+200 m. Given the 152 m elevation of the rockfill lift, the lift thickness is of 3.2 m around Sta. 1+340 m and would increase to 4 m around Sta. 1+200 m. Furthermore, as the tailings are thawing on the surface, the expected settling of soft tailings below the rockfill increases the lift thickness. Considering that the lift maximum thickness was 2 m per design, it is not recommended to continue placement of UM rockfill with a single lift thicker than 2 m, as the compaction quality will be compromised. AEM will have a meeting tomorrow regarding this situation.

**Photograph NCIS-028: From Sta. 1+340/+3 m, looking E. View of the UM rockfill lift approximately 3.2 m thick.**

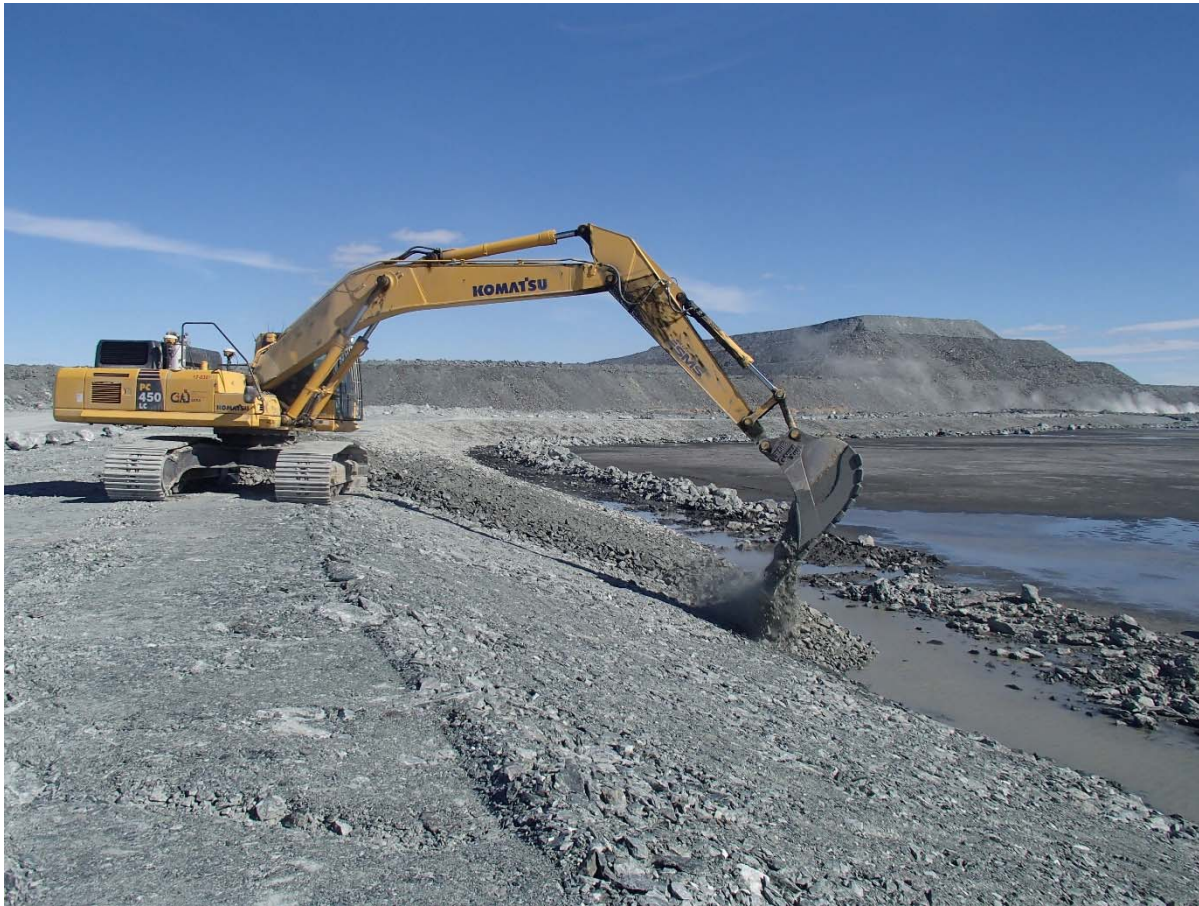
**Photograph NCIS-029: From Sta. 2+120/-27 m (approx.), looking SE. Placement of a 0.5 m thick lift of coarse filter in the upstream slope from El. 150 m to 152 m with an excavator from Sta. 2+280 m to 2+105 m.**

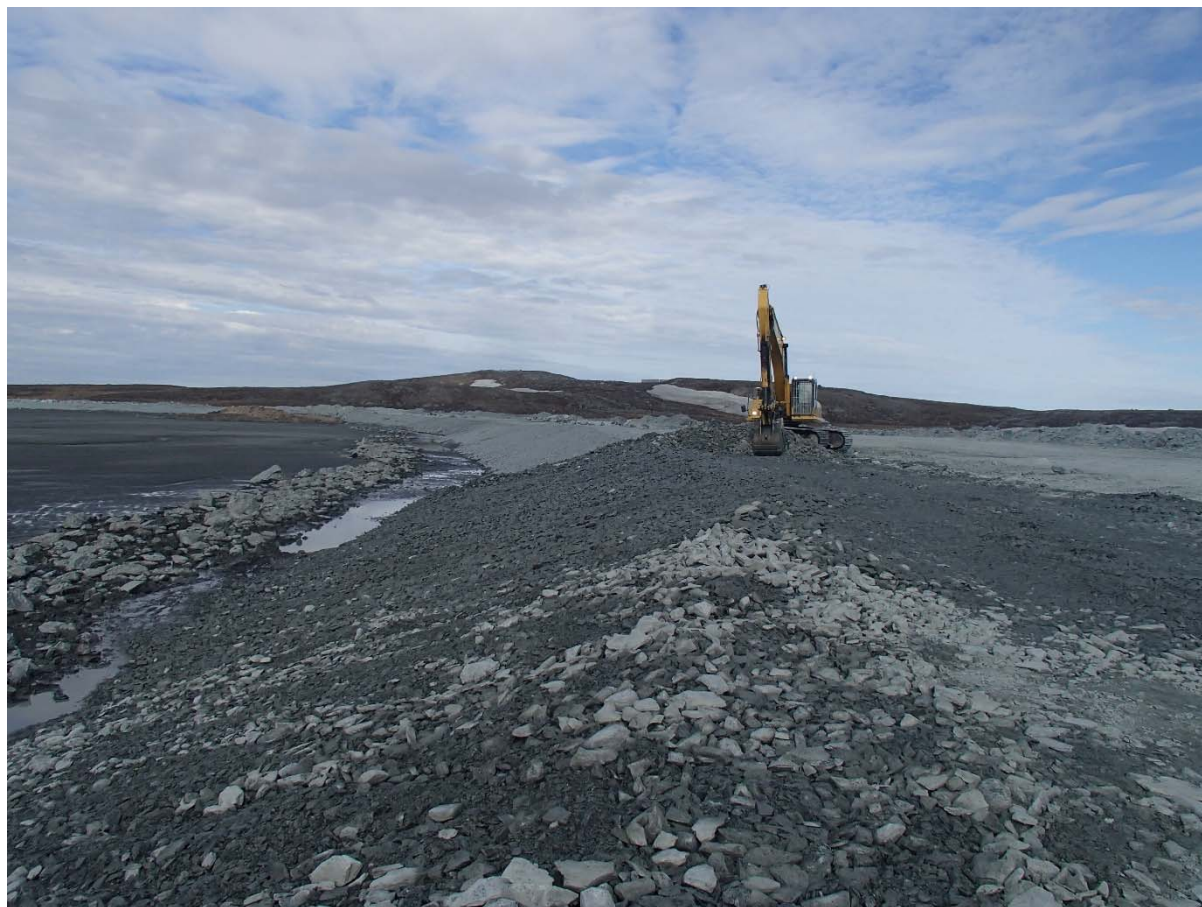
**Photograph NCIS-030: From Sta. 2+140/-29 m (approx.), looking W. Placement of a 0.5 m thick lift of coarse filter in the upstream slope from El. 150 m to 152 m with an excavator from Sta. 2+105 m to 1+930 m. Notice the presence of water ponding at the bottom of the slope.**

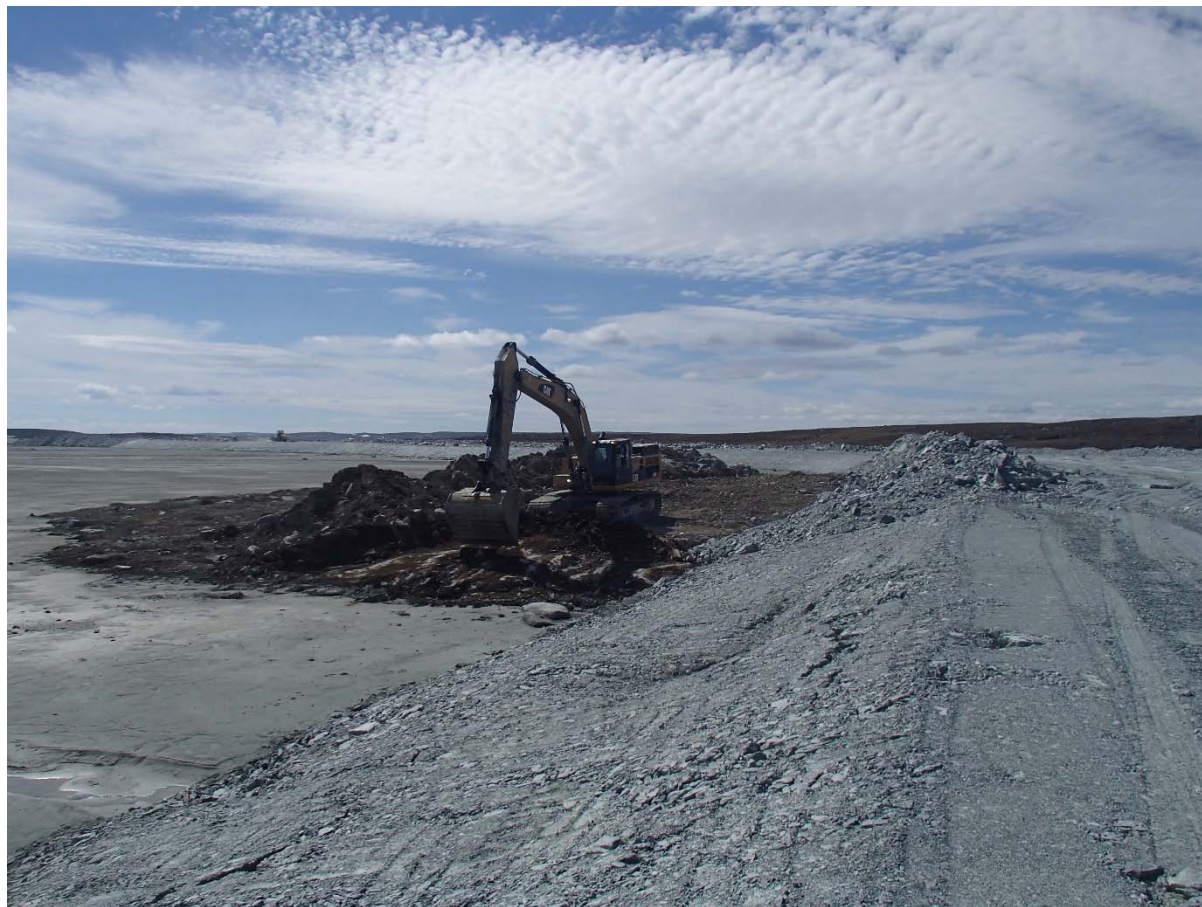
**Photograph NCIS-031: From Sta. 1+880/-21 m (approx.), looking SW. Final clean-up of the dike footprint with an excavator to reach a good quality bedrock from Sta. 1+800 to 1+850 m (o.s. -42 to -33 m).**

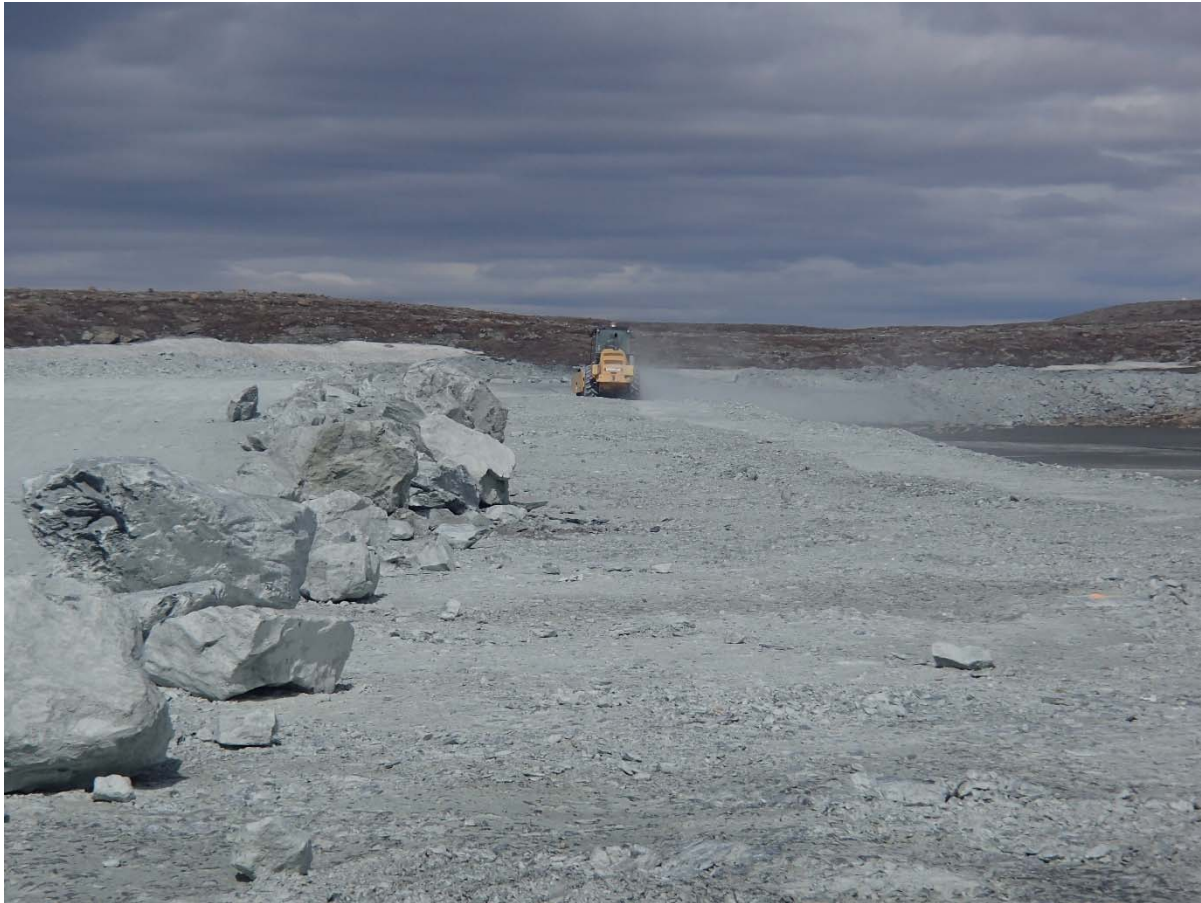
**Photograph NCIS-032: From Sta. 1+400/-24 m (approx.), looking N. Compaction of the 2 m lift (approx.) of ultramafic (UM) rockfill at El. 152 m with a 10-tonne smooth-drum compactor with vibration (6 passes) between the haul truck traffic lane and the upstream slope from Sta. 1+660 to 1+380 m (o.s. -45 to -24 m).**

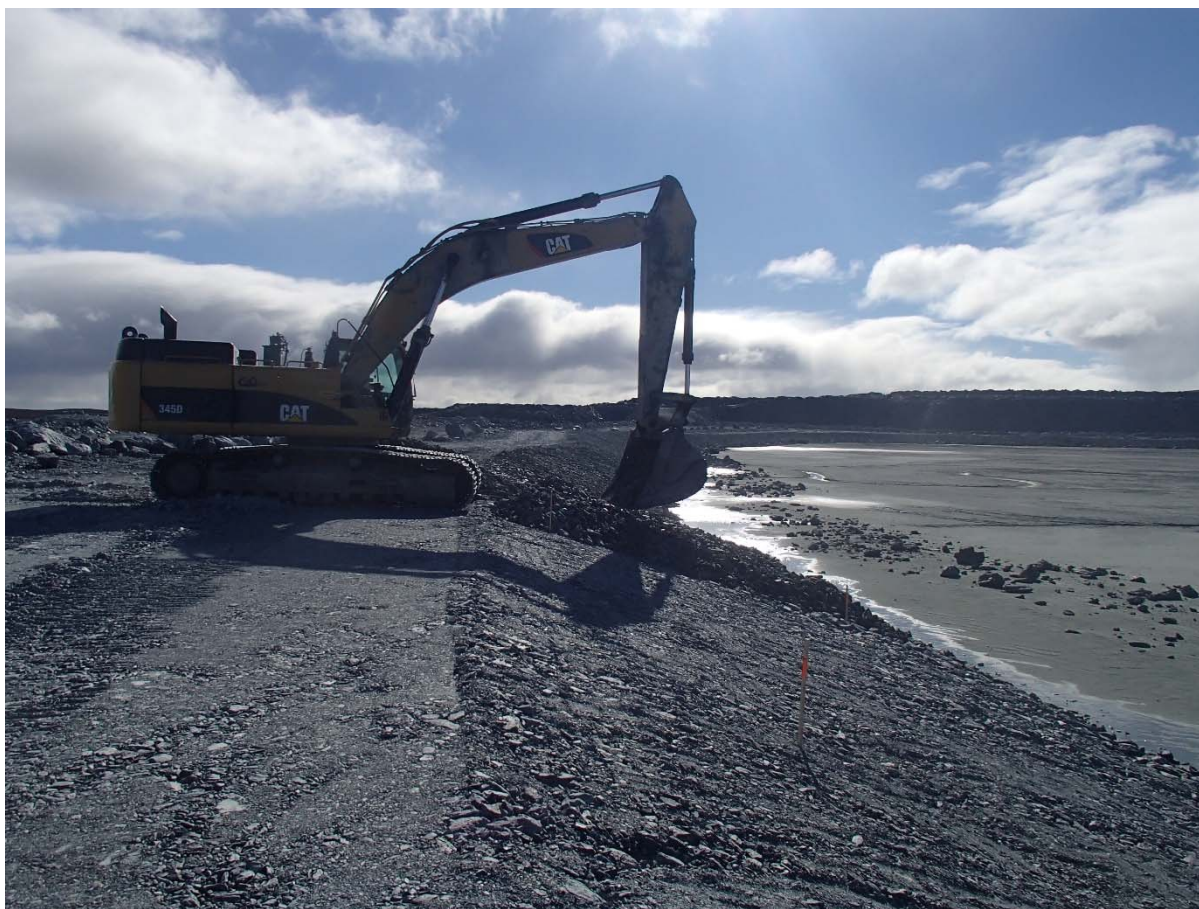
**Photograph NCIS-033: From Sta. 1+900/-21 m (approx.), looking E. Placement of a 0.5 m thick lift of coarse filter in the upstream slope from El. 150 m to 152 m with an excavator from Sta. 1+930 m to 1+715 m.**

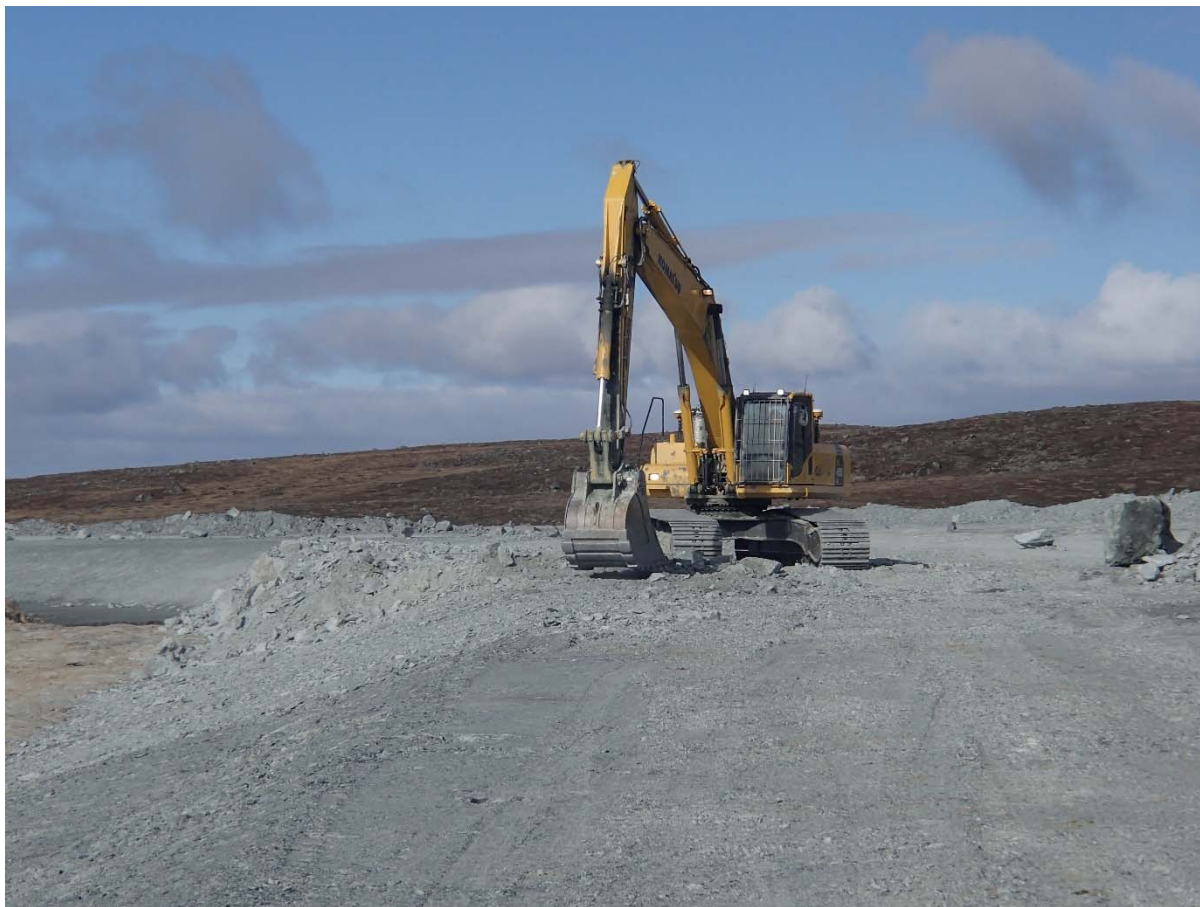
**Photograph NCIS-034: From Sta. 1+900/-21 m (approx.), looking W. Profiling of the upstream slope (3H:1V) from El. 150 to 152 m with an excavator from Sta. 1+860 m to 1+750 m.**

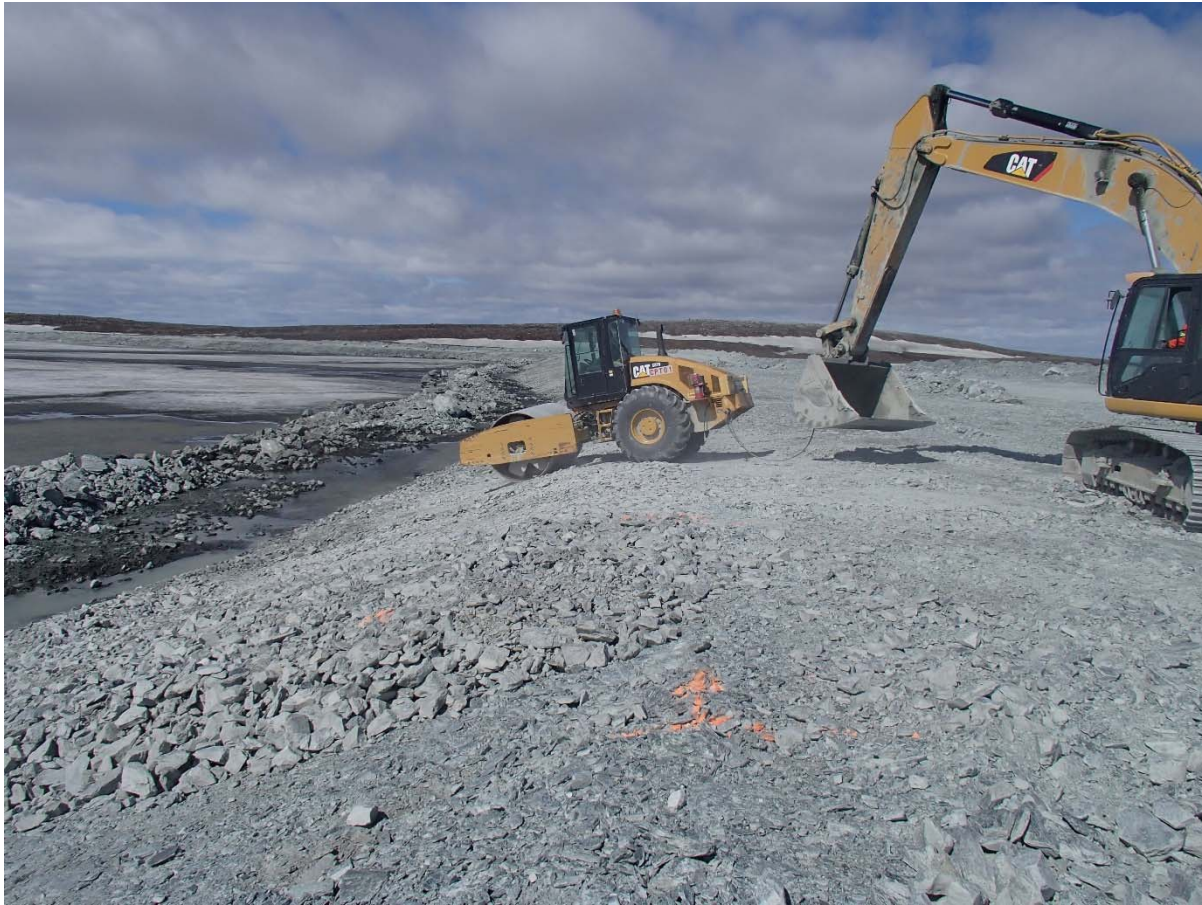
**Photograph NCIS-035: From Sta. 2+550/-25 m (approx.), looking N. Compaction of the 0.5 m lift (approx.) of coarse filter between El. 150 and 152 m with a 10-tonne smooth-drum compactor (4 passes) in the upstream slope from Sta. 2+524 m to 2+450 m.**

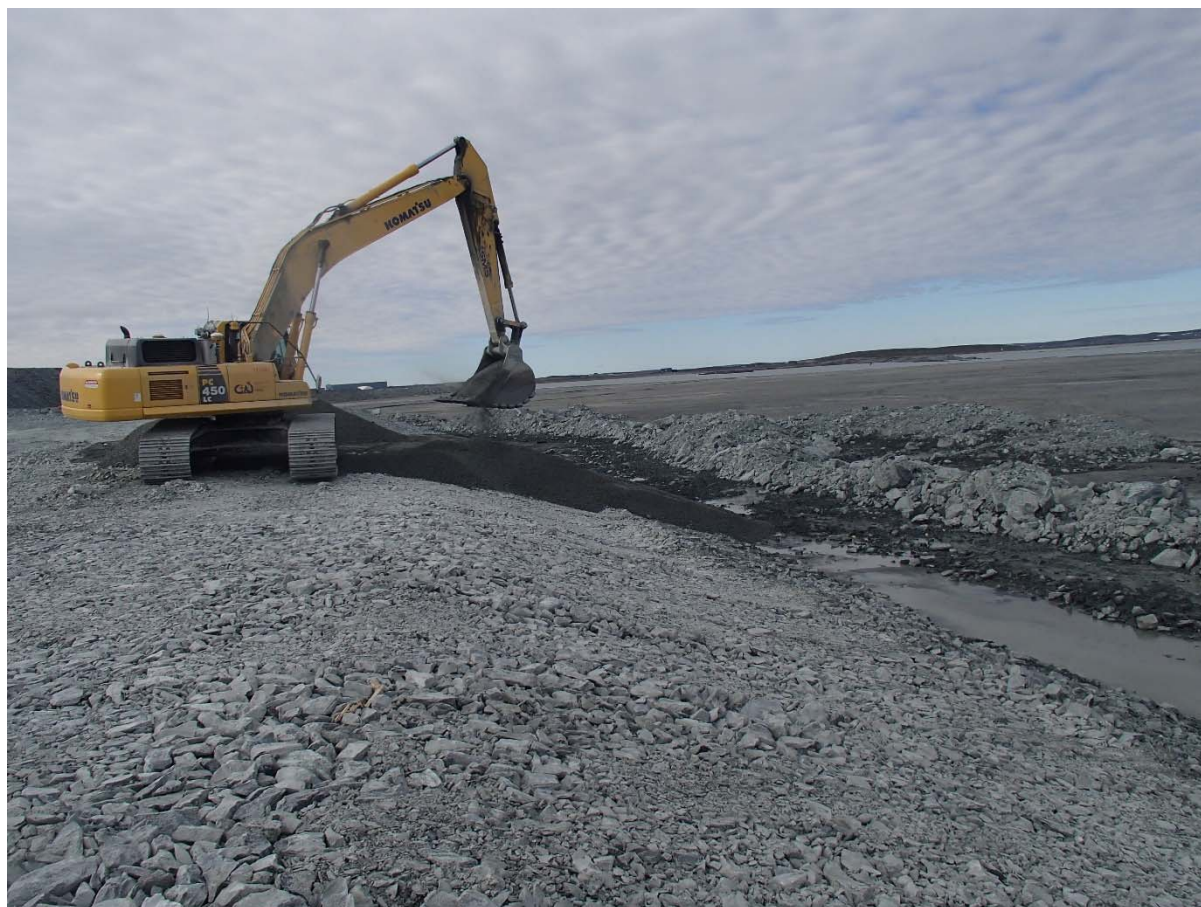
**Photograph NCIS-036: From Sta. 1+900/-21 m (approx.), looking SE. Placement of a 0.5 m thick lift of fine filter over the coarse filter in the upstream slope from El. 150 m to 152 m with an excavator from Sta. 2+542 m to 2+475 m.**

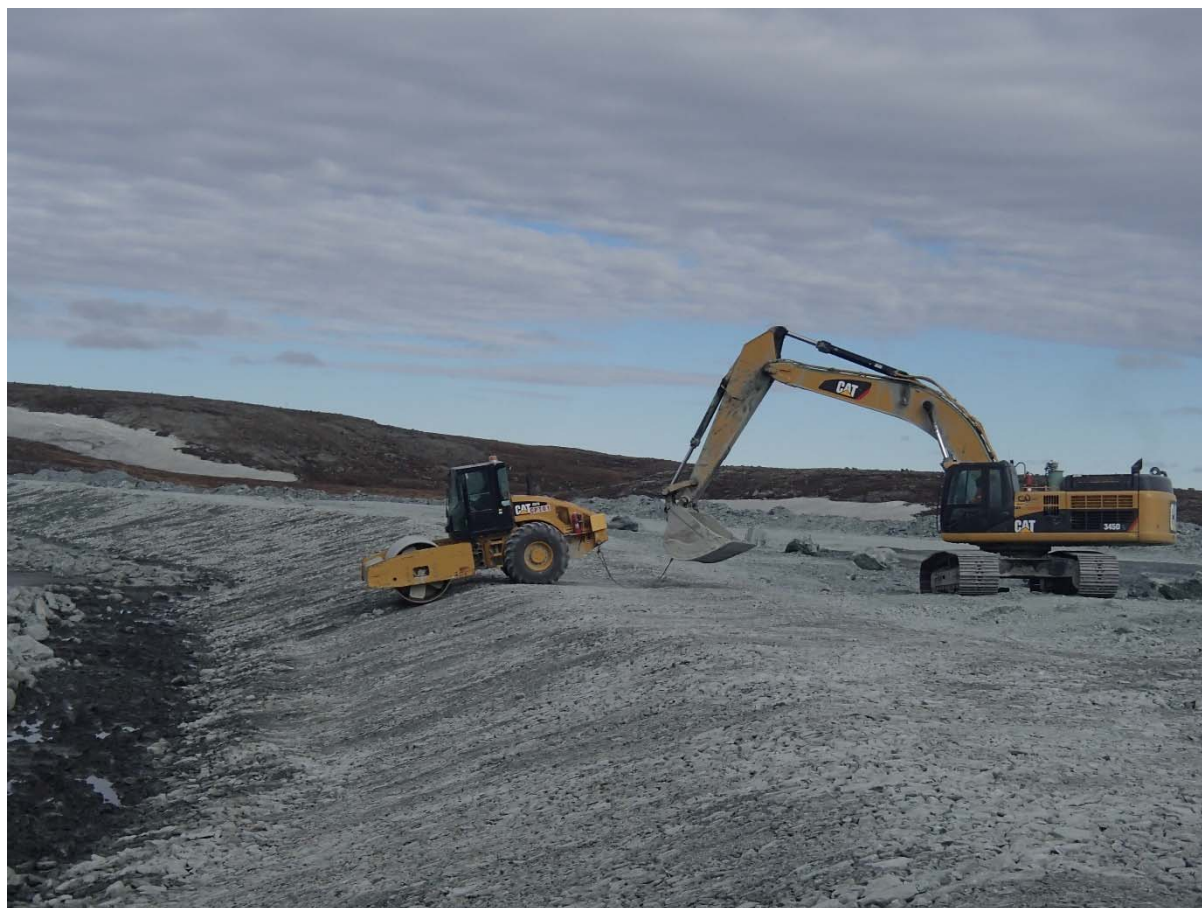
**Photograph NCIS-037: From Sta. 1+550/-25 m (approx.), looking NW. Compaction of the 0.5 m lift (approx.) of coarse filter between El. 150 and 152 m with a 10-tonne smooth-drum compactor (4 passes) in the upstream slope from Sta. 2+450 to 1+805 m.**

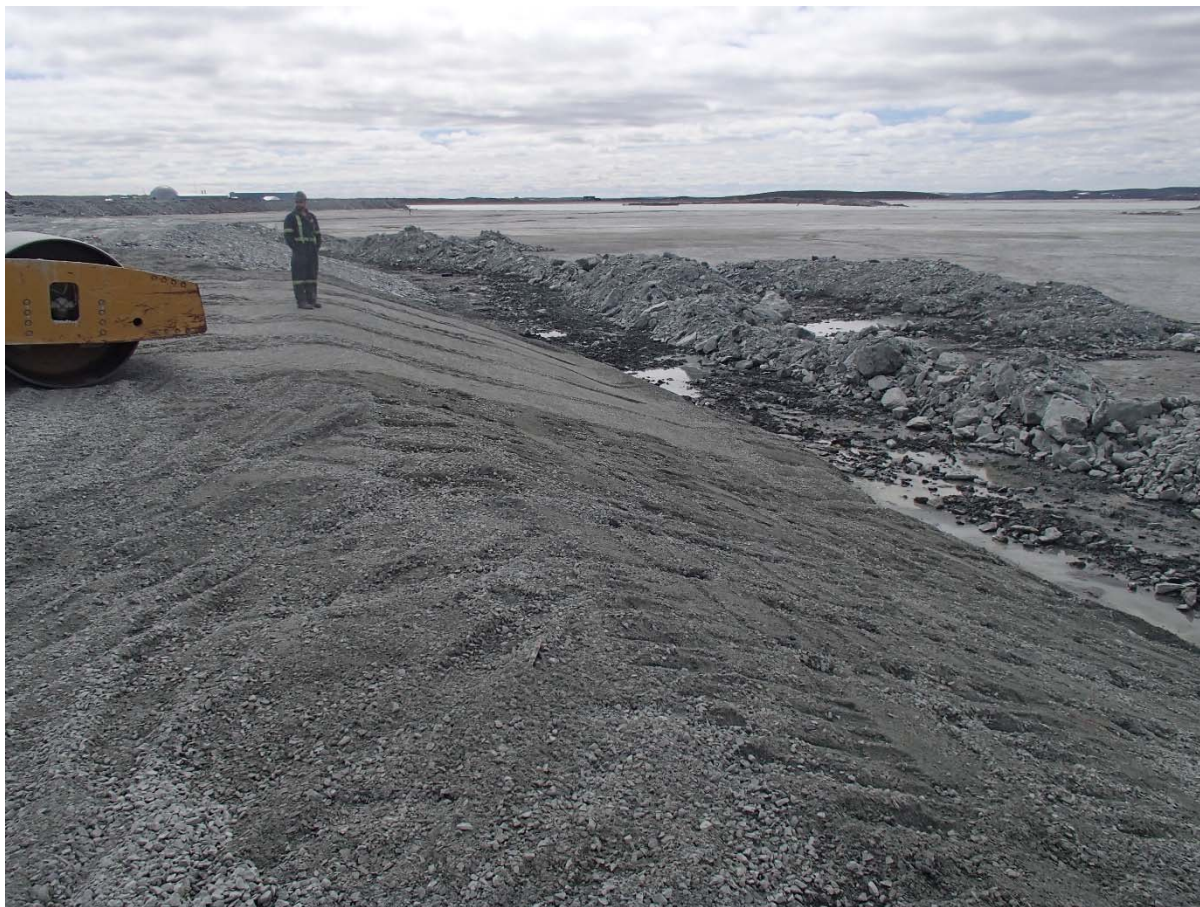
**Photograph NCIS-038: From Sta. 2+510/-28 m (approx.), looking SE. Compaction of the 0.5 m lift (approx.) of fine filter between El. 150 and 152 m with a 10-tonne smooth-drum compactor (4 passes) in the upstream slope from Sta. 2+542 m to 2+475 m.**

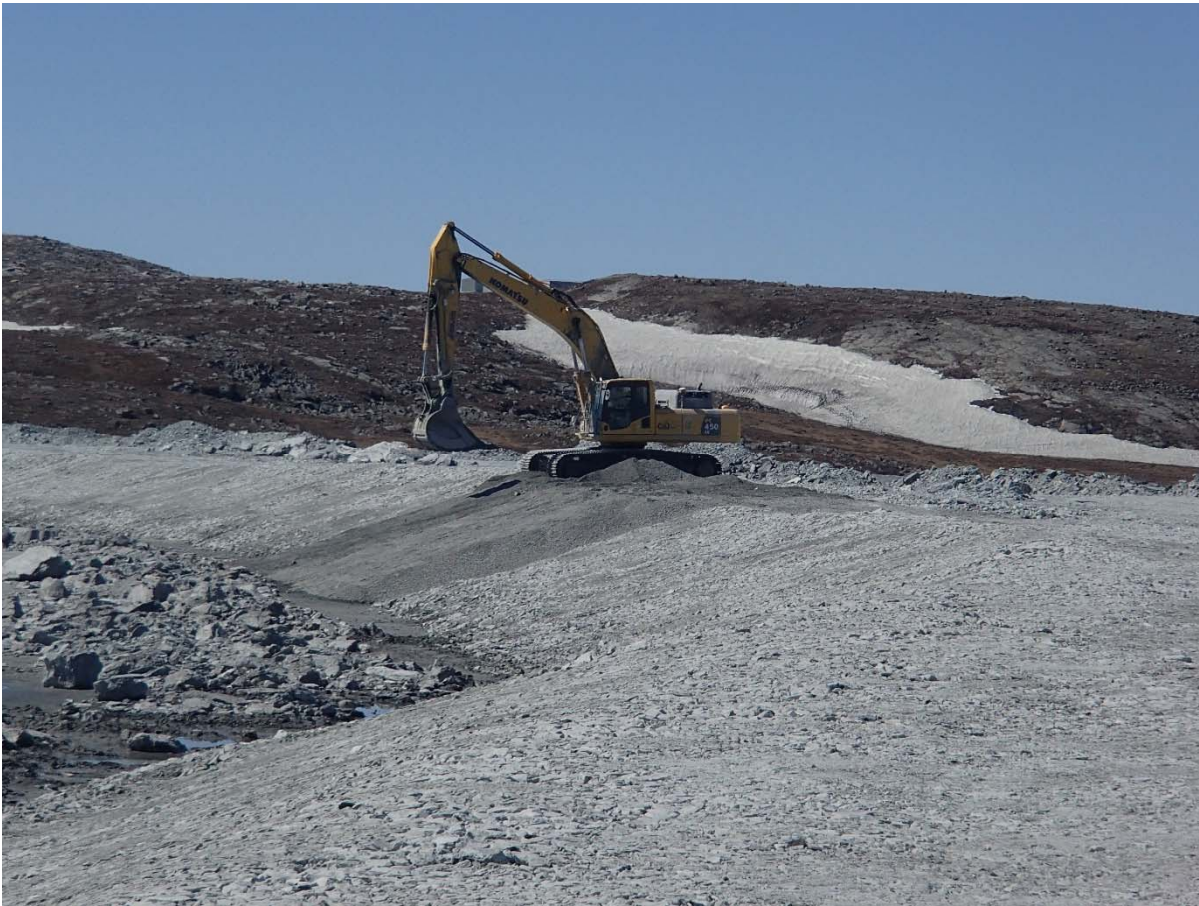
**Photograph NCIS-039: From Sta. 2+200/-24 m (approx.), looking W. Placement of a 0.5 m thick lift of fine filter over the coarse filter in the upstream slope from El. 150 m to 152 m with an excavator from Sta. 2+460 m to 2+475 m and from Sta. 2+065 m to 1+980 m.**

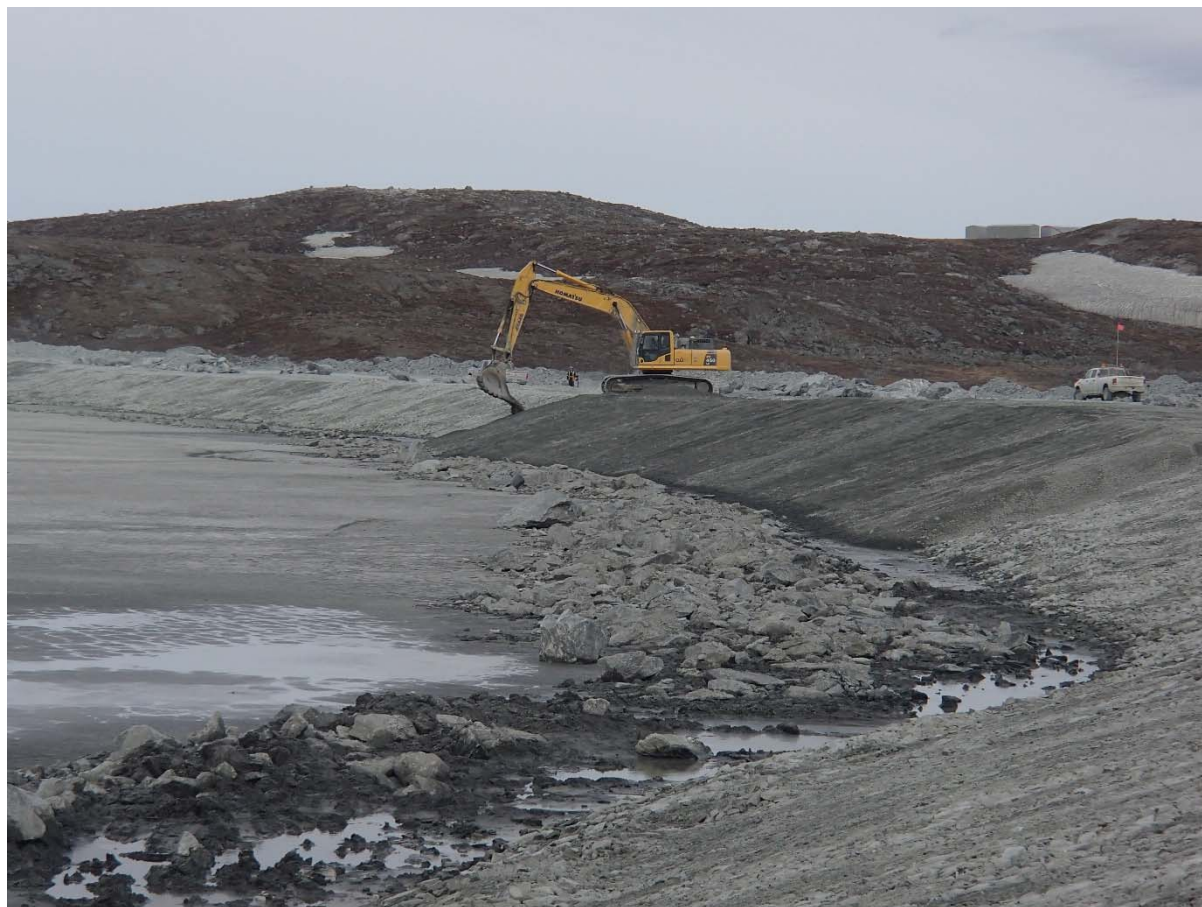
**Photograph NCIS-040: From Sta. 2+185/-25 m (approx.), looking W. Placement of a 0.5 m thick lift of fine filter over the coarse filter in the upstream slope from El. 150 m to 152 m with an excavator from Sta. 2+305 m to 2+460 m and from Sta. 1+980 m to 1+835 m.**

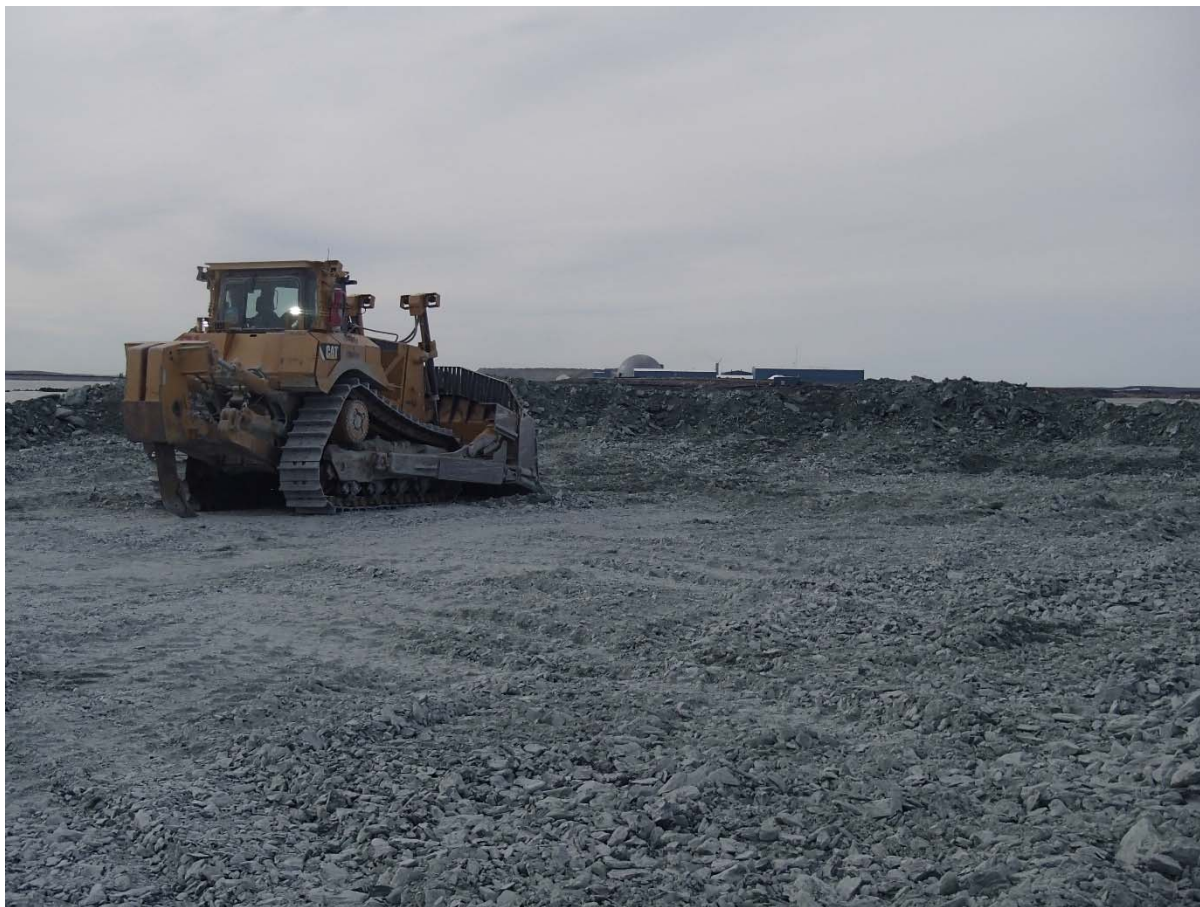
**Photograph NCIS-041: From Sta. 1+220/-7 m (approx.), looking S. Placement of a 1.5 to 2 m thick (approx.) lift of UM rockfill from El. 148 m to El. 150 m (approx.) with a dozer from Sta. 1+197 m to 1+150 m (-7 m to -41 m).**

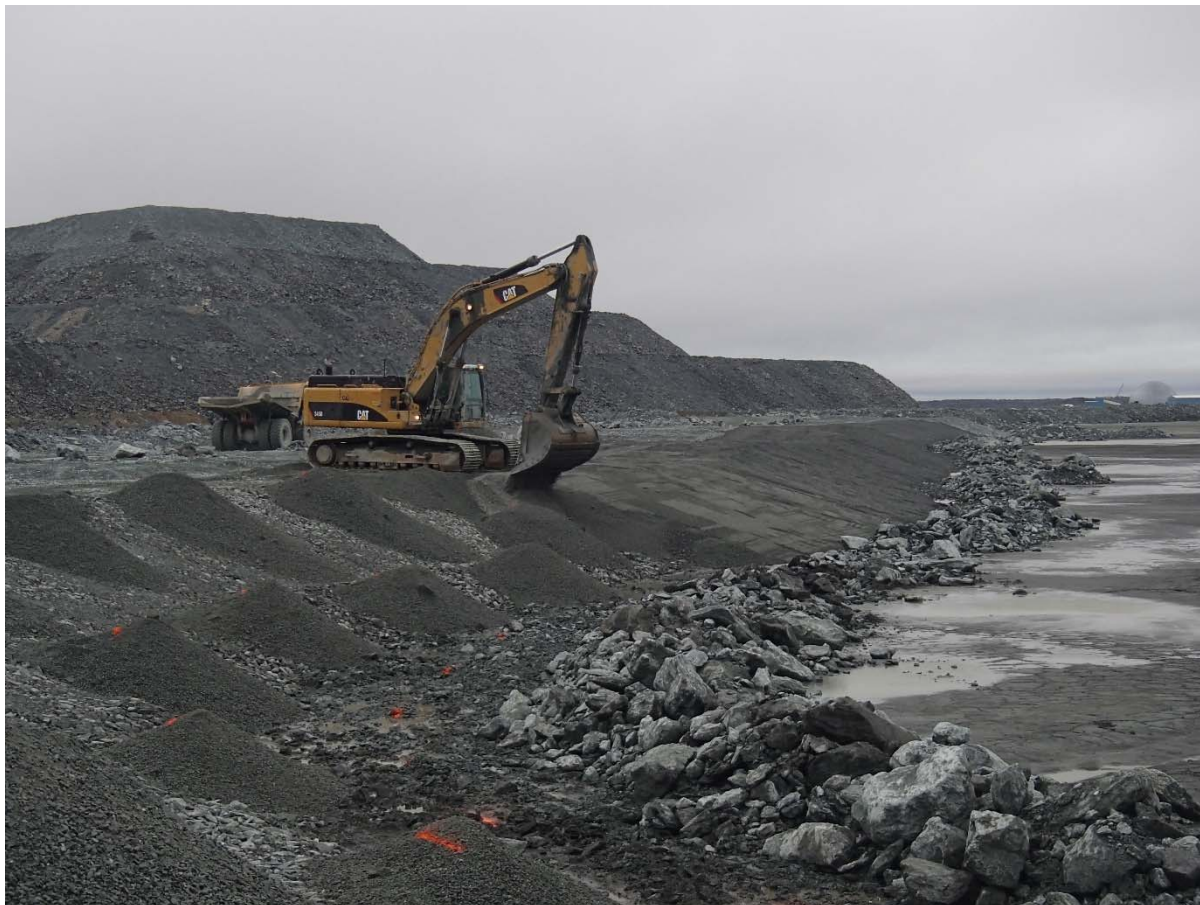
**Photograph NCIS-042:** From Sta. 2+210/-27 m (approx.), looking SE. Placement of a 0.5 m thick lift of fine filter over the coarse filter in the upstream slope from El. 150 m to 152 m with an excavator from Sta. 2+305 m to 2+040 m.

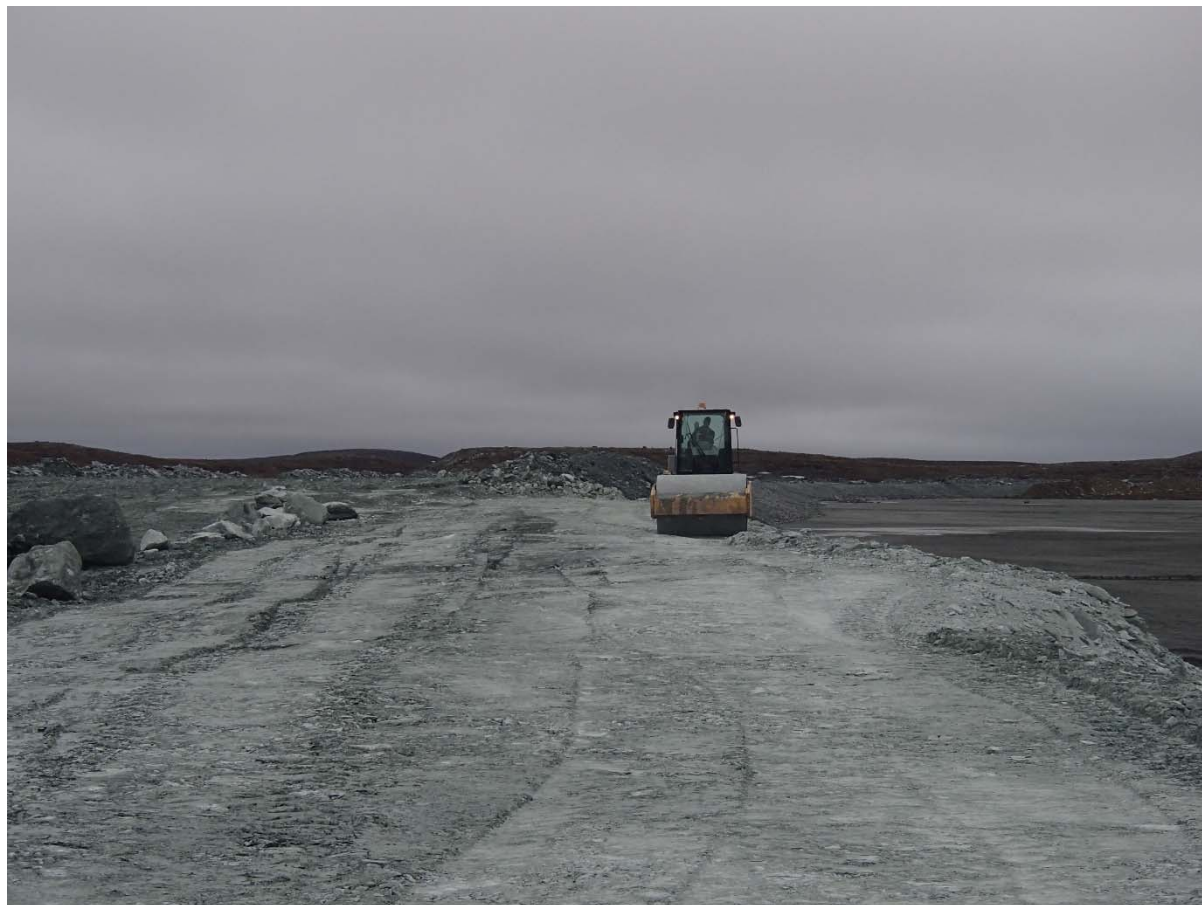
**Photograph NCIS-043: From Sta. 1+250/-38 m (approx.), looking N. Compaction of the 1.5 to 2 m lift (approx.) of ultramafic (UM) rockfill at El. 150 m with a 10-tonne smooth-drum compactor with vibration (6 passes) between the haul truck traffic lane and the upstream slope from Sta. 1+330 to 1+200 m (o.s. -53 to -24 m).**
