## QA DAILY REPORT

1897439-1576-TM-Rev0

### QA DAILY REPORT FOR JUNE 1<sup>ST</sup>, 2018 – TSF NORTH CELL CONSTRUCTION - MEADOWBANK (1897439)

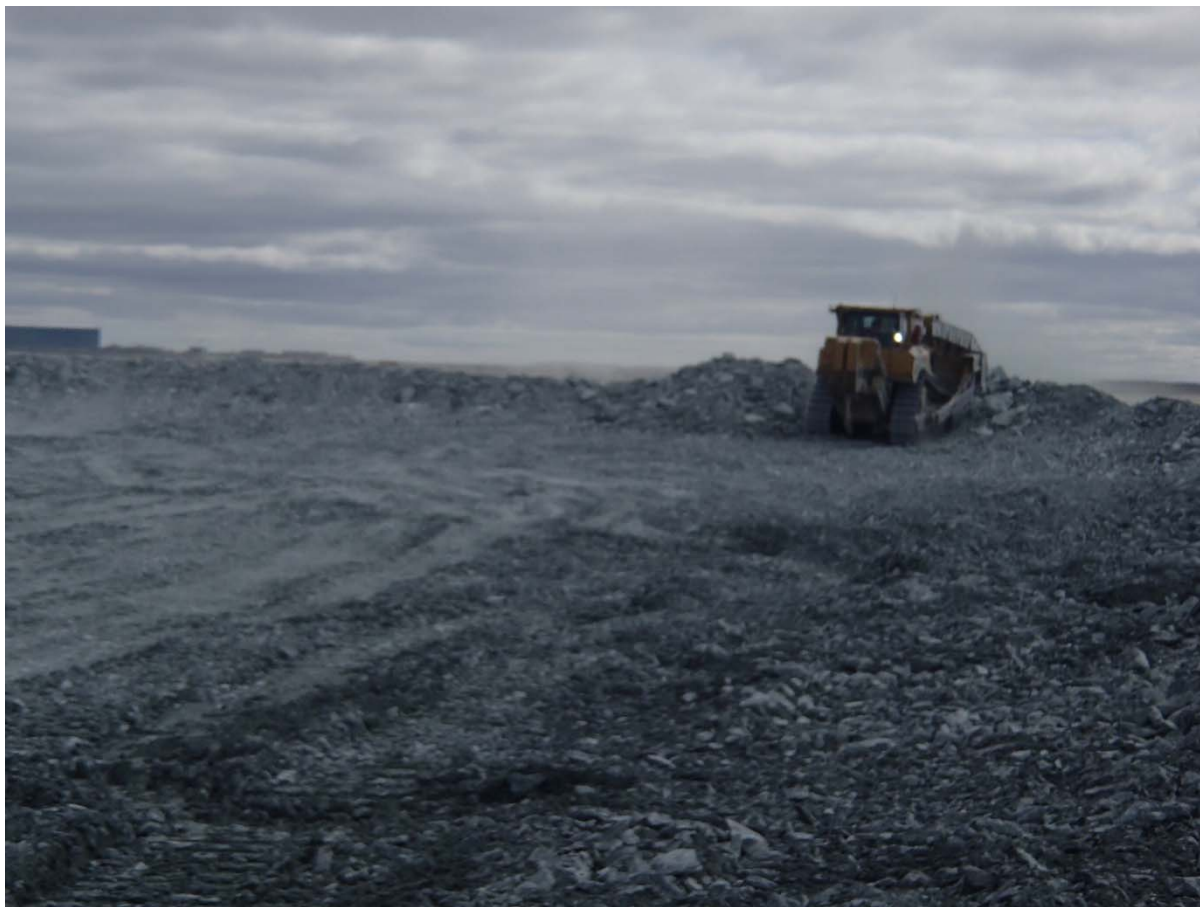
**Photograph NCIS-044: From Sta. 1+200/-19 m (approx.), looking S. Placement of a 1.5 to 2 m thick (approx.) lift of UM rockfill from El. 148 m to El. 150 m (approx.) with a dozer from Sta. 1+150 m to 1+120 m (-92 m to +10 m). The material is of good quality and is well graded.**

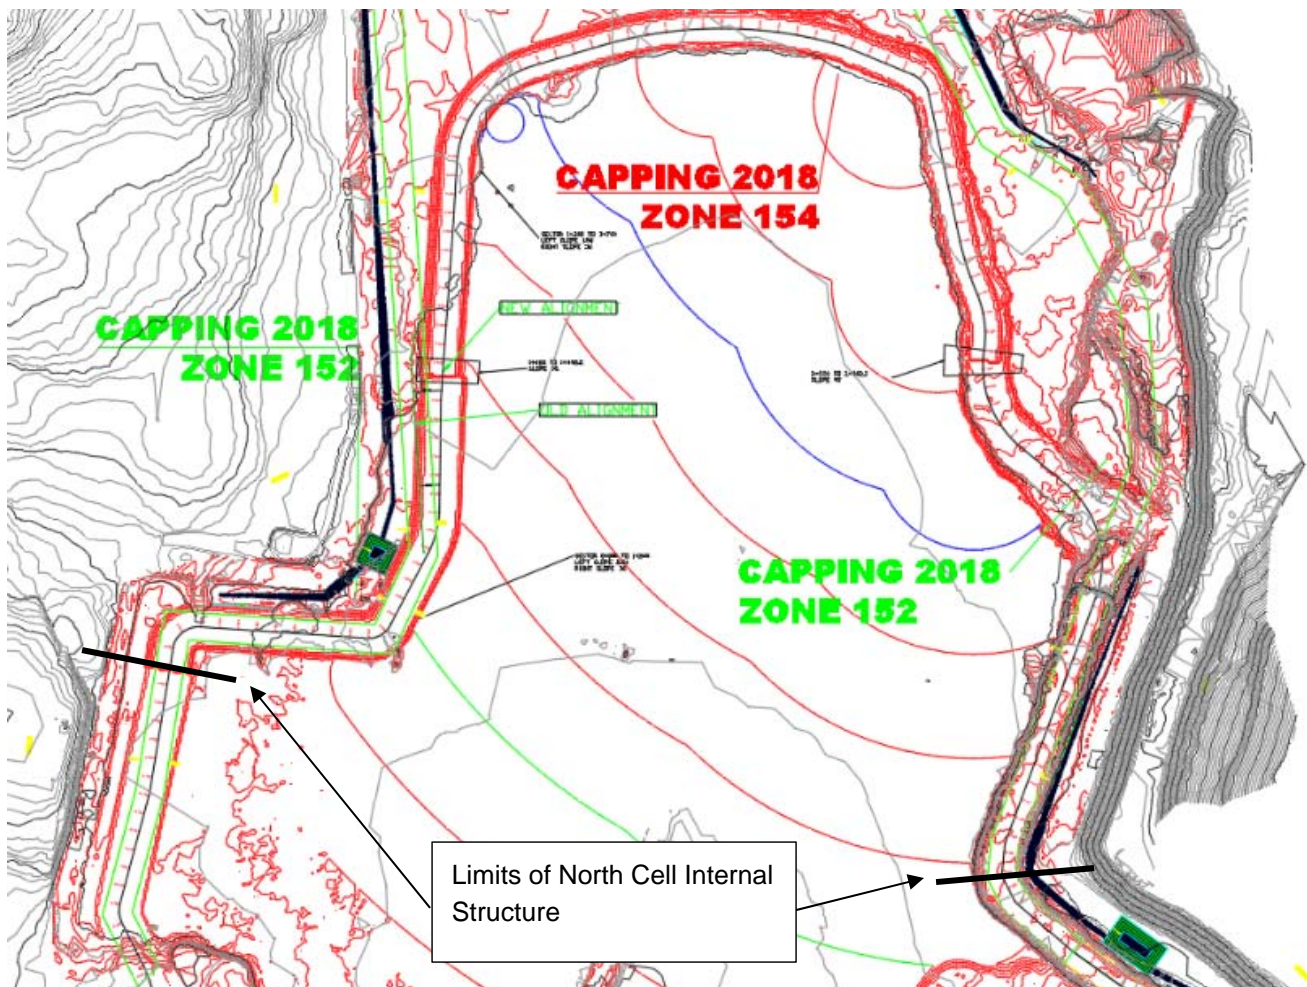
Figure 1: New proposed configuration for the North Cell Internal Structure and planned deposition

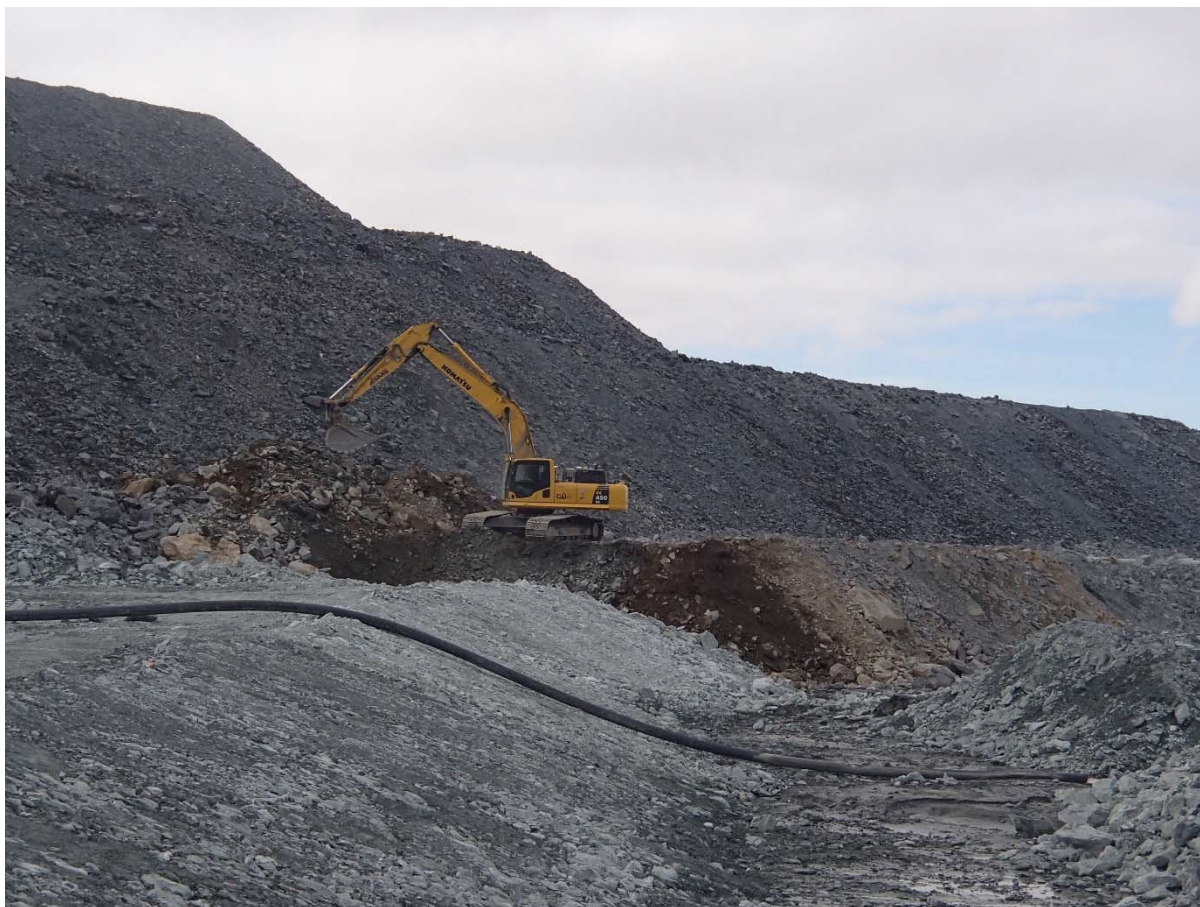
**Photograph NCIS-046:** From Sta. 2+680/-18 m (approx.), looking SE. Removal of till material mixed with the UM rockfill of the capping (about 1 to 2 m thick along the slope) with an excavator from Sta. 2+760 m to 2+850 m (o.s. -35 to -17 m).

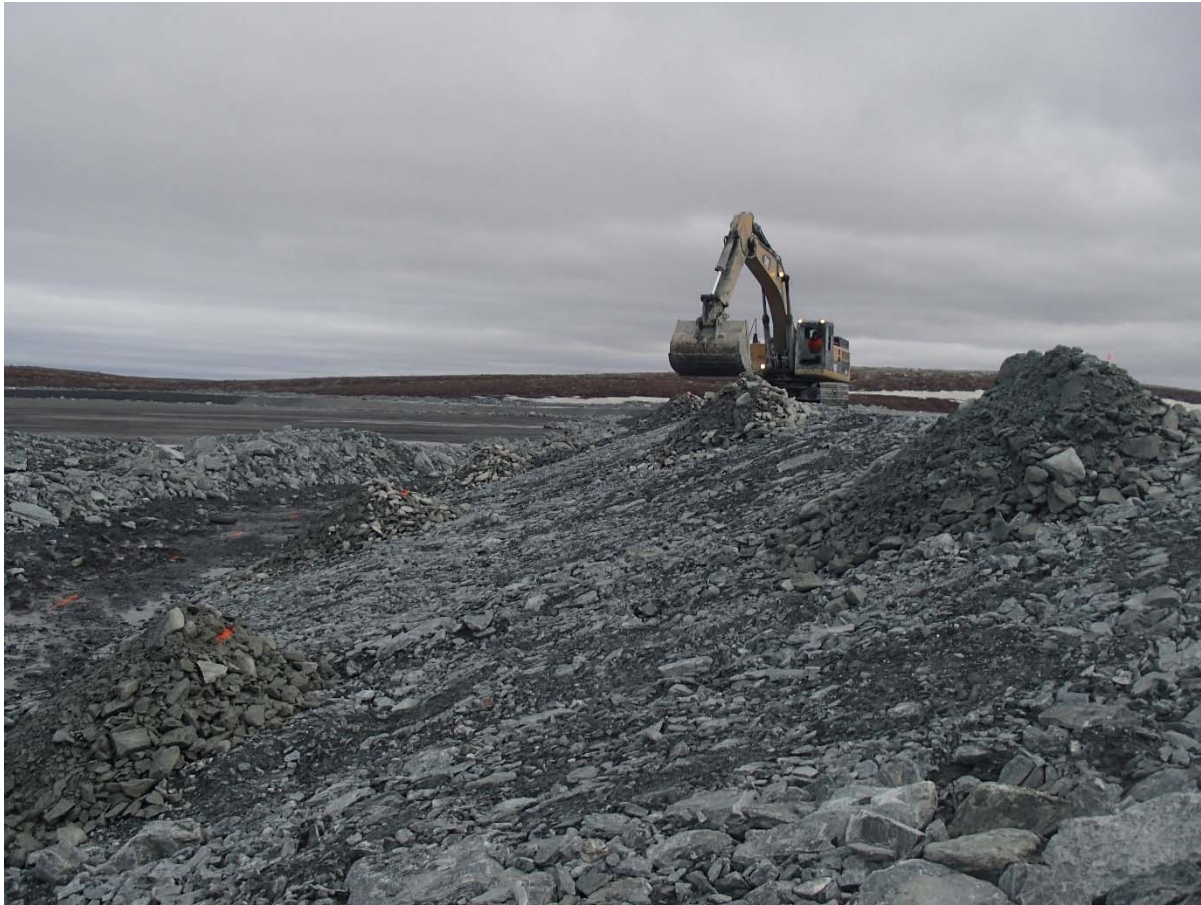
**Photograph NCIS-047: From Sta. 2+580/-35 m (approx.), looking N. Placement of a 0.5 m thick lift of coarse filter in the upstream slope from El. 150 m to 152 m with an excavator from Sta. 2+560 m to 2+640 m.**
