PROJECT
MEADOWBANK MINE, NUNAVUT
NORTH CELL INTERNAL STRUCTURE

TITLE
**INITIAL DESIGN OF THE NORTH CELL INTERNAL STRUCTURE
AND AS-BUILT FOOTPRINT**

APPENDIX C

Central Dike Stage 6 Photographs

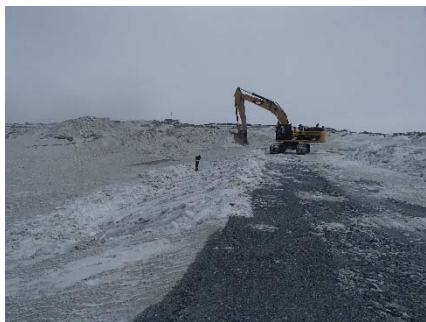
SD3-297 (2018-05-14), looking SE from Sta. 20+730/-10 m. Removal of snow on the upstream slope of SD3 with an excavator, from Sta. 20+640 to 20+760 m.

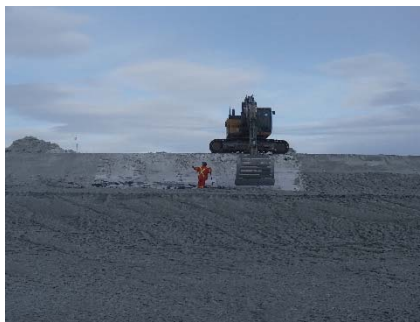
SD3-298 (2018-05-16), looking S from Sta. 20+680/-88 m. Removal of snow on the upstream slope of SD3 above El. 142 m, from Sta. 20+620 m to 20+780 m.

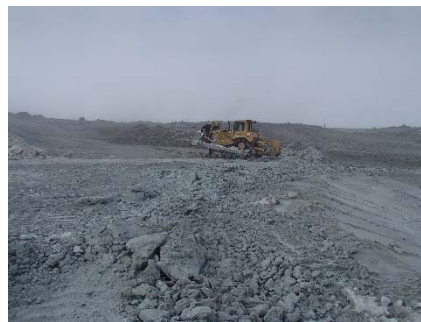
SD3-299 (2018-05-16), looking NW from Sta. 20+620/-26 m. Scarification of the frozen ultramafic volcanic (UM) rockfill on the crest with a dozer for the anchoring trench excavation between Sta. 20+605 m and 20+780 m.

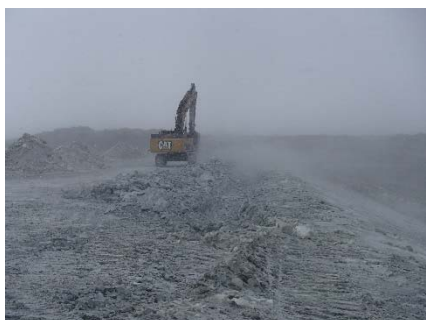
SD3-300 (2018-05-16), looking NW from Sta. 20+790/-33 m. Excavation of the LLDPE geomembrane crest anchoring trench with an excavator from Sta. 20+675 m to 20+780 m.

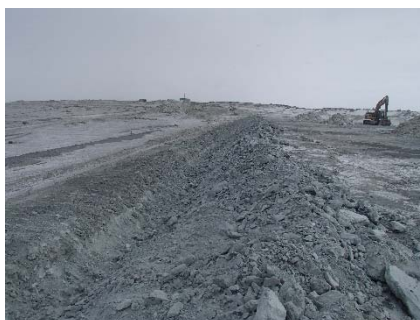
SD3-301 (2018-05-17), looking SE from Sta. 20+660/-22 m. Excavation of the LLDPE geomembrane crest anchoring trench with an excavator from Sta. 20+655 m to 20+675 m.

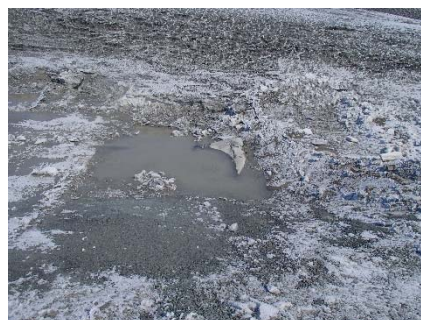
SD3-302 (2018-05-18), looking NE from Sta. 20+595/-42 m. View of water ponding on the first compacted sieved till layer of upstream toe liner tie-in. A portion of exposed damaged LLDPE liner is visible.

SD3-305 (2018-06-05), looking NE from Sta. 20+590/-48 m. Dewatering of the water ponding on the first compacted sieved till layer of upstream toe liner tie-in. A Genset Frost-fighter is heating the sieved till layer and a pump is evacuating the water.

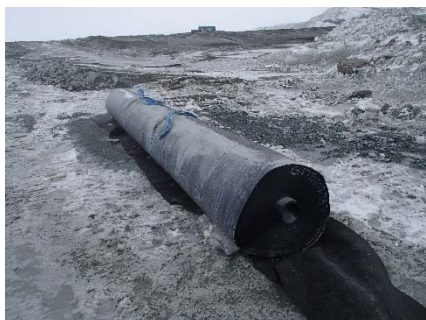
SD3-303 (2018-05-21), looking N from Sta. 20+780/-15 m. View of a LLDPE liner roll stored on geotextile.

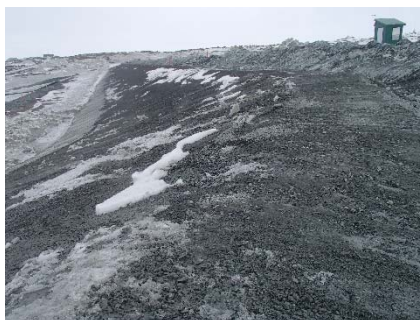
SD3-304 (2018-05-21), looking SE from Sta. 20+620/-36 m. Smoothing of the surface of the fine filter with an excavator on top of the upstream slope from Sta. 20+600 m to 20+780 m.

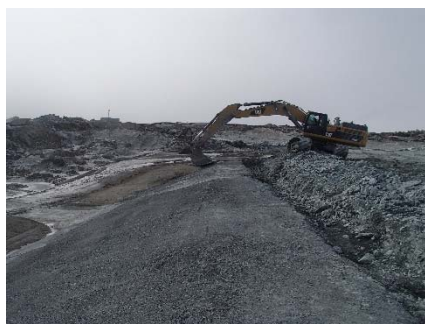
SD3-306 (2018-06-06), looking S from Sta. 20+780/-25 m. Correction of the surface of the fine filter in the upstream slope and the top of the first class compacted sieved till layer with an excavator from Sta. 20+803 m to 20+793 m.

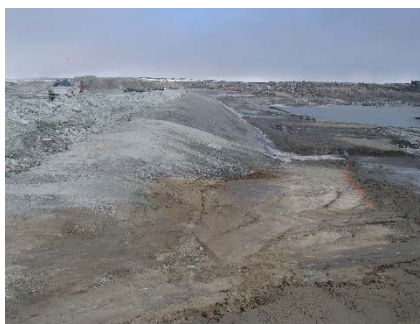
SD3-307 (2018-06-06), looking N from Sta. 20+800/-25 m. View of the liner bedding ready for geosynthetics installation.

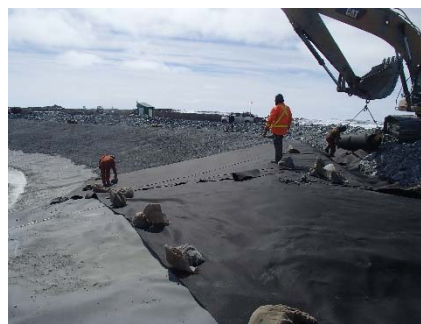
SD3-308 (2018-06-06), looking SW from Sta. 20+620/-48 m. Installation of the geotextile on the upstream slope 3H:1V between El. 143 m and 145 m from Sta. 20+620 m to 20+630 m.

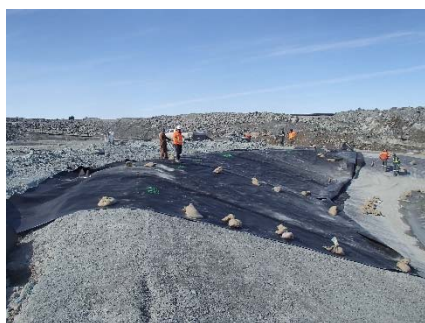
SD3-309 (2018-06-06), looking N from Sta. 20+640/-26 m. Installation of the LLDPE liner on the upstream slope 3H:1V between El. 143 m and 145 m from Sta. 20+620 m to 20+630 m (panel numbers 934 to 939).

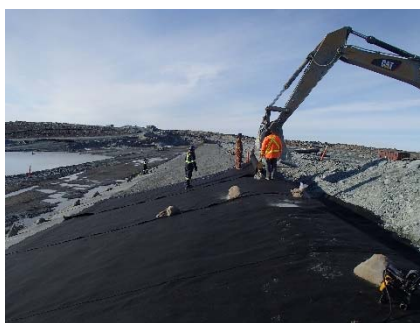
SD3-310 (2018-06-07), looking S from Sta. 20+635/-24 m. Installation of the geotextile on the upstream slope 3H:1V between El. 143 m and 145 m from Sta. 20+630 m to 20+800 m.

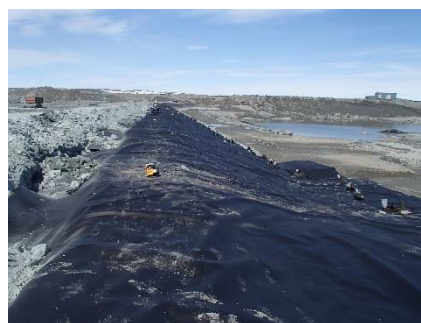
SD3-311 (2018-06-07), looking N from Sta. 20+810/-26 m. Installation of the LLDPE liner on the upstream slope 3H:1V between El. 143 m and 145 m from Sta. 20+630 m to 20+800 m (panel numbers 939 to 964).

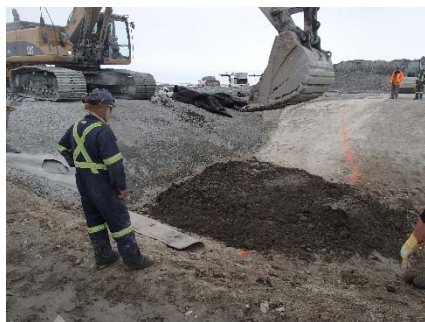
SD3-312 (2018-06-08), looking W from Sta. 20+610/-48 m. Placement of a 0.15 m-thick lift of compacted sieved till from Sta. 20+596.4 m to 20+601.6 m (o.s. -42.6 to -46.3 m) to fill the depression in the compacted sieved till layer.

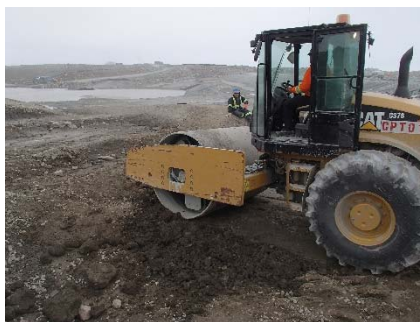
SD3-313 (2018-06-08), looking S from Sta. 20+600/-52 m. Compaction of the 0.15 m-thick lift of compacted sieved till with a 10-tonne smooth-drum compactor without vibration (4 passes) from Sta. 20+596 m to 20+601 m.

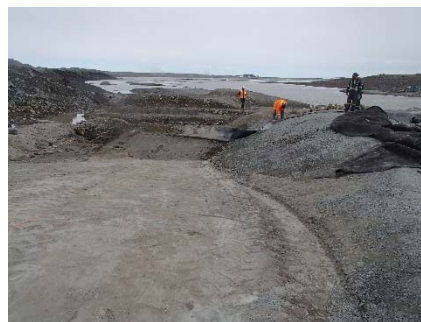
SD3-314 (2018-06-08), looking E from Sta. 20+590/-32 m. View of the liner bedding ready for geosynthetics installation.

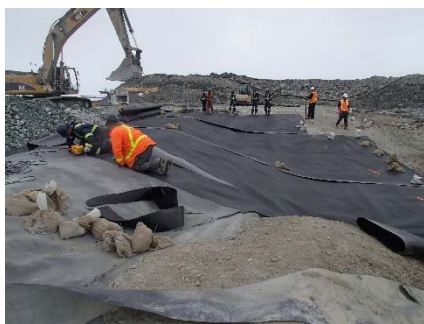
SD3-315 (2018-06-08), looking W from Sta. 20+615/-46 m. Installation of the geotextile on the upstream slope 3H:1V between El. 143 m and 145 m from Sta. 20+593 m to 20+610 m and installation of the LLDPE liner on the upstream slope 3H:1V between El. 143 m and 145 m from Sta. 20+593 m to 20+610 m (panel numbers 965 to 967).

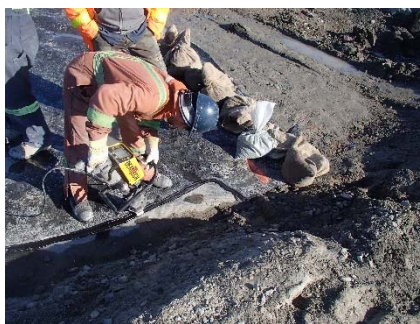
SD3-316 (2018-06-09), looking NW from Sta. 20+610/-45 m. Repairs on the extrusion fillet seam between LLDPE panel 965 and the existing LLDPE panel at Sta. 20+600 m (approx.).

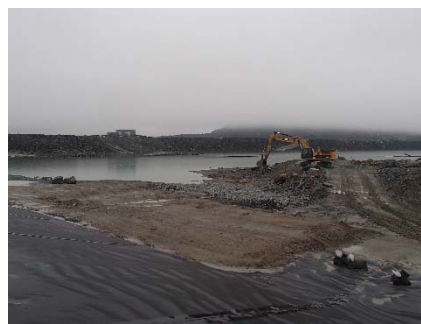
SD3-317 (2018-07-07), looking E from Sta. 20+800/-22 m. Reworking of the access to SD3.

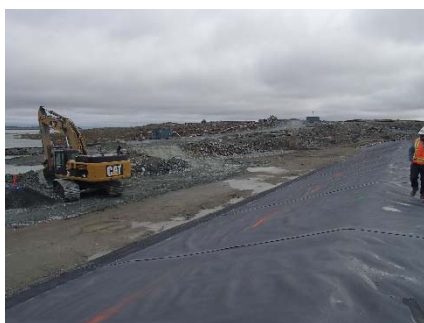
SD3-318 (2018-07-07), looking SE from Sta. 20+710/-24 m. Placement of IV rockfill in the water up to El. 142m with an excavator from Sta. 20+785 m to 20+730 m, at the bottom of the upstream slope of SD3 to widen the rockfill layer and allow access to the erosion protection.

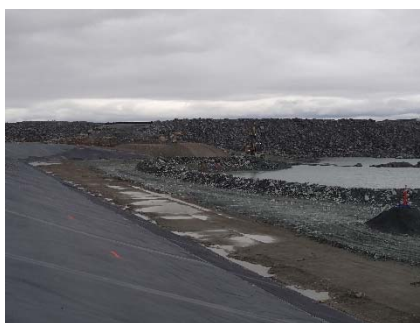
SD3-319 (2018-07-08), looking NE from Sta. 20+740/-31 m. Placement of IV rockfill in the water up to El. 142m with an excavator from Sta. 20+730 m to 20+610 m, at the bottom of the upstream slope of SD3 to widen the rockfill layer and allow access to the erosion protection.

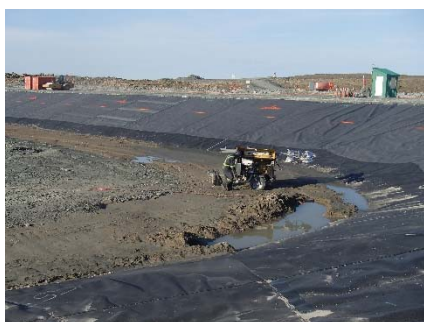
SD3-321 (2018-07-09), looking SW from Sta. 20+610/-56 m. Water ponding at El. 142m on the compacted sieved till layer of the upstream toe liner tie-in at approx. Sta. 20+620 m to 20+630 m was pumped.

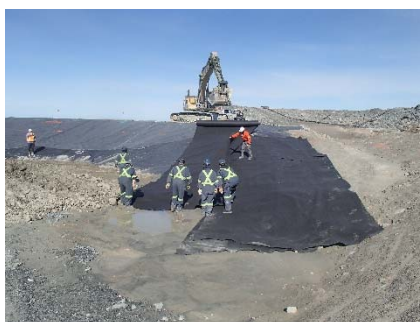
SD3-322 (2018-07-09), looking W from Sta. 20+625/-63 m. Installation of two layers of geotextile on the upstream slope 3H:1V between El. 142 m and 143 m (approx.) from Sta. 20+610 m to 20+800 m.

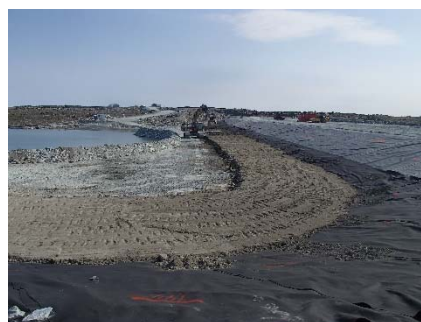
SD3-323 (2018-07-09), looking S from Sta. 20+610/-43 m. Placement of the first 0.5 m thick lift of low quality till (0-150 mm) from El. 142 m to 142.5 m from Sta. 20+610 m to 20+715 m.

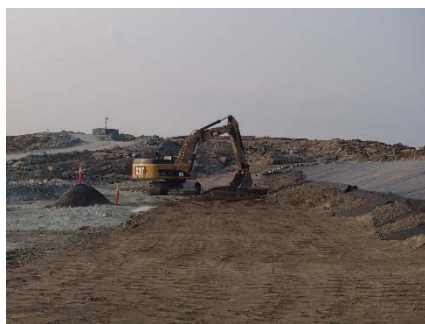
SD3-324 (2018-07-10), looking S from Sta. 20+680/-39 m. Placement of a 0.5 m thick lift of low quality till (0-150 mm) from El. 142 m to 142.5 m from Sta. 20+715 m to 20+760 m.

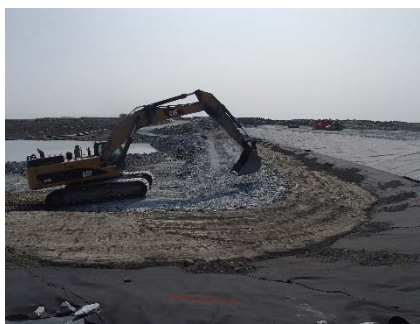
SD3-325 (2018-07-10), looking S from Sta. 20+610/-43 m. Placement of a first 0.5 m thick lift of fine rockfill (0-500 mm) upstream of the low quality till from El. 142 m to 142.5 m from Sta. 20+610 m to 20+760 m.

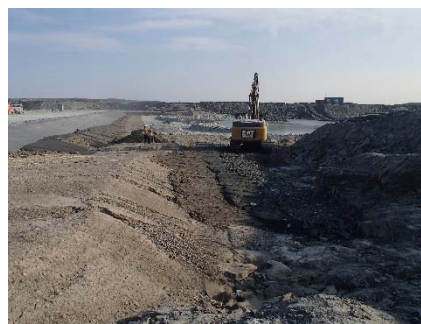
SD3-326 (2018-07-11), looking N from Sta. 20+820/-34 m. Placement of the 0.5 m thick lift of low class till, fine filter, coarse filter and fine rockfill on the upstream slope of the upstream toe liner tie-in with an excavator from Sta. 20+780 to 20+810 m.

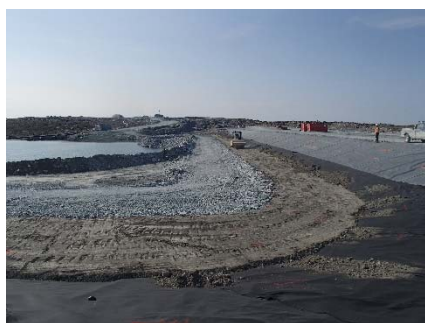
SD3-327 (2018-07-11), looking S from Sta. 20+610/-43 m. Compaction of the 0.5 m lift of low quality till (0-150 mm) at El. 142.5 m with a 10-tonne smooth-drum compactor with vibration (4 passes) from Sta. 20+610 m to 20+615 m and from Sta. 20+635 m to 20+760 m.

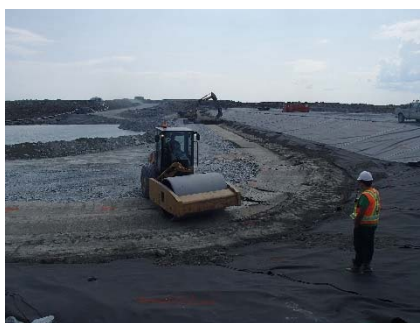
SD3-328 (2018-07-11), looking N from Sta. 20+820/-34 m. Compaction perpendicularly to the longitudinal axis of Saddle Dam 3 of the 0.5 m lift of low quality till (0-150 mm) at El. 142.5 m with a 10-tonne smooth-drum compactor without vibration (4 passes) from Sta. 20+615m to 20+635 m.

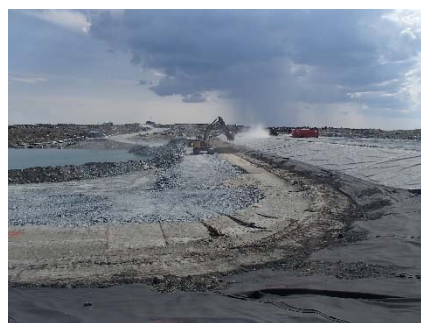
SD3-329 (2018-07-11), looking N from Sta. 20+820/-34 m. Placement of a 0.5 m thick lift of low quality till (0-150 mm) from El. 142.5 m to 143 m from Sta. 20+610 m to 20+760 m.

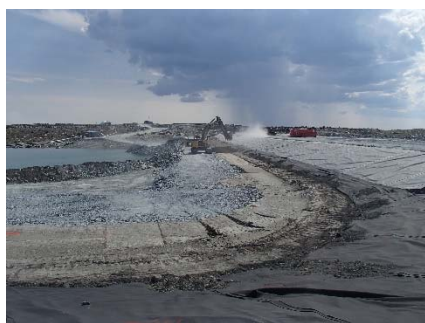
SD3-329 (2018-07-11), looking N from Sta. 20+820/-34 m. Placement of a 0.5 m thick lift of low quality till (0-150 mm) from El. 142.5 m to 143 m from Sta. 20+610 m to 20+760 m.

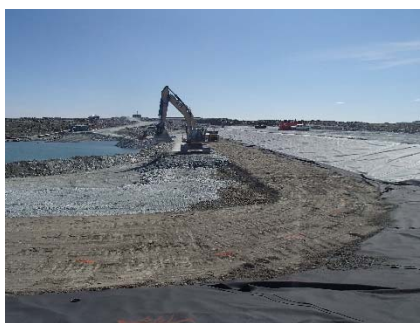
SD3-330 (2018-07-12), looking S from Sta. 20+610/-43 m. Placement of a second 0.5 m thick lift of fine rockfill (0-500 mm) upstream of the low quality till (0-150mm) from El. 142.5 m to 143 m from Sta. 20+610 m to 20+760 m.

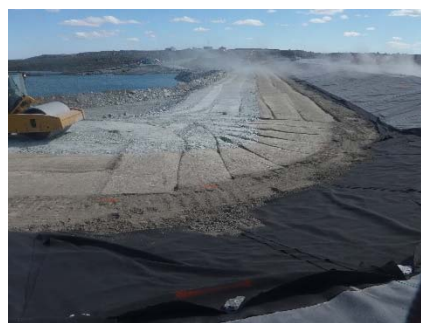
SD3-331 (2018-07-12), looking S from Sta. 20+610/-43 m. Compaction of the 0.5 m lift of low quality till (0-150 mm) at El. 143 m with a 10-tonne smooth-drum compactor with vibration (4 passes) from Sta. 20+610 m to 20+760 m.

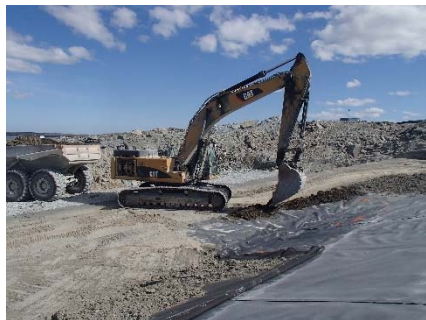
SD3-332 (2018-07-12), looking SE from Sta. 20+775/-23 m. Placement of a first 0.5 m thick lift of compacted sieved till over the LLDPE geomembrane on the upstream toe liner tie-in with an excavator from Sta. 20+775 m to 20+800 m.

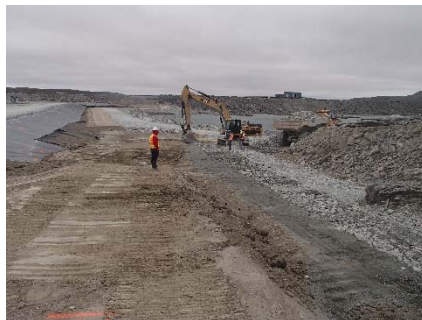
SD3-333 (2018-07-13), looking N from Sta. 20+817/-29 m. Placement of a second 0.5 m thick lift of fine rockfill on the upstream slope of the upstream toe liner tie-in with an excavator from Sta. 20+775 m to 20+800 m.

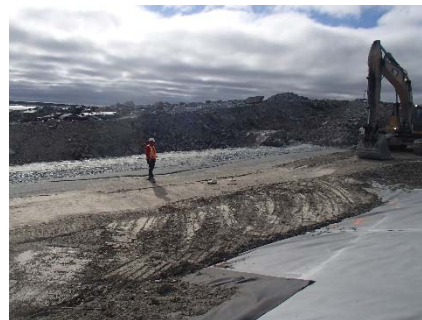
SD3-334 (2018-07-13), looking SE from Sta. 20+780/-26 m. Compaction of the second 0.5 m thick lift of compacted sieved till and third lift of fine filter, coarse filter and fine rockfill of the upstream toe liner tie-in with a 10 tonne smooth-drum compactor with vibrations from Sta. 20+770 m to 20+800 m.

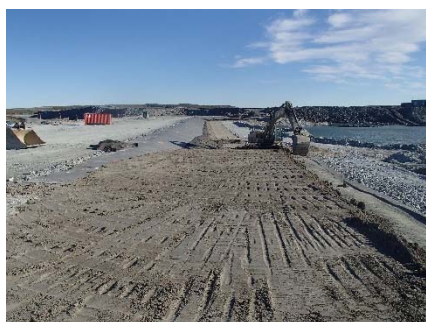
SD3-335 (2018-07-14), looking N from Sta. 20+815/-27 m. Placement of a third 0.5 m thick lift of compacted sieved till on the upstream toe liner tie-in with an excavator from Sta. 20+760 m to 20+810 m.

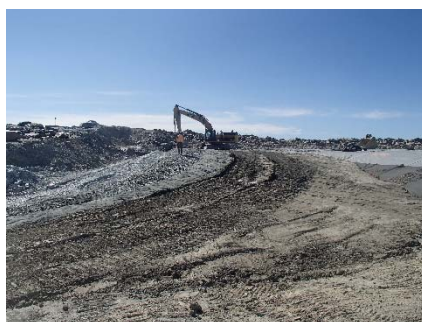
SD3-336 (2018-07-14), looking S from Sta. 20+755/-48 m. Placement of a fourth 0.5 m thick lift of fine filter, coarse filter and fine rockfill on the upstream slope of the upstream toe liner tie-in with an excavator from Sta. 20+770 to 20+800 m.

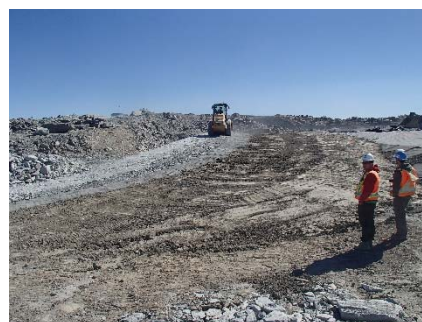
SD3-337 (2018-07-14), looking S from Sta. 20+760/-37 m. Compaction of the fourth 0.5 m thick lifts of fine filter, coarse filter and fine rockfill on the upstream slope of the upstream toe liner tie-in with a 10 tonne smooth-drum compactor with vibrations (4 passes) from Sta. 20+770 to 20+800 m.

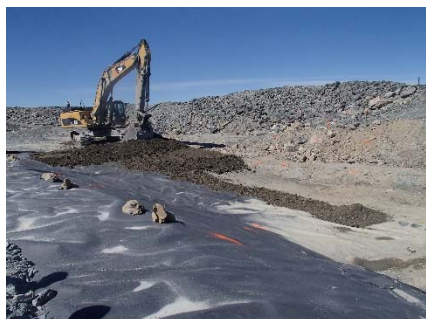
SD3-338 (2018-07-14), looking NW from Sta. 20+610/-43 m. Placement of a first 0.5 m thick lift of compacted sieved till over the LLDPE geomembrane on the upstream toe liner tie-in with an excavator from Sta. 20+588 m to 20+599 m.

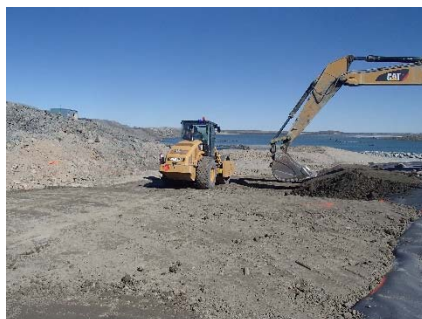
SD3-339 (2018-07-15), looking E from Sta. 20+600/-29 m. Compaction of a first 0.5 m thick lift of compacted sieved till on the upstream toe liner tie-in with an excavator from Sta. 20+588 m to 20+599 m.

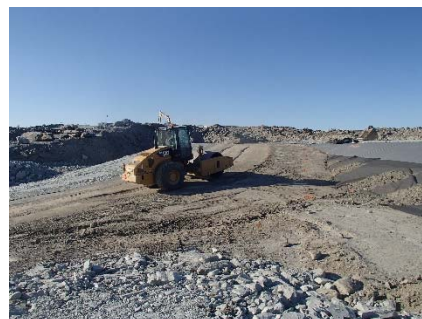
SD3-340 (2018-07-15), looking S from Sta. 20+750/-40 m. Compaction of the third 0.5 m thick lift of compacted sieved till on the upstream toe liner tie-in with an excavator from Sta. 20+760 m to 20+820 m.

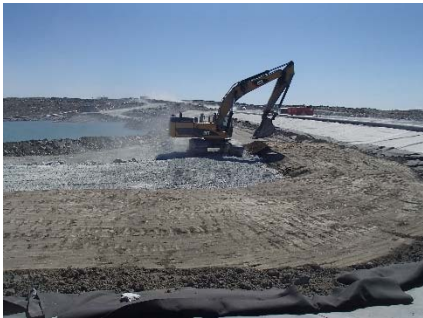
SD3-344 (2018-07-16), looking S from Sta. 20+610/-43 m. Placement of a third 0.5 m thick lift of low quality till (0-150 mm) from El. 142.5 m to 143 m from Sta. 20+570 m to 20+590 m.

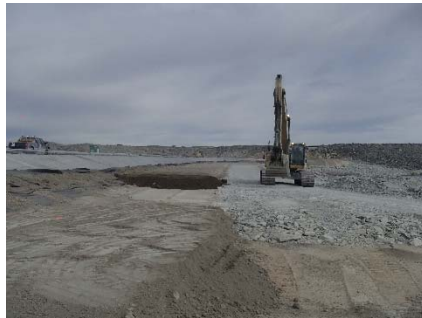
SD3-345 (2018-07-17), looking NW from Sta. 20+760/-42 m. Placement of a fourth 0.5 m thick lift of low quality till (0-150 mm) from El. 143 m to 143.5 m from Sta. 20+619 m to 20+777 m.

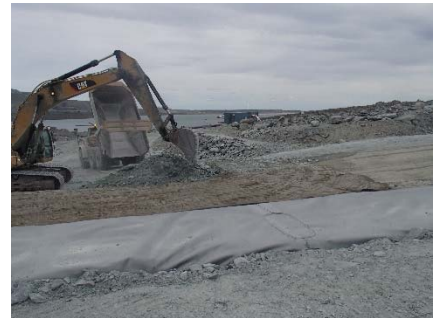
SD3-346 (2018-07-17), looking E from Sta. 20+760/-21 m. Placement of a third 0.5 m thick lift of fine UM rockfill (0-500 mm) upstream of the low quality till (0-150mm) from El. 143 m to 143.5 m from Sta. 20+668 m to 20+777 m.

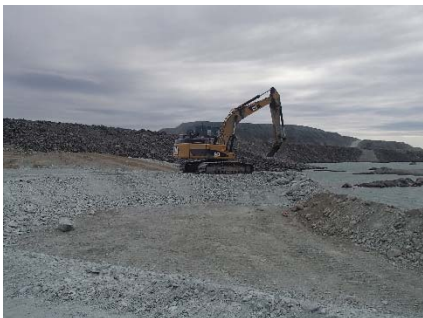
SD3-347 (2018-07-18), looking W from Sta. 20+640/-41 m. Placement of a third 0.5 m thick lift of fine UM rockfill (0-500 mm) upstream of the low quality till (0-150mm) from El. 143 m to 143.5 m from Sta. 20+688 m to 20+619 m.

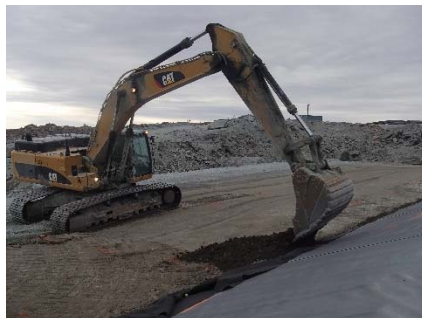
SD3-348 (2018-07-18), looking E from Sta. 20+760/-25 m. Placement of a 0.5 m thick layer of compacted sieved till on the upstream slope of SD3 with an excavator from Sta. 20+777 m to 20+807 m. No large rock was allowed to be placed against the LLDPE liner.

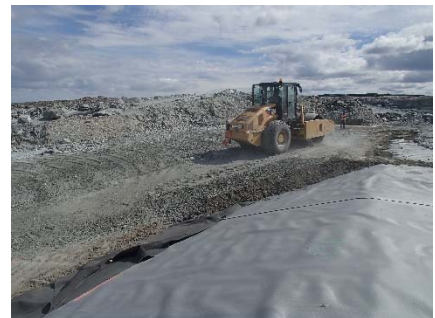
SD3-349 (2018-07-18), looking SE from Sta. 20+765/-29 m. Compaction of the 0.5 m thick lift of fine filter on the top of the upstream toe liner tie-in with a 10 tonne smooth-drum compactor with vibration (4 passes) from Sta. 20+777 m to 20+807 m.

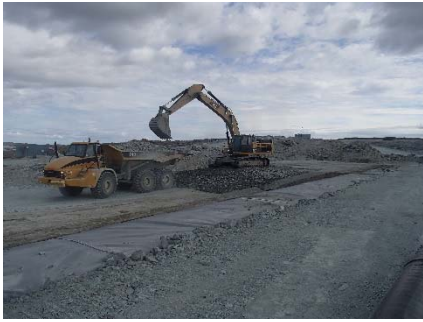
SD3-350 (2018-07-18), looking SE from Sta. 20+740/-24 m. Placement of a 0.5 m thick lift of coarse filter on the top of 0.5 m lift of low quality till (0-150 mm) the fine filter on the upstream toe liner at El. 143.5 m with an excavator from Sta. 20+777 m to 20+807 m.

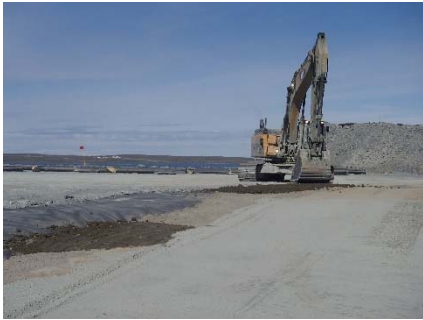
SD3-353 (2018-07-22), looking SW from Sta. 20+580/-49 m. View of SD3 at the end of the 2018 construction phase.

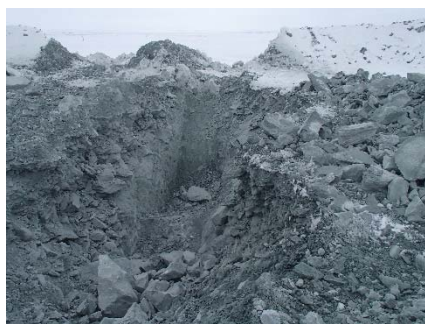
NCIS-001 (2018-05-19). View of a test pit in the UM rockfill lift at El. 152 m: a thick layer of snow (2 m) underlies the rockfill.

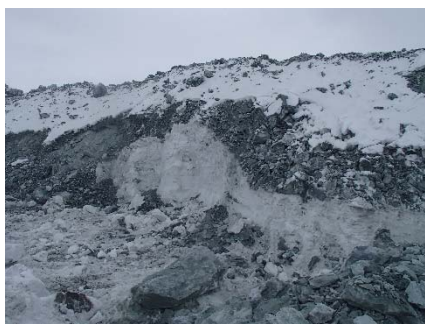
NCIS-002 (2018-05-19). View of the scraped upstream side of the UM rockfill lift at El. 152 m: a thick layer of snow (1.5 m) underlies the rockfill.

NCIS-003 (2018-05-19). Excavation of the snow-rich upstream toe material on an average width of 2 to 3 m with an excavator.

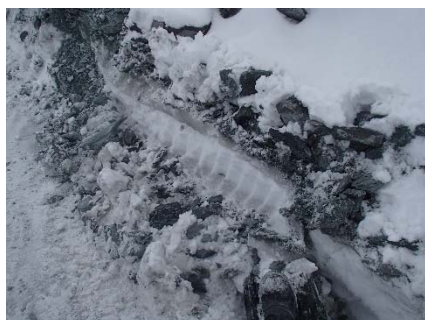
NCIS-004 (2018-05-19). View of the scraped upstream side of the UM rockfill lift at El. 152 m further to the north: the snow layer is only observed at the toe and is approximately 0.5 m thick.

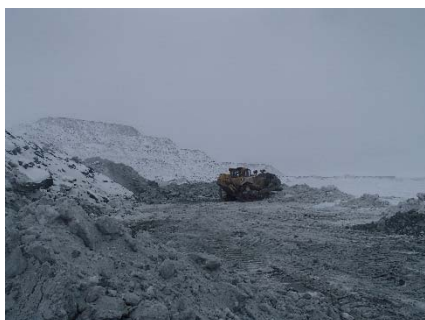
NCIS-005 (2018-05-19). Removal of the excavated material, pushed with a dozer towards the center of the North Cell to clear the upstream toe.

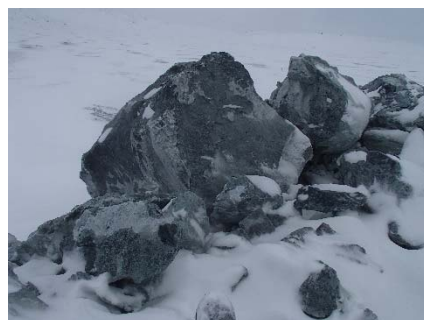
NCIS-006 (2018-05-19). View of oversized boulders on the UM rockfill lift at El. 152 m.

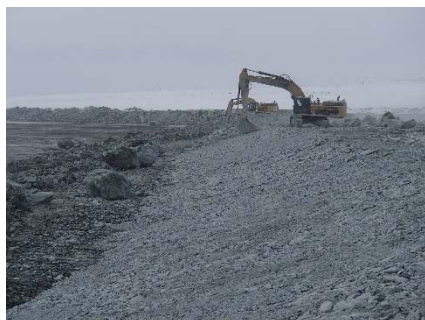
NCIS-007 (2018-05-20). Profiling of the upstream slope (3H:1V) from El. 150 to 152 m with an excavator.

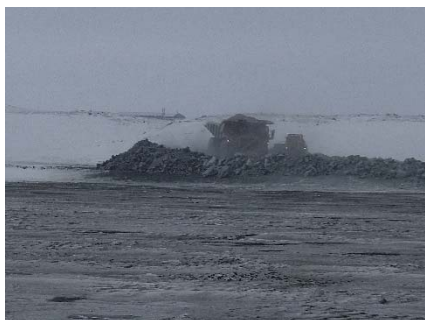
NCIS-008 (2018-05-20). Placement a 2 m thick (approx.) lift of UM rockfill from El. 150 m to El. 152 m (approx.) with a dozer. The material is of good quality and is well graded.

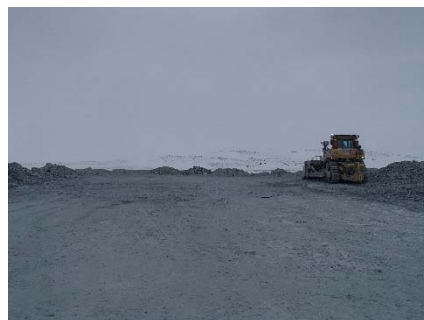
NCIS-009 (2018-05-21). Placement a 2 m thick (approx.) lift of UM rockfill from El. 150 m to El. 152 m (approx.) with a dozer from Sta. 1+880 m to 1+825 m (o.s. unavailable).

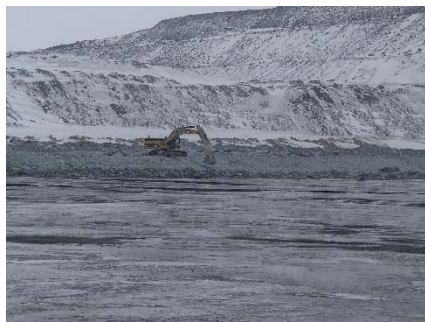
NCIS-010 (2018-05-21). Profiling of the upstream slope (3H:1V) from El. 150 to 152 m with an excavator from Sta. 2+777 m to 2+400 m.

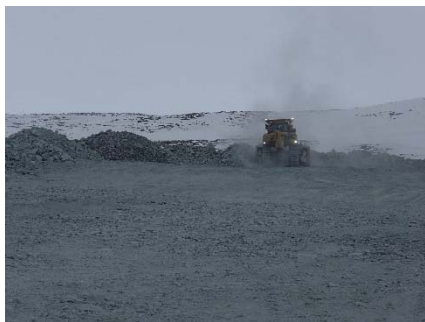
NCIS-011 (2018-05-22), looking SW from Sta. 2+000 m. Placement a 2 m thick (approx.) lift of UM rockfill from El. 150 m to El. 152 m (approx.) with a dozer from Sta. 1+880 m to 1+767 m (o.s. unavailable).

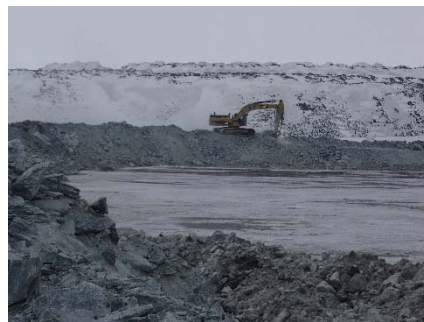
NCIS-012 (2018-05-22), looking NW from Sta. 2+000 m. Profiling of the upstream slope (3H:1V) from El. 150 to 152 m with an excavator from Sta. 2+325 m to 2+275 m (approx.).

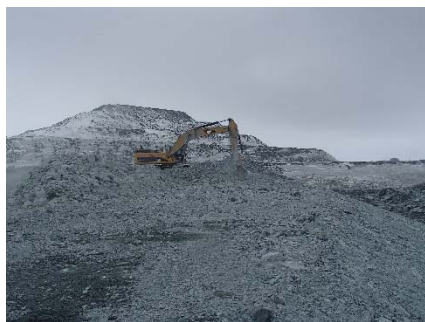
NCIS-013 (2018-05-22), looking NE from Sta. 2+600 m. Correction of the crest elevation with an excavator to achieve a closer elevation to 152 m around Sta. 2+650 m.

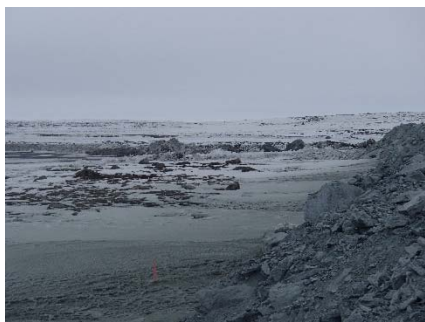
NCIS-014 (2018-05-22), looking SE from Sta. 1+900 m. View of the natural soil on which the 2015 capping is built.

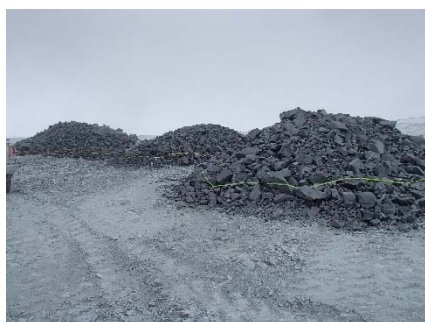
NCIS-016 (2018-05-23), looking SE from Sta. 1+750 m. View of the Iron Formation rockfill (PAG material) piles on the North Cell Internal Structure.

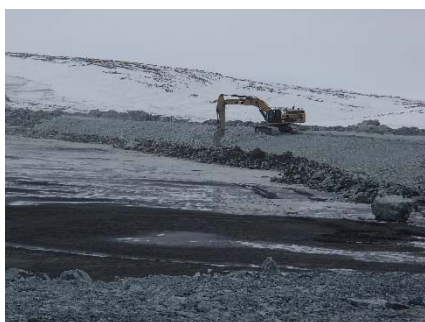
NCIS-017 (2018-05-24), looking SW from Sta. 2+290 m. Profiling of the upstream slope (3H:1V) from El. 150 to 152 m with an excavator from Sta. 2+138 m to 1+989 m.

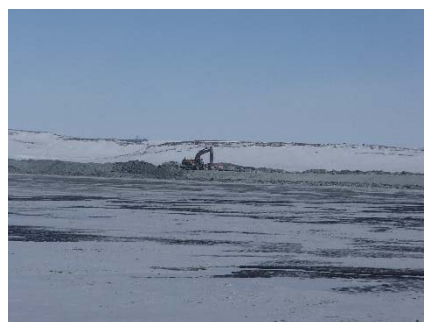
NCIS-018 (2018-05-25), looking NW from Sta. 2+310 m. Profiling of the upstream slope (3H:1V) from El. 150 to 152 m with an excavator from Sta. 1+989 m to 1+860 m.

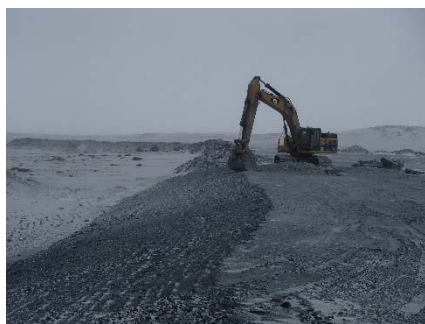
NCIS-019 (2018-05-26), looking SW from Sta. 2+100 m. Profiling of the upstream slope (3H:1V) from El. 150 to 152 m with an excavator from Sta. 1+860 m to 1+678 m. The portion between Sta. 1+900 m and 1+800 m, where the structure is built on the natural ground, was not profiled.

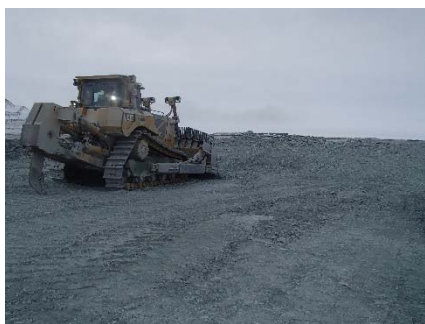
NCIS-020 (2018-05-27), looking S from Sta. 1+570 m. Placement a 2 m thick (approx.) lift of UM rockfill from El. 150 m to El. 152 m (approx.) with a dozer from Sta. 1+564 m to 1+535 m (o.s. unavailable).

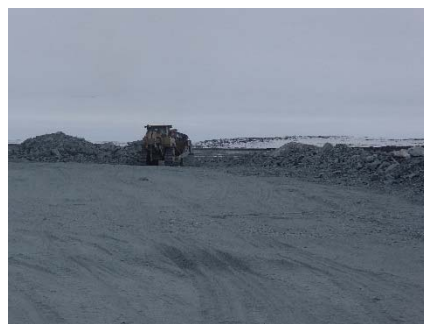
NCIS-021 (2018-05-28), looking S from Sta. 1+550 m. Placement a 2 m thick (approx.) lift of UM rockfill from El. 150 m to El. 152 m (approx.) with a dozer from Sta. 1+535 m to 1+500 m (o.s. unavailable).

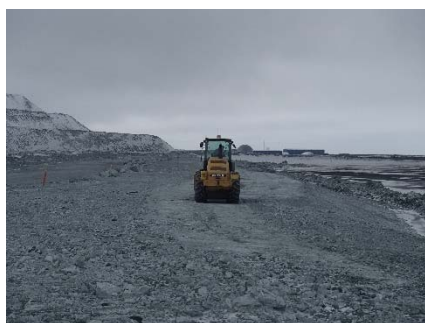
NCIS-022 (2018-05-30), looking SE from Sta. 2+245 m. Compaction of the 2 m lift (approx.) of ultramafic (UM) rockfill at El. 152 m with a 10-tonne smooth-drum compactor with vibration (6 passes) between the haul truck traffic lane and the upstream slope from Sta. 2+625 to 1+625 m (o.s. unavailable).

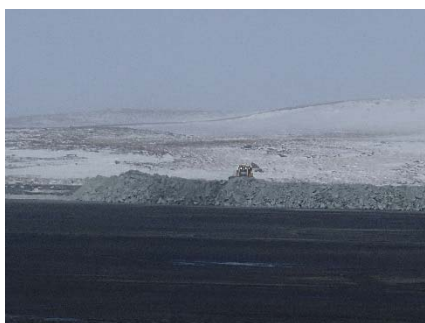
NCIS-023 (2018-05-31), looking W from Sta. 2+570 m. Placement of a 2 m thick (approx.) lift of UM rockfill from El. 150 m to El. 152 m (approx.) with a dozer from Sta. 1+500 m to 1+450 m (o.s. unavailable). The material is of good quality and is well graded.

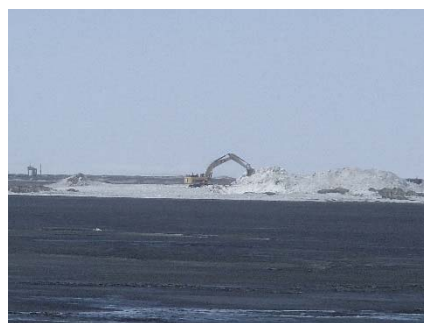
NCIS-024 (2018-05-31), looking SW from Sta. 2+570 m. Removal of the snow bank in the footprint with an excavator from Sta. 1+160 m to 1+120 m (approx.).

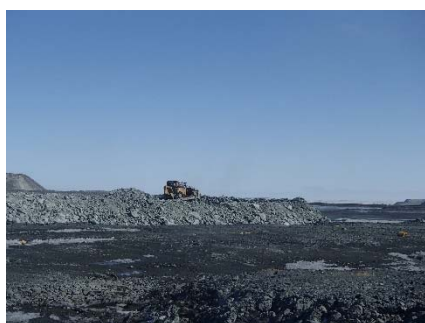
NCIS-025 (2018-06-01), looking SE from Sta. 1+475 m. Placement of a 2 m thick (approx.) lift of UM rockfill from El. 150 m to El. 152 m (approx.) with a dozer from Sta. 1+450 m to 1+390 m (o.s. unavailable). The material is of good quality and is well graded.

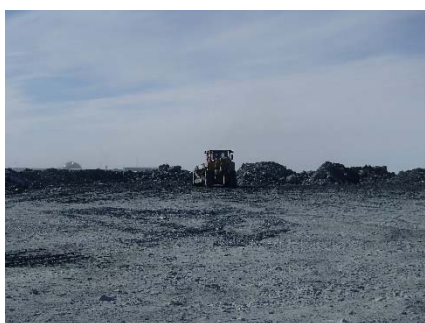
NCIS-026 (2018-06-06), looking S from Sta. 1+440/+2 m. Placement of a 2 m thick (approx.) lift of UM rockfill from El. 150 m to El. 152 m (approx.) with a dozer from Sta. 1+390 m to 1+365 m (+10 m to -29 m).

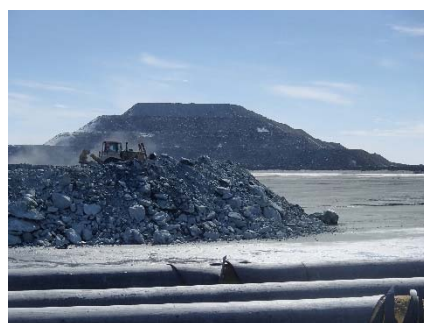
NCIS-027 (2018-06-07), looking E from Sta. 1+360/+67 m. Placement of a 2 m thick (approx.) lift of UM rockfill from El. 150 m to El. 152 m (approx.) with a dozer from Sta. 1+365 m to 1+360 m (+9 m to -28 m).

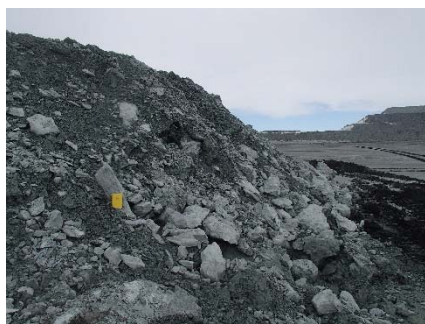
NCIS-028 (2018-06-09), looking E from Sta. 1+340/+3 m. View of the UM rockfill lift approximately 3.2 m thick.

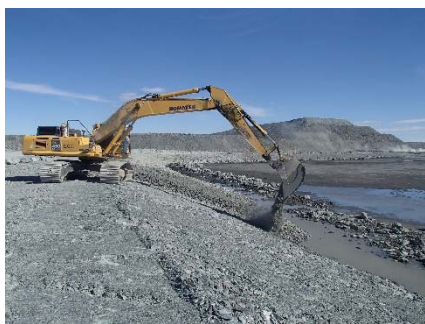
NCIS-029 (2018-06-19), looking SE from Sta. 2+120/-27 m. Placement of a 0.5 m thick lift of coarse filter in the upstream slope from El. 150 m to 152 m with an excavator from Sta. 2+280 m to 2+105 m.

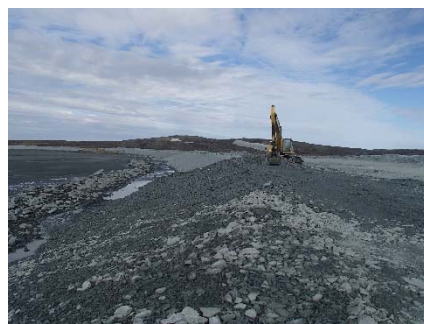
NCIS-030 (2018-06-20), looking W from Sta. 2+140/-29 m. Placement of a 0.5 m thick lift of coarse filter in the upstream slope from El. 150 m to 152 m with an excavator from Sta. 2+105 m to 1+930 m. Notice the presence of water ponding at the bottom of the slope.

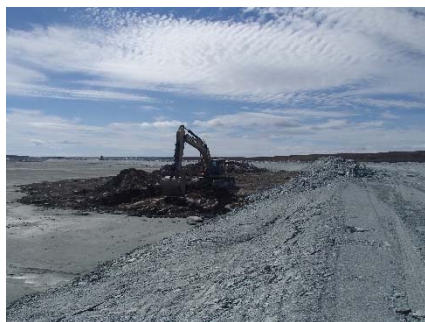
NCIS-031 (2018-06-20), looking SW from Sta. 1+880/-21 m. Final clean-up of the dike footprint with an excavator to reach a good quality bedrock from Sta. 1+800 to 1+850 m (o.s. -42 to -33 m).

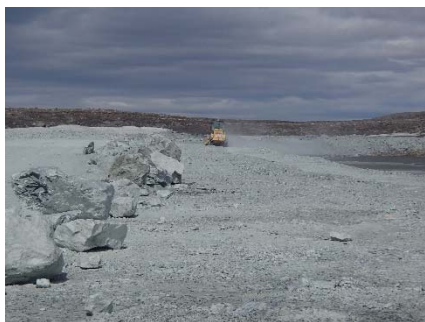
NCIS-032 (2018-06-20), looking N from Sta. 1+400/-24 m. Compaction of the 2 m lift (approx.) of ultramafic (UM) rockfill at El. 152 m with a 10-tonne smooth-drum compactor with vibration (6 passes) between the haul truck traffic lane and the upstream slope from Sta. 1+660 to 1+380 m (o.s. -45 to -24 m).

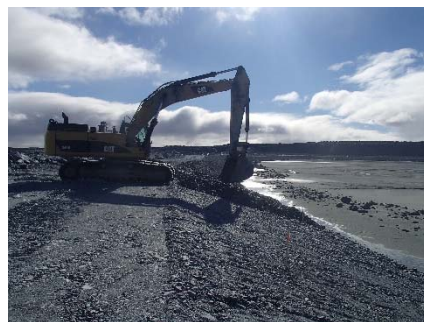
NCIS-033 (2018-06-21), looking E from Sta. 1+900/-21 m. Placement of a 0.5 m thick lift of coarse filter in the upstream slope from El. 150 m to 152 m with an excavator from Sta. 1+930 m to 1+715 m.

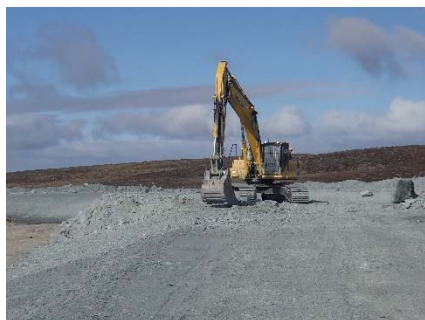
NCIS-034 (2018-06-21), looking W from Sta. 1+900/-21 m. Profiling of the upstream slope (3H:1V) from El. 150 to 152 m with an excavator from Sta. 1+860 m to 1+750 m.

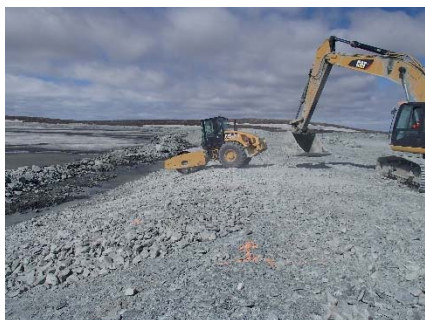
NCIS-035 (2018-06-21), looking N from Sta. 2+550/-25 m. Compaction of the 0.5 m lift (approx.) of coarse filter between El. 150 and 152 m with a 10-tonne smooth-drum compactor (4 passes) in the upstream slope from Sta. 2+524 m to 2+450 m.

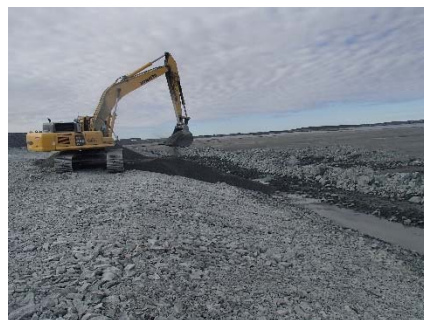
NCIS-036 (2018-06-22), looking SE from Sta. 1+900/-21 m. Placement of a 0.5 m thick lift of fine filter over the coarse filter in the upstream slope from El. 150 m to 152 m with an excavator from Sta. 2+542 m to 2+475 m.

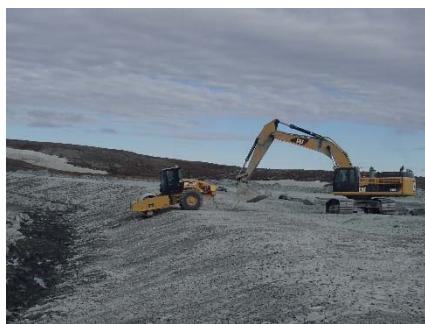
NCIS-037 (2018-06-22), looking NW from Sta. 1+550/-25 m. Compaction of the 0.5 m lift (approx.) of coarse filter between El. 150 and 152 m with a 10-tonne smooth-drum compactor (4 passes) in the upstream slope from Sta. 2+450 to 1+805 m.

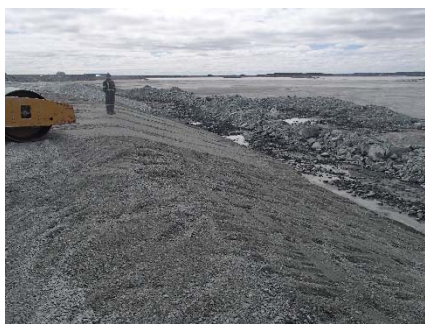
NCIS-038 (2018-06-22), looking SE from Sta. 2+510/-28 m. Compaction of the 0.5 m lift (approx.) of fine filter between El. 150 and 152 m with a 10-tonne smooth-drum compactor (4 passes) in the upstream slope from Sta. 2+542 m to 2+475 m.

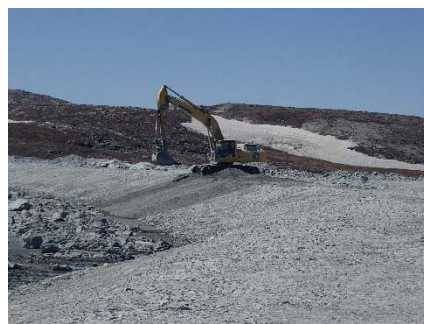
NCIS-039 (2018-06-23), looking W from Sta. 2+200/-24 m. Placement of a 0.5 m thick lift of fine filter over the coarse filter in the upstream slope from El. 150 m to 152 m with an excavator from Sta. 2+460 m to 2+475 m and from Sta. 2+065 m to 1+980 m.

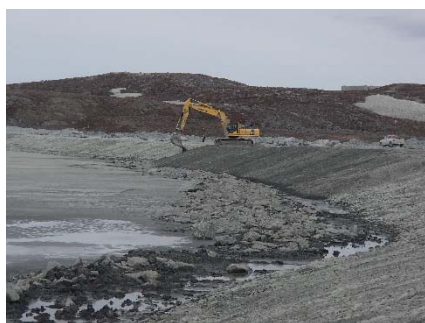
NCIS-040 (2018-06-24), looking W from Sta. 2+185/-25 m. Placement of a 0.5 m thick lift of fine filter over the coarse filter in the upstream slope from El. 150 m to 152 m with an excavator from Sta. 2+305 m to 2+460 m and from Sta. 1+980 m to 1+835 m.

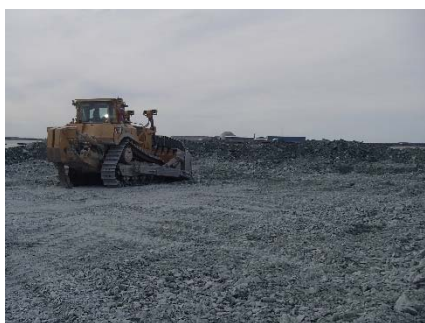
NCIS-041 (2018-06-24), looking S from Sta. 1+220/-7 m. Placement of a 1.5 to 2 m thick (approx.) lift of UM rockfill from El. 148 m to El. 150 m (approx.) with a dozer from Sta. 1+197 m to 1+150 m (-7 m to -41 m).

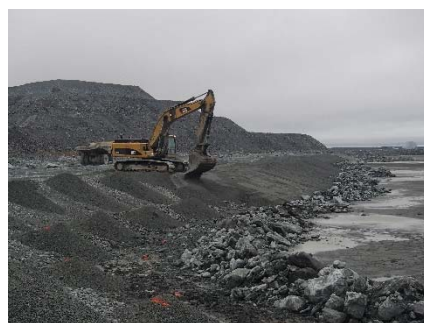
NCIS-042 (2018-06-25), looking SE from Sta. 2+210/-27 m. Placement of a 0.5 m thick lift of fine filter over the coarse filter in the upstream slope from El. 150 m to 152 m with an excavator from Sta. 2+305 m to 2+040 m.

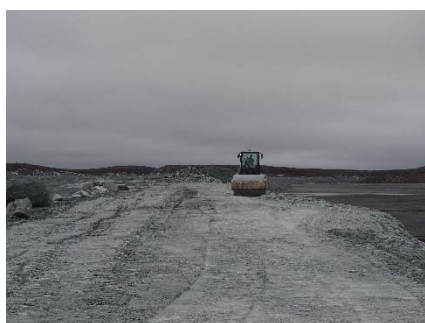
NCIS-043 (2018-06-25), looking N from Sta. 1+250/-38 m. Compaction of the 1.5 to 2 m lift (approx.) of ultramafic (UM) rockfill at El. 150 m with a 10-tonne smooth-drum compactor with vibration (6 passes) between the haul truck traffic lane and the upstream slope from Sta. 1+330 to 1+200 m (o.s. -53 to -24 m).

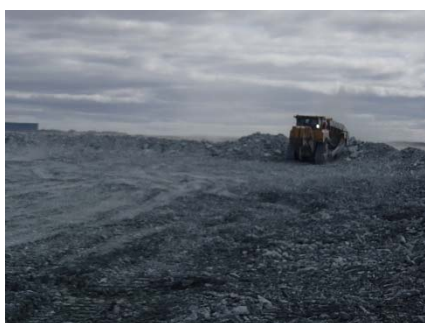
NCIS-044 (2018-06-25), looking S from Sta. 1+200/-19 m. Placement of a 1.5 to 2 m thick (approx.) lift of UM rockfill from El. 148 m to El. 150 m (approx.) with a dozer from Sta. 1+150 m to 1+120 m (-92 m to +10 m). The material is of good quality and is well graded.

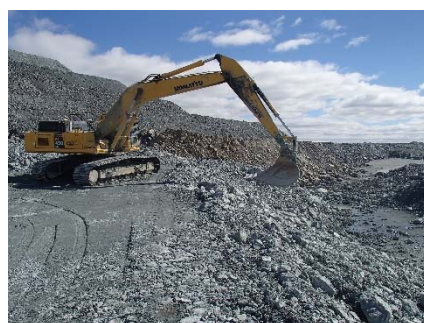
NCIS-045 (2018-06-25), looking S from Sta. 2+760/-40 m. Profiling of the upstream slope (3H:1V) from El. 150 to 152 m with an excavator from Sta. 2+715 m to 2+825 m.
