## QA DAILY REPORT

1897439-1576-TM-Rev0

### QA DAILY REPORT FOR JUNE 27<sup>TH</sup>, 2018 – TSF NORTH CELL CONSTRUCTION - MEADOWBANK (1897439)

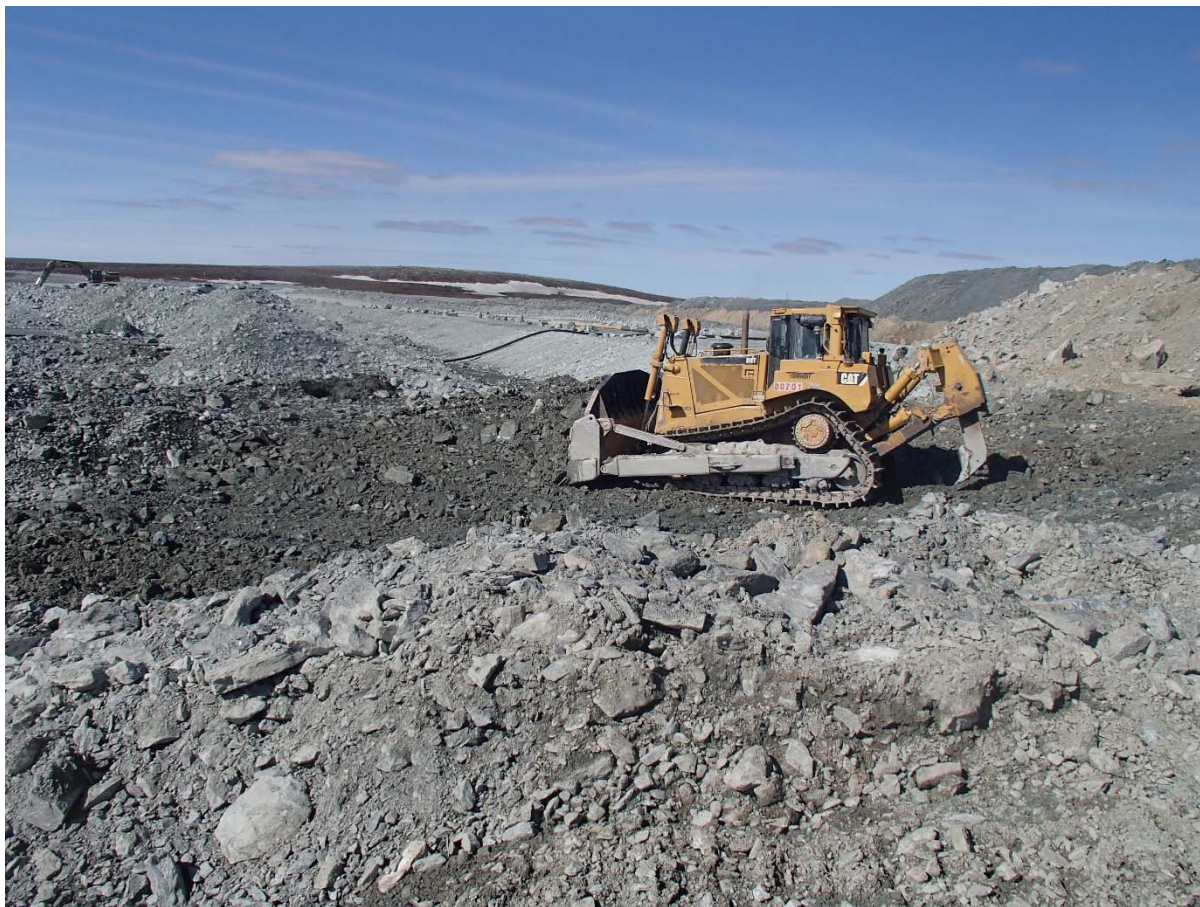
**Photograph NCIS-049: From Sta. 2+870/-28 m (approx.), looking N. Removing of UM rockfill material from the capping with a dozer to level the surface to El. 150 m from Sta. 2+760 m to 2+850 m (o.s. -29 to -17 m).**

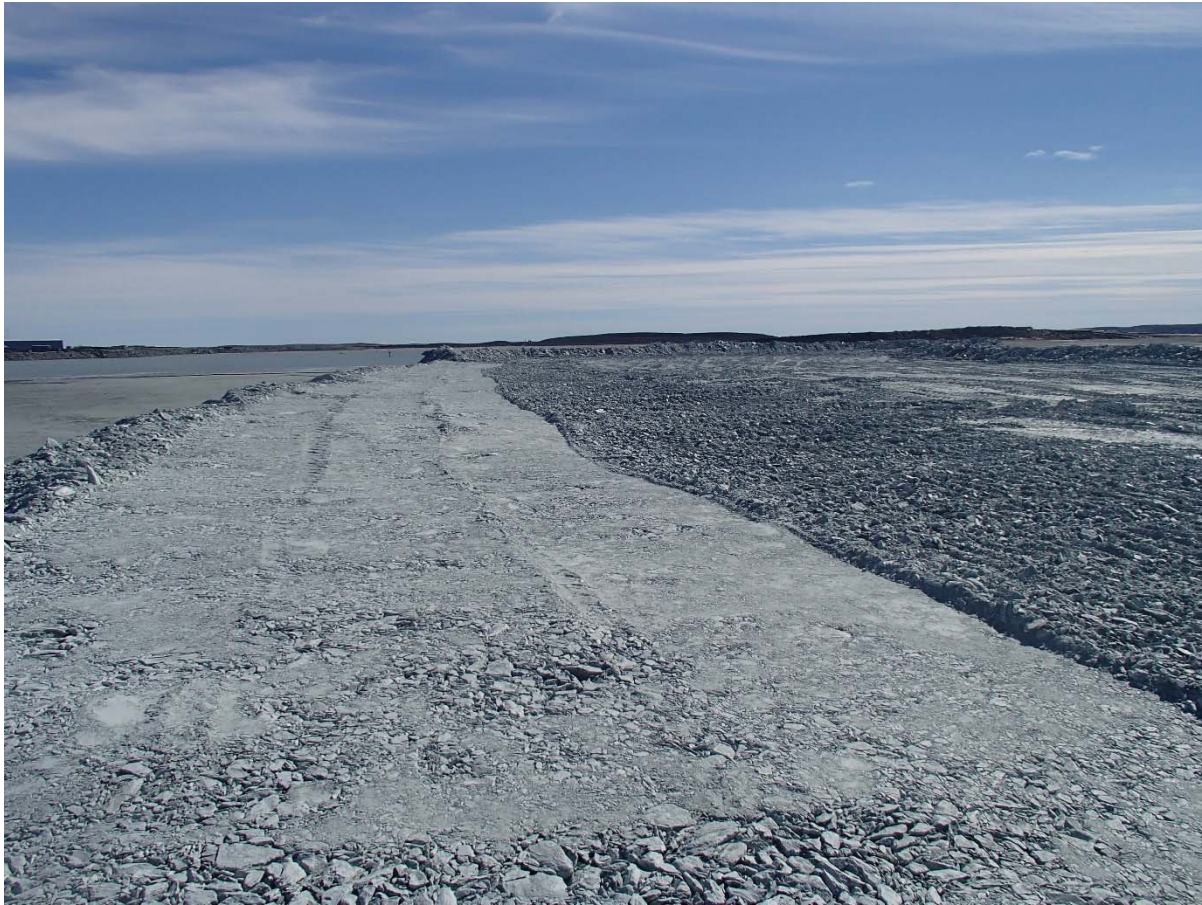
**Photograph NCIS-050: From Sta. 1+230/-55 m (approx.), looking S. Compaction of the 1.5 to 2 m lift (approx.) of ultramafic (UM) rockfill at El. 150 m with a 10-tonne smooth-drum compactor with vibration (6 passes) between the haul truck traffic lane and the upstream slope from Sta. 1+220 to 1+130 m (o.s. -91 to -44 m).**

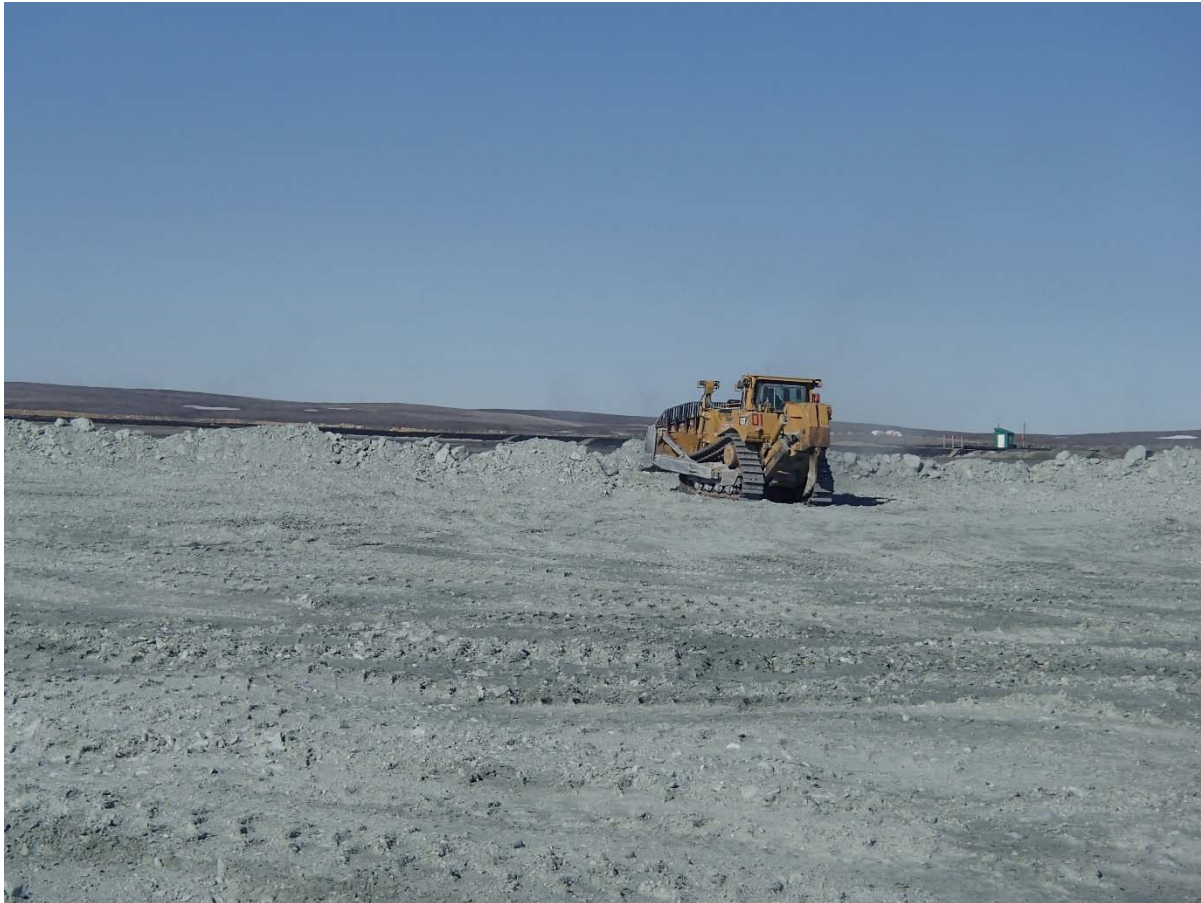
**Photograph NCIS-052: From Sta. 1+120/-87 m (approx.), looking SW. Placement of a 1.5 to 2 m thick (approx.) lift of UM rockfill from El. 148 m to El. 150 m (approx.) with a dozer from Sta. 1+115 m to 1+100 m (-107 m to -45 m). The material is of good quality and is well graded.**

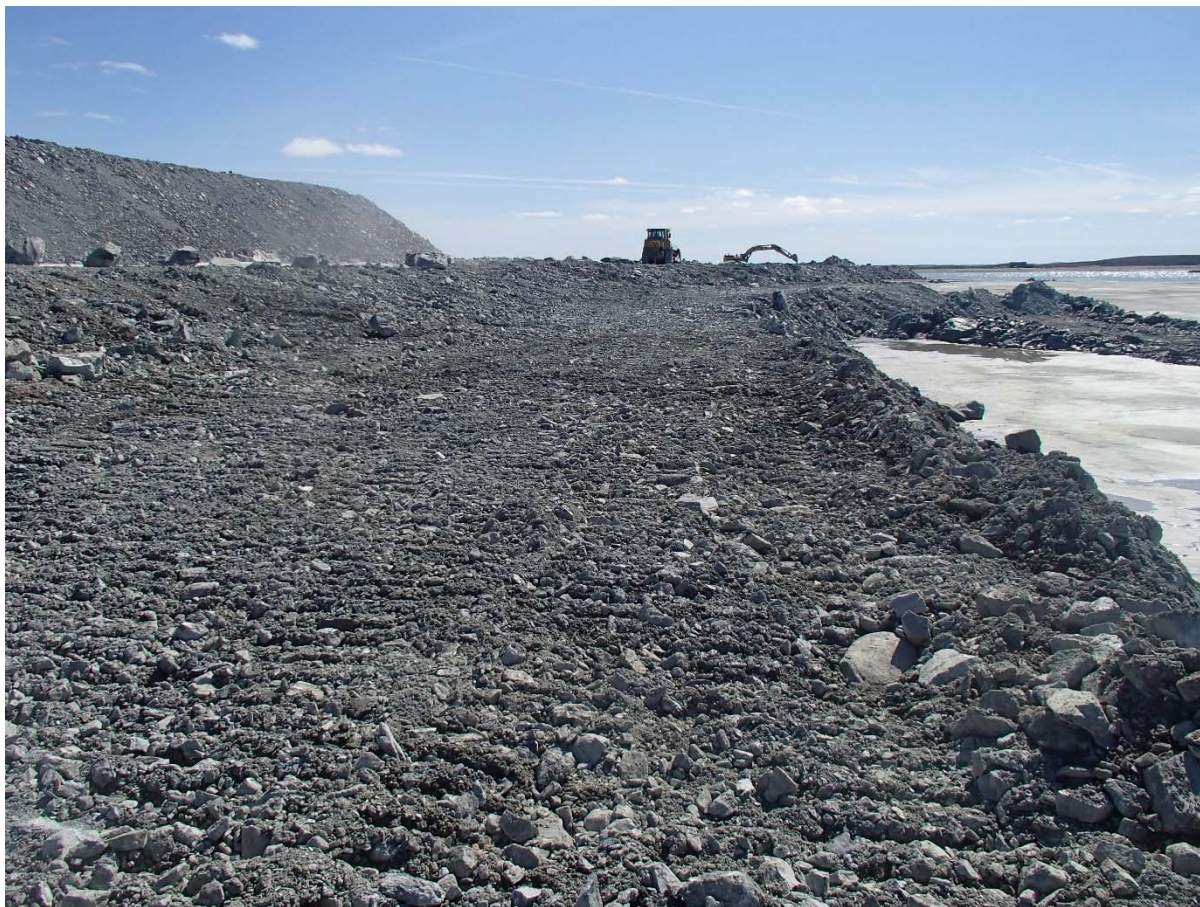
**Photograph NCIS-053: From Sta. 2+840/-37 m (approx.), looking S. Removing of UM rockfill material from the capping with a dozer to level the surface to El. 152 m from Sta. 2+850 m to 2+980 m (o.s. -38 to -24 m).**

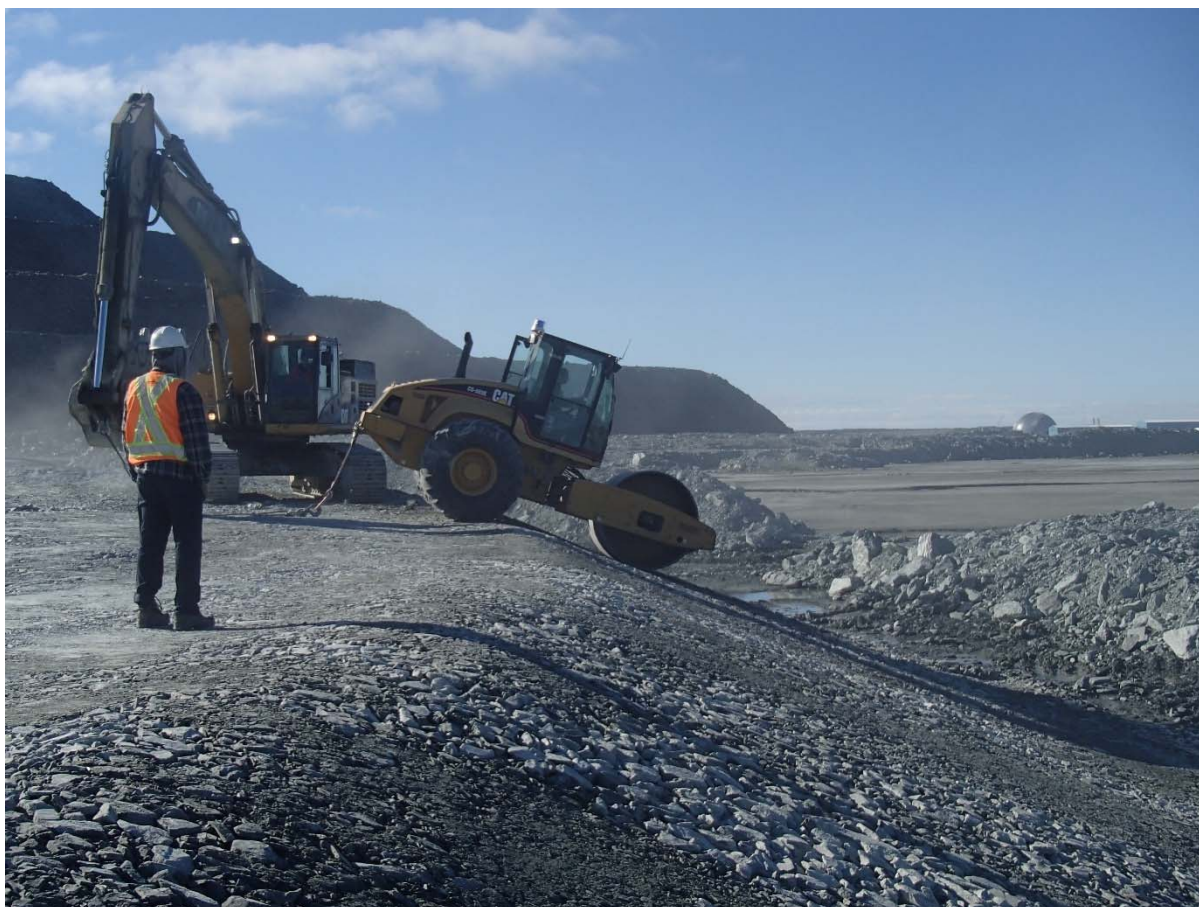
**Photograph NCIS-054:** From Sta. 2+580/-31 m (approx.), looking SE. Compaction of the 0.5 m lift (approx.) of coarse filter between El. 150 and 152 m with a 10-tonne smooth-drum compactor with vibration (4 passes) in the upstream slope from Sta. 2+560 m to 2+815 m.

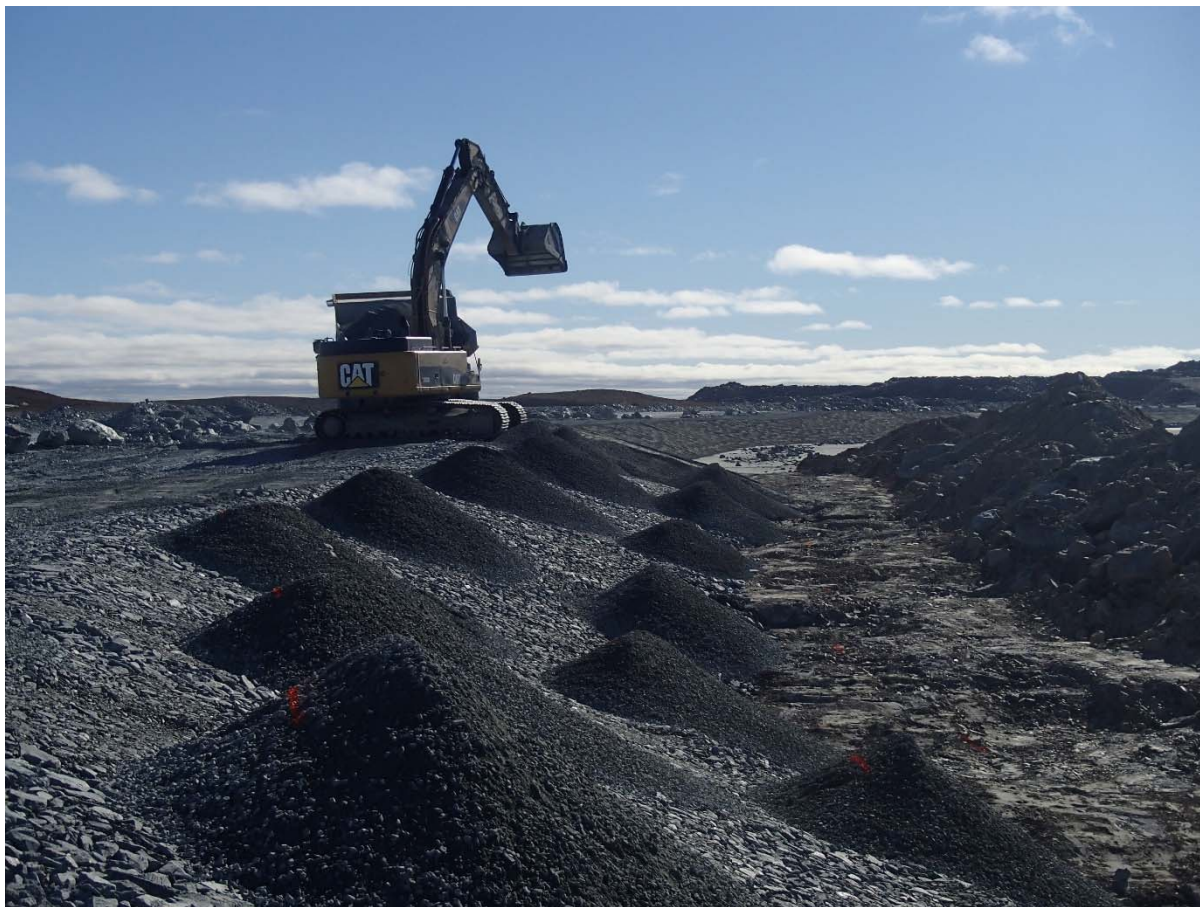
**Photograph NCIS-055: From Sta. 1+730/-42 m (approx.), looking NE. Placement of a 0.5 m thick lift of fine filter over the coarse filter in the upstream slope from El. 150 m to 152 m with an excavator from Sta. 1+820 m to 1+595 m.**

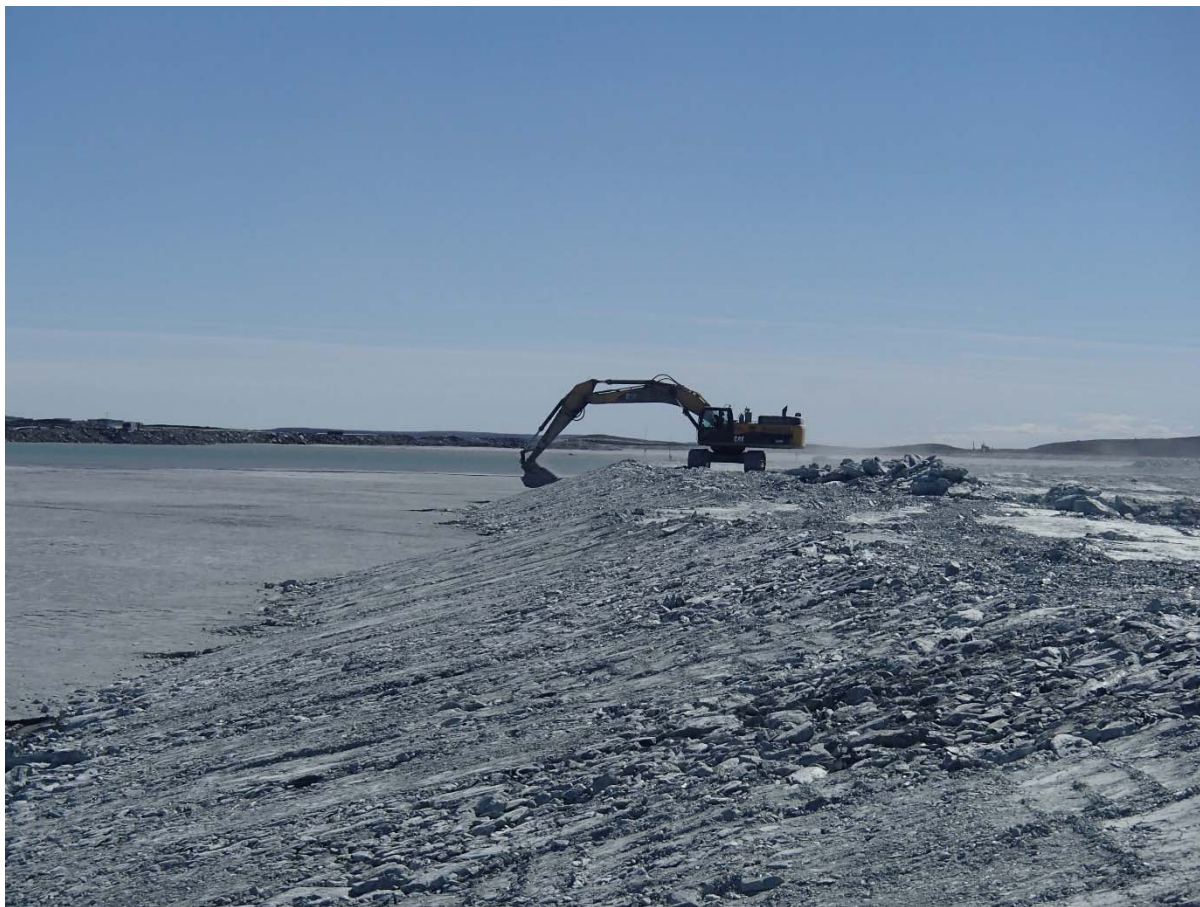
**Photograph NCIS-056: From Sta. 1+290/-39 m (approx.), looking S. Profiling of the upstream slope (3H:1V) from El. 148 to 150 m with an excavator from Sta. 1+340 m to 1+130 m.**

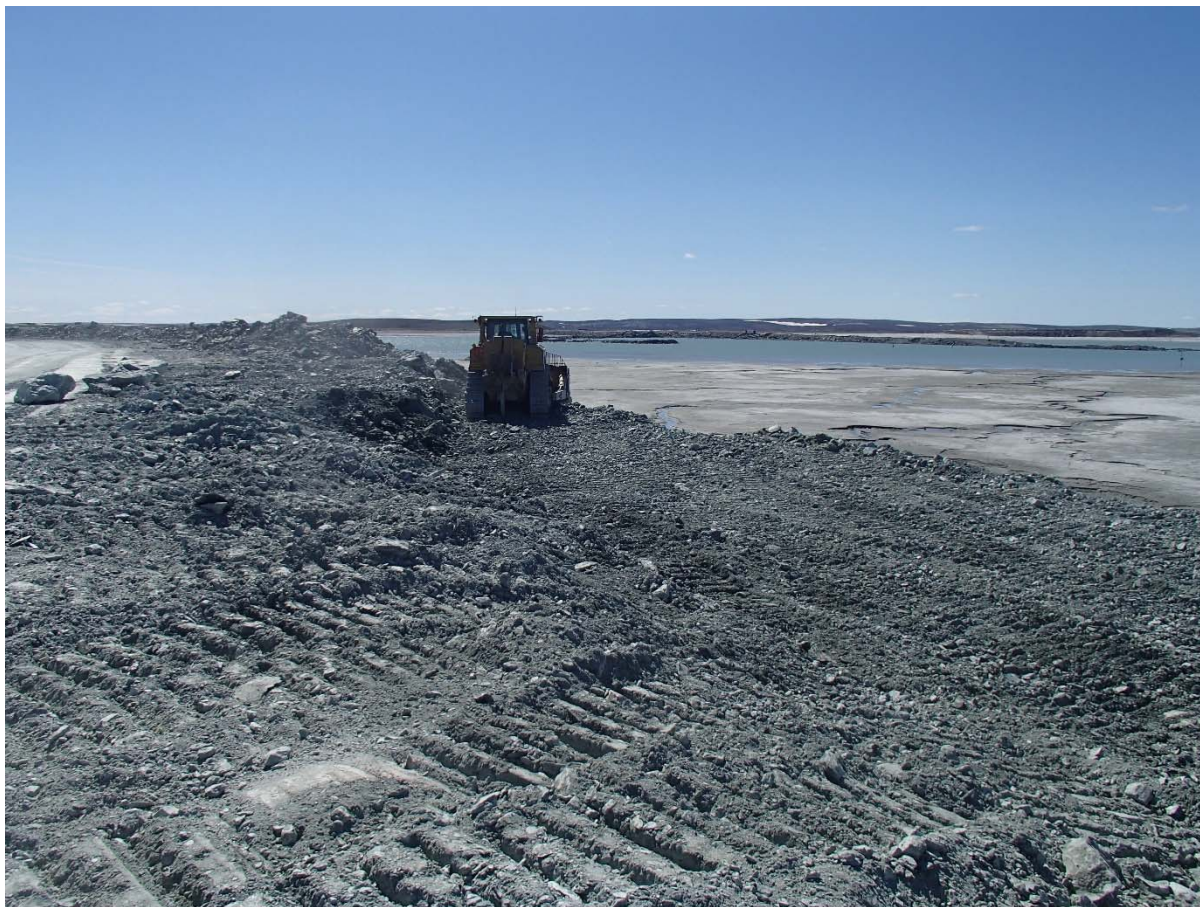
**Photograph NCIS-057: From Sta. 3+010/-15 m (approx.), looking SW. Removing of UM rockfill material from the capping with a dozer to level the surface to El. 152 m from Sta. 2+980 m to 3+050 m (o.s. -30 to -20 m).**

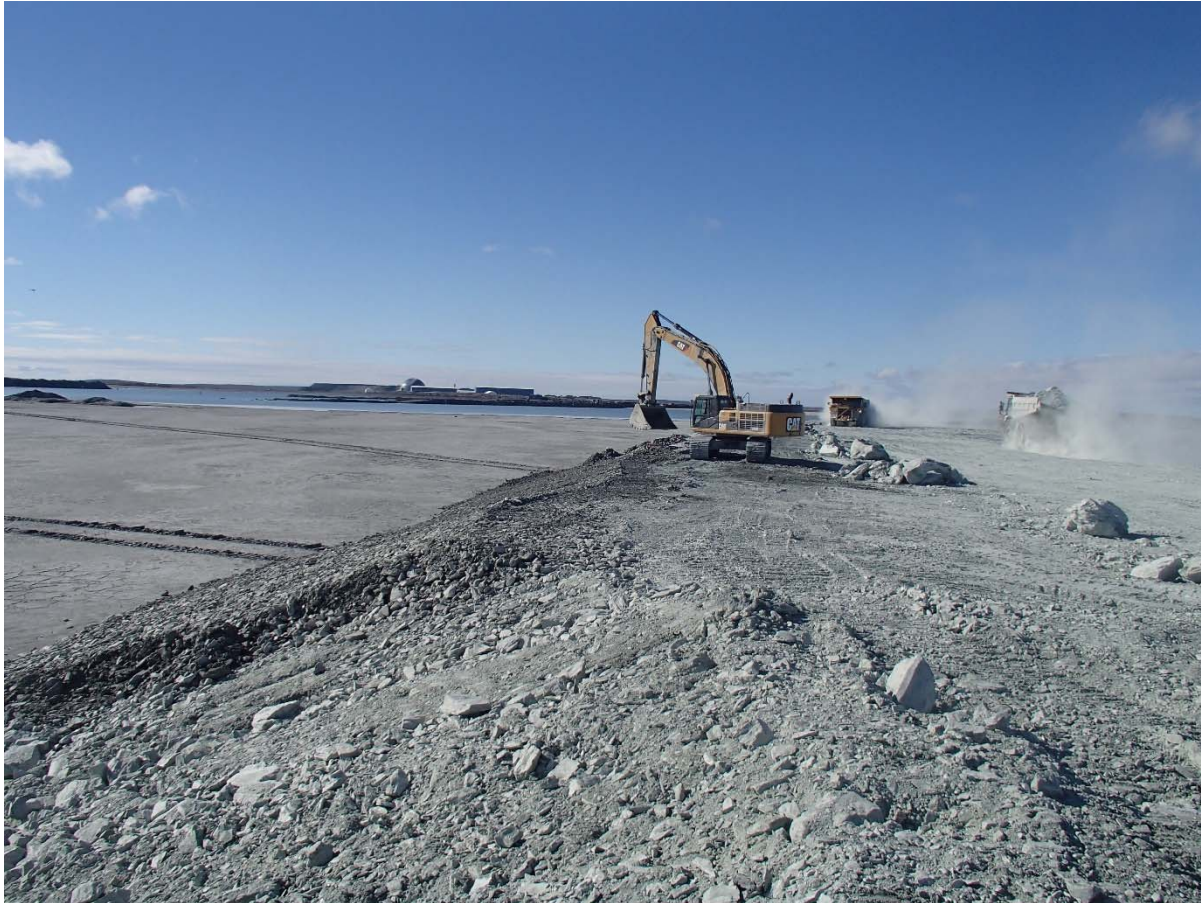
**Photograph NCIS-058:** From Sta. 1+340/-34 m (approx.), looking S. Placement of a 0.5 m thick lift of coarse filter in the upstream slope from El. 148 m to 152 m with an excavator from Sta. 1+340 m to 1+270 m.

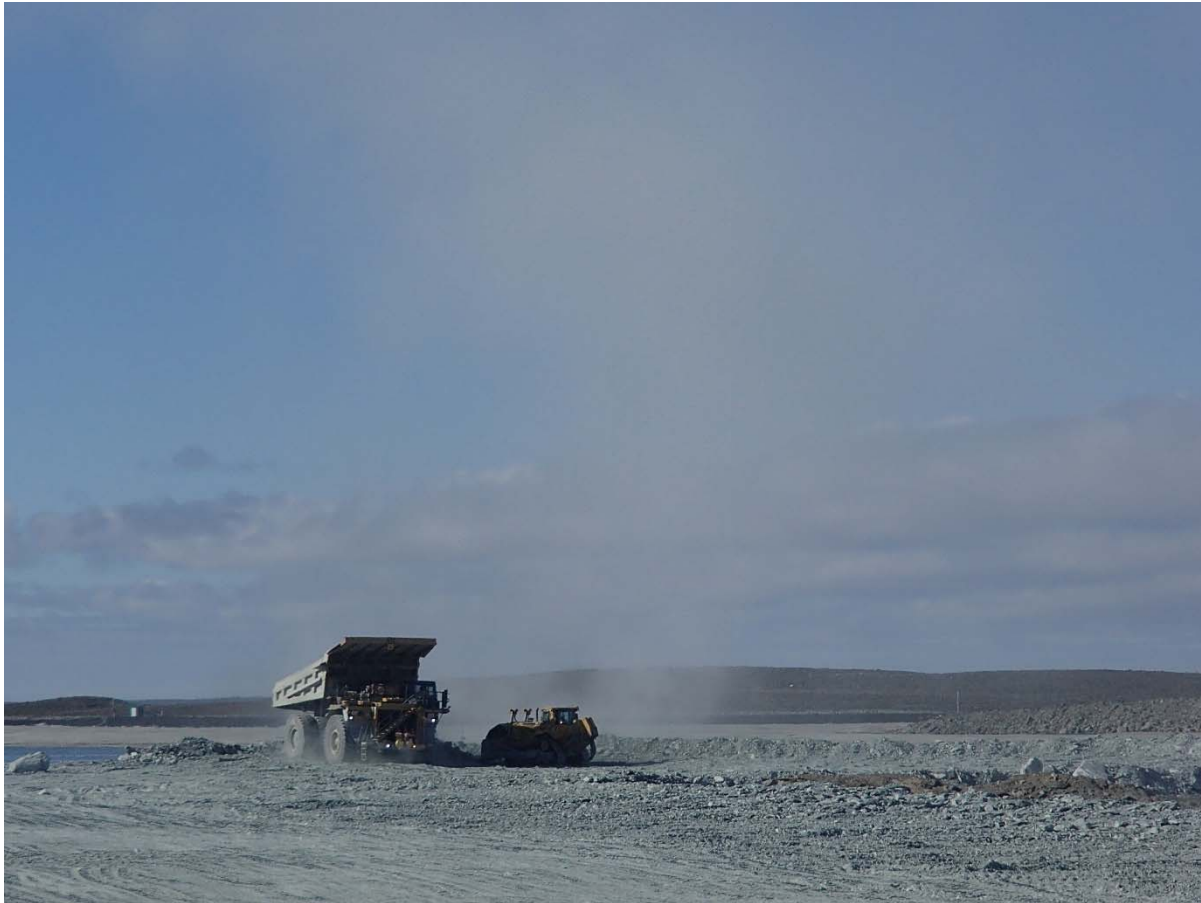
**Photograph NCIS-059: From Sta. 1+330/-34 m (approx.), looking S. Placement of a 1.5 to 2 m thick (approx.) lift of UM rockfill from El. 148 m to El. 150 m (approx.) with a dozer from Sta. 1+120 m to 1+100 m (-96 m to -60 m). The material is of good quality and is well graded.**

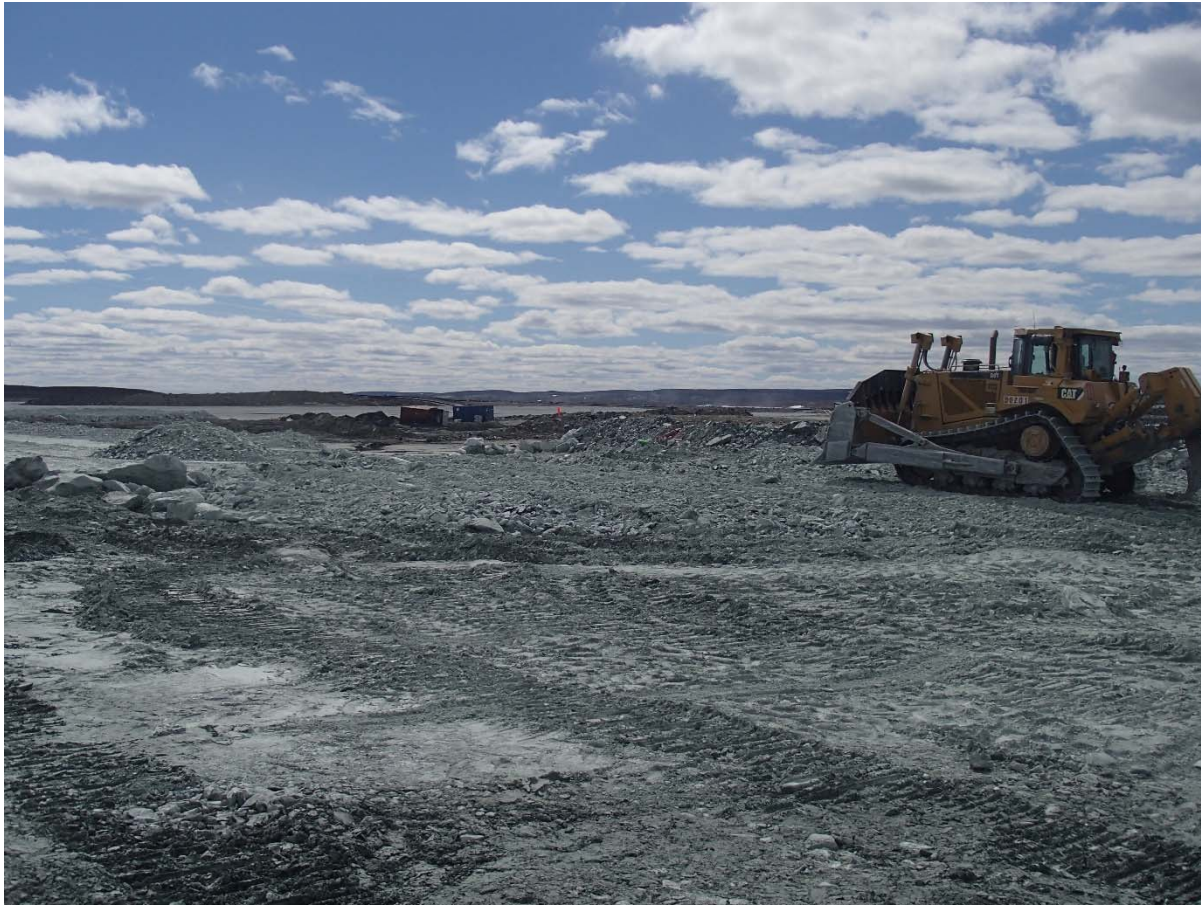
**Photograph NCIS-060: From Sta. 1+365/-35 m (approx.), looking SW. Placement of a 2 m thick (approx.) lift of UM rockfill from El. 150 m to El. 152 m (approx.) with a dozer from Sta. 1+340 m to 1+320 m (-19 m to +16 m). The material is of good quality and is well graded.**

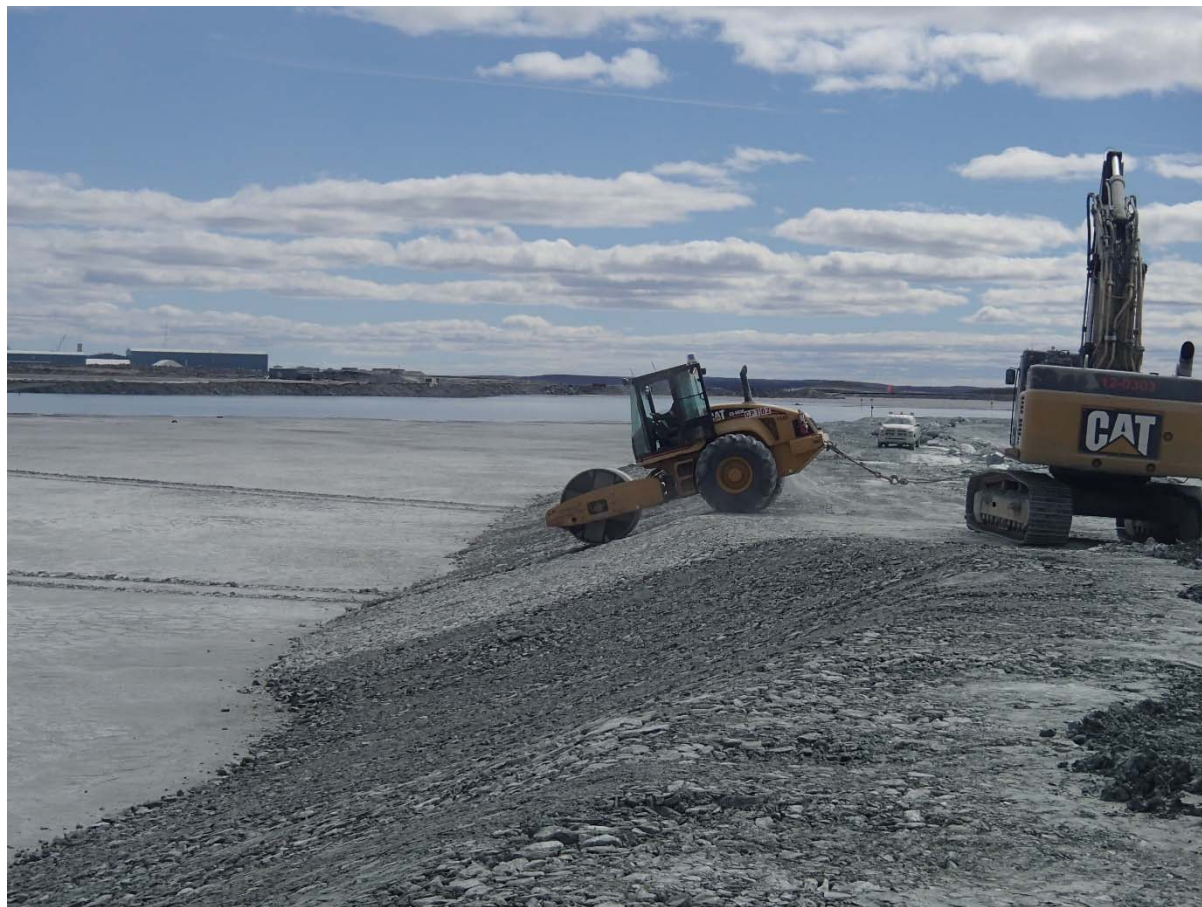
**Photograph NCIS-061: From Sta. 1+365/-35 m (approx.), looking S. Compaction of the 0.5 m lift of coarse filter between El. 148 and 152 m with a 10-tonne smooth-drum compactor with vibration (4 passes) in the upstream slope from Sta. 1+340 m to 1+270 m.**

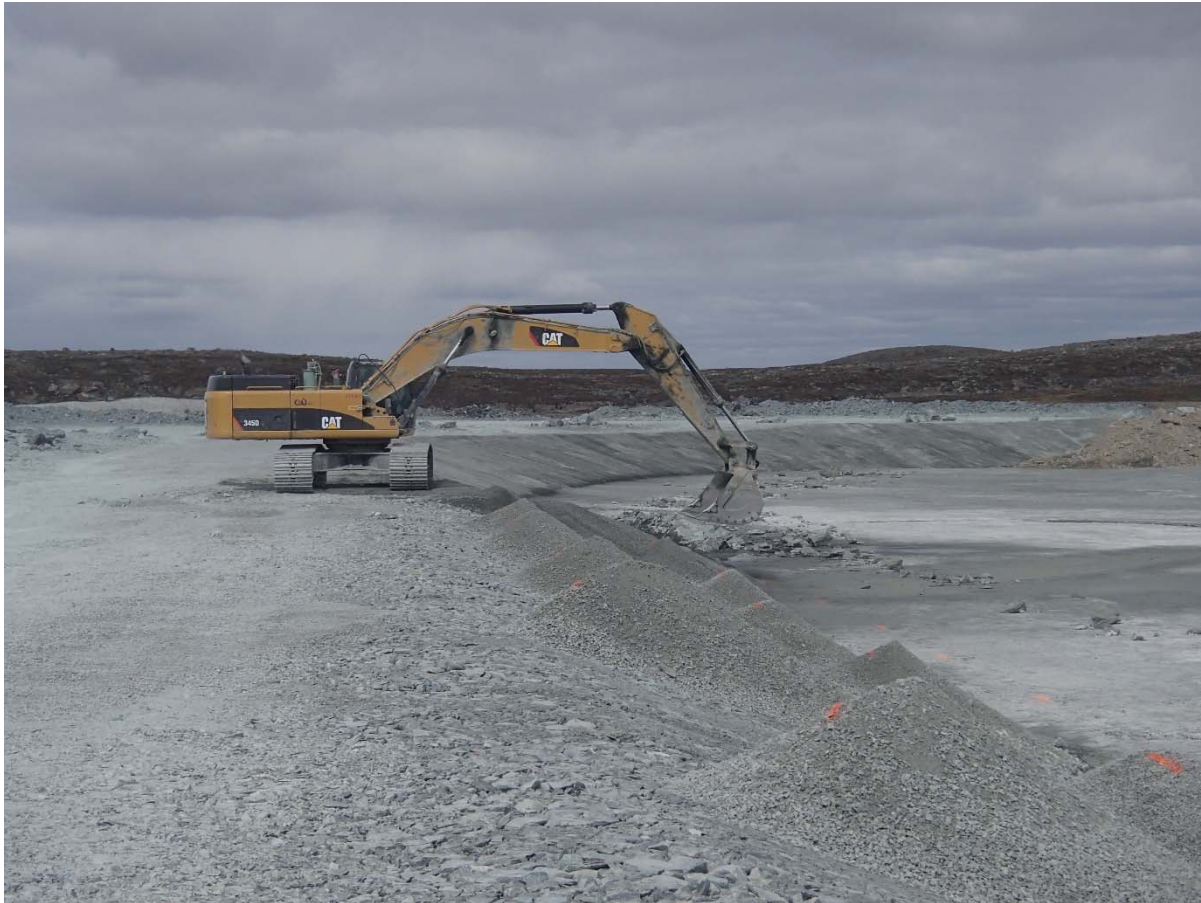
**Photograph NCIS-062: From Sta. 1+525/-33 m (approx.), looking N. Placement of a 0.5 m thick lift of fine filter over the coarse filter in the upstream slope from El. 150 m to 152 m with an excavator from Sta. 1+330 m to 1+260 m and from Sta. 1+595 m to 1+550 m.**

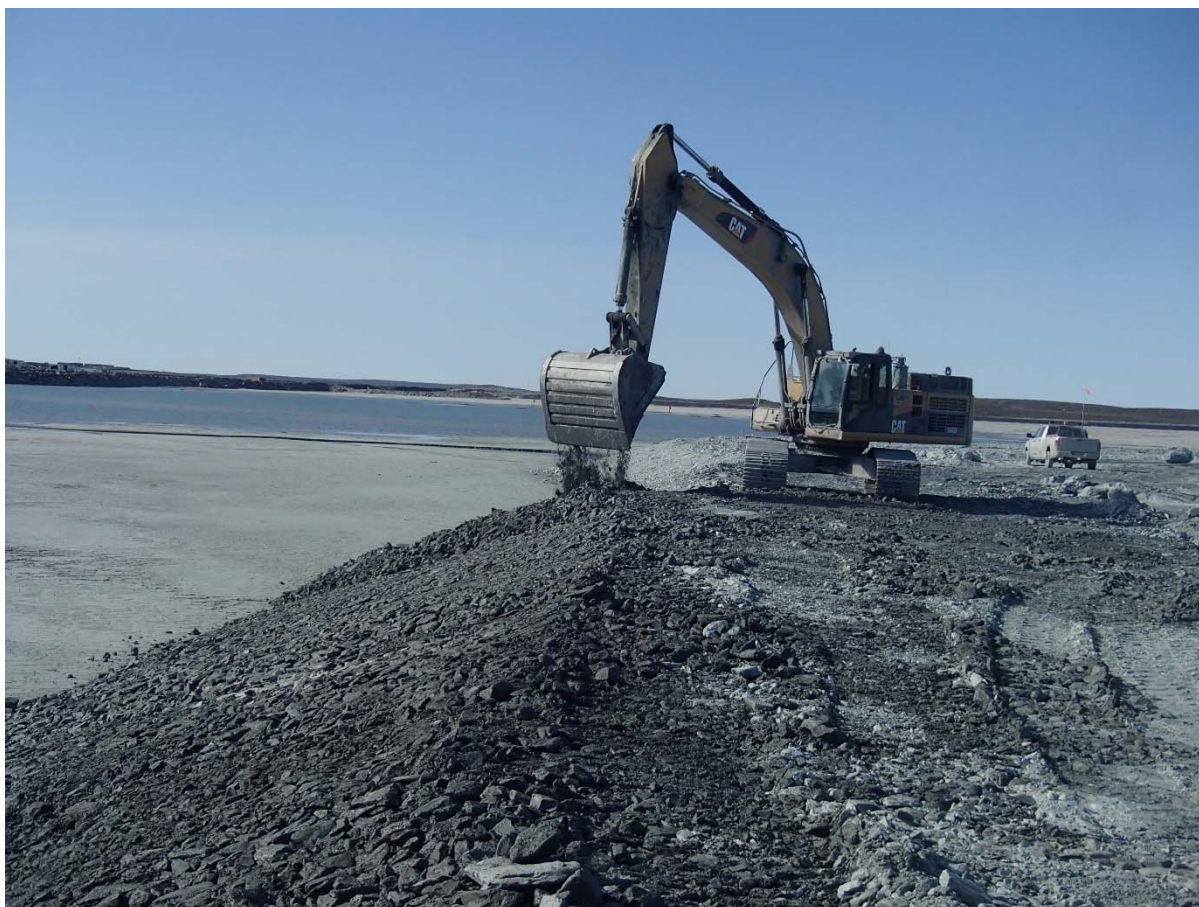
Photograph NCIS-063: From Sta. 1+200/-65 m (approx.), looking SW. Placement of a 0.5 m thick lift of coarse filter in the upstream slope from El. 148 m to 150 m with an excavator from Sta. 1+270 m to 1+100 m.

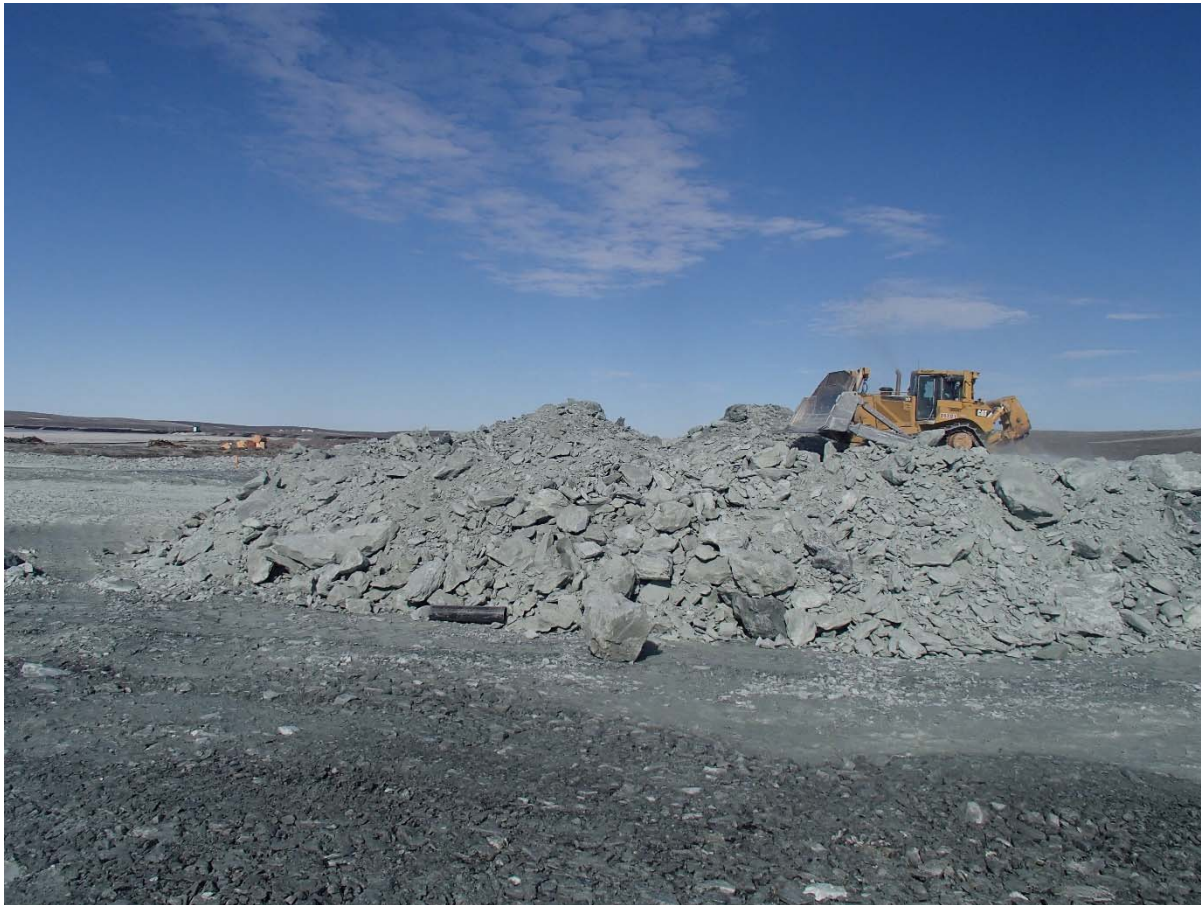
**Photograph NCIS-064: From Sta. 1+200/-65 m (approx.), looking W. Placement of a 2 m thick (approx.) lift of UM rockfill from El. 150 m to El. 152 m (approx.) with a dozer from Sta. 1+320 m to 1+235 m (-65 m to -45 m). The material is of good quality and is well graded.**

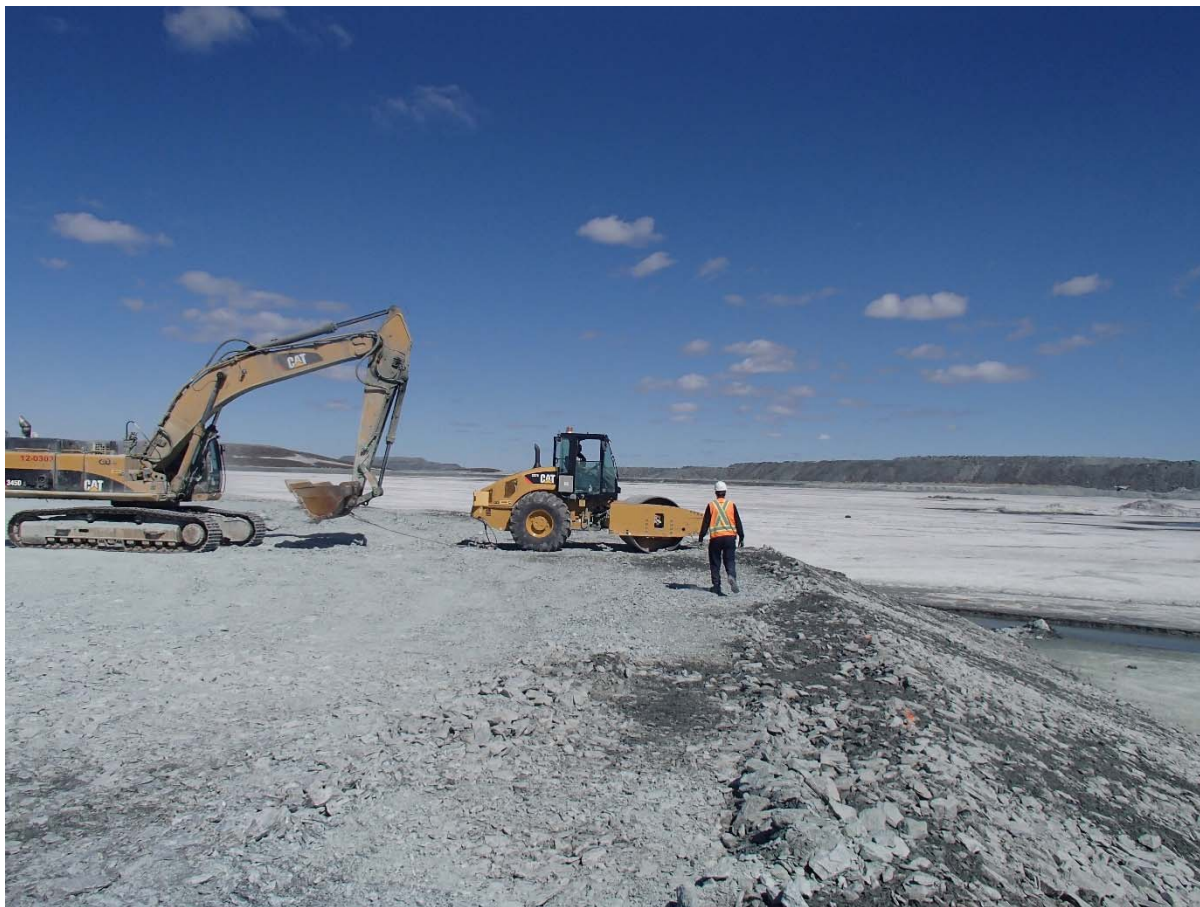
**Photograph NCIS-065: From Sta. 1+140/-96 m (approx.), looking NE. Compaction of the 0.5 m lift of coarse filter between El. 148 and 150 m with a 10-tonne smooth-drum compactor with vibration (4 passes) in the upstream slope from Sta. 1+270 m to 1+100 m.**

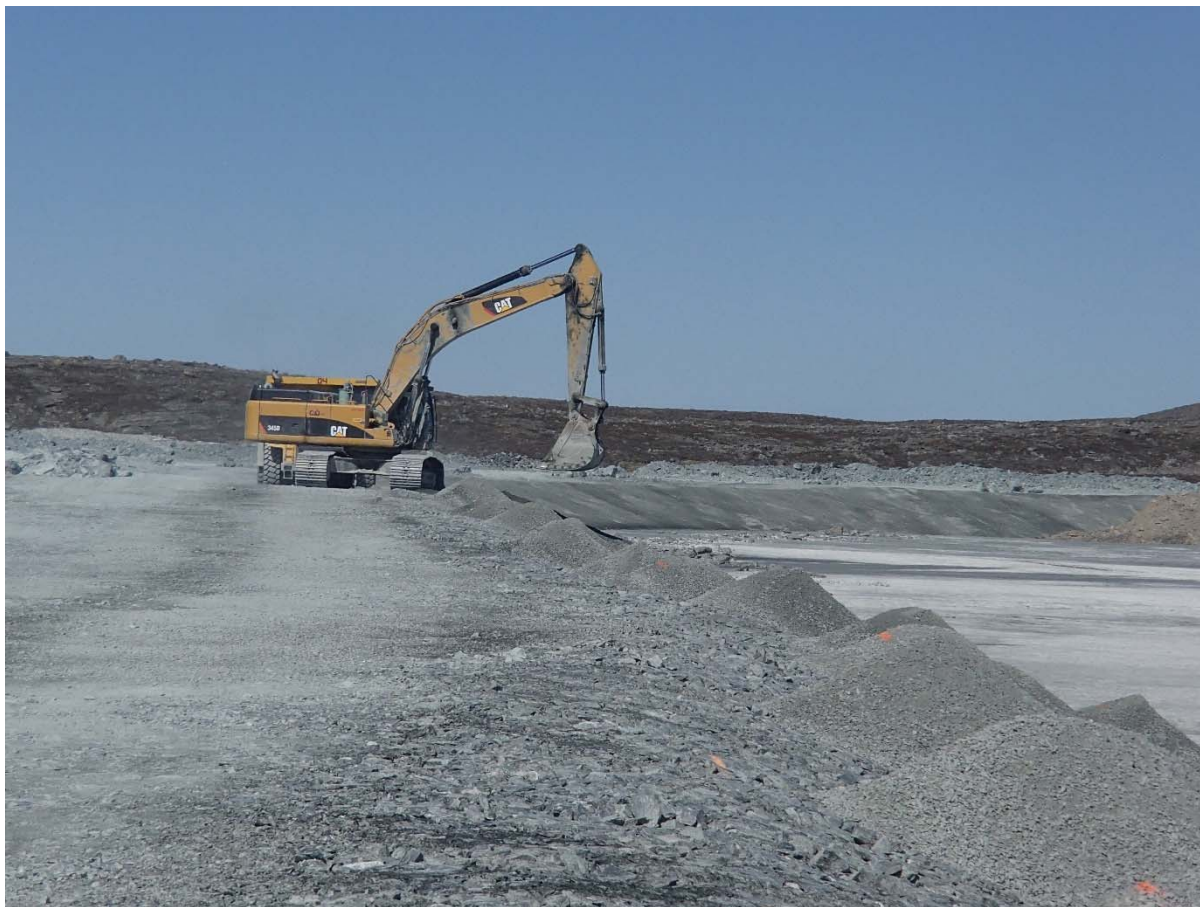
**Photograph NCIS-066: From Sta. 1+400/-34 m (approx.), looking N. Placement of a 0.5 m thick lift of fine filter over the coarse filter in the upstream slope from El. 150 m to 152 m with an excavator from Sta. 1+595 m to 1+550 m.**

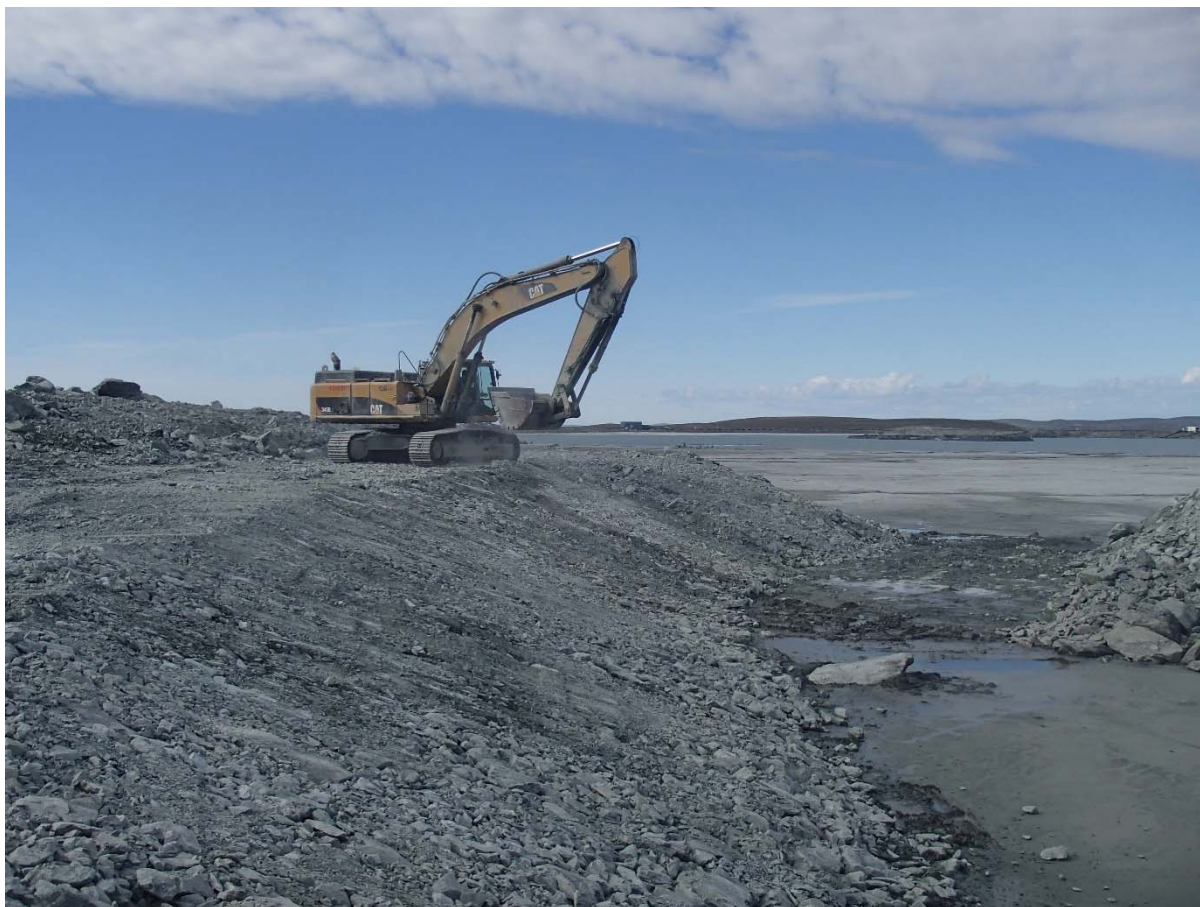
**Photograph NCIS-067: From Sta. 2+880/-26 m (approx.), looking SW. Profiling of the upstream slope (3H:1V) from El. 150 to 152 m with an excavator from Sta. 2+860 m to 2+975 m.**

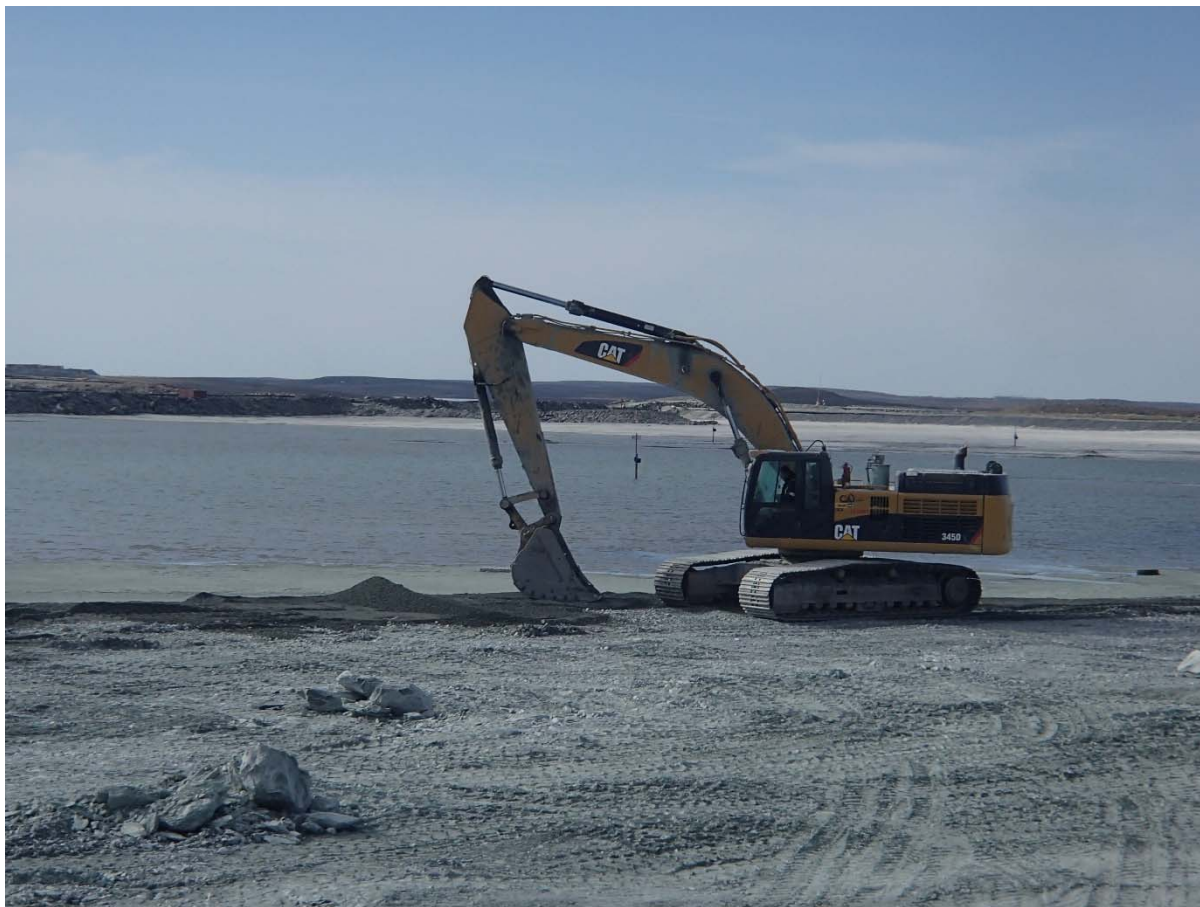
**Photograph NCIS-068:** From Sta. 1+150/-62 m (approx.), looking S. Placement of a 0.5 m thick lift of fine filter over the coarse filter in the upstream slope from El. 148 m to 150 m with an excavator from Sta. 1+180 m to 1+100 m.

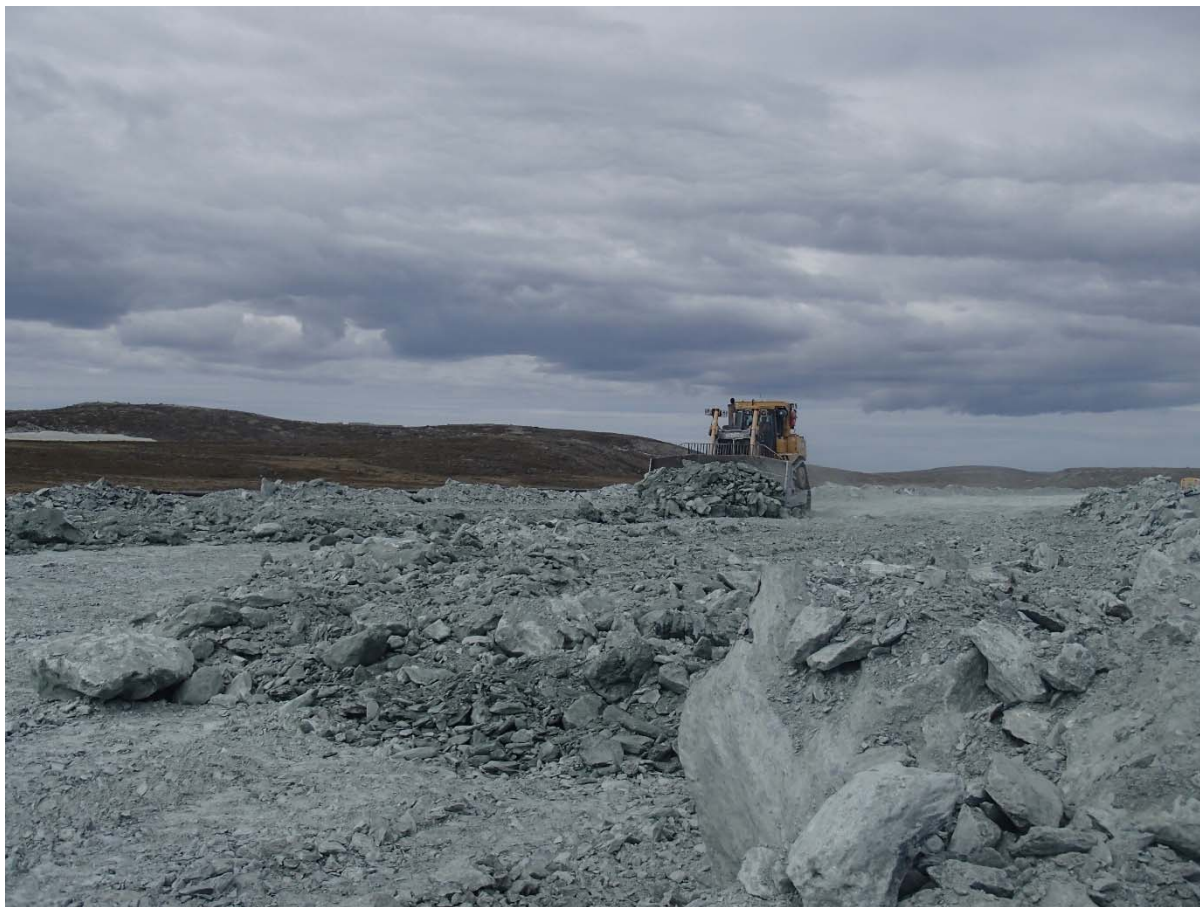
**Photograph NCIS-069: From Sta. 1+180/-56 m (approx.), looking NW. Placement of a 2 m thick (approx.) lift of UM rockfill from El. 150 m to El. 152 m (approx.) with a dozer from Sta. 1+235 m to 1+160 m (-60 m to -44 m). The material is of good quality and is well graded.**
