## QA DAILY REPORT

1897439-1576-TM-Rev0

### QA DAILY REPORT FOR JUNE 27<sup>TH</sup>, 2018 – TSF NORTH CELL CONSTRUCTION - MEADOWBANK (1897439)

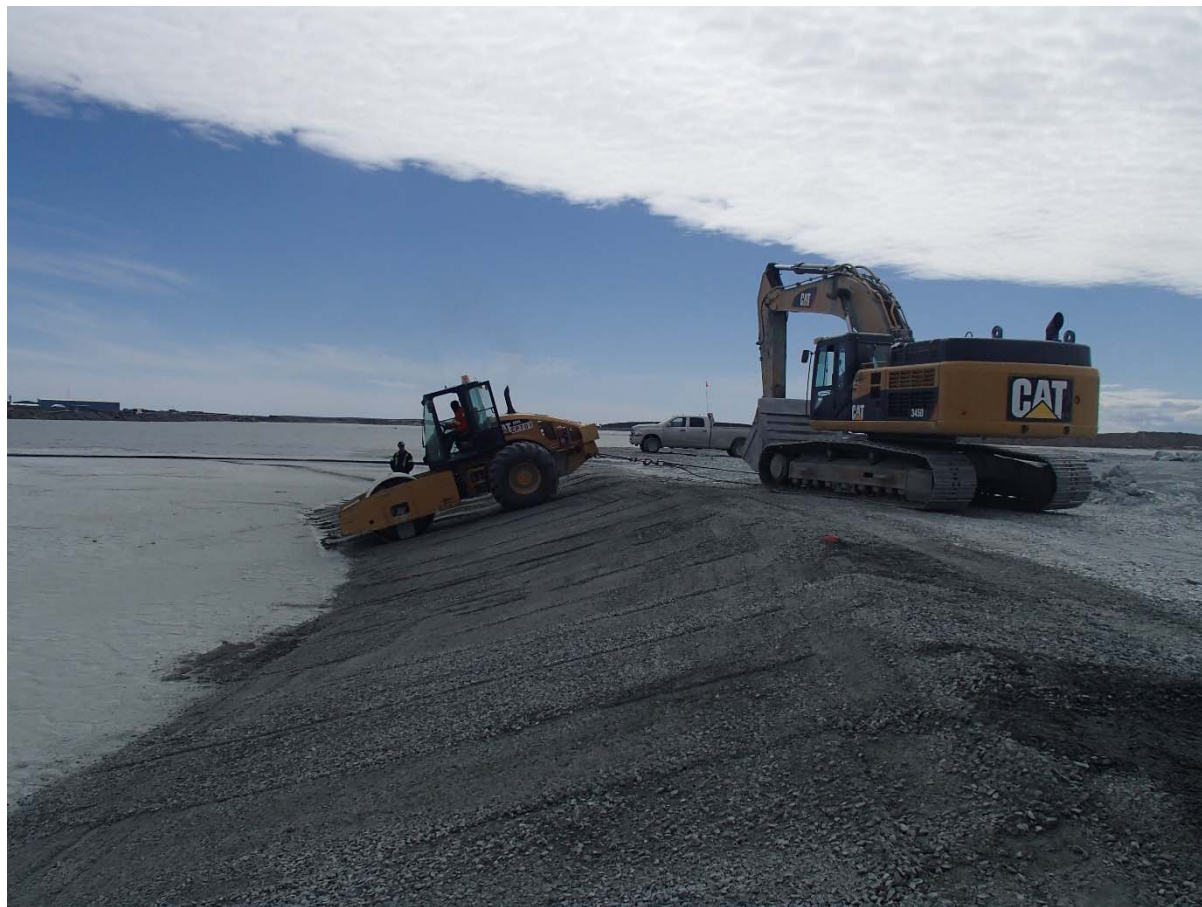
**Photograph NCIS-070: From Sta. 1+160/-89 m (approx.), looking S. Compaction of the 0.5 m lift of fine filter between El. 150 and 152 m with a 10-tonne smooth-drum compactor with vibration (4 passes) in the upstream slope from Sta. 1+335 m to 1+100 m.**

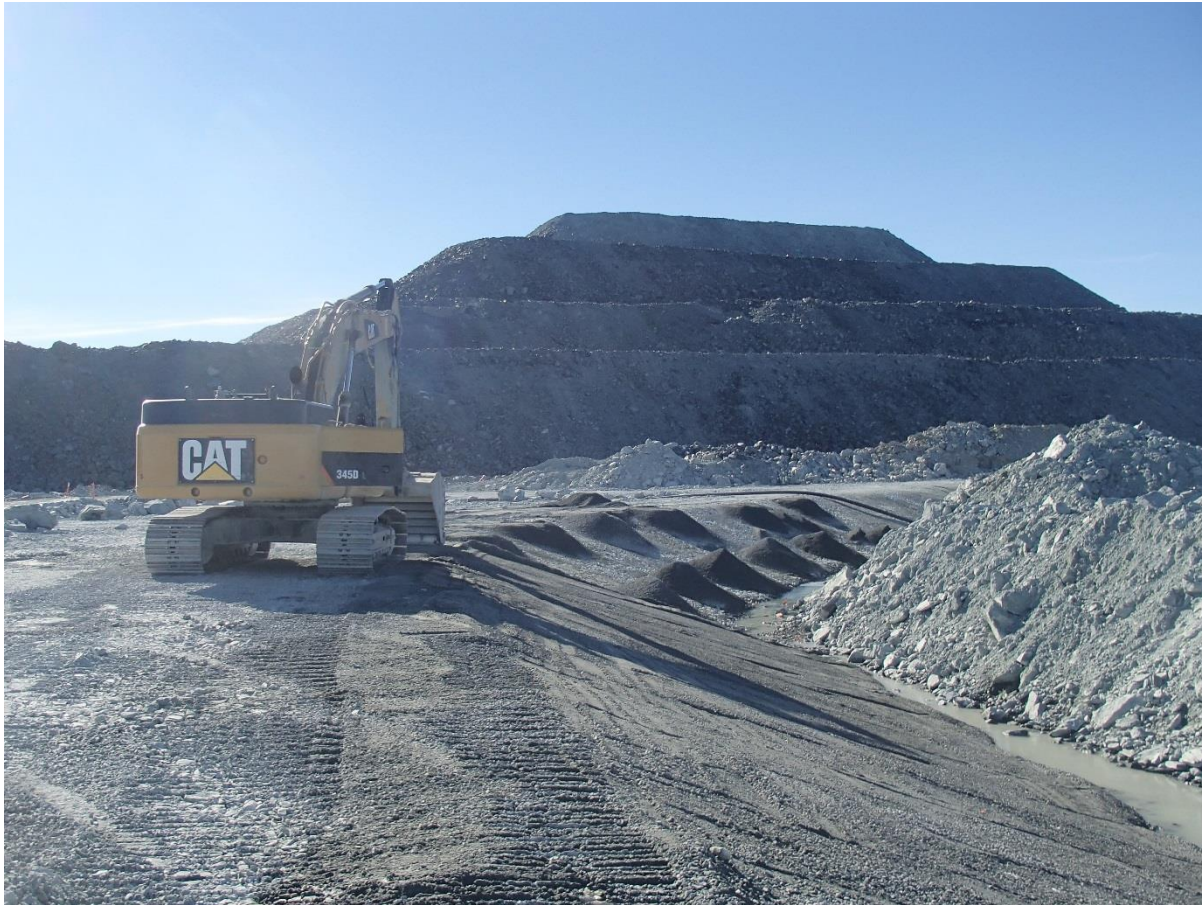
**Photograph NCIS-071: From Sta. 2+670/-28 m (approx.), looking SE. Placement of a 0.5 m thick lift of fine filter over the coarse filter in the upstream slope from El. 150 m to 152 m with an excavator from Sta. 1+550 m to 1+320 m and 1+630 m to 1+610 m.**

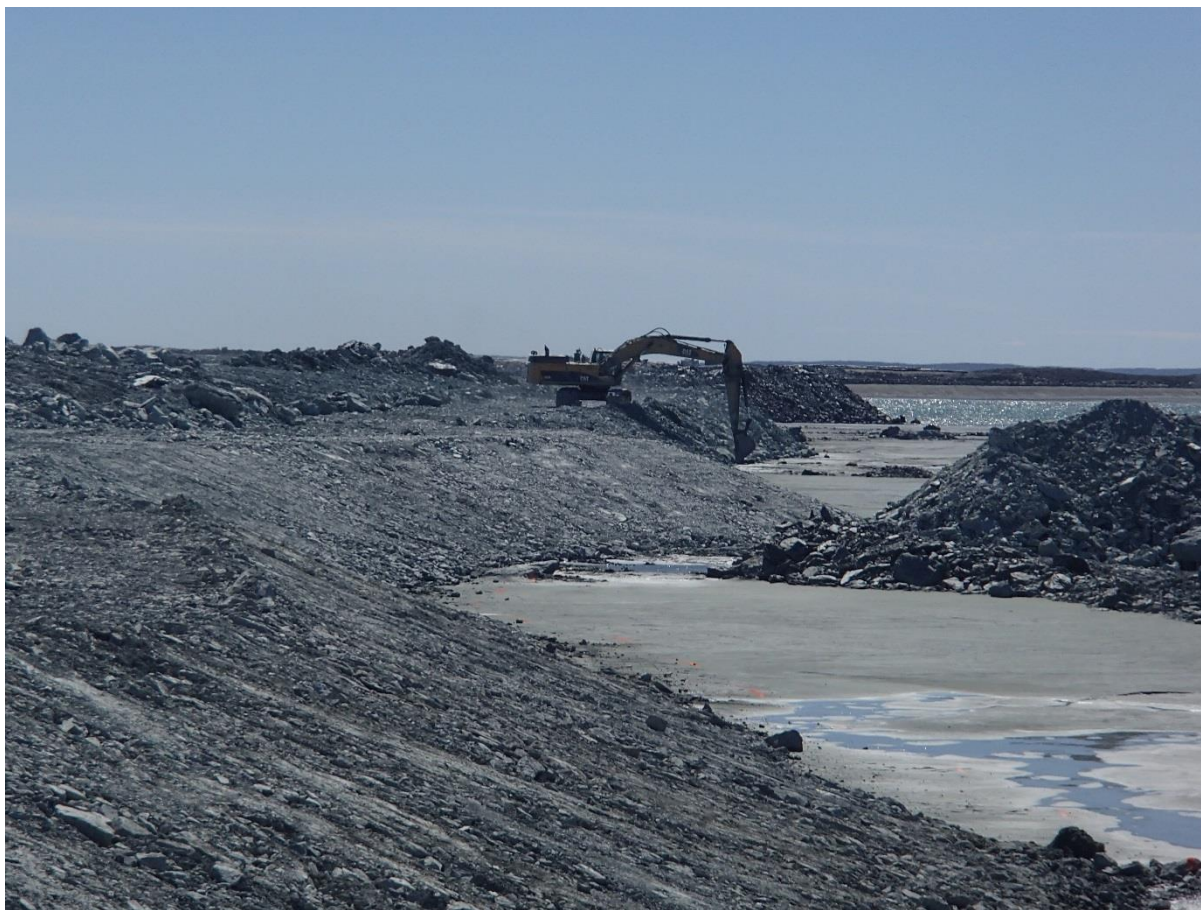
**Photograph NCIS-072: From Sta. 2+790/-38 m (approx.), looking W. Profiling of the upstream slope (3H:1V) from El. 150 to 152 m with an excavator from Sta. 2+975 m to 3+070 m.**
