QA DAILY REPORT

1897439-1576-TM-Rev0

QA DAILY REPORT FOR JULY 4TH, 2018 – TSF NORTH CELL CONSTRUCTION - MEADOWBANK (1897439)

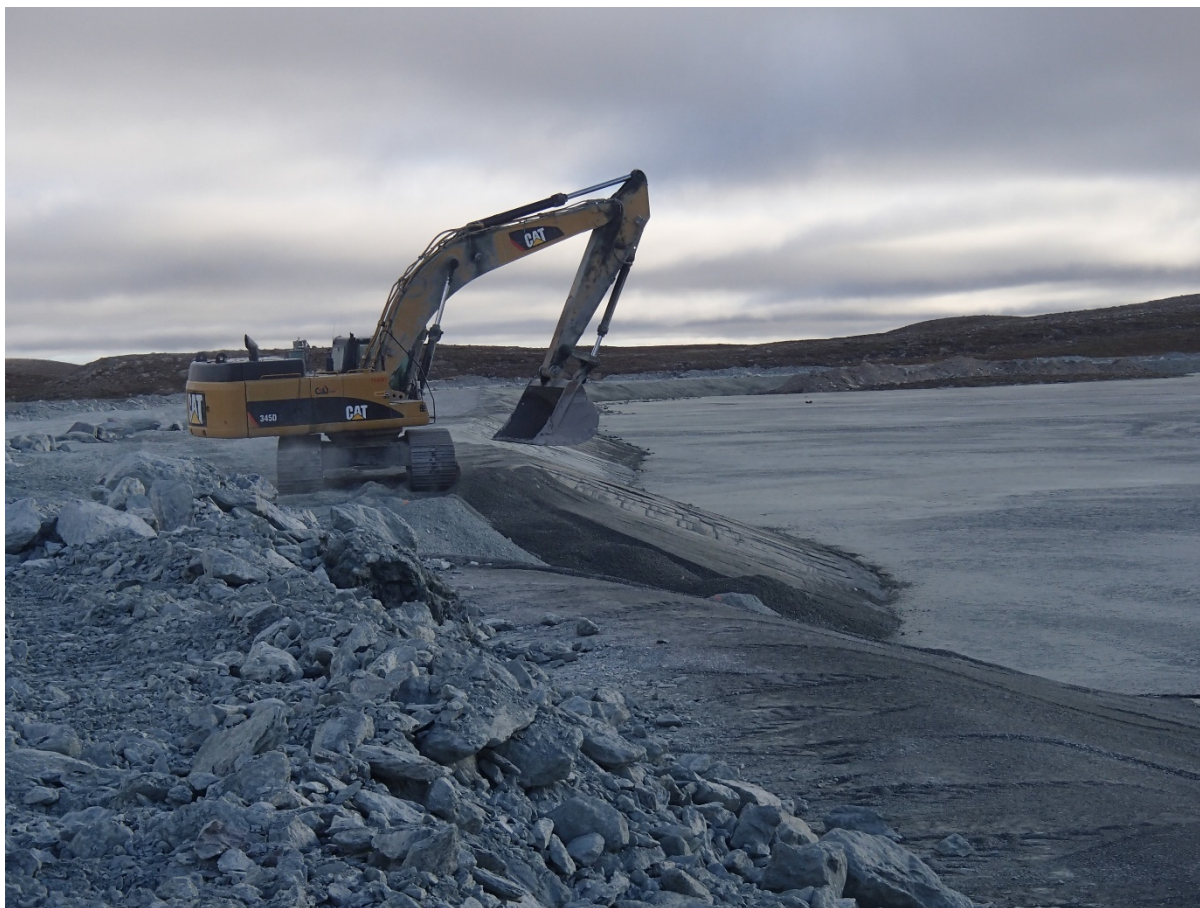
Photograph NCIS-073: From Sta. 1+300/-33 m (approx.), looking N. Placement of a 0.5 m thick lift of fine filter over the coarse filter in the upstream slope from El. 150 m to 152 m with an excavator from Sta. 1+320 m to 1+300 m.

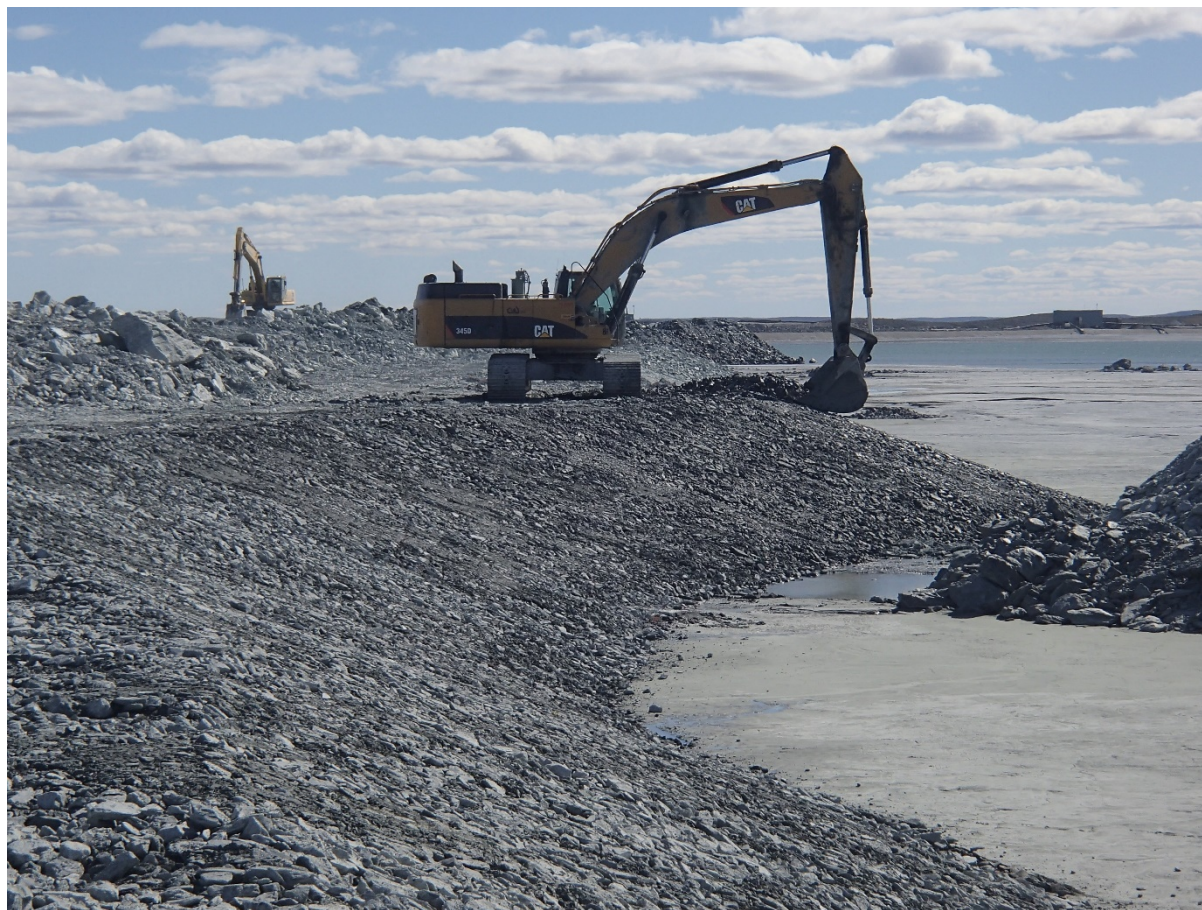
Photograph NCIS-075: From Sta. 2+860/-36 m (approx.), looking S. Placement of a 0.5 m thick lift of coarse filter in the upstream slope from El. 150 m to 152 m with an excavator from Sta. 2+815 m to 2+980 m.

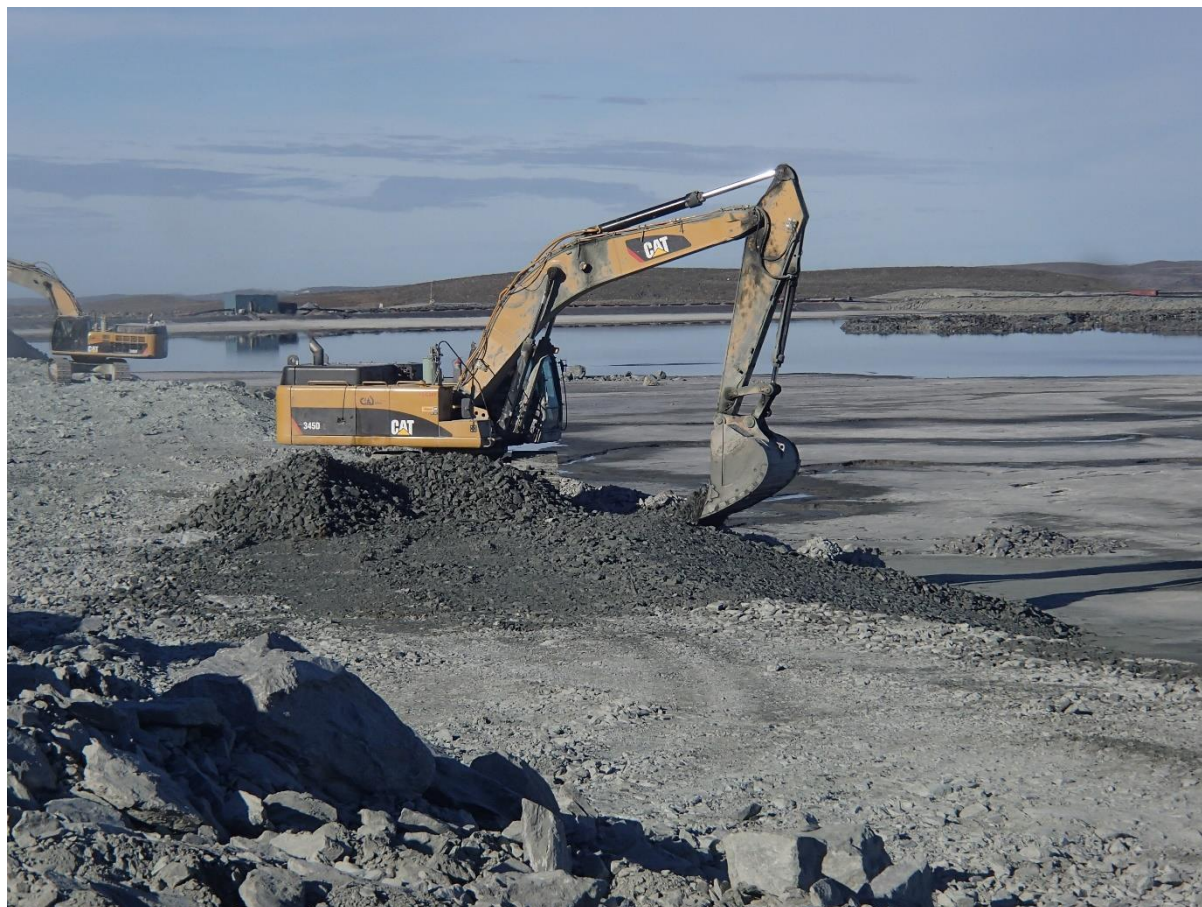
Photograph NCIS-076: From Sta. 2+940/-15 m (approx.), looking SW. Placement of a 0.5 m thick lift of coarse filter in the upstream slope from El. 150 m to 152 m with an excavator from Sta. 2+980 m to 3+160 m.

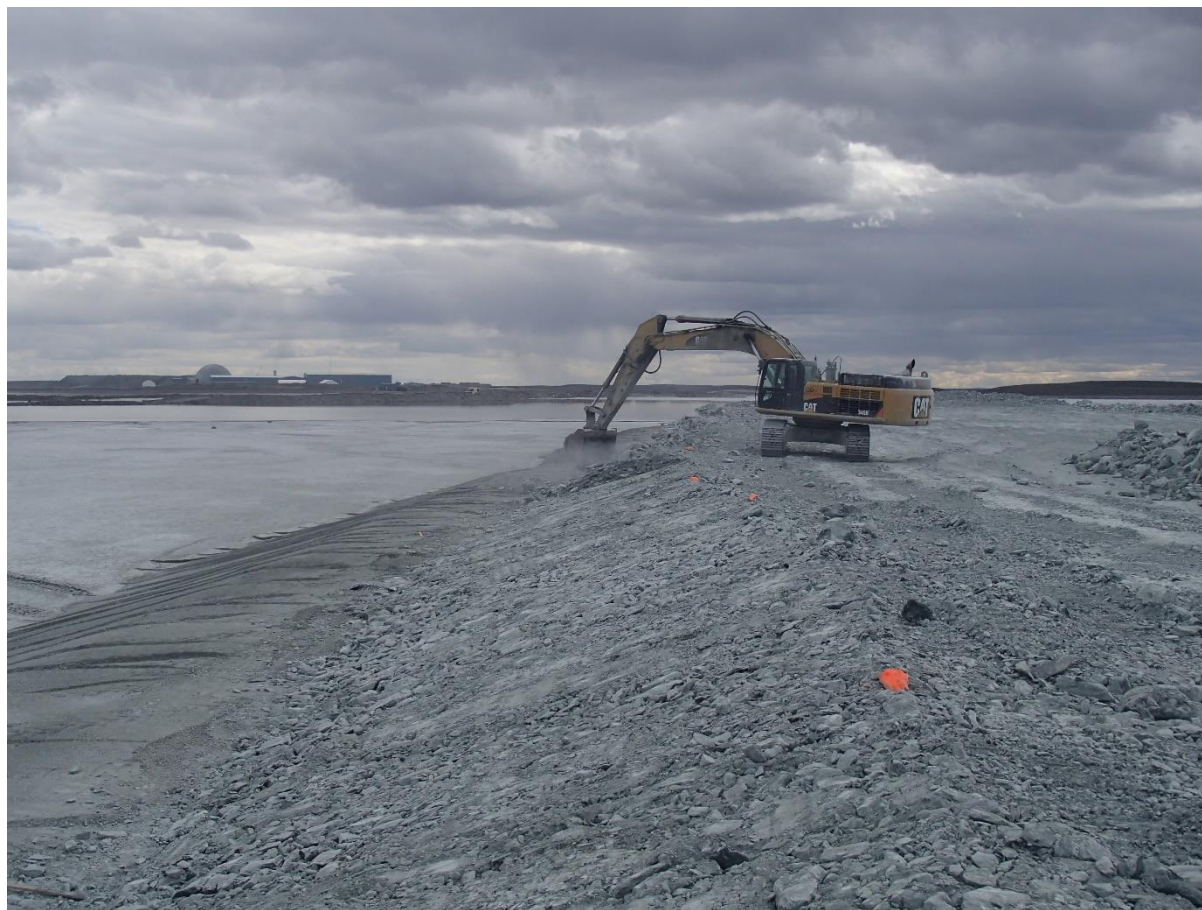
Photograph NCIS-077: From Sta. 1+310/-32 m (approx.), looking S. Profiling of the upstream slope (3H:1V) from El. 150 to 152 m with an excavator from Sta. 1+300 m to 1+175 m and from 3+070 m to 3+160 m.

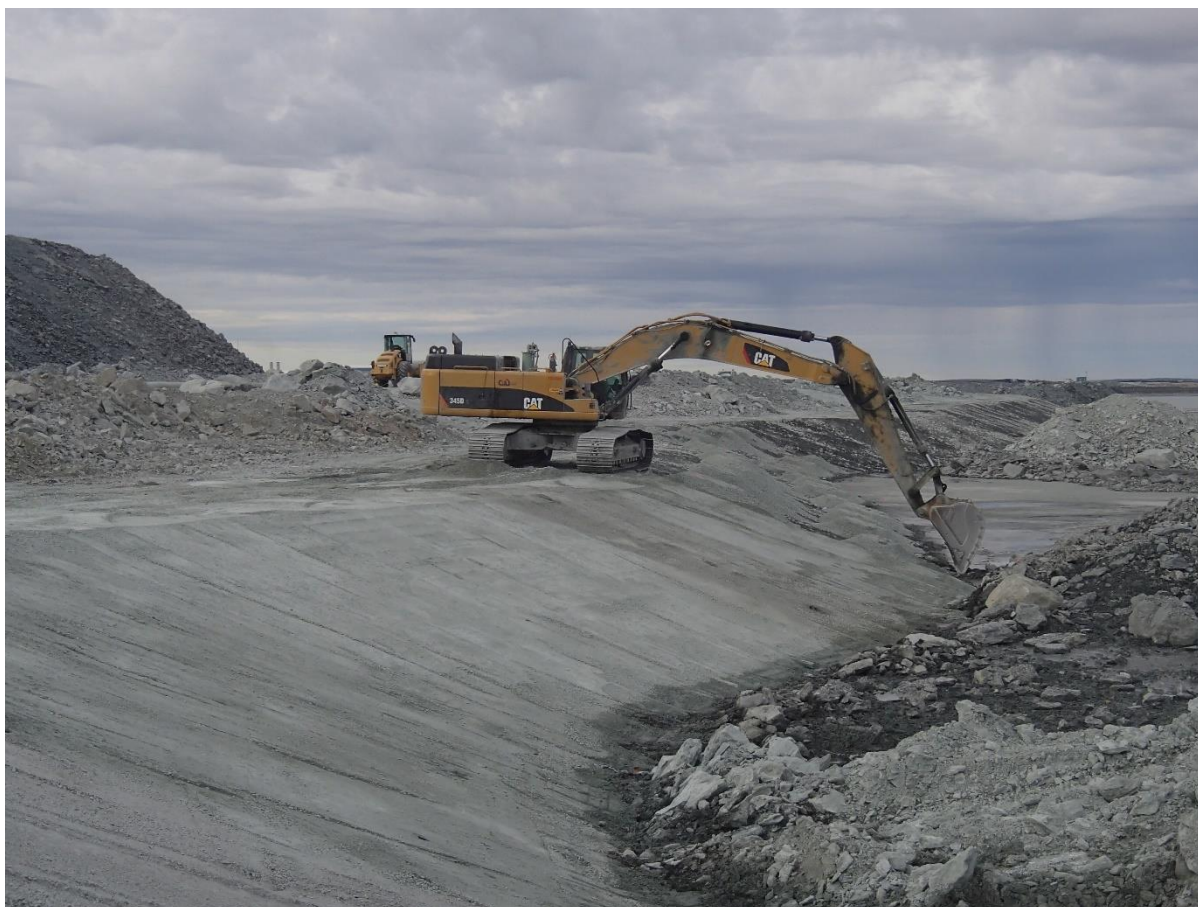
Photograph NCIS-078: From Sta. 2+760/-39 m (approx.), looking S. Placement of a 0.5 m thick lift of fine filter over the coarse filter in the upstream slope from El. 150 m to 152 m with an excavator from Sta. 2+800 m to 2+980 m.

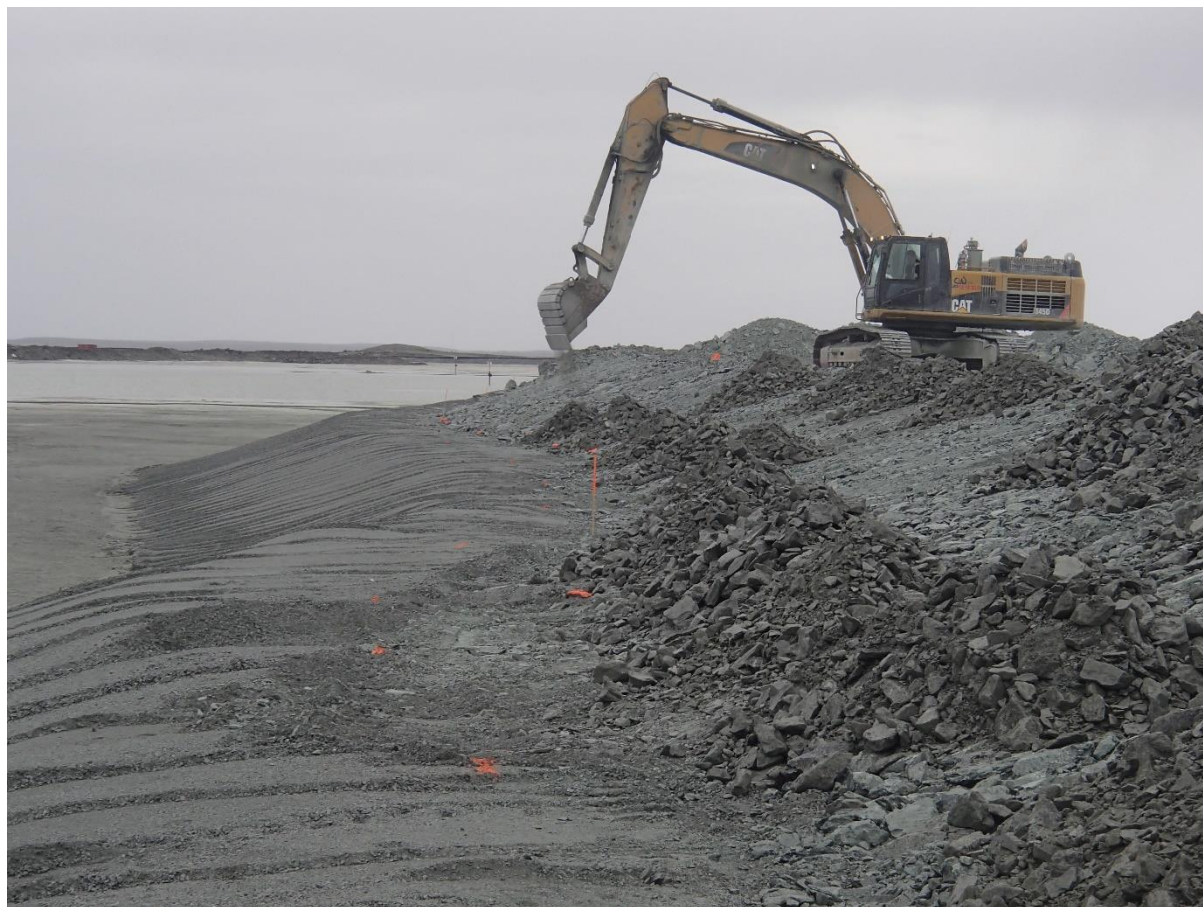
Photograph NCIS-079: From Sta. 1+280/-39 m (approx.), looking SW. Placement of a 0.5 m thick lift of coarse filter in the upstream slope from El. 150 m to 152 m with an excavator from Sta. 1+300 m to 1+200 m.

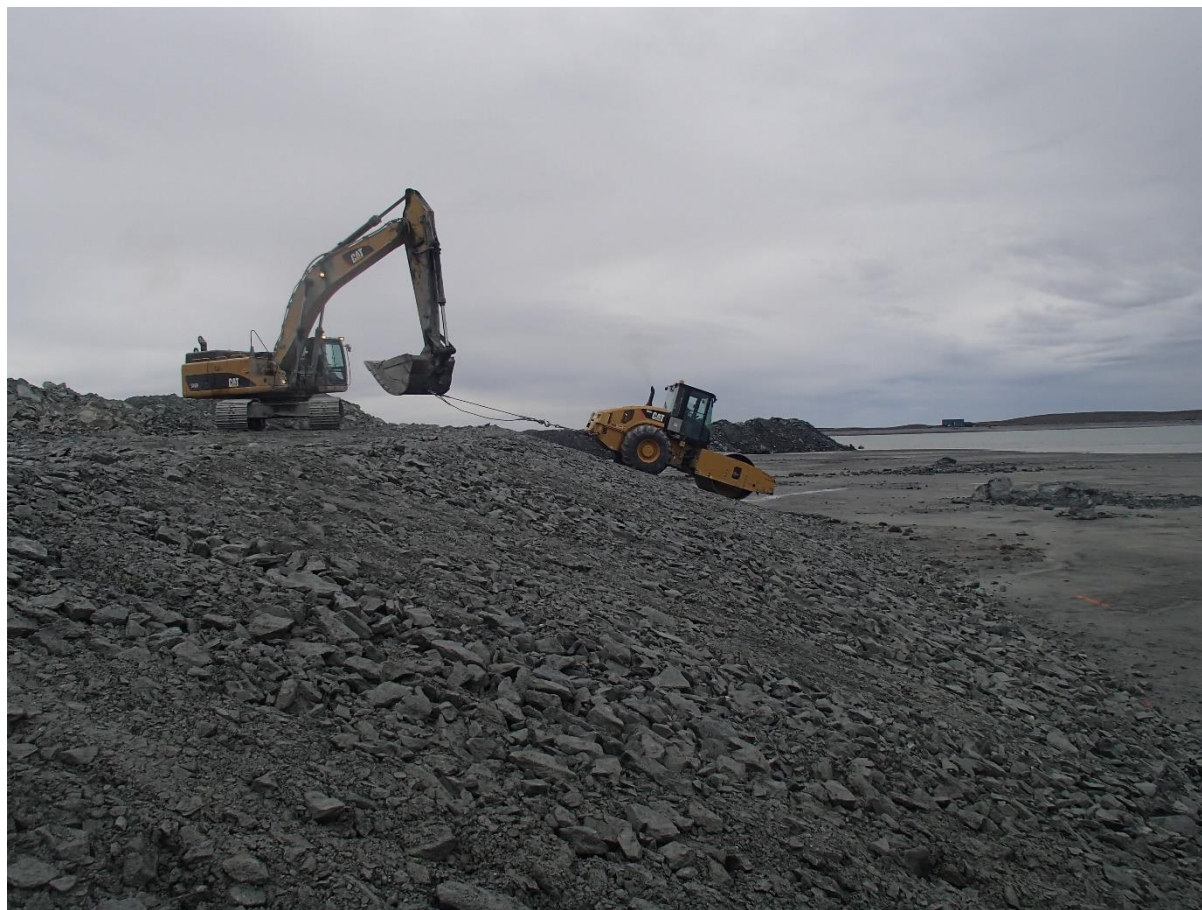
Photograph NCIS-080: From Sta. 2+800/-38 m (approx.), looking S. Compaction of the 0.5 m lift (approx.) of coarse filter between El. 150 and 152 m with a 10-tonne smooth-drum compactor (4 passes) in the upstream slope from Sta. 2+925 m to 3+160 m and from Sta. 1+300 m to 1+200 m.

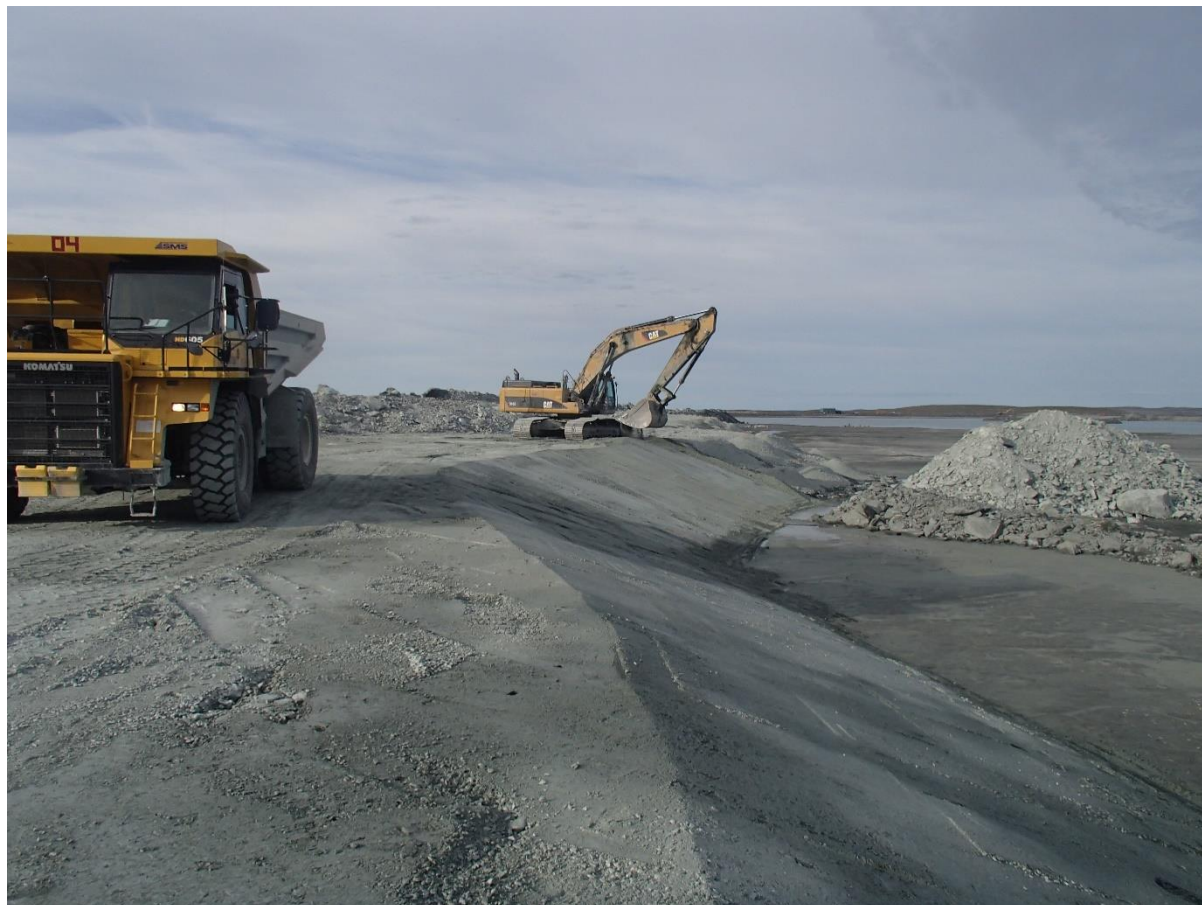
Photograph NCIS-081: From Sta2+975/-37 m (approx.), looking SE. Placement of a 0.5 m thick lift of fine filter over the coarse filter in the upstream slope from El. 150 m to 152 m with an excavator from Sta. 1+300 m to 1+210 m and from Sta. 2+940 m to 3+120 m.

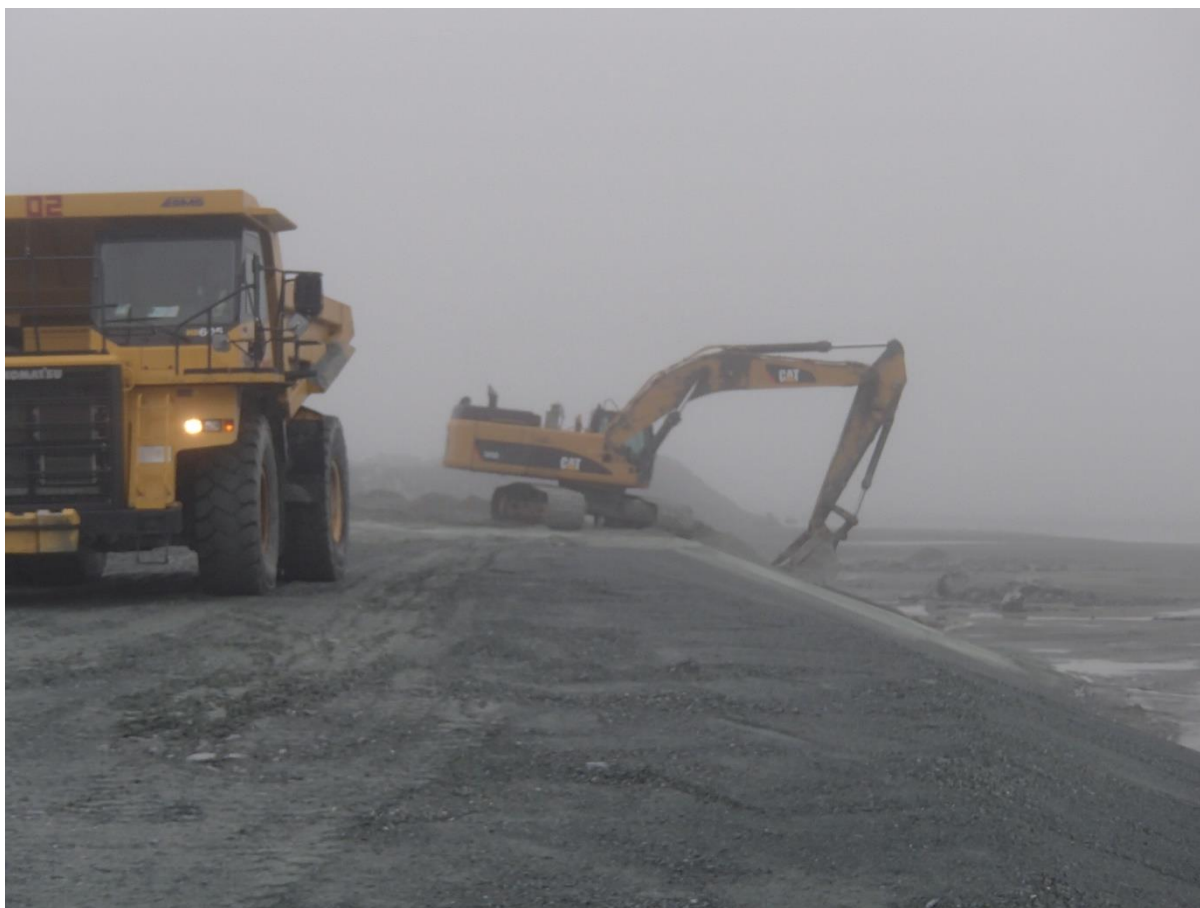
Photograph NCIS-082: From Sta 3+060/-33 m (approx.), looking S. Placement of a 0.5 m thick lift of fine filter over the coarse filter in the upstream slope from El. 150 m to 152 m with an excavator from Sta. 3+120 m to 3+160 m.

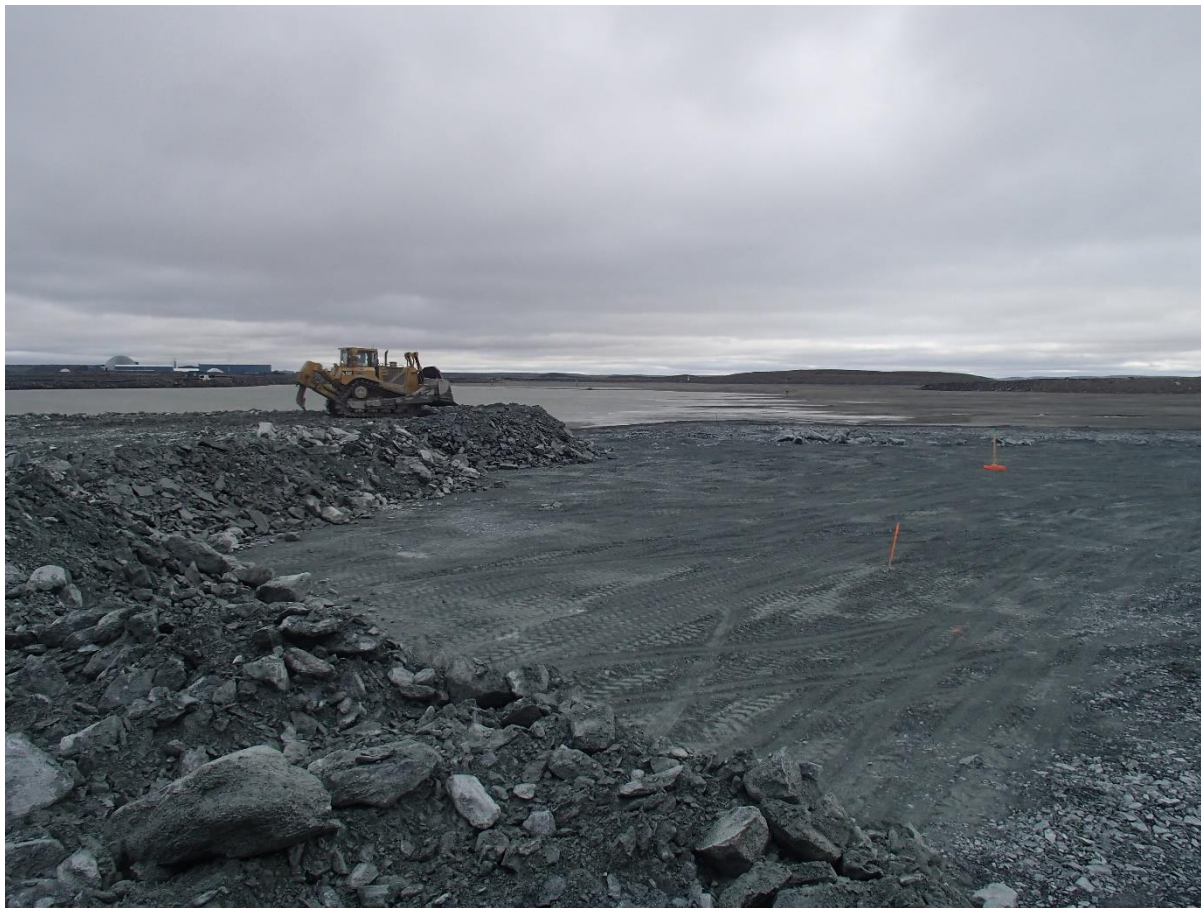
Photograph NCIS-082: From Sta 1+140/-52 m (approx.), looking SW. Placement of a 2 m thick (approx.) lift of IV rockfill from El. 150 m to El. 152 m (approx.) with a dozer from Sta. 1+160 m to 1+170 m (-64 m to -111 m). The material is of good quality and is well graded.

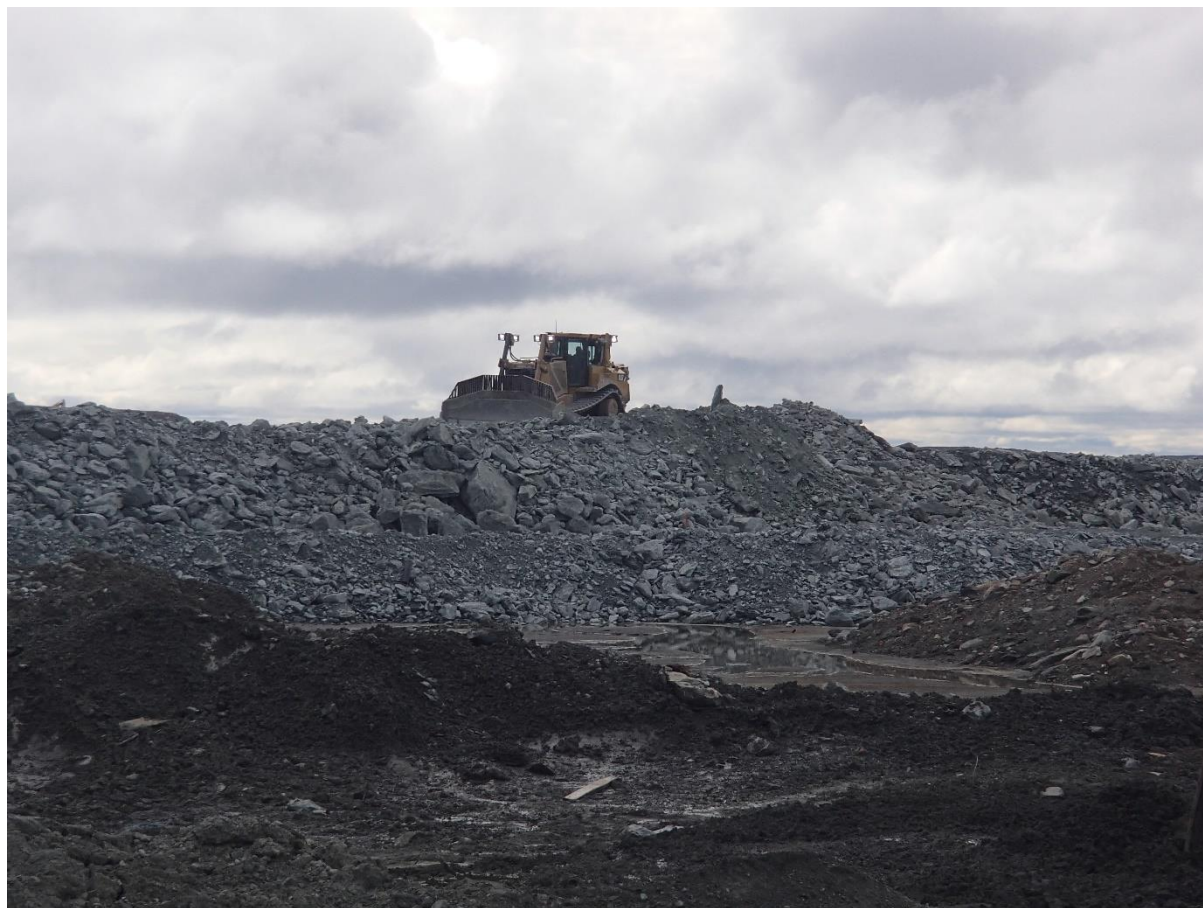
Photograph NCIS-084: From Sta 1+080/+47 m (approx.), looking E. Placement of a 2 m thick (approx.) lift of UM rockfill from El. 150 m to El. 152 m (approx.) with a dozer from Sta. 1+160 m to 1+130 m (-55 m to -102 m).

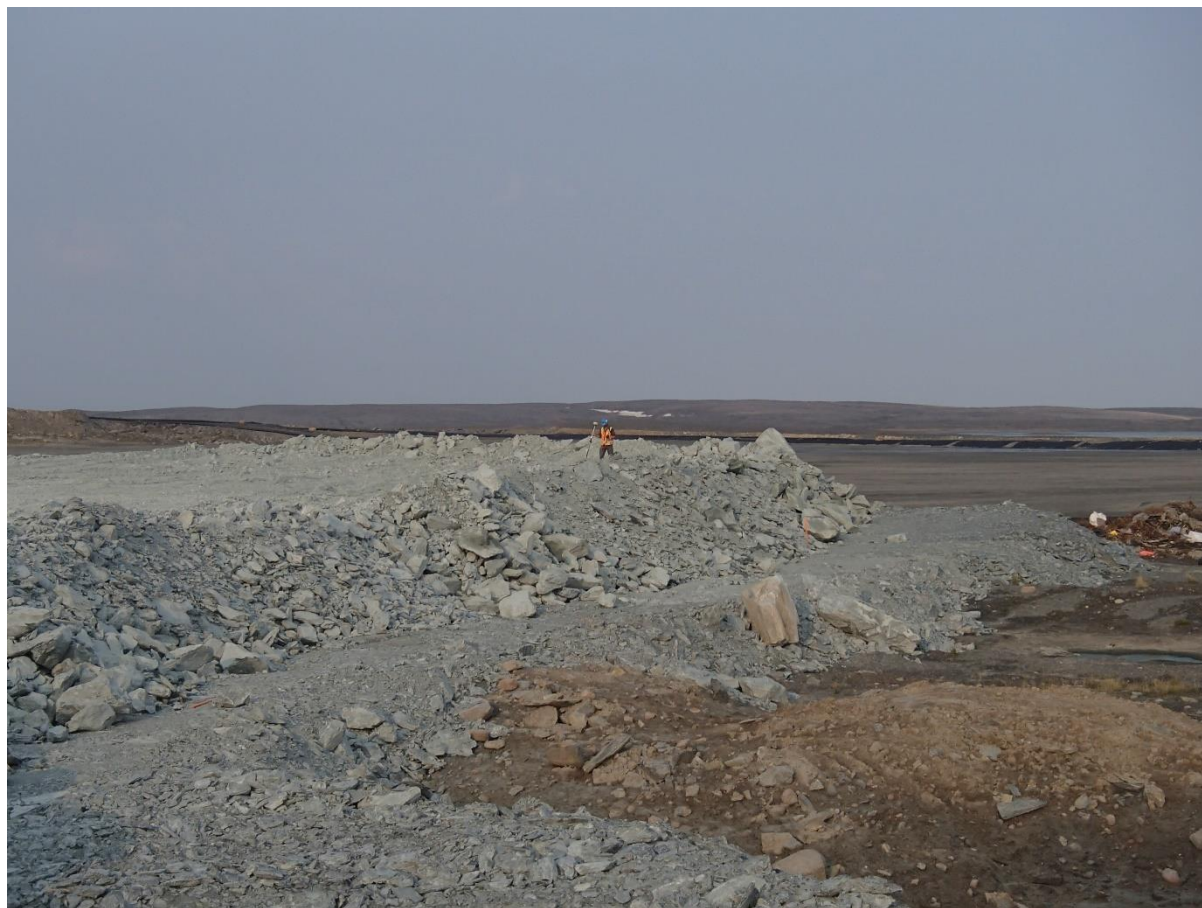
Photograph NCIS-085: From Sta 1+150/-67m (approx.), looking SW. Placement of a 2 m thick (approx.) lift of UM rockfill from El. 150 m to El. 152 m (approx.) with a dozer from Sta. 1+130 m to 1+100 m (-55 m to -78 m).

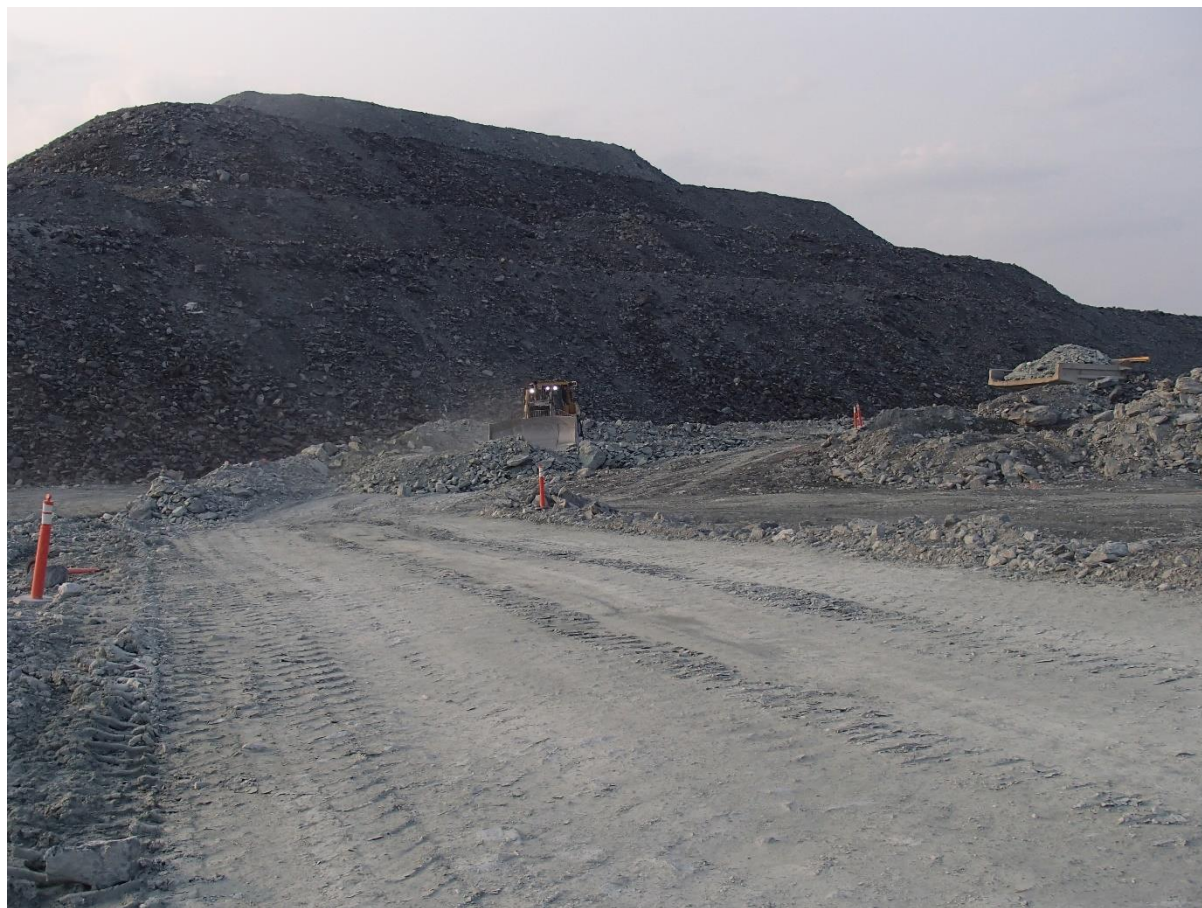
Photograph NCIS-086: From Sta 2+750/+14 m (approx.), looking E. Placement of a 2 m thick (approx.) lift of UM rockfill from El. 152 m to El. 154 m (approx.) with a dozer from Sta. 2+780 m to 2+760 m (-60 m to -44 m).

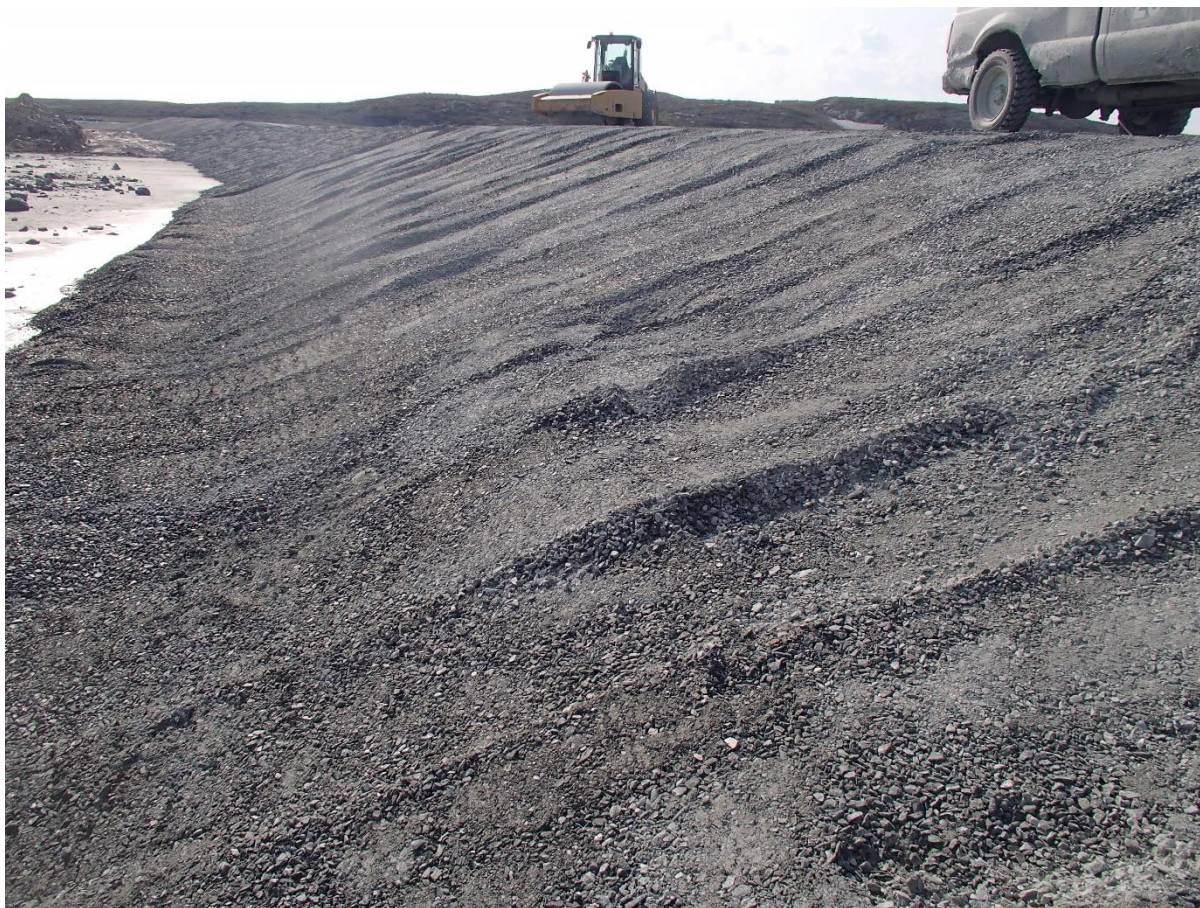
- The QA Manager observed large deformations in the fine filter surface on the North Cell Internal Structure around Sta. 1+940 m following the compaction. According to SANA foreman, the deformations are due to a new operator on the excavator towing the compactor. The surface will be corrected tomorrow.

Photograph NCIS-087: From Sta 1+950/-34 m (approx.), looking W. Compaction of the 0.5 m lift (approx.) of fine filter between El. 150 and 152 m with a 10-tonne smooth-drum compactor (4 passes) in the upstream slope from Sta. 2+000 m to 1+930 m. Vibration is used except for the first pass down the slope in order to stabilize the material and limit deformation of the lift.

- The deformations observed yesterday in the fine filter surface on the North Cell Internal Structure around Sta. 1+940 m were corrected with the compactor.
- SANA Surveyor reports that the lift is 0.3 m to 0.5 m to thick around Sta. 2+610 m (approx.) as it was placed during the night shift. SANA surveyor will install picket at the end of the day shift to guide the bulldozer during the night shift.
- An approx. 30 m shift between the Station measured by SANA Surveyor and the QA Manager was noted. A new alignment for the North Cell Internal Structure centerline at El. 154 m had been emitted about 2 weeks ago. The new GPX file was provided to the QA Manager today.
