**APPENDIX D**

# Construction Meeting Minutes

CENTRAL DIKE

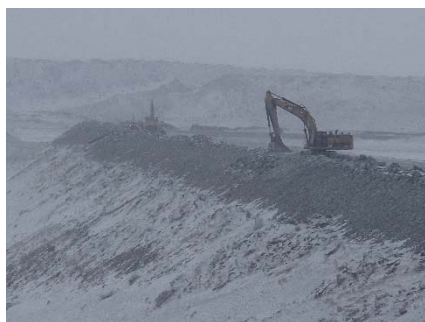
**CD-1850 (2018-05-13), looking SW from Sta. 0+160/+20 m. Profiling of the downstream slope (1.5H:1V) from El. 143 to 145 m with an excavator between Sta. 0+440 m and 0+530 m and between Sta. 0+745 m and 0+835 m.**

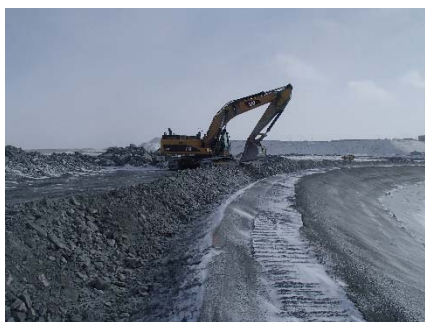
**CD-1851 (2018-05-13), looking S from Sta. 0+910/-18 m. Excavation of the LLDPE geomembrane crest anchoring trench from Sta. 40+730 m to 0+830 m.**

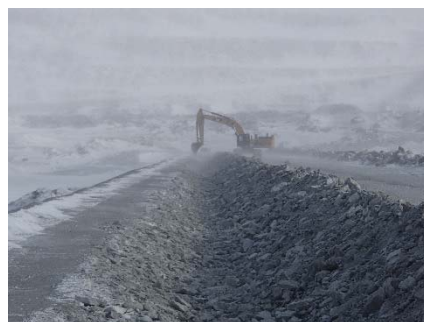
**CD-1852 (2018-05-14), looking N from Sta. 0+500/-25 m. Excavation of the LLDPE geomembrane crest anchoring trench from Sta. 0+830 m to 0+170 m.**

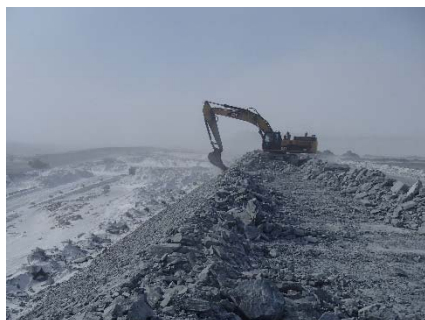
**CD-1853 (2018-05-14), looking S from Sta. 0+850/+3 m. Profiling of the downstream slope (1.5H:1V) from El. 143 to 145 m with an excavator between Sta. 0+835 m and 0+940.**

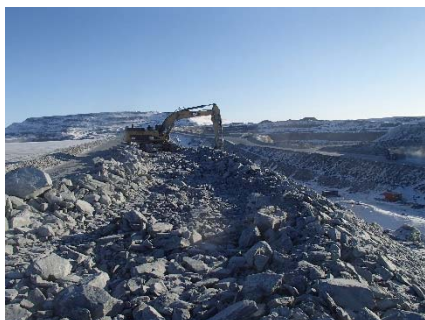
**CD-1854 (2018-05-15), looking N from Sta. 0+860/-13 m. Profiling of the downstream slope (1.5H:1V) from El. 143 to 145 m with an excavator between Sta. 0+940 m and 0+990 m.**

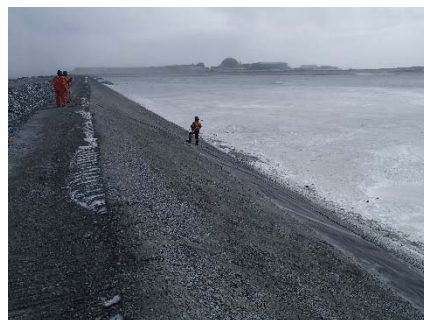
**CD-1855 (2018-05-16), looking S from Sta. 0+230/-22 m. Clean-up of the existing LLDPE with pressurized air stream in preparation for liner installation between Sta. 0+170 m and 40+780 m3.**

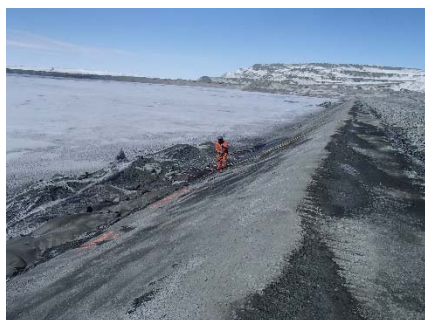
**CD-1856 (2018-05-18), looking N from Sta. 0+670/-24 m. Clean-up of the fine filter placed against the slope at the deposition finger at approx. Sta. 0+670 m with pressurized air stream to expose 1 m of LLDPE liner, in preparation for the new liner installation.**

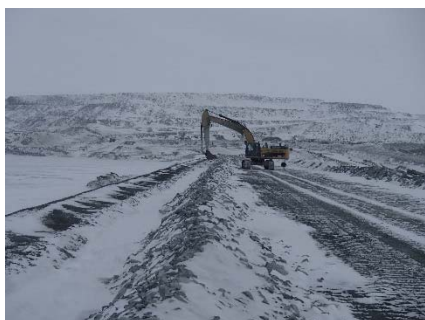
**CD-1857 (2018-05-21), looking N from Sta. 0+700/-20 m. Snow removal in the anchoring trench with an excavator between Sta. 0+170 m and 40+780 m.**

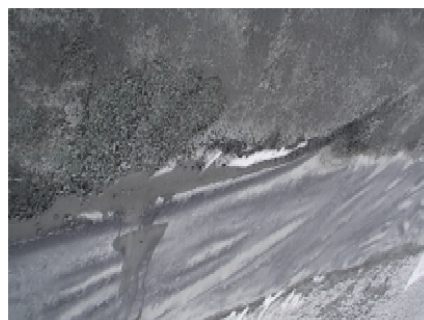
**CD-1858 (2018-05-21), looking S from Sta. 0+970/-45 m. View of the bottom of the fine filter upstream slope. Some material is missing to achieve a smooth slope.**

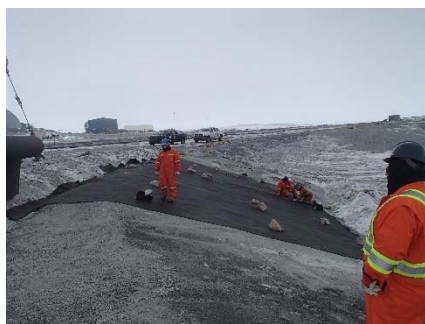
**CD-1859 (2018-05-22), looking SW from Sta. 40+780/-38 m. Installation of the geotextile on the upstream slope 3H:1V (SD5 side) to 2H:1V (Central Dike side) between El. 143 m and 145 m from Sta. 40+640 m to 0+830 m.**

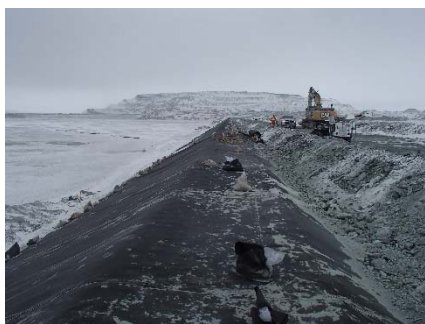
**CD-1860 (2018-05-23), looking N from Sta. 0+790/-26 m. Installation of the geotextile on the upstream slope 2H:1V between El. 143 m and 145 m from Sta. 0+830 m to 0+750 m.**

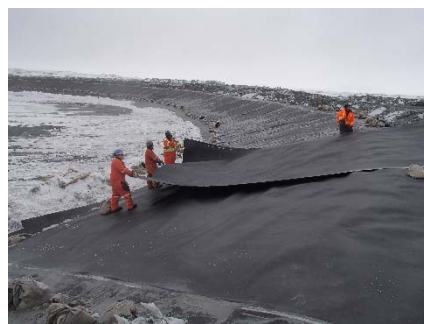
**CD-1861 (2018-05-24), looking NE from Sta. 40+680/-8 m. Installation of the LLDPE liner on the upstream slope 3H:1V (SD5 side) to 2H:1V (Central Dike side) between El. 143 m and 145 m from Sta. 40+680 m to 0+950 m (panel numbers 802 to 817).**

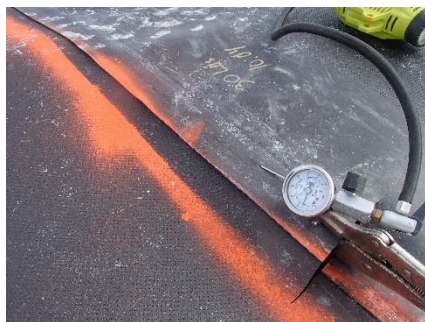
**CD-1862 (2018-05-24), looking from Sta. 40+960/-24 m. View of an air channel test.**

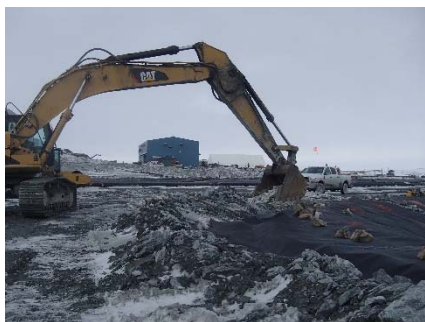
**CD-1863 (2018-05-24), looking SW from Sta. 40+750/-18 m. Backfilling of the geosynthetic tie-in from Sta. 40+680 m to 0+950 m.**

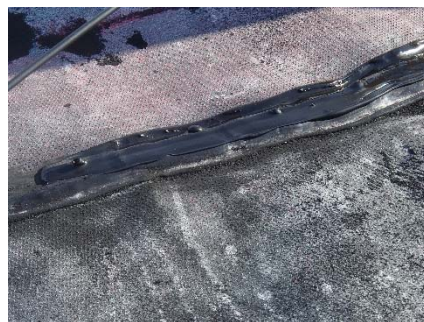
**CD-1864 (2018-05-25), looking from Sta. 40+700/-38 m. View of bubbles formed in the extrusion weld because of humidity.**

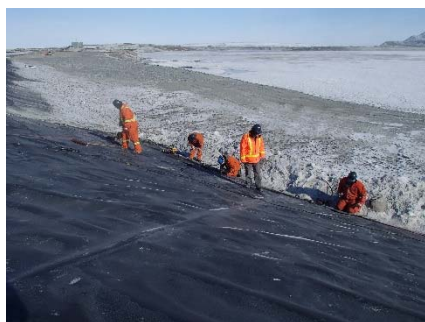
**CD-1865 (2018-05-25), looking NW from Sta. 40+740/-35 m. Repairs on the extrusion fillet seam at the bottom of the LLDPE liner panels between Sta. 40+680 m and 0+950 m, on panels 802 to 807, and 811 to 813.**

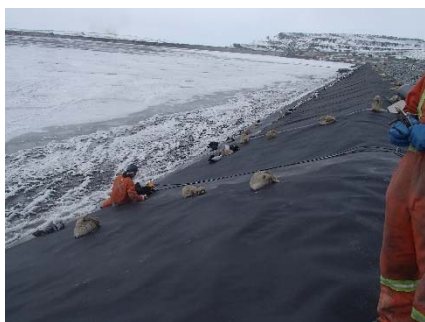
**CD-1866 (2018-05-25), looking NW from Sta. 0+940/-25 m. Installation of the LLDPE liner on the upstream slope 2H:1V between El. 143 m and 145 m from Sta. 0+950 m to 0+935 m (panel numbers 818 and 819).**

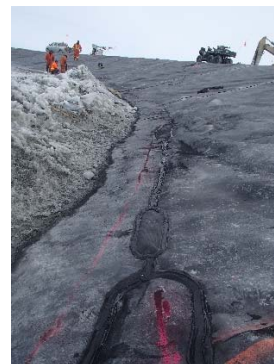
**CD-1867 (2018-05-25), looking E from Sta. 40+680/-37 m. View of repair patches on the extrusion weld at the bottom of the panels.**

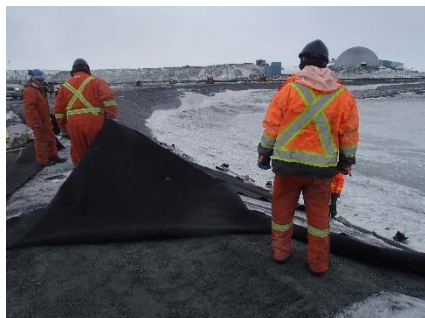
**CD-1868 (2018-05-27), looking S from Sta. 0+915/-24 m. Removal of the wet geotextile in place from Sta. 0+935 m to 0+900 m.**

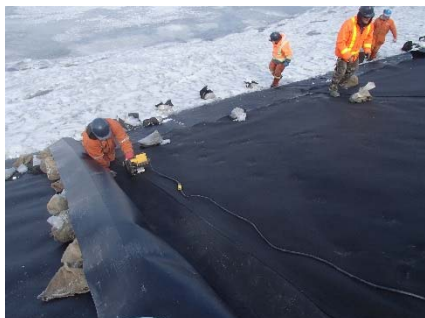
**CD-1869 (2018-05-27), looking W from Sta. 0+915/-30 m. Installation of the geotextile on the upstream slope 2H:1V between El. 143 m and 145 m from Sta. 0+935 m to 0+900 m.**

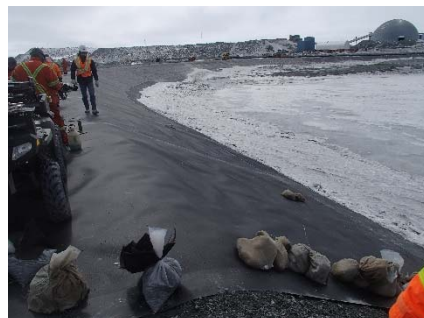
**CD-1870 (2018-05-27), looking S from Sta. 0+900/-26 m. Installation of the LLDPE liner on the upstream slope 2H:1V between El. 143 m and 145 m from Sta. 0+935 m to 0+900 m (panel numbers 820 to 823).**

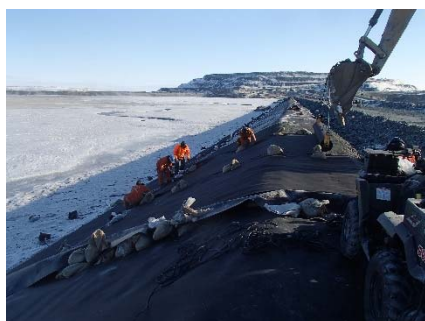
**CD-1871 (2018-05-28), looking N from Sta. 0+910/-25 m. Installation of the geotextile on the upstream slope 2H:1V between El. 143 m and 145 m from Sta. 0+900 m to 0+870 m.**

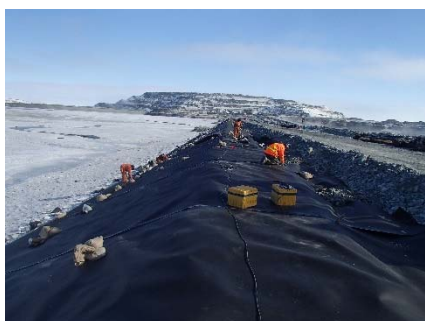
**CD-1872 (2018-05-28), looking N from Sta. 0+900/-24 m. Installation of the LLDPE liner on the upstream slope 2H:1V between El. 143 m and 145 m from Sta. 0+900 m to 0+760 m (panel numbers 824 to 844).**

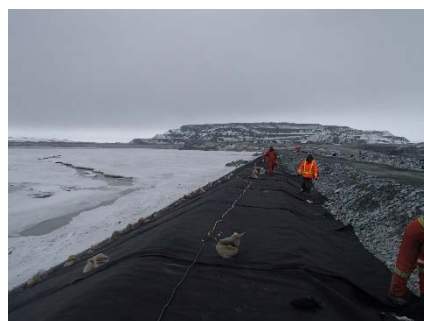
**CD-1873 (2018-05-29), looking N from Sta. 0+760/-26 m. Installation of the geotextile on the upstream slope 2H:1V between El. 143 m and 145 m from Sta. 0+760 m to 0+740 m.**

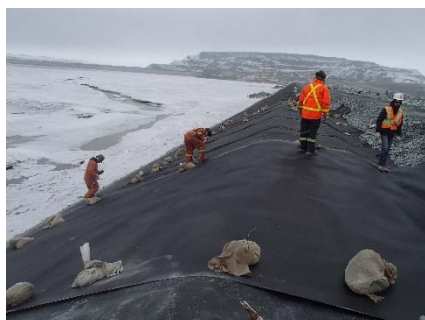
**CD-1874 (2018-05-29), looking N from Sta. 0+760/-26 m. Installation of the LLDPE liner on the upstream slope 2H:1V between El. 143 m and 145 m from Sta. 0+760 m to 0+740 m (panel numbers 845 to 848).**

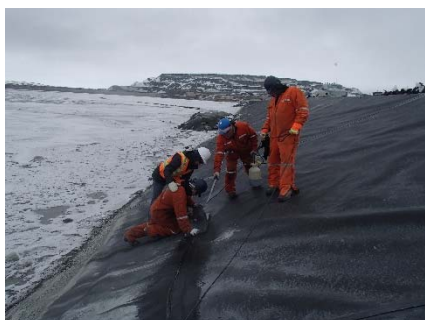
**CD-1875 (2018-05-30), looking N from Sta. 0+835/-26 m. View of a vacuum box testing.**

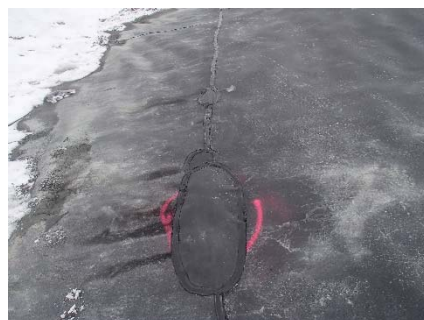
**CD-1876 (2018-05-30), looking N from Sta. 0+820/-26 m. View of repair patches on the extrusion weld at the bottom of the panel 838.**

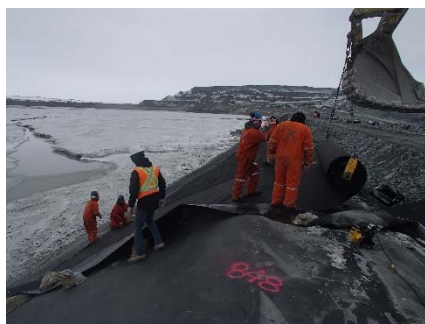
CD-1877 (2018-06-01), looking N from Sta. 0+745/-22 m. Installation of the geotextile on the upstream slope 2H:1V between El. 143 m and 145 m from Sta. 0+740 m to 0+610 m.

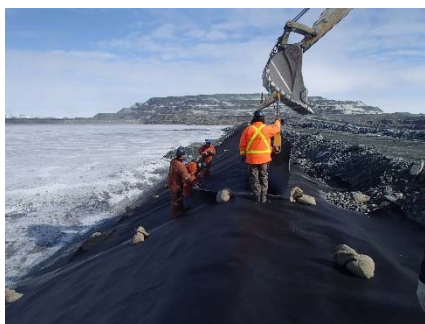
CD-1878 (2018-06-01), looking N from Sta. 0+720/-22 m. Installation of the LLDPE liner on the upstream slope 2H:1V between El. 143 m and 145 m from Sta. 0+740 m to 0+610 m (panel numbers 849 to 867).

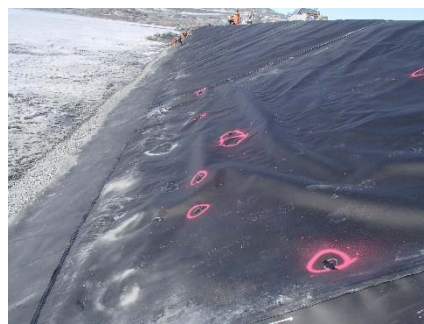
CD-1879 (2018-06-01), looking N from Sta. 0+735/-28 m. View of the repaired holes on panel 850.

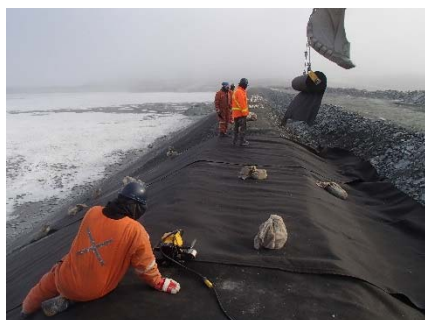
CD-1880 (2018-06-02), looking N from Sta. 0+600/-25 m. Installation of the geotextile on the upstream slope 2H:1V between El. 143 m and 145 m from Sta. 0+610 m to 0+480 m.

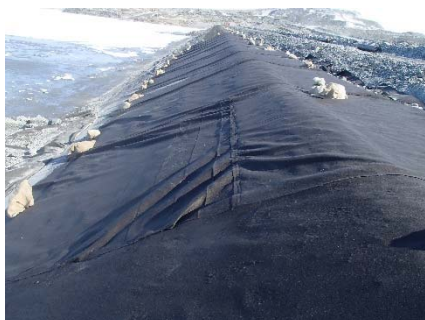
CD-1881 (2018-06-02), looking N from Sta. 0+530/-27 m. View of a geotextile panel with a horizontal weld in the slope at Sta. 0+520 m before its removal.

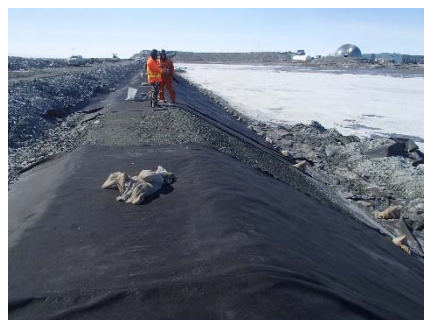
CD-1882 (2018-06-02), looking S from Sta. 0+510/-25 m. View of the emplacement of the geotextile panel with a horizontal weld in the slope at Sta. 0+520 following its removal.

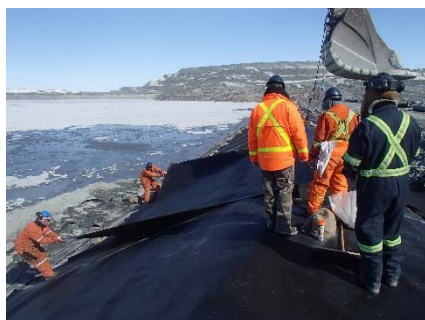
CD-1883 (2018-06-02), looking N from Sta. 0+525/-26 m. Installation of the LLDPE liner on the upstream slope 2H:1V between El. 143 m and 145 m from Sta. 0+610 m to 0+480 m (panel numbers 868 to 886).

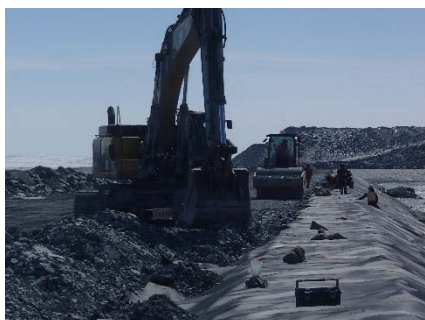
CD-1884 (2018-06-02), looking S from Sta. 0+530/-25 m. Backfilling of the geosynthetic tie-in from Sta. 0+610 m to 0+480 m and compaction of the tie-in material with a 10-tonne smooth-drum compactor with vibration (4 passes) from Sta. 0+610 to 0+480 m.

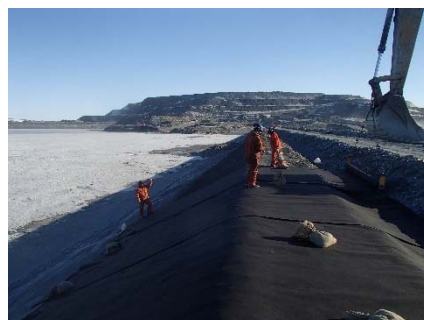
CD-1885 (2018-06-03), looking N from Sta. 0+460/-26 m. Installation of the geotextile on the upstream slope 2H:1V between El. 143 m and 145 m from Sta. 0+480 m to 0+320 m. compactor with vibration (4 passes) from Sta. 0+610 to 0+480 m.

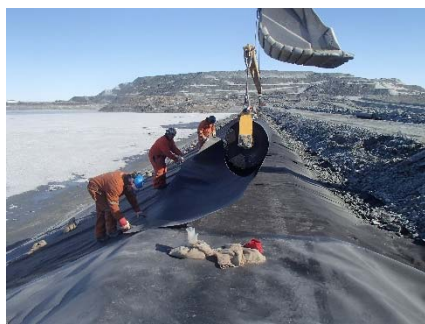
**CD-1886 (2018-06-03), looking N from Sta. 0+485/-26 m. Installation of the LLDPE liner on the upstream slope 2H:1V between El. 143 m and 145 m from Sta. 0+480 m to 0+320 m (panel numbers 887 to 910).**

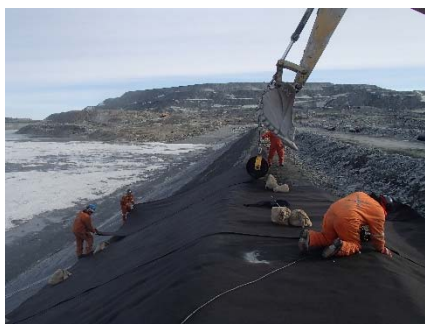
**CD-1887 (2018-06-04), looking N from Sta. 0+310/-26 m. Installation of the geotextile on the upstream slope 2H:1V between El. 143 m and 145 m from Sta. 0+320m to 0+160 m.**

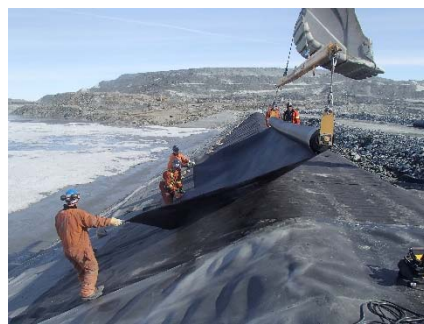
**CD-1888 (2018-06-04), looking N from Sta. 0+325/-26 m. Installation of the LLDPE liner on the upstream slope 2H:1V between El. 143 m and 145 m from Sta. 0+320 m to 0+160 m (panel numbers 911 to 910).**

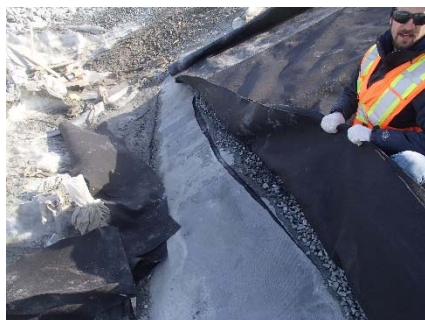
**CD-1889 (2018-06-04), looking N from Sta. 0+150/-28 m. View of the underlying liner that has been cut at around Sta. 0+160 m to drain the water.**

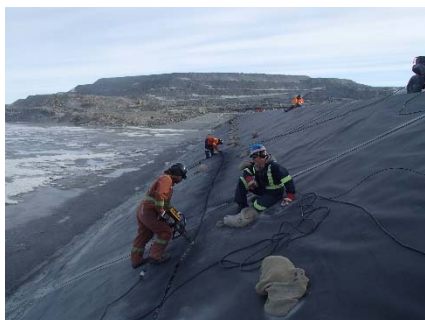
**CD-1890 (2018-06-05), looking N from Sta. 0+310/-26 m. View of the extrusion welding.**

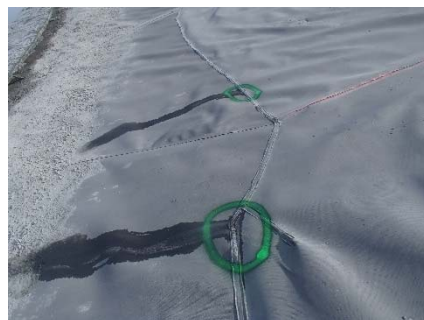
**CD-1891 (2018-06-05), looking NE from Sta. 0+960/-28 m. View of leaking extrusion fillet seams before their repair on panel 816 and 818.**

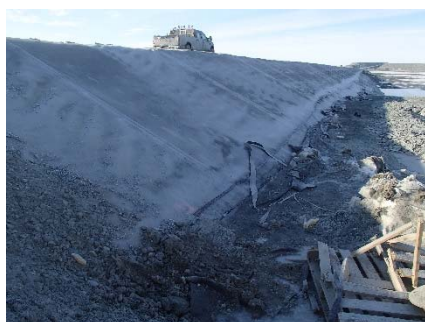
**CD-1892 (2018-06-06), looking S from Sta. 0+155/-32 m. View of the liner panel 933 overlapping the underlying liner that has been cut at around Sta. 0+160 m to drain the water.**

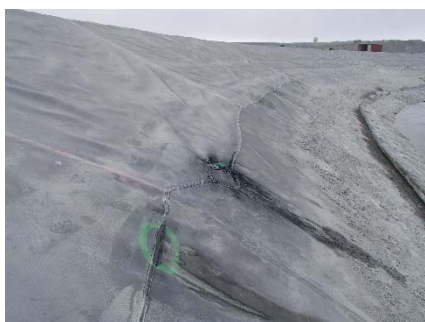
**CD-1893 (2018-06-06), looking SW from Sta. 0+950/-27 m. View of repair patches on the extrusion weld at the bottom of the panels 803, 807, 808, 810, 814, 815, 816 and 818.**

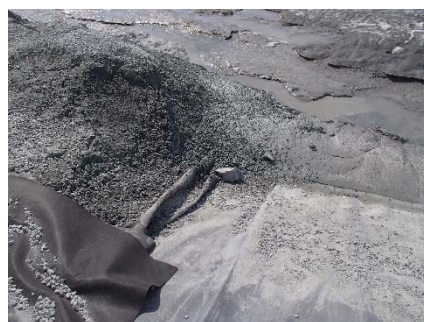
**CD-1894 (2018-06-10), looking W from Sta. 0+800/-28 m. View of a block in direct contact with the LLDPE liner following the construction of the deposition fingers on Central Dike.**

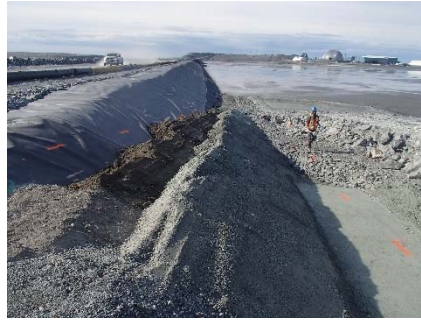
**CD-1896 (2018-07-22), looking S from Sta. 0+140/-30 m. Placement of 0.5 m thick layers of compacted sieved till and fine filter on the upstream slope of Central Dike with an excavator from Sta. 0+147 m to 0+177 m.**

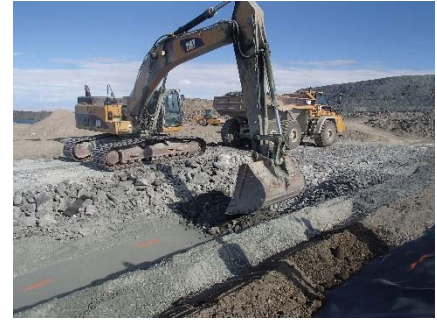
**CD-1897 (2018-07-22), looking NW from Sta. 0+145/-30 m. Placement of a 0.5 m thick lift of coarse filter on the top of the fine filter on the top of the upstream toe liner tie-in and on the upstream slope with an excavator from Sta. 0+147 m to 0+177 m.**

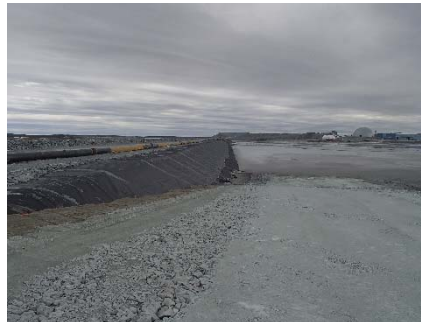
**CD-1899 (2018-07-22), looking S from Sta. 0+140/-33 m. View of Central Dike at the end of the 2018 construction phase.**

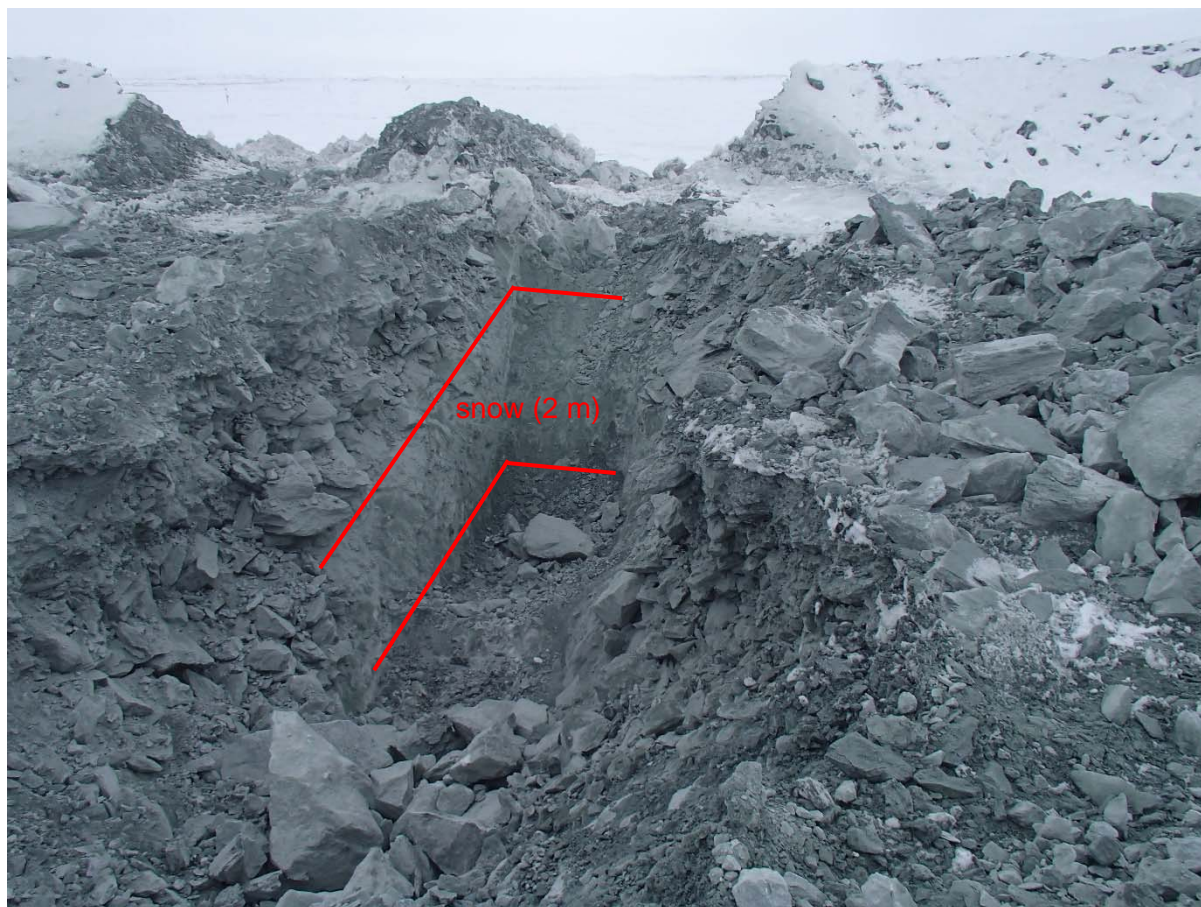
- It was noticed that the 2-m thick UM rockfill at El. 152 m (approx.) was placed on an important layer of hard snow (up to 2 m thick) without QA/QC supervision earlier in the season (see photographs and sketch below), over a distance of approx. 100 m along the dike. It is required to remove this rockfill and clear the snow before placing rockfill again, as the presence of an underlying snow layer will cause excessive settlement in the structure. It was reiterated that per the design, the foundation of the structure must be snow-free, compacted rockfill material constituting the capping of the North Cell.

**Photograph NCIS-001: View of a test pit in the UM rockfill lift at El. 152 m: a thick layer (2 m) of snow underlies the rockfill.**

- Test pits were excavated to identify the extent of the snow layer. Since snow was not observed in the northern part of the UM rockfill lift, which appears to be built directly on the North Cell capping, it was decided to move the operations there and progress towards the north. The excavator removes the snow-rich toe of the UM rockfill lift until snow is no longer observed (a 2-3 m wide zone in average), and a dozer pushes the excavated material (UM rockfill mixed with snow) toward the center of the North Cell to clear the upstream toe.

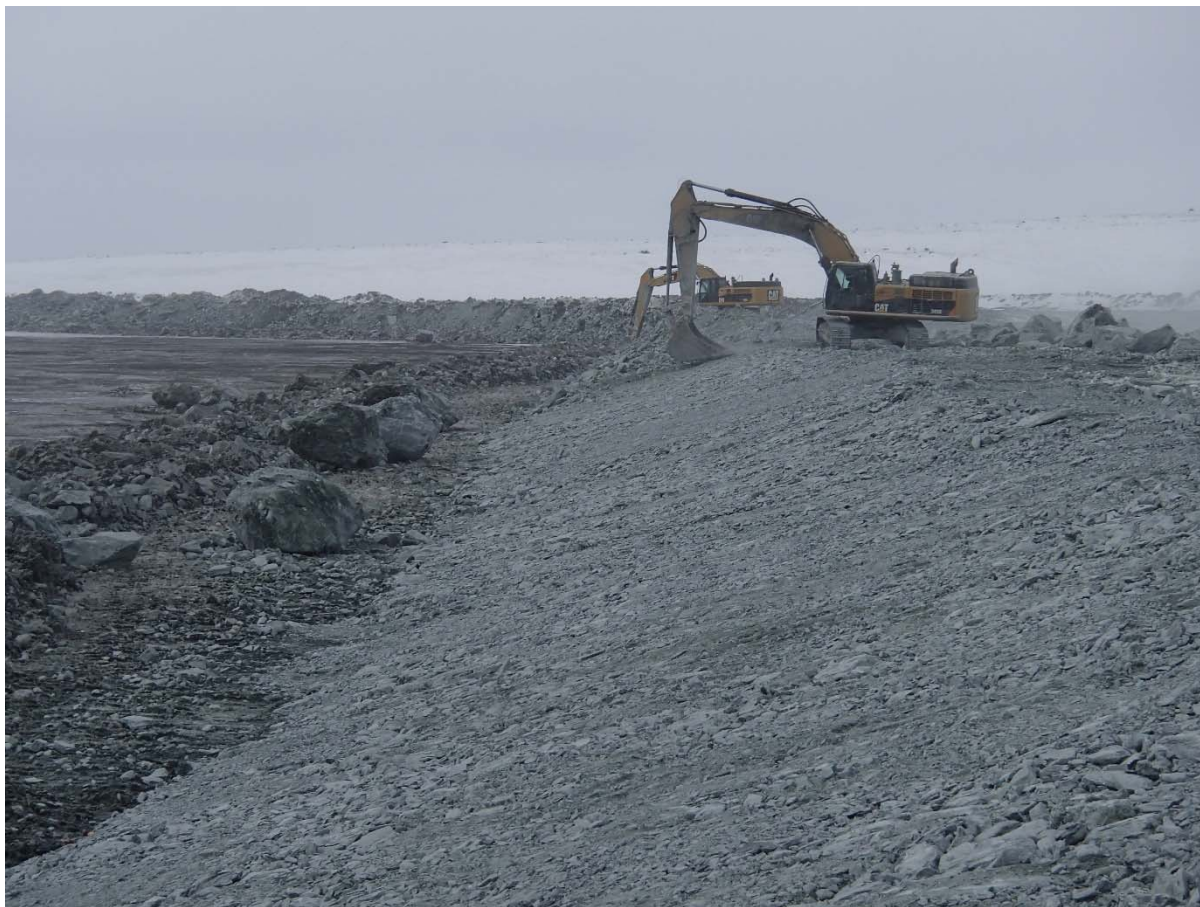
**Photograph NCIS-007: Profiling of the upstream slope (3H:1V) from El. 150 to 152 m with an excavator.**
