MEADOWBANK DIVISION
GEOTECHNICAL ENGINEERING
2018-2019 CAPPING

QA WEEKLY REPORT FROM MAY 21ST TO MAY 27TH – TSF NORTH CELL CONSTRUCTION MEADOWBANK (1897439)

QA WEEKLY REPORT FROM MAY 28TH TO JUNE 3RD – TSF NORTH CELL CONSTRUCTION MEADOWBANK (1897439)

QA WEEKLY REPORT FROM JUNE 4TH TO JUNE 11TH – TSF NORTH CELL CONSTRUCTION MEADOWBANK (1897439)

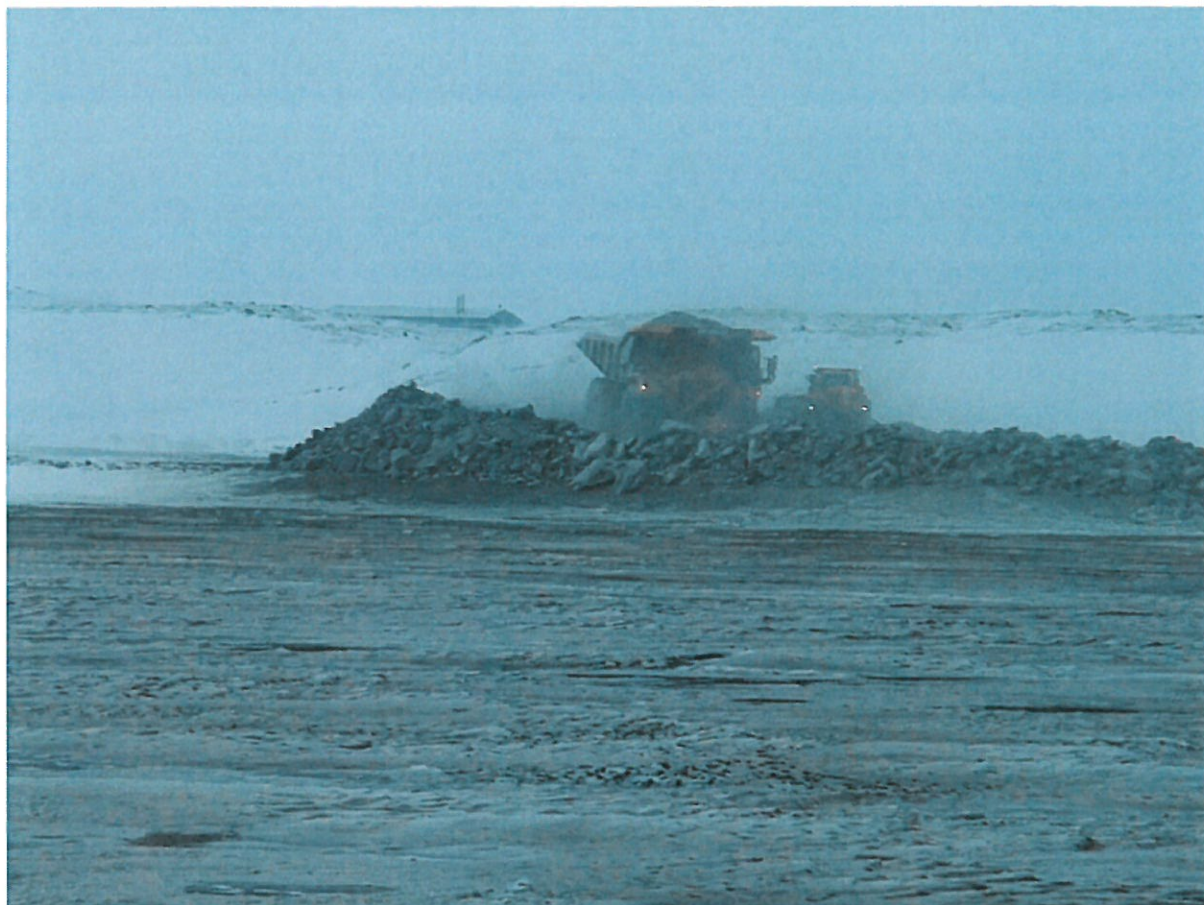
Photograph NCIS-008: Placement a 2 m thick (approx.) lift of UM rockfill from El. 150 m to El. 152 m (approx.) with a dozer. The material is of good quality and is well graded.

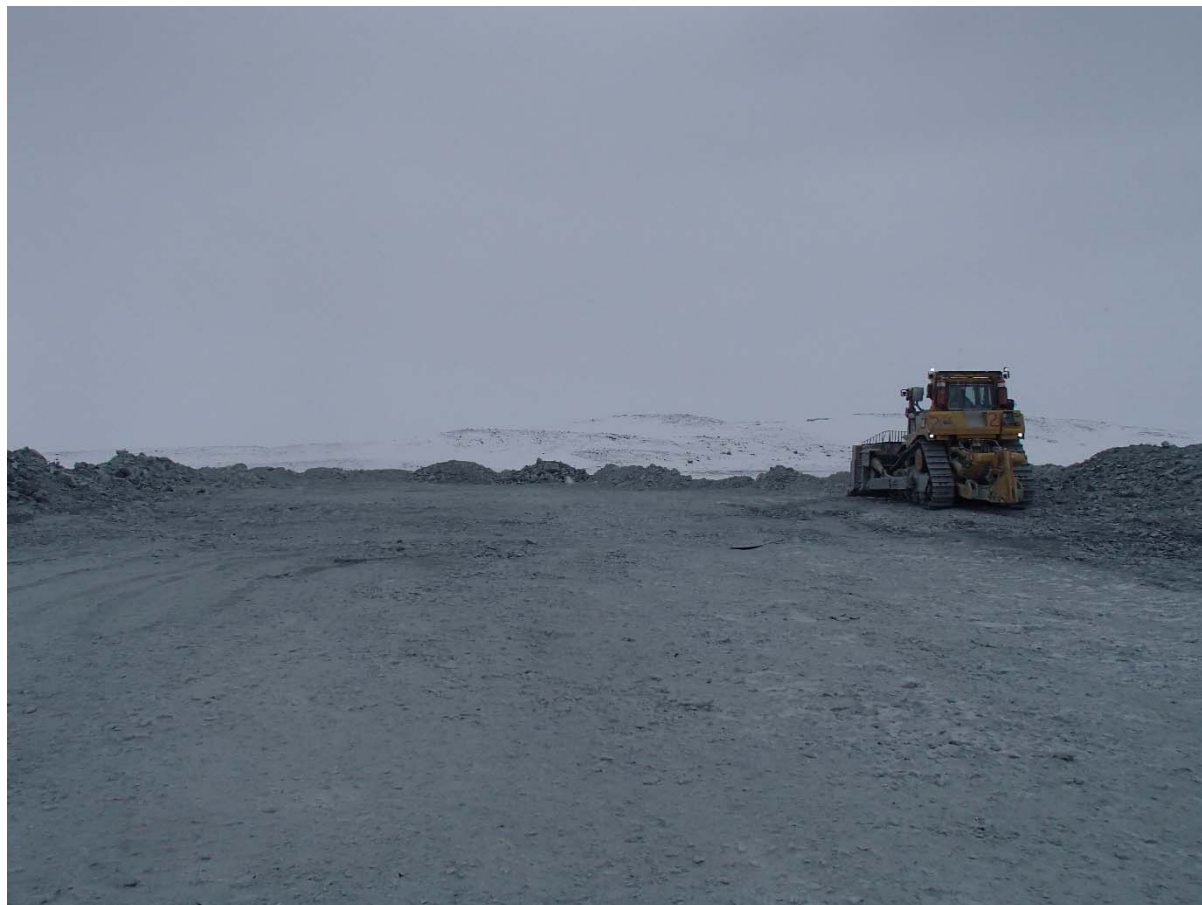
Photograph NCIS-009: Placement of a 2 m thick (approx.) lift of UM rockfill from El. 150 m to El. 152 m (approx.) with a dozer from Sta. 1+880 m to 1+825 m (offset unavailable).

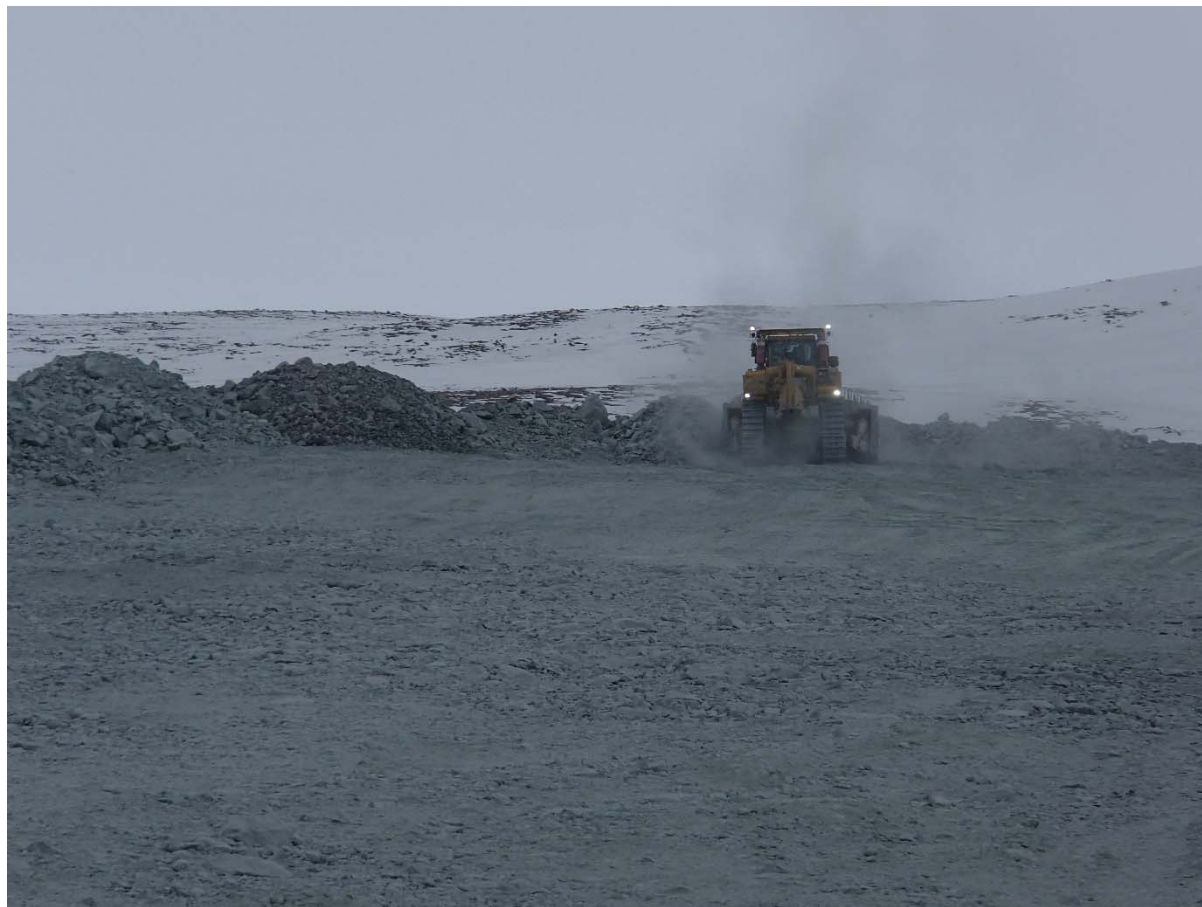
Photograph NCIS-011: From Sta. 2+000 m (approx.), looking SW. Placement a 2 m thick (approx.) lift of UM rockfill from El. 150 m to El. 152 m (approx.) with a dozer from Sta. 1+880 m to 1+767 m (offset unavailable).

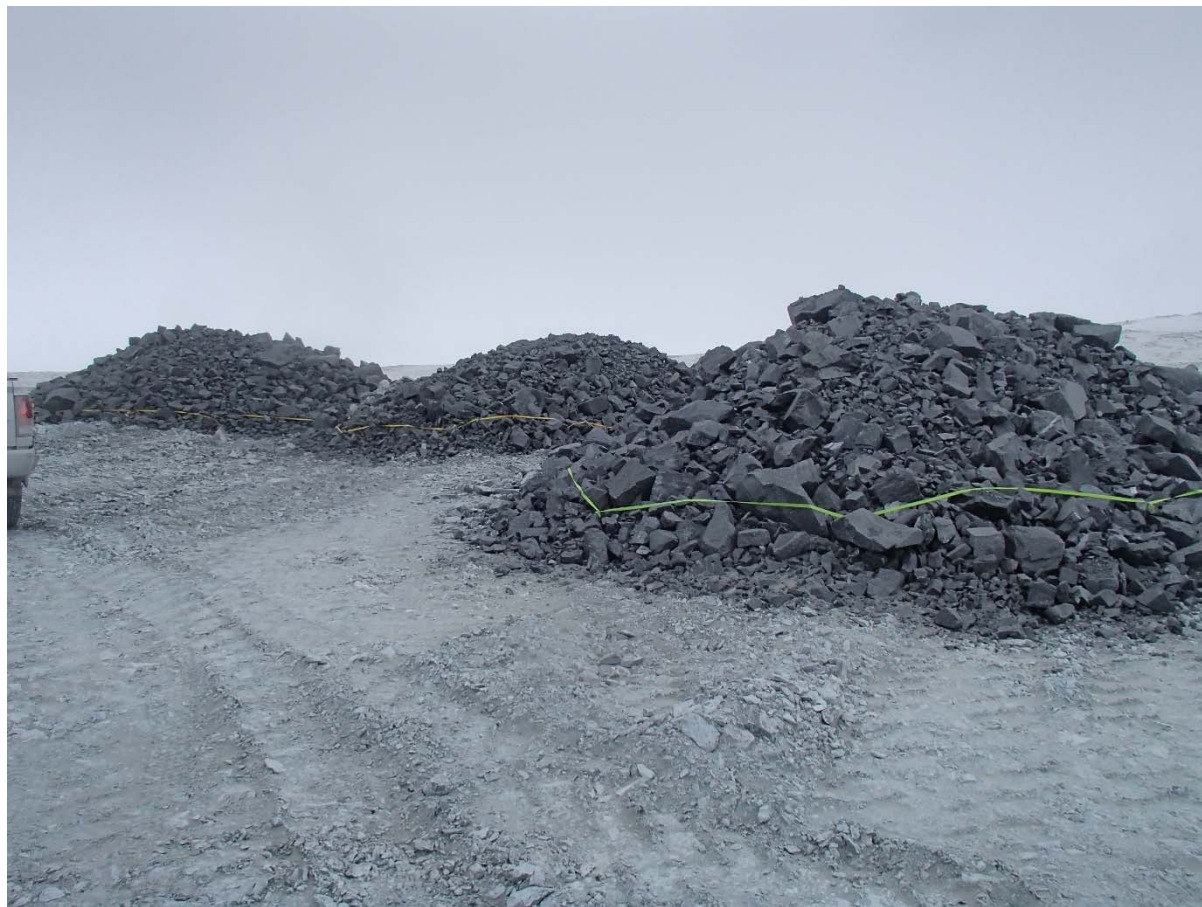
- A small amount of Iron Formation (IF) rockfill was mistakenly placed on the North Cell Internal Structure (see photograph below). IF rockfill is a PAG material and is not suitable for dike construction; it was therefore removed before further placement of UM rockfill.

Photograph NCIS-016: From Sta. 1+750 m (approx.), looking SE. View of the Iron Formation rockfill (PAG material) piles on the North Cell Internal Structure to be cleaned from the structure embankment.

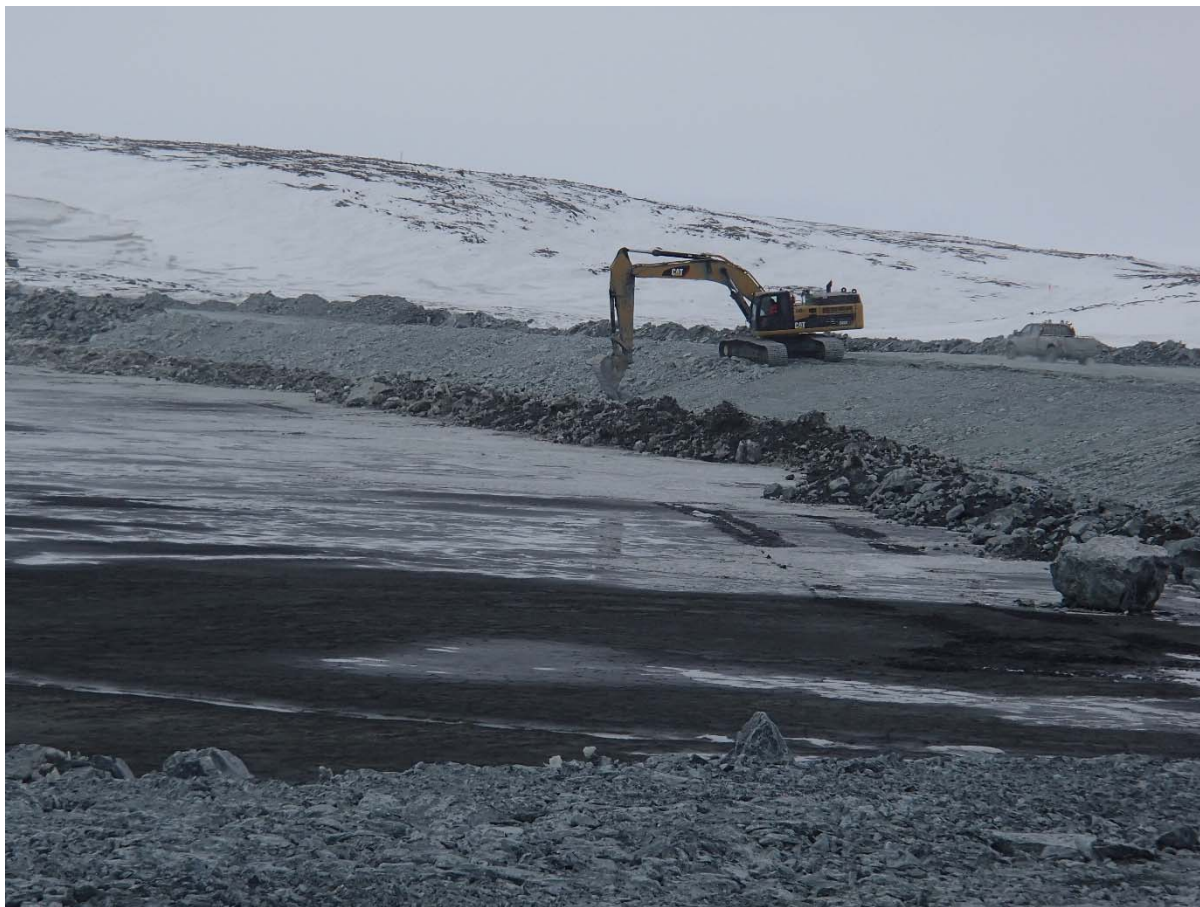
Photograph NCIS-017: From Sta. 2+290 m (approx.), looking SW. Profiling of the upstream slope (3H:1V) from El. 150 to 152 m with an excavator from Sta. 2+138 m to 1+989 m.

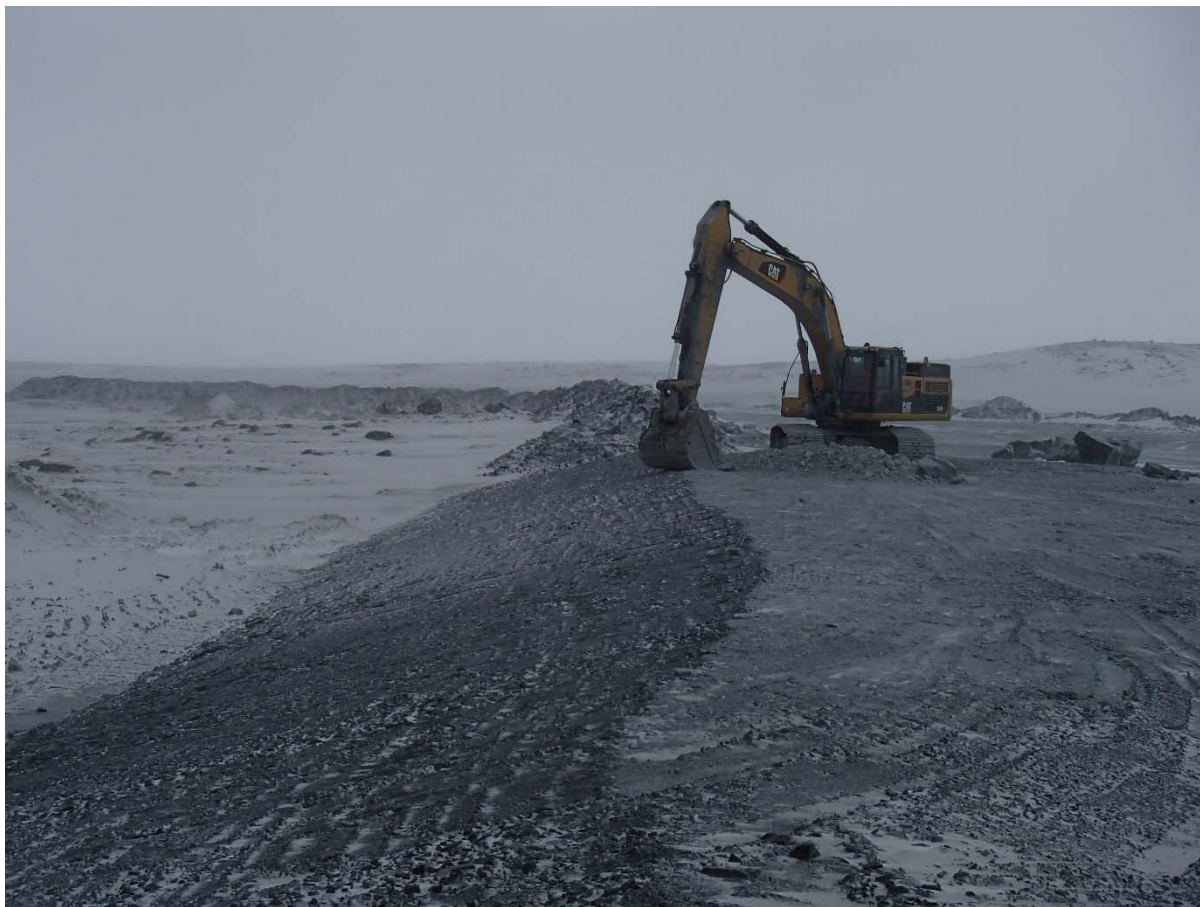
Photograph NCIS-019: From Sta. 2+100 m (approx.), looking SW. Profiling of the upstream slope (3H:1V) from El. 150 to 152 m with an excavator from Sta. 1+860 m to 1+678 m. The portion between Sta. 1+900 m and 1+800 m, where the structure is built on the natural ground, was not profiled.

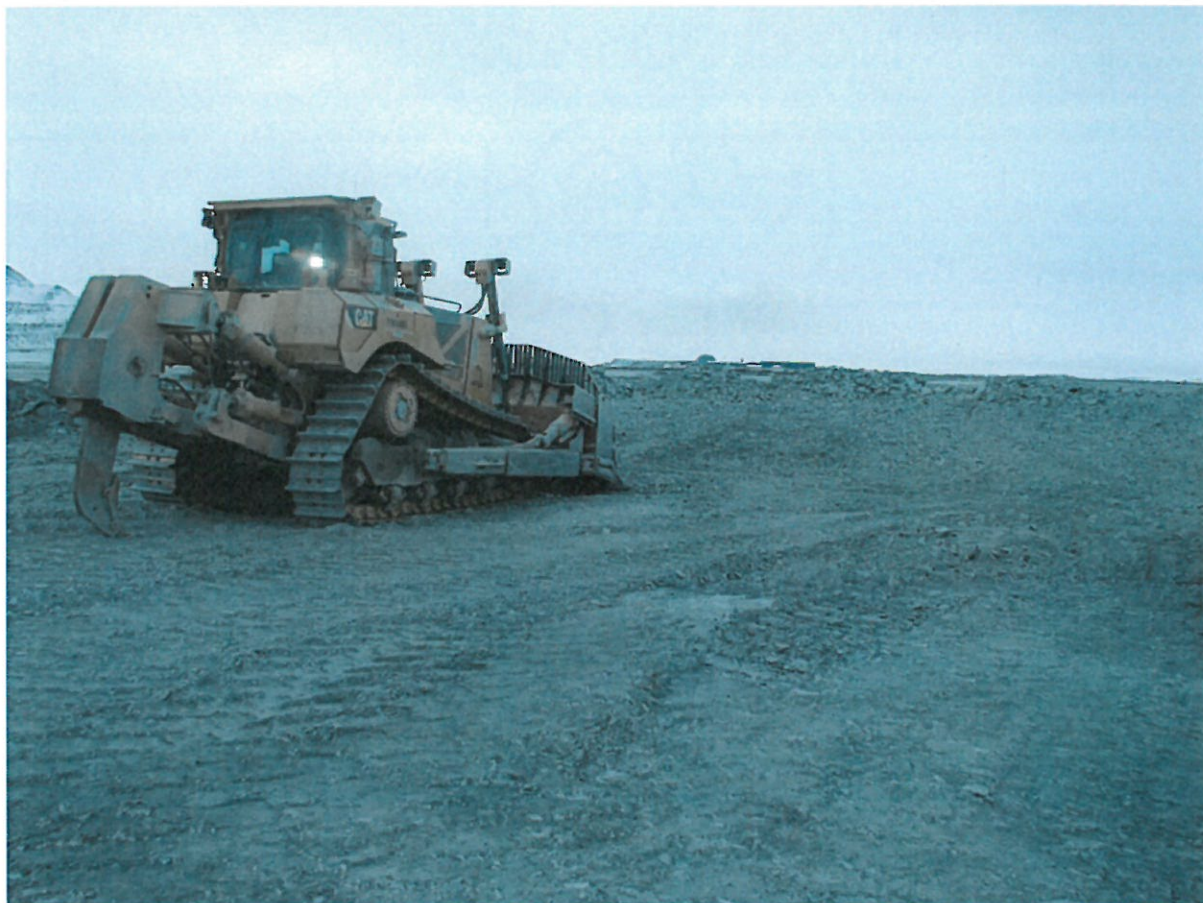
Photograph NCIS-020: From Sta. 1+570 m (approx.), looking S. Placement of a 2 m thick (approx.) lift of UM rockfill from El. 150 m to El. 152 m (approx.) with a dozer from Sta. 1+564 m to 1+535 m (offset unavailable).

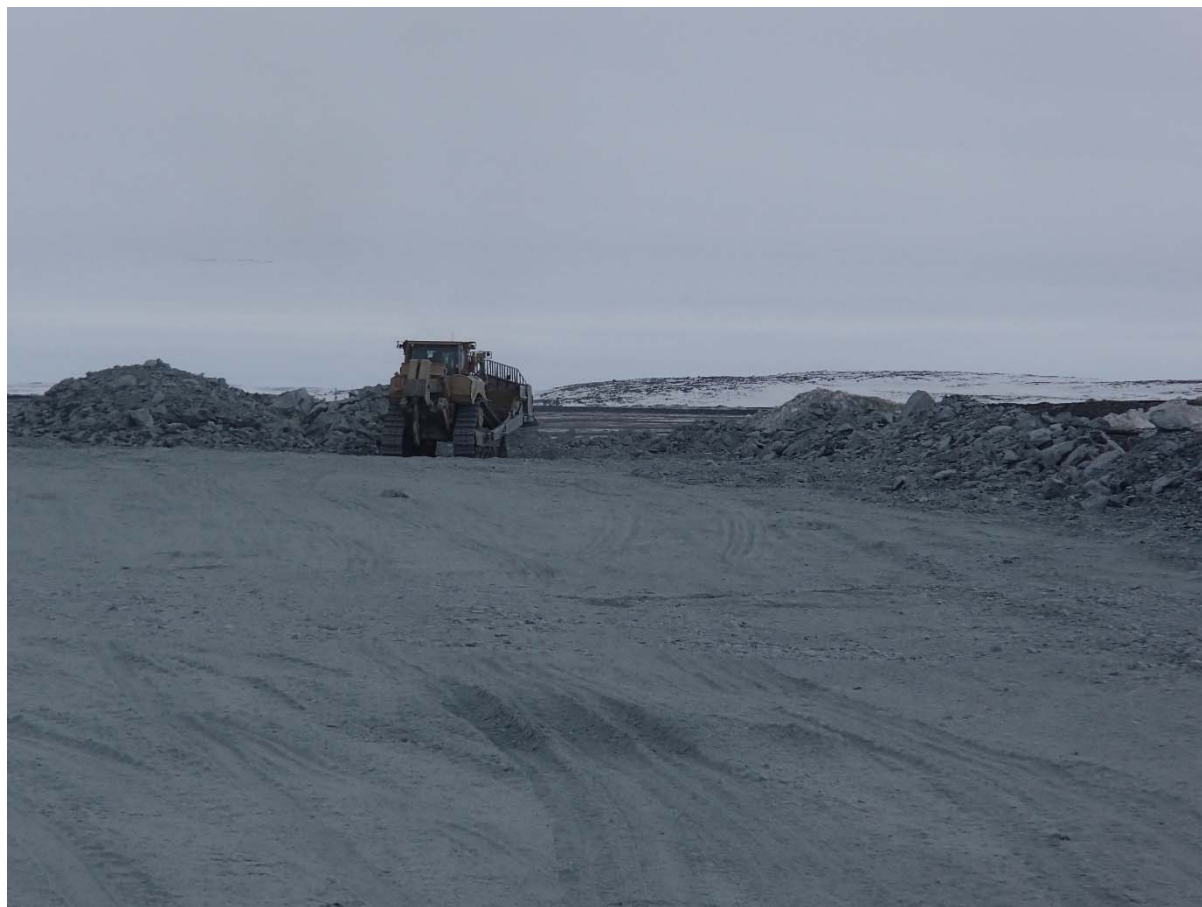
Photograph NCIS-021: From Sta. 1+550 m (approx.), looking S. Placement a 2 m thick (approx.) lift of UM rockfill from El. 150 m to El. 152 m (approx.) with a dozer from Sta. 1+535 m to 1+500 m (offset unavailable).

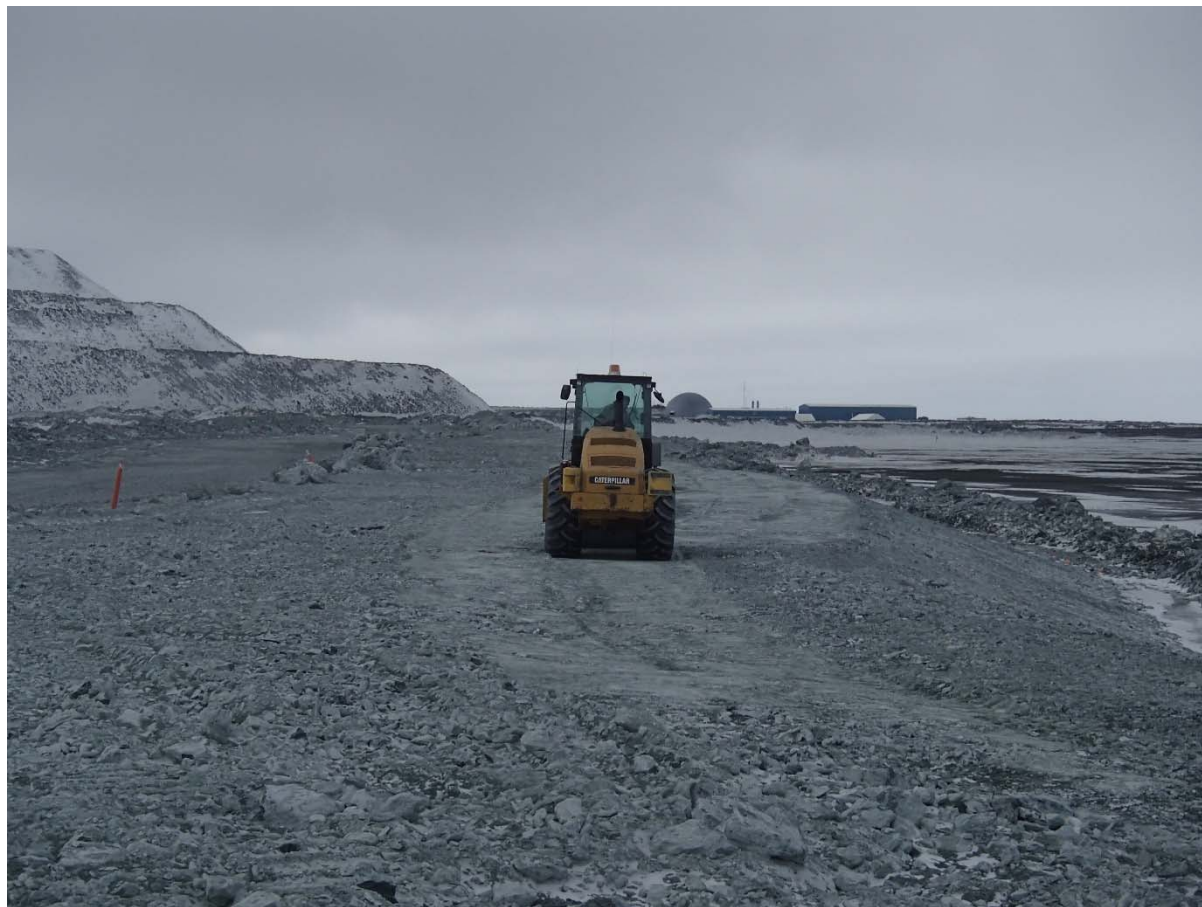
Photograph NCIS-022: From Sta. 2+245 m (approx.), looking SE. Compaction of the 2 m lift (approx.) of ultramafic (UM) rockfill at El. 152 m with a 10-tonne smooth-drum compactor with vibration (6 passes) between the haul truck traffic lane and the upstream slope from Sta. 2+625 to 1+625 m (offset unavailable).

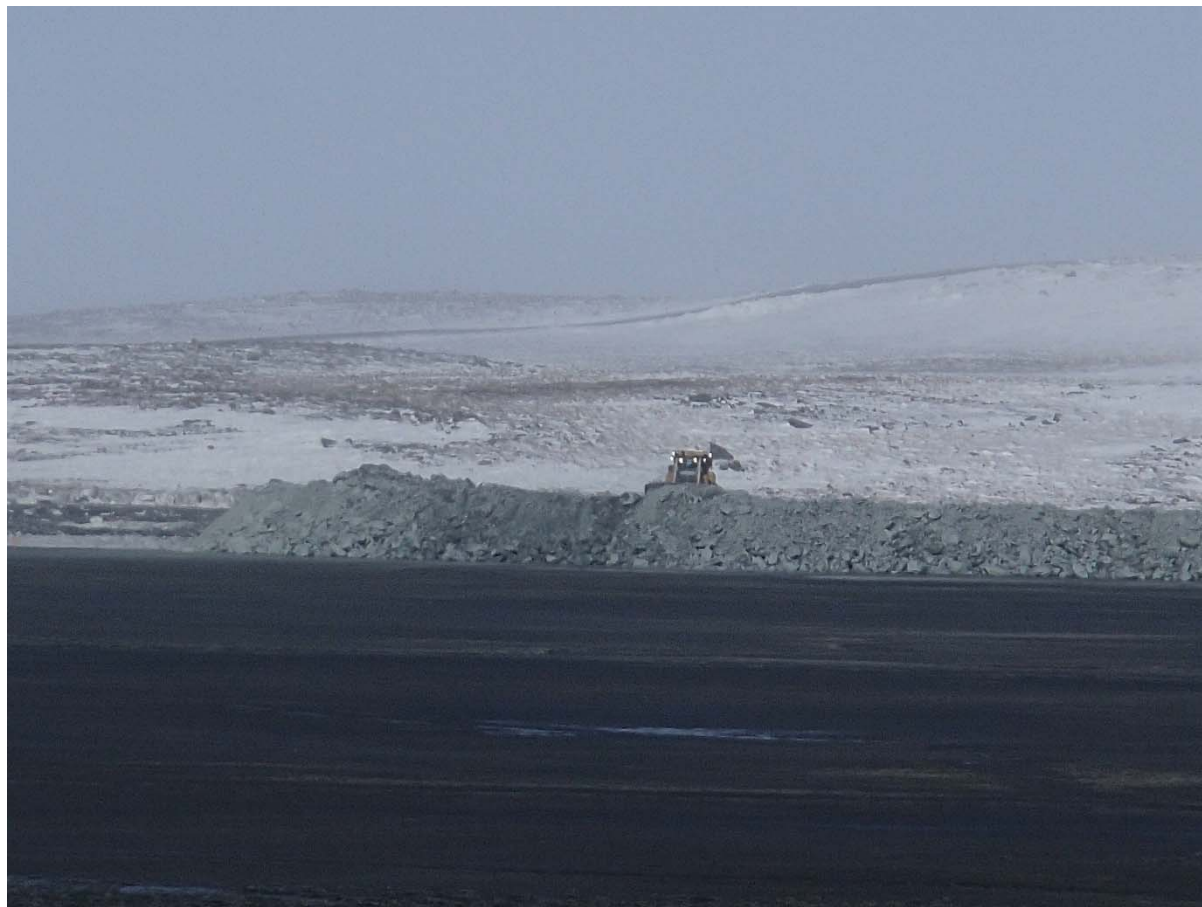
Photograph NCIS-023: From Sta. 2+570 m (approx.), looking W. Placement of a 2 m thick (approx.) lift of UM rockfill from El. 150 m to El. 152 m (approx.) with a dozer from Sta. 1+500 m to 1+450 m (offset unavailable). The material is of good quality and is well graded.

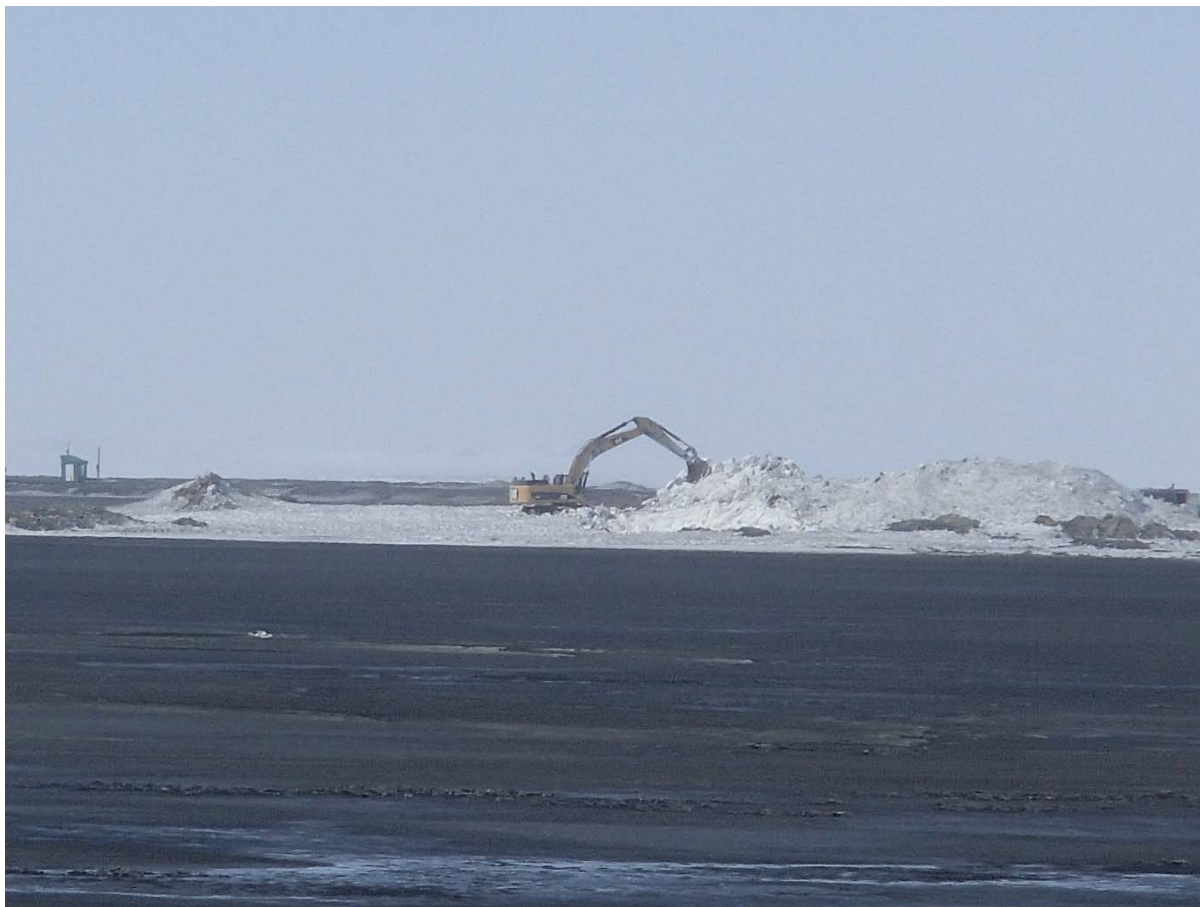
Photograph NCIS-024: From Sta. 2+570 m (approx.), looking SW. Removal of the snow bank in the footprint with an excavator from Sta. 1+160 m to 1+120 m (approx.).

- Ensure that the layer of hard snow (up to 2 m thick) under the 2 m thick UM rockfill at El. 152 m (approx.) is not within the footprint of the dike, or that it is removed during the profiling of the slope. The foundation of the structure must be snow-free, compacted rockfill material constituting the capping of the North Cell.

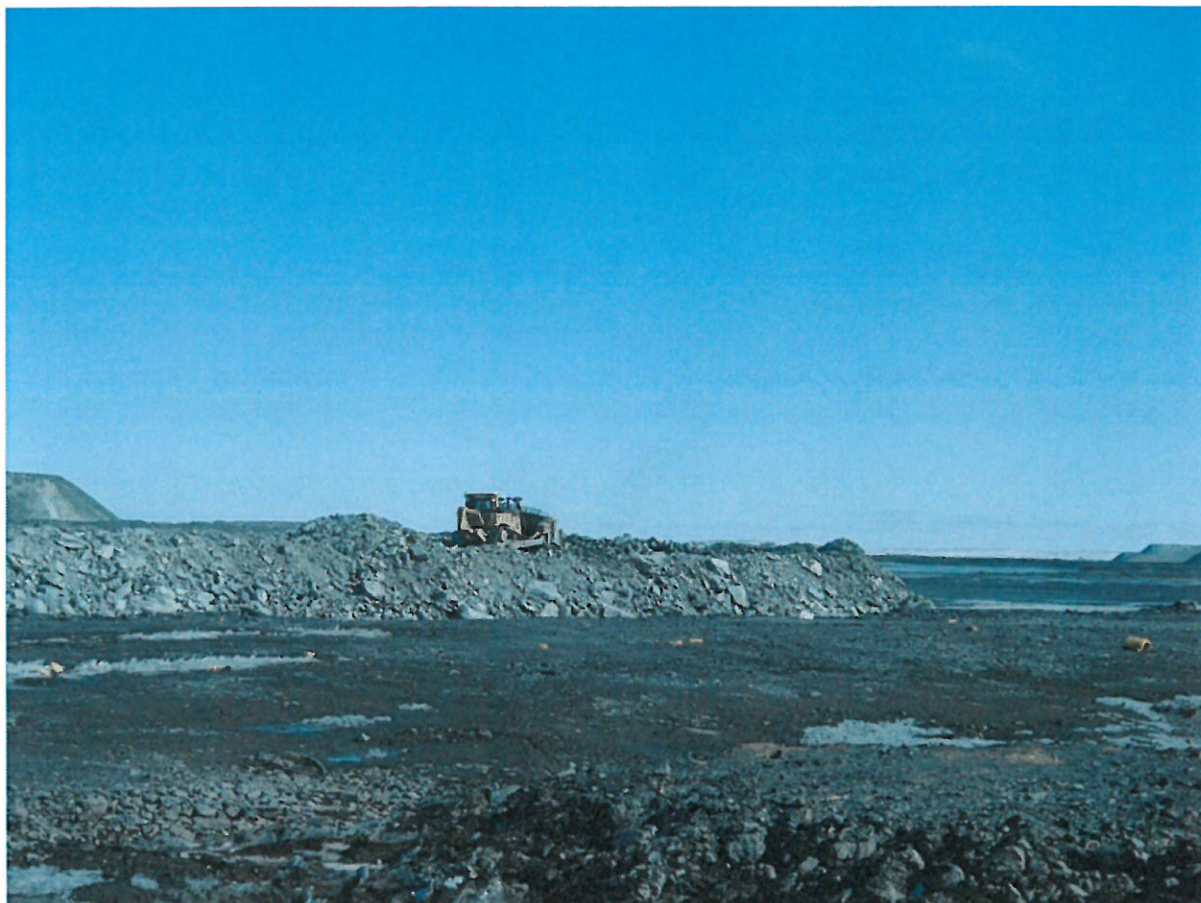
Photograph NCIS-025: From Sta. 1+475 m (approx.), looking SE. Placement of a 2 m thick (approx.) lift of UM rockfill from El. 150 m to El. 152 m (approx.) with a dozer from Sta. 1+450 m to 1+390 m (offset unavailable). The material is of good quality and is well graded.

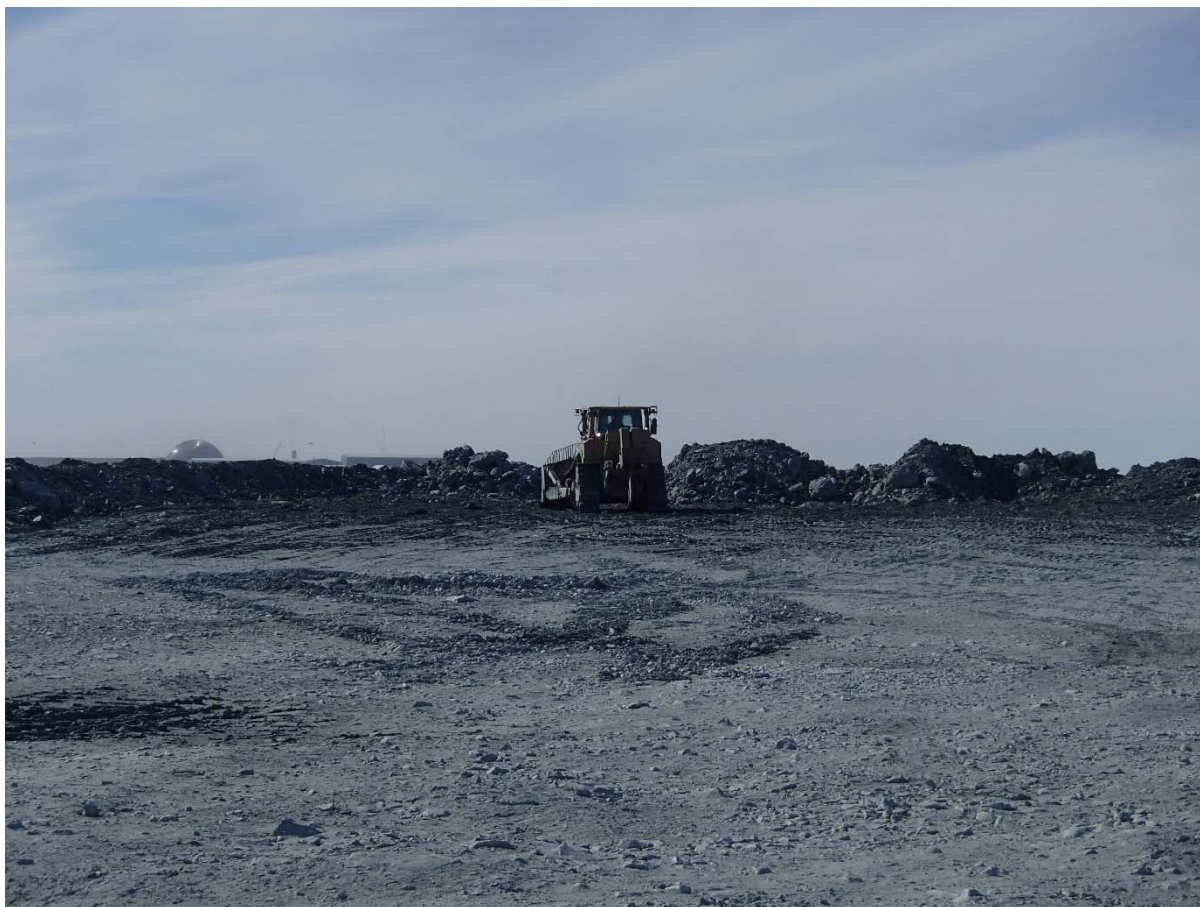
Photograph NCIS-026: From Sta. 1+440/+2 m, looking S. Placement of a 2 m thick (approx.) lift of UM rockfill from El. 150 m to El. 152 m (approx.) with a dozer from Sta. 1+390 m to 1+365 m (offset +10 m to -29 m).
