QA WEEKLY REPORT

1897439-1577-TM-Rev0

QA WEEKLY REPORT FROM JUNE 19TH TO JUNE 24TH– TSF NORTH CELL CONSTRUCTION MEADOWBANK (1897439)

QA WEEKLY REPORT FROM JUNE 25TH TO JULY 1ST – TSF NORTH CELL CONSTRUCTION MEADOWBANK (1897439)

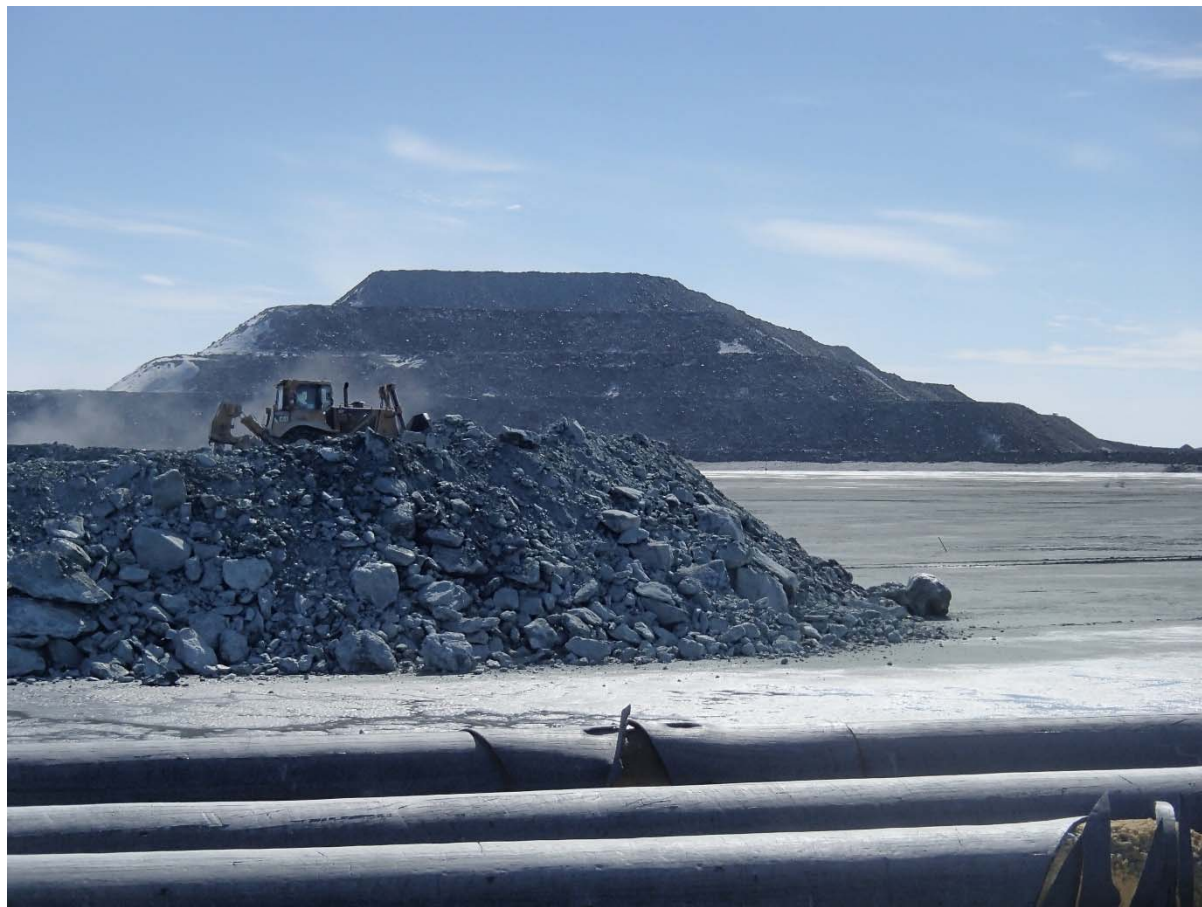
Photograph NCIS-027: From Sta. 1+360/+67 m, looking S. Placement of a 2 m thick (approx.) lift of UM rockfill from El. 150 m to El. 152 m (approx.) with a dozer from Sta. 1+365 m to 1+360 m (offset +9 m to -28 m).

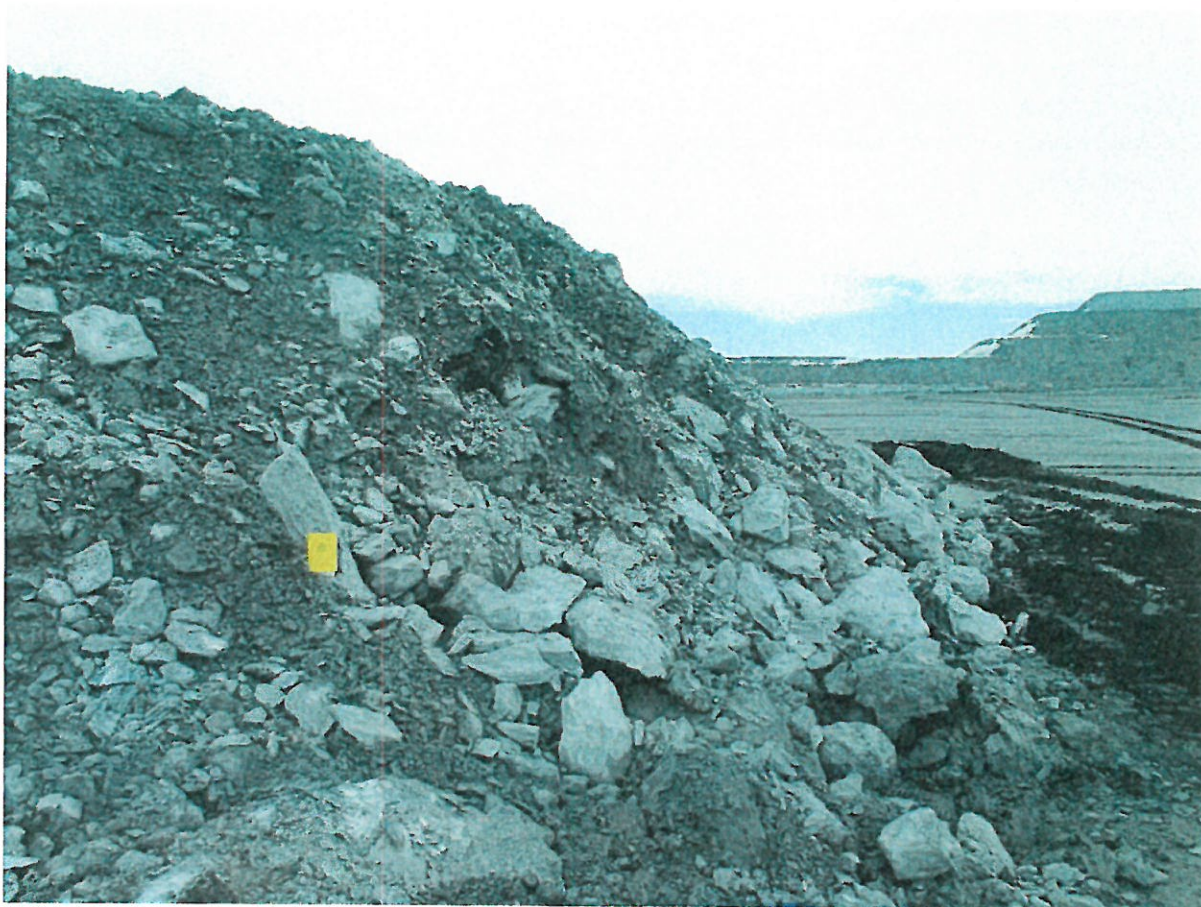
Photograph NCIS-028: From Sta. 1+340/+3 m, looking E. View of the LM rockfill lift approximately 3.2 m thick.

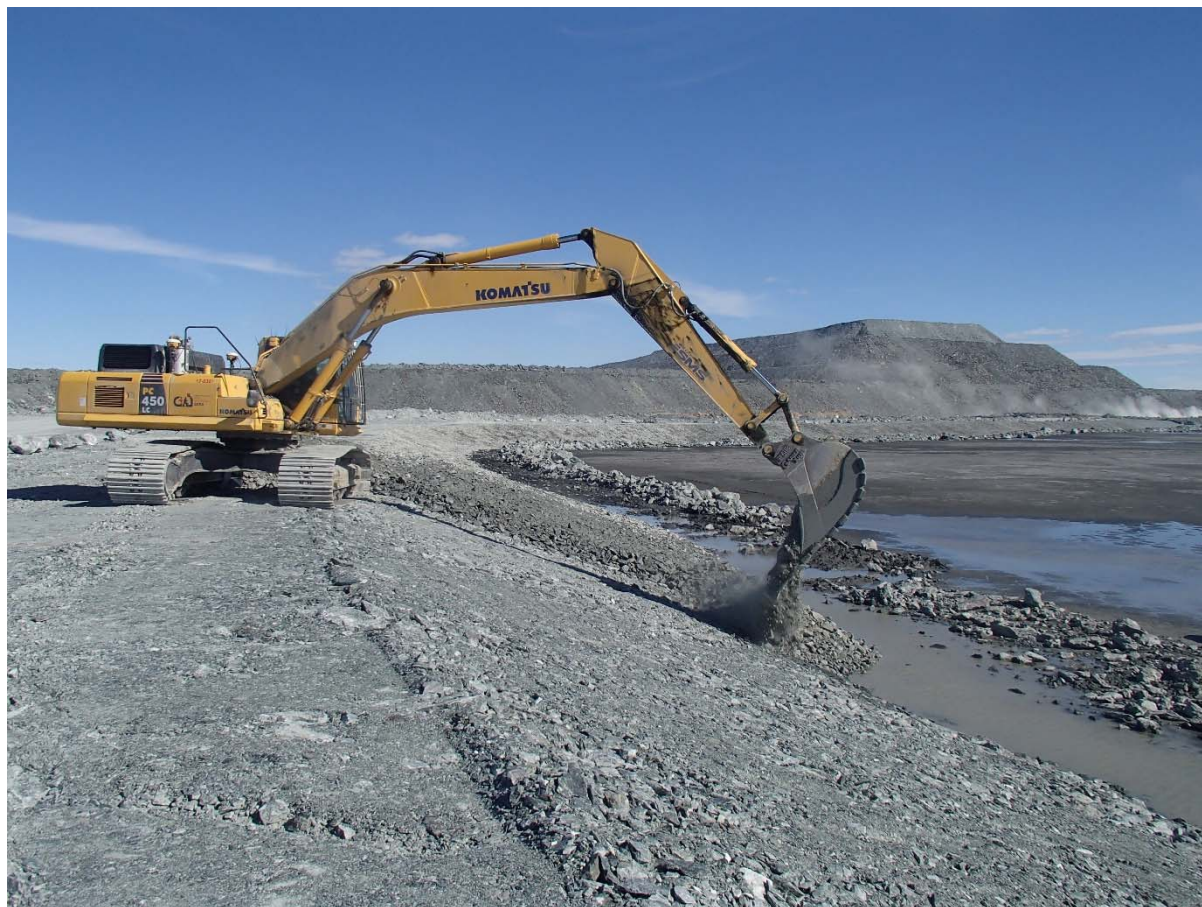
Photograph NCIS-029: From Sta. 2+120/-27 m (approx.), looking SE. Placement of a 0.5 m thick lift of coarse filter in the upstream slope from El. 150 m to 152 m with an excavator from Sta. 2+280 m to 2+105 m.

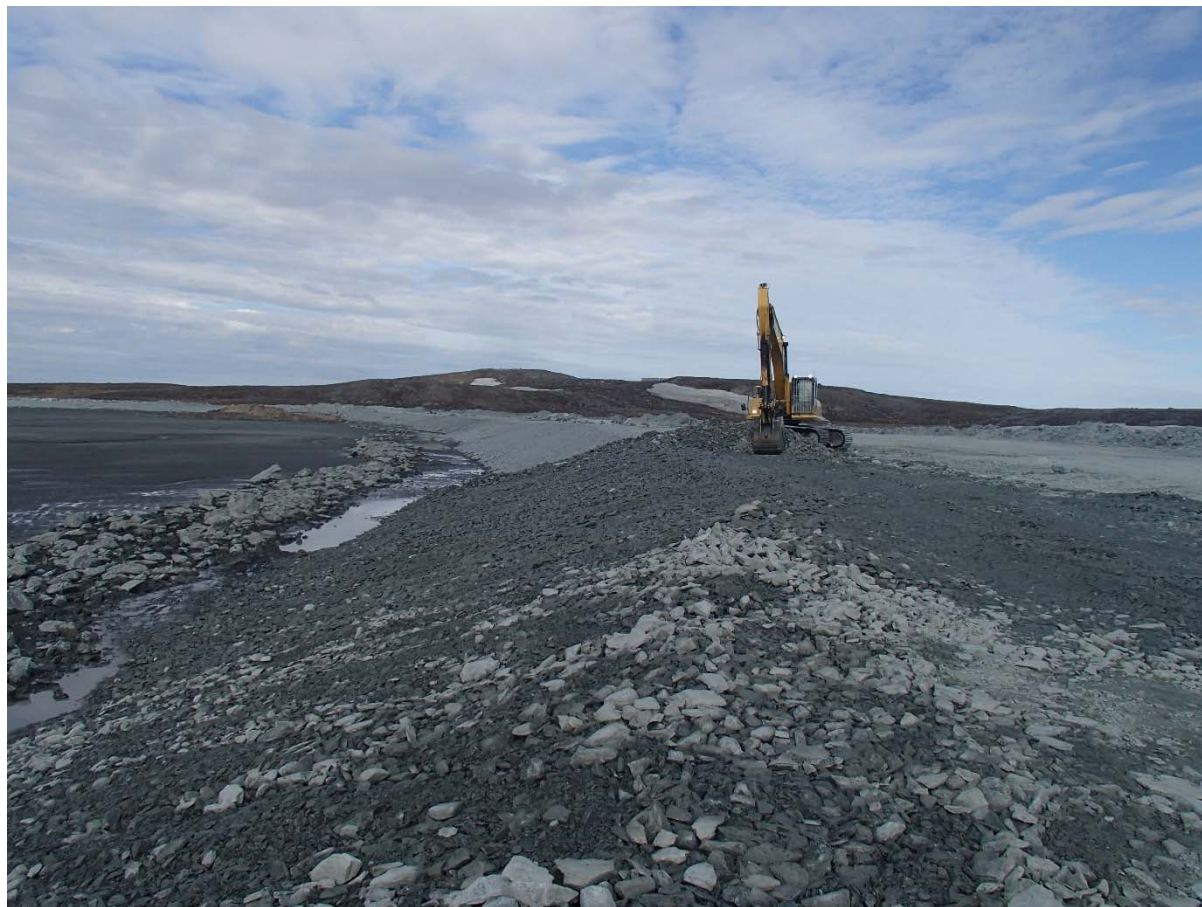
Photograph NCIS-030: From Sta. 2+140/-29 m (approx.), looking W. Placement of a 0.5 m thick lift of coarse filter in the upstream slope from El. 150 m to 152 m with an excavator from Sta. 2+105 m to 1+930 m. Notice the presence of water ponding at the bottom of the slope.

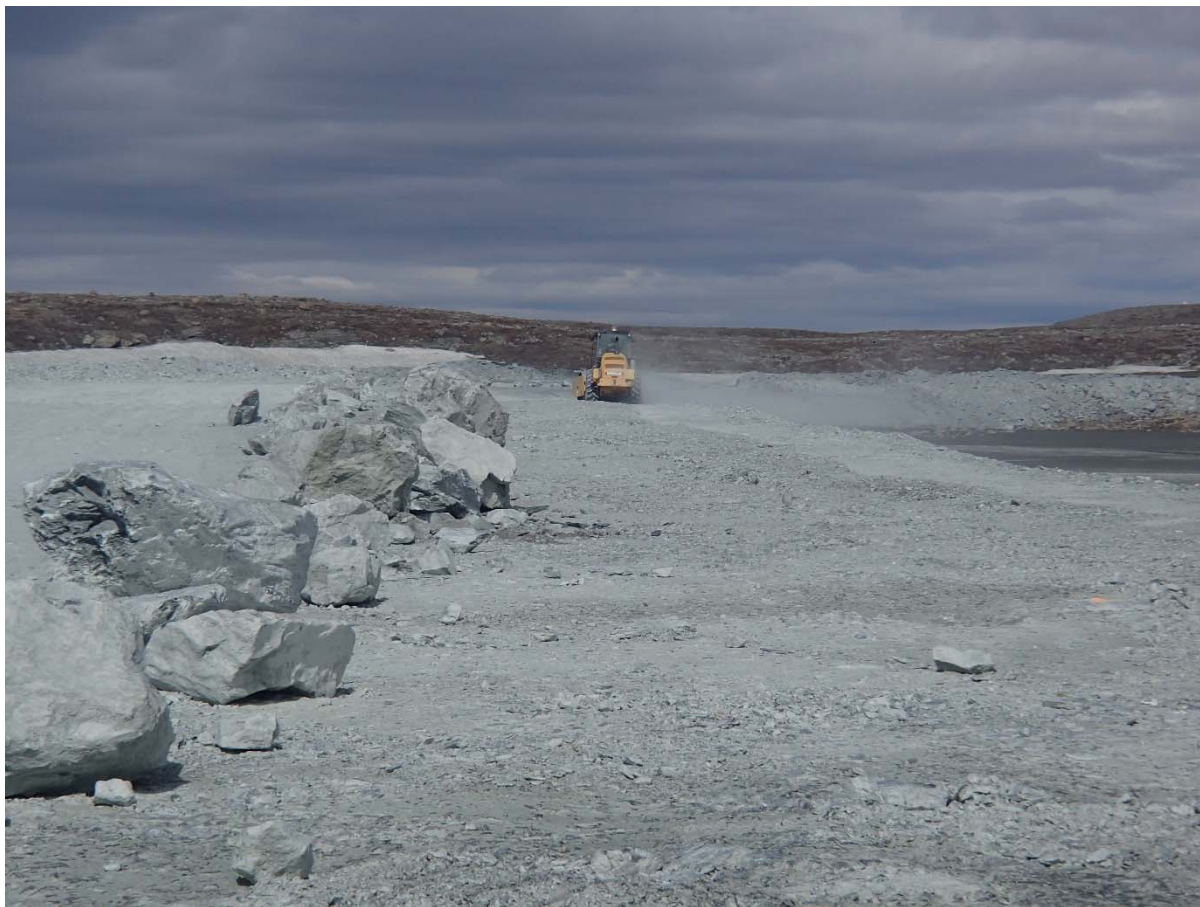
Photograph NCIS-032: From Sta. 1+400/-24 m (approx.), looking N. Compaction of the 2 m lift (approx.) of ultramafic (UM) rockfill at El. 152 m with a 10-tonne smooth-drum compactor with vibration (6 passes) between the haul truck traffic lane and the upstream slope from Sta. 1+660 to 1+380 m (offset -45 to -24 m).

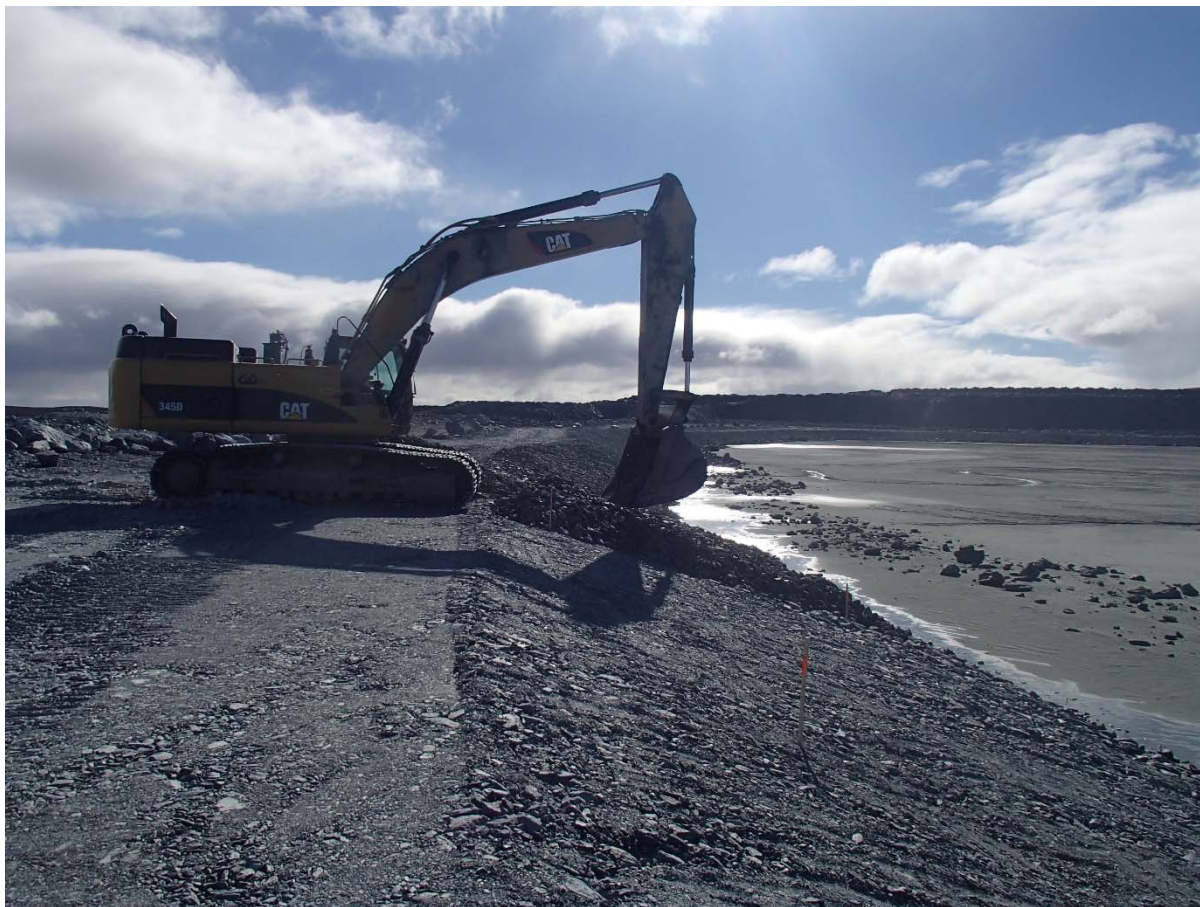
Photograph NCIS-033: From Sta. 1+900/-21 m (approx.), looking E. Placement of a 0.5 m thick lift of coarse filter in the upstream slope from El. 150 m to 152 m with an excavator from Sta. 1+930 m to 1+715 m.

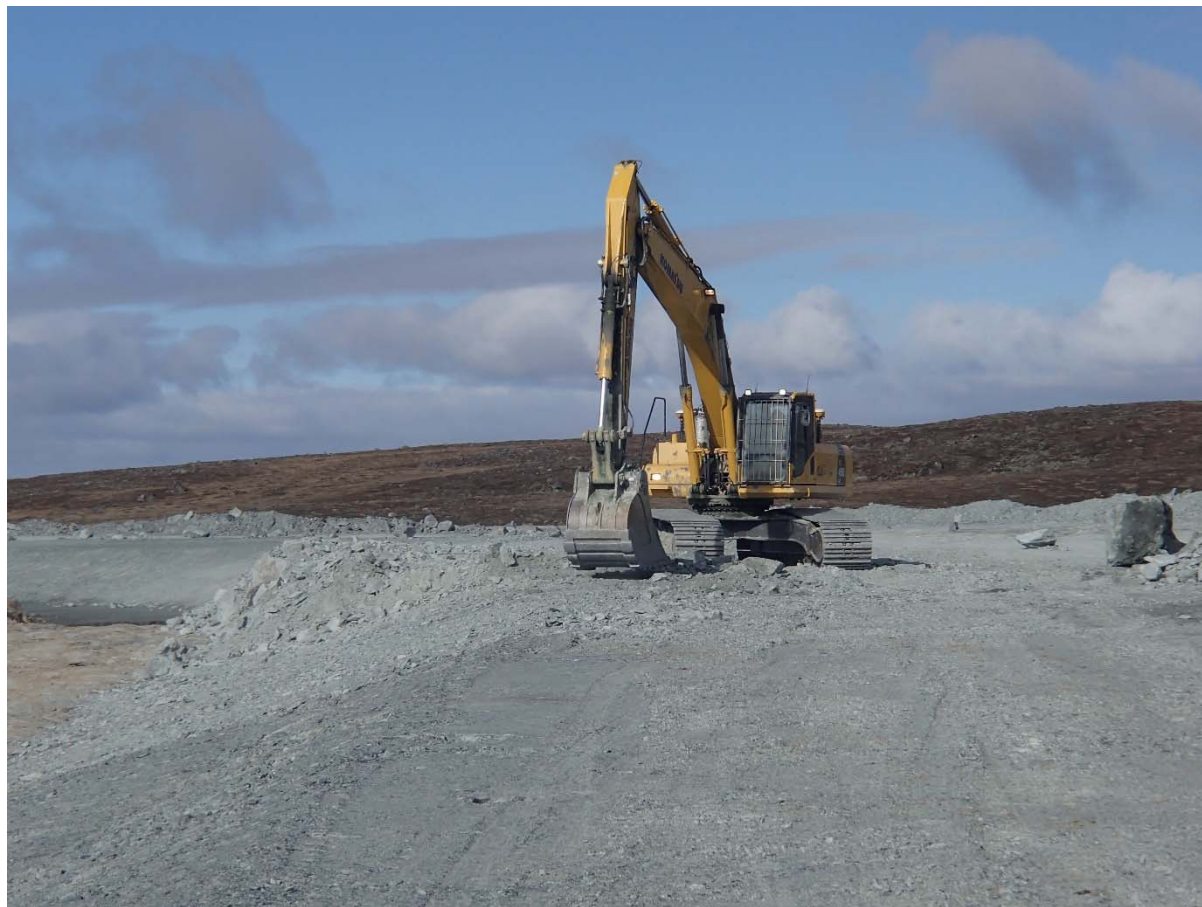
Photograph NCIS-034: From Sta. 1+900/-21 m (approx.), looking W. Profiling of the upstream slope (3H:1V) from El. 150 to 152 m with an excavator from Sta. 1+860 m to 1+750 m.

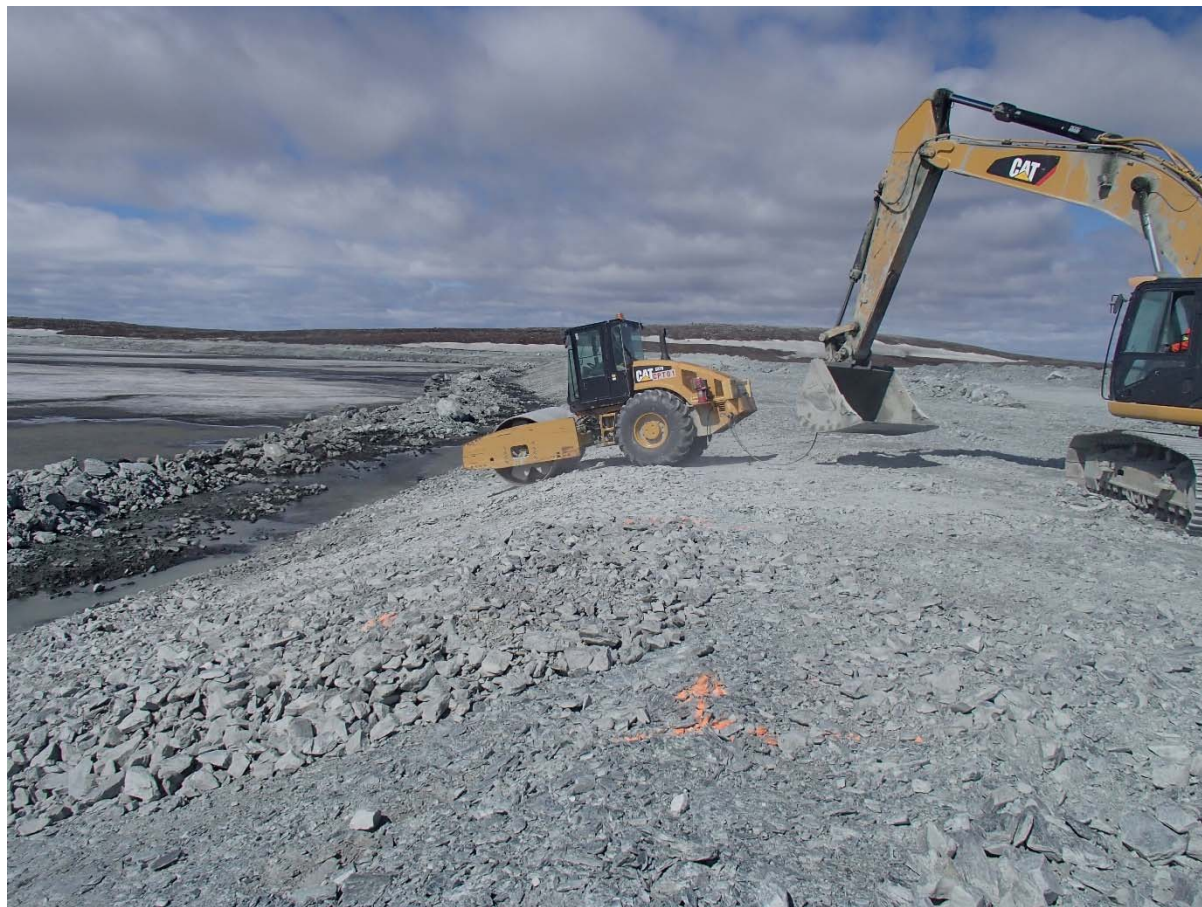
Photograph NCIS-035: From Sta. 2+550/-25 m (approx.), looking N. Compaction of the 0.5 m lift (approx.) of coarse filter between El. 150 and 152 m with a 10-tonne smooth-drum compactor (4 passes) in the upstream slope from Sta. 2+524 m to 2+450 m.

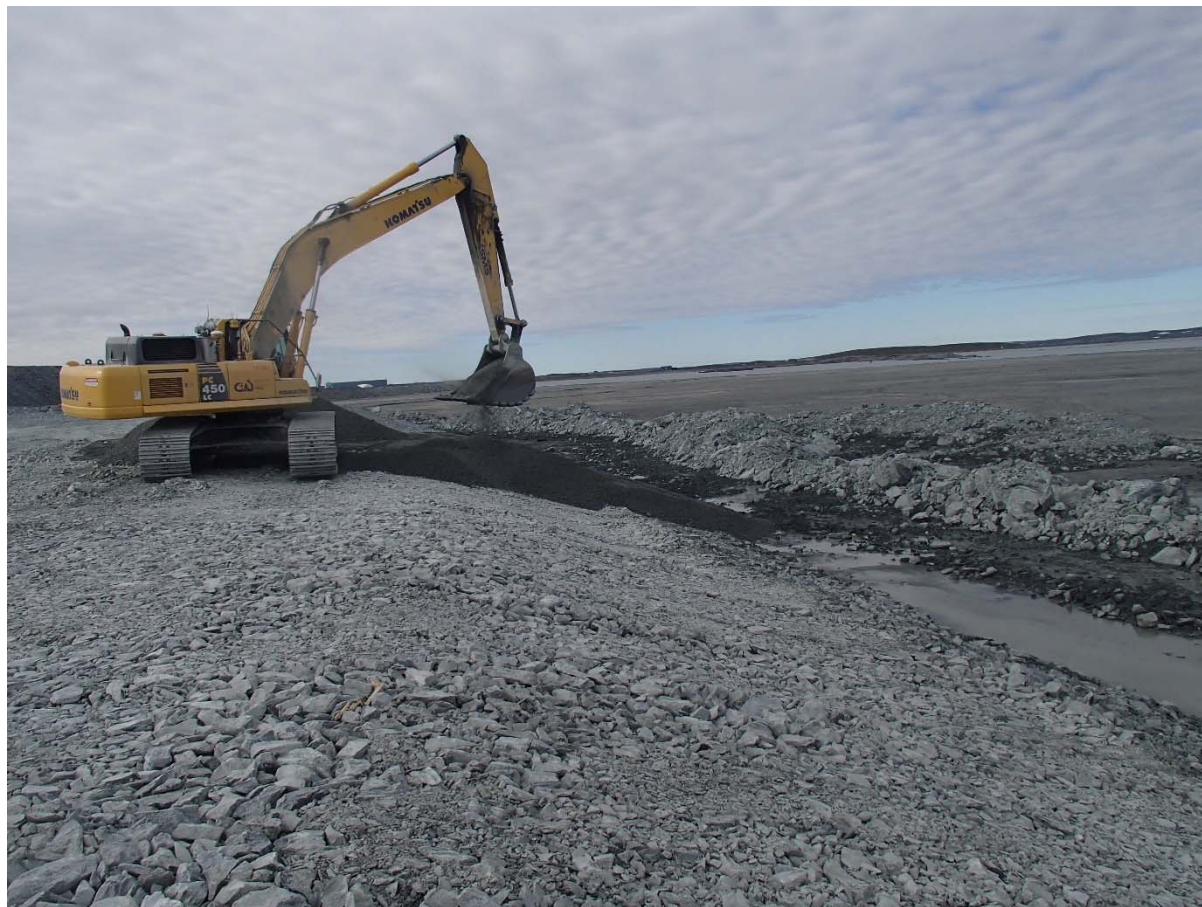
Photograph NCIS-036: From Sta. 1+900/-21 m (approx.), looking SE. Placement of a 0.5 m thick lift of fine filter over the coarse filter in the upstream slope from El. 150 m to 152 m with an excavator from Sta. 2+542 m to 2+475 m.

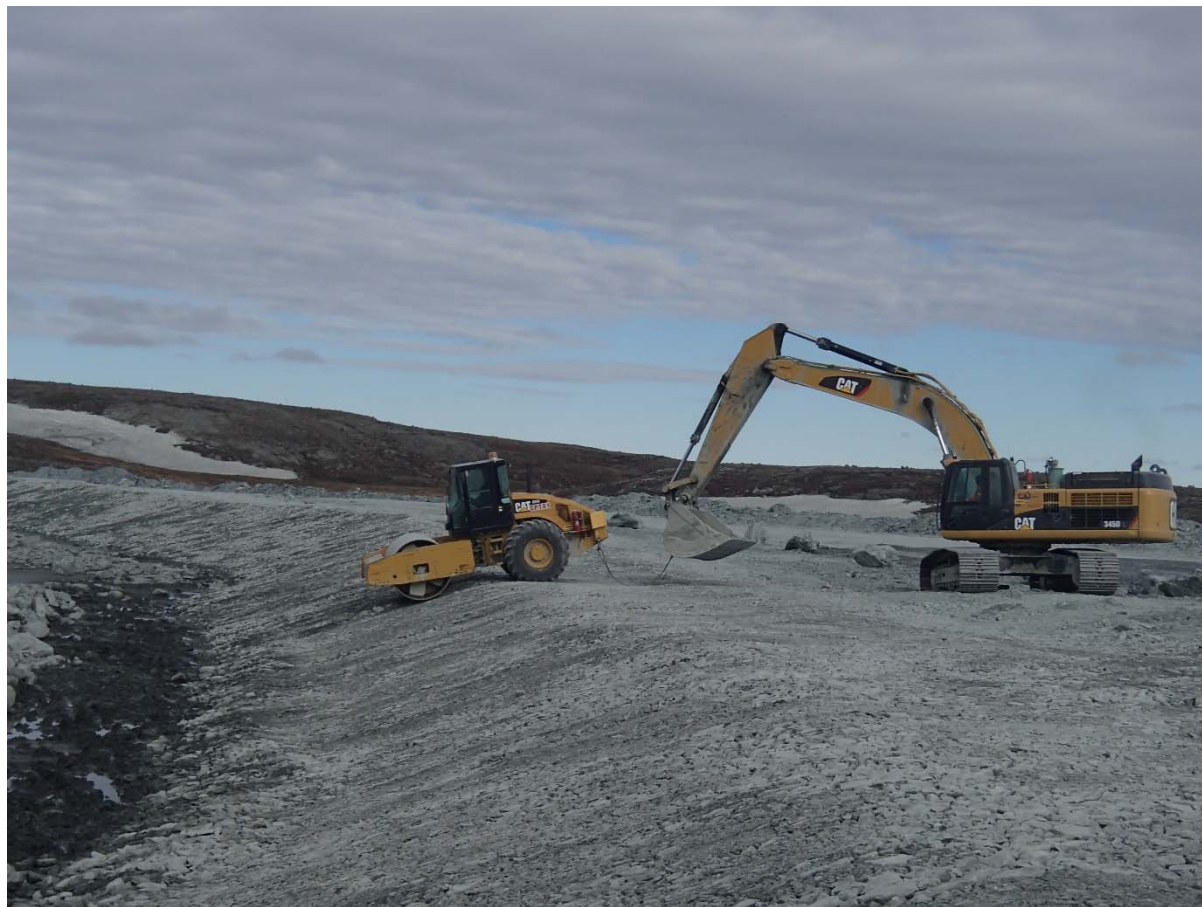
Photograph NCIS-037: From Sta. 1+550/-25 m (approx.), looking NW. Compaction of the 0.5 m lift (approx.) of coarse filter between El. 150 and 152 m with a 10-tonne smooth-drum compactor (4 passes) in the upstream slope from Sta. 2+450 to 1+805 m.

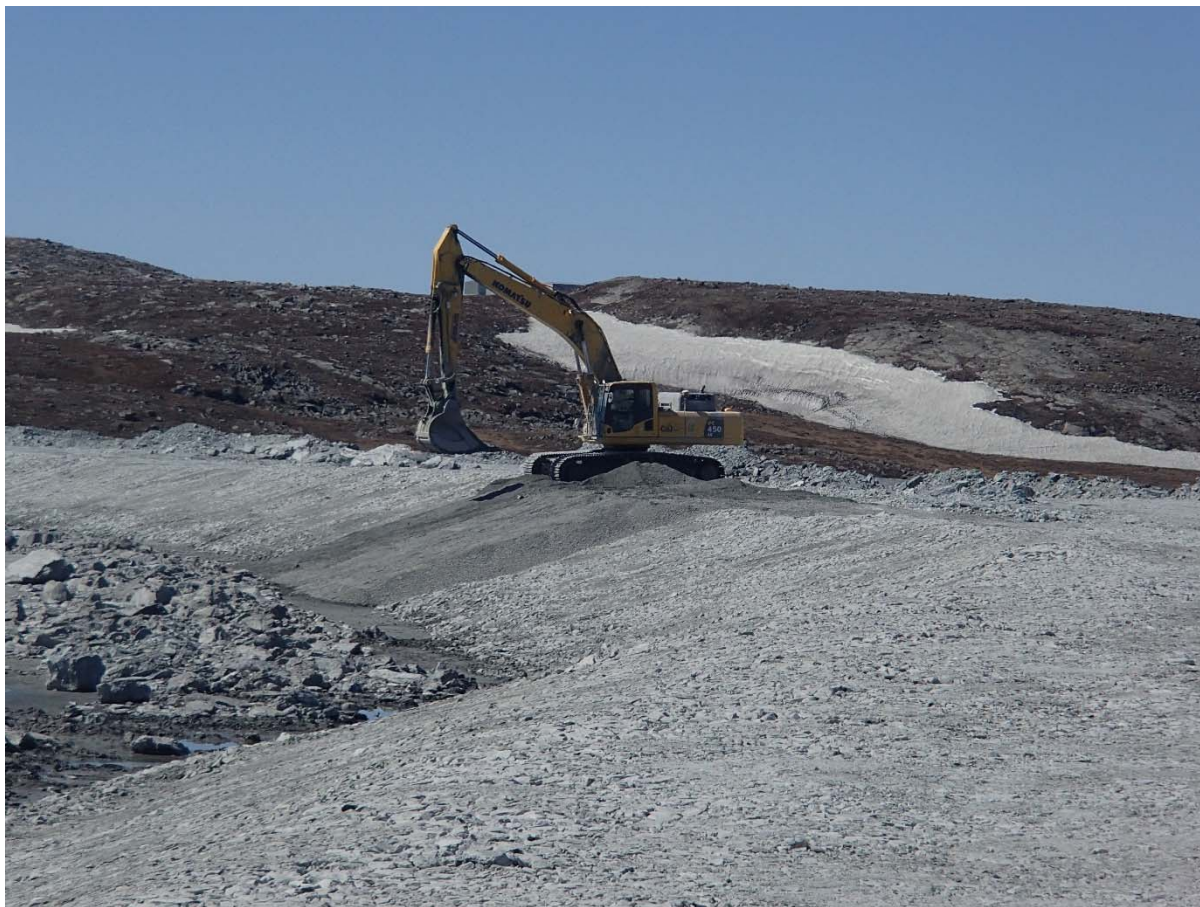
Photograph NCIS-039: From Sta. 2+200/-24 m (approx.), looking W. Placement of a 0.5 m thick lift of fine filter over the coarse filter in the upstream slope from El. 150 m to 152 m with an excavator from Sta. 2+460 m to 2+475 m and from Sta. 2+065 m to 1+980 m.

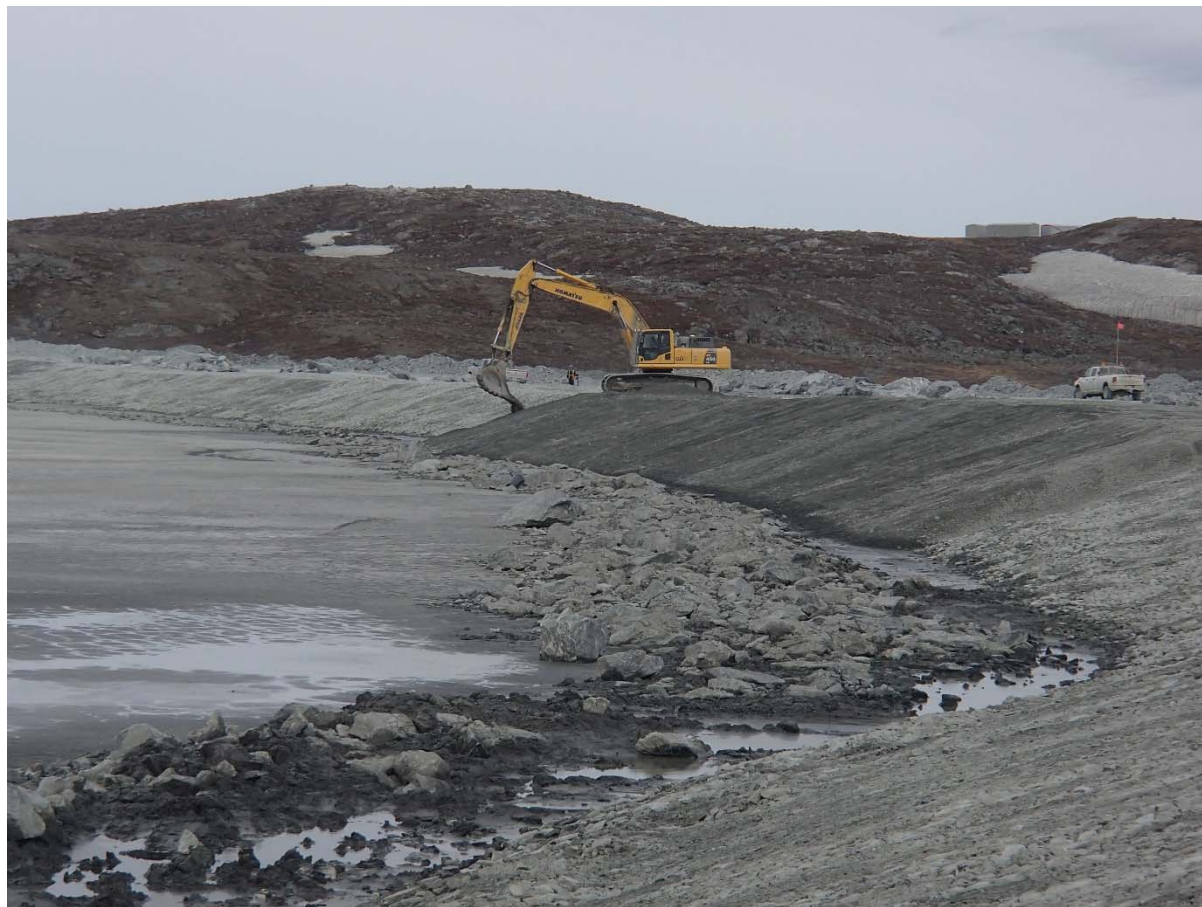
Photograph NCIS-040: From Sta. 2+185/-25 m (approx.), looking W. Placement of a 0.5 m thick lift of fine filter over the coarse filter in the upstream slope from El. 150 m to 152 m with an excavator from Sta. 2+305 m to 2+460 m and from Sta. 1+980 m to 1+835 m.

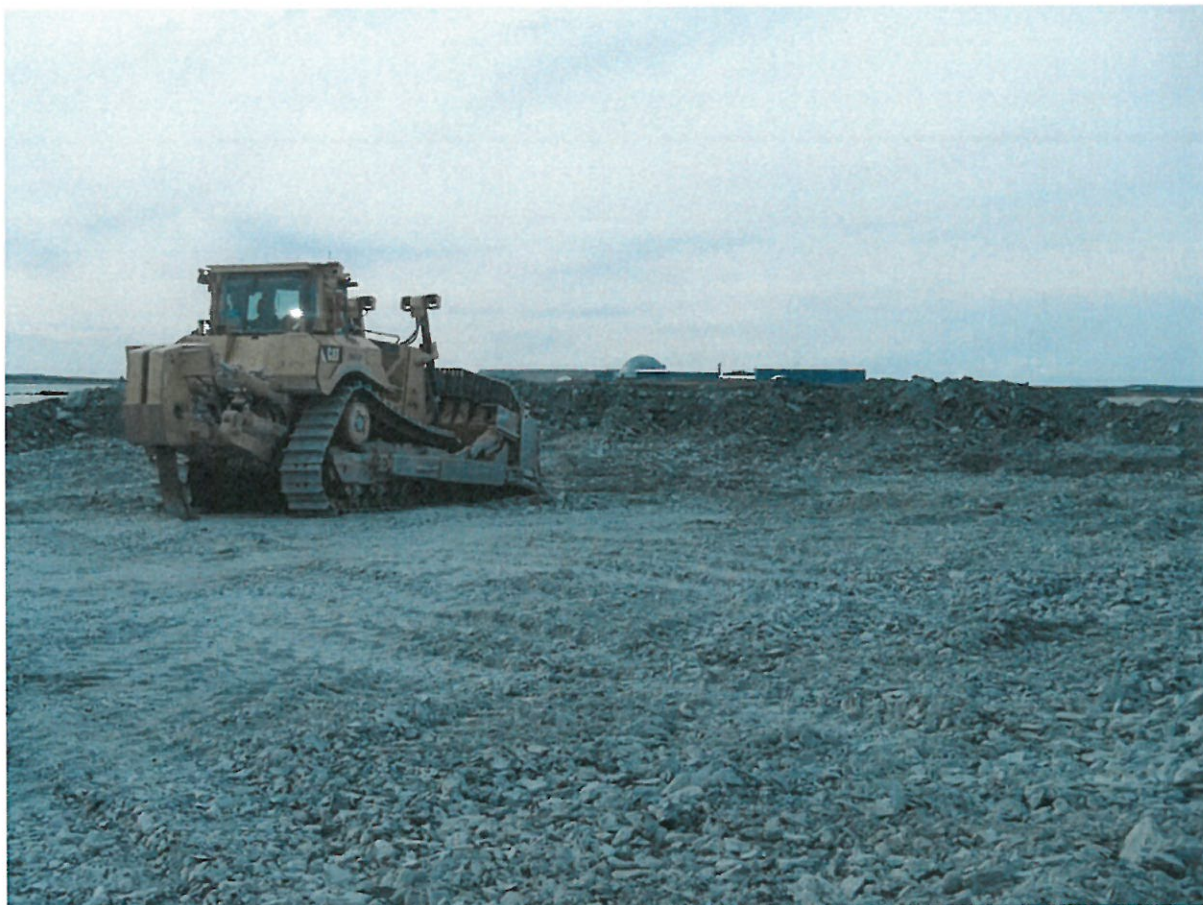
Photograph NCIS-041: From Sta. 1+220/-7 m (approx.), looking S. Placement of a 1.5 to 2 m thick (approx.) lift of UM rockfill from El. 148 m to El. 150 m (approx.) with a dozer from Sta. 1+197 m to 1+150 m (-7 m to -41 m).

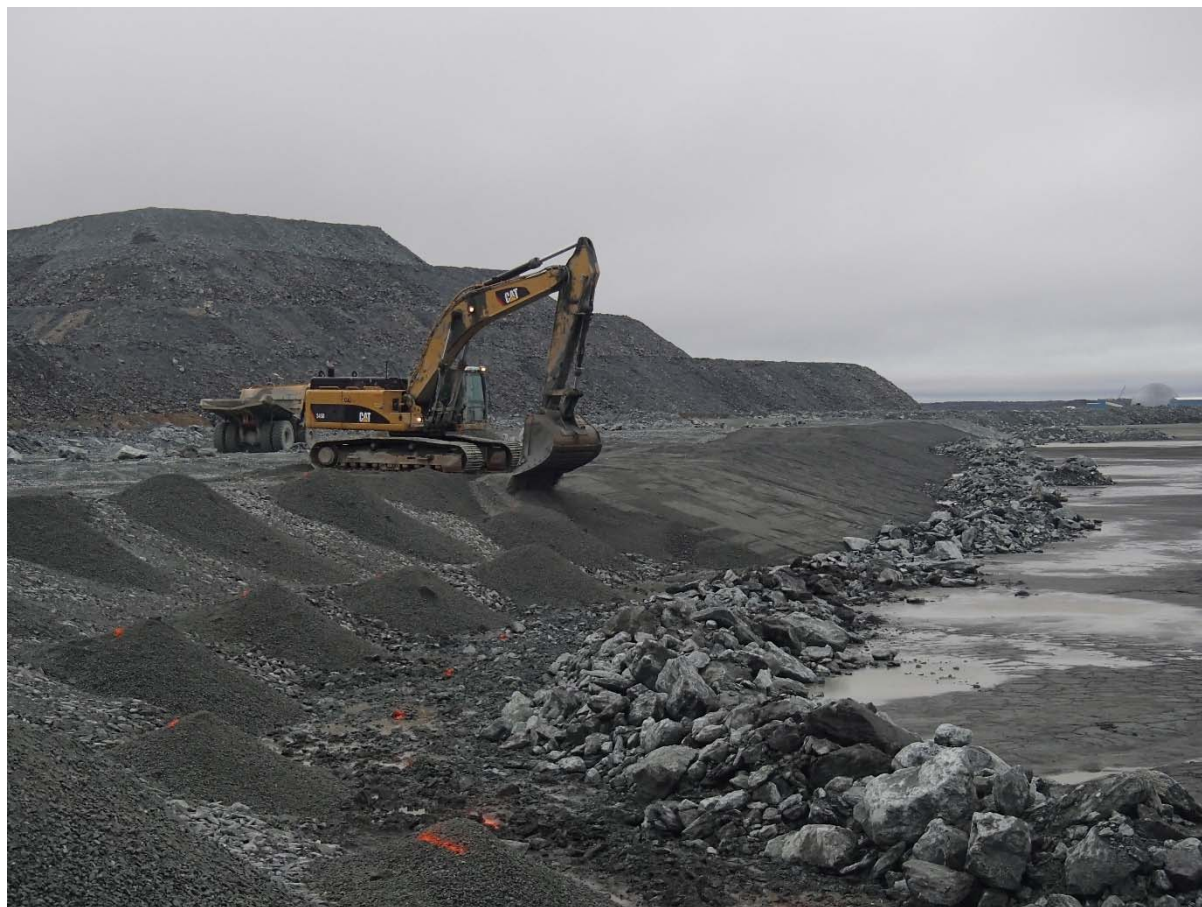
Photograph NCIS-042: From Sta. 2+210/-27 m (approx.), looking SE. Placement of a 0.5 m thick lift of fine filter over the coarse filter in the upstream slope from El. 150 m to 152 m with an excavator from Sta. 2+305 m to 2+040 m.

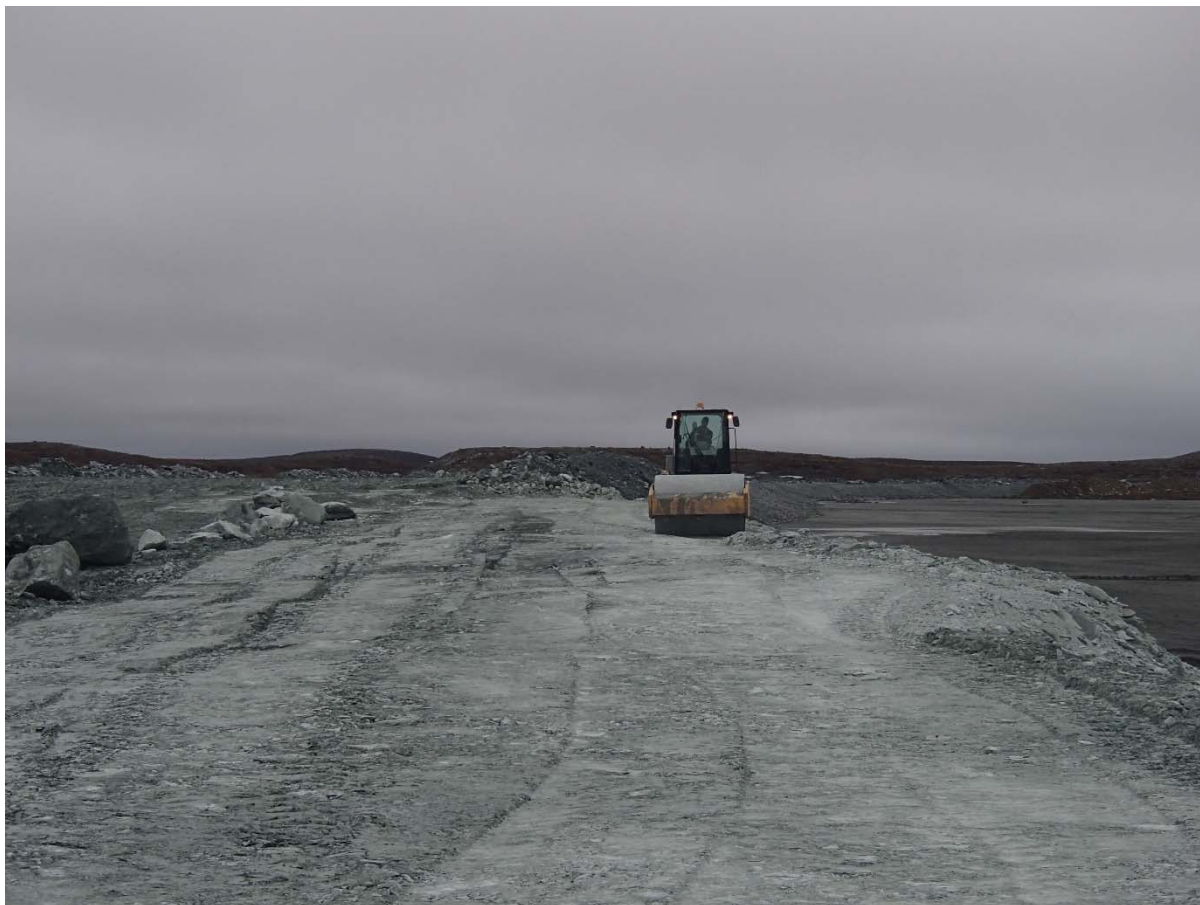
Photograph NCIS-043: From Sta. 1+250/-38 m (approx.), looking N. Compaction of the 1.5 to 2 m lift (approx.) of ultramafic (UM) rockfill at El. 150 m with a 10-tonne smooth-drum compactor with vibration (6 passes) between the haul truck traffic lane and the upstream slope from Sta. 1+330 to 1+200 m (offset -53 to -24 m).

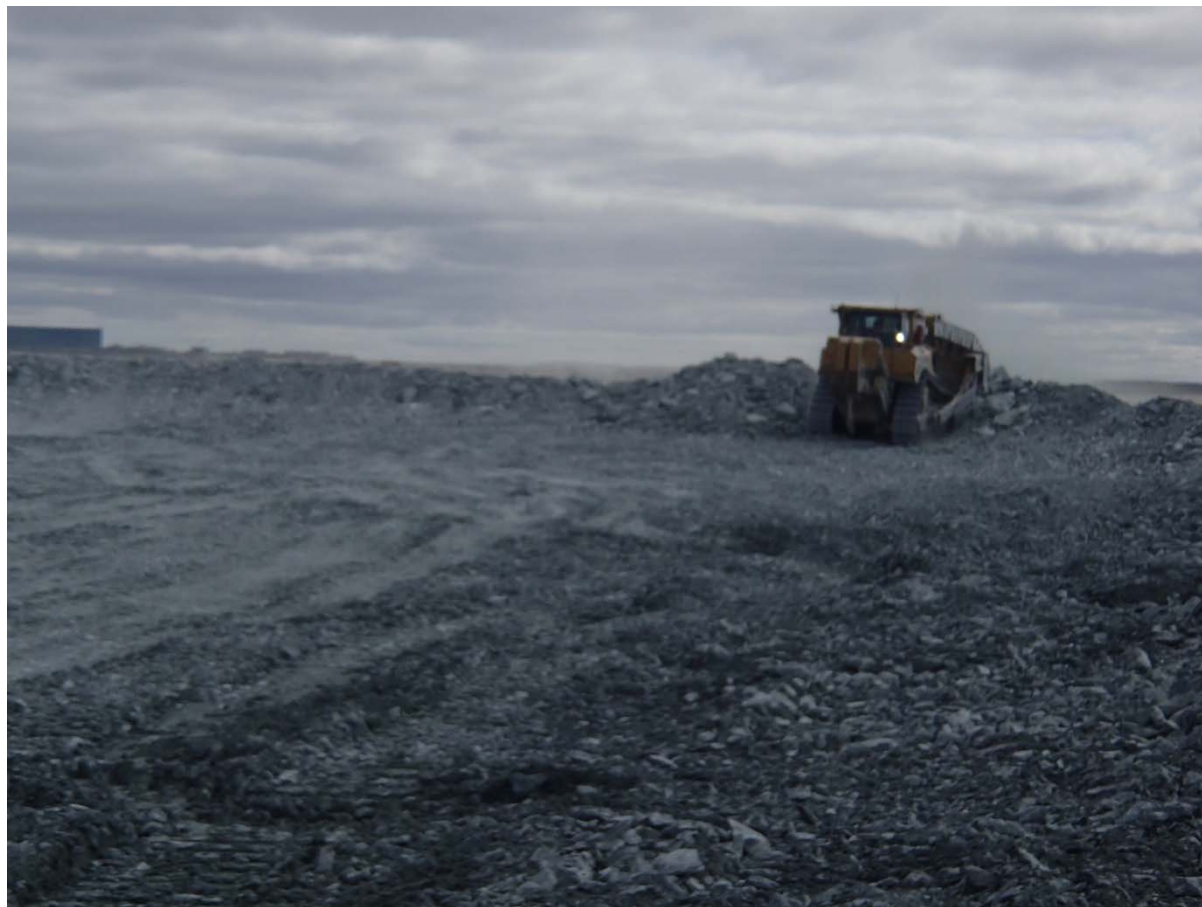
Photograph NCIS-044: From Sta. 1+200/-19 m (approx.), looking S. Placement of a 1.5 to 2 m thick (approx.) lift of UM rockfill from El. 148 m to El. 150 m (approx.) with a dozer from Sta. 1+150 m to 1+120 m (-92 m to +10 m). The material is of good quality and is well graded.

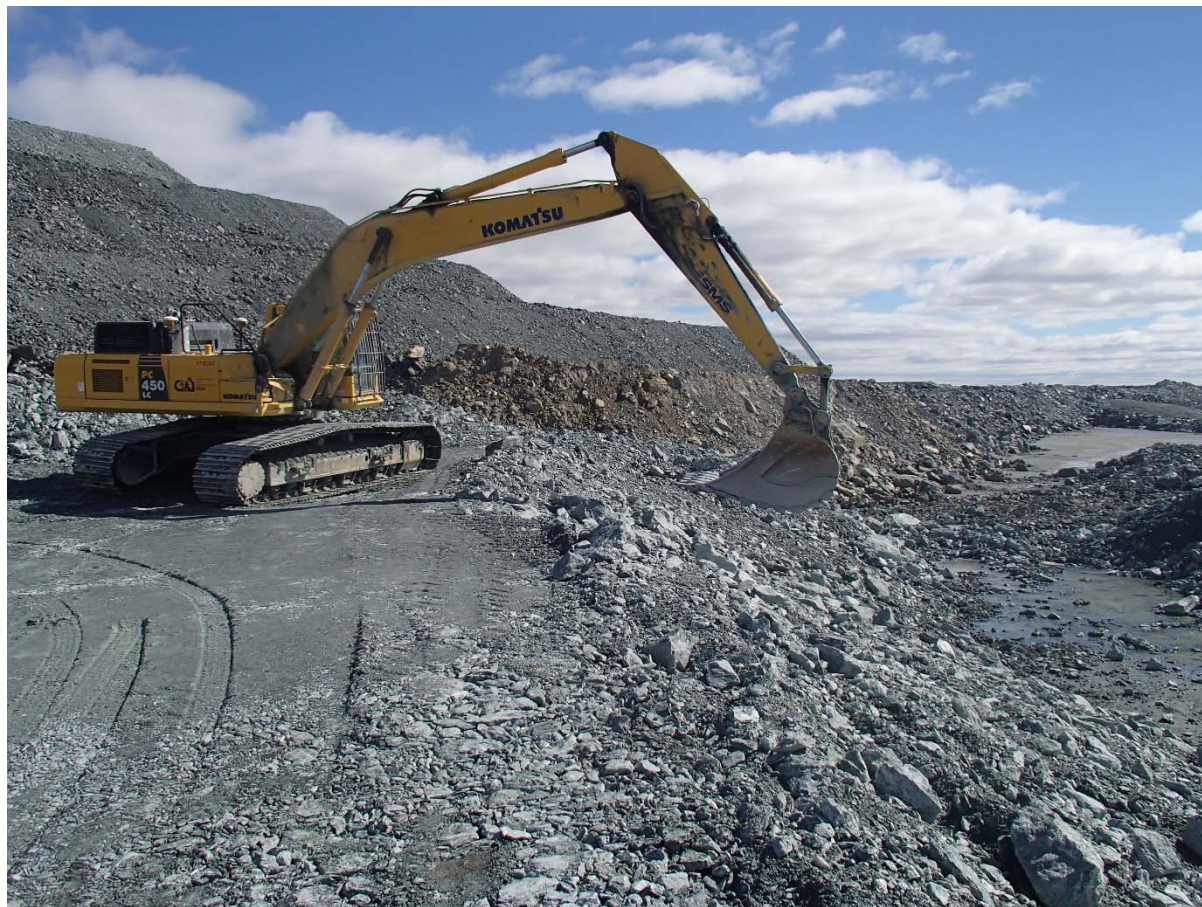
Photograph NCIS-045: From Sta. 2+760/-40 m (approx.), looking S. Profiling of the upstream slope (3H:1V) from El. 150 to 152 m with an excavator from Sta. 2+715 m to 2+825 m.

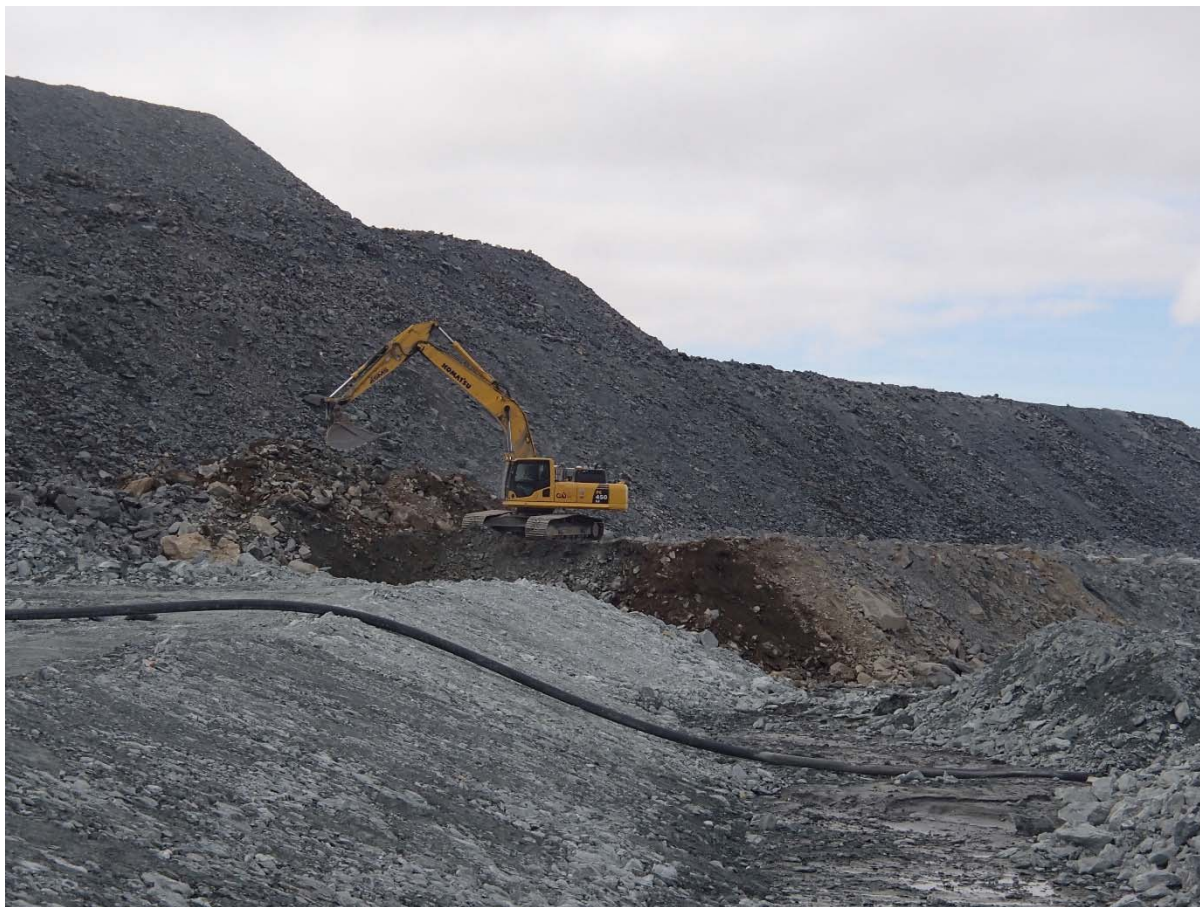
Photograph NCIS-046: From Sta. 2+680/-18 m (approx.), looking SE. Removal of till material mixed with the UM rockfill of the capping (about 1 to 2 m thick along the slope) with an excavator from Sta. 2+760 m to 2+850 m (offset -35 to -17 m).

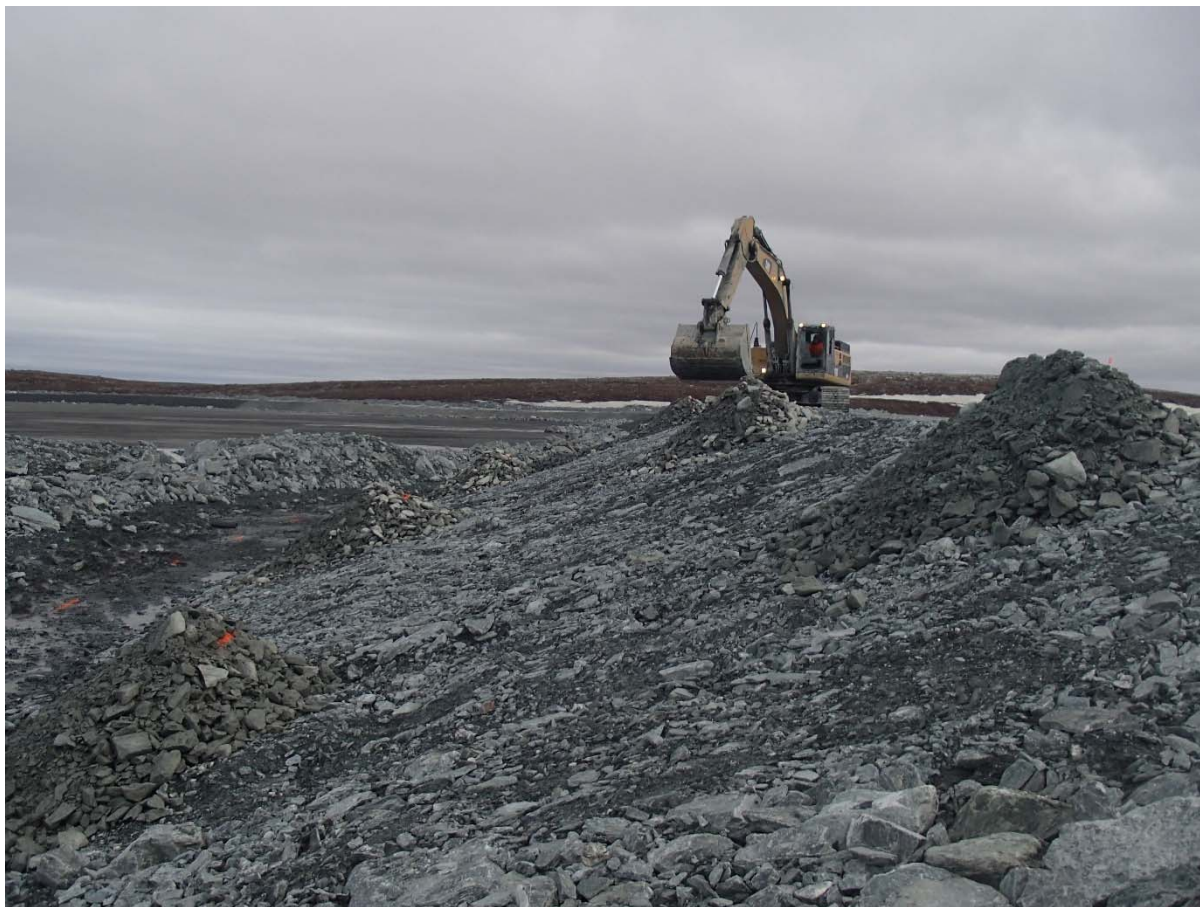
Photograph NCIS-047: From Sta. 2+580/-35 m (approx.), looking N. Placement of a 0.5 m thick lift of coarse filter in the upstream slope from El. 150 m to 152 m with an excavator from Sta. 2+560 m to 2+640 m.

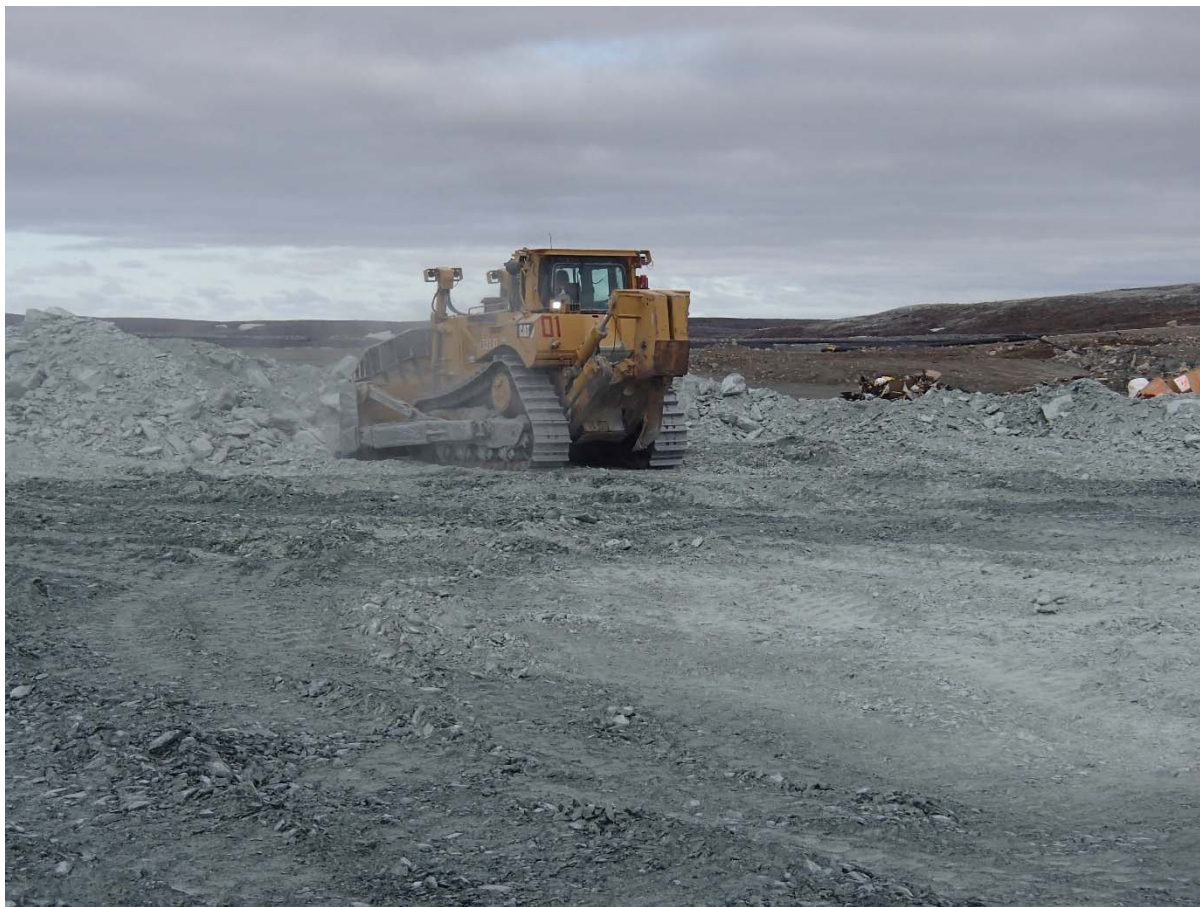
Photograph NCIS-048: From Sta. 1+120/-92 m (approx.), looking SW. Placement of a 1.5 to 2 m thick (approx.) lift of UM rockfill from El. 148 m to El. 150 m (approx.) with a dozer from Sta. 1+125 m to 1+115 m (-92 m to -47 m). The material is of good quality and is well graded.
