QA WEEKLY REPORT

1897439-1577-TM-Rev0

QA WEEKLY REPORT FROM JUNE 19TH TO JUNE 24TH– TSF NORTH CELL CONSTRUCTION MEADOWBANK (1897439)

QA WEEKLY REPORT FROM JUNE 25TH TO JULY 1ST – TSF NORTH CELL CONSTRUCTION MEADOWBANK (1897439)

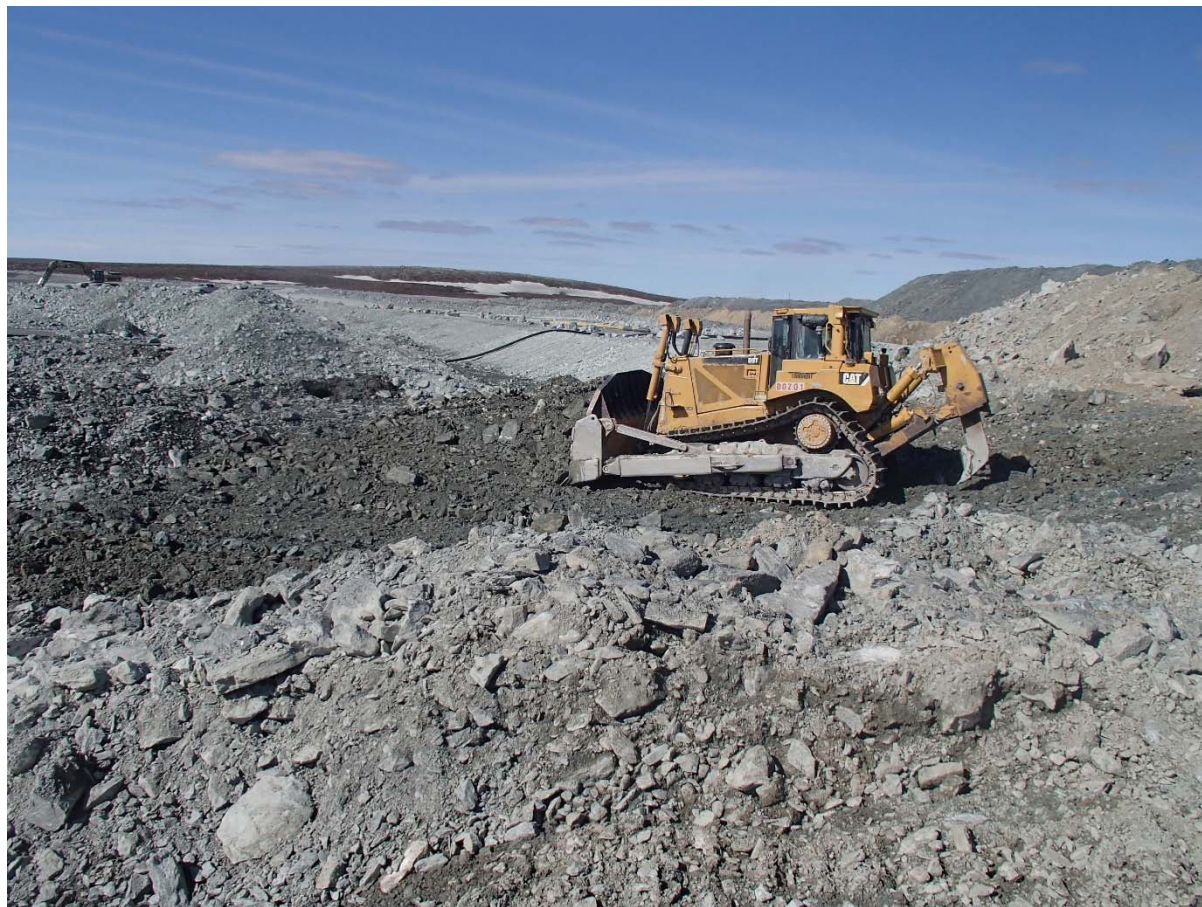
Photograph NCIS-049: From Sta. 2+870/-28 m (approx.), looking N. Removing of UM rockfill material from the capping with a dozer to level the surface to El. 150 m from Sta. 2+760 m to 2+850 m (offset -29 to -17 m).

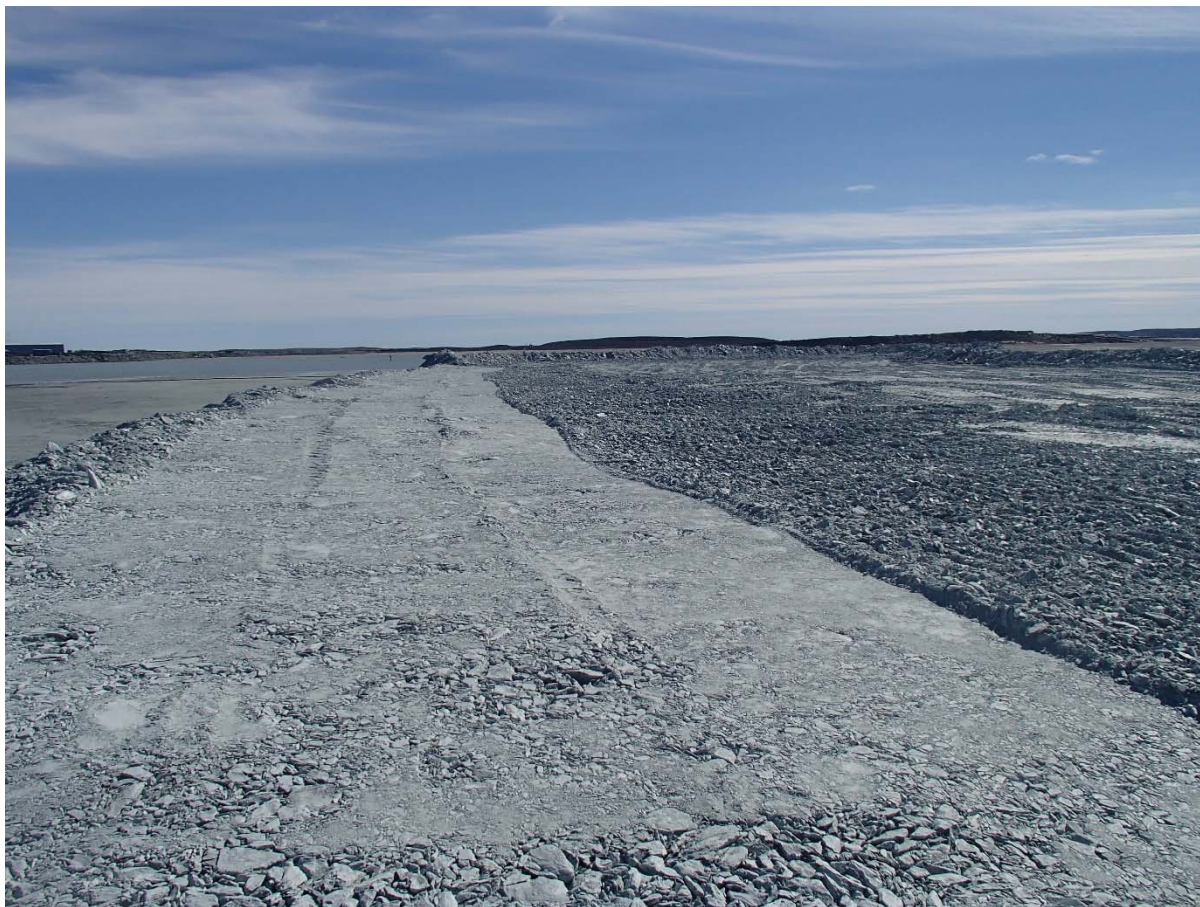
Photograph NCIS-050: From Sta. 1+230/-55 m (approx.), looking S. Compaction of the 1.5 to 2 m lift (approx.) of ultramafic (UM) rockfill at El. 150 m with a 10-tonne smooth-drum compactor with vibration (6 passes) between the haul truck traffic lane and the upstream slope from Sta. 1+220 to 1+130 m (offset -91 to -44 m).

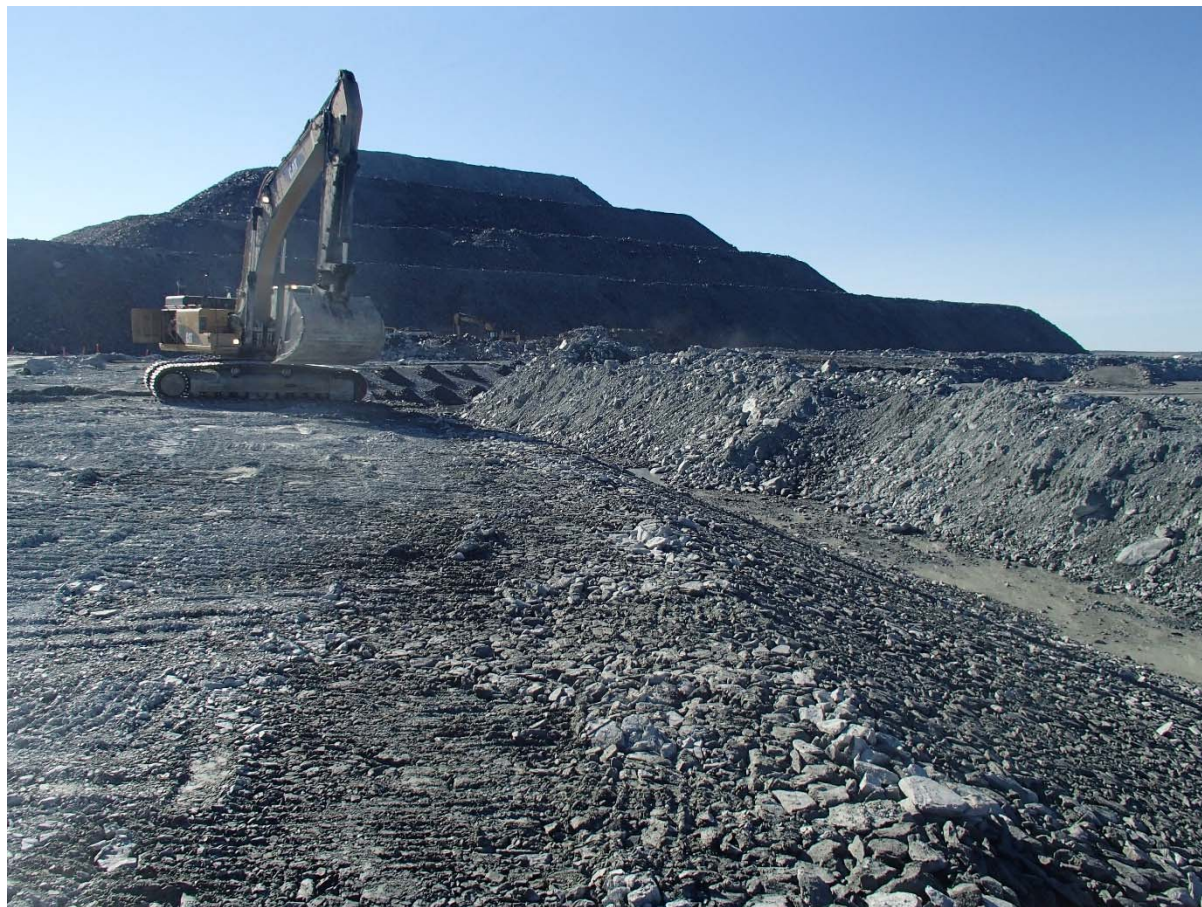
Photograph NCIS-051: From Sta. 2+630/-34 m (approx.), looking SE. Placement of a 0.5 m thick lift of coarse filter in the upstream slope from El. 150 m to 152 m with an excavator from Sta. 2+640 m to 2+815 m.
