QA WEEKLY REPORT

DATE July 9th 2018 1897439-1577-TM-Rev0

QA WEEKLY REPORT FROM JULY 2^{ND} TO JULY 8^{TH} – TSF NORTH CELL CONSTRUCTION MEADOWBANK (1897439)

This document summarizes QA activities performed by Golder from July 2nd to July 8th, 2018 inclusively, related to the construction activities of the North Cell Internal Structure at the Meadowbank mine site.

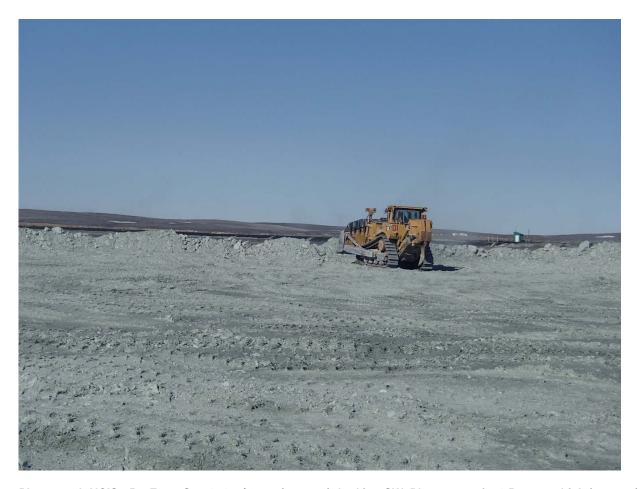
Photograph NCIS-052: From Sta. 1+120/-87 m (approx.), looking SW. Placement of a 1.5 to 2 m thick (approx.) lift of UM rockfill from El. 148 m to El. 150 m (approx.) with a dozer from Sta. 1+115 m to 1+100 m (-107 m to -45 m). The material is of good quality and is well graded.

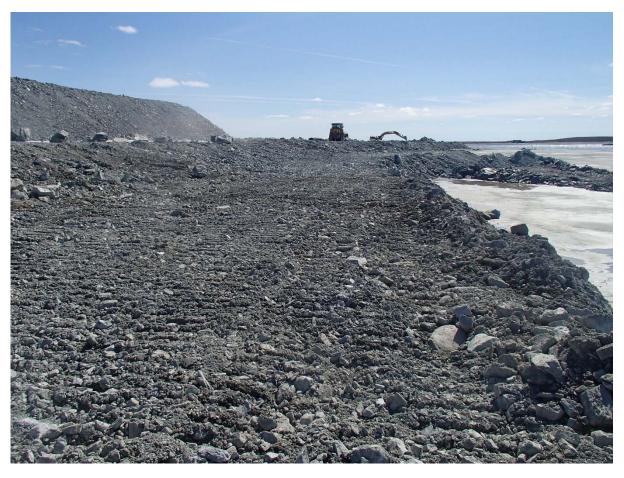
Photograph NCIS-053: From Sta. 2+840/-37 m (approx.), looking S. Removing of UM rockfill material from the capping with a dozer to level the surface to El. 152 m from Sta. 2+850 m to 2+980 m (offset -38 to -24 m).

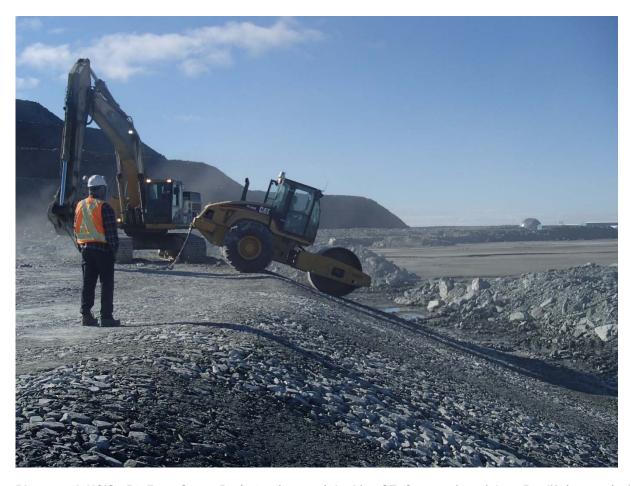
Photograph NCIS-054: From Sta. 2+580/-31 m (approx.), looking SE. Compaction of the 0.5 m lift (approx.) of coarse filter between El. 150 and 152 m with a 10-tonne smooth-drum compactor with vibration (4 passes) in the upstream slope from Sta. 2+560 m to 2+815 m.

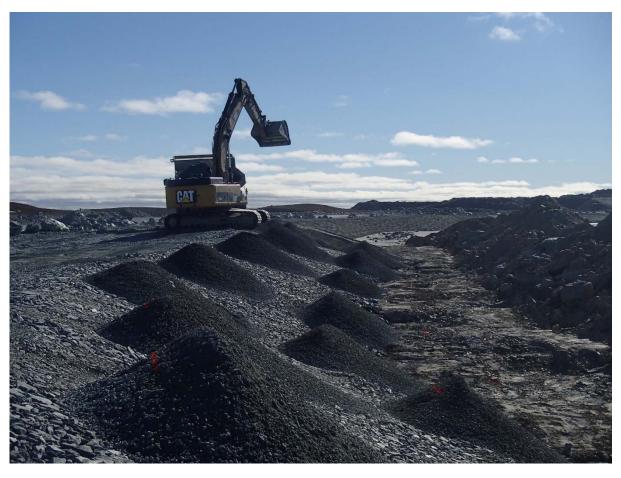
Photograph NCIS-055: From Sta. 1+730/-42 m (approx.), looking NE. Placement of a 0.5 m thick lift of fine filter over the coarse filter in the upstream slope from El. 150 m to 152 m with an excavator from Sta. 1+820 m to 1+595 m.

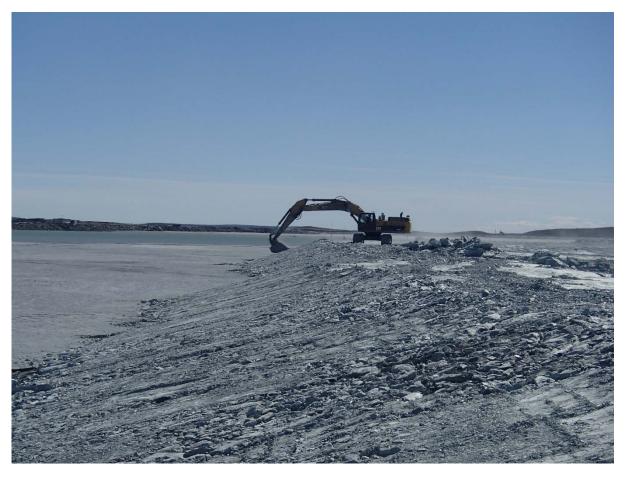
Photograph NCIS-056: From Sta. 1+290/-39 m (approx.), looking S. Profiling of the upstream slope (3H:1V) from El. 148 to 150 m with an excavator from Sta. 1+340 m to 1+130 m.

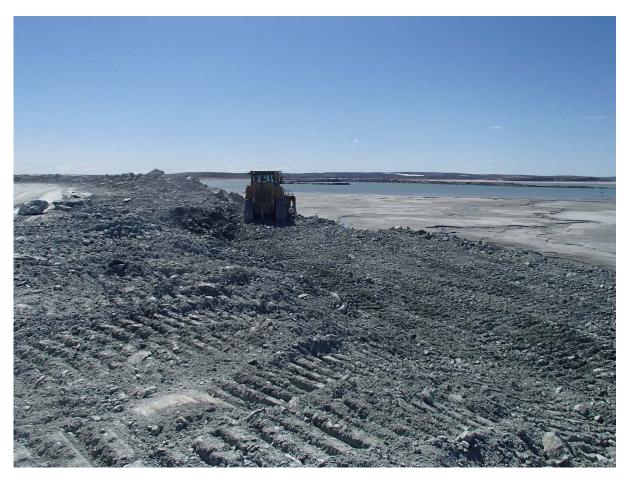
Photograph NCIS-057: From Sta. 3+010/-15 m (approx.), looking SW. Removing of UM rockfill material from the capping with a dozer to level the surface to El. 152 m from Sta. 2+980 m to 3+050 m (offset -30 to -20 m).

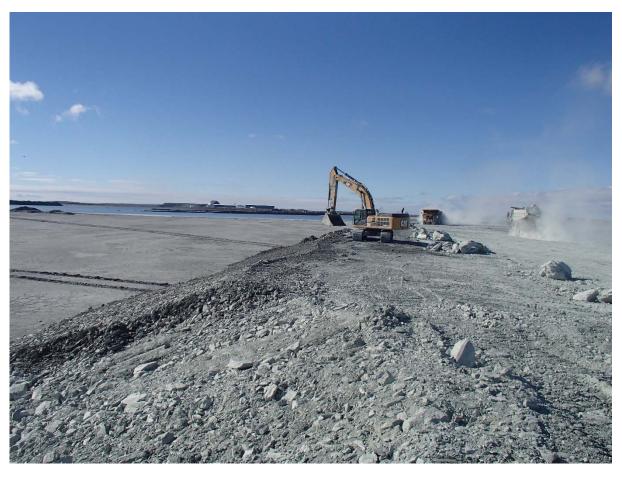
Photograph NCIS-058: From Sta. 1+340/-34 m (approx.), looking S. Placement of a 0.5 m thick lift of coarse filter in the upstream slope from El. 148 m to 152 m with an excavator from Sta. 1+340 m to 1+270 m.

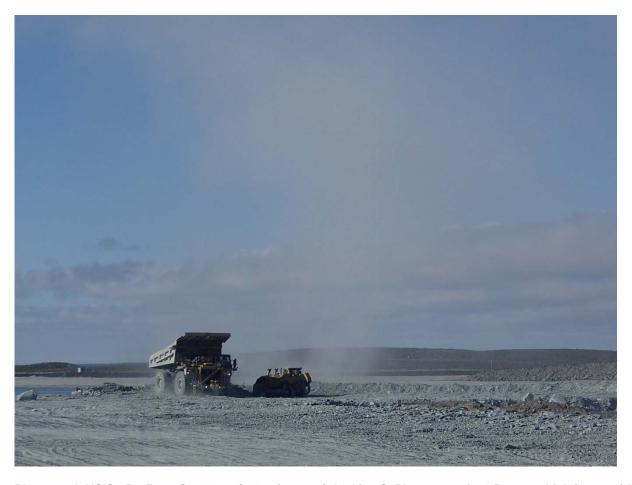
Photograph NCIS-059: From Sta. 1+330/-34 m (approx.), looking S. Placement of a 1.5 to 2 m thick (approx.) lift of UM rockfill from El. 148 m to El. 150 m (approx.) with a dozer from Sta. 1+120 m to 1+100 m (-96 m to -60 m). The material is of good quality and is well graded.

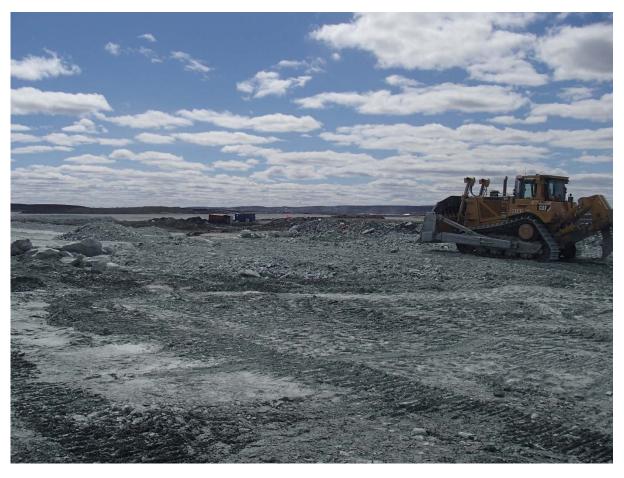
Photograph NCIS-060: From Sta. 1+365/-35 m (approx.), looking SW. Placement of a 2 m thick (approx.) lift of UM rockfill from El. 150 m to El. 152 m (approx.) with a dozer from Sta. 1+340 m to 1+320 m (-19 m to +16 m). The material is of good quality and is well graded.

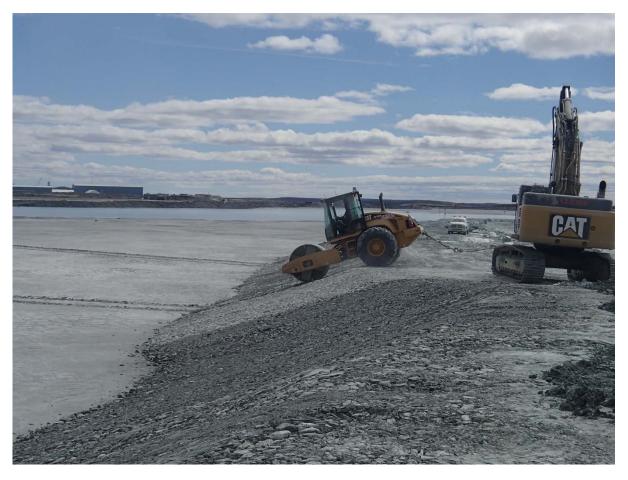
Photograph NCIS-061: From Sta. 1+365/-35 m (approx.), looking S. Compaction of the 0.5 m lift of coarse filter between El. 148 and 152 m with a 10-tonne smooth-drum compactor with vibration (4 passes) in the upstream slope from Sta. 1+340 m to 1+270 m.

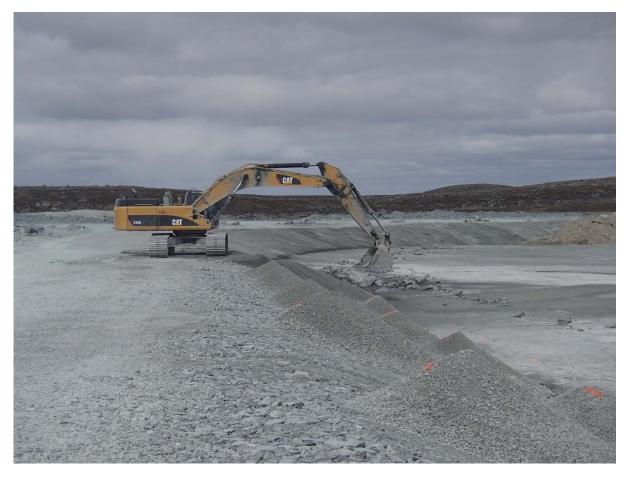
Photograph NCIS-062: From Sta. 1+525/-33 m (approx.), looking N. Placement of a 0.5 m thick lift of fine filter over the coarse filter in the upstream slope from El. 150 m to 152 m with an excavator from Sta. 1+330 m to 1+260 m and from Sta. 1+595 m to 1+550 m.

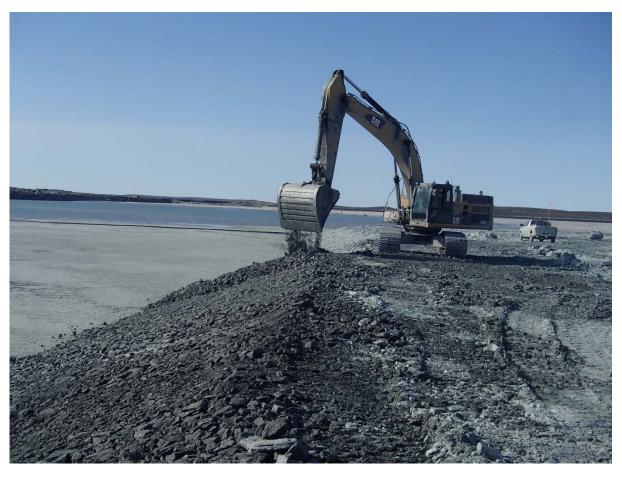
Photograph NCIS-063: From Sta. 1+200/-65 m (approx.), looking SW. Placement of a 0.5 m thick lift of coarse filter in the upstream slope from El. 148 m to 152 m with an excavator from Sta. 1+270 m to 1+100 m.

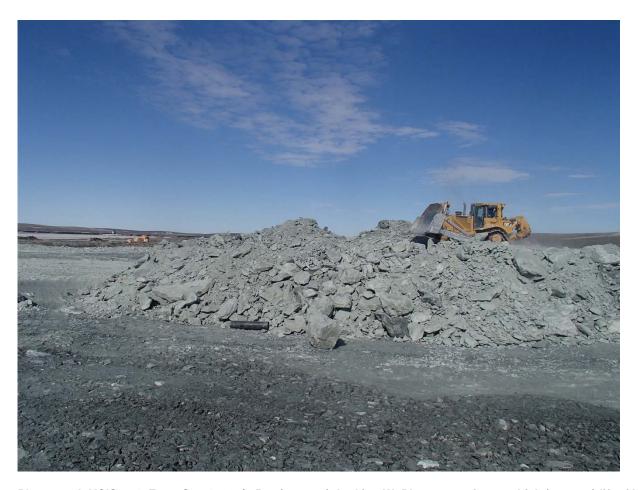
Photograph NCIS-064: From Sta. 1+200/-65 m (approx.), looking W. Placement of a 2 m thick (approx.) lift of UM rockfill from El. 150 m to El. 152 m (approx.) with a dozer from Sta. 1+320 m to 1+235 m (-65 m to -45 m). The material is of good quality and is well graded.

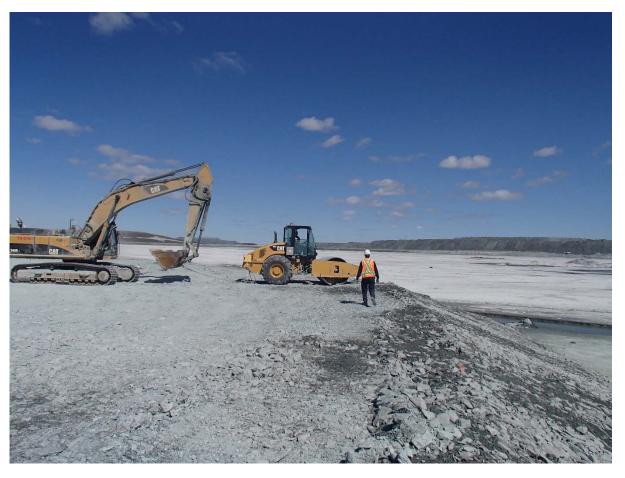
Photograph NCIS-065: From Sta. 1+140/-96 m (approx.), looking NE. Compaction of the 0.5 m lift of coarse filter between El. 148 and 152 m with a 10-tonne smooth-drum compactor with vibration (4 passes) in the upstream slope from Sta. 1+270 m to 1+100 m.

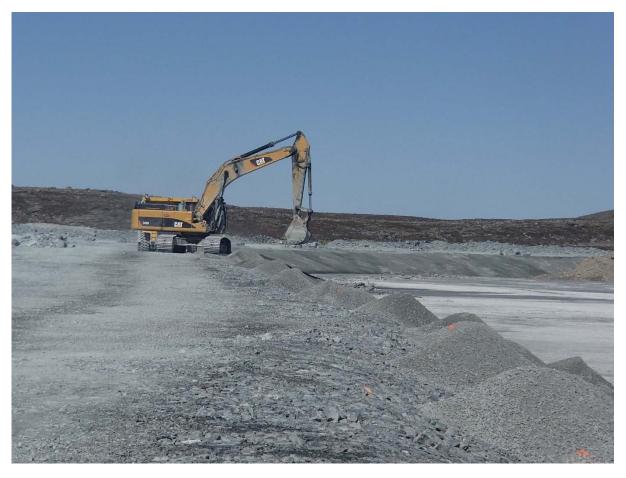
Photograph NCIS-066: From Sta. 1+400/-34 m (approx.), looking N. Placement of a 0.5 m thick lift of fine filter over the coarse filter in the upstream slope from El. 150 m to 152 m with an excavator from Sta. 1+595 m to 1+550 m.

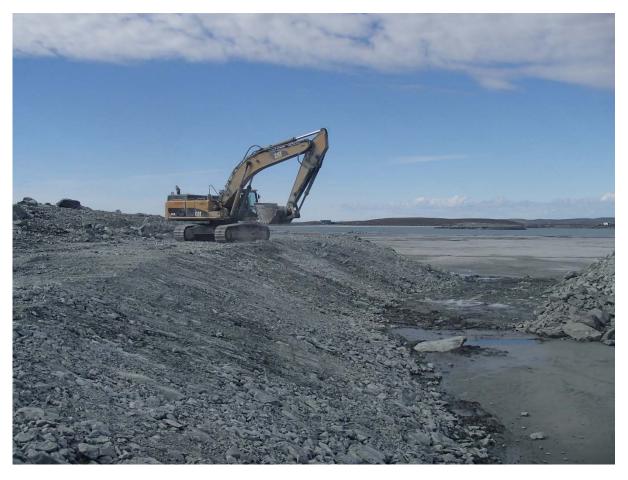
Photograph NCIS-067: From Sta. 2+880/-26 m (approx.), looking SW. Profiling of the upstream slope (3H:1V) from El. 150 to 152 m with an excavator from Sta. 2+860 m to 2+975 m.

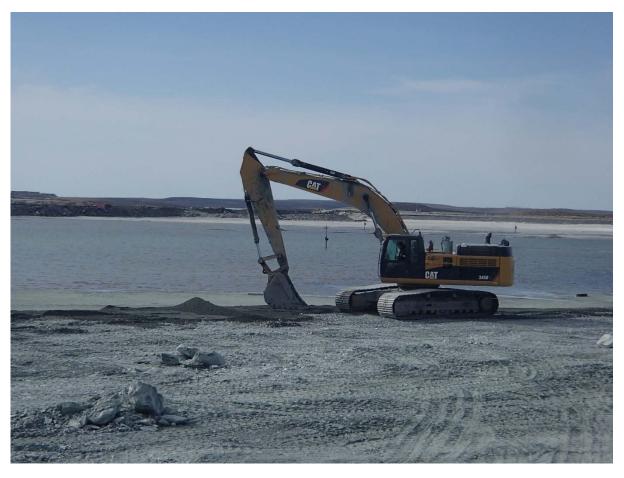
Photograph NCIS-068: From Sta. 1+150/-62 m (approx.), looking S. Placement of a 0.5 m thick lift of fine filter over the coarse filter in the upstream slope from El. 148 m to 150 m with an excavator from Sta. 1+180 m to 1+100 m.

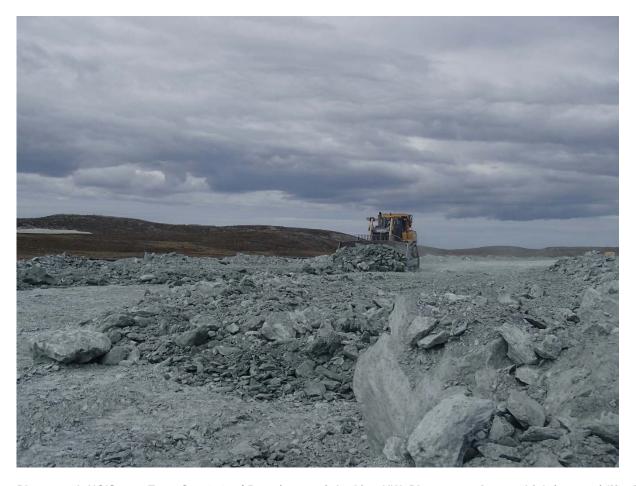
Photograph NCIS-069: From Sta. 1+180/-56 m (approx.), looking NW. Placement of a 2 m thick (approx.) lift of UM rockfill from El. 150 m to El. 152 m (approx.) with a dozer from Sta. 1+235 m to 1+160 m (-60 m to -44 m). The material is of good quality and is well graded.

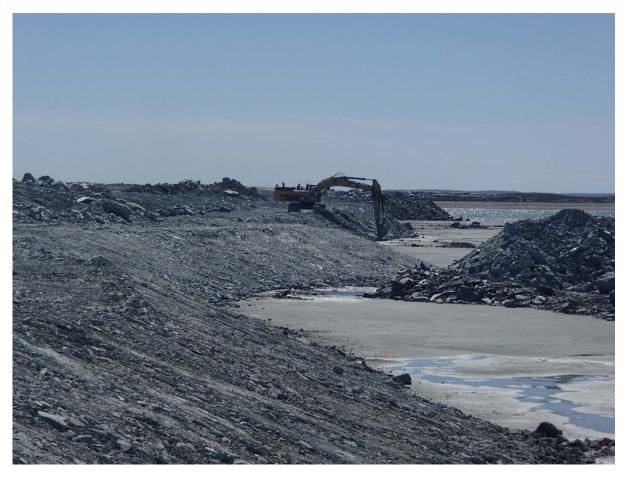
Photograph NCIS-072: From Sta. 2+790/-38 m (approx.), looking W. Profiling of the upstream slope (3H:1V) from El. 150 to 152 m with an excavator from Sta. 2+975 m to 3+070 m.

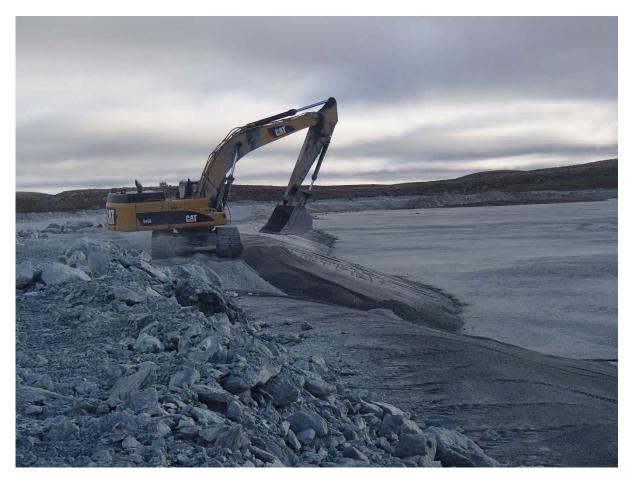
Photograph NCIS-073: From Sta. 1+300/-33 m (approx.), looking N. Placement of a 0.5 m thick lift of fine filter over the coarse filter in the upstream slope from El. 150 m to 152 m with an excavator from Sta. 1+320 m to 1+300 m.

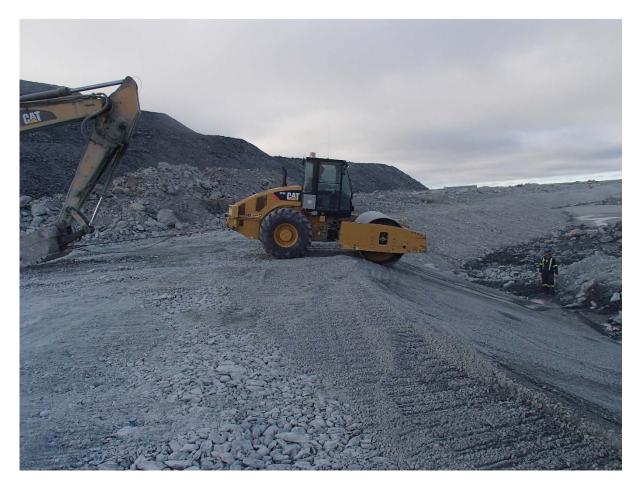
Photograph NCIS-074: From Sta. 2+750/-37 m (approx.), looking SE. Compaction of the 0.5 m lift (approx.) of fine filter between El. 150 m and 152 m with a 10-tonne smooth-drum compactor (4 passes) in the upstream slope from Sta. 2+810 m to 2+095 m. Vibration is used except for the first pass down the slope in order to stabilize the material and limit deformation of the lift.

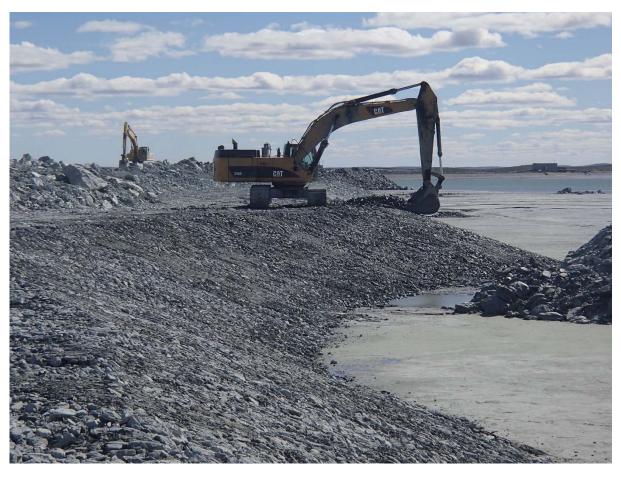
Photograph NCIS-075: From Sta. 2+860/-36 m (approx.), looking S. Placement of a 0.5 m thick lift of coarse filter in the upstream slope from El. 150 m to 152 m with an excavator from Sta. 2+815 m to 2+980 m.

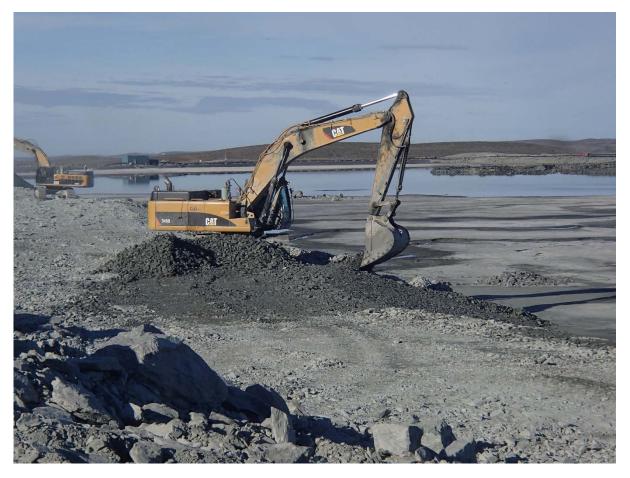
Photograph NCIS-076: From Sta. 2+940/-15 m (approx.), looking SW. Placement of a 0.5 m thick lift of coarse filter in the upstream slope from El. 150 m to 152 m with an excavator from Sta. 2+980 m to 3+160 m.

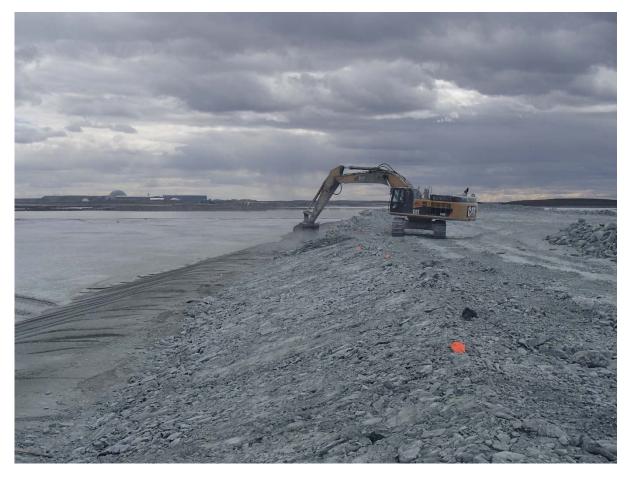
Photograph NCIS-077: From Sta. 1+310/-32 m (approx.), looking S. Profiling of the upstream slope (3H:1V) from El. 150 to 152 m with an excavator from Sta. 1+300 m to 1+175 m and from 3+070 m to 3+160 m.
