## QA WEEKLY REPORT

### QA WEEKLY REPORT FROM JULY 9<sup>TH</sup> TO JULY 15<sup>TH</sup>– TSF NORTH CELL CONSTRUCTION MEADOWBANK (1897439)

This document summarizes QA activities performed by Golder from July 9<sup>th</sup> to July 15<sup>th</sup>, 2018 inclusively, related to the construction activities of the North Cell Internal Structure at the Meadowbank mine site.

### QA WEEKLY REPORT FROM JULY 16<sup>TH</sup> TO JULY 22<sup>ND</sup> – TSF NORTH CELL CONSTRUCTION MEADOWBANK (1897439)

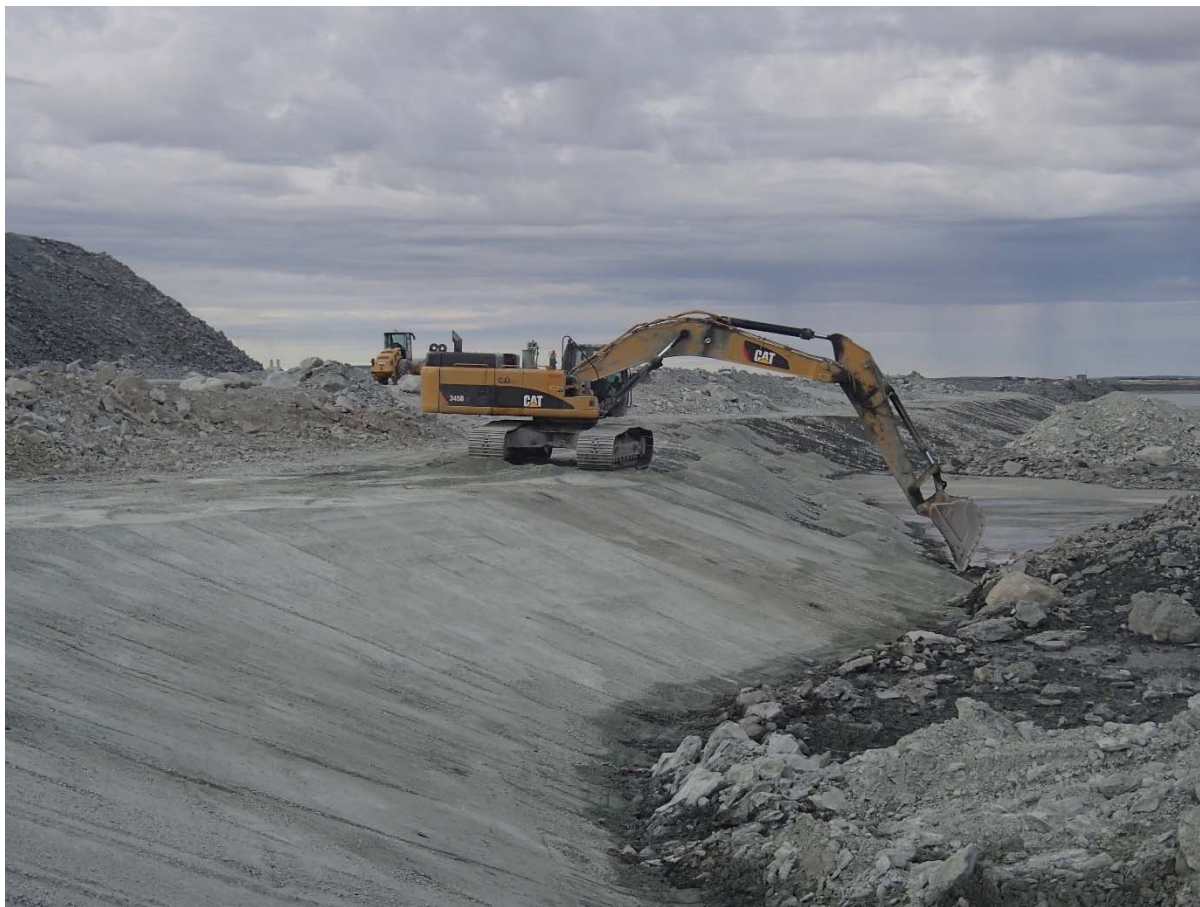
**Photograph NCIS-078: From Sta. 2+760/-39 m (approx.), looking S. Placement of a 0.5 m thick lift of fine filter over the coarse filter in the upstream slope from El. 150 m to 152 m with an excavator from Sta. 2+800 m to 2+980 m.**

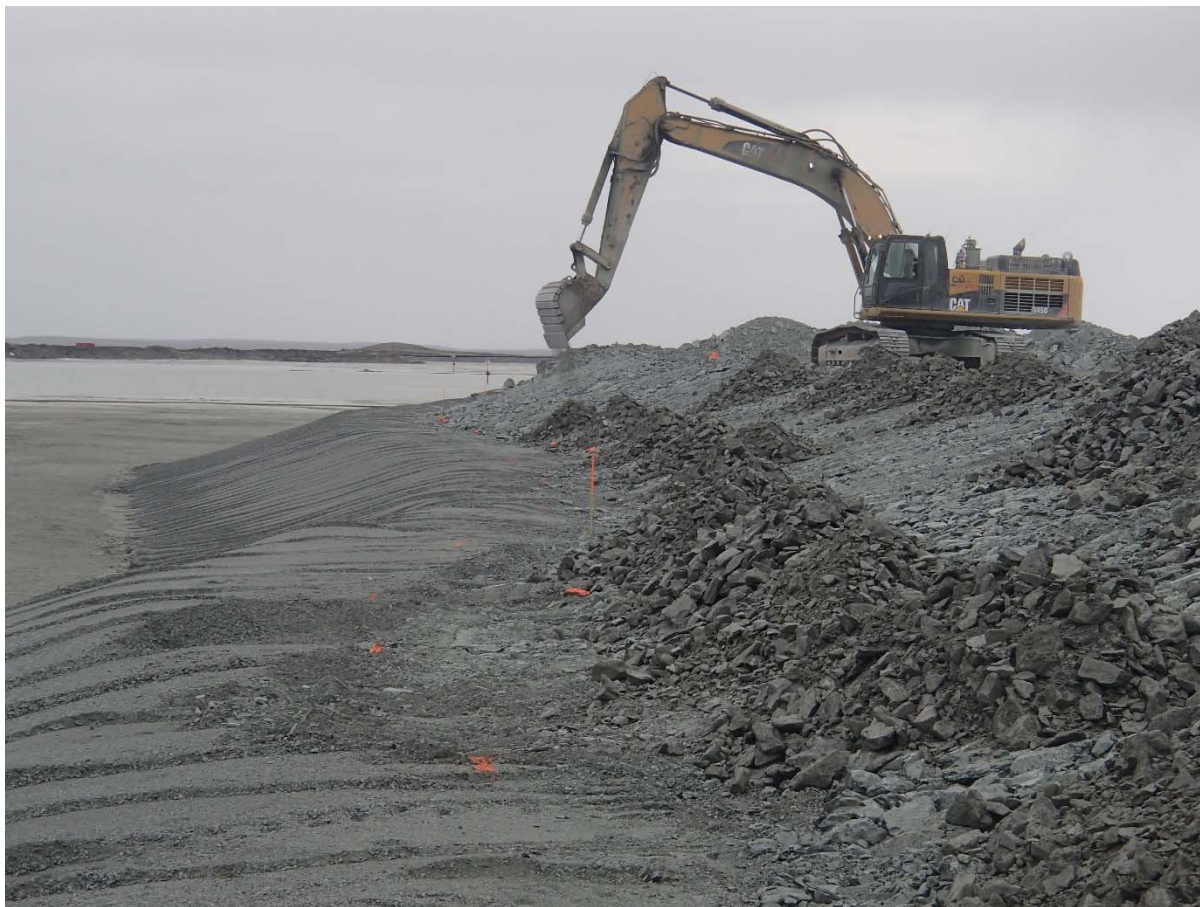
**Photograph NCIS-079: From Sta. 1+280/-39 m (approx.), looking SW. Placement of a 0.5 m thick lift of coarse filter in the upstream slope from El. 150 m to 152 m with an excavator from Sta. 1+300 m to 1+200 m.**

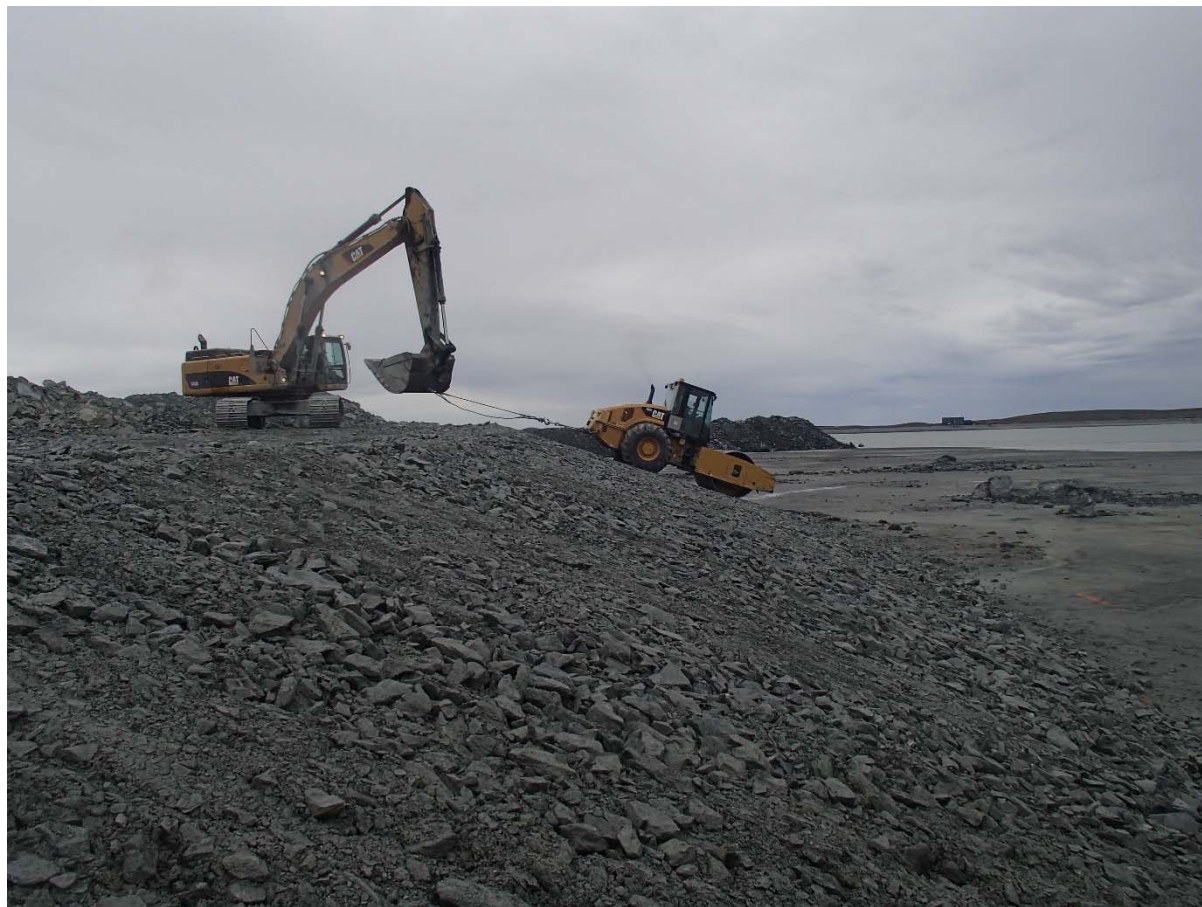
**Photograph NCIS-080: From Sta. 2+800/-38 m (approx.), looking S. Compaction of the 0.5 m lift (approx.) of coarse filter between El. 150 and 152 m with a 10-tonne smooth-drum compactor (4 passes) in the upstream slope from Sta. 2+925 m to 3+160 m and from Sta. 1+300 m to 1+200 m.**

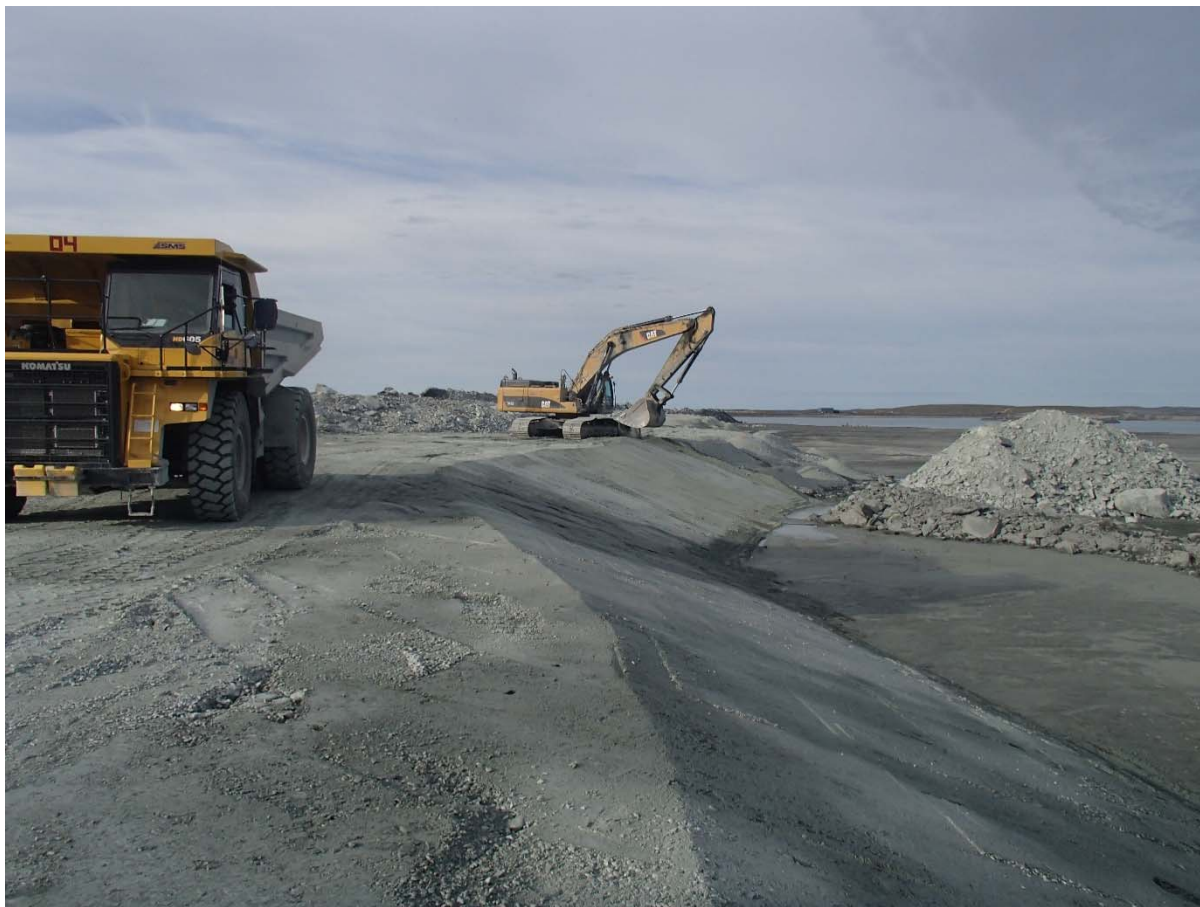
**Photograph NCIS-081: From Sta2+975/-37 m (approx.), looking SE. Placement of a 0.5 m thick lift of fine filter over the coarse filter in the upstream slope from El. 150 m to 152 m with an excavator from Sta. 1+300 m to 1+210 m and from Sta. 2+940 m to 3+120 m.**

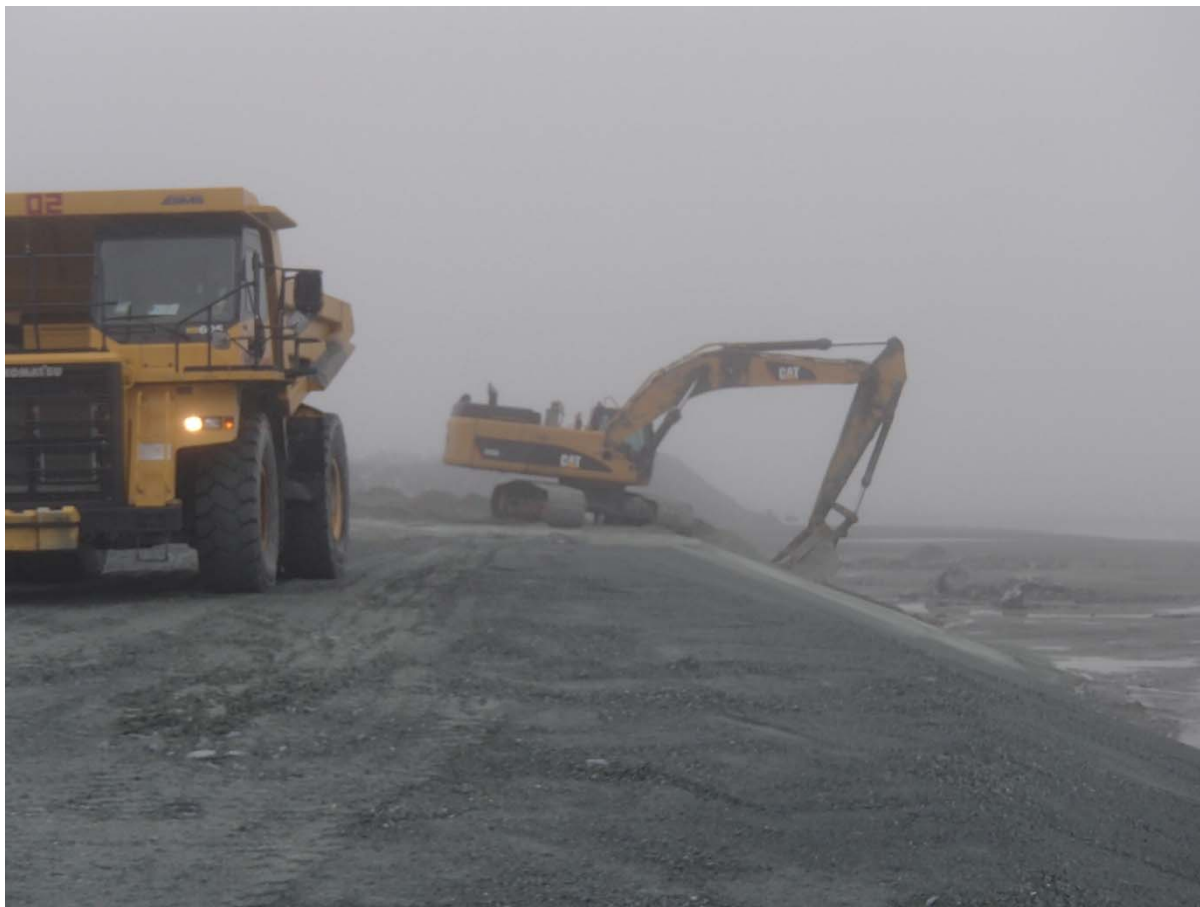
**Photograph NCIS-082: From Sta 3+060/-33 m (approx.), looking S. Placement of a 0.5 m thick lift of fine filter over the coarse filter in the upstream slope from El. 150 m to 152 m with an excavator from Sta. 3+120 m to 3+160 m.**

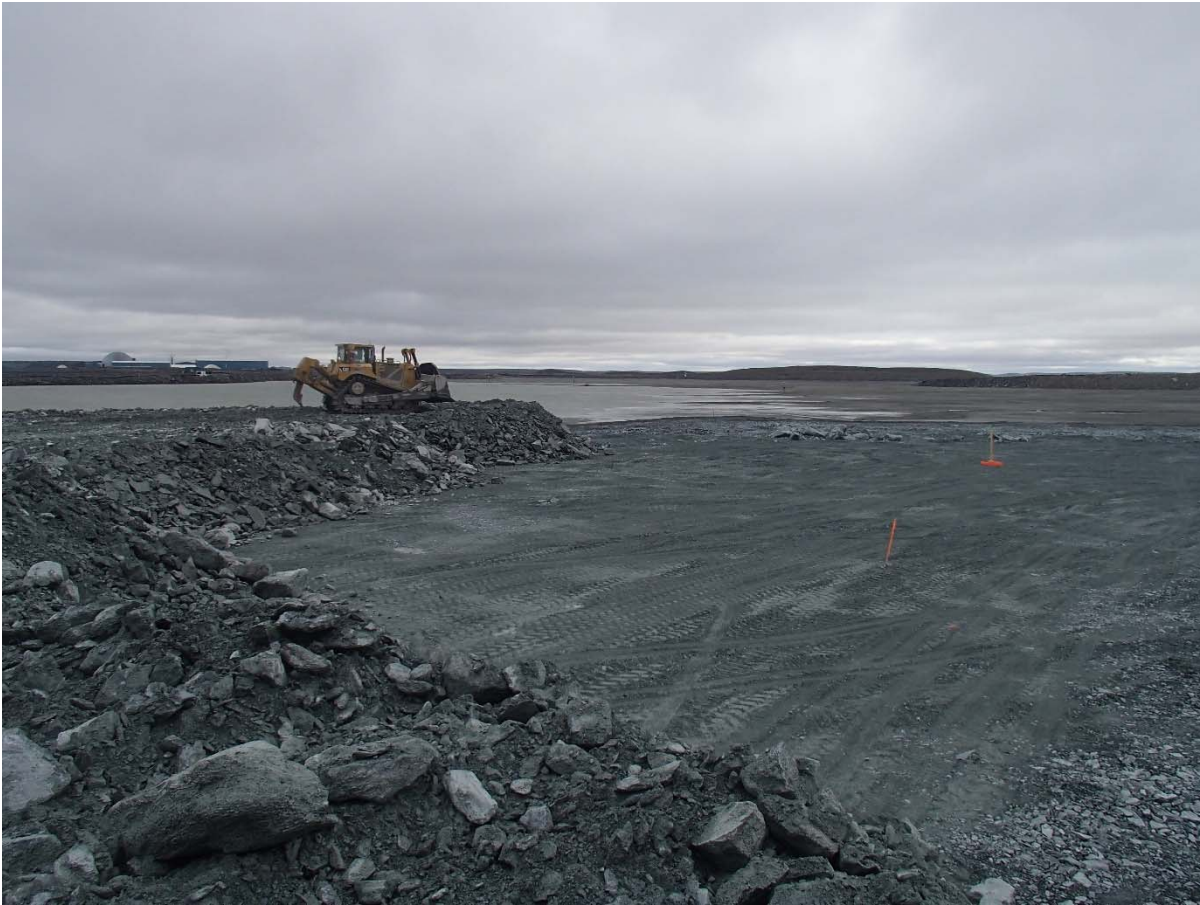
**Photograph NCIS-083: From Sta 1+140/-52 m (approx.), looking SW. Placement of a 2 m thick (approx.) lift of IV rockfill from El. 150 m to El. 152 m (approx.) with a dozer from Sta. 1+160 m to 1+170 m (-64 m to -111 m). The material is of good quality and is well graded.**

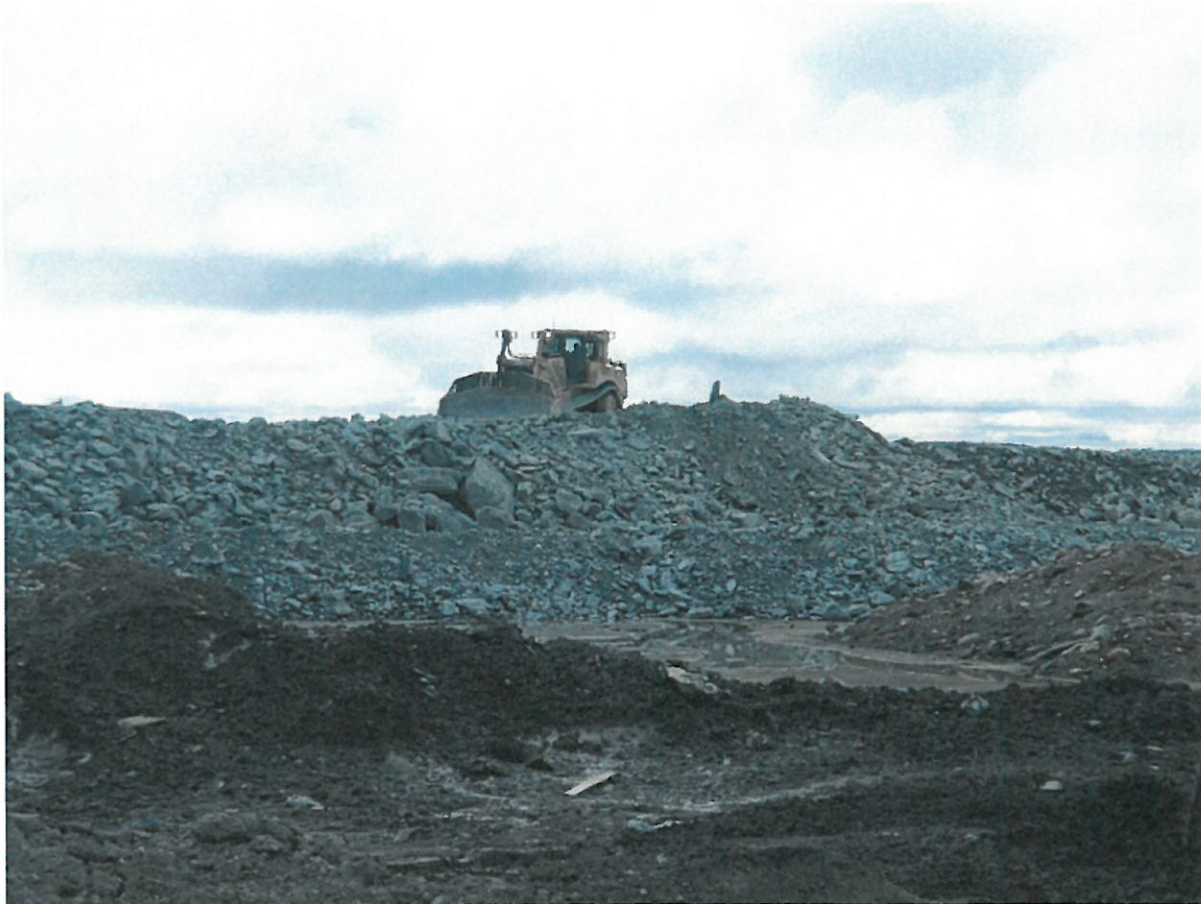
Photograph NCIS-084: From Sta 1+080/+47 m (approx.), looking E. Placement of a 2 m thick (approx.) lift of UM rockfill from El. 150 m to El. 152 m (approx.) with a dozer from Sta. 1+160 m to 1+130 m (-55 m to -102 m).

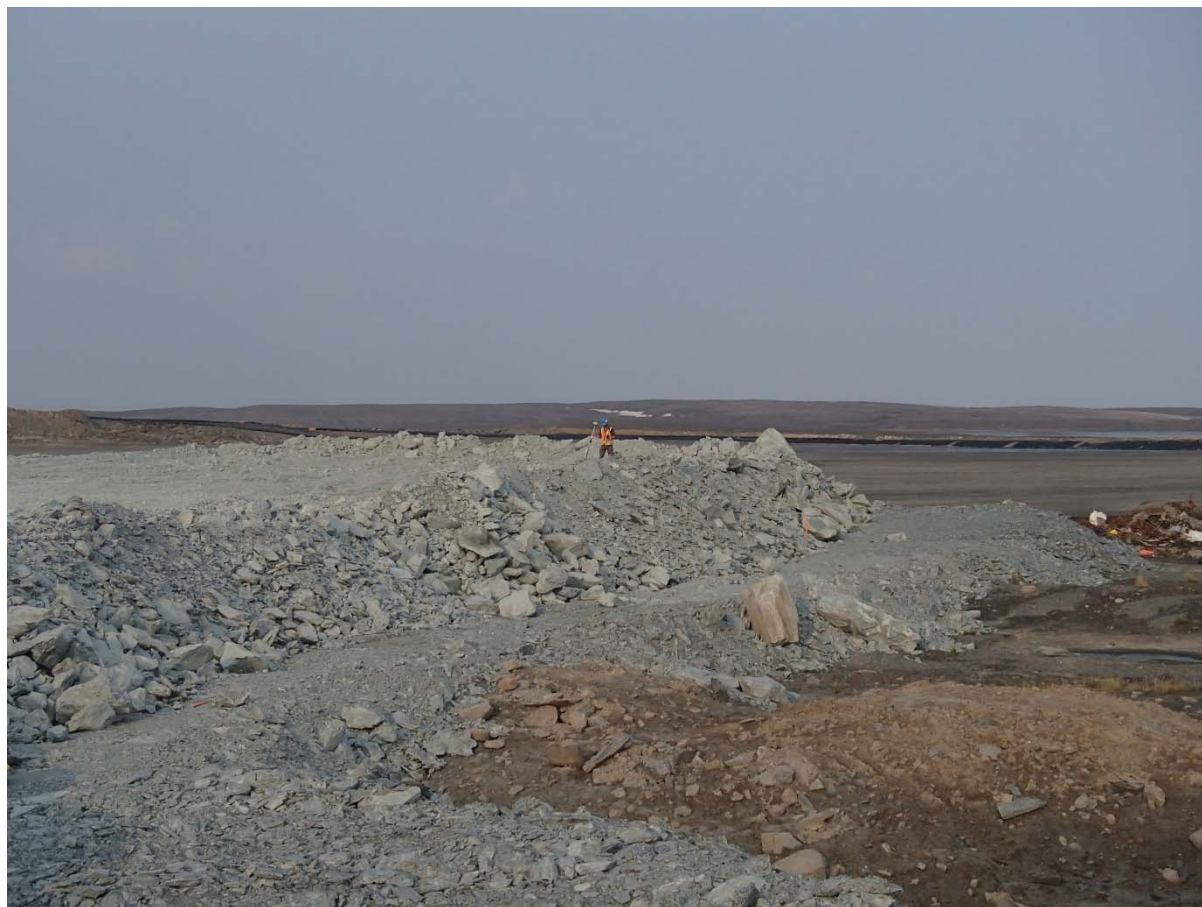
**Photograph NCIS-085: From Sta 1+150/-67m (approx.), looking SW. Placement of a 2 m thick (approx.) lift of UM rockfill from El. 150 m to El. 152 m (approx.) with a dozer from Sta. 1+130 m to 1+100 m (-55 m to -78 m).**

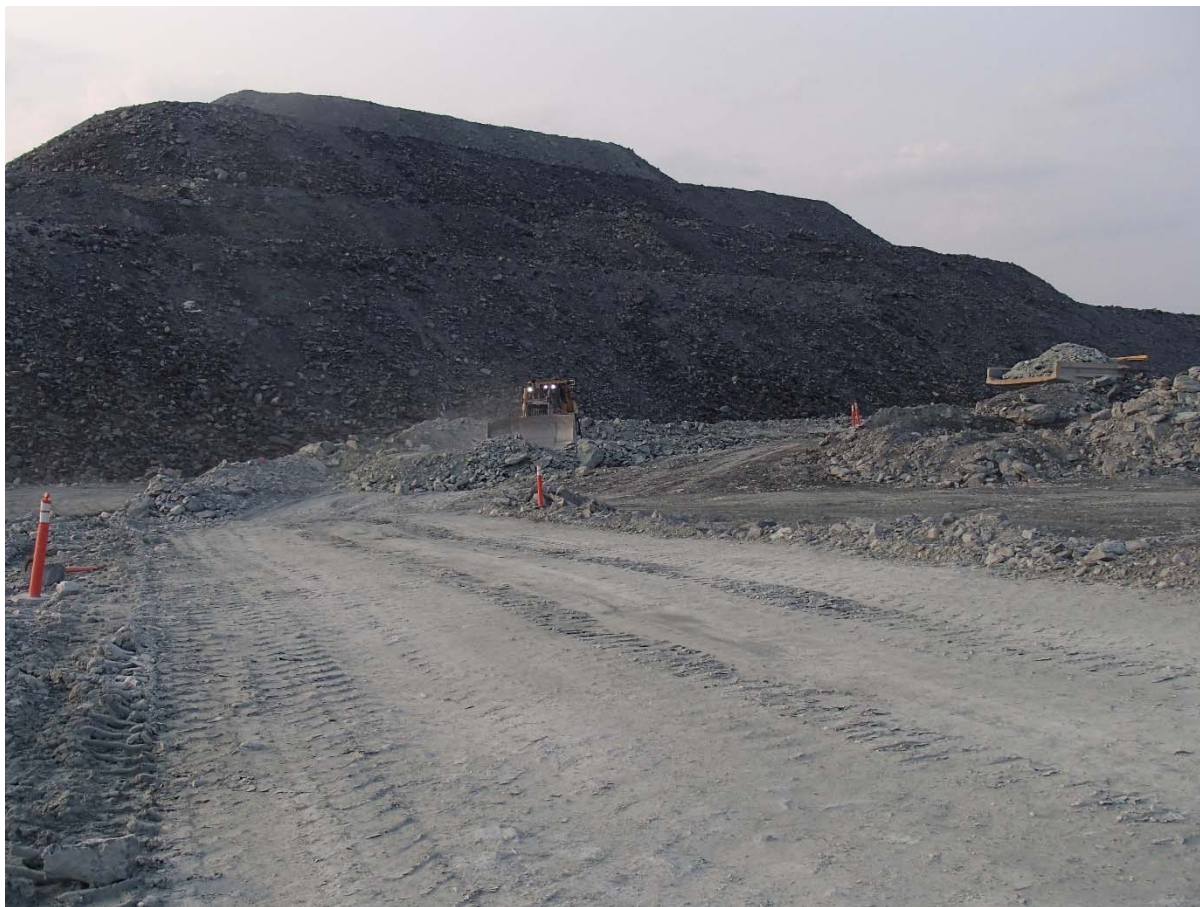
**Photograph NCIS-086: From Sta 2+750/+14 m (approx.), looking E. Placement of a 2 m thick (approx.) lift of UM rockfill from El. 152 m to El. 154 m (approx.) with a dozer from Sta. 2+780 m to 2+760 m (-60 m to -44 m).**

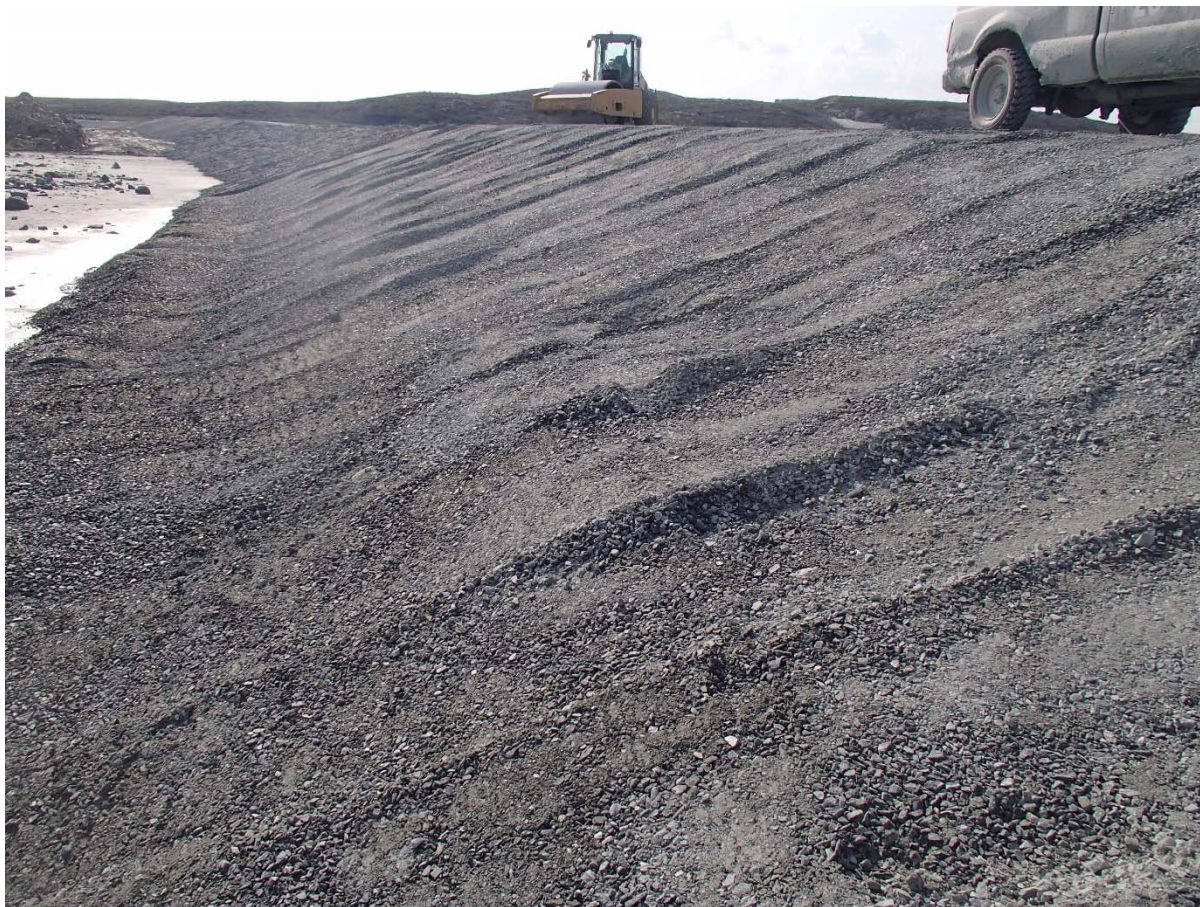
**Photograph NCIS-087: From Sta 1+950/-34 m (approx.), looking W. Compaction of the 0.5 m lift (approx.) of fine filter between El. 150 and 152 m with a 10-tonne smooth-drum compactor (4 passes) in the upstream slope from Sta. 2+000 m to 1+930 m. Vibration is used except for the first pass down the slope in order to stabilize the material and limit deformation of the lift.**

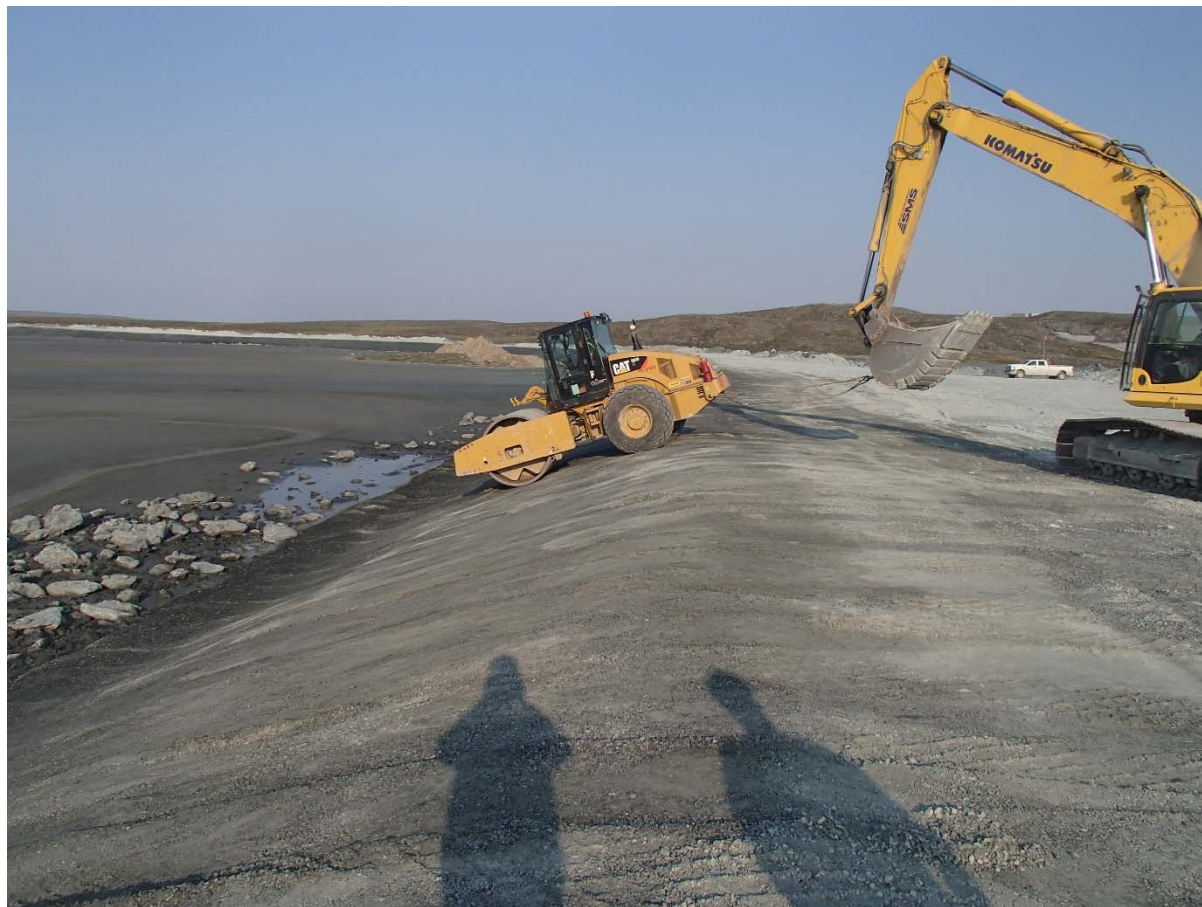
**Photograph NCIS-088: From Sta 2+000/-35 m (approx.), looking W. Compaction of the 0.5 m lift (approx.) of fine filter between El. 150 m and 152 m with a 10-tonne smooth-drum compactor (4 passes) in the upstream slope from Sta. 2+028 m to 1+650 m.**

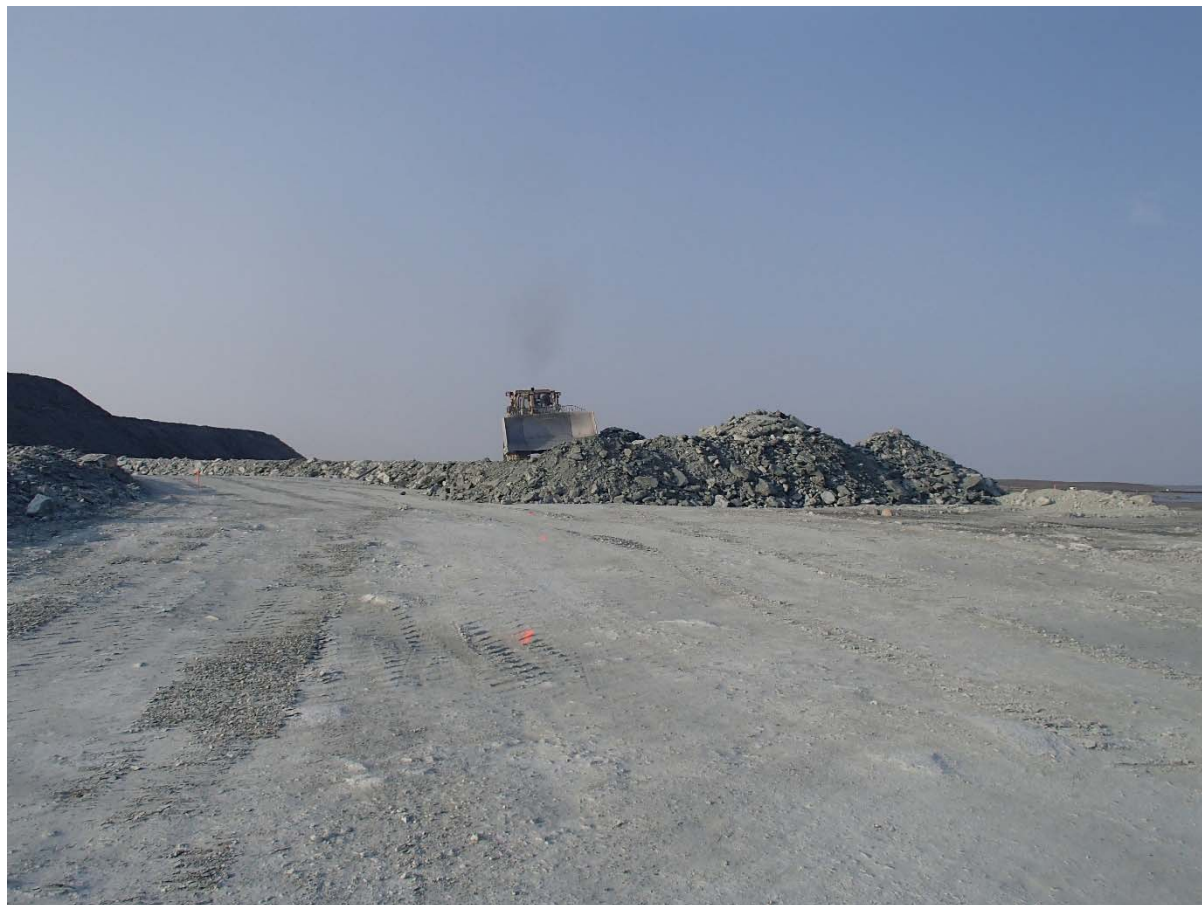
**Photograph NCIS-089: From Sta 2+525/+4 m (approx.), looking S. Placement of a 2 m thick (approx.) lift of UM rockfill from El. 152 m to El. 154 m (approx.) with a dozer from Sta. 2+605 m to 2+455 m (+3 m to -23 m).**

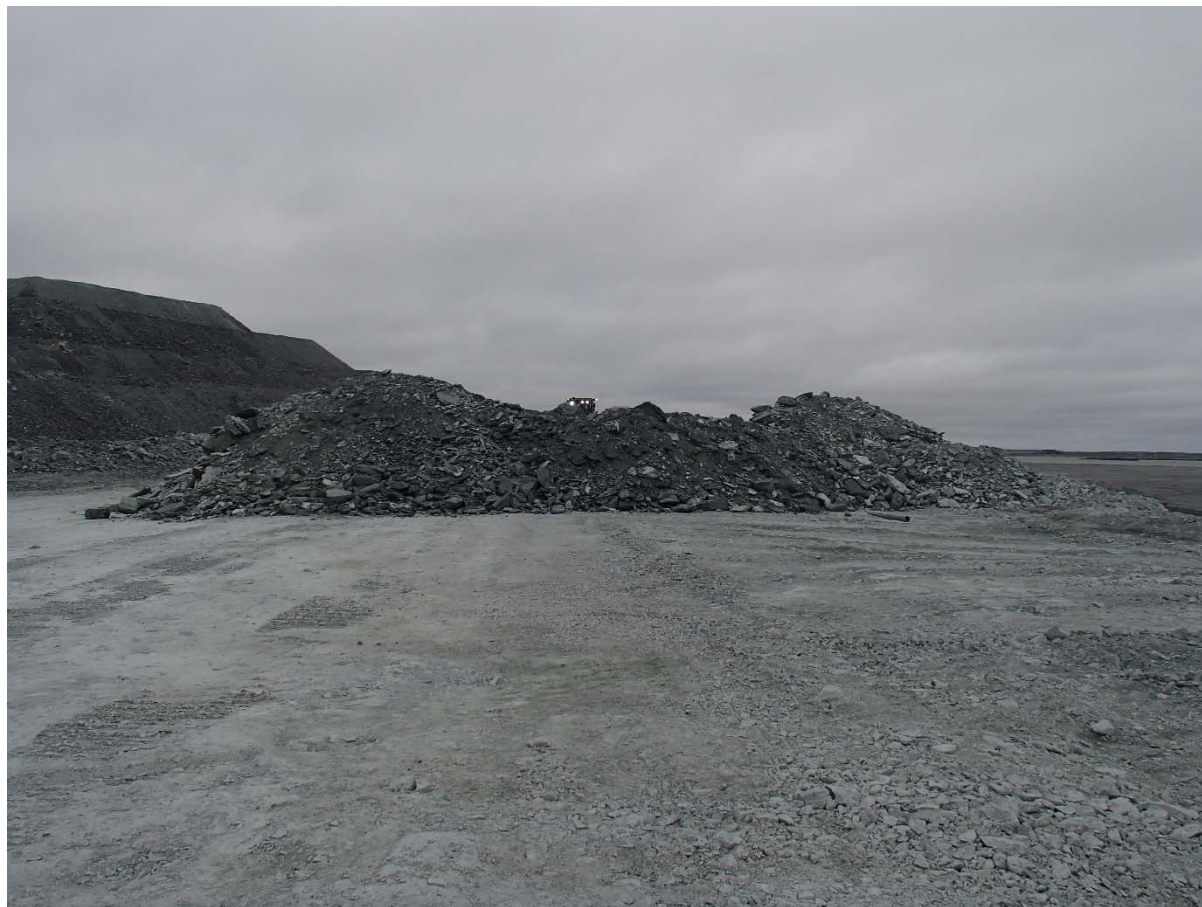
**Photograph NCIS-090: From Sta 2+440/-1 m (approx.), looking SE. Placement of a 2 m thick (approx.) lift of UM rockfill from El. 152 m to El. 154 m (approx.) with a dozer from Sta. 2+455 m to 2+370 m (+4 m to -24 m).**

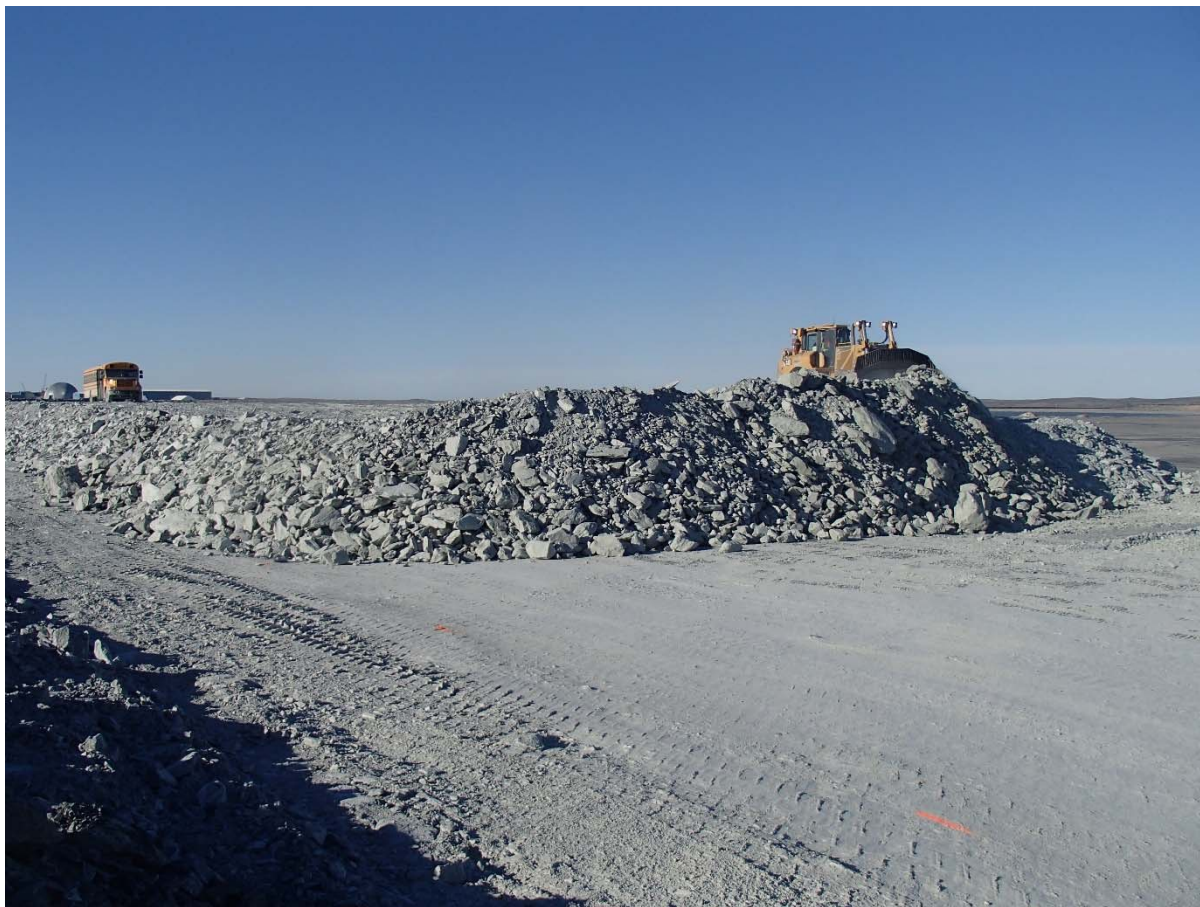
**Photograph NCIS-091: From Sta 2+330/+13 m (approx.), looking S. Placement of a 2 m thick (approx.) lift of UM rockfill from El. 152 m to El. 154 m (approx.) with a dozer from Sta. 2+370 m to 2+290 m (+9 m to -22 m). The material is of good quality and is well graded.**

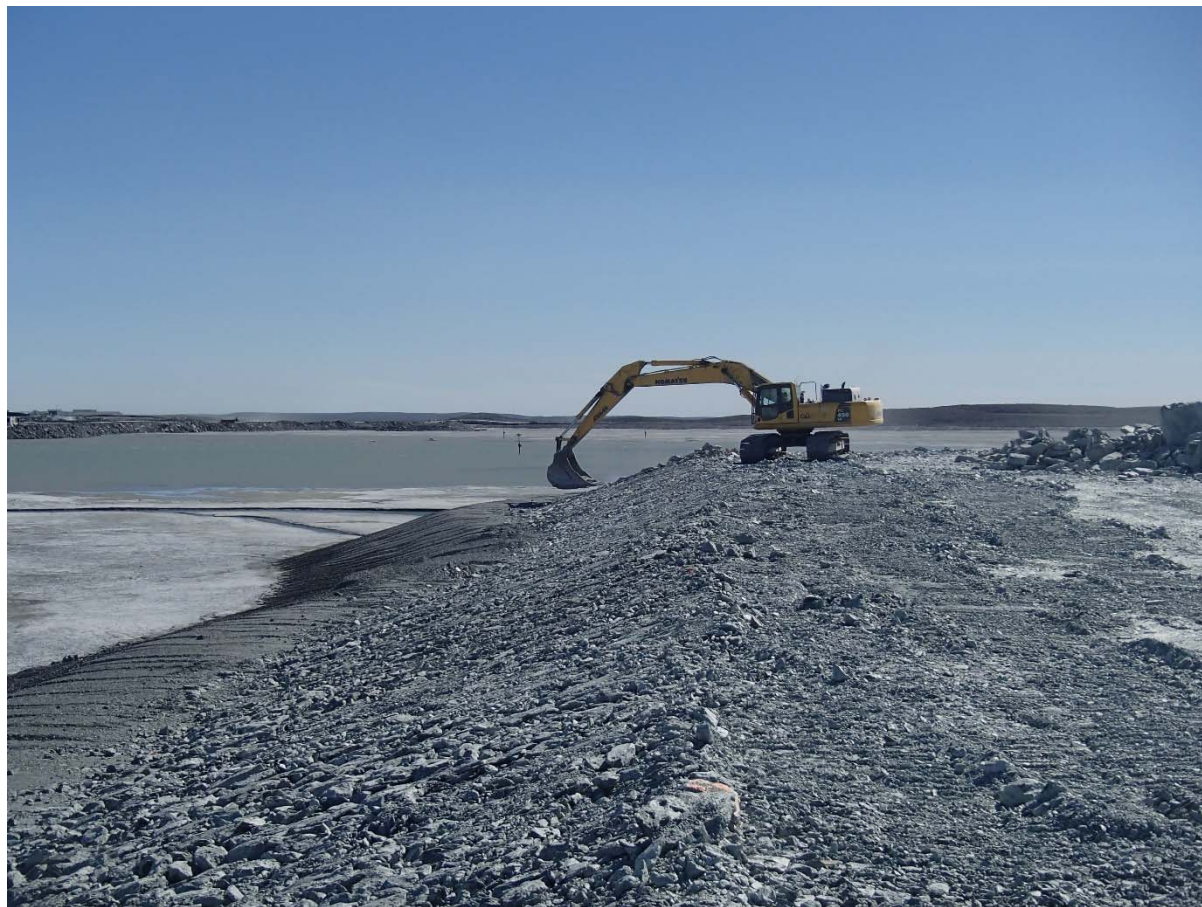
**Photograph NCIS-092: From Sta 1+160/-77 m (approx.), looking S. Profiling of the upstream slope (3H:1V) from El. 150 to 152 m with an excavator from Sta. 1+185 m to 1+135 m.**

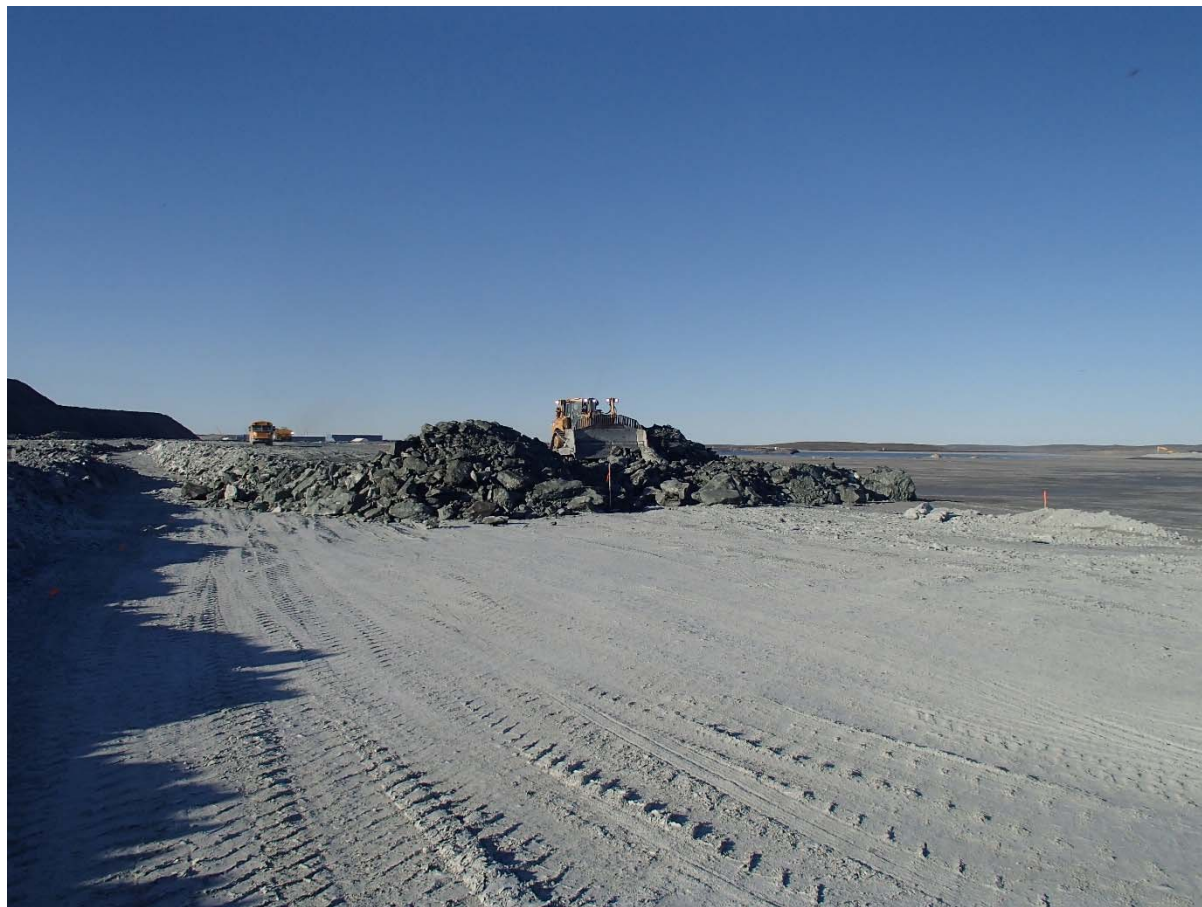
**Photograph NCIS-093: From Sta 2+260/+12 m (approx.), looking S. Placement of a 2 m thick (approx.) lift of UM rockfill from El. 152 m to El. 154 m (approx.) with a dozer from Sta. 2+290 m to 2+280 m (+9 m to -22 m).**

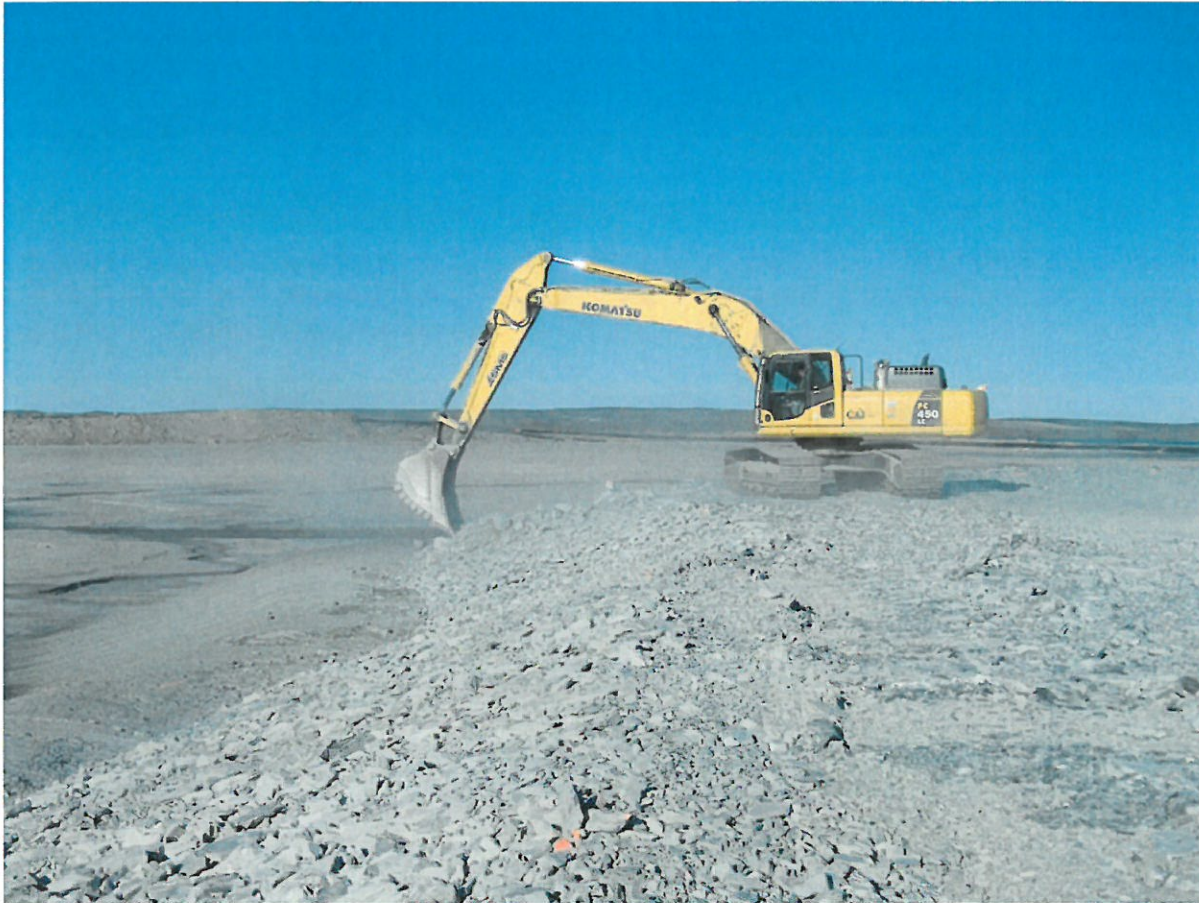
Photograph NCIS-094: From Sta 1+125/-109 m (approx.), looking SW. Profiling of the upstream slope (3H:1V) from El. 150 to 152 m with an excavator from Sta. 1+135 m to 1+100 m

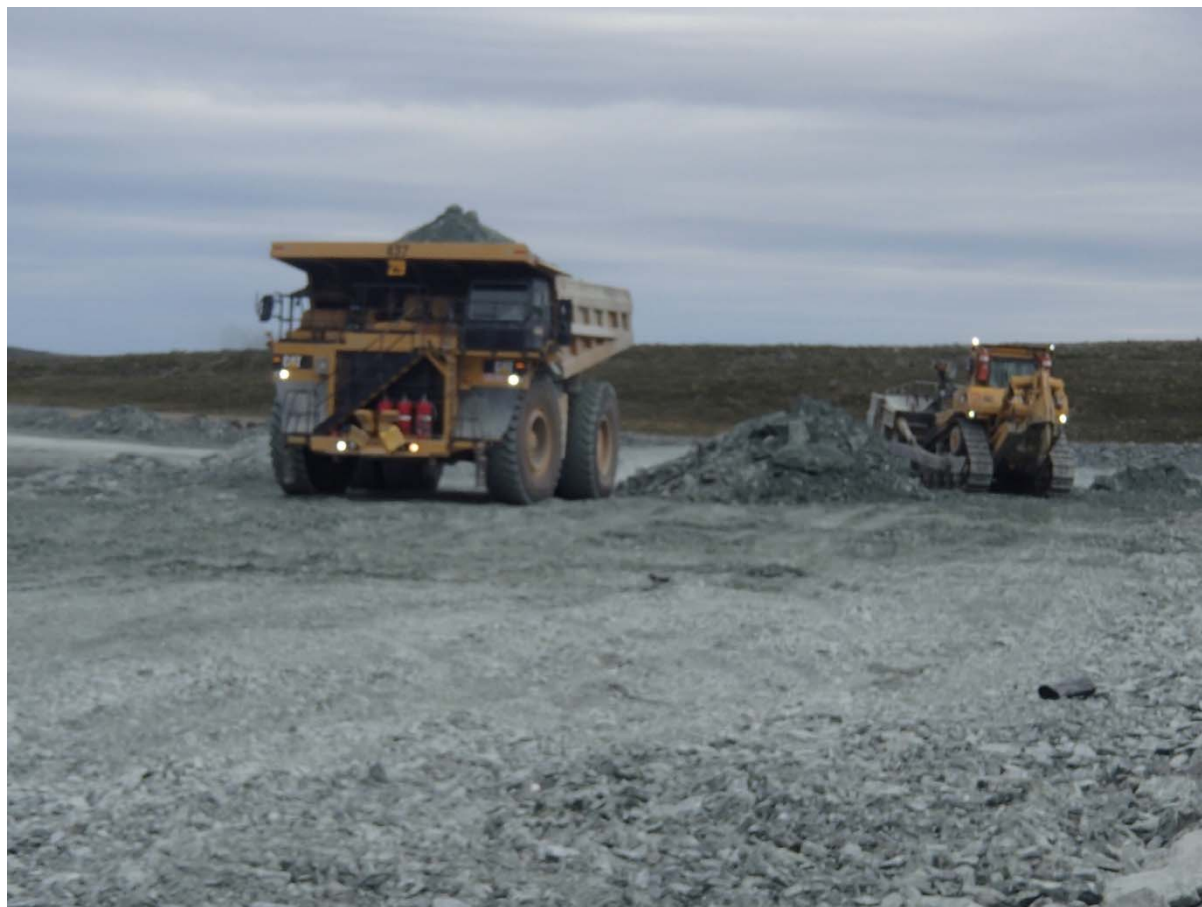
**Photograph NCIS-096: From Sta 2+355/+9 m (approx.), looking N. Placement of a 2 m thick (approx.) lift of UM rockfill from El. 152 m to El. 154 m (approx.) with a dozer from Sta. 2+190 m to 2+103 m (+7 m to -22 m). The material is of good quality and is well graded.**

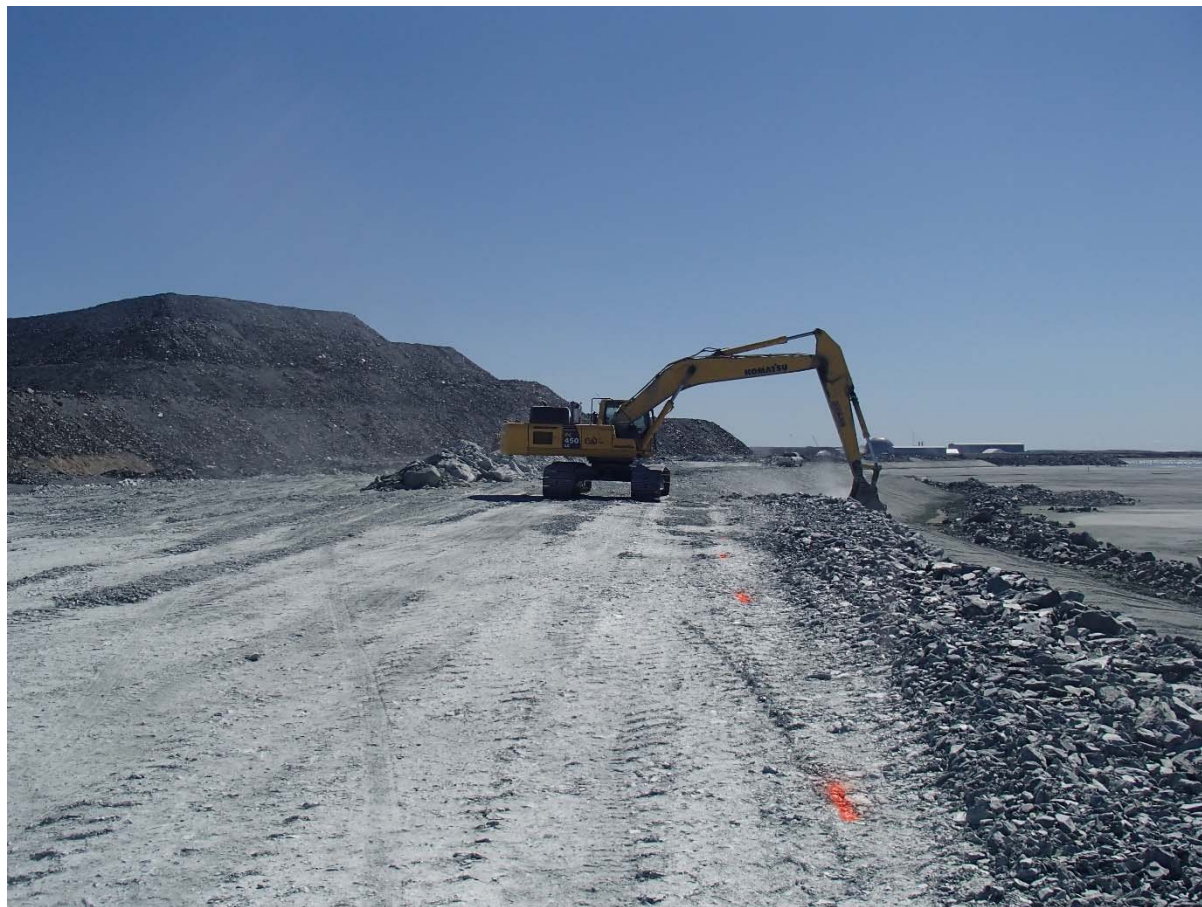
**Photograph NCIS-095: From Sta 2+375/-18 m (approx.), looking S. Profiling of the upstream slope (3H:1V) from El. 152 to 154 m with an excavator from Sta. 2+545 m to 2+410 m.**

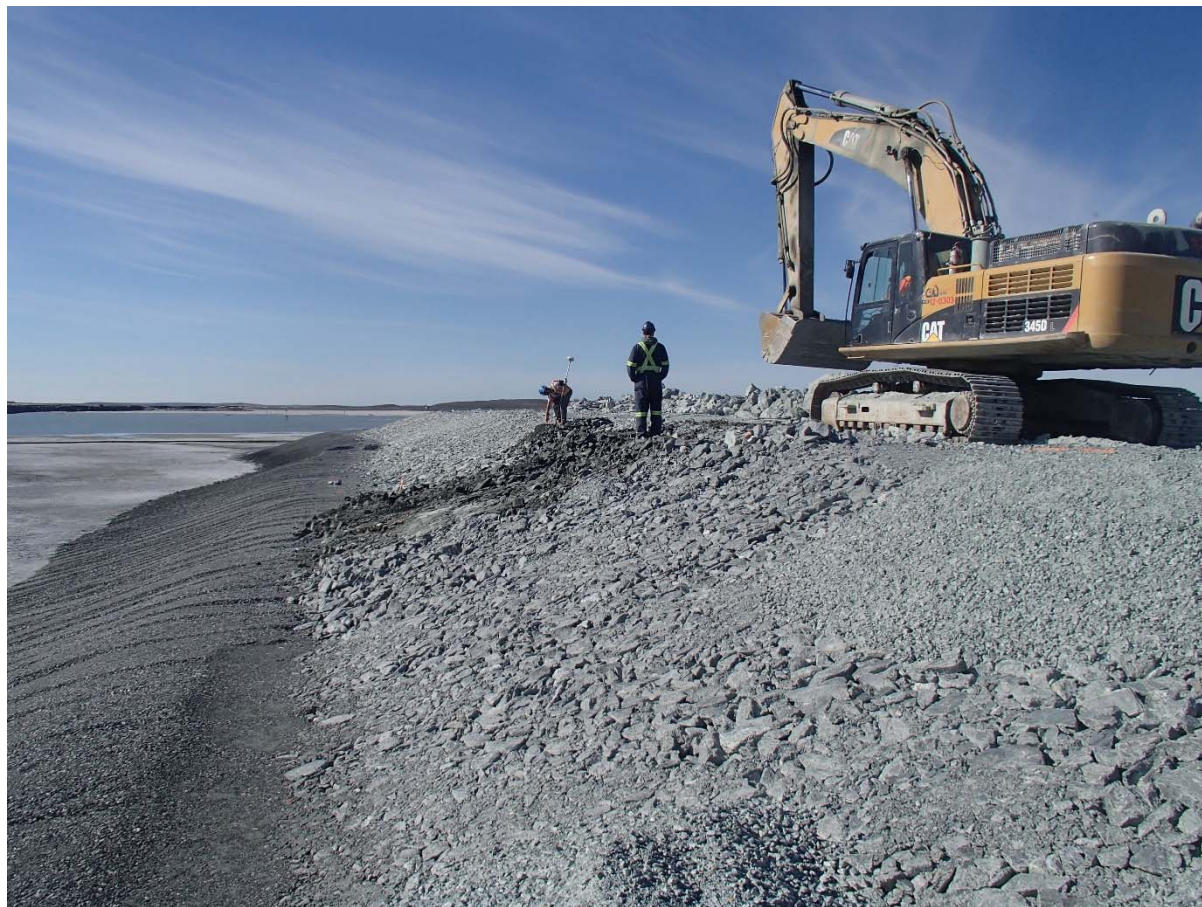
**Photograph NCIS-097: From Sta. 1+180/-75 m (approx.), looking SW. Placement of a 0.5 m thick lift of coarse filter in the upstream slope from El. 150 m to 152 m with an excavator from Sta. 1+200 m to 1+113 m.**
