## QA WEEKLY REPORT

### QA WEEKLY REPORT FROM JULY 9<sup>TH</sup> TO JULY 15<sup>TH</sup>– TSF NORTH CELL CONSTRUCTION MEADOWBANK (1897439)

This document summarizes QA activities performed by Golder from July 9<sup>th</sup> to July 15<sup>th</sup>, 2018 inclusively, related to the construction activities of the North Cell Internal Structure at the Meadowbank mine site.

### QA WEEKLY REPORT FROM JULY 16<sup>TH</sup> TO JULY 22<sup>ND</sup> – TSF NORTH CELL CONSTRUCTION MEADOWBANK (1897439)

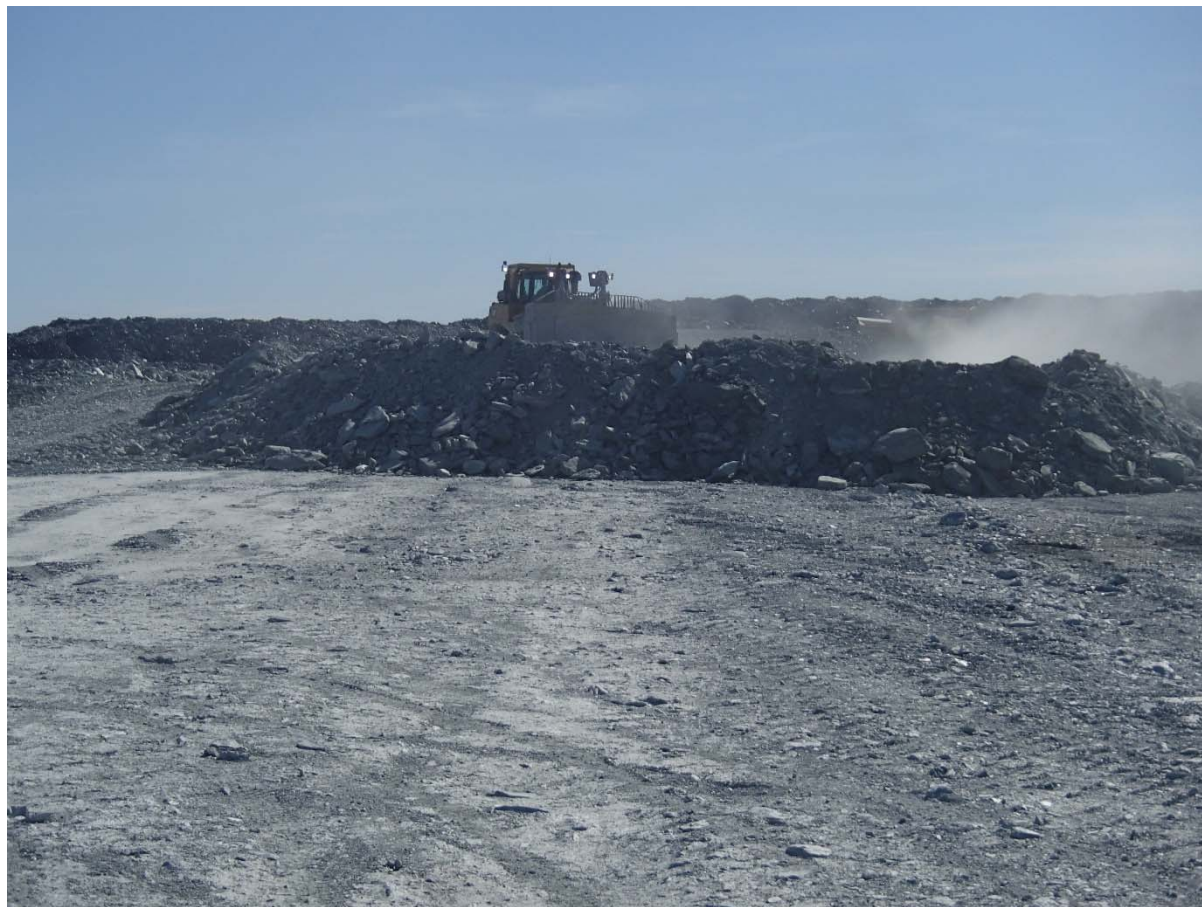
**Photograph NCIS-098: From Sta. 2+040/-9 m (approx.), looking E. Placement of a 2 m thick (approx.) lift of UM rockfill from El. 152 m to El. 154 m (approx.) with a dozer from Sta. 2+103 m to 1+984 m (+7 m to -22 m). The material is of good quality and is well graded.**

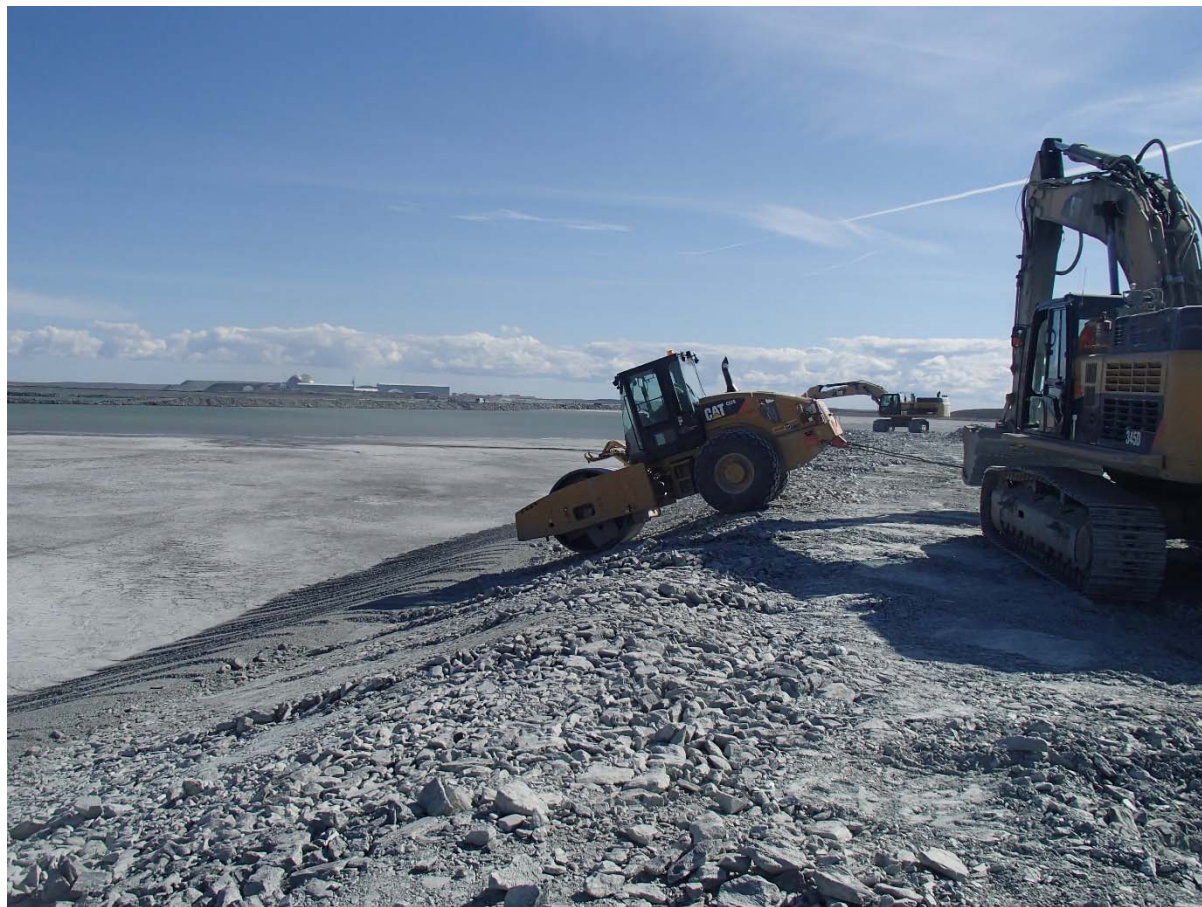
**Photograph NCIS-099: From Sta. 1+180/-76 m (approx.), looking SE. Compaction of the 0.5 m lift (approx.) of coarse filter between El. 150 m and 152 m with a 10-tonne smooth-drum compactor with vibration (4 passes) in the upstream slope from Sta. 1+200 m to 1+170 m.**

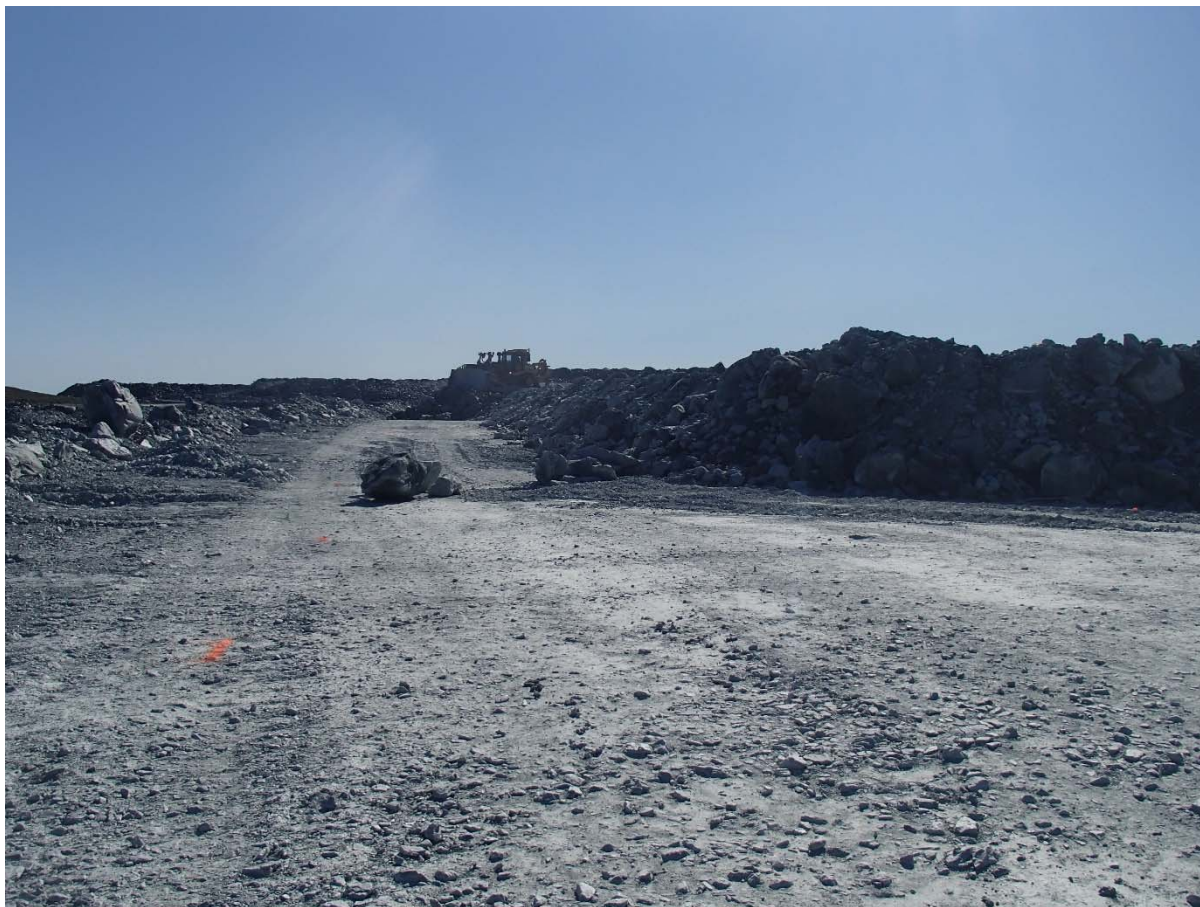
**Photograph NCIS-100: From Sta. 1+960/+10 m (approx.), looking E. Placement of a 2 m thick (approx.) lift of UM rockfill from El. 152 m to El. 154 m (approx.) with a dozer from Sta. 1+984 m to 1+947 m (+14 m to -26 m). The material is of good quality and is well graded.**

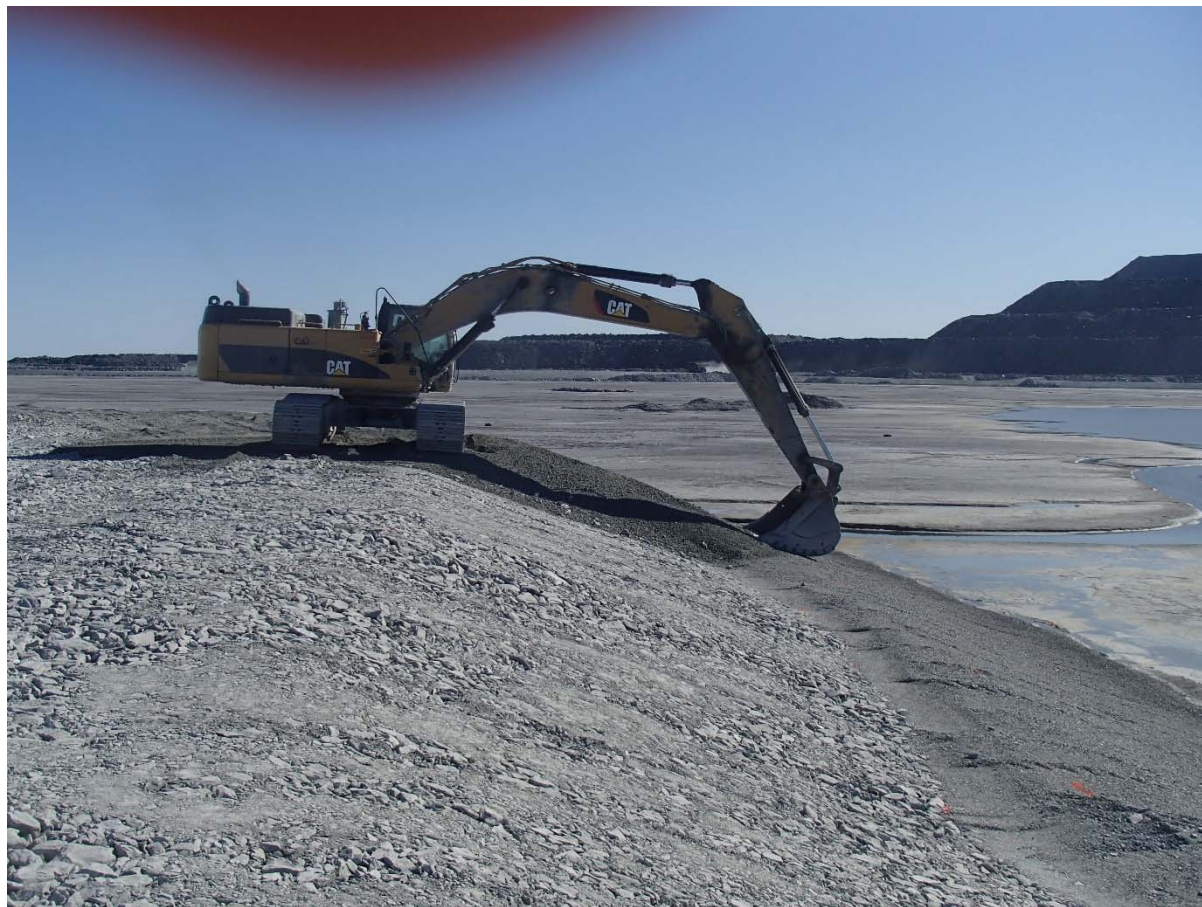
**Photograph NCIS-101: From Sta. 1+120/-89 m (approx.), looking N. Placement of a 0.5 m thick lift of fine filter in the upstream slope from El. 150 m to 152 m with an excavator from Sta. 1+113 m to 1+205 m.**

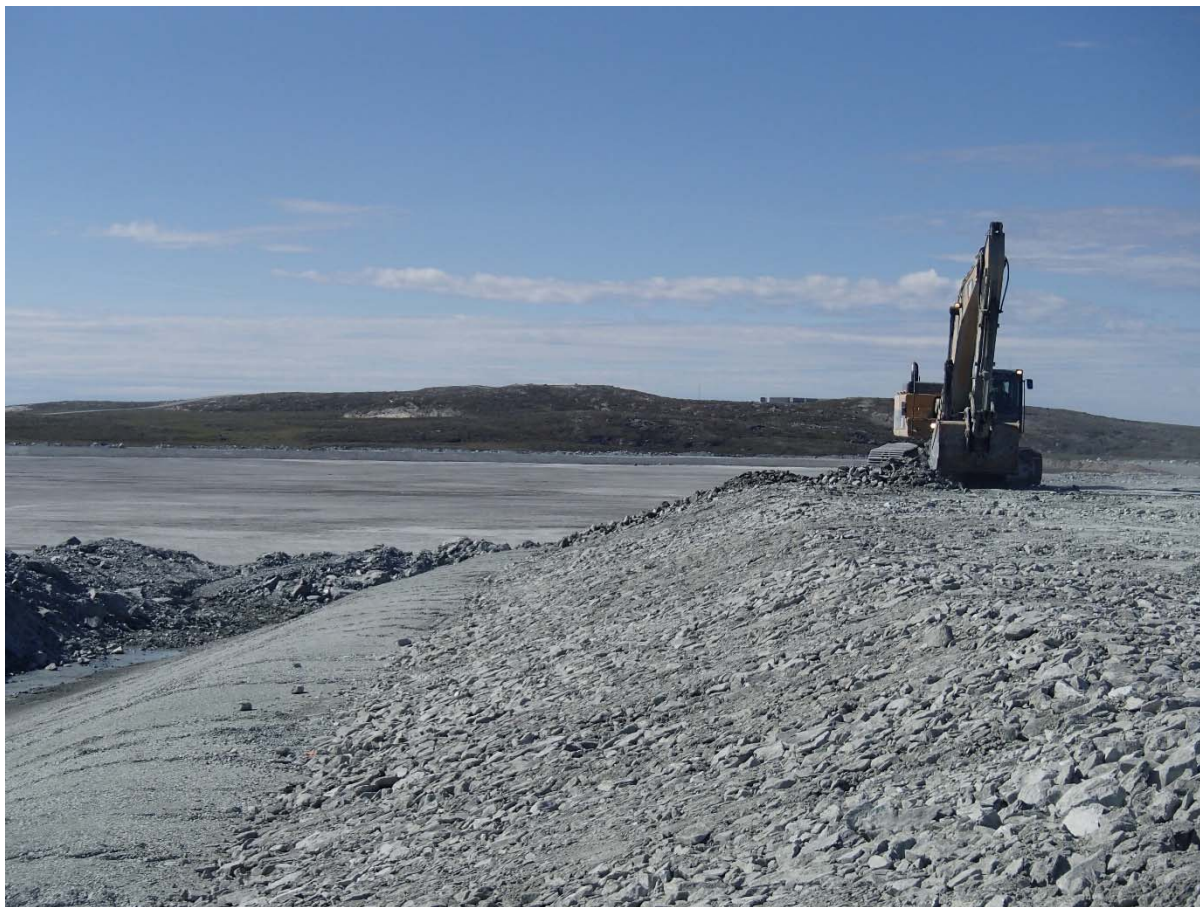
**Photograph NCIS-102: From Sta. 2+680/-21 m (approx.), looking W. Placement of a 0.5 m thick lift of coarse filter in the upstream slope from El. 152 m to 154 m with an excavator from Sta. 2+575 m to 2+710 m and from Sta. 2+411 m to 2+460 m.**

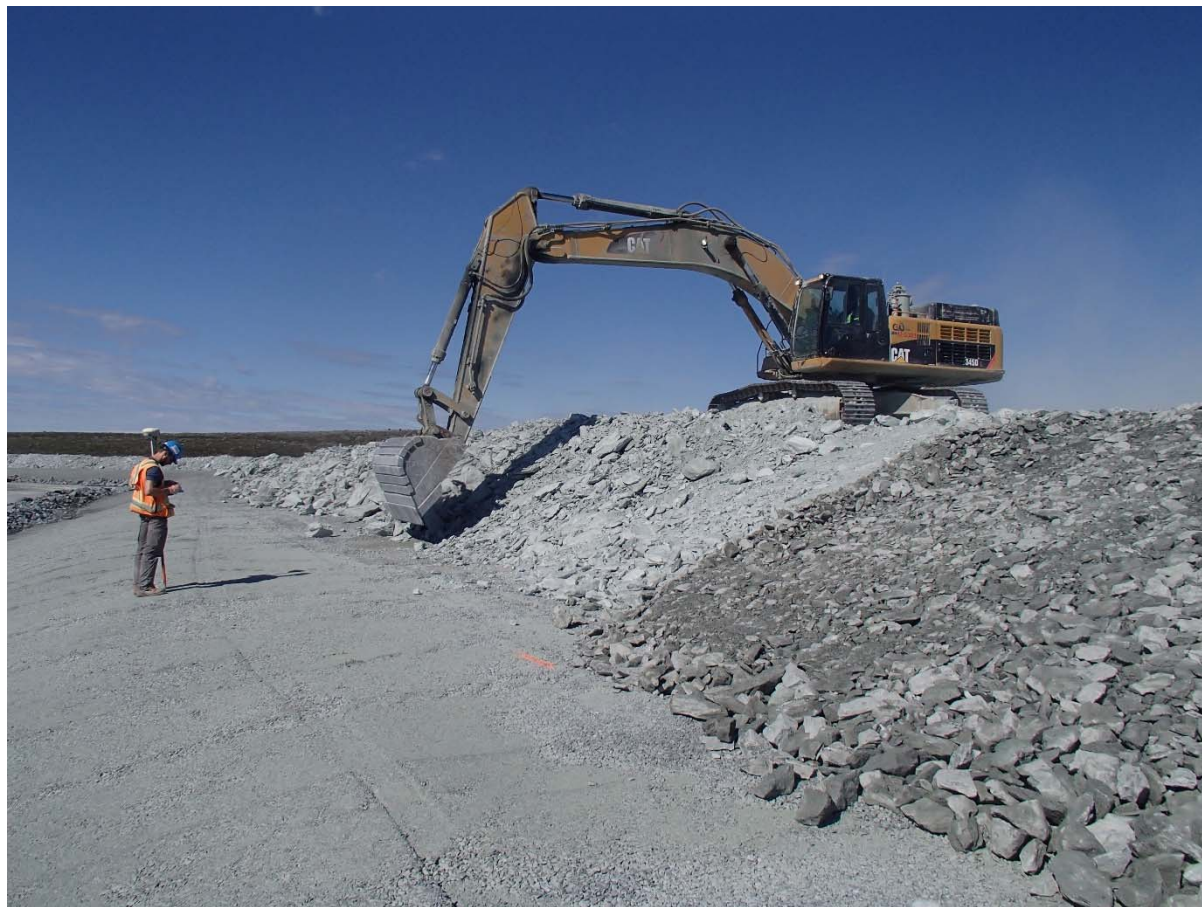
**Photograph NCIS-103: From Sta. 2+420/-27 m (approx.), looking NE. Profiling of the upstream slope (3H:1V) from El. 152 to 154 m with an excavator from Sta. 2+400 m to 2+410 m. Oversize boulders were removed.**

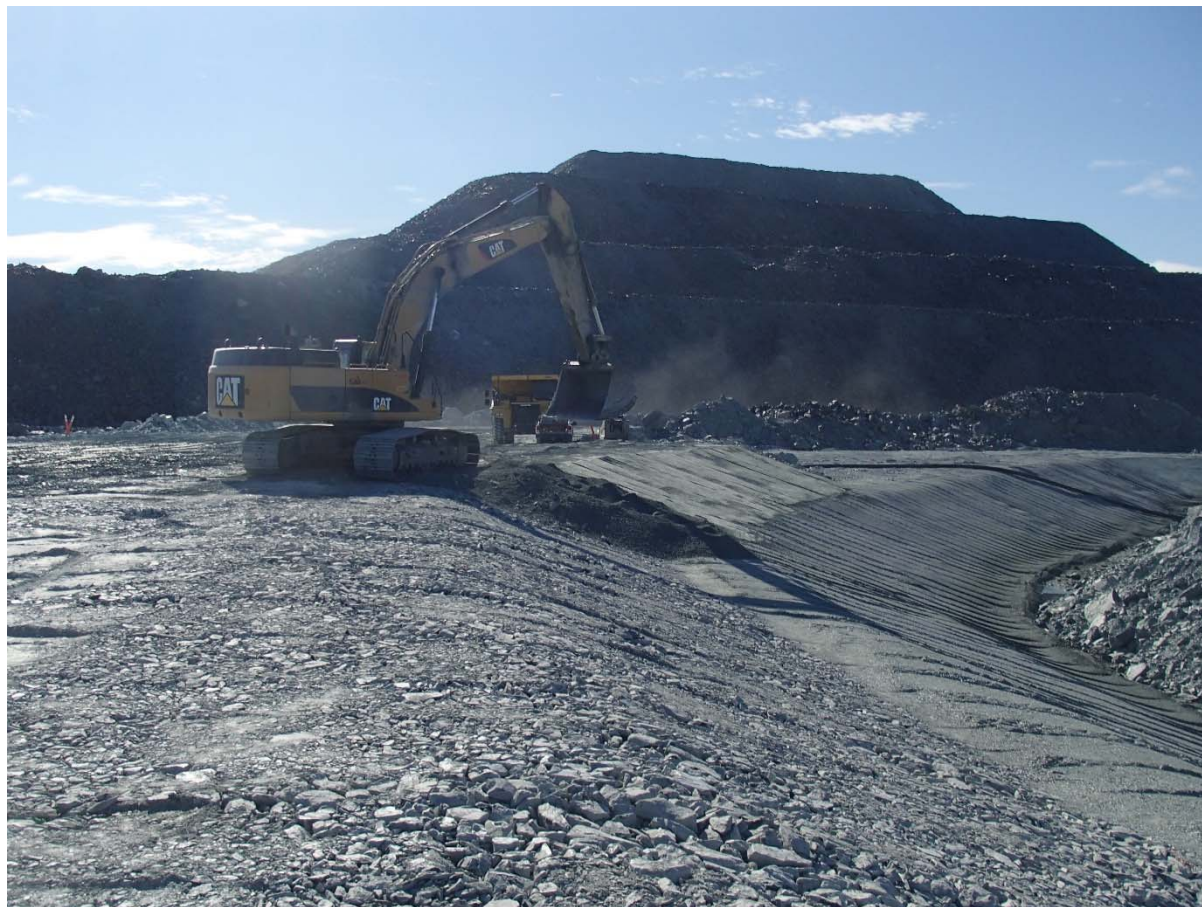
**Photograph NCIS-104: From Sta. 2+650/-23 m (approx.), looking SE. Placement of a 0.5 m thick lift of fine filter in the upstream slope from El. 152 m to 154 m with an excavator from Sta. 2+710 m to 2+445 m.**
