Construction Summary Report

Baker Lake Fuel Storage Tank #8

Agnico Eagle Mines Ltd

6129-740-132-REP-001

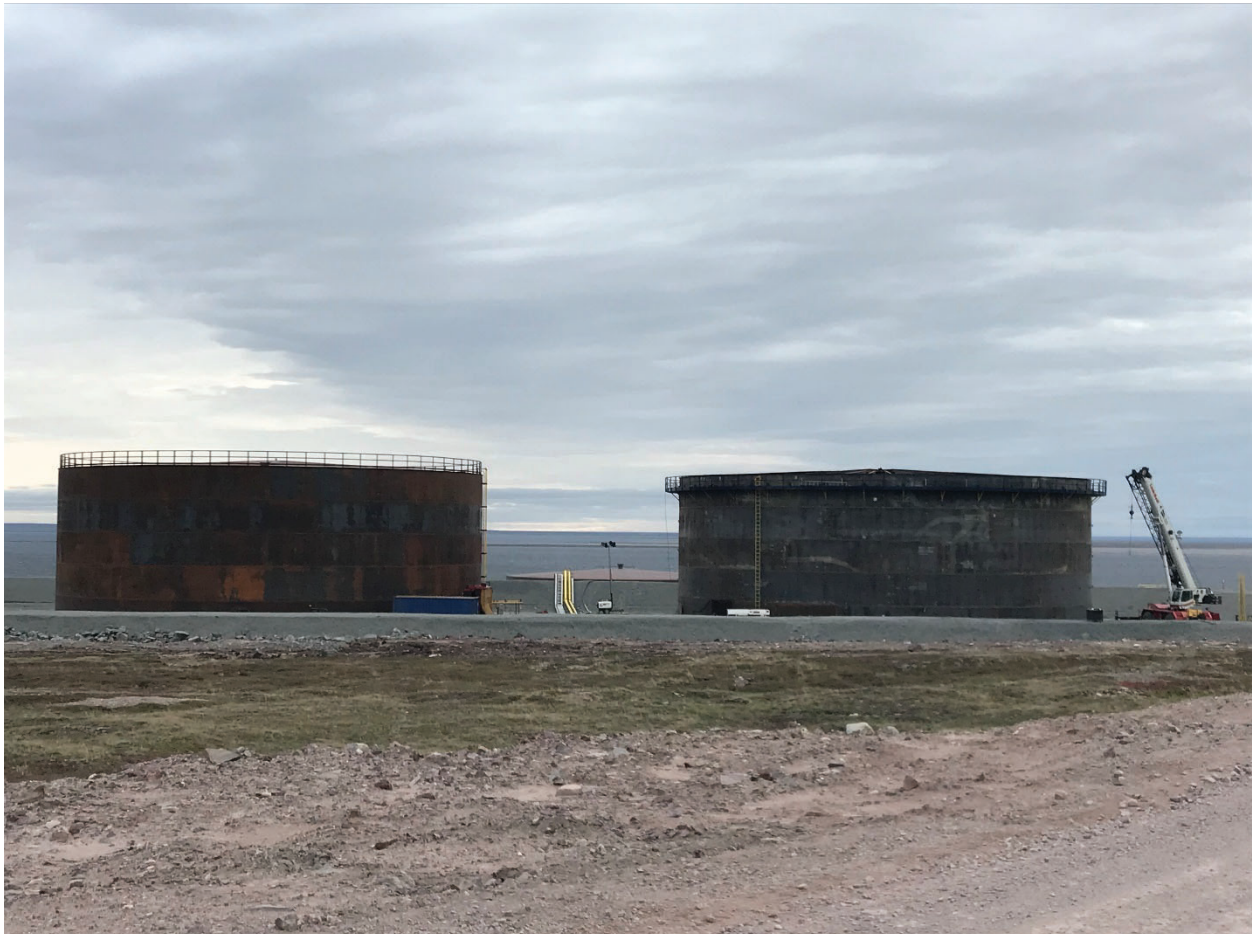
Figure 1 – Baker Lake Fuel Farm Site Overview (tank #7 and #8)

Agnico Eagle is developing the Whale Tail Project in the Kivalliq Region of Nunavut (65°24'25" N, 96°41'50" W). The 99,878-hectare Amaruq property is located on Inuit-owned and federal crown land, approximately 55 km north of the Meadowbank mine. The Meadowbank mine is accessible from Baker Lake, located 70 kilometers to the south. The Baker Lake Bulk Fuel Storage Tank Facility is located east of the hamlet of Baker Lake, on the north shore of Baker Lake.
