Follow-up Quick Lime Spill May 13th, 2014

This detailed report is submitted to the Inspector in compliance with the conditions under the Nunavut Water Board License 2AM-MEA0815, Part H, Item 9c.

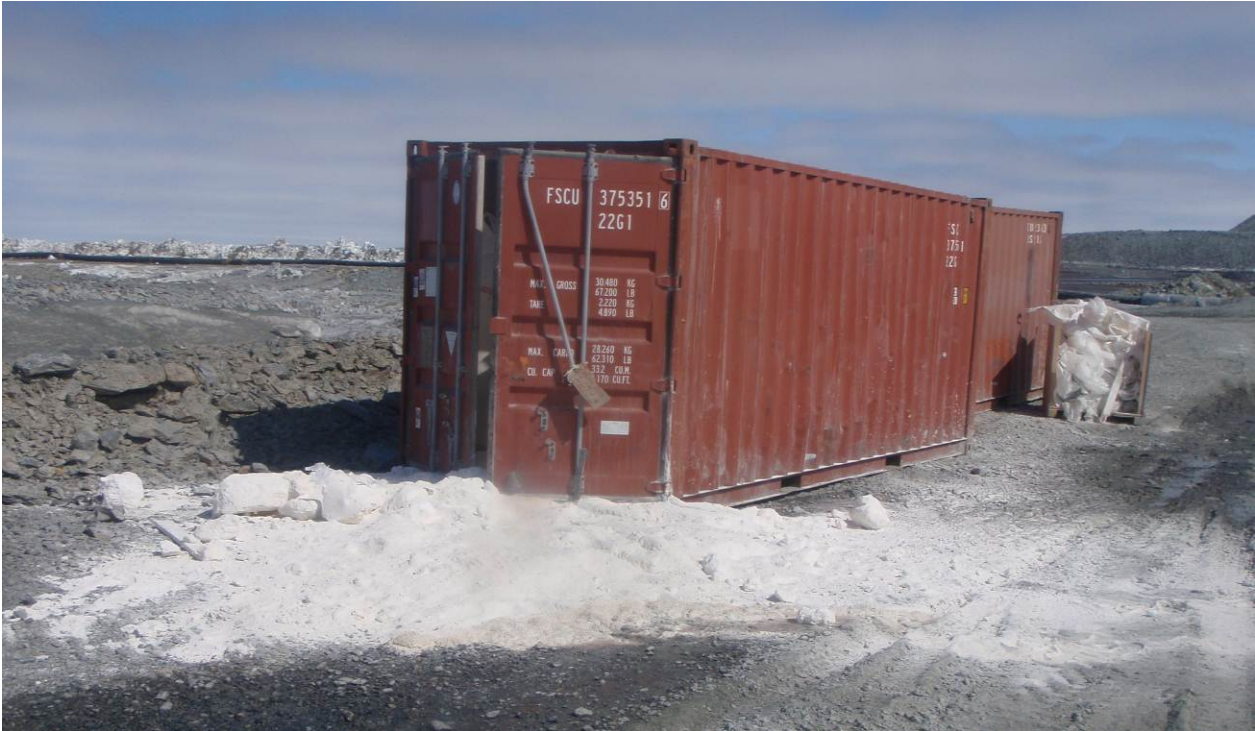
A sea-can containing unusable bag of quick lime, due to their condition, was stored near the tailings pond for disposition into the tailings pond. The zoom boom operator picked up a bag to move it to the disposition point. The bottom of the bag had rotted out and when the bag was lifted out of the seacan the product spilled on the ground. Approximately 500 Kg of quick lime was spilled on the ground. See photo below.

Photo of spill above; Below spill cleaned up, Lime Seacan Removed, and new seacan for Dewatering supplies in place

Site Services cleaned-up contaminated material and soil with the loader and disposed of into the tailings pond.

In the future, Seacan's full of outdated lime will only be unloaded in a location that prevents any contaminants from reaching the environment. i.e from inside the TSF boundary or on a ramp into the TSF, this way if there is a spill, the material spilt is with the TSF, also any water run off or rain will carry the chemical into the TSF and not the surrounding environment.
