December 18, 2015 Laydown spill

Please find the following information as a follow up to the Spill report submitted December 18th, 2015 by Agnico Eagle Meadowbank division. This detailed report is submitted to the Inspector in compliance with the conditions under the Nunavut Water Board License 2AM-MEA1525, Part H, Item 8b.

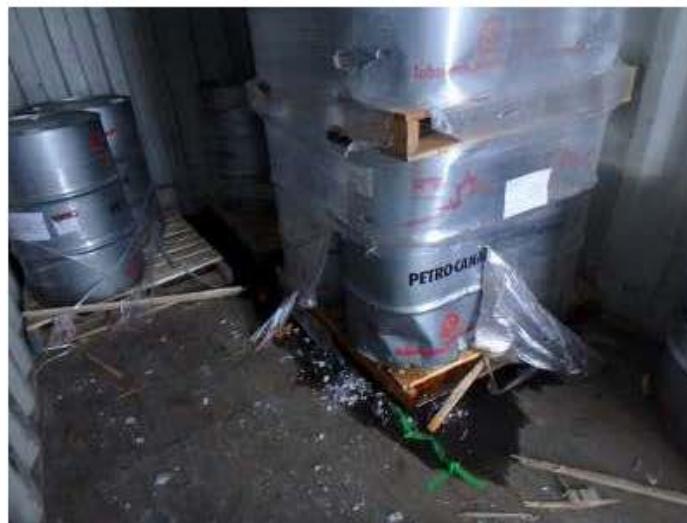
When a warehouse operator entered the c-can to get a drum of Endurex EP150 oil for delivery for use on site, he noticed that one drum was empty and some spilled oil was visible on the floor. After investigation, it was found that the drum was probably punctured in a previous handling of the material inside the c-can without being noticed. Puncture occurred when the forks of zoom-boom went through drums that were behind the ones being handled.
