Cause of Spill

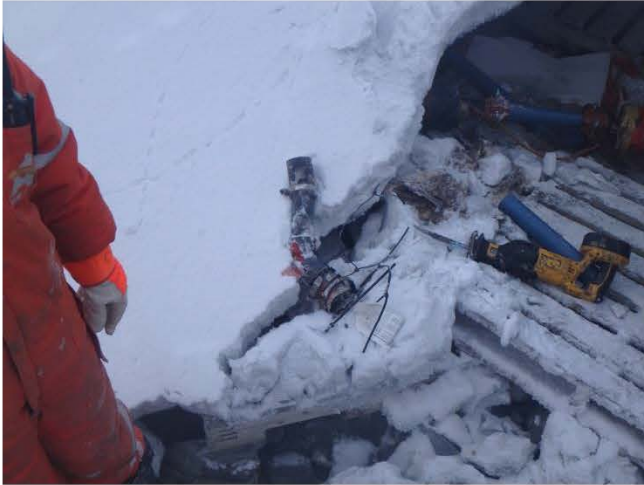
The fitting on the line broke because external pressure was being added to the pipe by snow being pushed over from the iron pad towards the discharge line. The sewage was thus discharge closer to the road. This created a change in the path of the flow, resulting in water being observed on the north side.

Broken fitting and pipe

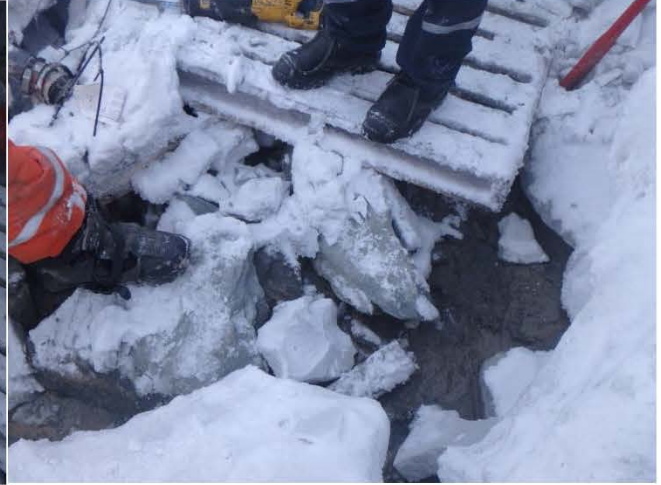
Area of broken line

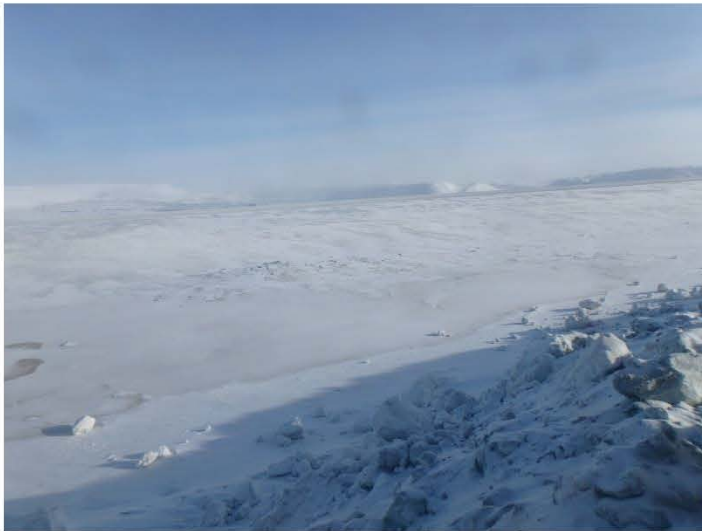
North side

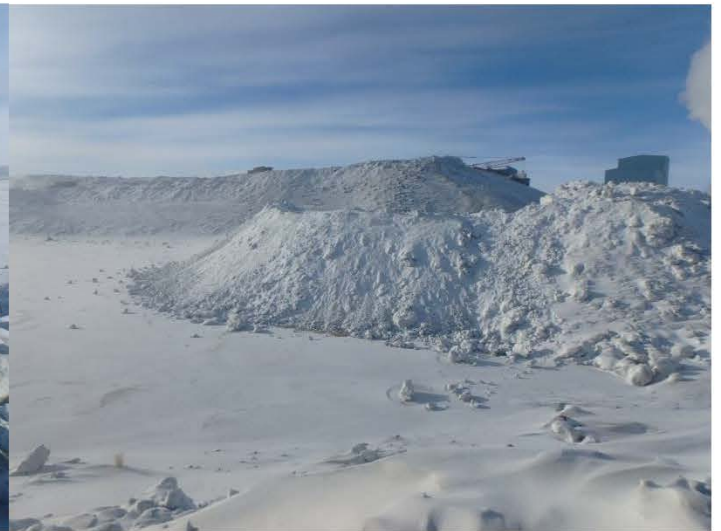
Snow bank on Stormwater pond
