May 3rd, 2016 Vault backhoe spill

Please find the following information as a follow up to the Spill report submitted May 3rd, 2016 by Agnico Eagle Meadowbank division. This detailed report is submitted to the Inspector in compliance with the conditions under the Nunavut Water Board License 2AM-MEA1525, Part H, Item 8c.

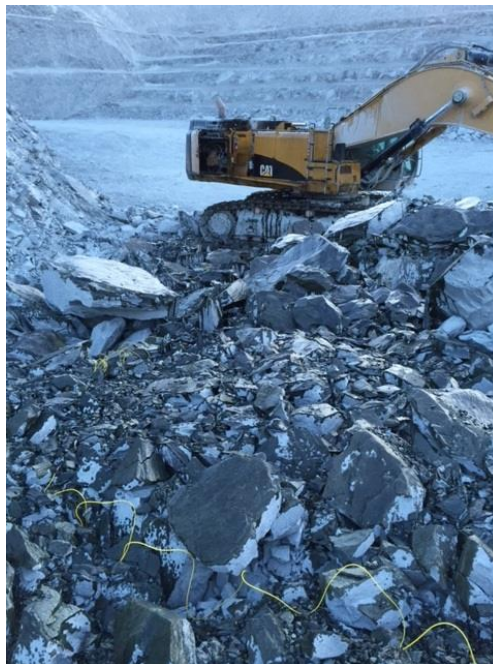
On May 3rd at 21:00, Backhoe #6 was working in Vault pit when a valve from the hydraulic system busted causing the oil to spill onto the ground

The spill was caused by a busted valve from the hydraulic system. The operator shut down the equipment right away to prevent further contamination than called a mechanic to do the repairs on the equipment

The spill on the ground was picked up immediately, backhoe gathered contaminated material onto a spot than was picked up using a 980 loader and brought to the yellow roll-off bin. Once placed in yellow roll-off bin, Site Services were contacted to empty the bin at the landfarm

Modifications were made in the preventive maintenance log and planning to address specific inspections of hoses on equipment. A visual inspection was already being done on equipment, but a specific item related to hose inspections is now included to PM's executed on those type machinery. The item "[Inspect all hydraulic hoses for leaks or potential failures](#)" was added to the planning module and is now part of all hydraulic systems maintenance.

Also, 2ndary containments have been made and distributed to prevent spilling onto the ground and advised to use them during replacing or repairing equipment. Tool box meetings with departments have been completed to discuss the use of 2ndary containments.

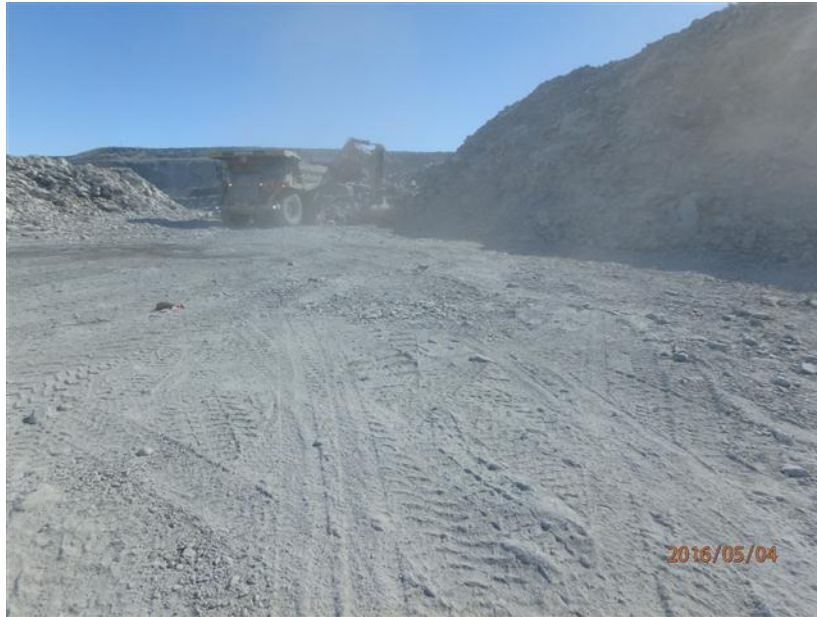
Area after clean-up
