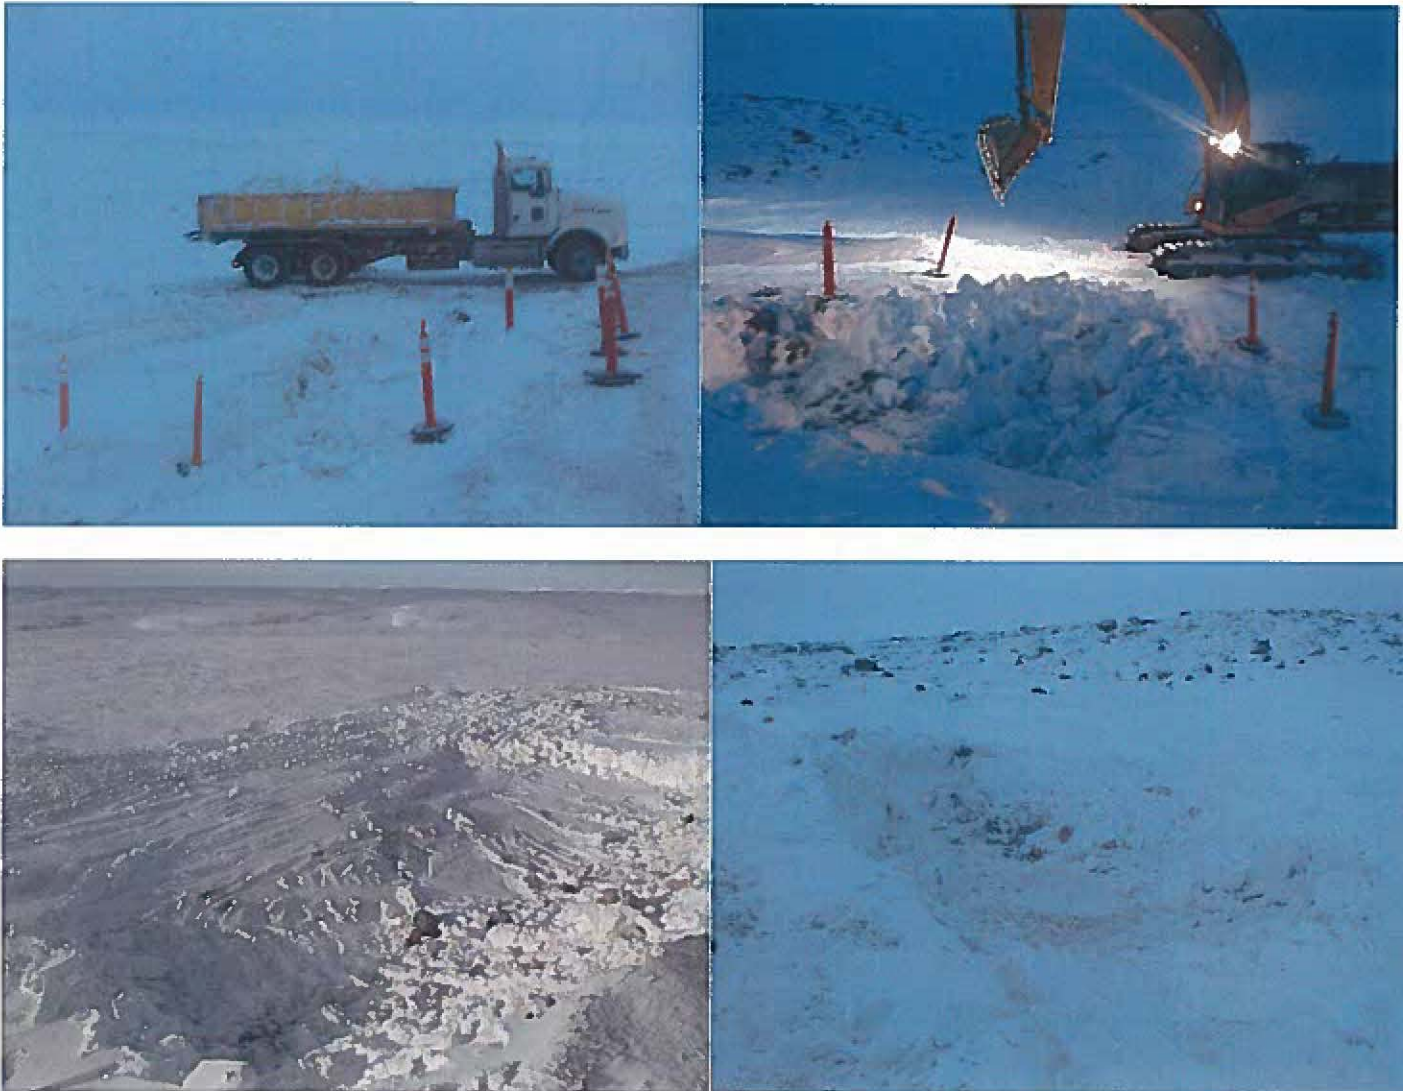
The cleanup at the location was also done in multiple steps. First the ammonium nitrate that spilled on the snow from the damaged c-cans was manually shoveled and collected into a drum. One full drum of snow and material was collected and brought to the Emulsion plant for disposal. Secondly, the area where fuel spilled from the tanks was cleaned with a backhoe and all the contaminated snow and material was brought to the Tailings Storage Facility using roll-off bins. Thirdly, the area where the ammonium nitrate was spilled was also cleaned; this product was also disposed at the TSF, since the ammonium nitrate was previously removed.
