October 2nd, 2016 MBK Crusher glycol spill

Please find the following information as a follow up to the Spill report submitted October 2nd, 2016 by Agnico Eagle Meadowbank division. This detailed report is submitted to the Inspector in compliance with the conditions under the Nunavut Water Board License 2AM-MEA1525, Part H, Item 8c.

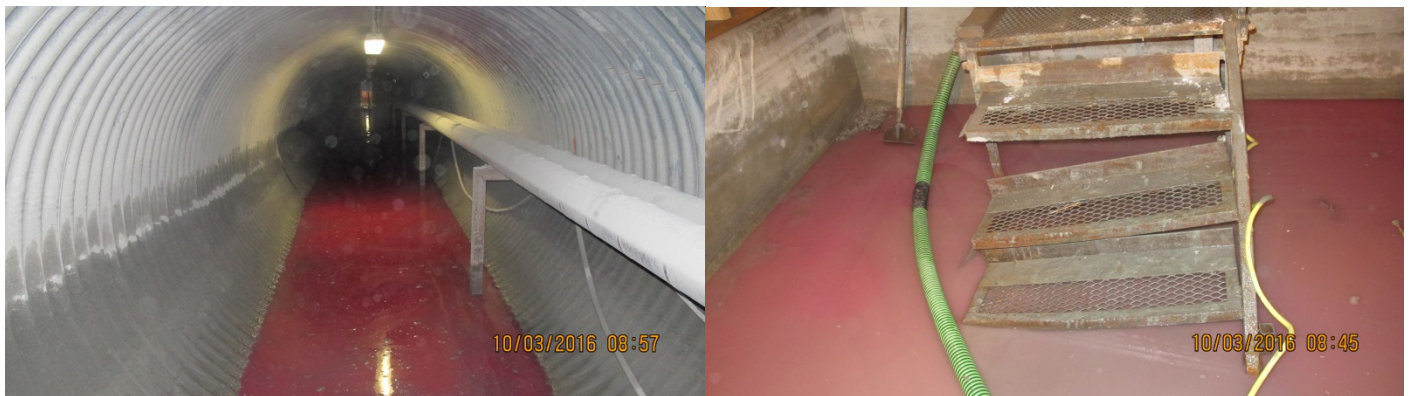
During routine inspections, an operator noticed glycol leaking from a pipe in the emergency underground access tunnel from the crusher to the dome area. Quickly the valve of the system was closed to prevent more spillage. A volume of 12 000 liters was estimated to have leaked inside the enclosure.

There were no off site impact or discharge to any receiving watercourses. The distance to the closest lake is estimated at 550 meters.

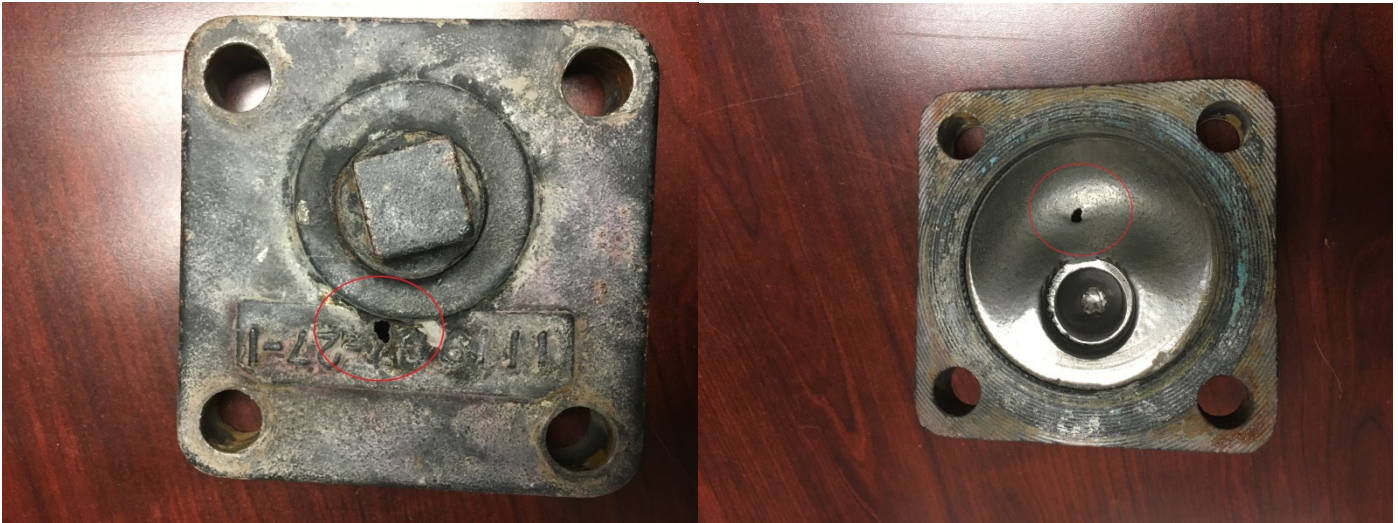
Upon further inspection, an end cap was found to have a hole causing glycol to leak from the line

The failed end cap piece was replaced and the glycol system was inspected for any more issues or signs of defect. The system is also connected to an alarm panel for quick intervention.
