2021-09-08 MBK AWAR Coolant & Oil

GN reference #: 2021-387

Spill Description

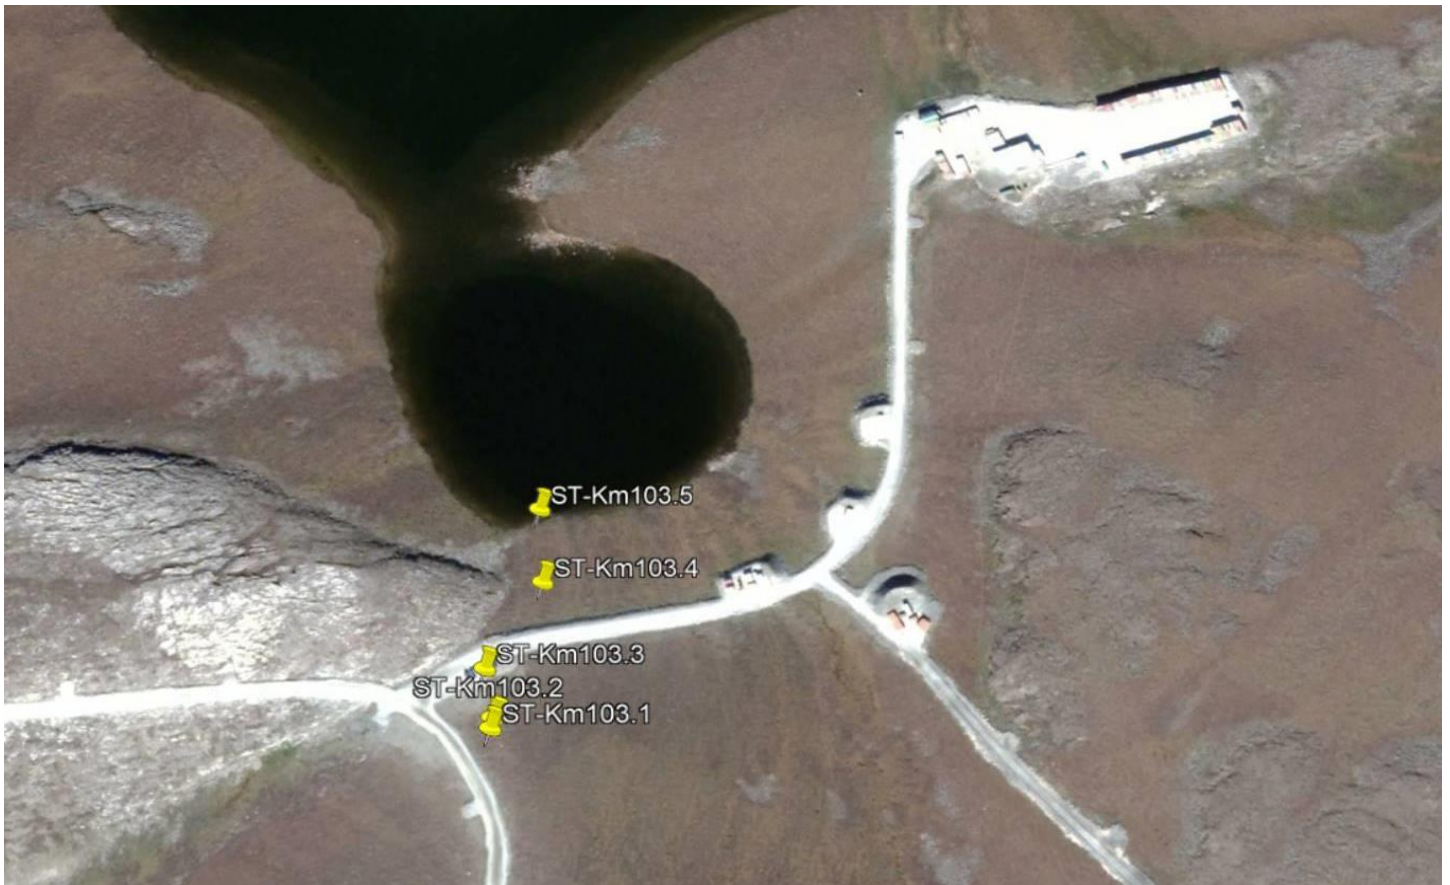
Monitoring measures at the KM 103 spill area were initiated immediately on September 8th and included daily water quality sampling from September 8th – 16th and weekly until freeze-up, visual inspections and soil sampling within the excavated area. Certain initial soil sampling results were not satisfactory, therefore, additional excavation of the soil was initiated on September 26th for the areas identified. Samples were taken following the re-excavation and were again above CCME guidelines for industrial soil. Consequently, further excavation was re-initiated to reach. Soil samples will be collected once excavation is completed, and further remediation may be necessary based on results. Water analysis results demonstrate the spill was well contained in the immediate area and did not reach the lake. Sample analysis results are presented in tables 1 through 4.

Figure 2. EMR Area, Water Sample Location

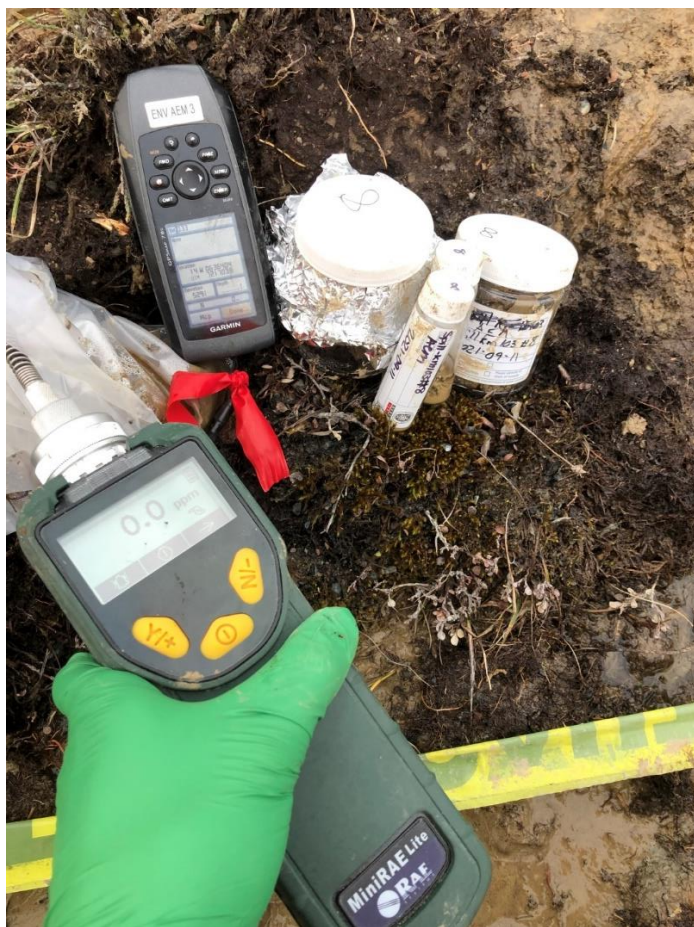
Figure 7. Use of PID and soil sampling following excavation (2021-09-11)

- 425m³ of contaminated soil was excavated on September 11th-12th, and temporarily stored on the Portage RSF, as described in the Landfarm Design and Management Plan. A PID was used to help determine excavation delimitation.
