2021-10-19 MBK 250kg Lead Nitrate

GN reference #: 2021-450

Spill Description

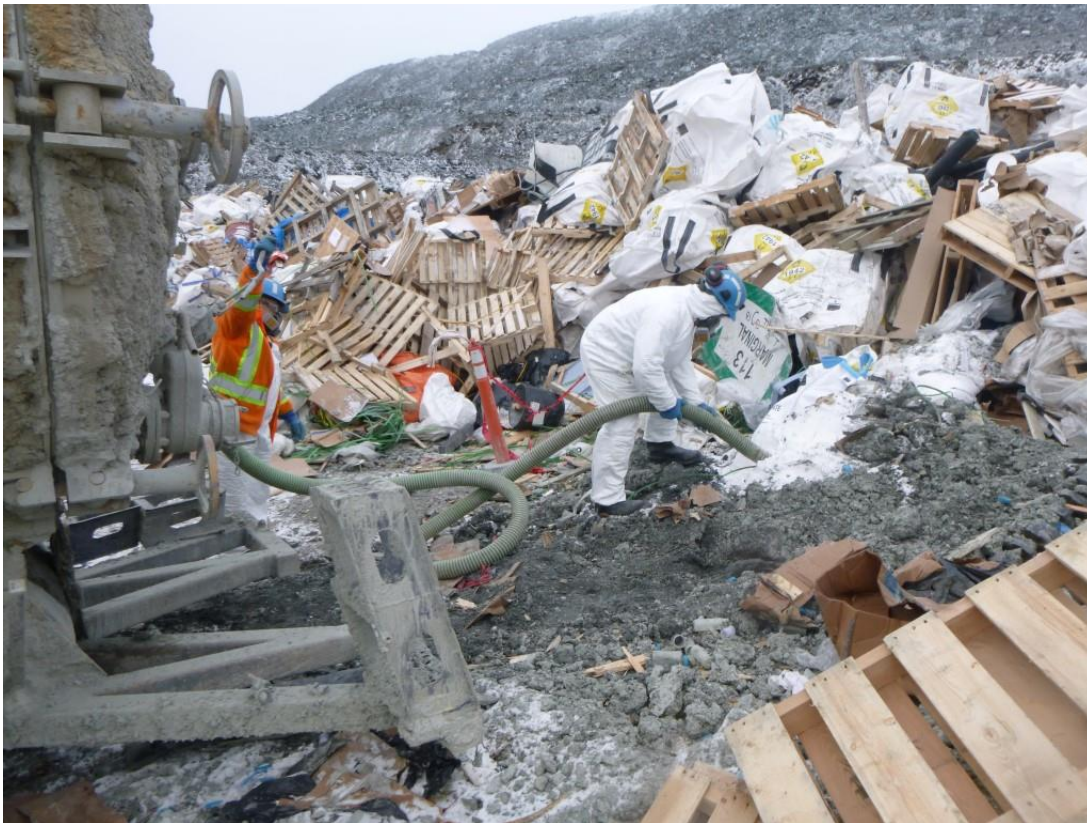
During operations at Meadowbank, a damaged lead nitrate bag was placed into a secondary mega bag to prevent a spill. The mega bag was not properly identified and mistaken for general waste during the next shift and brought to the landfill.

Spill location: 65°1'1.3" 96°03'50" on IOL.

There were no off site impacts or discharge to any receiving watercourses. Distance to the closest water body is 750 meters to Dog Leg Lake.

The dayshift operator advised the supervisor who immediately notified Environment. Mill workers identified the damaged Lead Nitrate bag at the landfill and barricaded the area off. The vacuum truck and excavator were used to collect the spilled Lead Nitrate and brought to the tailings area at Meadowbank where it was buried. The lead nitrate remaining in the original mega bag was brought back to the Mill for use. Approximately 2m3 of contaminated material was buried within the south cell tailings area.
