MEADOWBANK GOLD PROJECT

Baker Lake Bulk Fuel Storage Facility: Environmental Performance Monitoring Plan

In Accordance with Water License 2AM-MEA0815

Version 1 December 2009

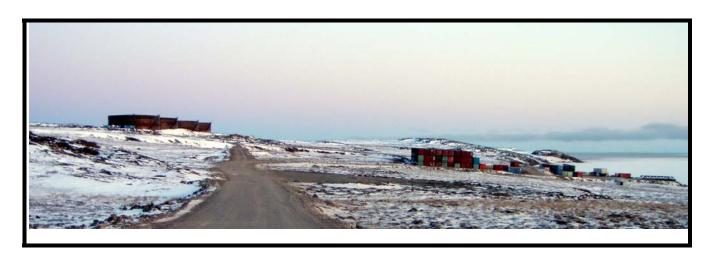
Photo No 1: Bulk Fuel Storage Facility is located up-gradient from the marshalling area and Baker Lake. Note proximity to Baker Lake north shore.

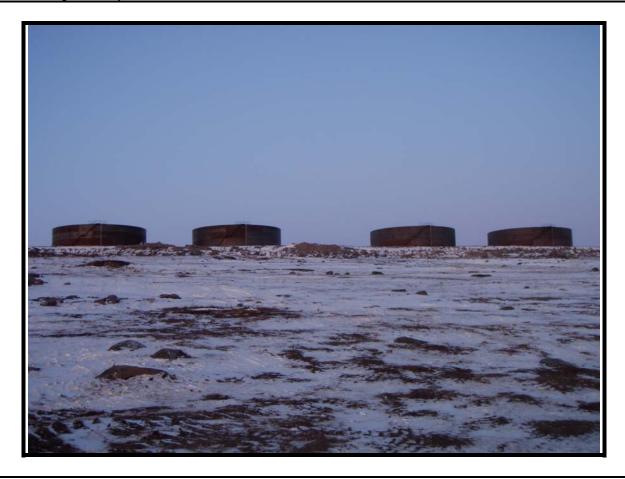
Photo No 2: Photo taken looking north from the Baker Lake shoreline. Note gradient and vegetation / soil conditions between the bulk fuel storage facility and shoreline.

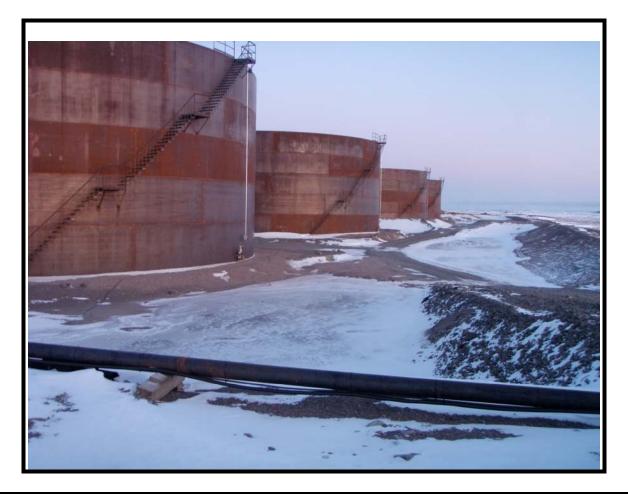
AEM environmental personnel visually inspected the bulk fuel secondary containment structures on October 25th, 2009. At the time of the inspection there were no observed environmental concerns regarding the installation, condition of the secondary containment and the HDPE liner at the bulk fuel storage facility (see photos in Appendix B). Based on construction reports and photos it is evident that the impermeable HDPE liner was installed according to the CCME environmental code of practice (CCME, 2003).

Photo No 3: South side of the Baker Lake bulk fuel secondary containment area.

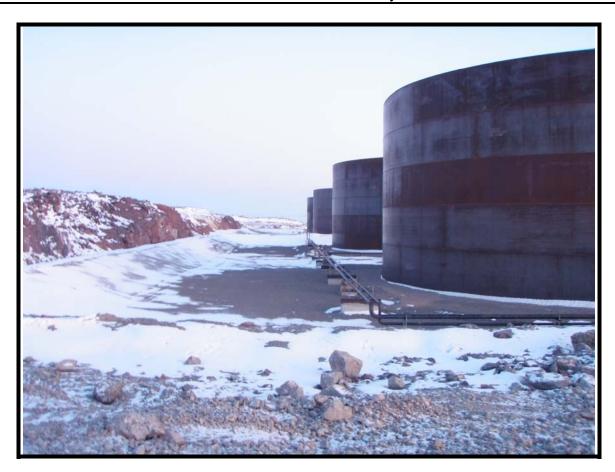
Photo No 4: North side of the Baker Lake bulk fuel secondary containment area.

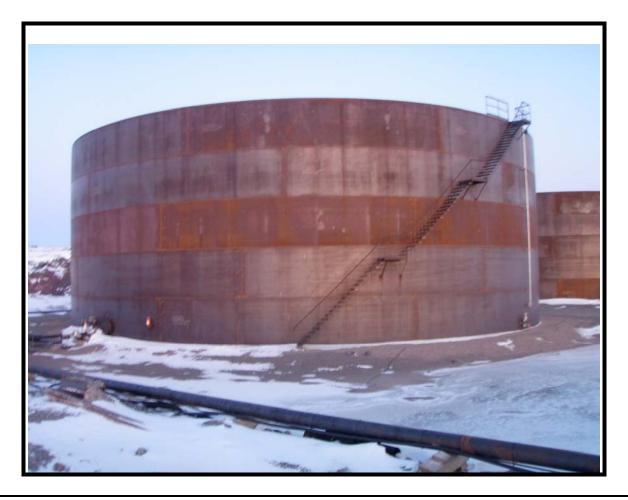
AEM environmental personnel visually inspected the bulk fuel storage tanks on October 25th, 2009. At the time of the inspection there were no observed environmental concerns regarding the tanks, pipes or module installations (see photos in Appendix B). As reported and based on the visual inspection the primary containment structures are functioning as designed.

Photo No 5: Bulk fuel storage tank.

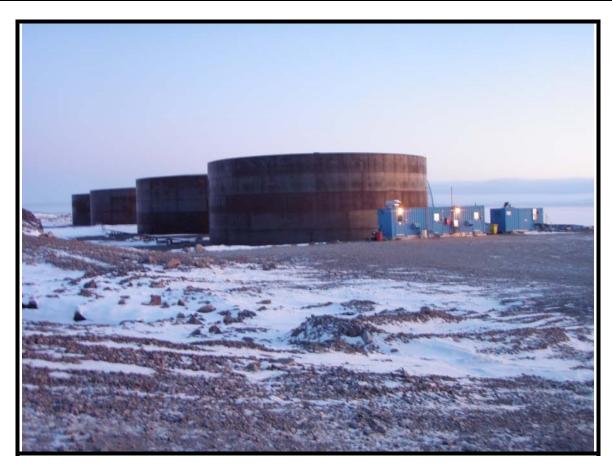
Photo No 6: Baker Lake bulk fuel storage facility – fuel tanks and refueling module.
