MEADOWBANK GOLD PROJECT

Monitoring Program Summary Report

October 2010

Type A Water License 2AM-MEA0815

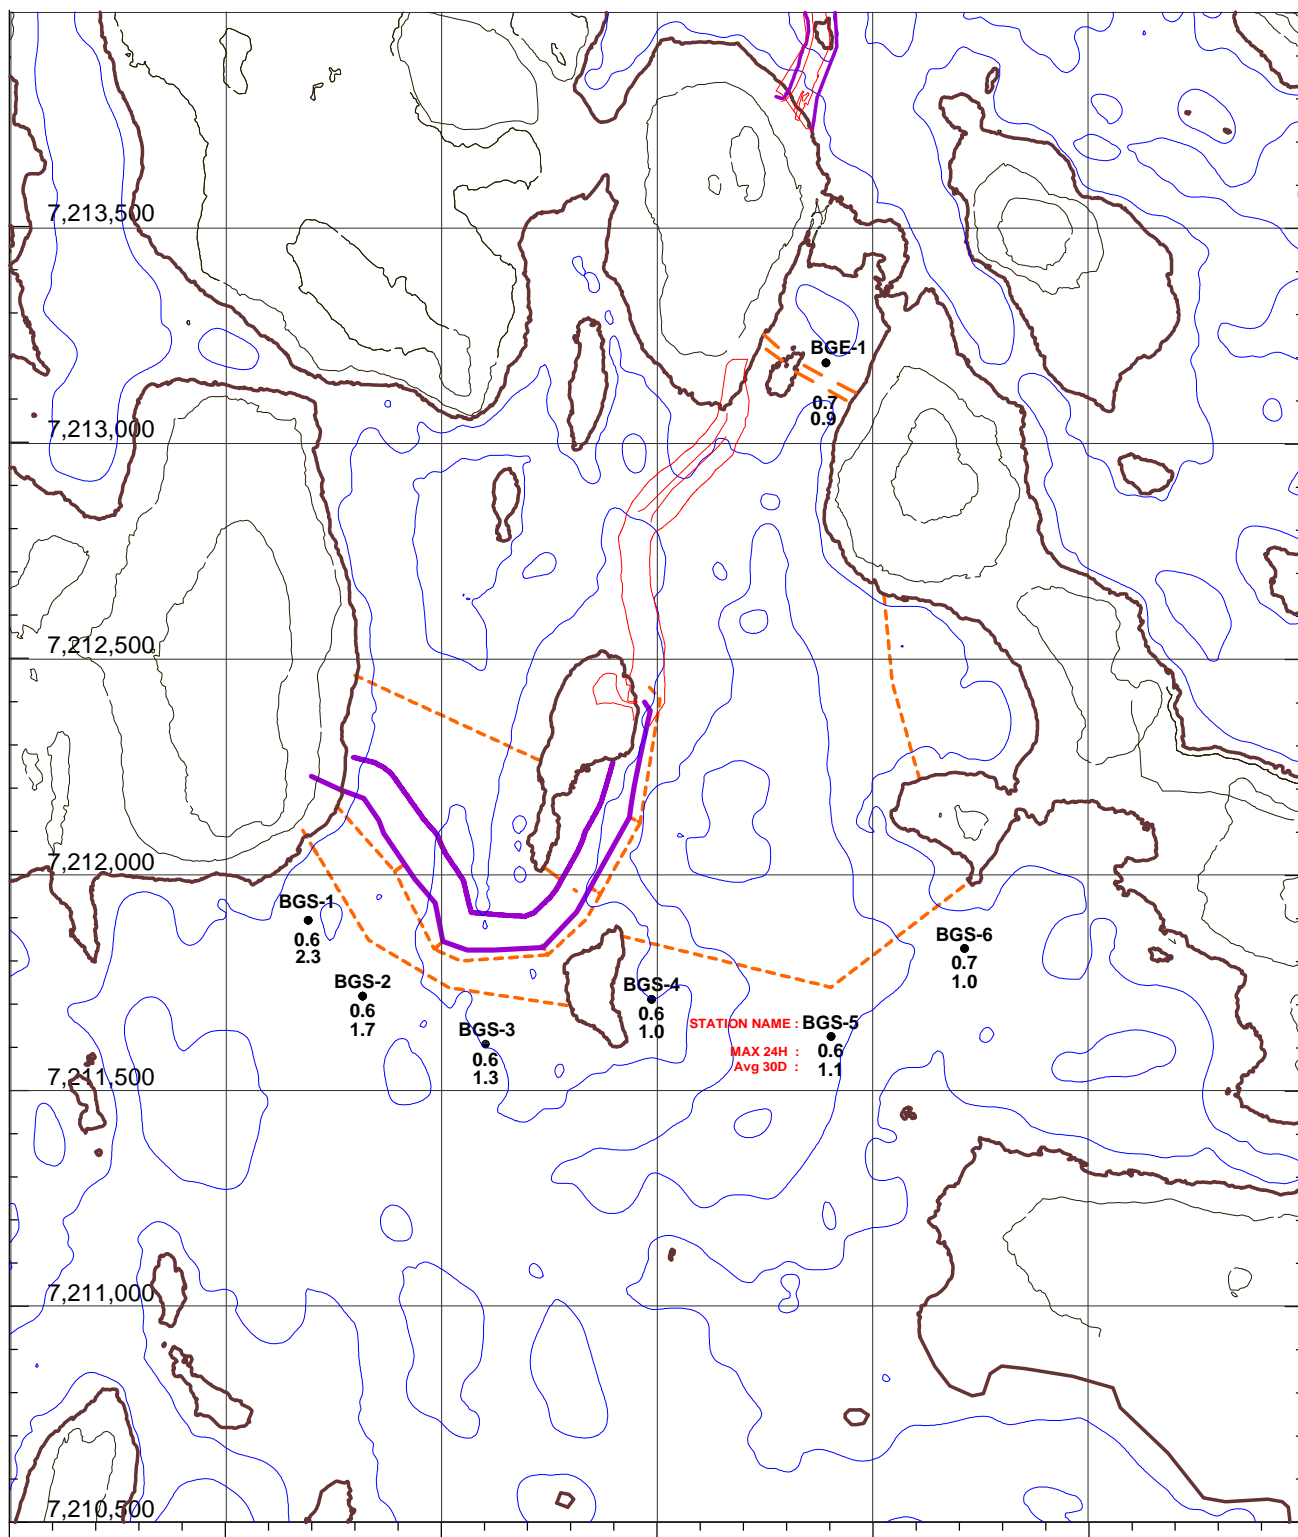
REPORTED TSS IS THE MAXIMUM VALUE ALONG THE PROFILE

TURBIDITY-BASED ESTIMATES OF TOTAL SUSPENDED SOLIDS
(TSS in mg/L)

BAY-GOOSE DIKE CONSTRUCTION

TSS MONITORING DURING CONSTRUCTION

The October 2010 dike construction monitoring results are provided in Table 2.5 and the station locations are shown on Figure 1.

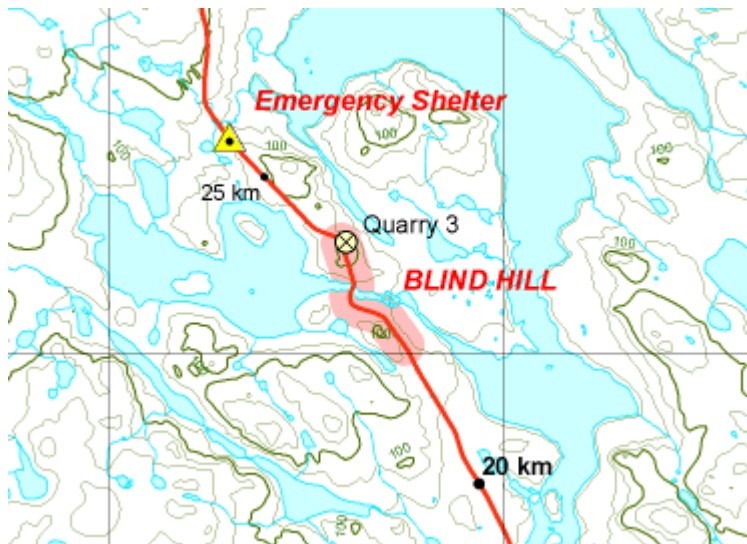
Wednesday, October 16 at 4:45 AM, due to slippery condition on the road, a tanker truck hauling fuel from Baker Lake to Meadowbank mine site rolled over off the road (Photo No 1) just after bridge #3 and just before Quarry 3 at KM 22 (N 64 30 019, W 096 07 451, IOL land parcel BL 18). The tanker truck was hauling 40,000L of diesel fuel to site. The vehicle is owned by AEM however the drivers are under contract with Arctic Fuels in Baker Lake. The tank was damaged on a rock and the fuel was leaking on the ground.

Spill occurred approximately 80 meters north of unnamed river on a hillside with a downward slope of 10-15% towards the river.

AEM emergency response team and the environmental staff arrived immediately on-site (7:00 am) to contain the spill. AEM caught the diesel building a berm and with two ponds lined with tarps (photo No 2). One pond to recover the fuel directly where is escaping from the tank and another at 35 meters down

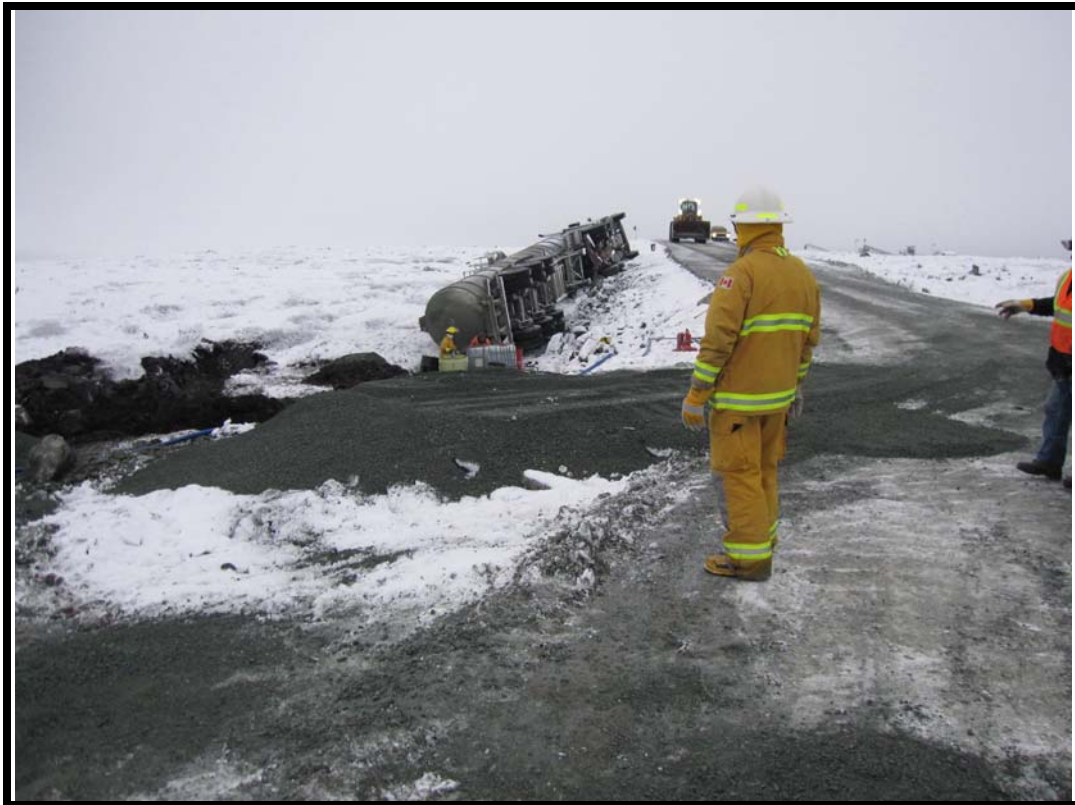
Photo No 1: Accident of a tanker truck of 40,000L of fuel. The truck rolled over on the road's side.

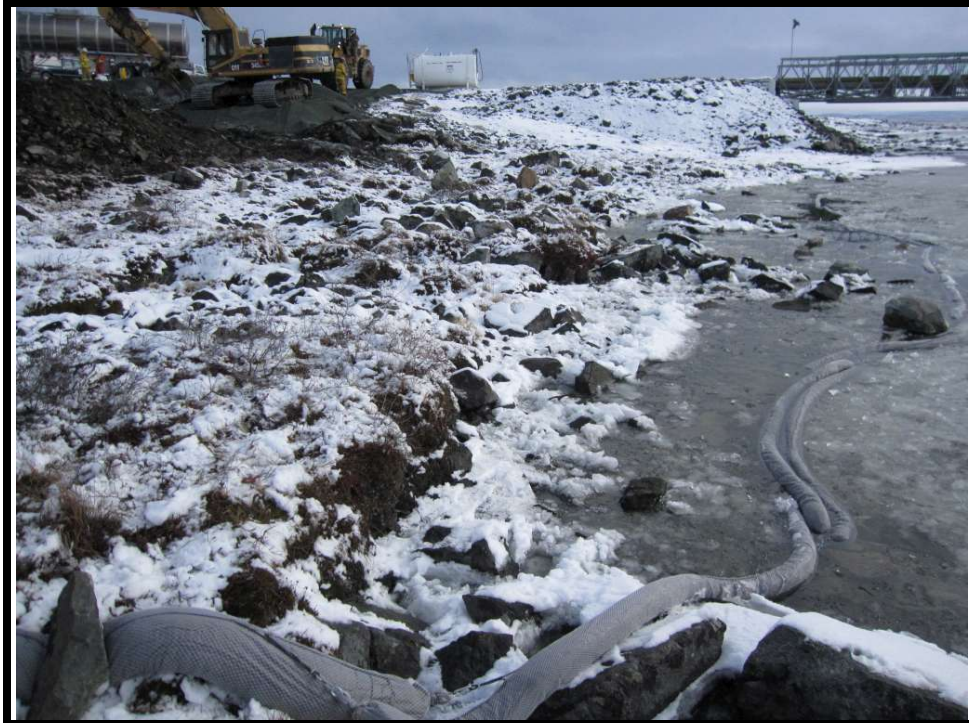
Photo No 4 : Booms installed in the river to prevent the river contamination.

slope from the leak before it can reach the water in the river. Booms were installed in the river, five meters from the shore by prevention (photo No 4). We installed two pumps, one in each pond. The liquid pumped from both ponds was transfer directly in another tanker truck of 40,000 L (photo No 3). With this method, we estimate that 37,000 L of fuel was recovered. Therefore approximately 3,000 L were spill in the environment. We begun to excavate the contaminated soil during the afternoon and 210 tons of material was removed and store in the quarry #6. We observed then we have around 30 to 60 centimetres of overburden and the contamination run directly under the soil to infiltrate the fractured bedrock. A fault caught the majority of the product. The second pond was made to stop the progression of the fuel in that fault. In total 48,000 litres of fuel and water has been pumped during that first day of intervention (photo No 6). The tanker was moved from the accident site around 18:00.

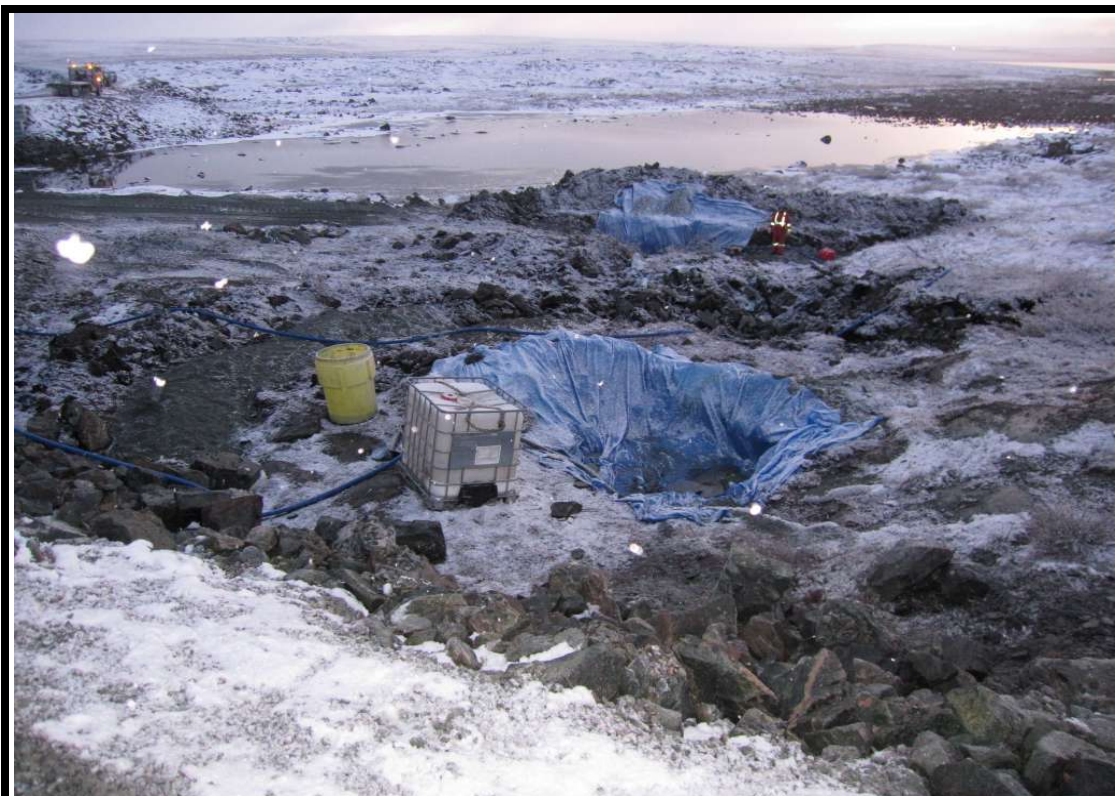
Photo No 5 : General view at the end of the first day of the intervention. The area of the spill was secured.

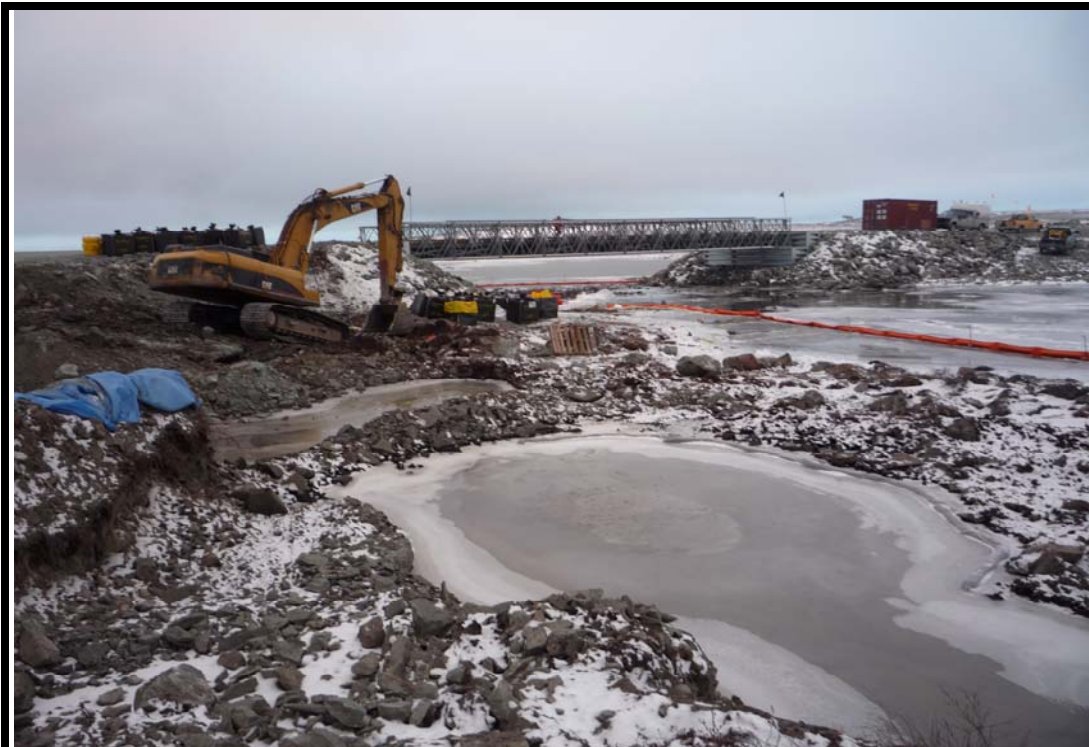
Photo No 9 : Beginning of the excavation between the bridge abutment and the first ditch.

Thursday October 14, we began to remove the material in the area near the abutment of the Bridge 1 (Photo No 9). The material not contaminated was put back into the Northeast wall of the large excavation. A ditch was done between the abutment of the bridge and the first ditch. We began to excavate and reach the water, odours of fuel are noted. A small sheen is noted under the bridge, recuperated with booms.

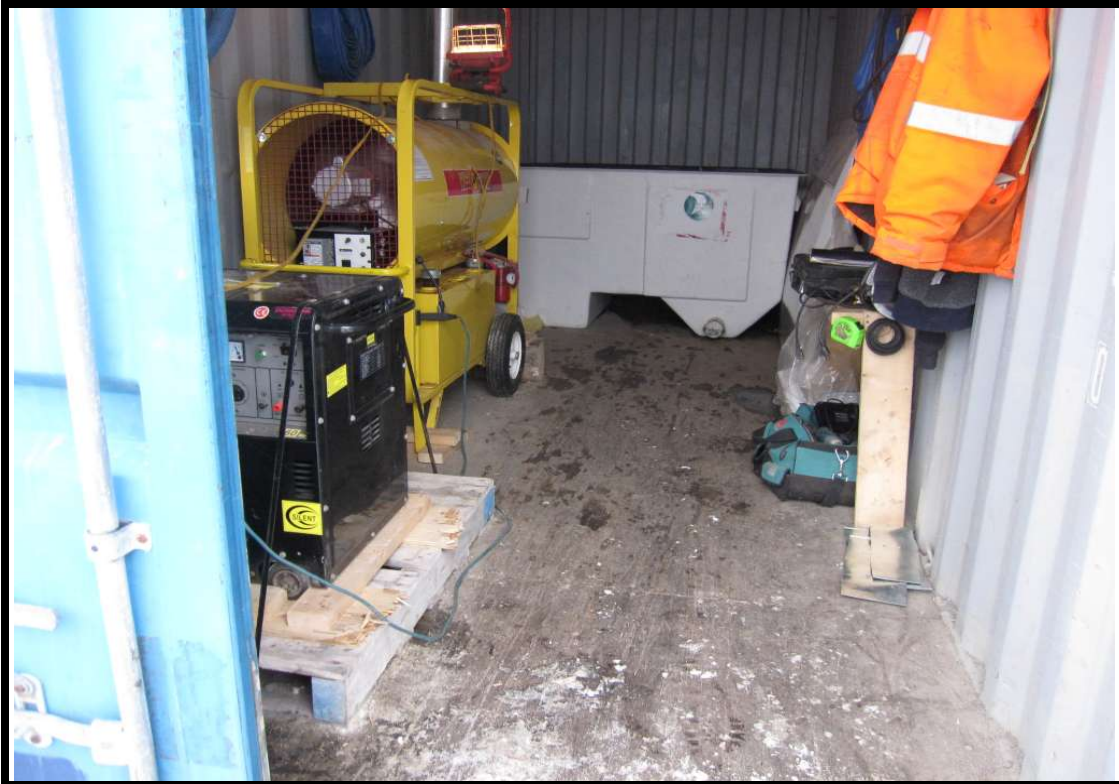
Photo No 11 : Inside the heated seacan where the oil separator is installed.

Thursday October 21 to Monday 25, AEM work to build a water treatment. An oil separator installed inside a heated seacan will recover the contamination (photo No 11). To avoid having an effluent, the water needs to be conserving inside the excavation done. The water will be pump in recirculation, passing through the oil separator and returning inside the ponds.

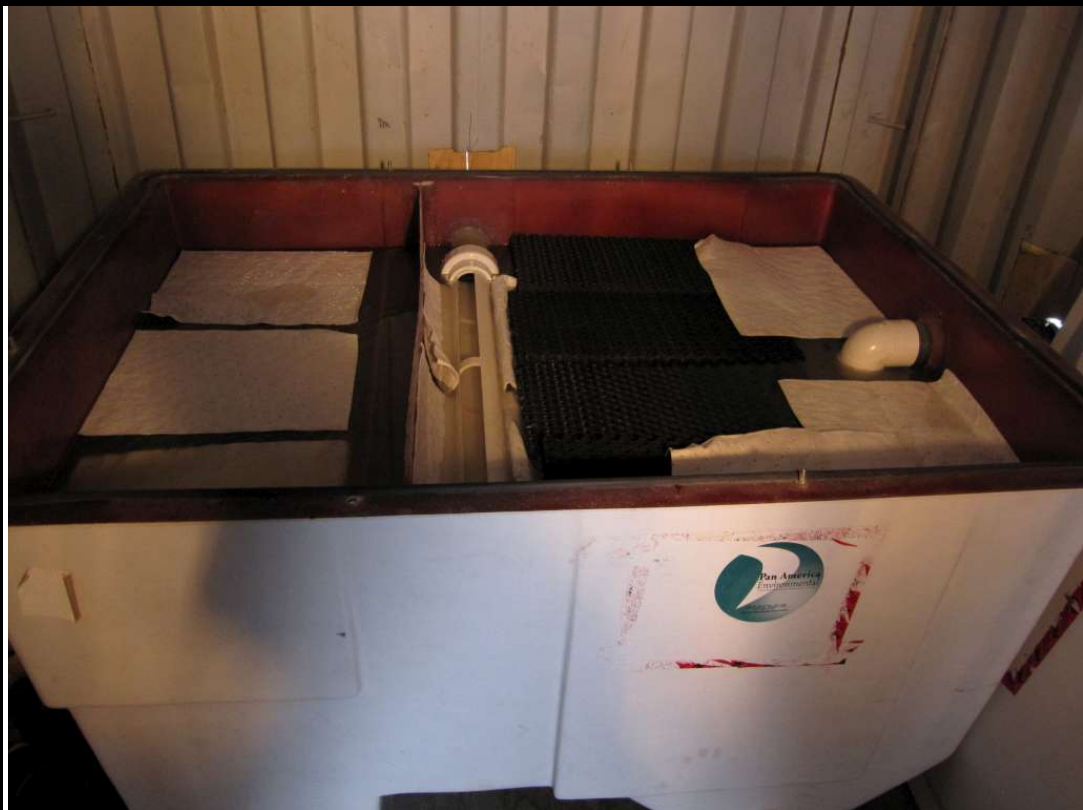
Photo No 12: Absorbents pads placed in the oil separator to help the contamination recovery.

On Monday we observed that the treatment of the water is slow but efficient. We apply absorbents pads inside the oil separator and in the ponds inside the excavation to accelerate the recovery (photo No12 and No 13).
