MEADOWBANK DIVISION

Monitoring Program Summary Report

November 2013

Type A Water License 2AM-MEA0815

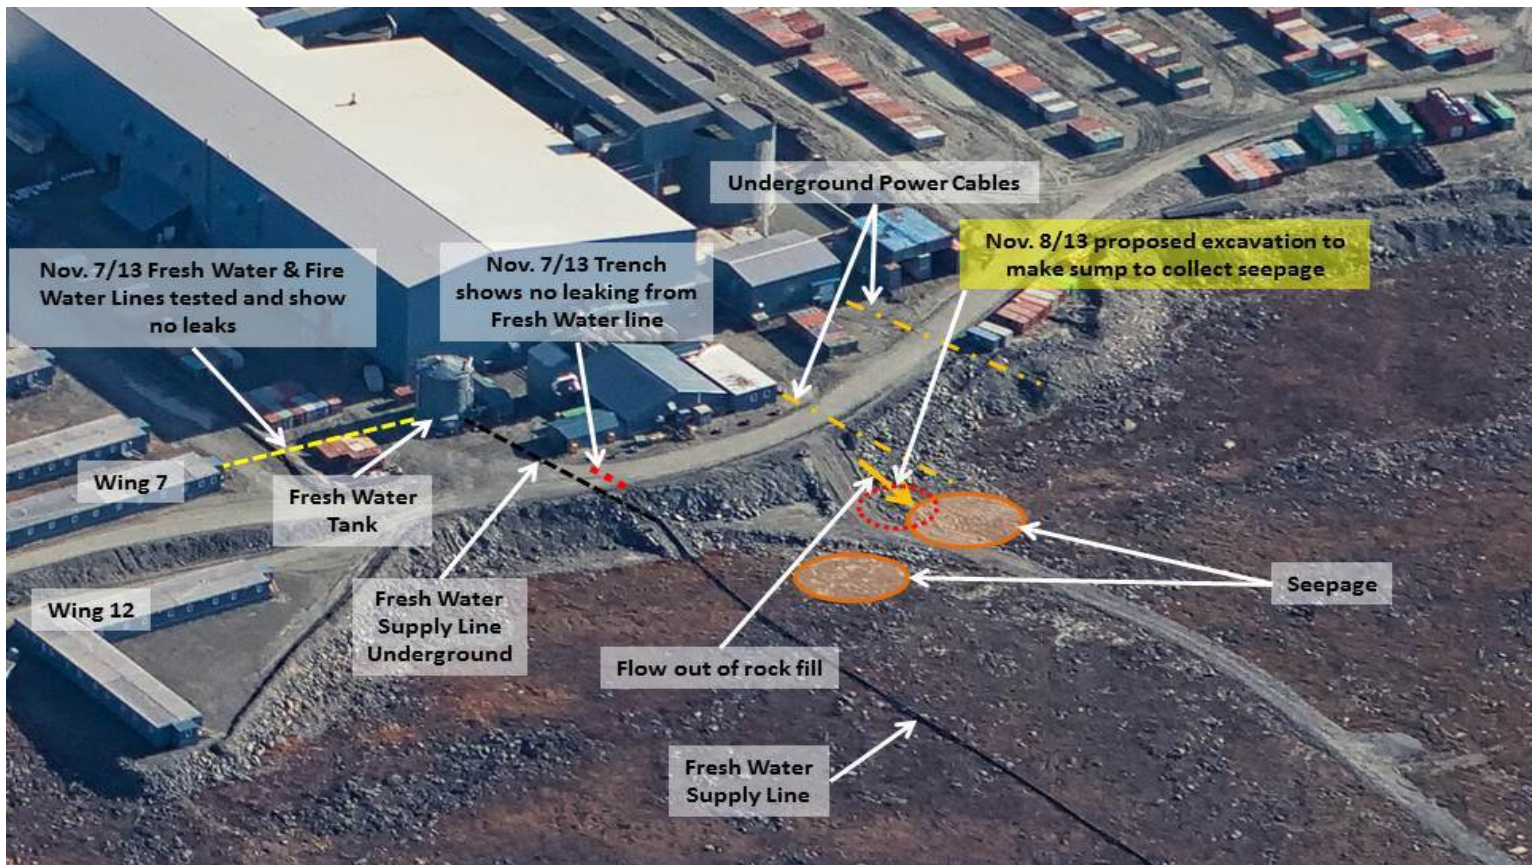
Area of Concern

- Meeting held with Mill staff, Env, and Manager to try to determine source The following was checked; leach pad (appears to be no leakage), reclaim and tailings line (no apparent leaks). Determine there is a two inch sump line from Assay Lab to mill, new underground freshwater drain pipe, and freshwater line from lake goes under road; freshwater line to camp in same area as fire protection line.

- Senior Env Tech determines seep still evident. Meeting held with Mill, Mine, Env, Manager. Mill reports that there is no leakage from Assay Lab sump line. Will test freshwater overflow pipe. Env to sample seepage for Copper, Iron, CN – to be submitted to on and off site labs. Possibly excavate freshwater line Nov 7 to check for leaks depending on overflow line test.
- Freshwater drain checked for leakage with flow test – appears to be no leak. Investigation to continue Nov 7 with check of Fire Protection water line and fresh water line from barge for leakage.

- Meeting held – 0930 – Site Service, Power Plant, Mill, Env, Mine, Manager. Excavation around freshwater line will commence, JHA will be done. To determine if freshwater is leaking out.
- Env to submit samples to Multi Lab – Cu, Fe, CN Total of seep and leach tank overflow – RUSH analysis requested.
- Pressure test on fire protection line near freshwater tank at mill – no leakage confirmed by SS. Also testing freshwater line to camp.

- Freshwater line to camp checked no leakage found
- Meeting held – 0900 – Site Service, Power Plant, Mill, Enviro, Eng., Mine, Manager.
- Installation of containment to hold back any further seepage from migrating forward – joint effort between S.S., Mine, Enviro, Eng., also electrician present to watch utilities.
- Once containment is in place delineation of seepage source to take place. This will not take place without input from all associated departments. Meeting will take place shortly after containment is finalized.

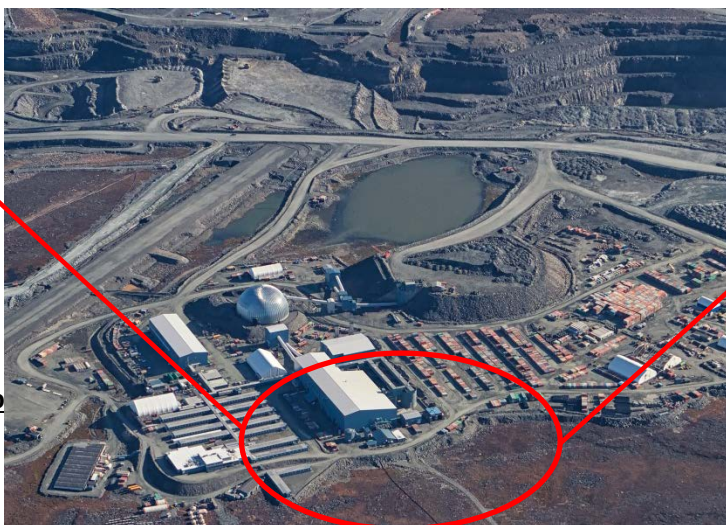
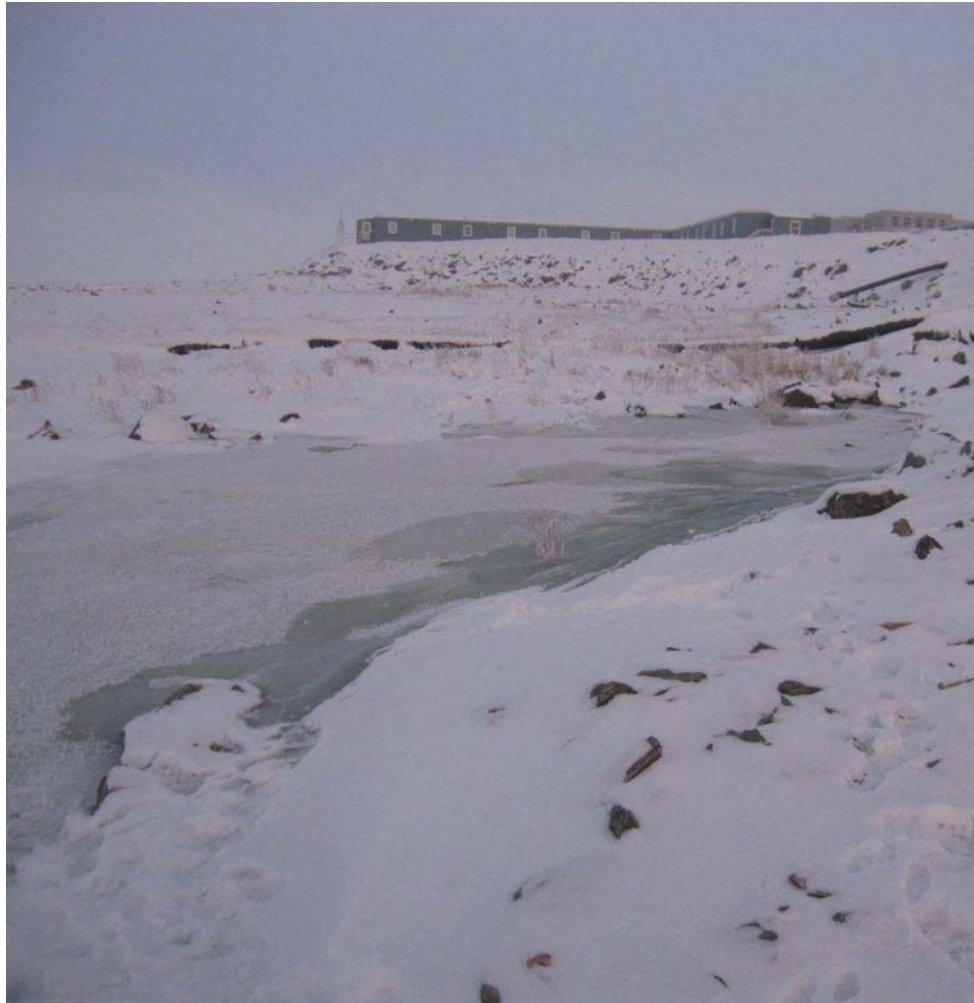
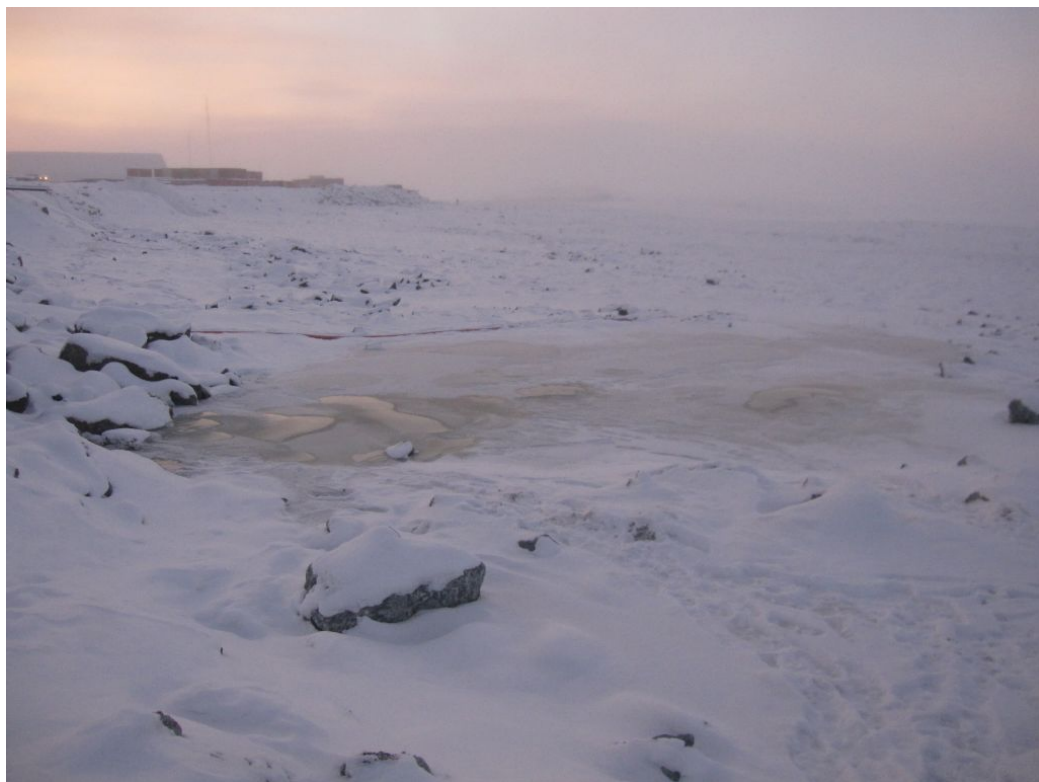
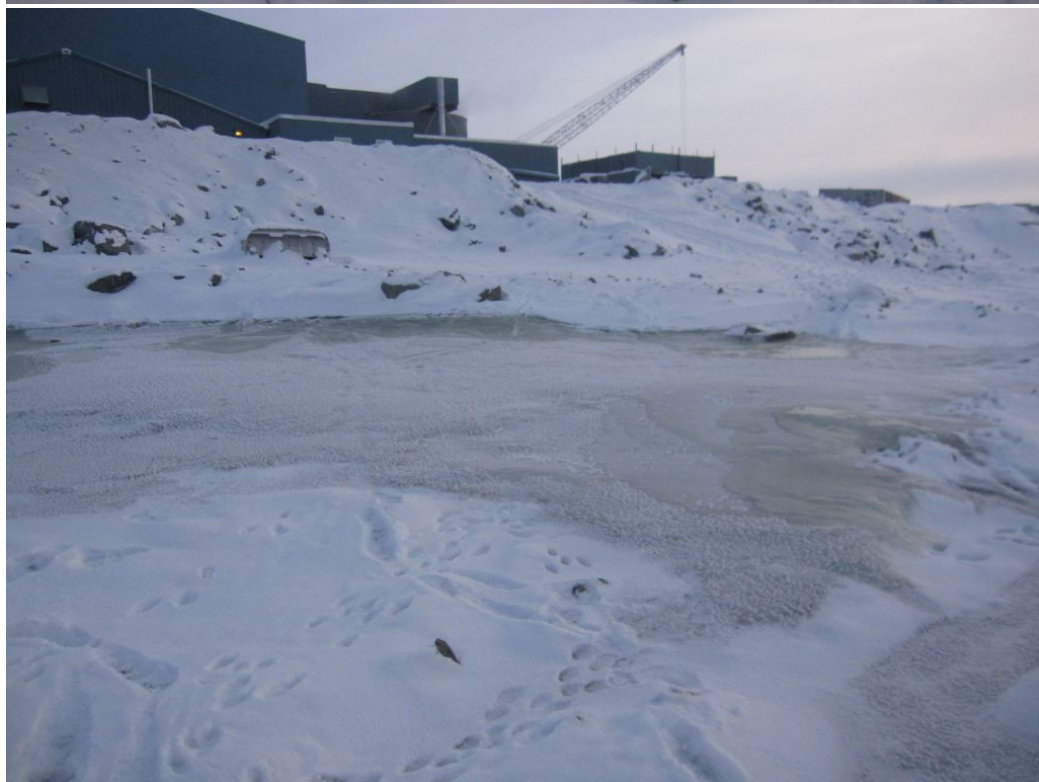
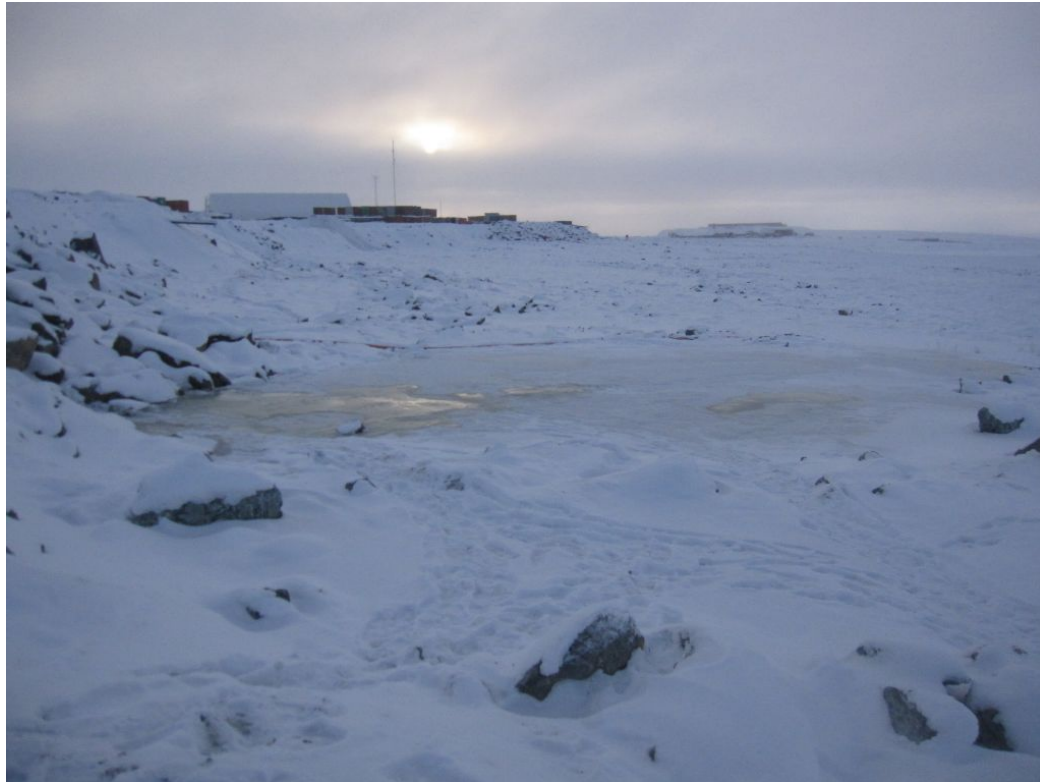
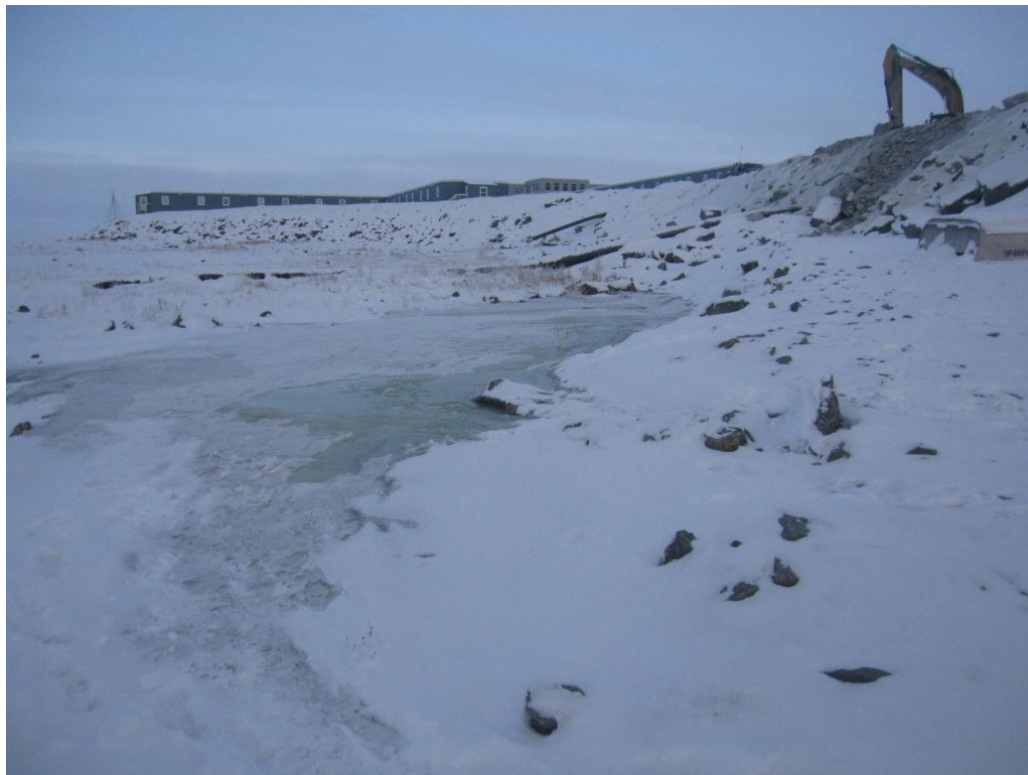
Photos of Area Mo

On November 4th, 2013, it was observed that water was seeping thru the road in front of the Assay Lab Road. After investigation, it was determined that the seepage was coming from the process plant (due to the presence of CN, Cu and Fe in sample analysis results). On November 8th, the discharge of seepage was reported to Government Agencies. On November 12th, AEM sent spill report update #1 and #2 to Government Agencies and on November 19th, AEM sent spill report update #3. Sample monitoring indicates that no contamination has reached Third Portage Lake. Please refer to the spill report and update #1 to #3 for more information (Appendix 3). No more seepage has been visible since November 24th. On November 28th, AEM held a meeting with the Baker Lake council to provide an update on this situation.

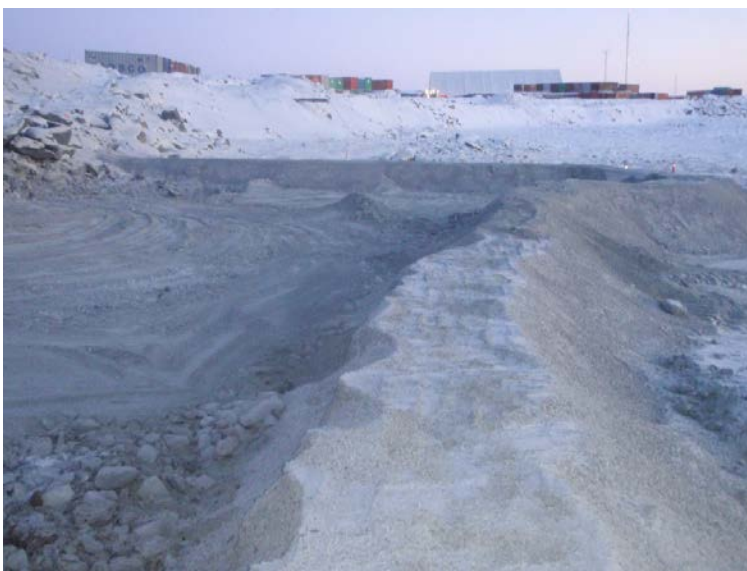
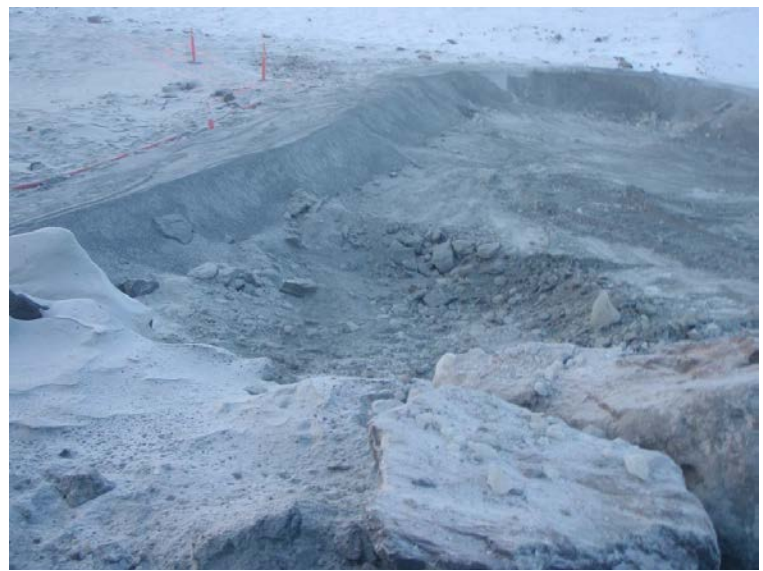
This letter is intended to give an update to the spill report that was submitted on November 8, 2013. This spill report is GN Spill Report 13-379.

- No material has reached lake
- Confirm spillage is from the process plant due to CN analysis on site – CN present, samples sent to off-site accredited lab for analysis – results not available yet
- A bermed area was erected around the area which had the frozen seepage fluid. Once the bermed area was created
- All contaminated ice was removed from the area and was taken to the Tailings Storage Facility
- AEM will continue to remove any build of ice in this area on a regular basis.
- AEM has developed a drilling program to identify exact area of leakage – sources that will be checked include area around leach tank containment (concrete containment), area in front of mill in conjunction with testing of sumps in mill for leakage
- An updated will be provided when drilling program completed

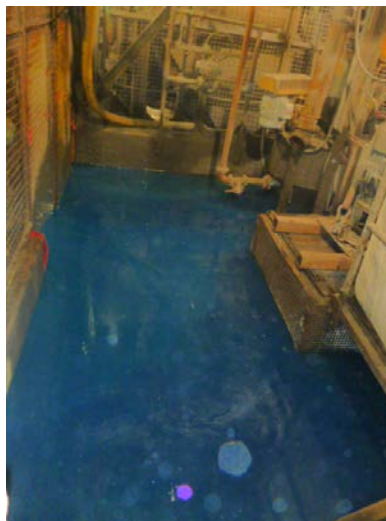
- No process water has reached lake (contain in the berm area)
- Investigations took place through-out the mill area to determine where the source of process water was leaking from
- A drilling campaign took place Nov 15 – 17, with a total of 21 holes being drilled the seep location and the mill area (see figure 1). Out of the 21 holes,
 - 4 holes were wet and sample water was obtained (blue)
 - 4 holes were drilled and wet and no sample could be obtained
 - 13 holes were drilled dry (green)

- To try and determine the source of the leakage, water was added to the sumps with tracer dye within the Mill. By doing this, the location of the seepage was determined to be in the CIP sump.

- The seepage area increased due to the testing of the sumps and water seeped out of the previous reported location as well as an adjacent area at the base of the assay lab road. Another containment berm was immediately constructed, this water was sampled (CN WAD taken at our on-site assay lab = 4.23ppm Copper = 2.55, Iron = 1.64). Please note the attached diagram for reference. Additional samples will be sent to our off site accredited lab on Monday Nov 18. Samples were also taken in Third Portage Lake using AEM's on site assay lab. Results to date indicate "no detect" in the lake. See attached table of sample results and location.
- Crews removed any build of ice in this area and continue to remove it on a regular basis.

- AEM is now working on a plan to properly seal the CIP sump, in the meantime all water has been removed from this sump to prevent any further seepage and allow for repairs.
- The bermed containment area is to prevent access to wildlife and unauthorized personnel.
