**Meliadine Gold Mine**

**Itivia Bulk Fuel Storage  
Facility**

**Environmental Performance  
Monitoring Plan**

**DECEMBER 2022  
VERSION 2\_NWB**

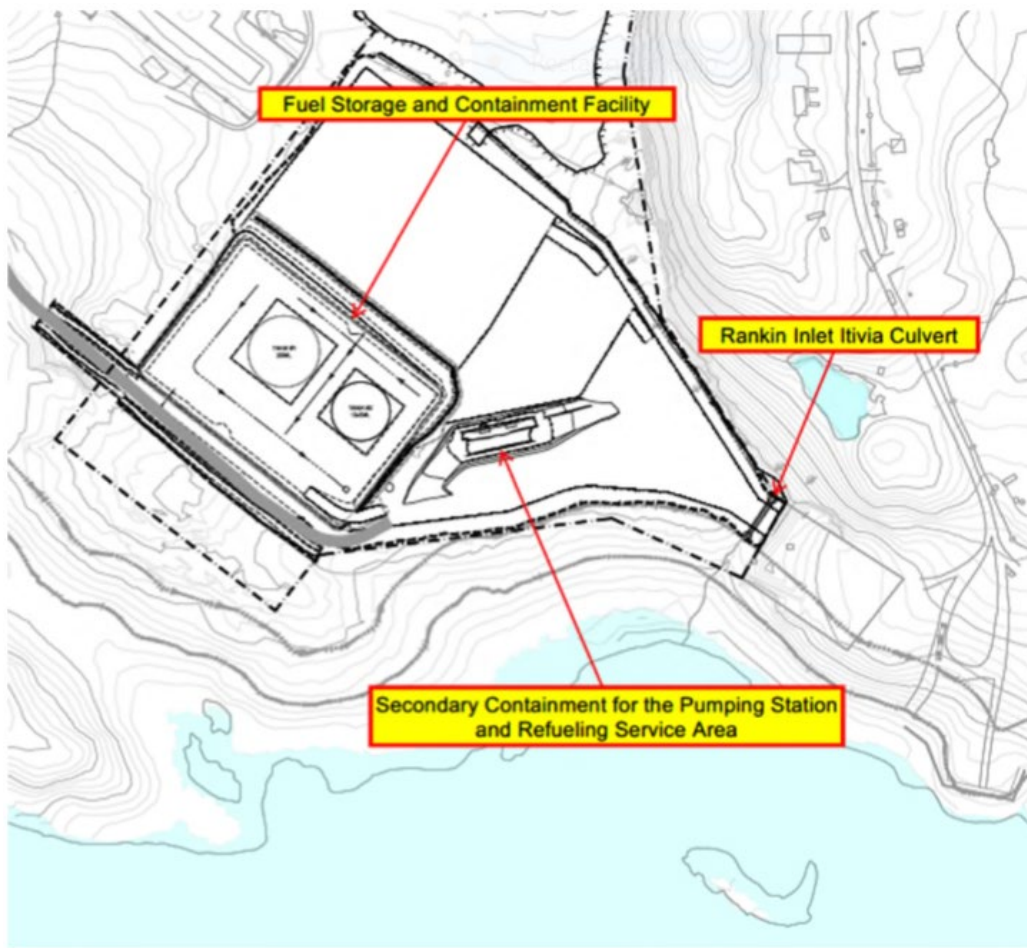
Figure 1: Itivia Bulk Fuel Storage Facility Location Plan

The Itivia Bulk Fuel Storage Facility (the Facility) is located in Rankin Inlet (Nunavut) and consists of two above ground fuel storage tanks, associated containment area and auxiliary facilities. The fuel tanks have a capacity of approximately 20.0 million liter (ML) and 13.5 ML, respectively. The Facility is located at the approximate UTM coordinates (NAD83, Zone 15) 546070 E and 6963760 N; Figure 1 below presents the general site location plan.
