Appendix 15 : 2020 Reportable Spills

Appendix F-3
Reportable Spills and Follow-up Reports

Follow Up Report: #20-010

January 14, 2020 Hydraulic Oil Spill

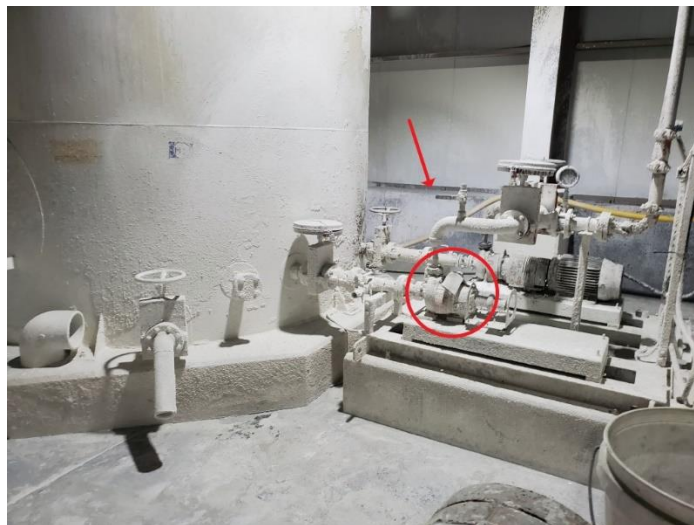
On January 24th the Environment Department was contacted by a worker at the Process Plant informing that 50 L of 20 % liquid calcium hydroxide had spilled to the ground. A dosing pipe seal ruptured on a pressurized line, causing the solution to spray onto the interior wall of the process plant above the concrete secondary containment. As the solution flowed down the aluminum cladding walls to the concrete containment, some seeped out between the cladding and the concrete, which then flowed onto the industrial pad.

Figure 2: Calcium Hydroxide solution sprayed from the ruptured seal (circled) and seeped out between the cladding and concrete (arrow).

Parts are on order to replace the damaged seal. The pump was removed and reinstalled on the backup dosing line. The installation of spray guards has been recommended and feasibility is being evaluated.

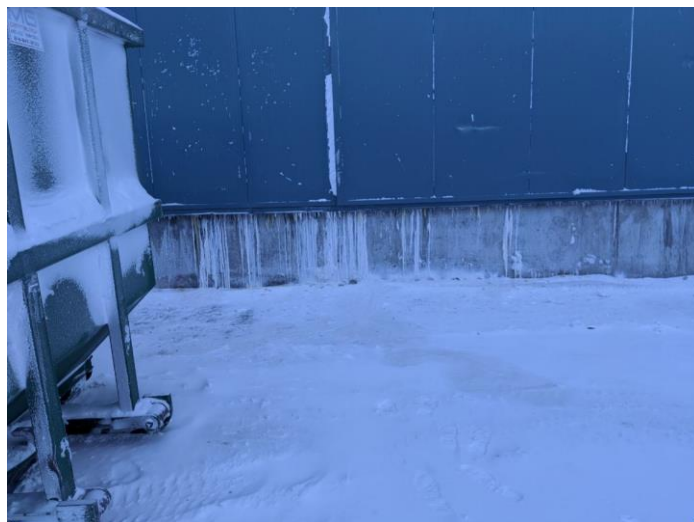
Figure 3: 50 L of 20 % Calcium Hydroxide prior to clean-up.

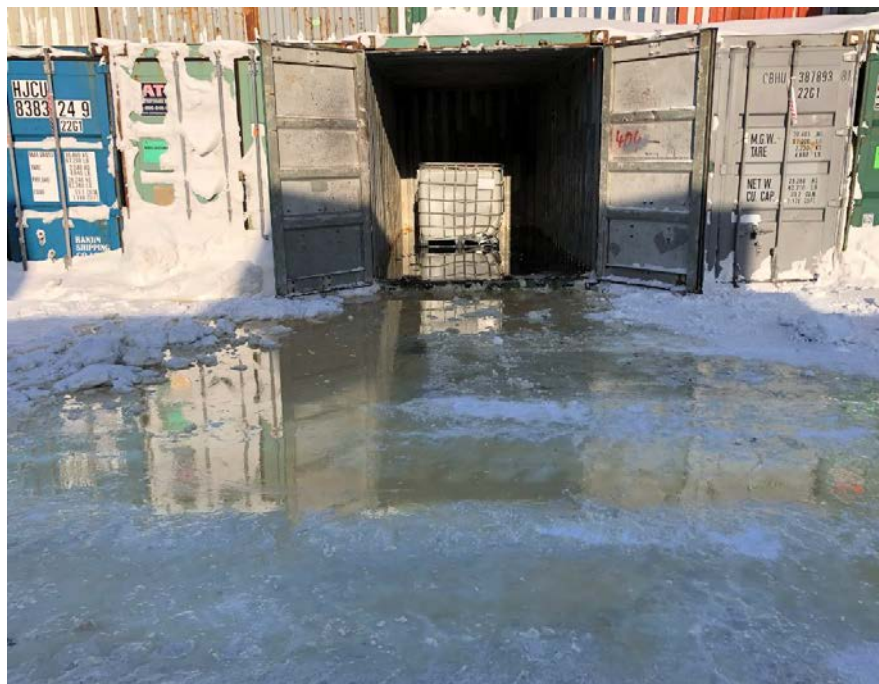
The incident occurred when a warehouse worker was attempting to retrieve a full, 1000 L tote containing engine oil, from inside a sea-can. While attempting to align the equipment's forks into the tote, the operator accidentally crushed and punctured a corner of the tote, which led to the release of the contents inside the sea-can. The tote was located in the back of the sea-can, so a large amount of oil settled on the floor inside, while the rest slowly flowed outside onto the gravel pad.

Figure 1: Spill site the morning of March 9, 2020.

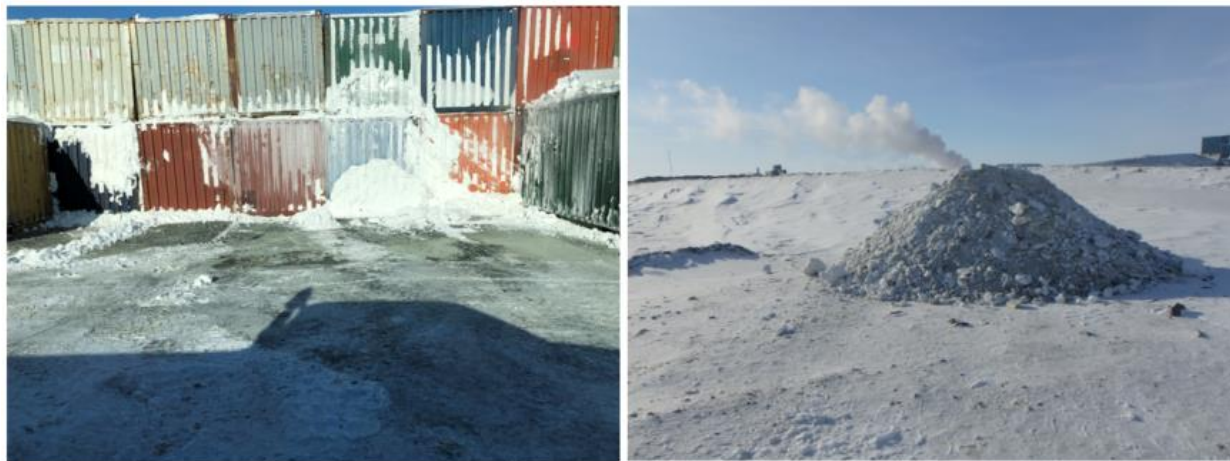
Used absorbent pads and Oil-Dri Quicksorb was disposed of as hazmat in Quatrex bags. Sea-cans impeding the clean-up were removed from the area. A loader was used to scrape the surface and remove 7 m³ of contaminated material from the spill site. The contaminated material was placed in the landfarm.

Figure 4: Initial clean-up of the area after sea-cans removed and loader began removing material (Left). Contaminated material brought to the landfarm (Right).

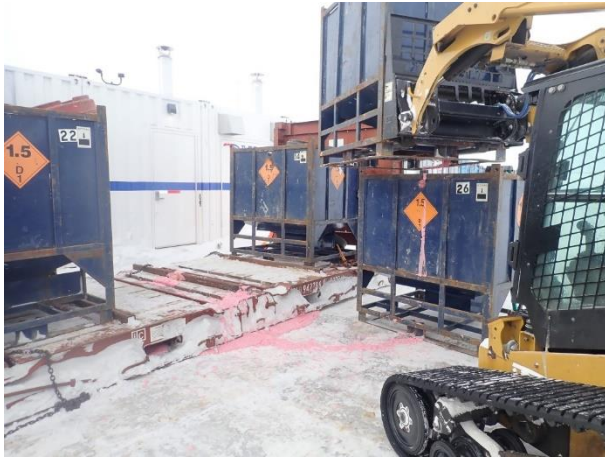
Emulsion plant personnel removed the damaged bin from the flat-rack using a forklift, and drained the emulsion from the damaged bin into another bin (Figure 2). The flat-rack was moved using a hyster, to provide access to the spill (Figure 3). Spilled emulsion was pumped into an emulsion bin for reprocessing and reuse (Figure 4). A bobcat was used to scrape remaining emulsion residue from the ground. This material was brought back into the emulsion plant and neutralized.

Figure 2: Forklift removing emulsion bin from flat-rack.

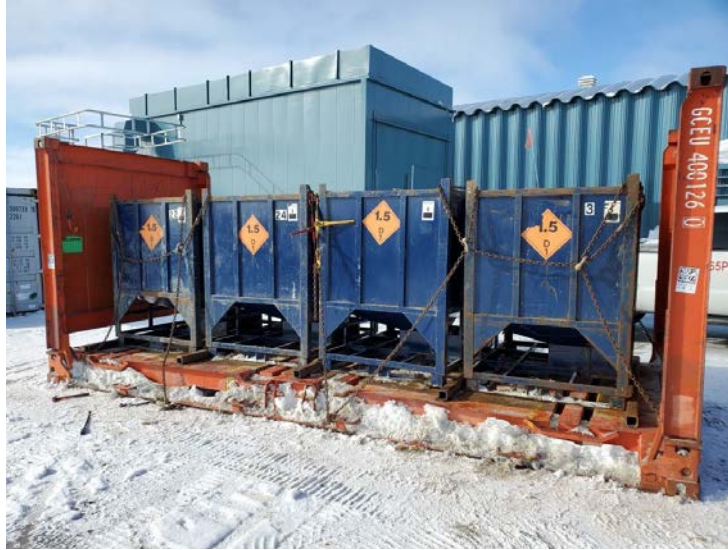
Figure 6: Steel dividers installed to improve visibility during pre-loading inspection.

The Environment Department held a follow-up meeting with the Mine Department and Dyno Nobel (Emulsion Contractor) to discuss the cause and corrective measures. Operators loading and unloading emulsion bins will now require a spotter to ensure forks are correctly positioned under emulsion bins. Flat-racks used to transport emulsion bins between the emulsion plant are now equipped with dividers, to ensure all sides of the bin can be thoroughly inspected prior to filling (Figure 6). Bins must be placed on the flat-rack with valves facing out to provide quick access in the event of a hose connection failure.

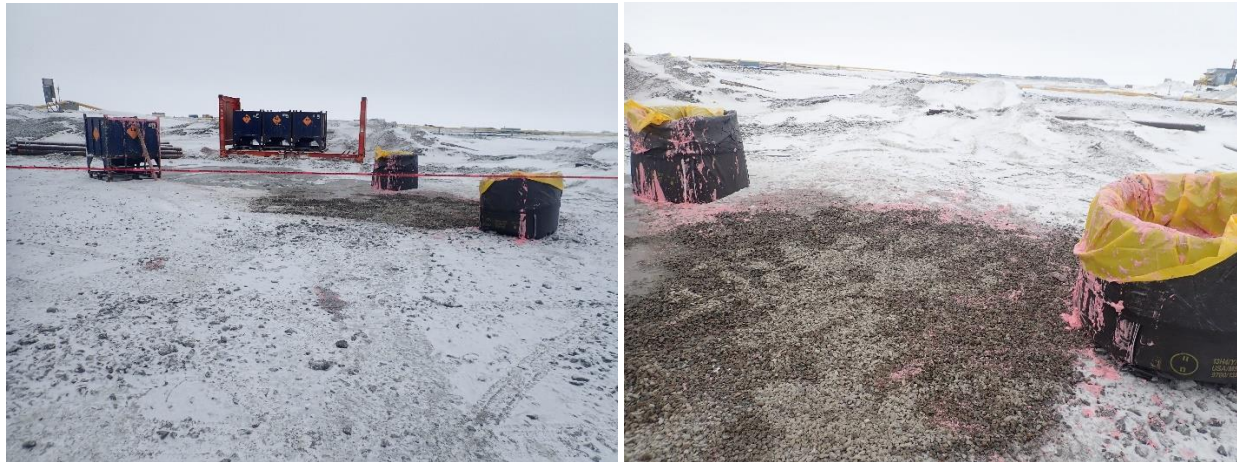
Figure 3: Photos taken at 7:22 a.m. Spill recovery was underway and material was being moved into quatrex bags to be stored at the DYNO Nobel emulsion plant.

The Environment Department held additional toolbox meetings with the underground mine department, to further discuss methods for spill prevention, the importance of using a spotter, and ensuring that loads are secure before moving them. Since this specific incident had the potential to cause injury if there had been a worker next to the bin, this incident was also reported to the Health and Safety Department. Supervisor job task observations are being completed in order to improve the training for this task. In addition, a long-term solution for an improved emulsion handling and distribution system is currently being investigated.

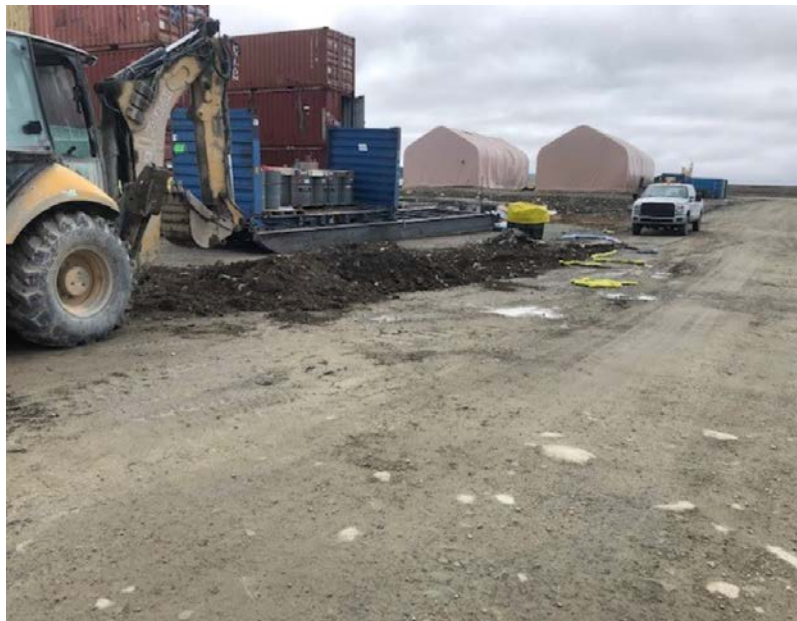
After the water was removed, the back hoe began clearing the contaminated gravel into piles, and a loader was used to transport all of this material to Landfarm A (Figure 3).

Figure 3: Contaminated gravel being removed from Jet A spill area.

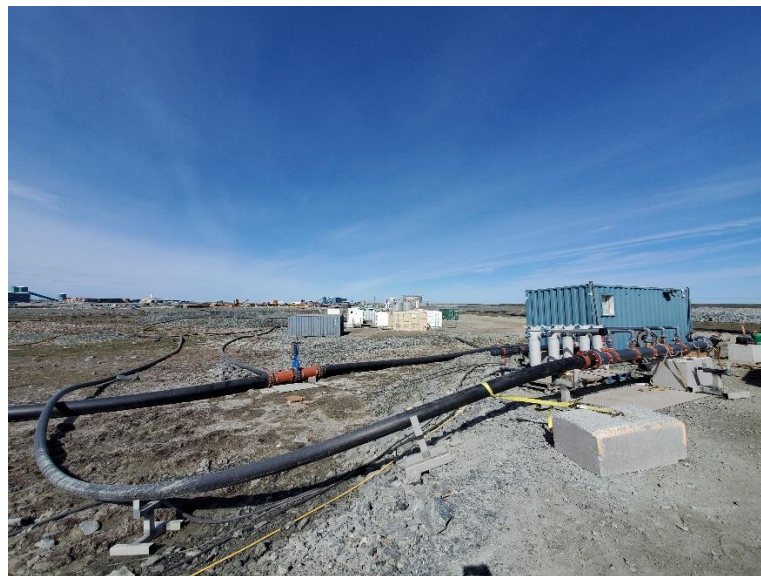
Figure 3: Piping replaced from SP3 to loading station.

The Energy and Infrastructure (E&I) department replaced the piping August 10th and inspected the line before resuming operations. When the line was brought back into service, E&I personnel remained at the point of the spill to ensure that the replaced piping was operating correctly. No issues were observed.

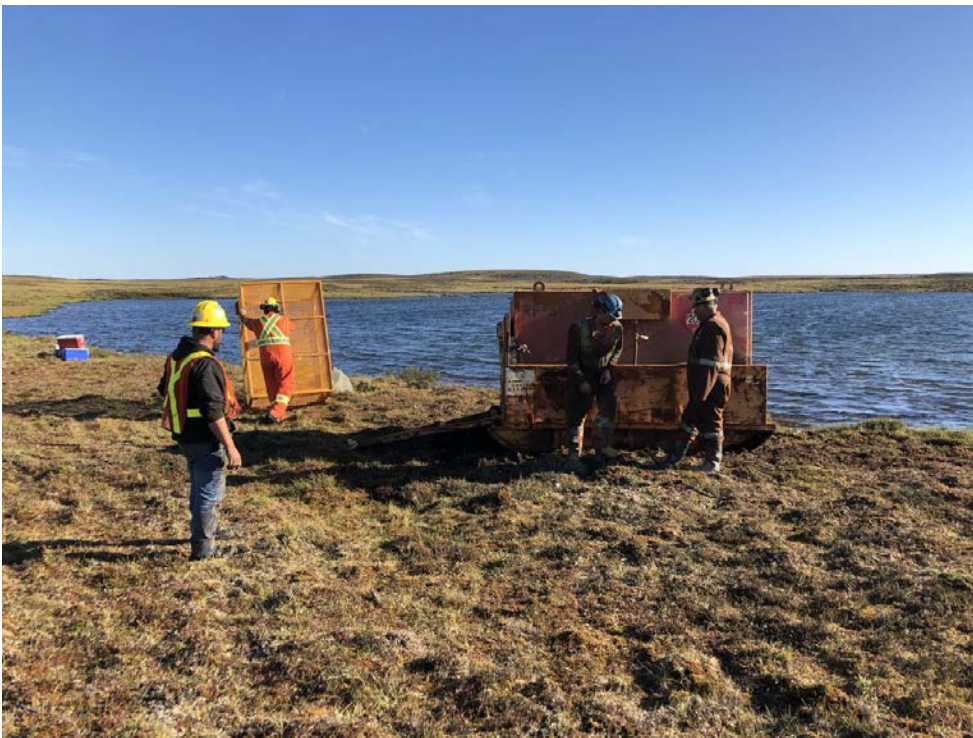
Figure 6. Fuel tank being extracted from the lake

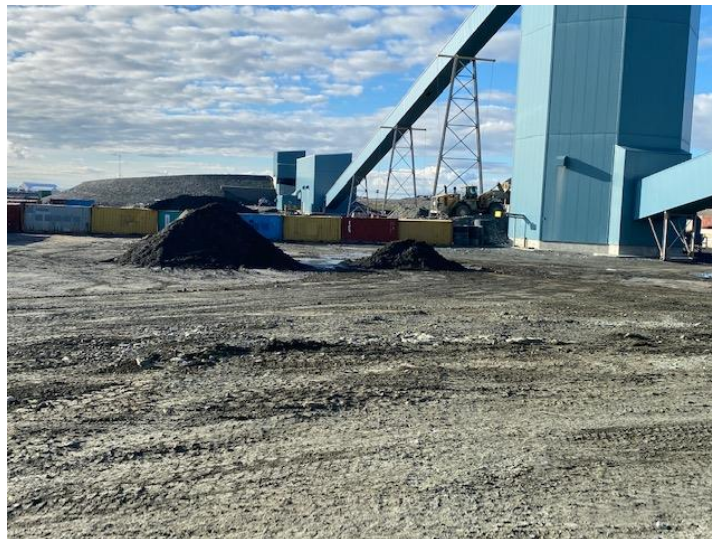
Figure 3: Spilled slurry added to existing ore feed pile for immediate reprocessing.

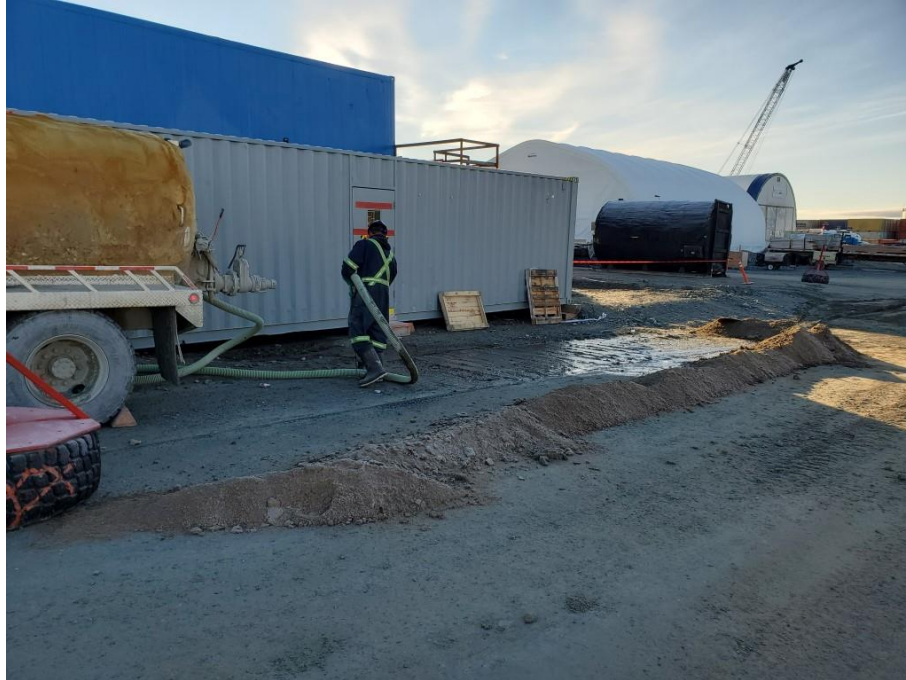
In response to the overflow, the treatment plant operator redirected influent flow to another tank. Effluent contained within the building was removed using a vacuum truck and input back into the system. A soil berm was deployed to isolate the spill at the source (Figure 2). Effluent contaminated gravel on the industrial pad was removed and disposed of in accordance with the waste management plan (Figure 3).

Figure 2: Soil berm deployed to isolate the spill. Vacuum truck used to removed spill material.

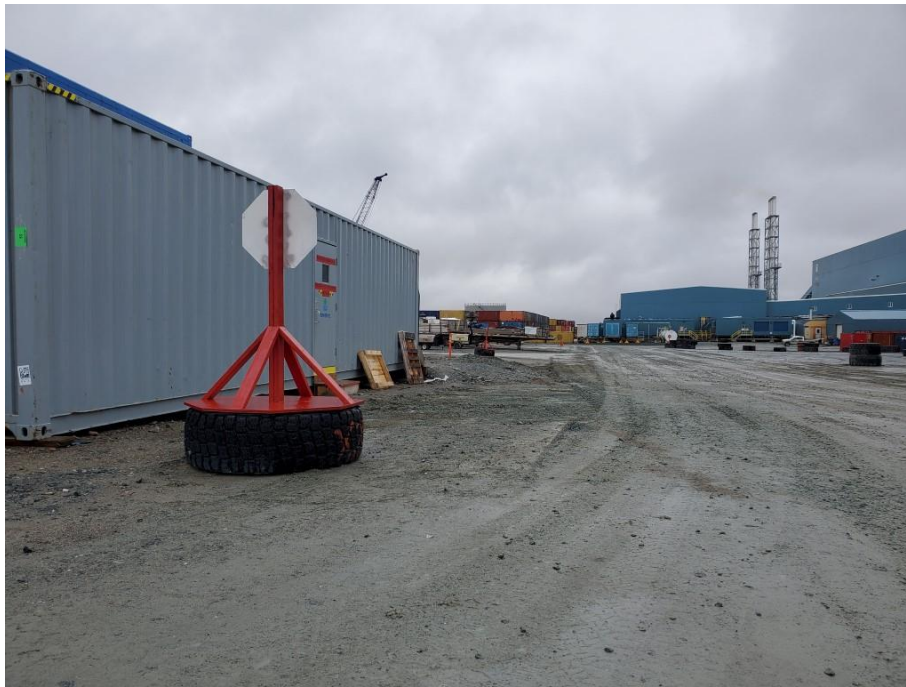
Figure 3: Spilled material and contaminated gravel removed.

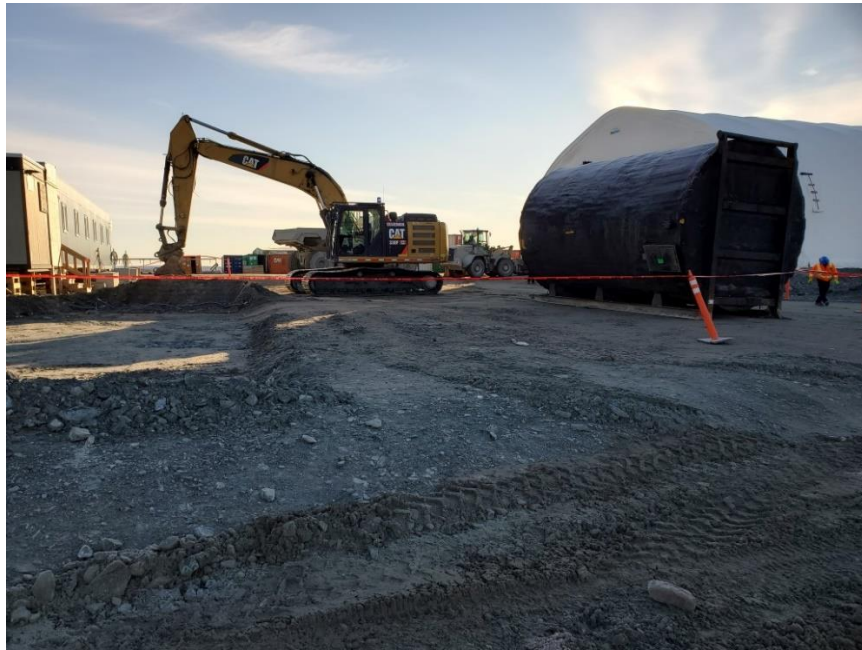
Figure 4: Construction of pad for addition of new equalizing tank.

to the spill. System upgrades are in progress and include the addition of a larger equalizing tank, which will improve capacity and reduce the chance of overflow events (Figure 4).

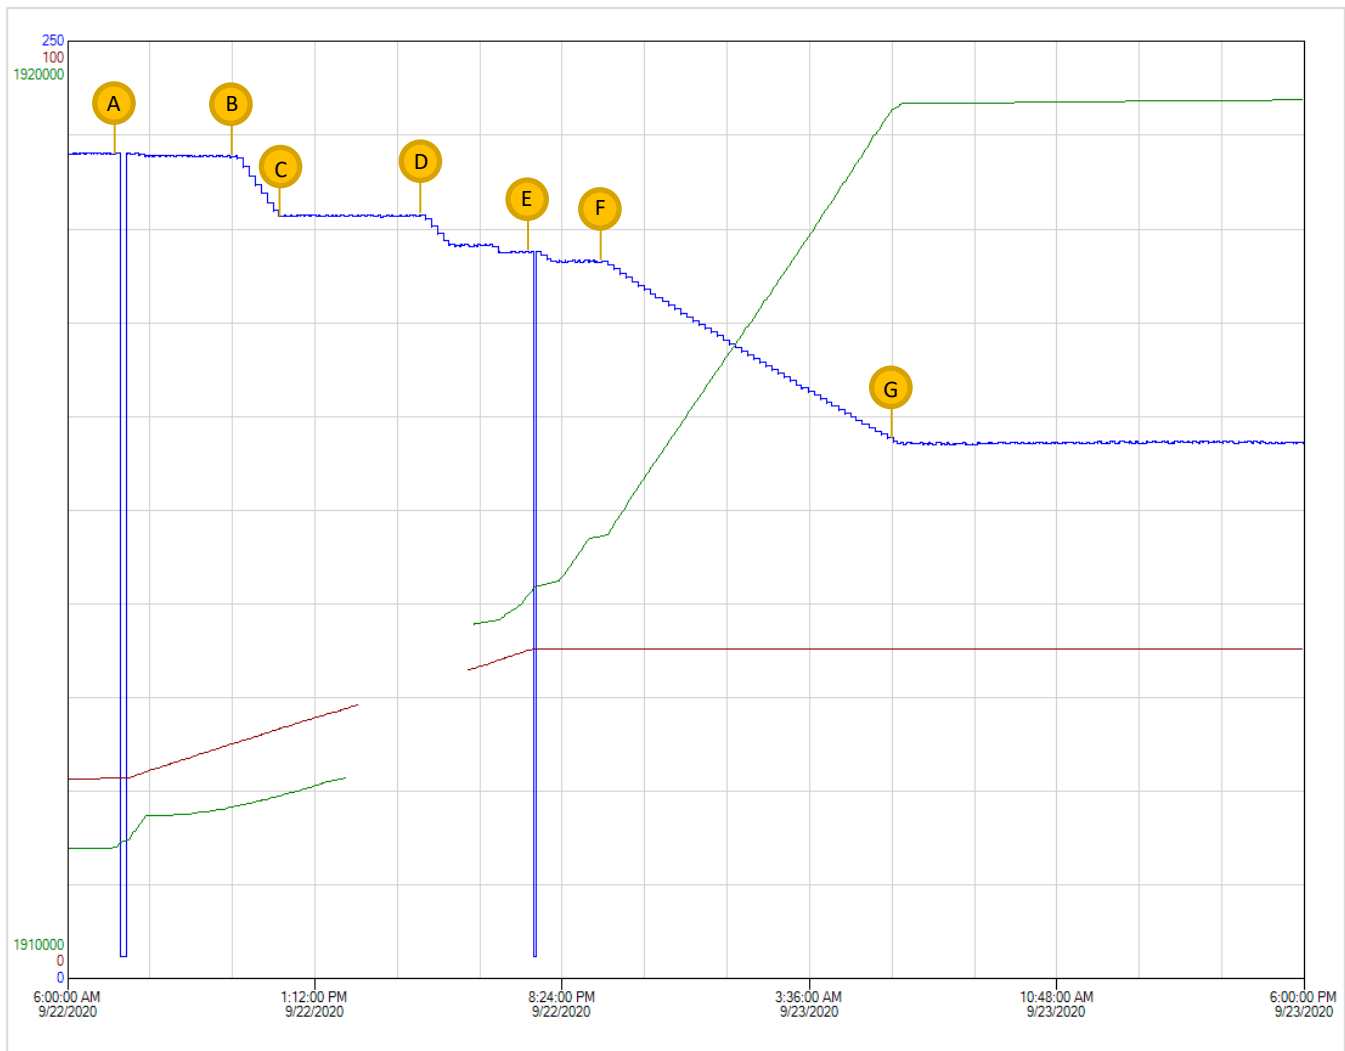
Figure 1 shows the event's timeline. Main camp complex fuel tank level in blue. The tank supplies the camp complex boiler module (CCBM) and the camp complex emergency generator (CCEG). Their energy totalizer are graphed in green and red respectively. Seven (7) points, i.e. A, B, C, D, E, F and G describe the event's timeline.

Figure 1: Main Camp Complex Fuel Tank Level (blue), CCBM Energy Totalizer (green) and CCEG Totalizer (red)

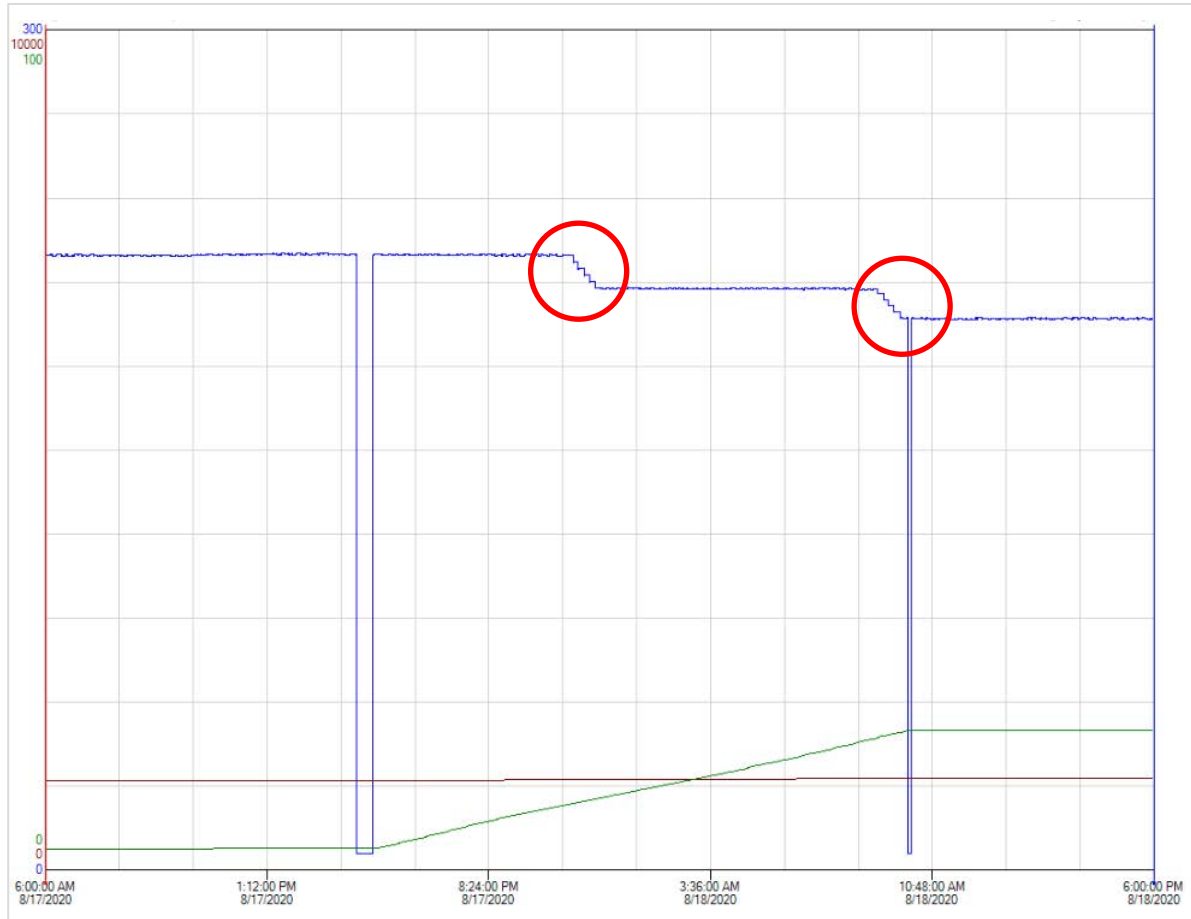
- It is a reasonable assumption that the CCEG tanks are at 40% capacity at point B. The CCEG daily tanks are being filled by the main camp complex tank from point B to point C. In normal operation, the CCEG daily tanks are supplied from 40% capacity to 85% capacity. Normal operation is presumed from point B to point C because the trend is comparable to previous data as shown in Figure 2.

Figure 2: Main Camp Complex Fuel Tank Level (blue), CCBM Energy Totalizer (green) and CCEG Totalizer (red)

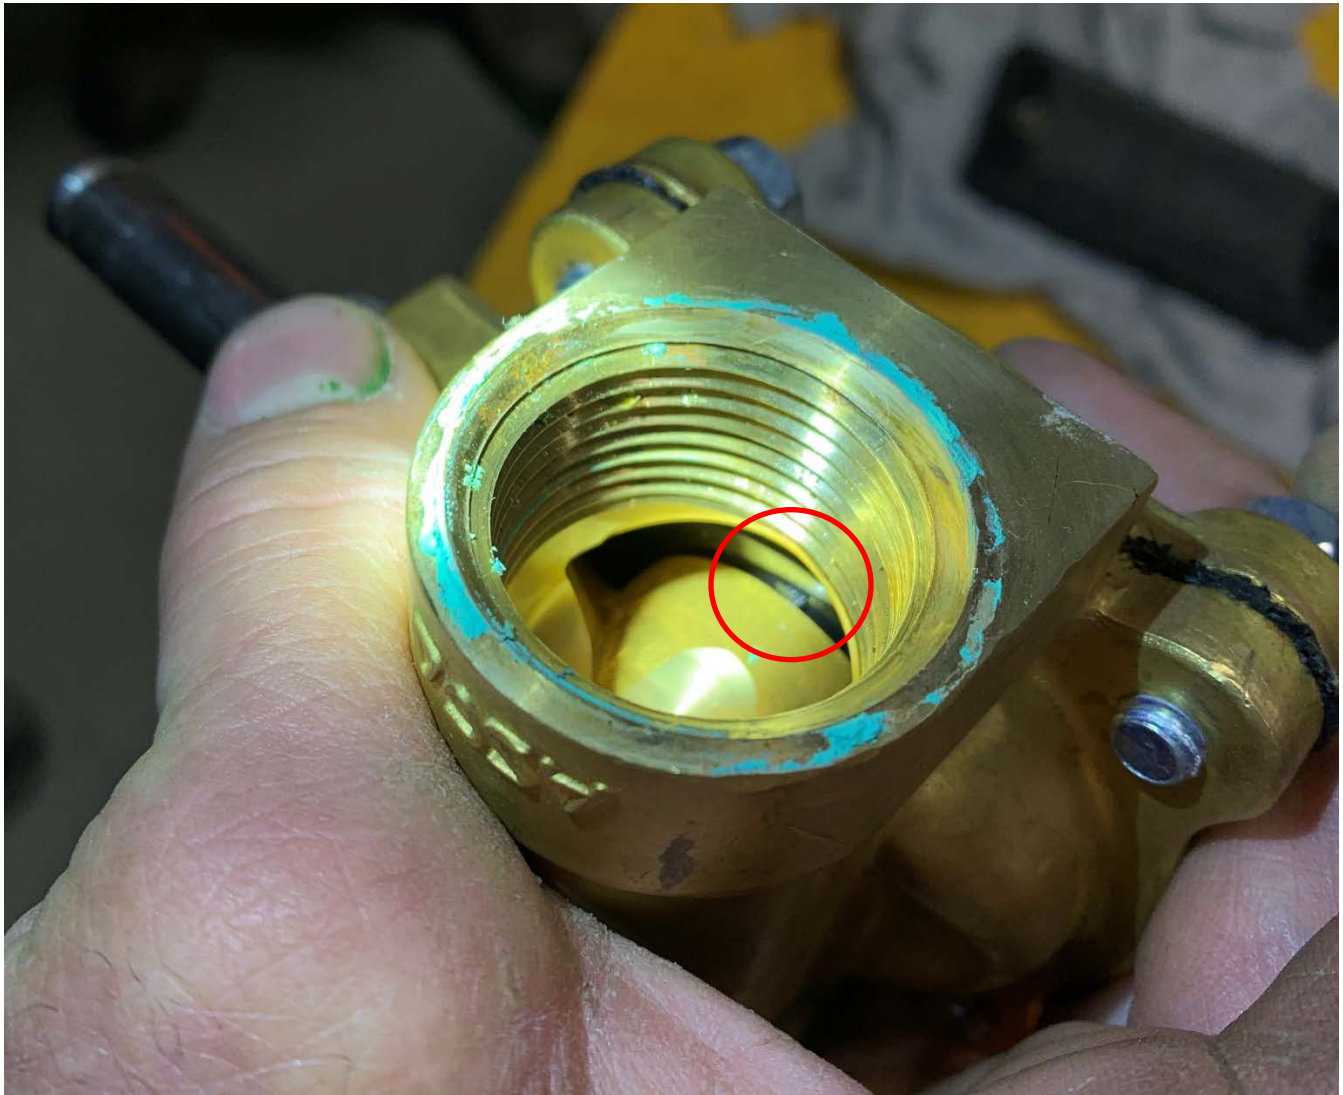
Figure 4: Piece of Metal Stuck seen Through Valve Body

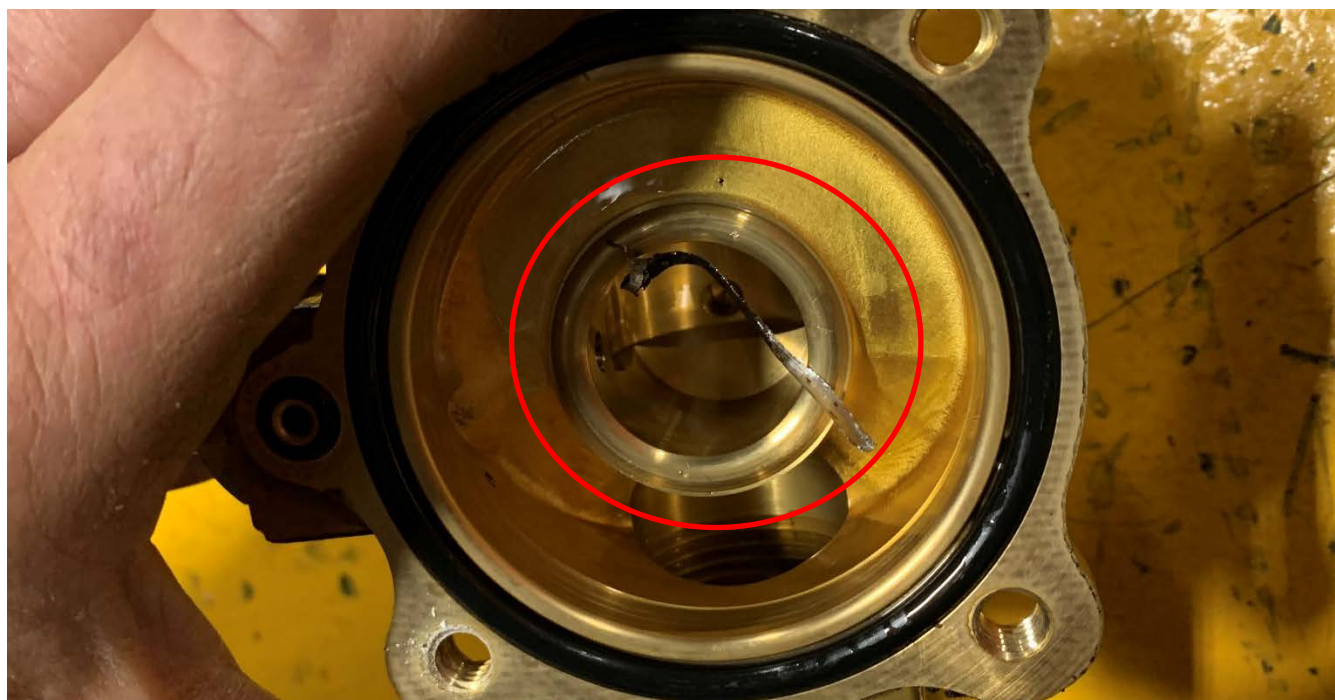
Figure 5: Piece of Metal through Body Passage

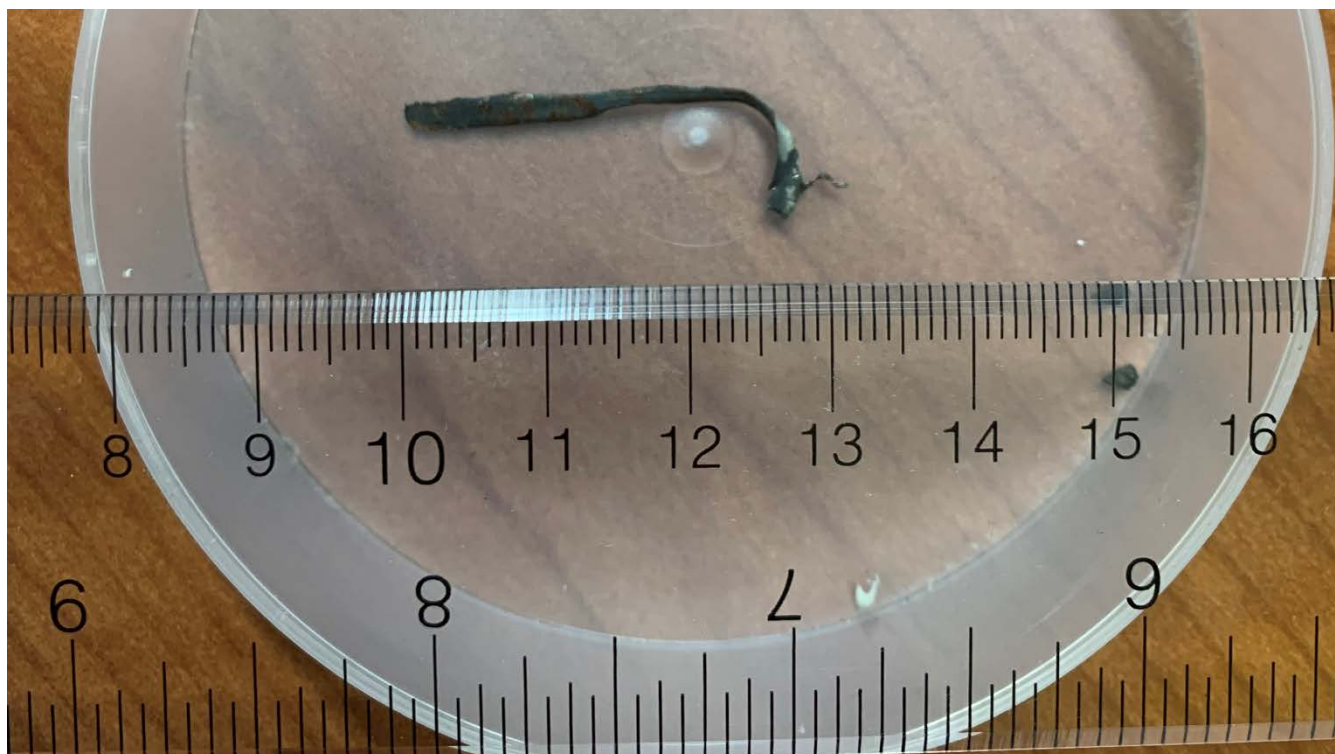
Figure 6: Measurement of Piece of Metal

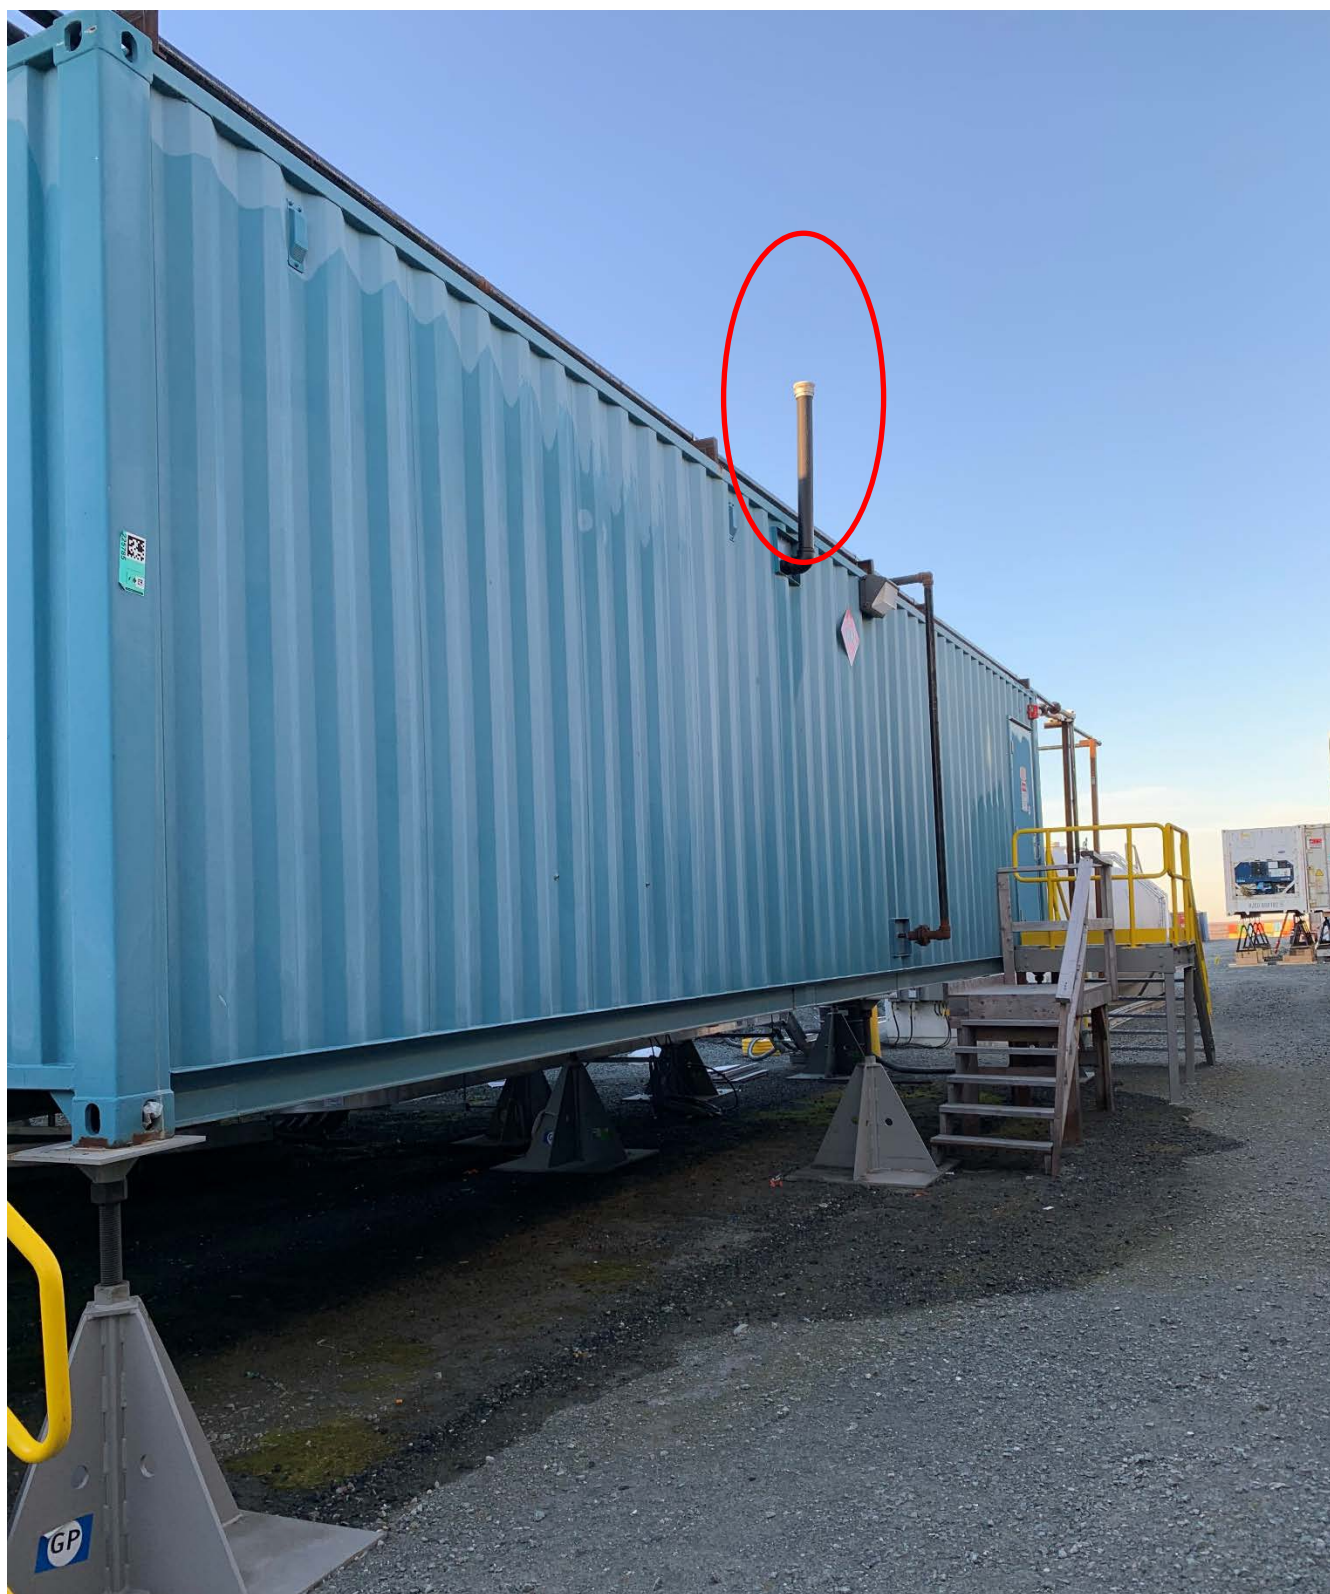
Figure 11: CCEG Daily Tanks Vent Missing Piping to Main Camp Complex Tank

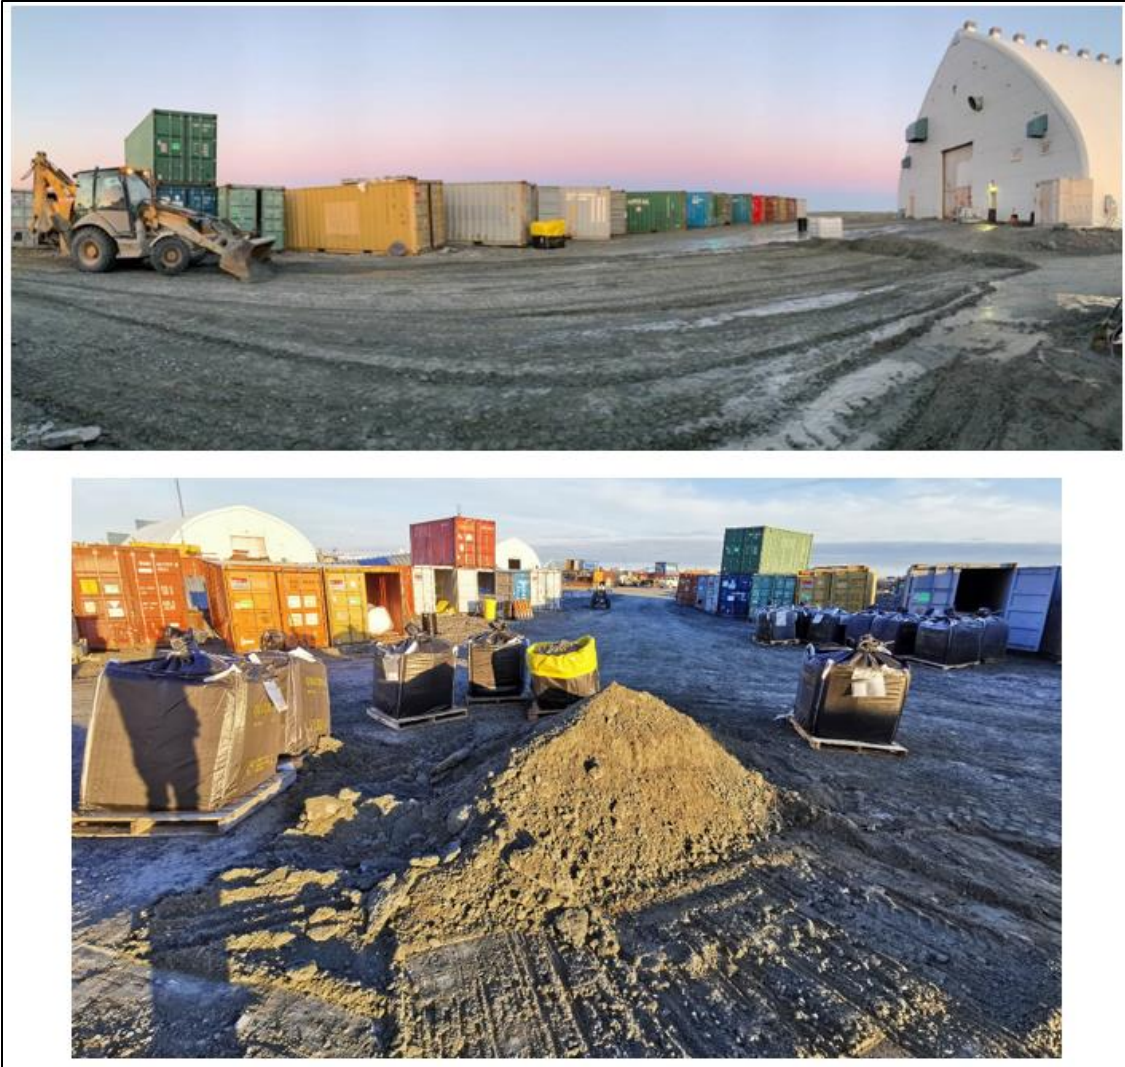
Figure 4: Spilled material and contaminated gravel removed.

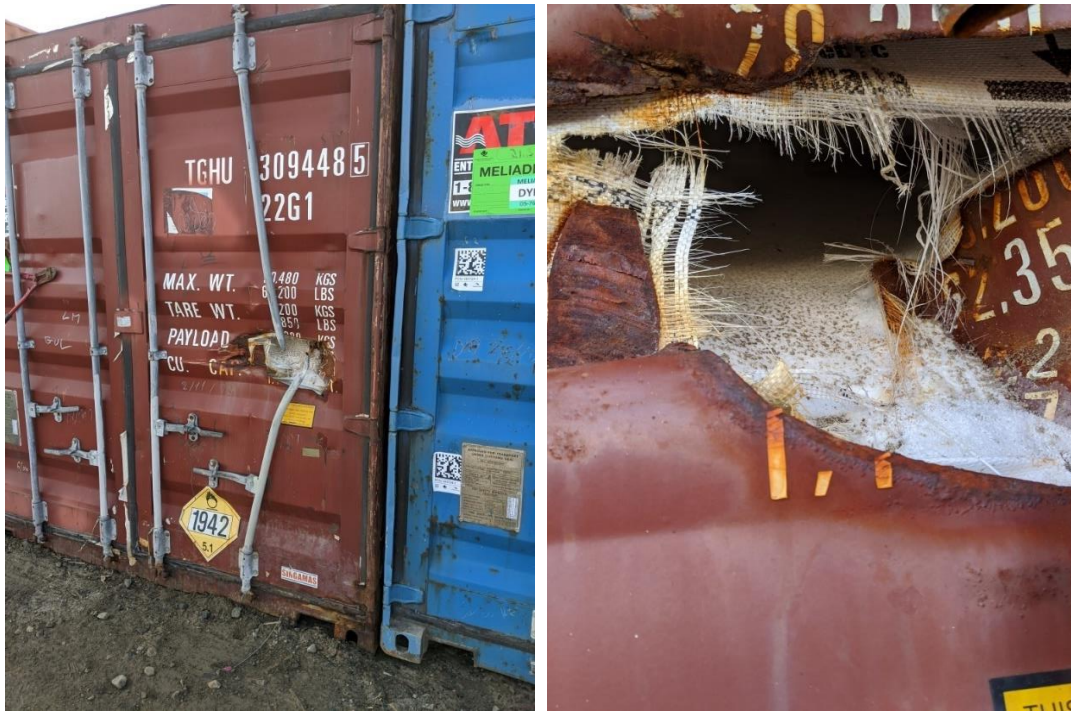
Figure 2: Damaged seacan containing Ammonium Nitrate.

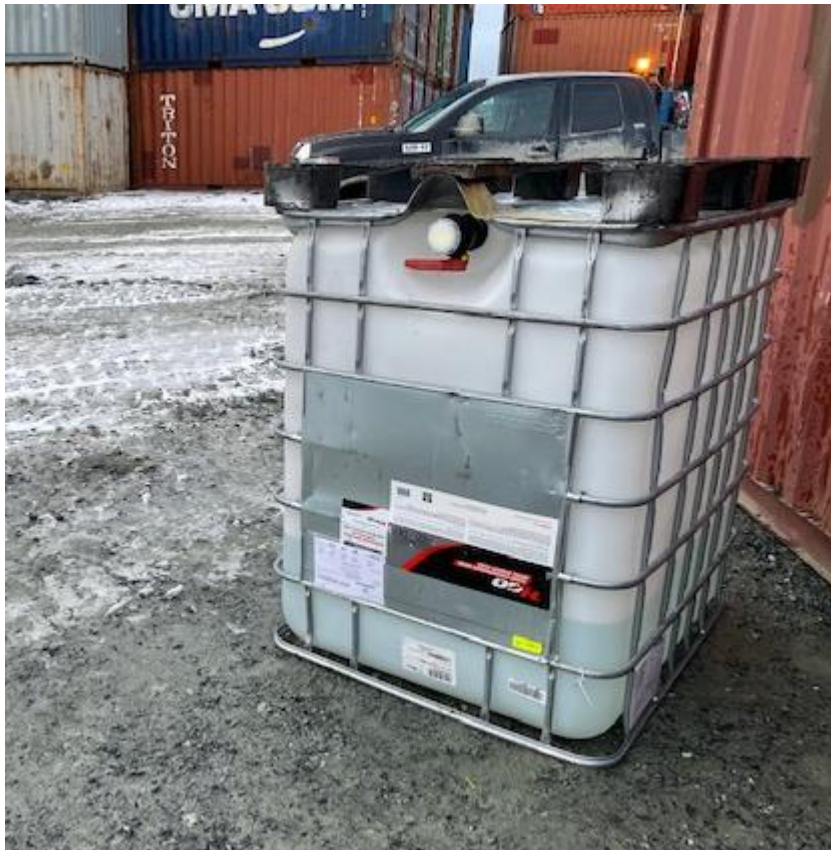
Figure 2: Tote Flipped to Reduce Volume of Urea Released

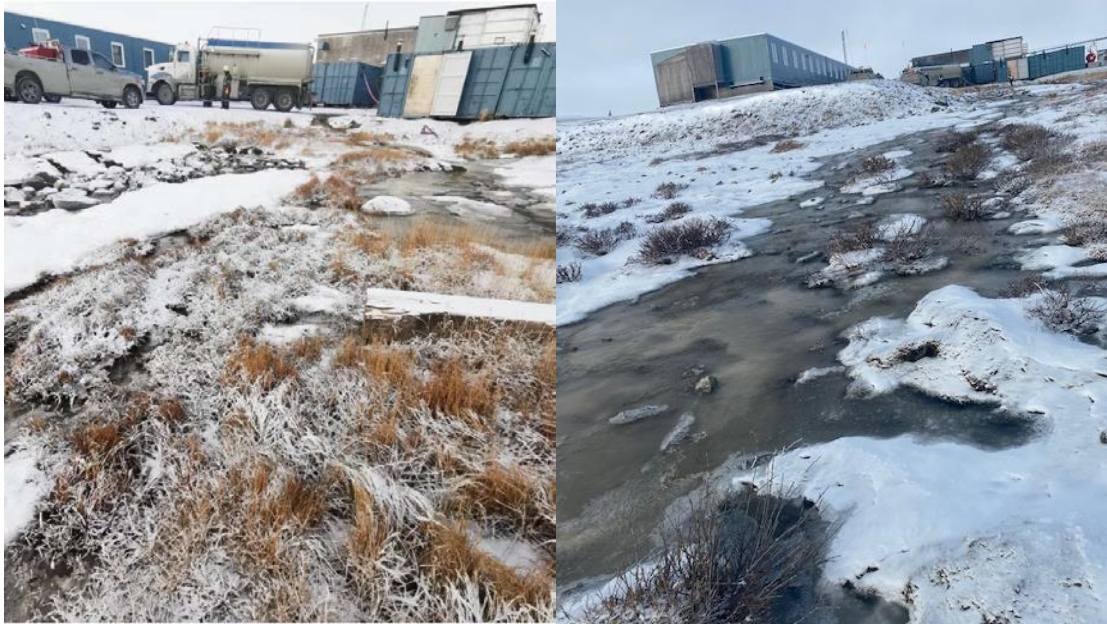
Figure 2: Treated Water Migrating Downhill

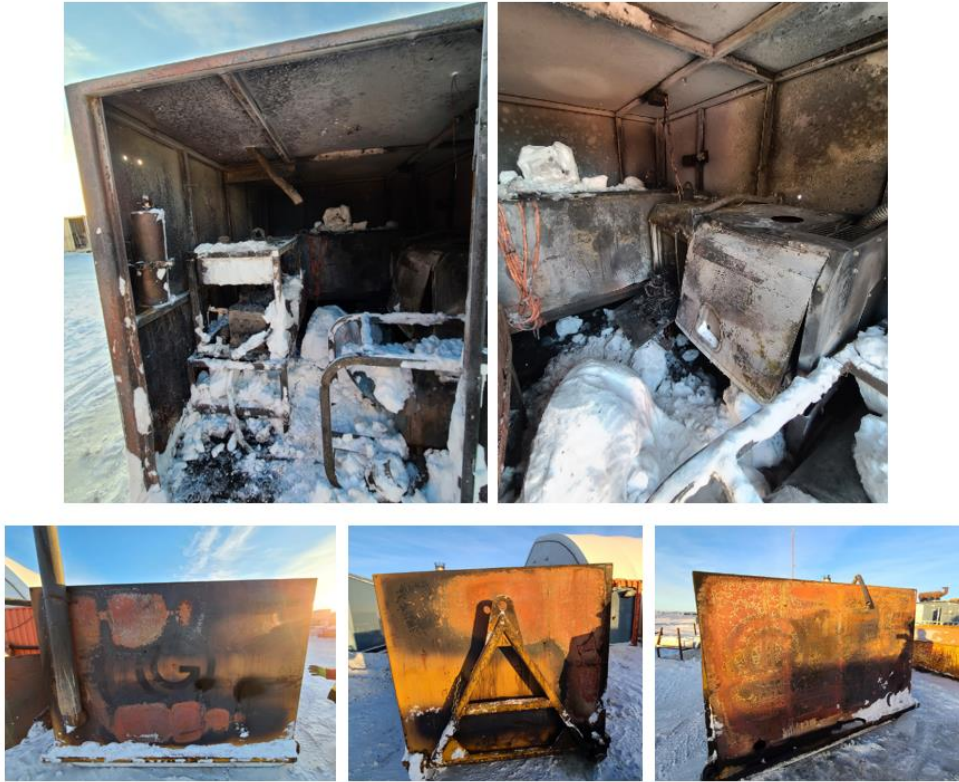
Figure 2: Photos of the pump shack after the fire was suppressed and the shack was towed back to the shop.

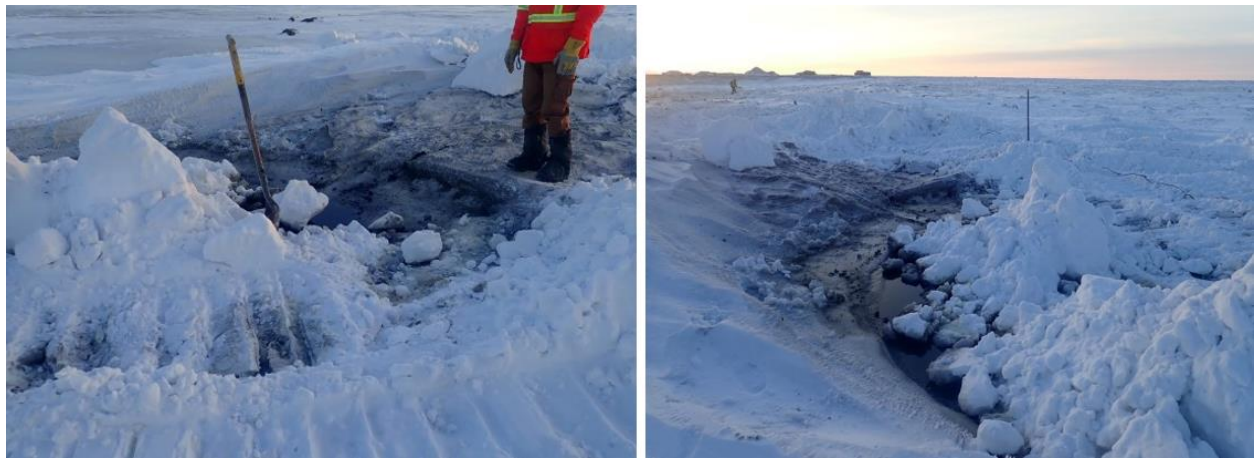
Figure 3: Fire suppression water which was not contained within the shack, absorbed into the surrounding snow and ice, and contained charred material.

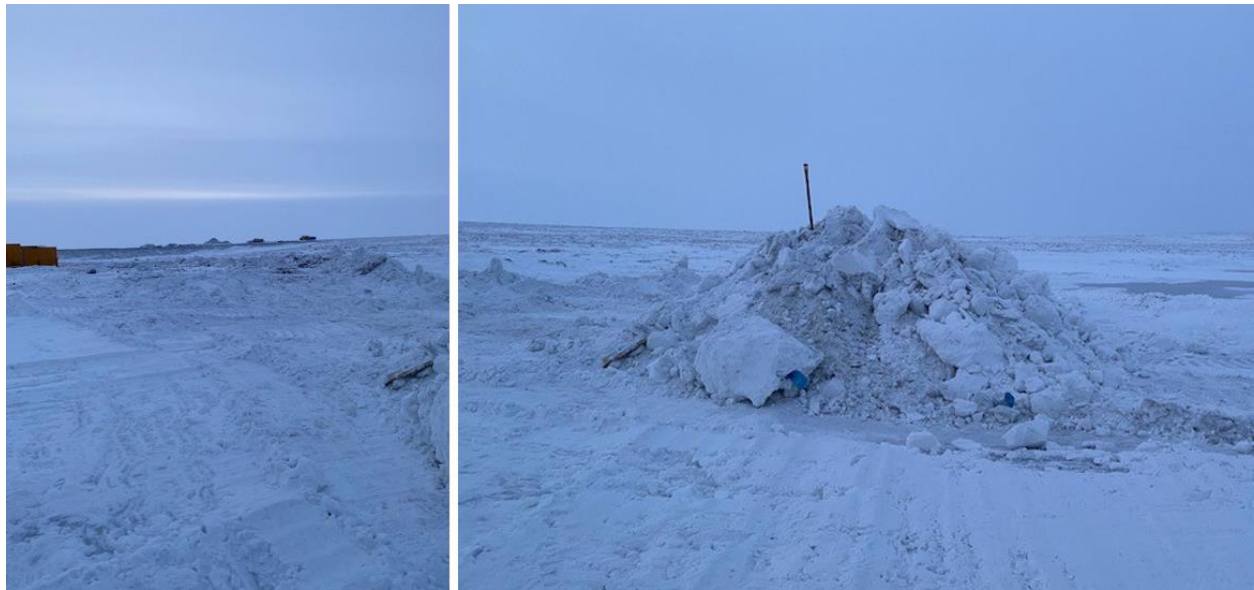
Figure 4: All contaminated snow and ice was scraped into a pile and brought to the snow cell.
