Appendix 15 : 2020 Reportable Spills

Appendix F-3
Reportable Spills and Follow-up Reports

Follow Up Report: #20-010

January 14, 2020 Hydraulic Oil Spill

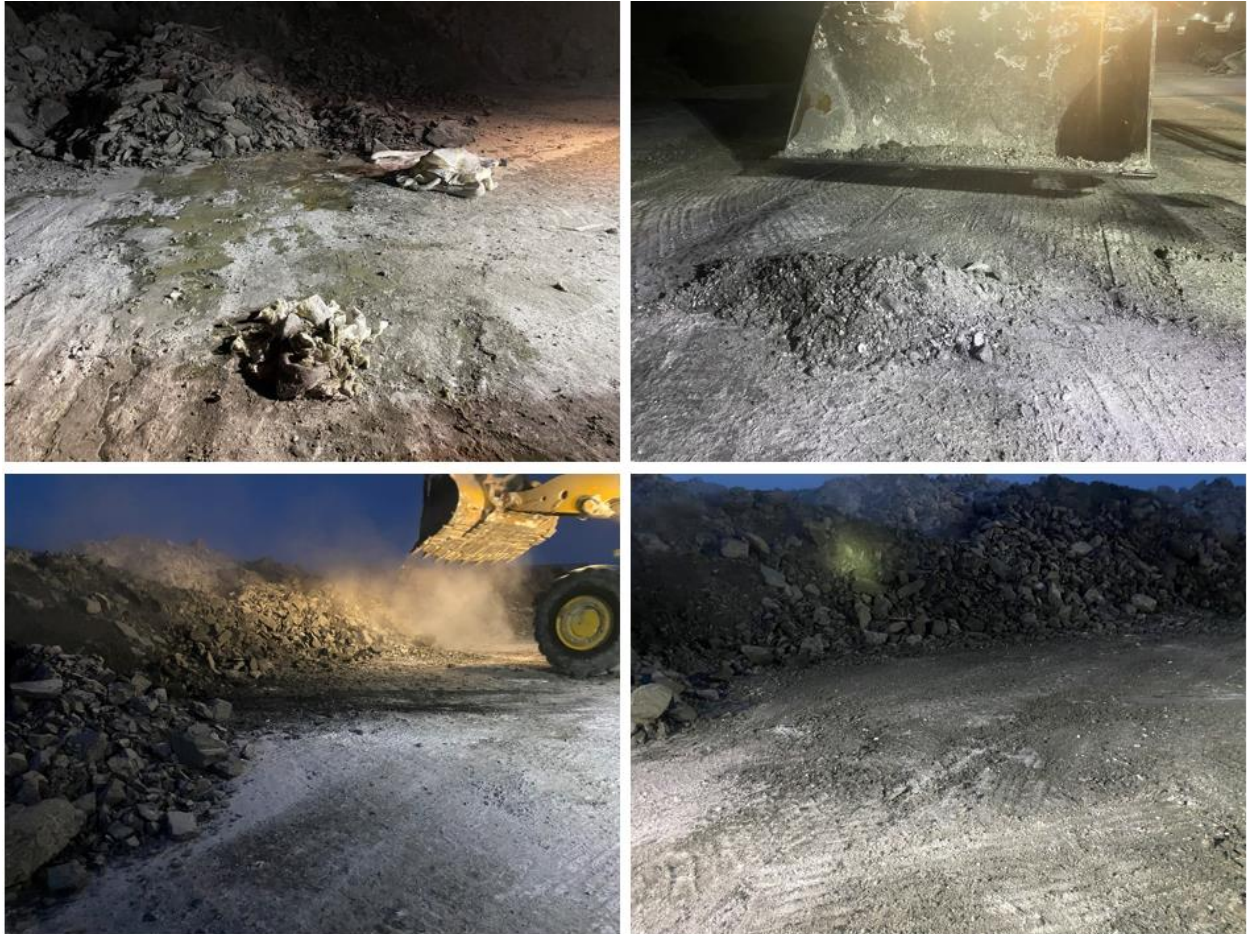
Figure 2: Process photos of the clean up of the contaminated ore.
