Re: Water License 2AM-MEL1631 Part D, Item 3 / NIRB Project Certificate 11MN034
Condition 18 - Submission of Construction Summary Report for P-Area Containment

MELIADINE – P-AREA CONTAINMENT CONSTRUCTION RECORD REPORT

SEPTEMBER 2016
ISSUED FOR USE
FILE: ENG.EARC03038-01
AGNICO EAGLE DOCUMENT NUMBER: 6515-C-230-002 P1 DAMS

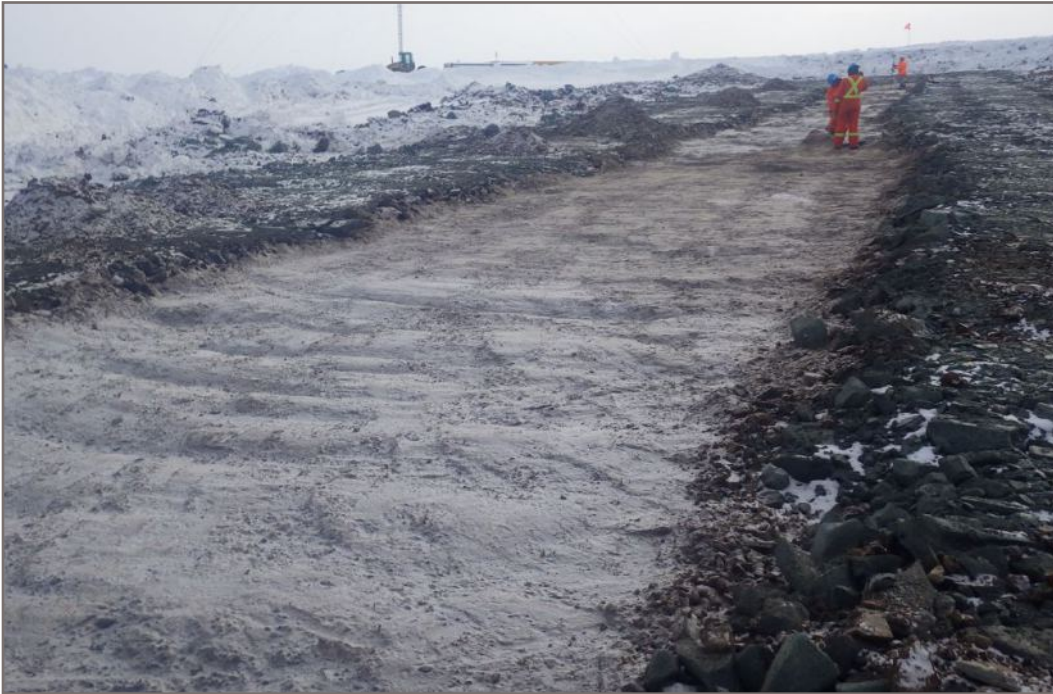
Photo 1: Prepared foundation at DP1-A (looking south). March 30, 2016.

Foundation preparation was undertaken below the dike footprint to remove snow, ice, boulders, and surface organics. More thorough cleaning was undertaken under the core area to provide a good contact between the cleaned existing ground and the new dike core material. The cleaning was carried out primarily with a CAT 420E backhoe with a steel plate welded across the teeth of the backhoe bucket. Photo 1 shows a section of the dike foundation cleaned prior to placement of the dike core material. The prepared foundation within the core base comprised frozen organic natural ground with relatively small amounts of residual loose material.

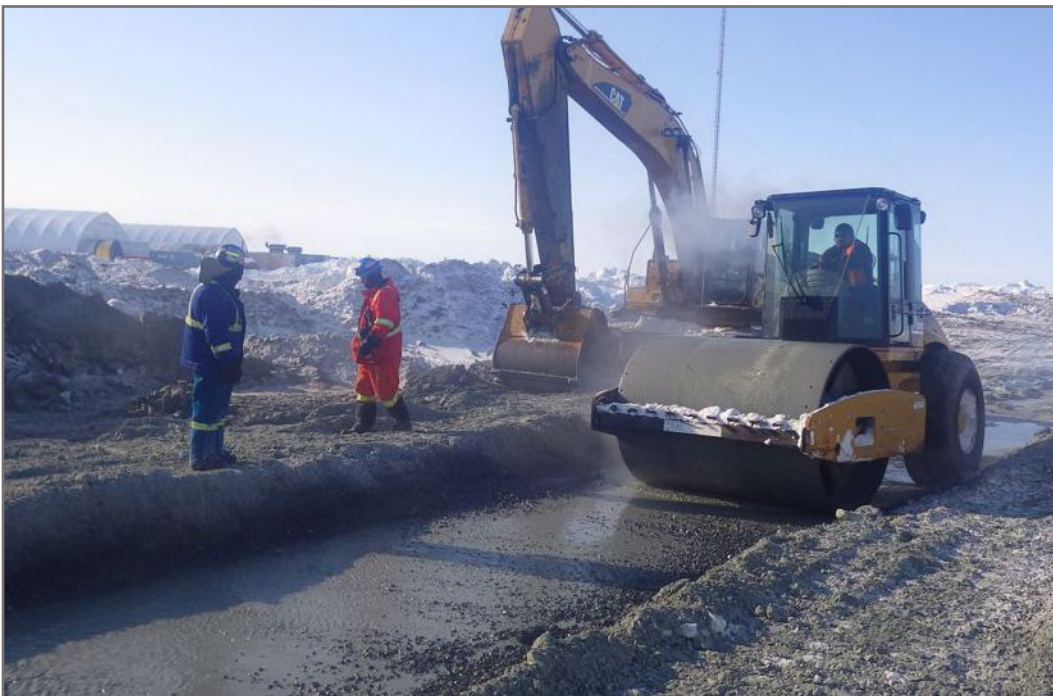
Photo 2: Compaction of watered lift at DP1-A. April 10, 2016.

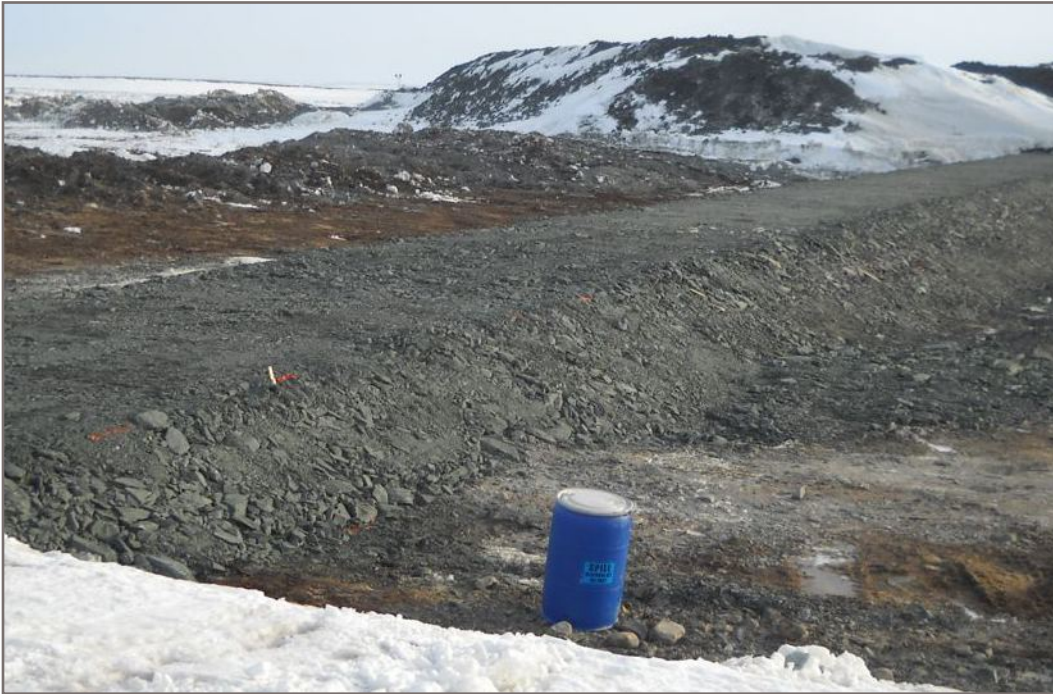
Photo 3: DP1-A at completion (looking north). April 30, 2016.

The dike was constructed between approximately March 25 and April 25, 2016. Construction activities for DP1-A consisted of foundation preparation, construction of the dike core, and placement and compaction of Material 0-200 and Underground Waste Rock. The location of the dike is shown on Drawing 2. It is an approximately 120 m long structure with a maximum height of 3.7 m to the top of the waste rock.

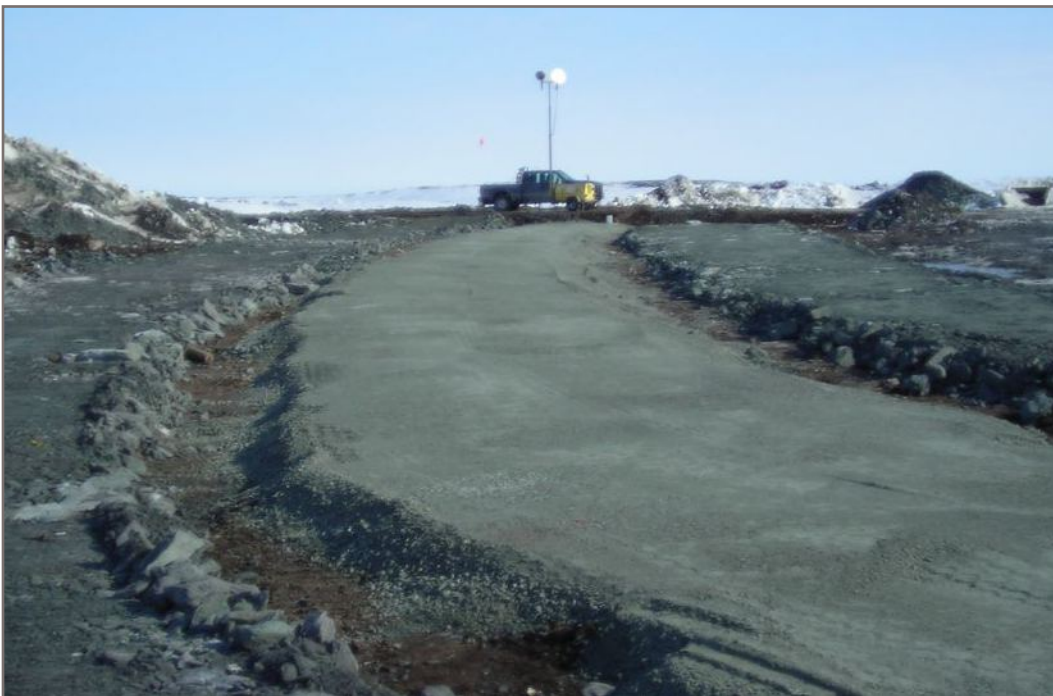
Photo 4: DB1-B during construction (looking south). April 29, 2016.

The dike core was constructed of Material 0-30 using construction Method B. The Method B core construction started on April 26, 2016 and was in progress when Tetra Tech EBA left site on May 4, 2016. When Tetra Tech EBA left site, Material 0-30 was not yet placed on the road section and two (2) lifts were completed on the off road section of the dike. Material 0-30 was placed in lifts ranging between 200 mm and 300 mm and compacted with a CAT CS-563E compactor with a minimum of six (6) full passes (Photo 4). No moisture conditioning was used on the Material 0-30 during placement and compaction. QA/QC monitoring consisted of visual observations during placement and compaction. The maximum average as-built elevation of the top of core is 69.0 m.

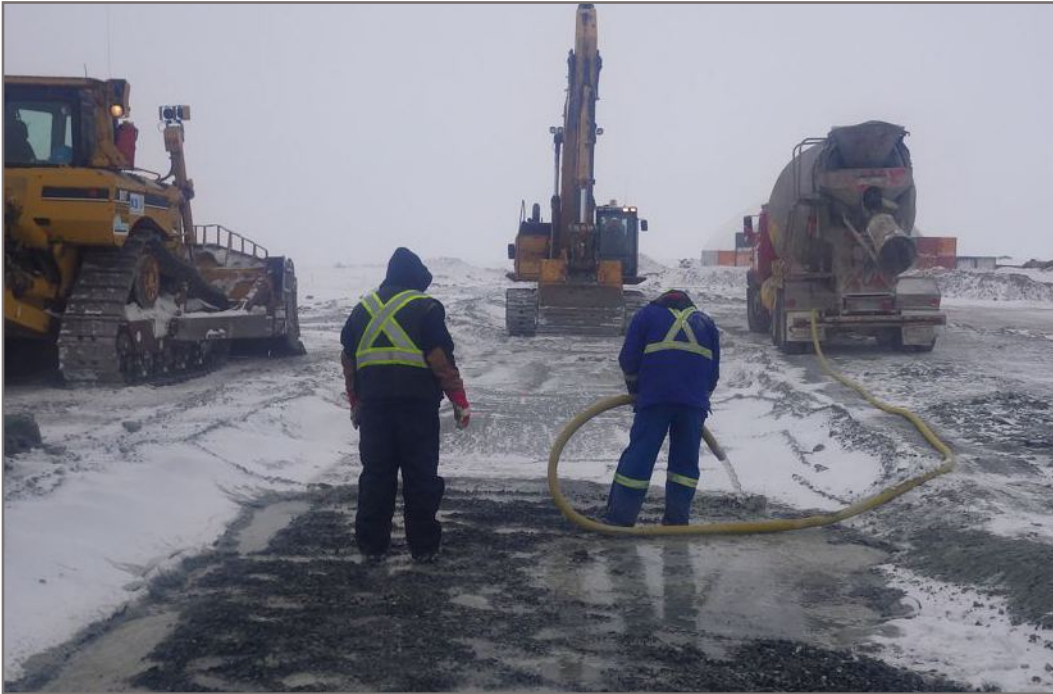
Photo 5: Watering a lift of Material 0-30 at DP3-A. April 15, 2016.

Generally, visual observations and penetration tests during flooding indicated that the material was wet and saturated. Occasionally, the water did not penetrate to the bottom of the lifts. Water penetration was poor when the water temperature was less than 40°C, the core material was not flooded right after placement, and during cold, windy conditions.

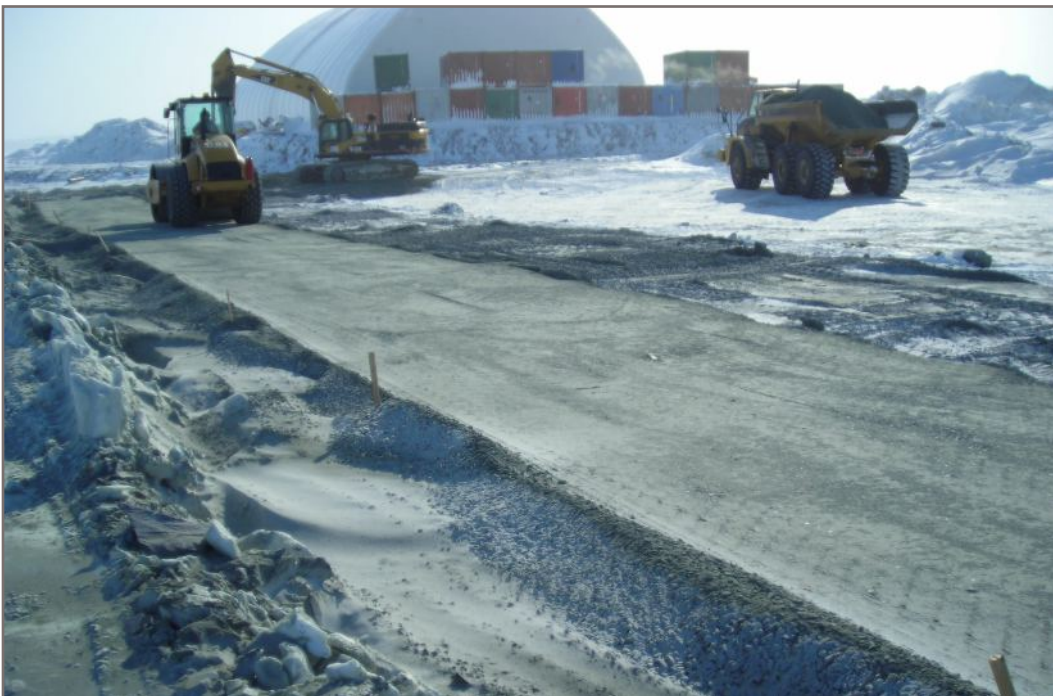
Photo 6: Compaction of the core material at DP3-A. April 22, 2016.

The construction placement technique was switched from Method A to Method B on April 22 and continued until April 28, 2016. Method B was used from the elevations reached with Method A described in the above paragraph and continued to the top of core elevation at 67.5 m. Method B, Material 0-30 was placed in lifts ranging between 200 mm and 300 mm and compacted with a CAT CS-563E compactor with a minimum of six (6) full passes (Photos 6 and 7). No moisture conditioning was used on the Material 0-30 during placement, compaction, and final grading. QA/QC monitoring during Method B consisted of visual observations during placement and compaction testing. Compaction test results are included in Appendix D. The average percent compaction was 98% of Standard Proctor maximum dry density.

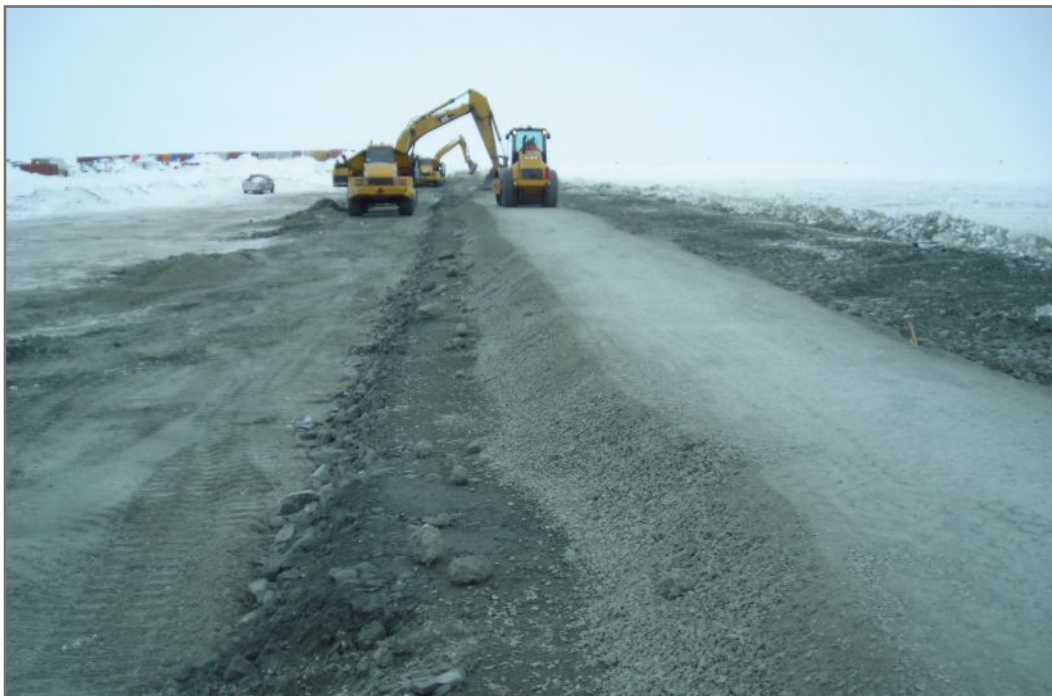
Photo 7: Compaction of core material at DP3-A (looking north). April 24, 2016.

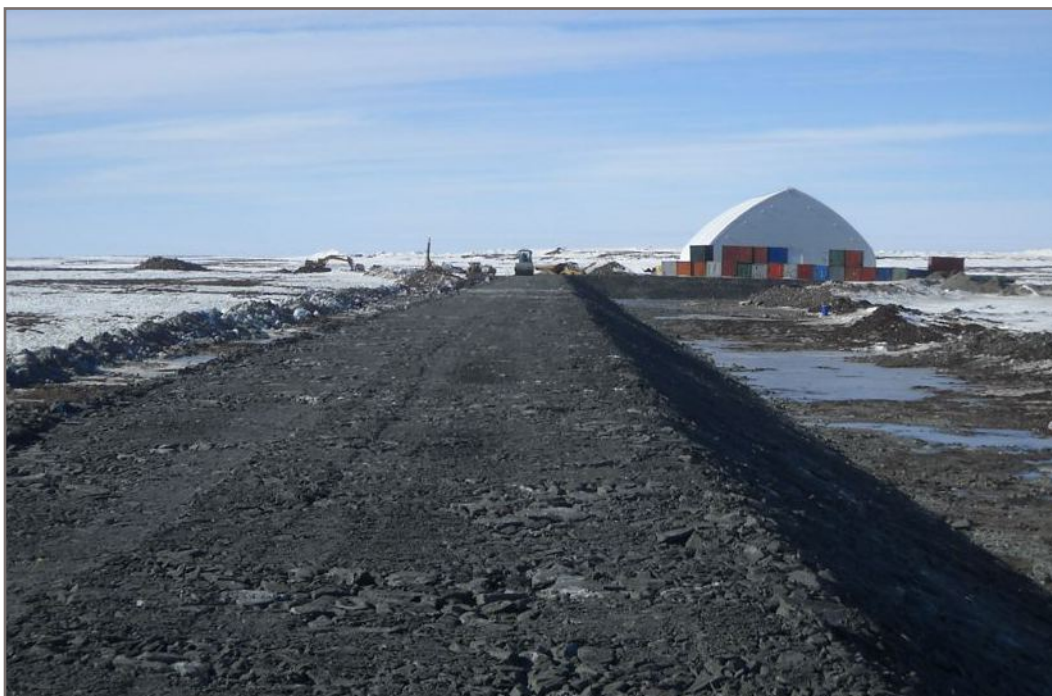
Photo 8: DP3-A at completion (looking south). May 4, 2016.

The construction activities for DP3-A consisted of foundation preparation, construction of the dike core, and placement and compaction of Material 0-200 and Underground Waste Rock. The location of the dike is shown on Drawings 8 through 10. It is an approximately 300 m long structure with a maximum height of 3.4 m to the top of the waste rock. The dike was constructed between approximately March 28 and May 4, 2016.

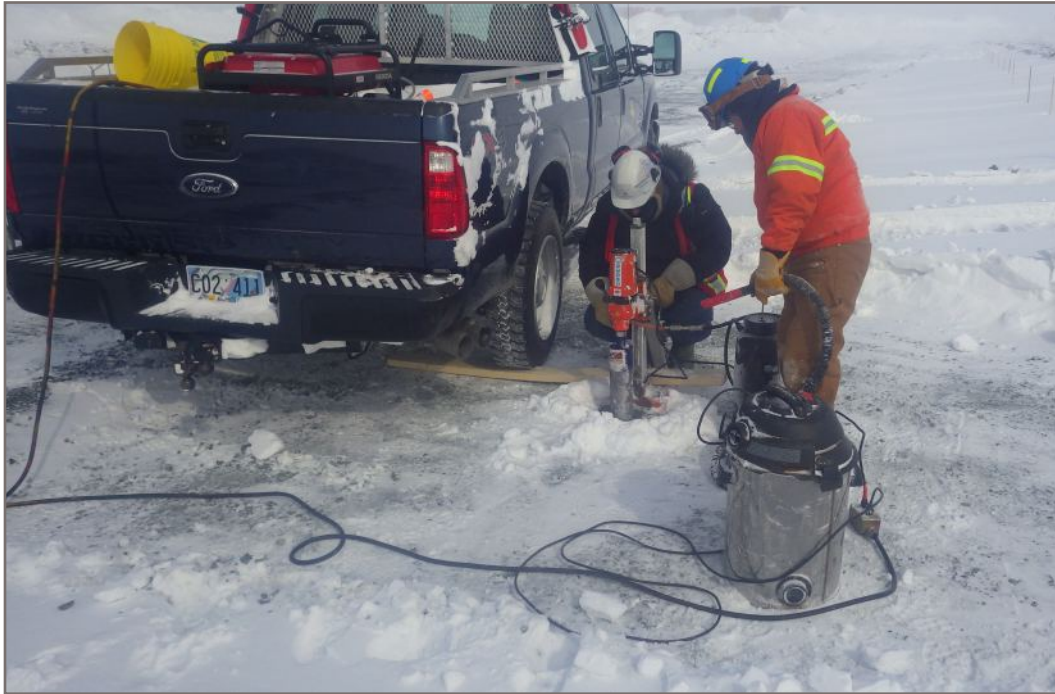
Photo 9: Coring at DP3-A. April 21, 2016.

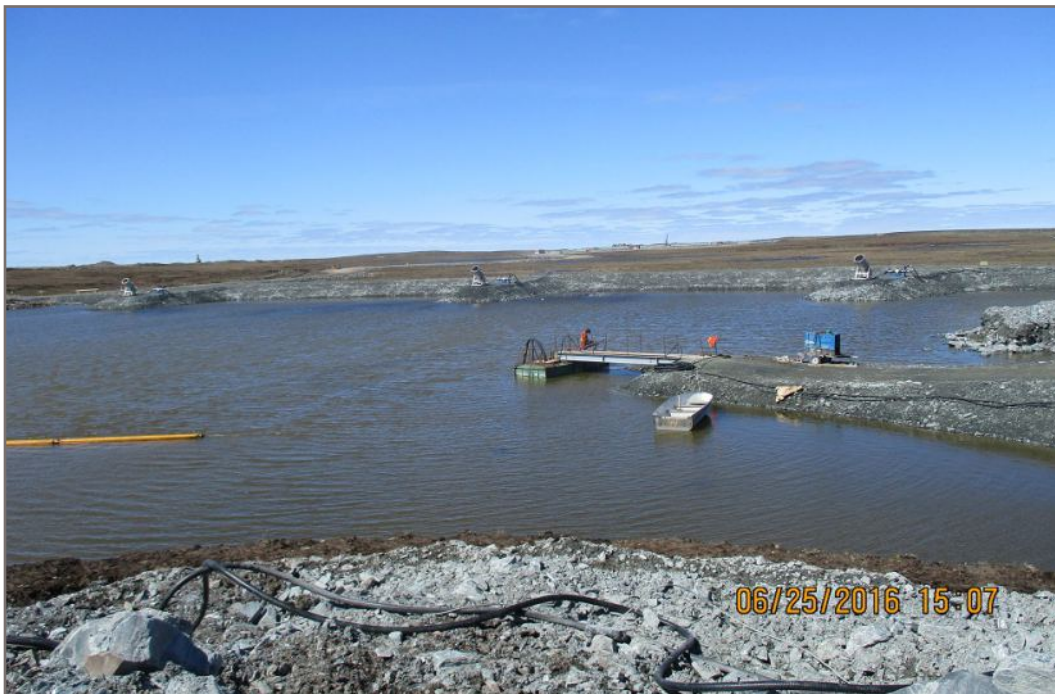
Photo 10: P-Area 1. June 25, 2016.

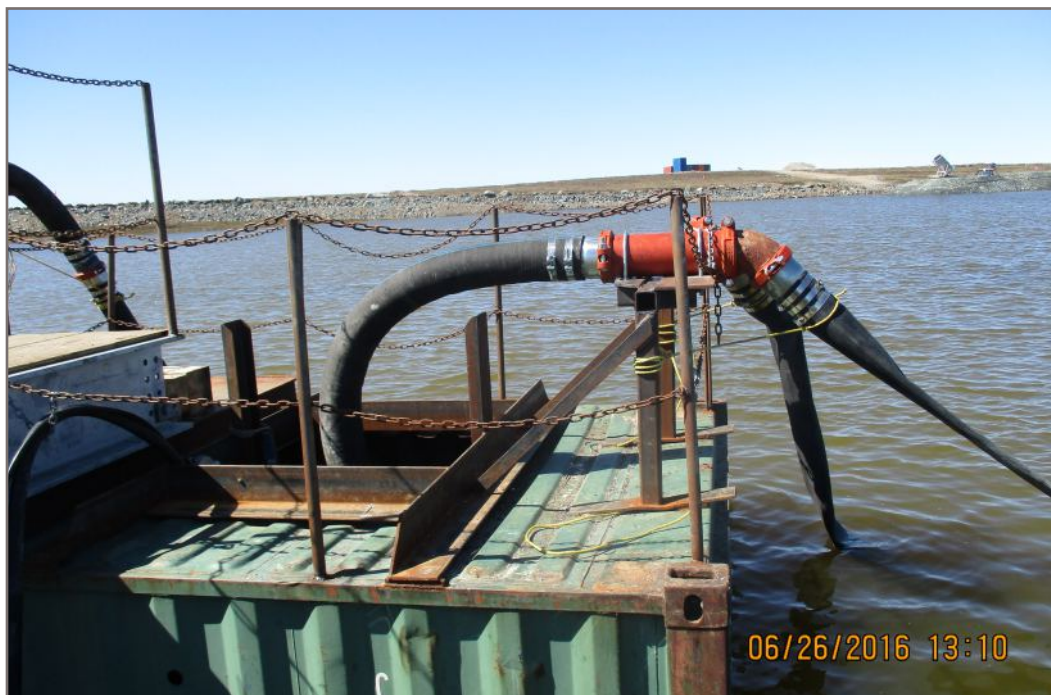
Photo 11: A pumping station. June 26, 2016.

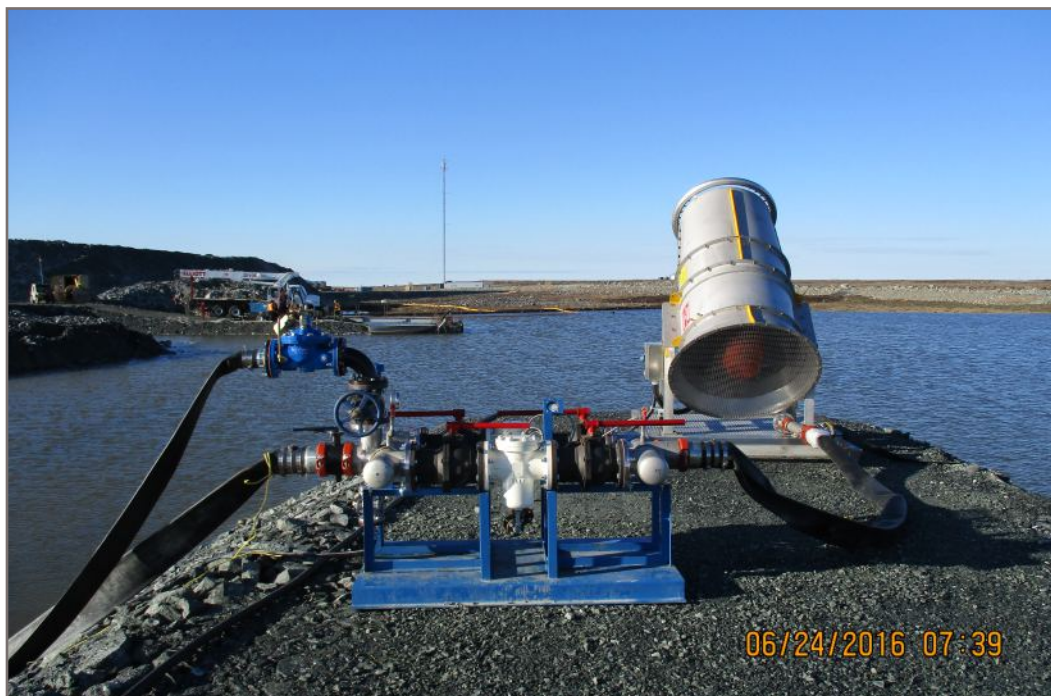
Photo 12: Strainer skid. June 24, 2016.

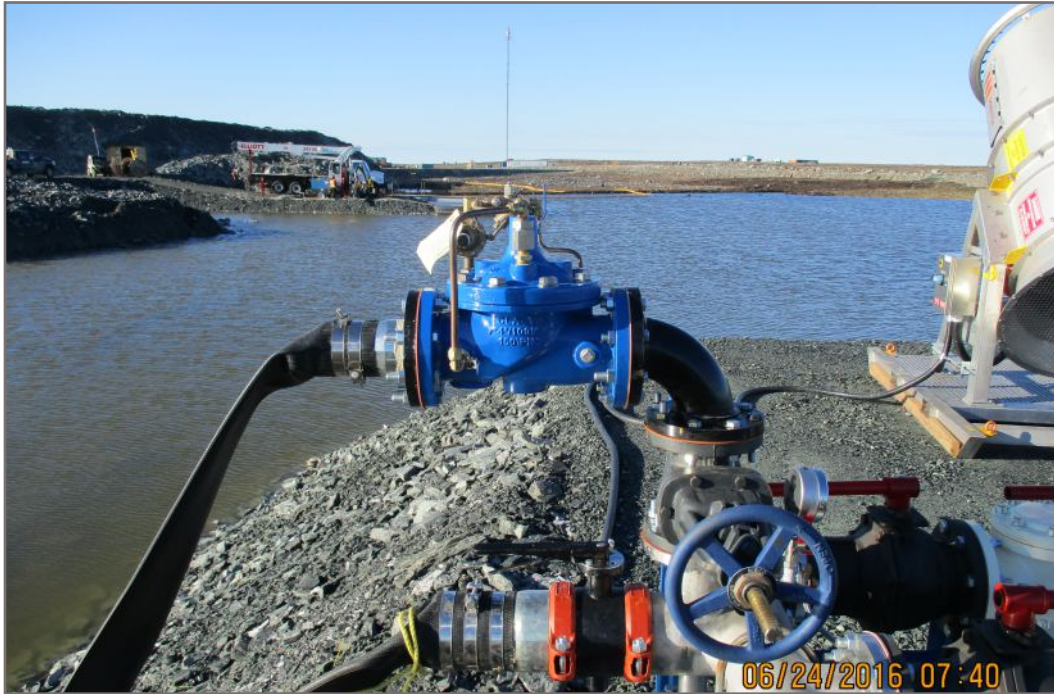
Photo 13: Pressure relief valve. June 24, 2016.

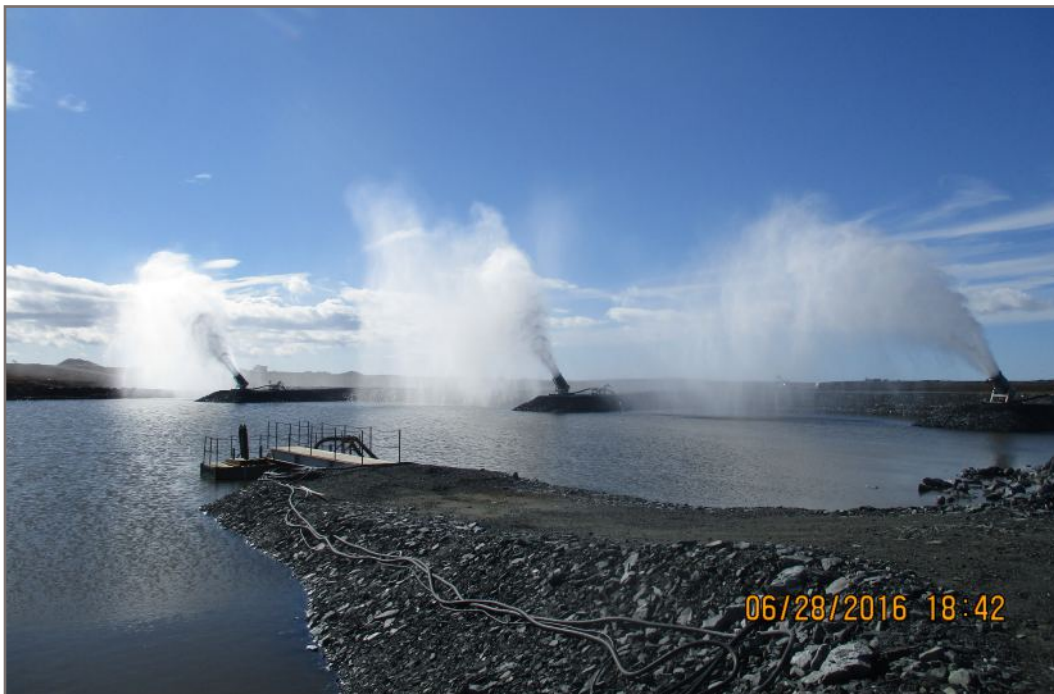
Photo 14: Three evaporators during operation. June 28, 2016.

The evaporator unit achieves increased evaporation by discharging water into a patented spiral water spray nozzle assembly designed to achieve an optimal water droplet size immediately prior to the introduction into a high velocity air stream. An extremely high air to water ratio mixture is generated and propelled into the atmosphere maximizing the exposed surfaces of fractured droplets to fresh, low humidity air resulting in water evaporation.

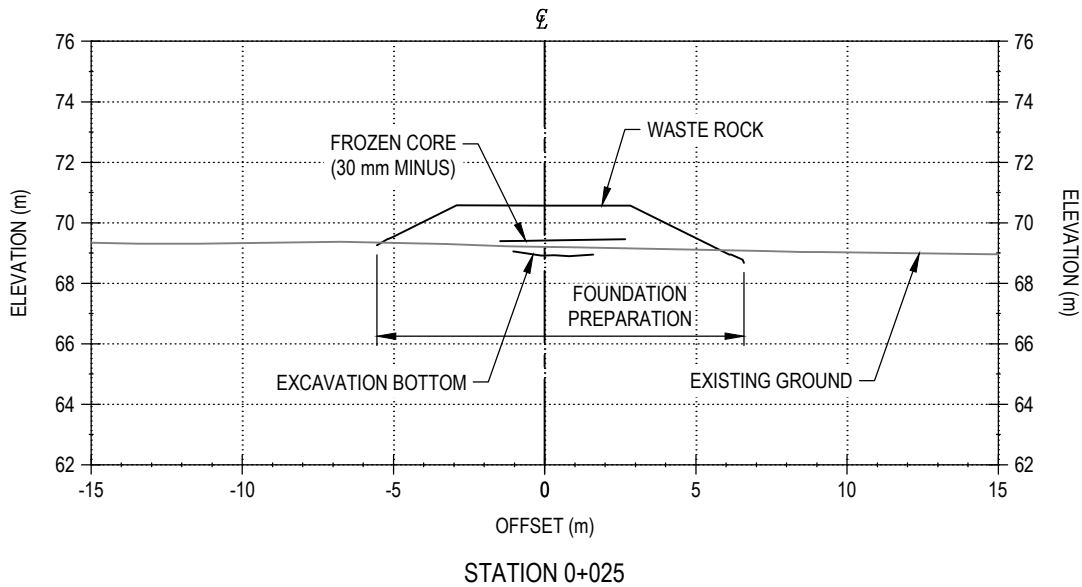
ÉCHELLE/ SCALE	1:250	FICHIER FILE	
No. DESSIN/ DRAWING NO.	3	REVISION	00
		FEUILLE/SHT	3 / 13

TITRE / TITLE
AGNICO EAGLE MELIADINE GOLD PROJECT
TEMPORARY WATER CONTAINMENT STRUCTURES
DP1-A
SECTIONS

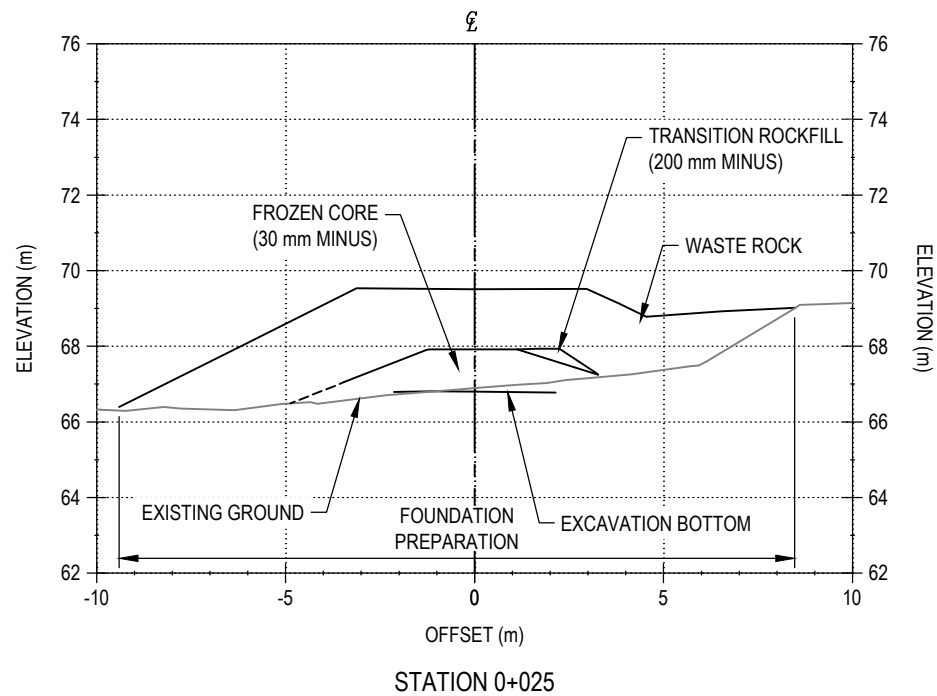
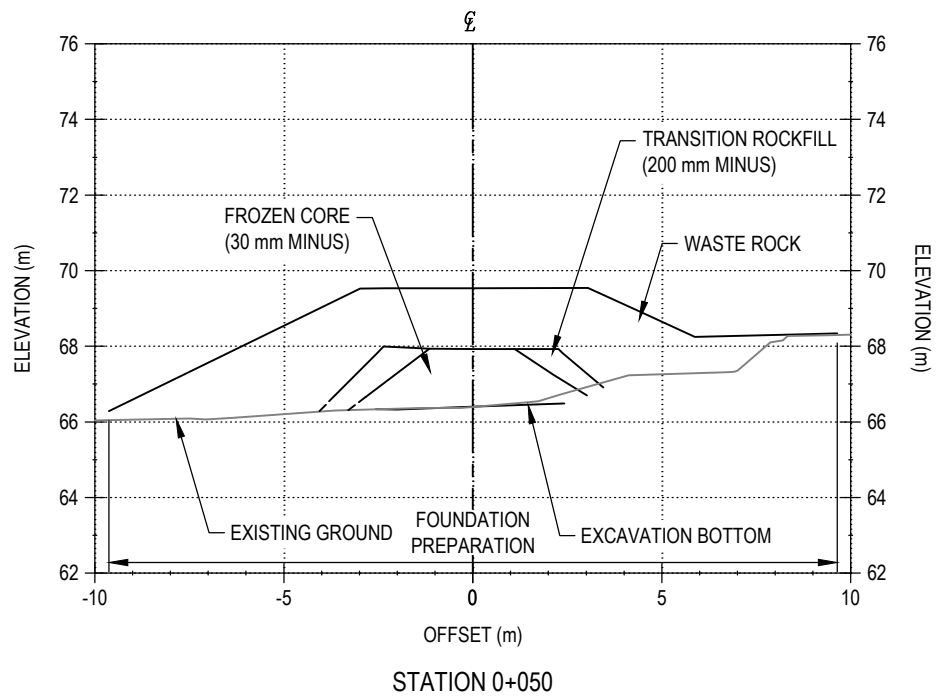
ÉCHELLE/ SCALE	1:200	FICHIER FILE	
No. DESSIN/ DRAWING NO.	7	REVISION	00
		FEUILLE/SHT	7 / 13

DESSINÉ PAR DRAWN BY	EL	DATE	2016-09-15
VÉRIFIÉ PAR CHECKED BY	NG		2016-09-15
APPROUVÉ PAR APPROVED BY			
No. PROJET PROJECT NO.			
DATE			
TITRE / TITLE	AGNICO EAGLE MELIADINE GOLD PROJECT		
	TEMPORARY WATER CONTAINMENT STRUCTURES		
	DP2-A		
	SECTIONS
