Re: Water License 2AM-MEL1631 Part D, Item 3 / NIRB Project Certificate 11MN034
Condition 18 - Submission of Construction Summary Report for Channel 5

Construction Summary (As-built) Report for Channel5, Meliadine Gold Project

AGNICO EAGLE DOCUMENT NUMBER: 6515-E-132-007-132-REP-008

Tetra Tech Canada Inc. (Tetra Tech) was retained by Agnico Eagle Mines Limited (Agnico Eagle) to prepare a construction summary (as-built) report for Channel5 at the Meliadine Gold Project, Nunavut. Tetra Tech previously prepared the design drawing for construction of Channel5 in September 2016. Channel5 is located around UTM (NAD83, Zone 15) coordinate of 540,000E and 6,988,500N.

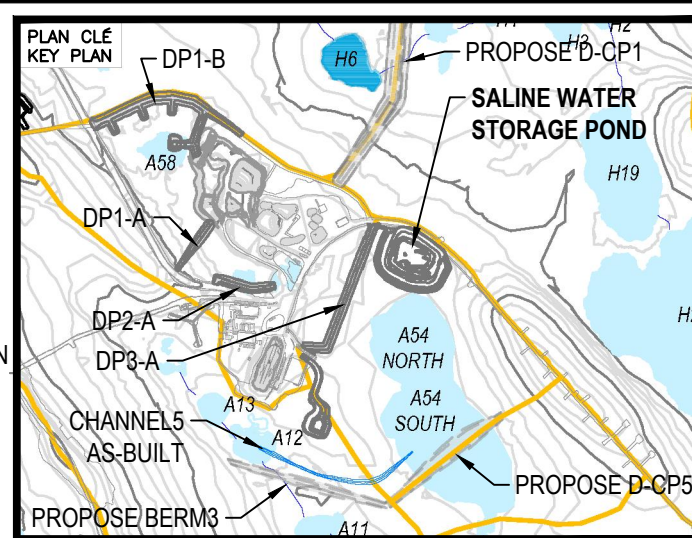
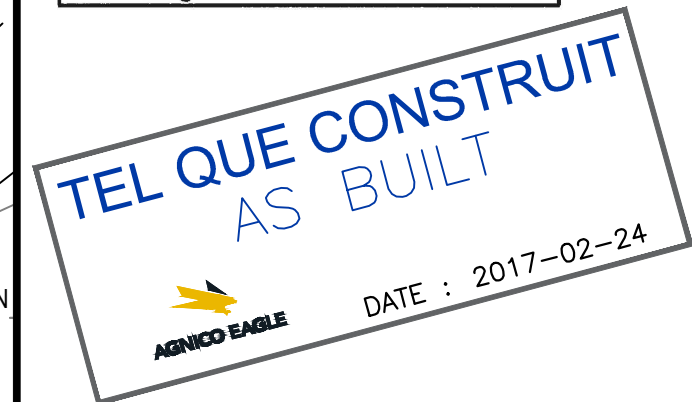
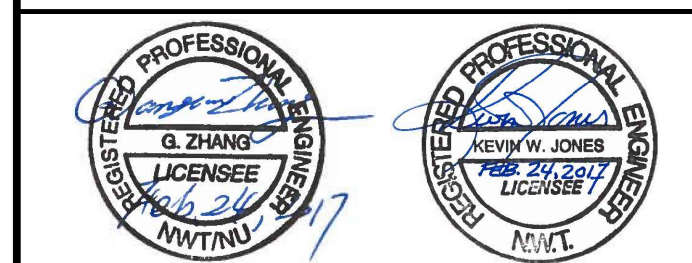
CHANNEL5 AS-BUILT
PLAN AND PROFILE

- From Station 0+010 (upstream start of Channel5) to Station 0+046, survey data could not be taken because the access was limited due to the presence of water. Photos taken during the channel construction show that the rip-rap fill and nonwoven geotextile were placed over the excavated channel bottom in this section.
- The channel side slopes at some locations (Stations 0+040, 0+200 to 0+320) are slightly steeper (1.9(H):1(V) to 2.4(H):1(V)) than the design slope of 2.5(H):1(V), mainly due to the frozen conditions during the construction. It is not expected that this would significantly increase the potential risk of local channel slope instability at these

- The as-built drawings indicate that the minimum thickness of the rip-rap fill over the channel bottom is 0.2 m at some locations, which is less than the design value of 0.3 m. This is generally acceptable. If required during channel operation, additional rip-rap fill can be placed over the locations.

- The channel bottom widths at some locations (Stations 0+060 to 0+220, 0+300 to 0+340) range from 2.3 m to 2.9 m, which is slightly less than the design value of 3.0 m. Due to the reduced channel bottom widths, the maximum water levels in the channel at these locations under an extreme flood event will be slightly higher than designed. This is manageable and acceptable because any water that may temporarily overflow the channel during an extreme flood event will be retained by Berm3 in the short term and then be drained through the channel into CP5; therefore, the water will not flow to the outside environment.

locations, but should this happen during channel operation, local remediation measures (flattening the channel side slopes where required and re-placing the geotextile and rip-rap layers) can be undertaken.

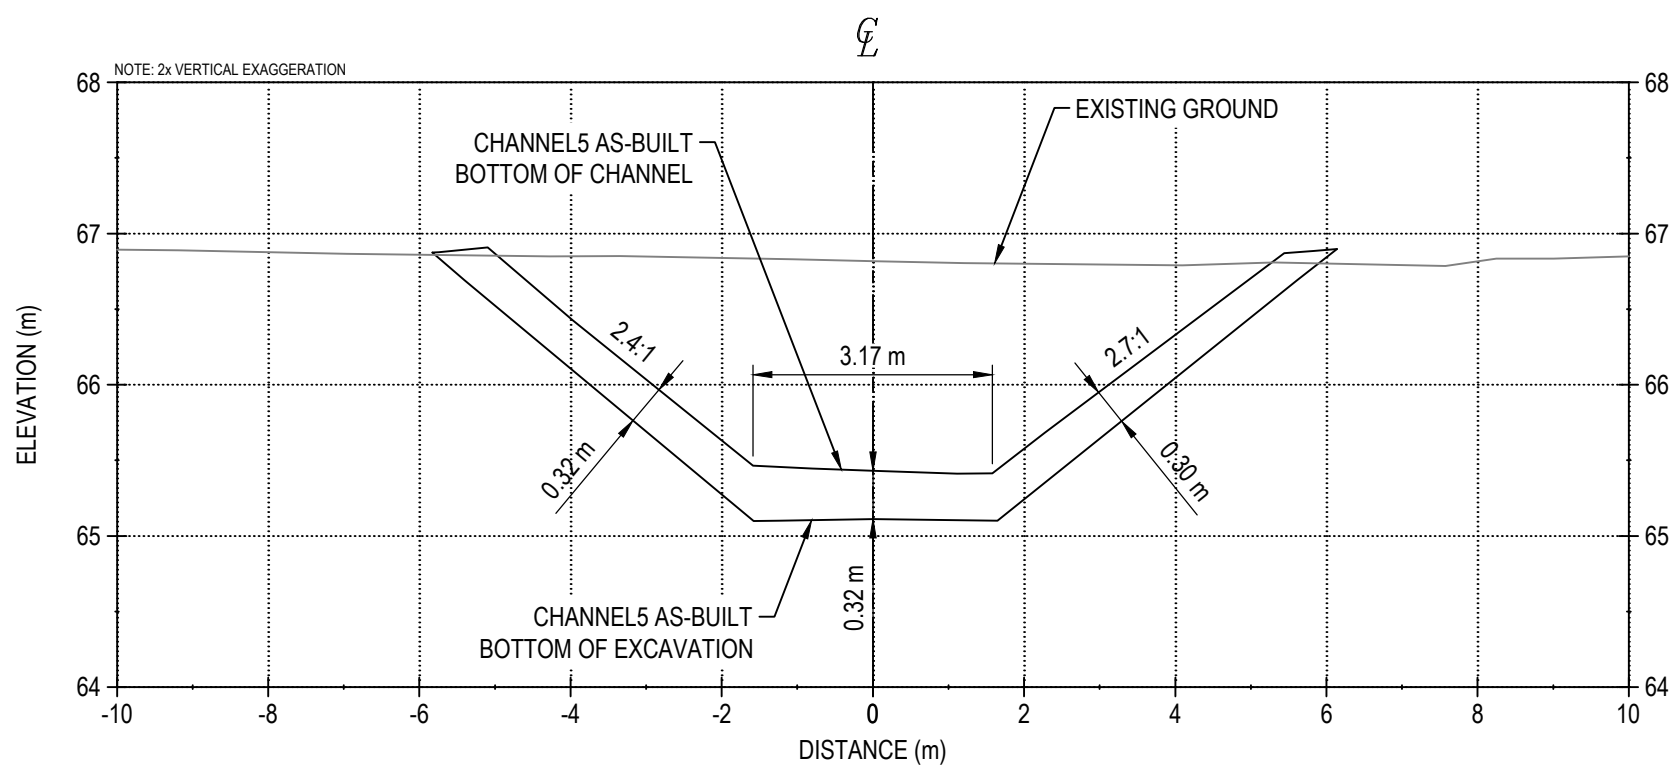
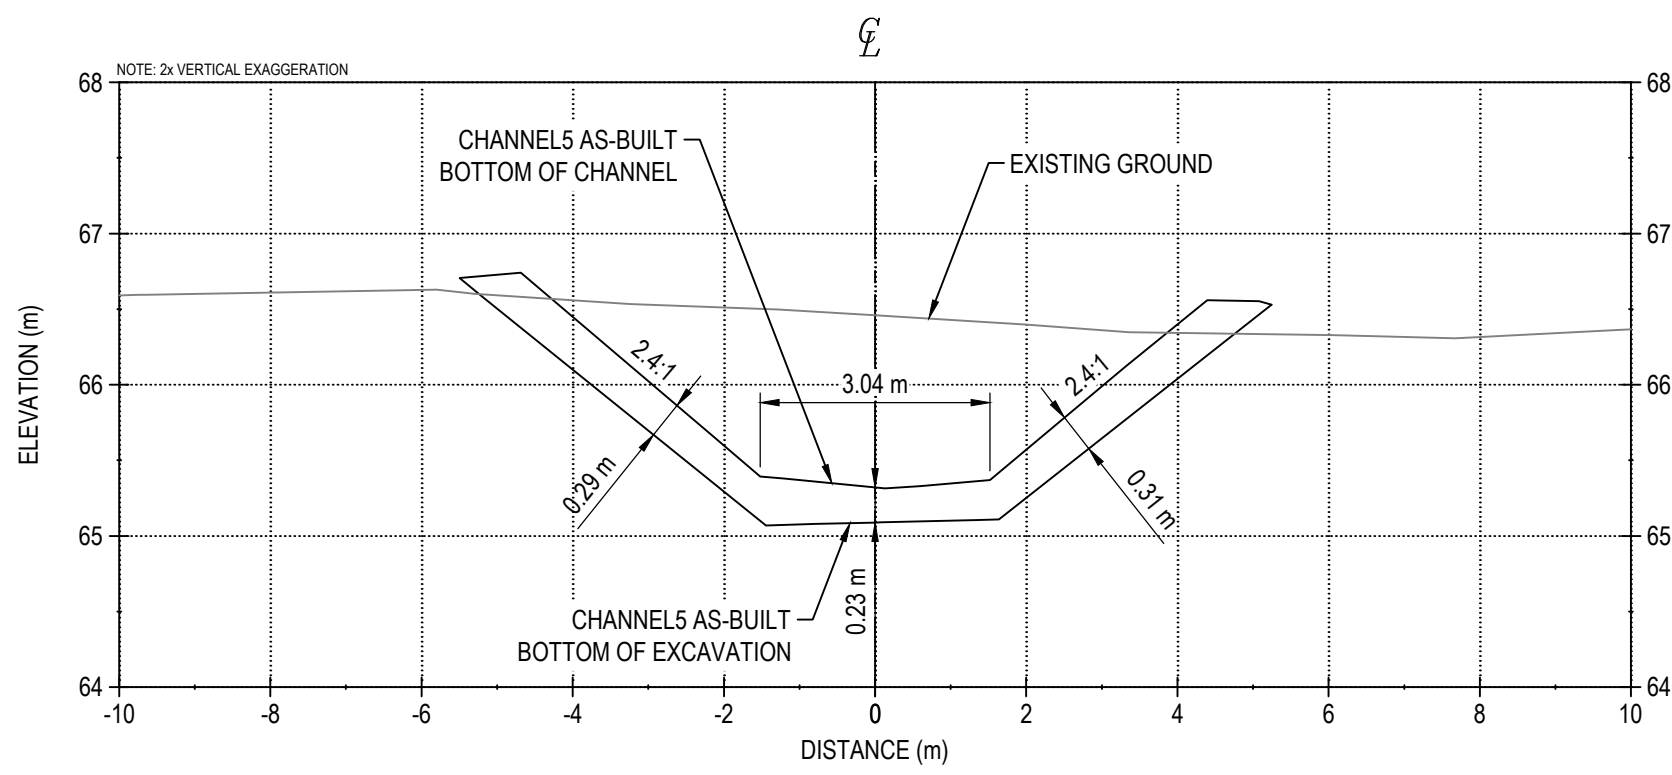
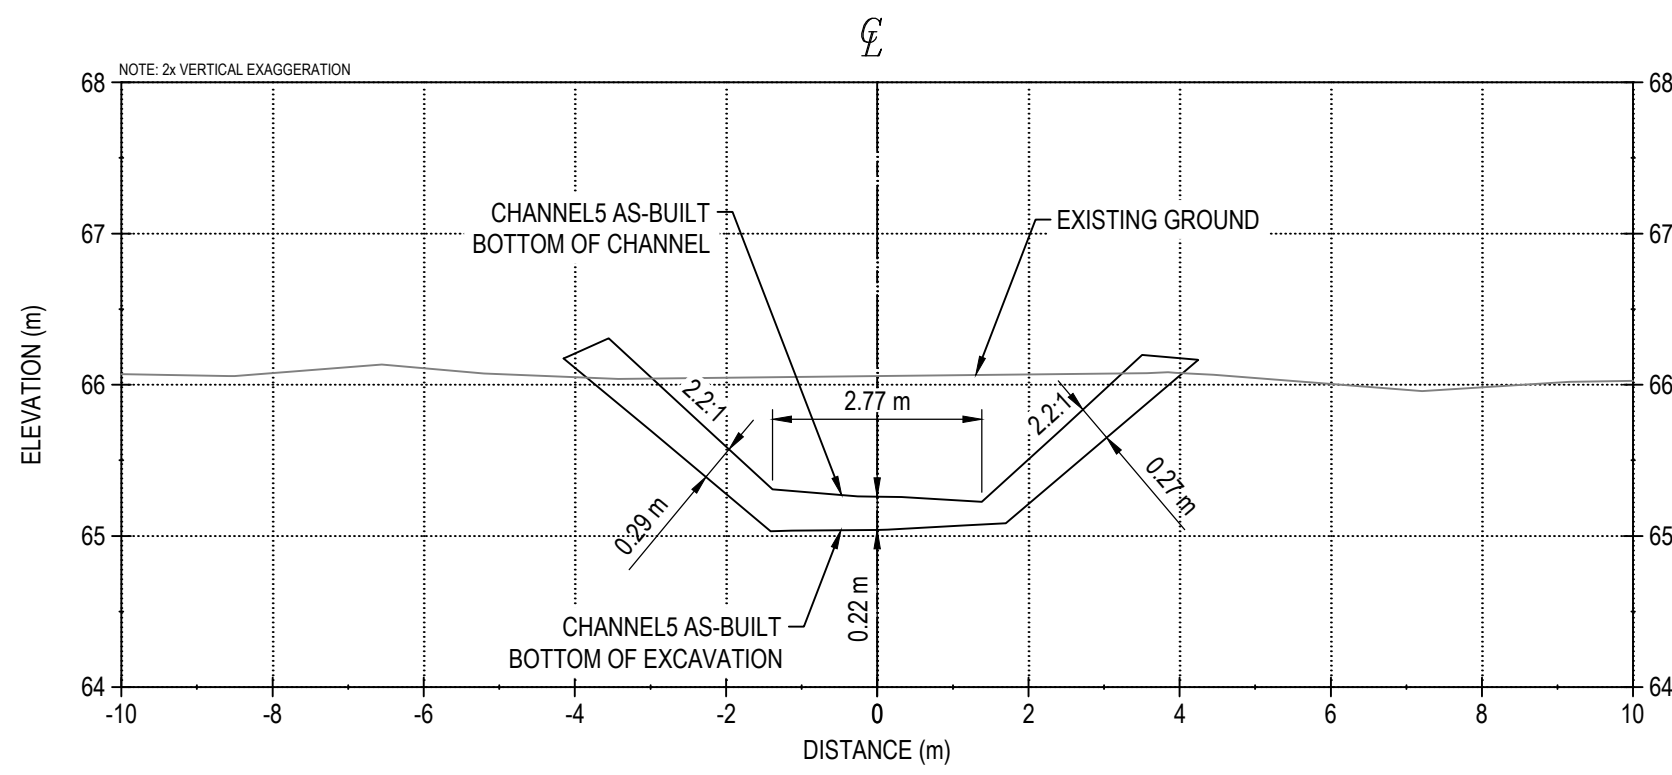
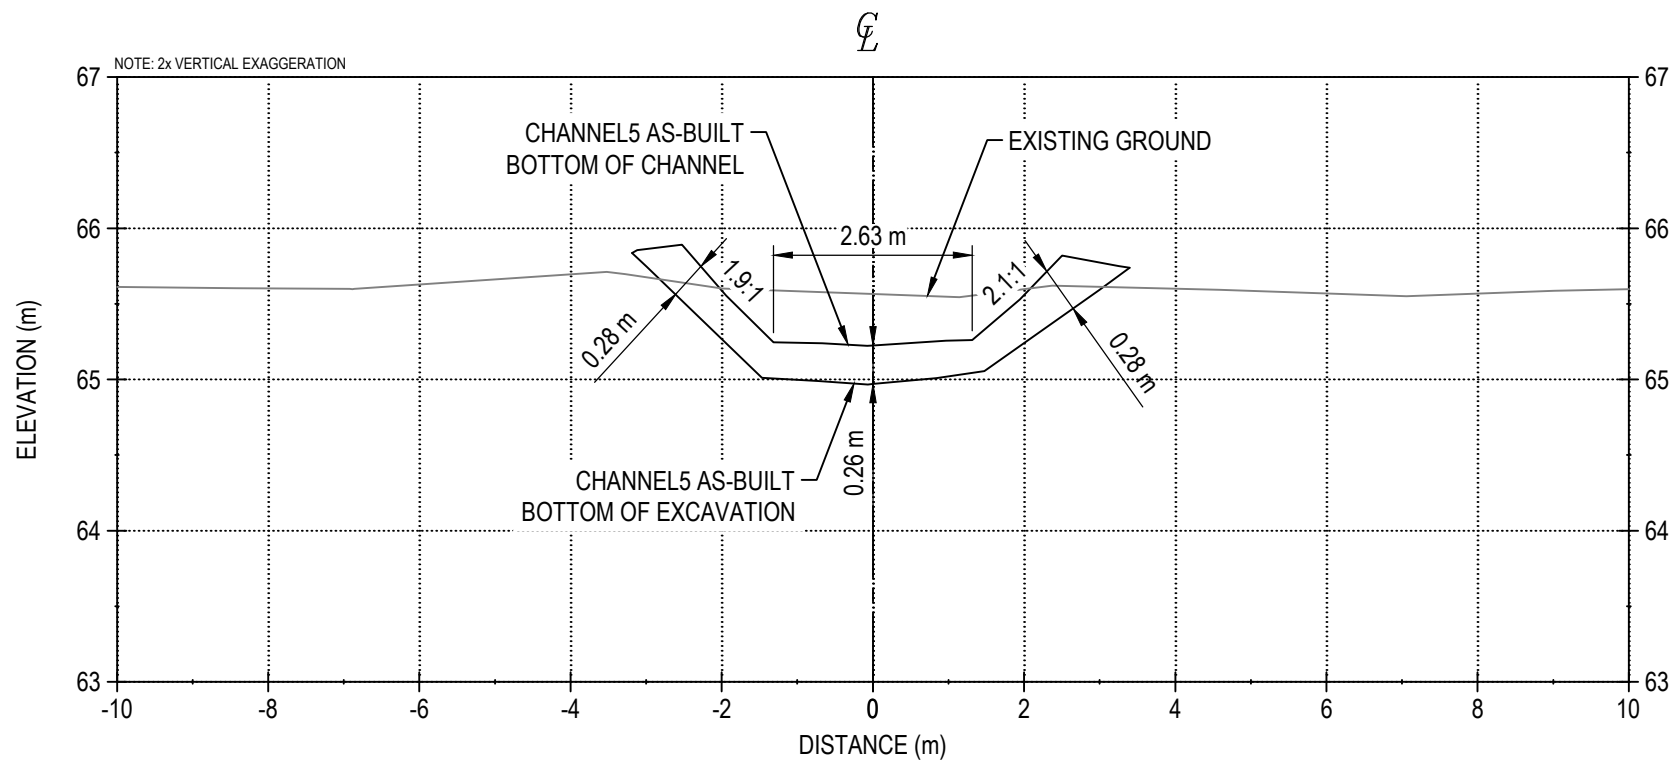
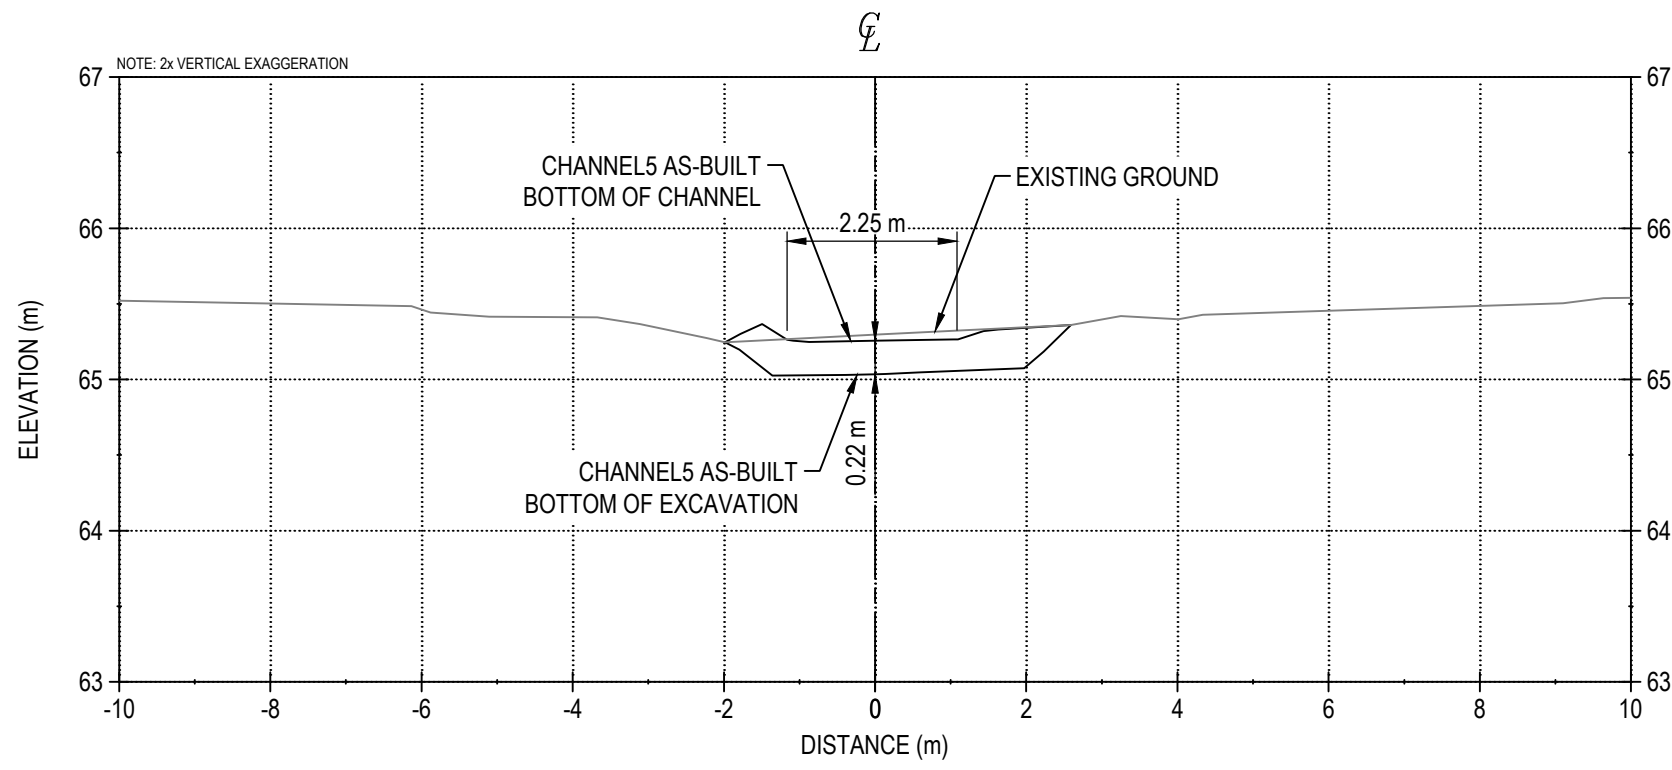
NO. DESSIN
DRAWING NO. 65-695-230-231

- The as-built channel section drawings (see 65-695-230-230 and 65-695-230-231) indicate that the rip-rap fill materials on the channel side slope crests were over-built above the existing ground at most of sections. This is acceptable.

CHANNELS AS-BUILT SECTIONS
STATION 0+260 TO 0+340
TYPICAL DESIGN SECTION AND QUANTITIES
