Meliadine Sewage Treatment Plant

Construction Summary Report (As-Built report)

In Accordance with Water License 2AM-MEL1631 (Part D, Item 3)

Agnico Eagle Mines Limited – Meliadine Division

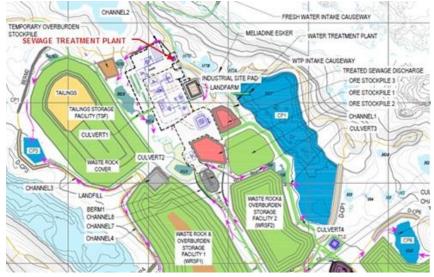
Figure 1. Plan of the site and location of the STP

The figure below presents a site location plan (Figure 1).

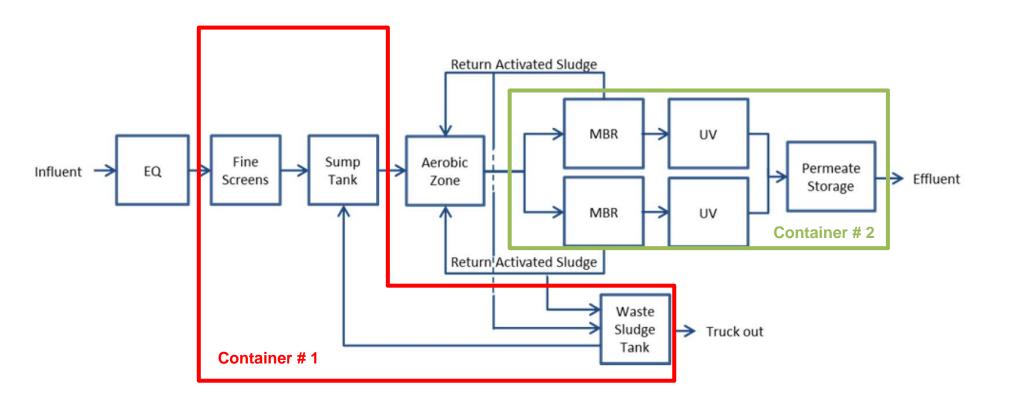
The STP relies on bacterial activity. The process is composed of five (5) steps described below: screening and flow equalization, aerobic biological treatment, membrane filtration, ultraviolet disinfection, and sludge handling. The flow diagram is available in Appendix B.

Figure 2: Process Flow Schematics (The steps in the boxes occur in the structure (the red box is in container 1 and the green box is in container 2; the others occur in tanks outside)

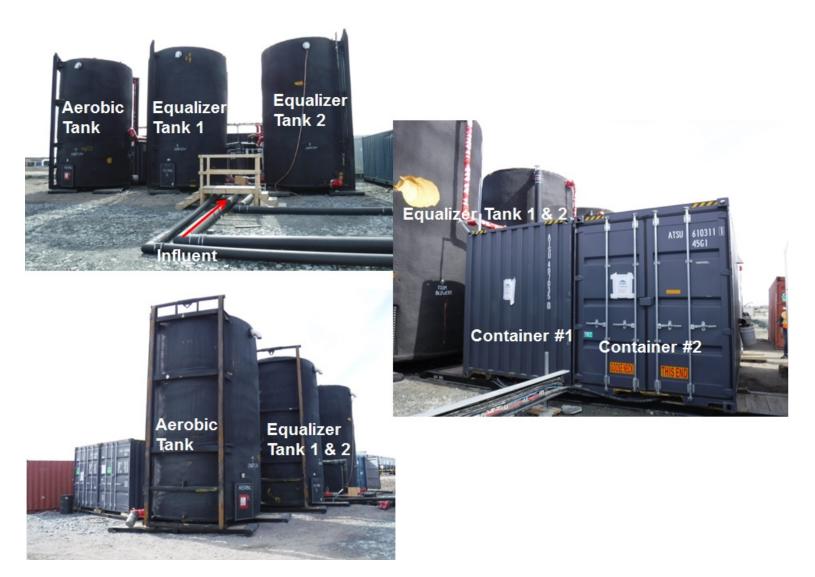
Photos of the ouside view of the Sewage Treatment Plant

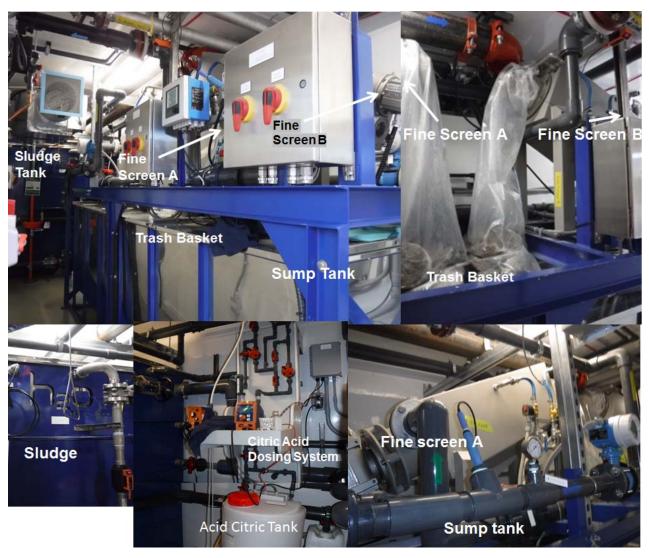
Photos of the inside view of Container # 1

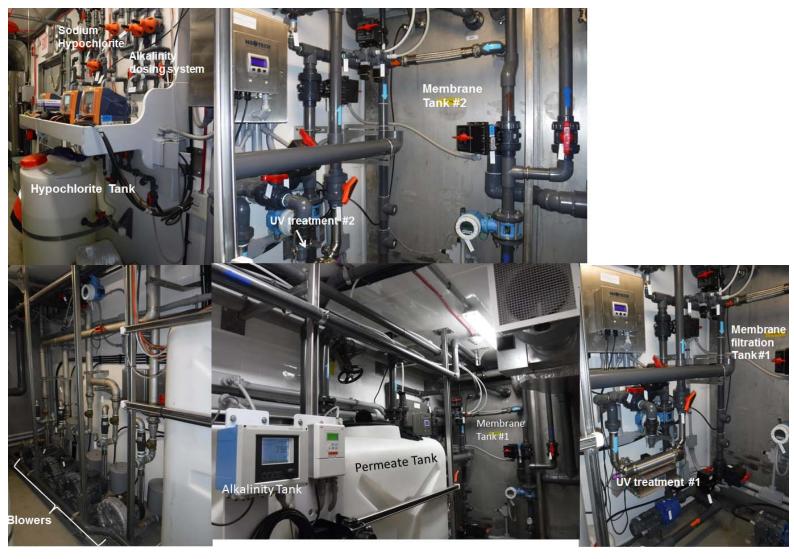
Photos of the inside view of Container # 2
