CONSTRUCTION SUMMARY (AS-BUILT) REPORT FOR OPERATION LANDFILL (STAGE 1) MELIADINE PROJECT, NUNAVUT

DECEMBER 2017
ISSUED FOR USE
TETRA TECH PROJECT NUMBER: 28920
AGNICO EAGLE DOCUMENT NUMBER: 6515-E-132-007-132-REP-014

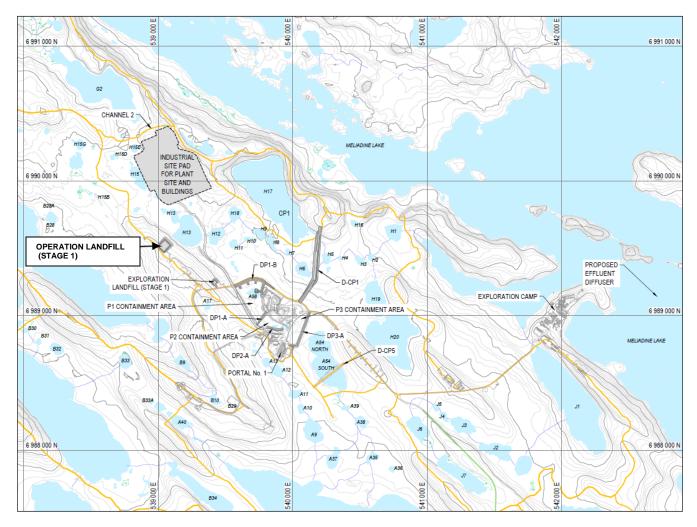
The figure below presents a site location plan for the Operation Landfill (Stage 1).

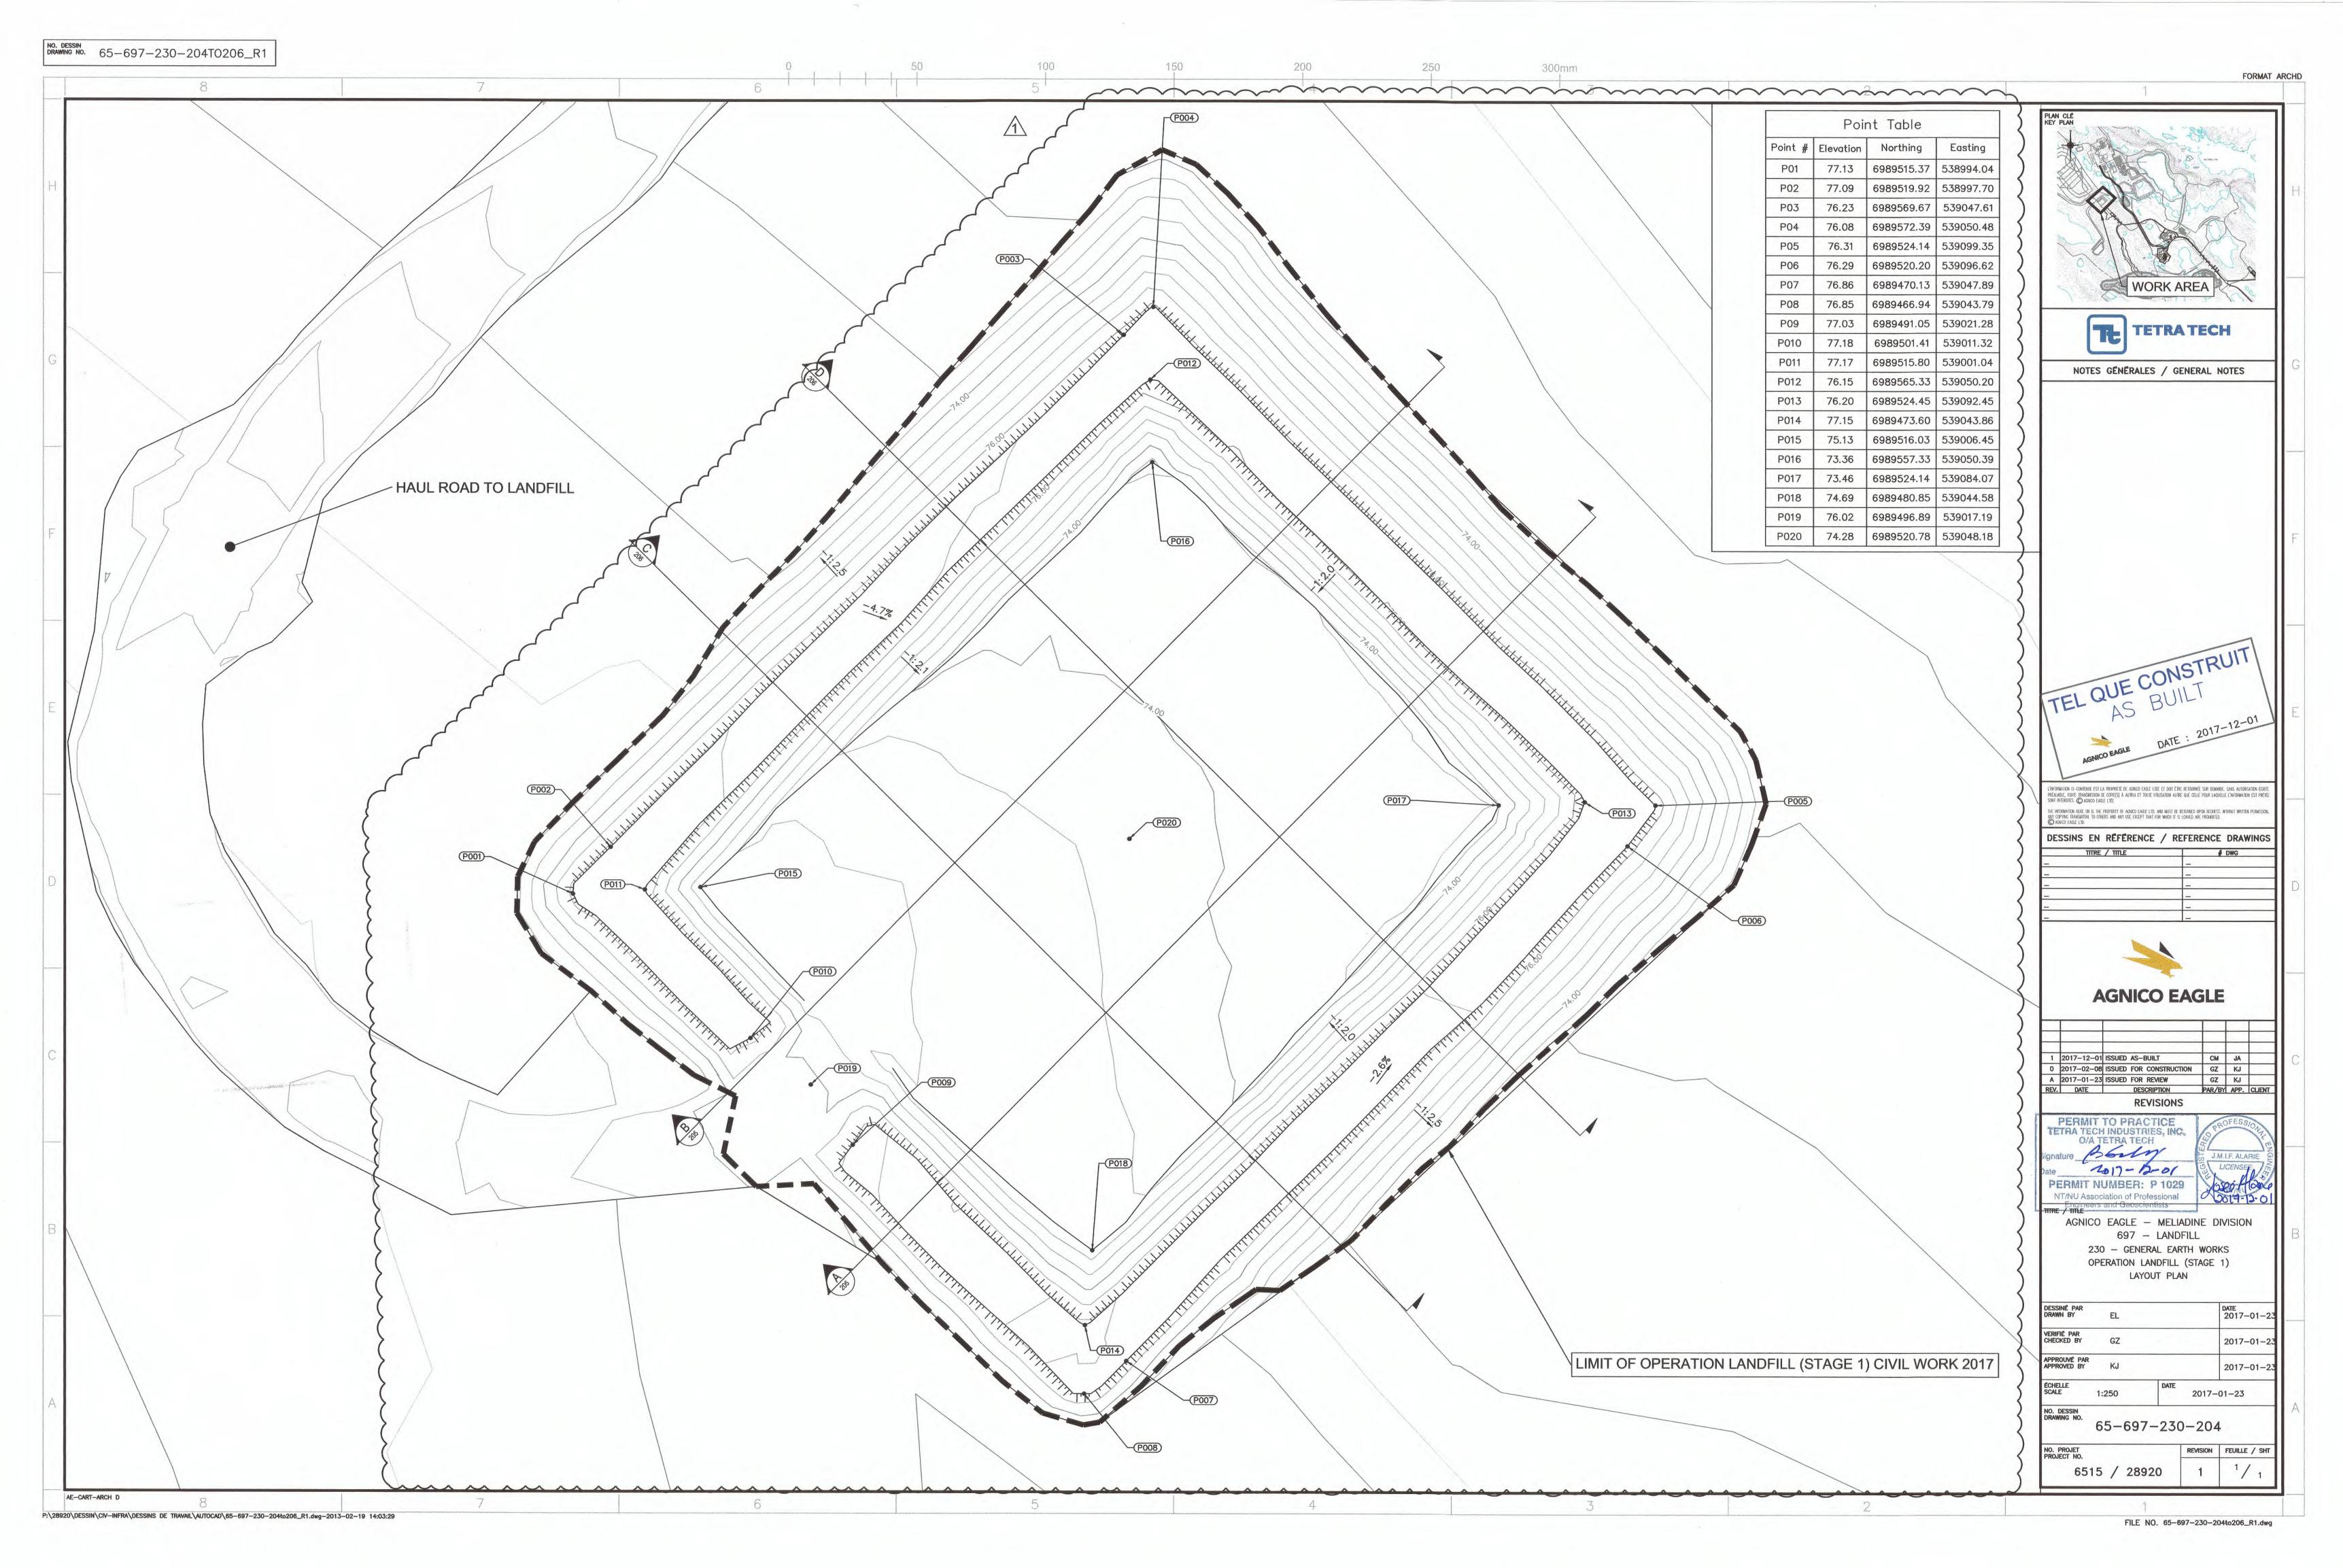
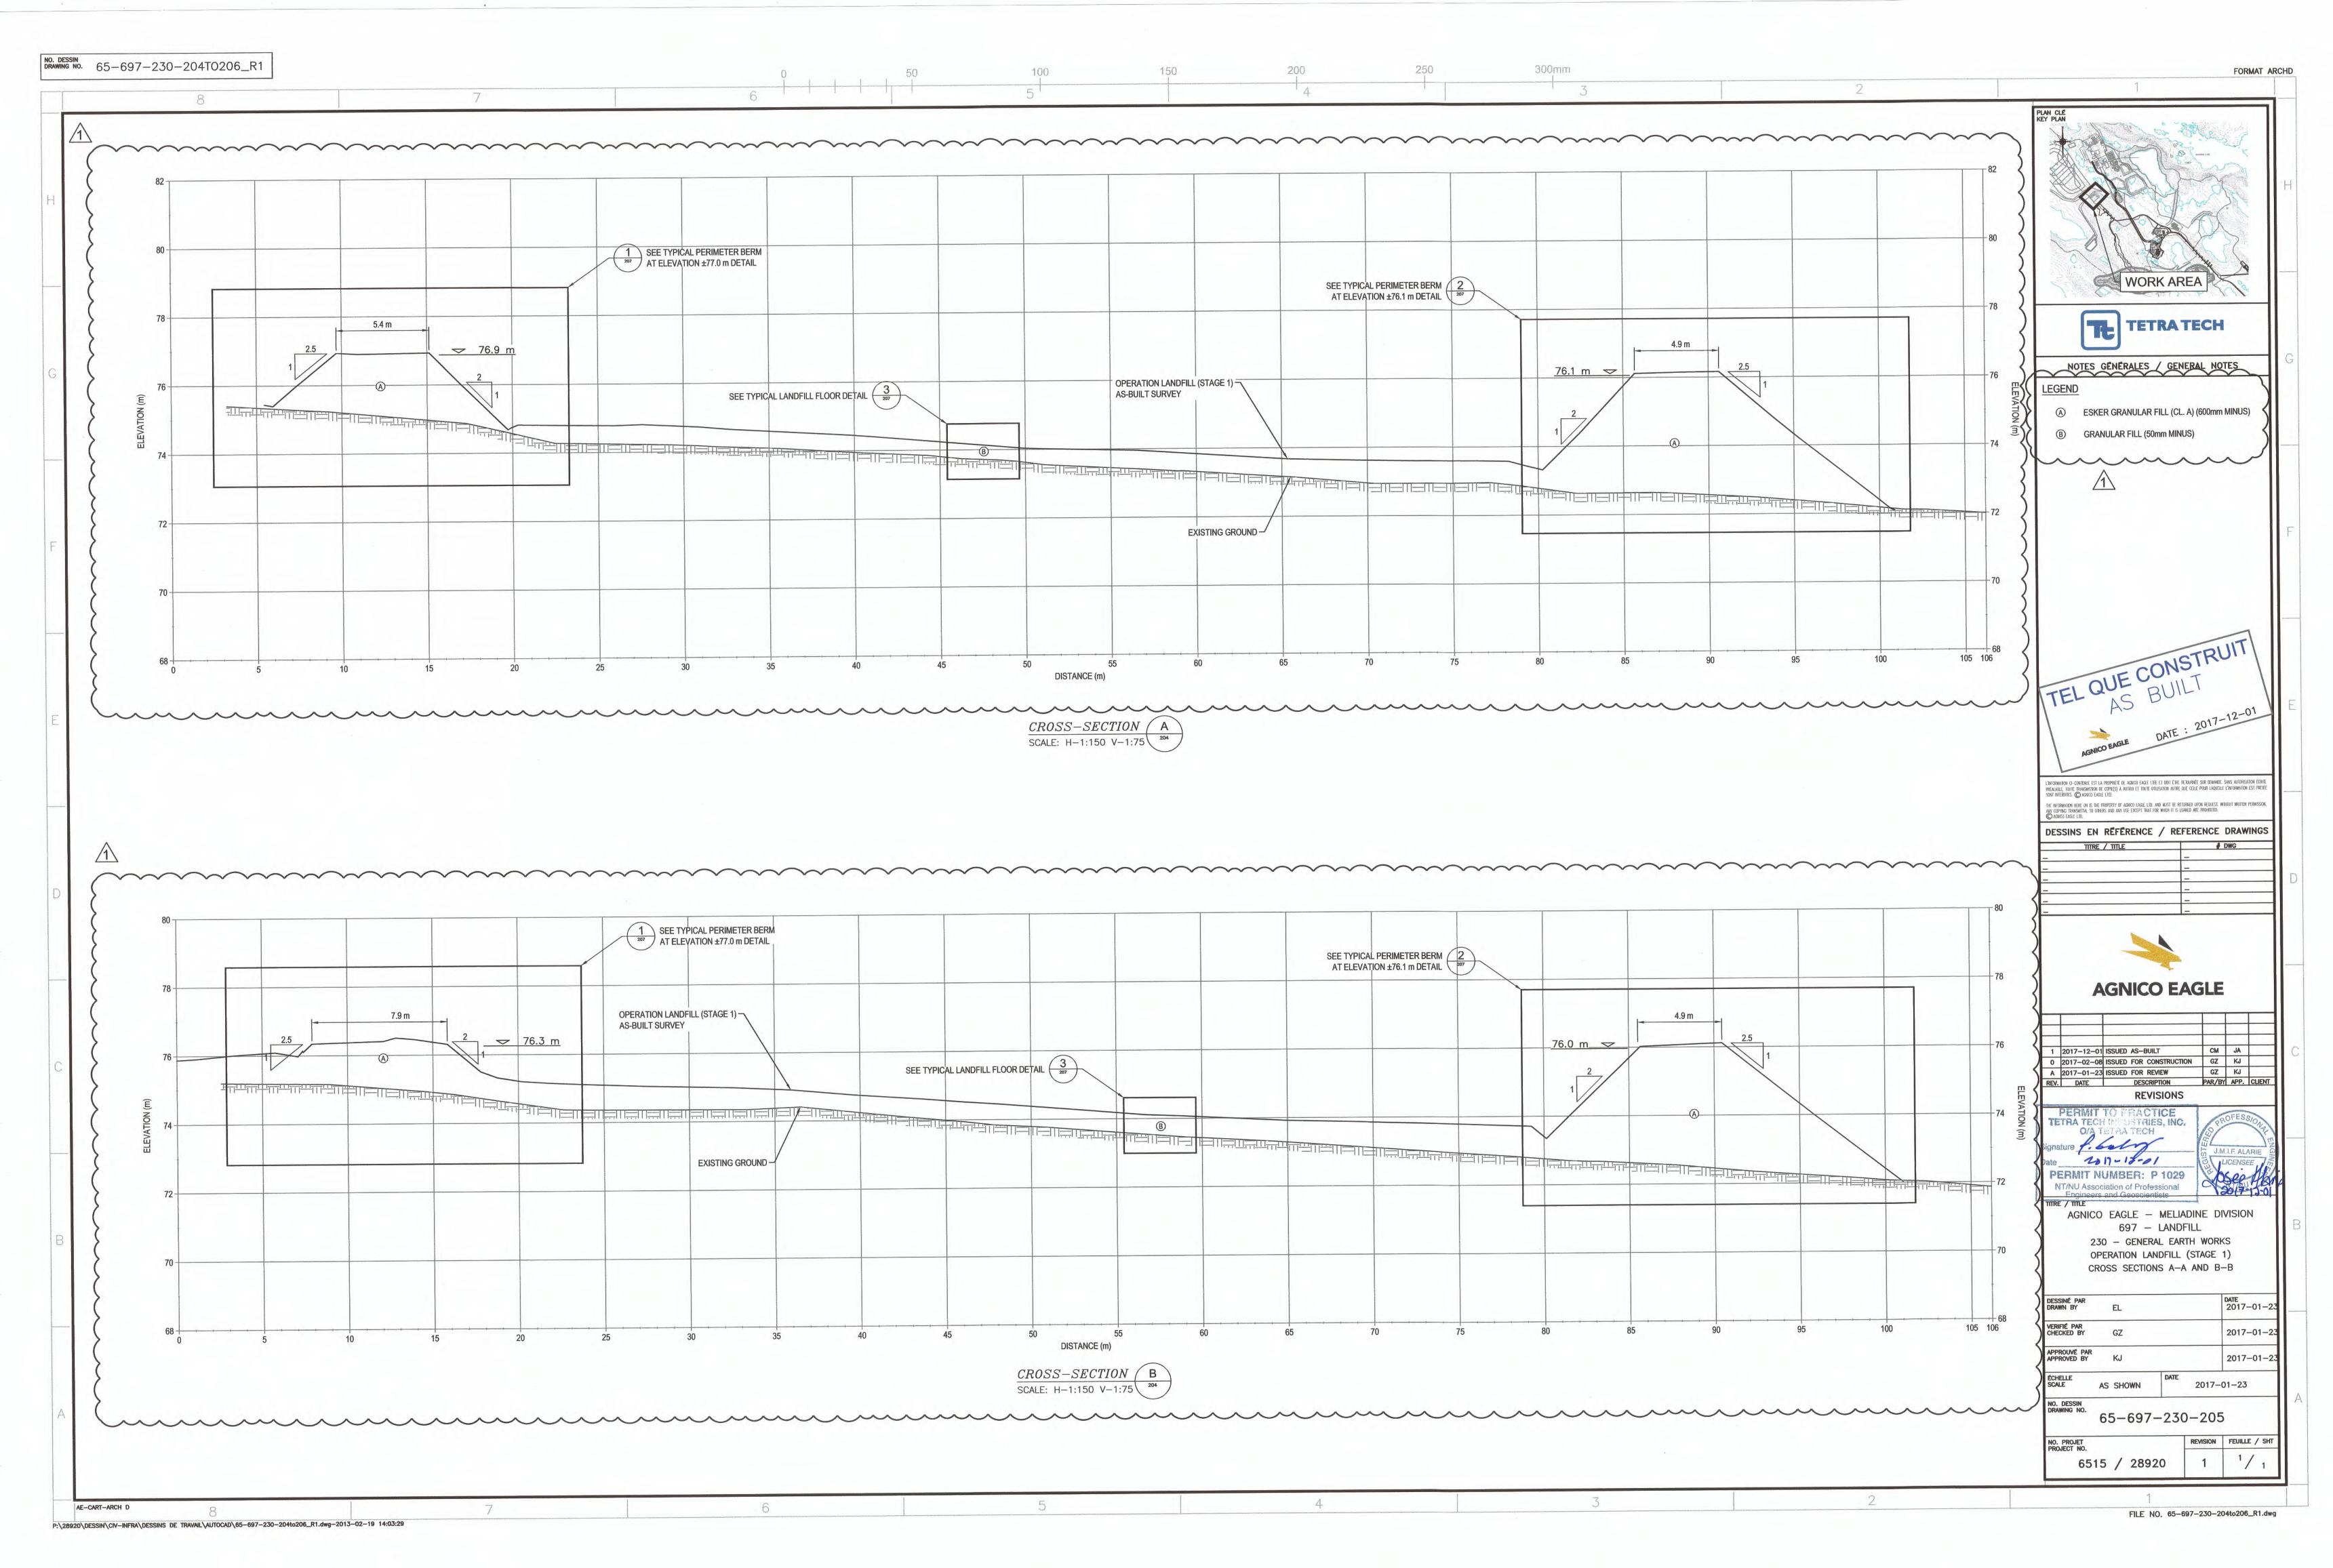
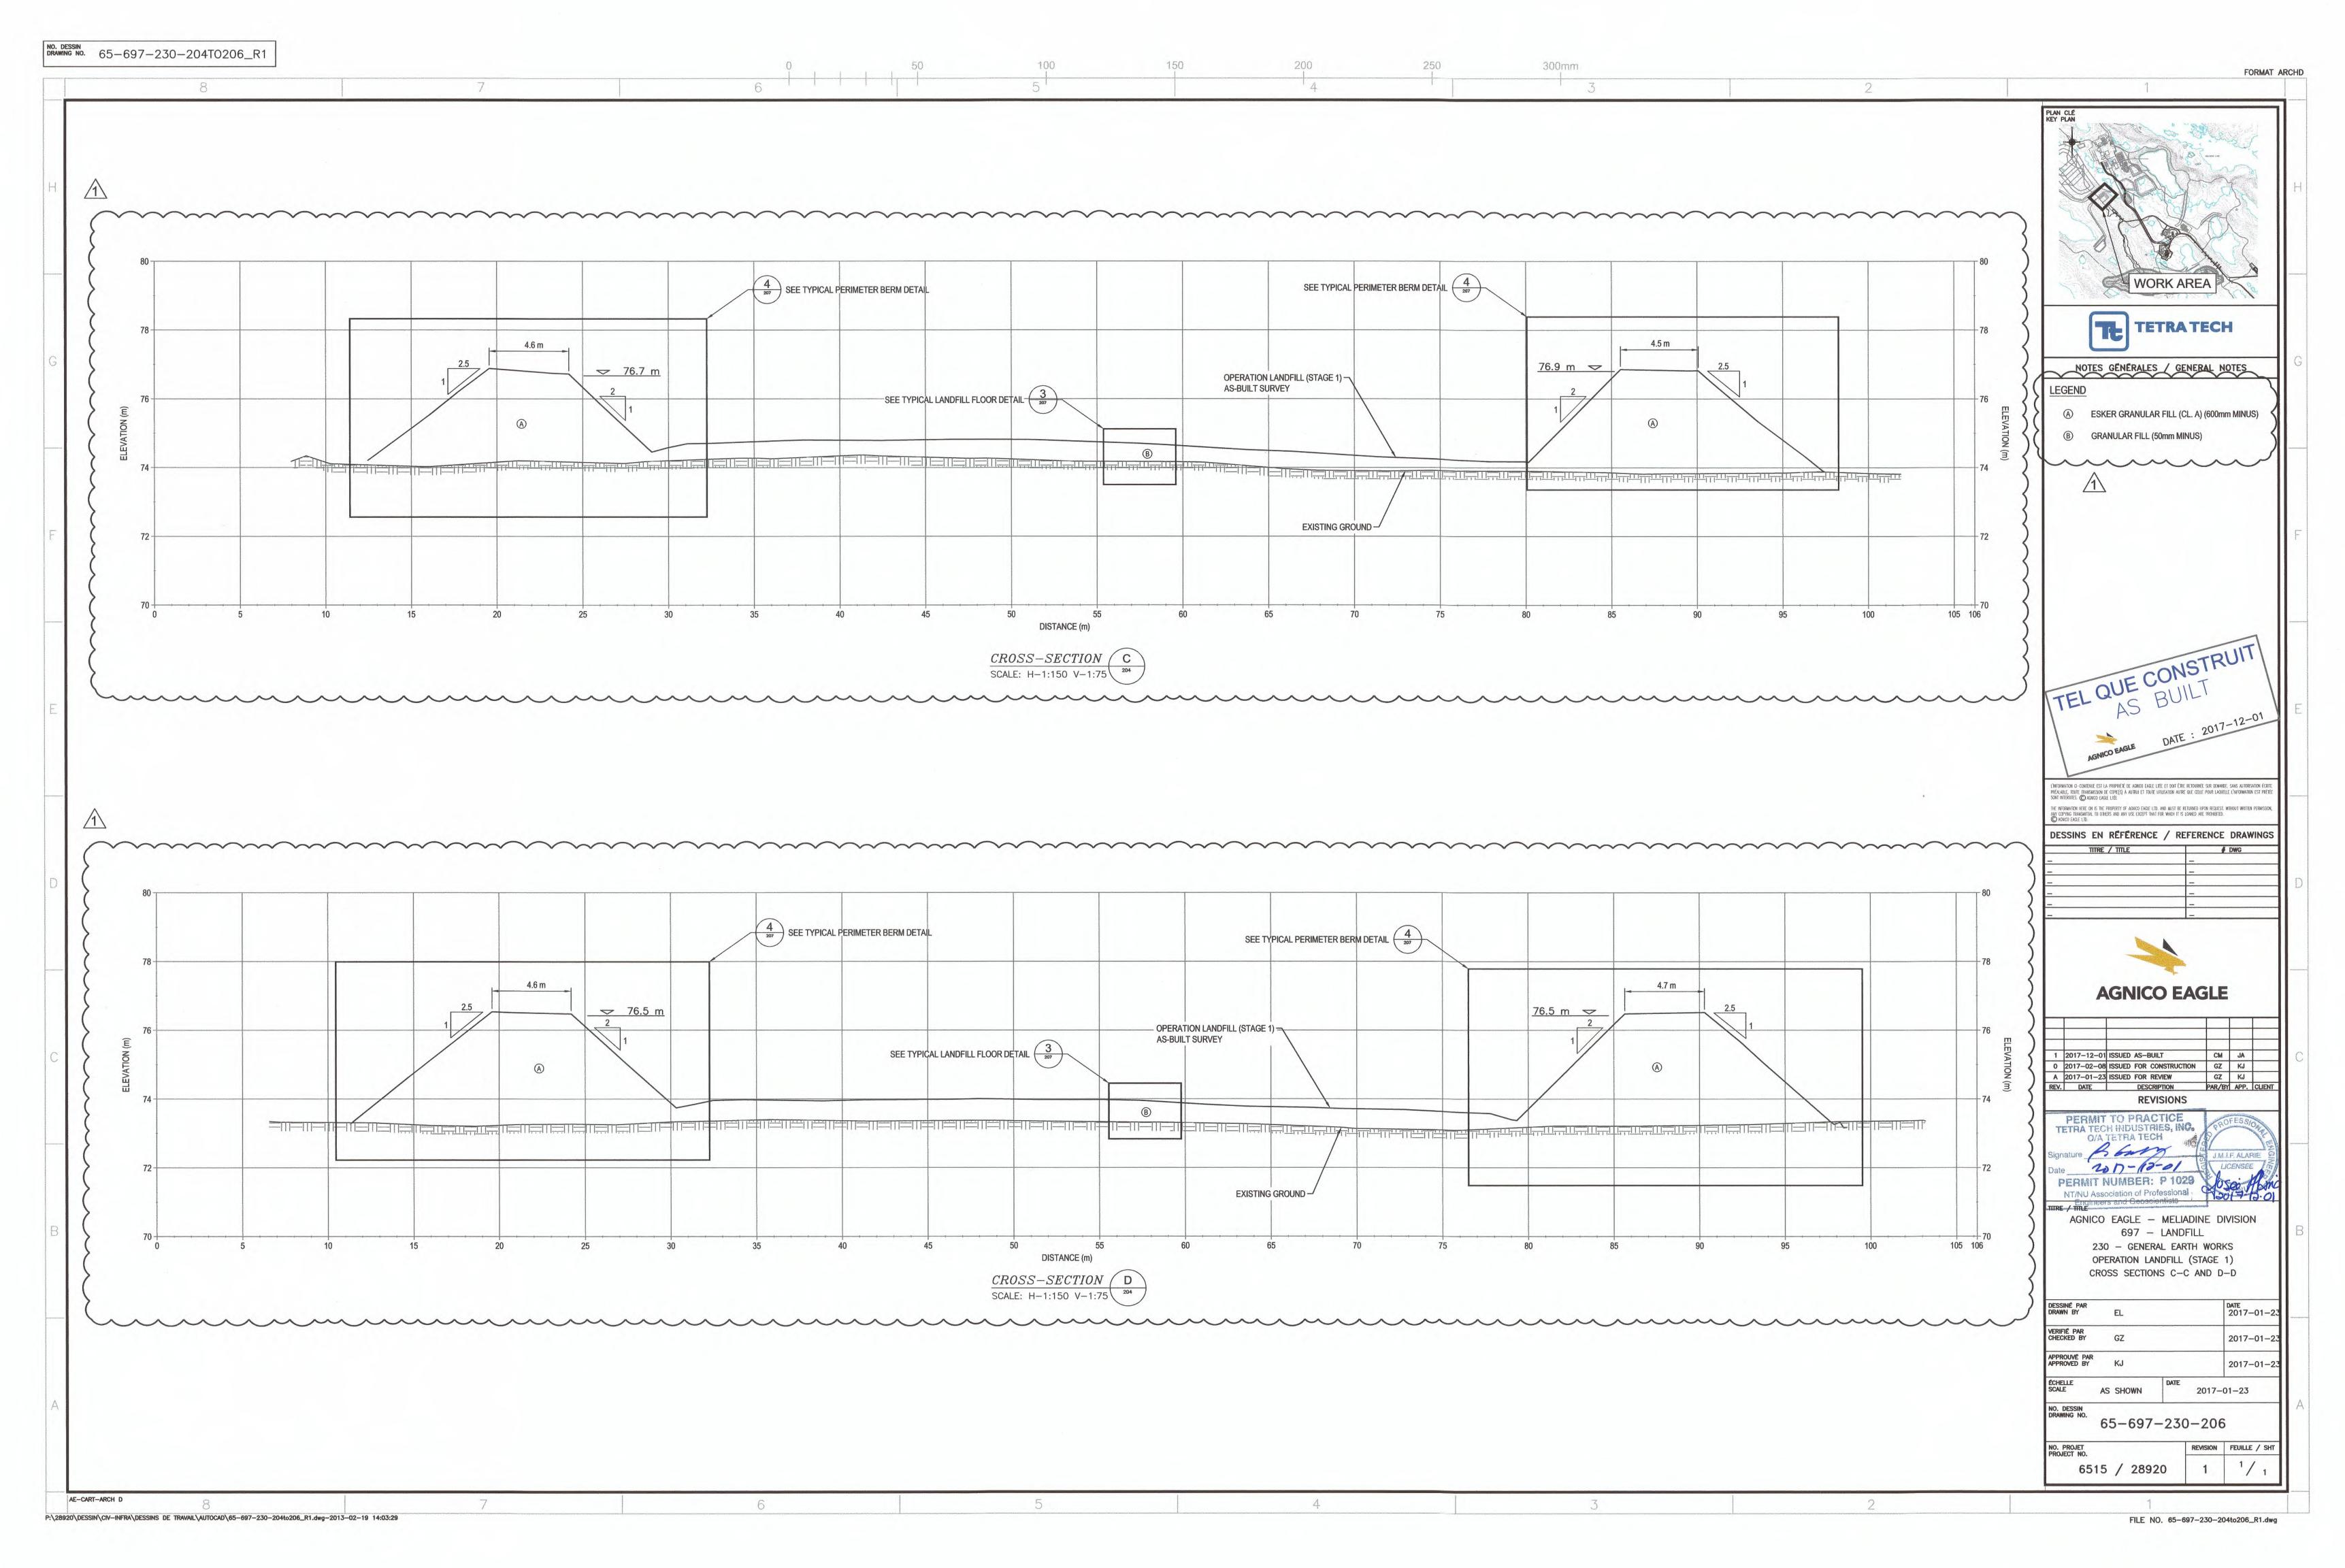
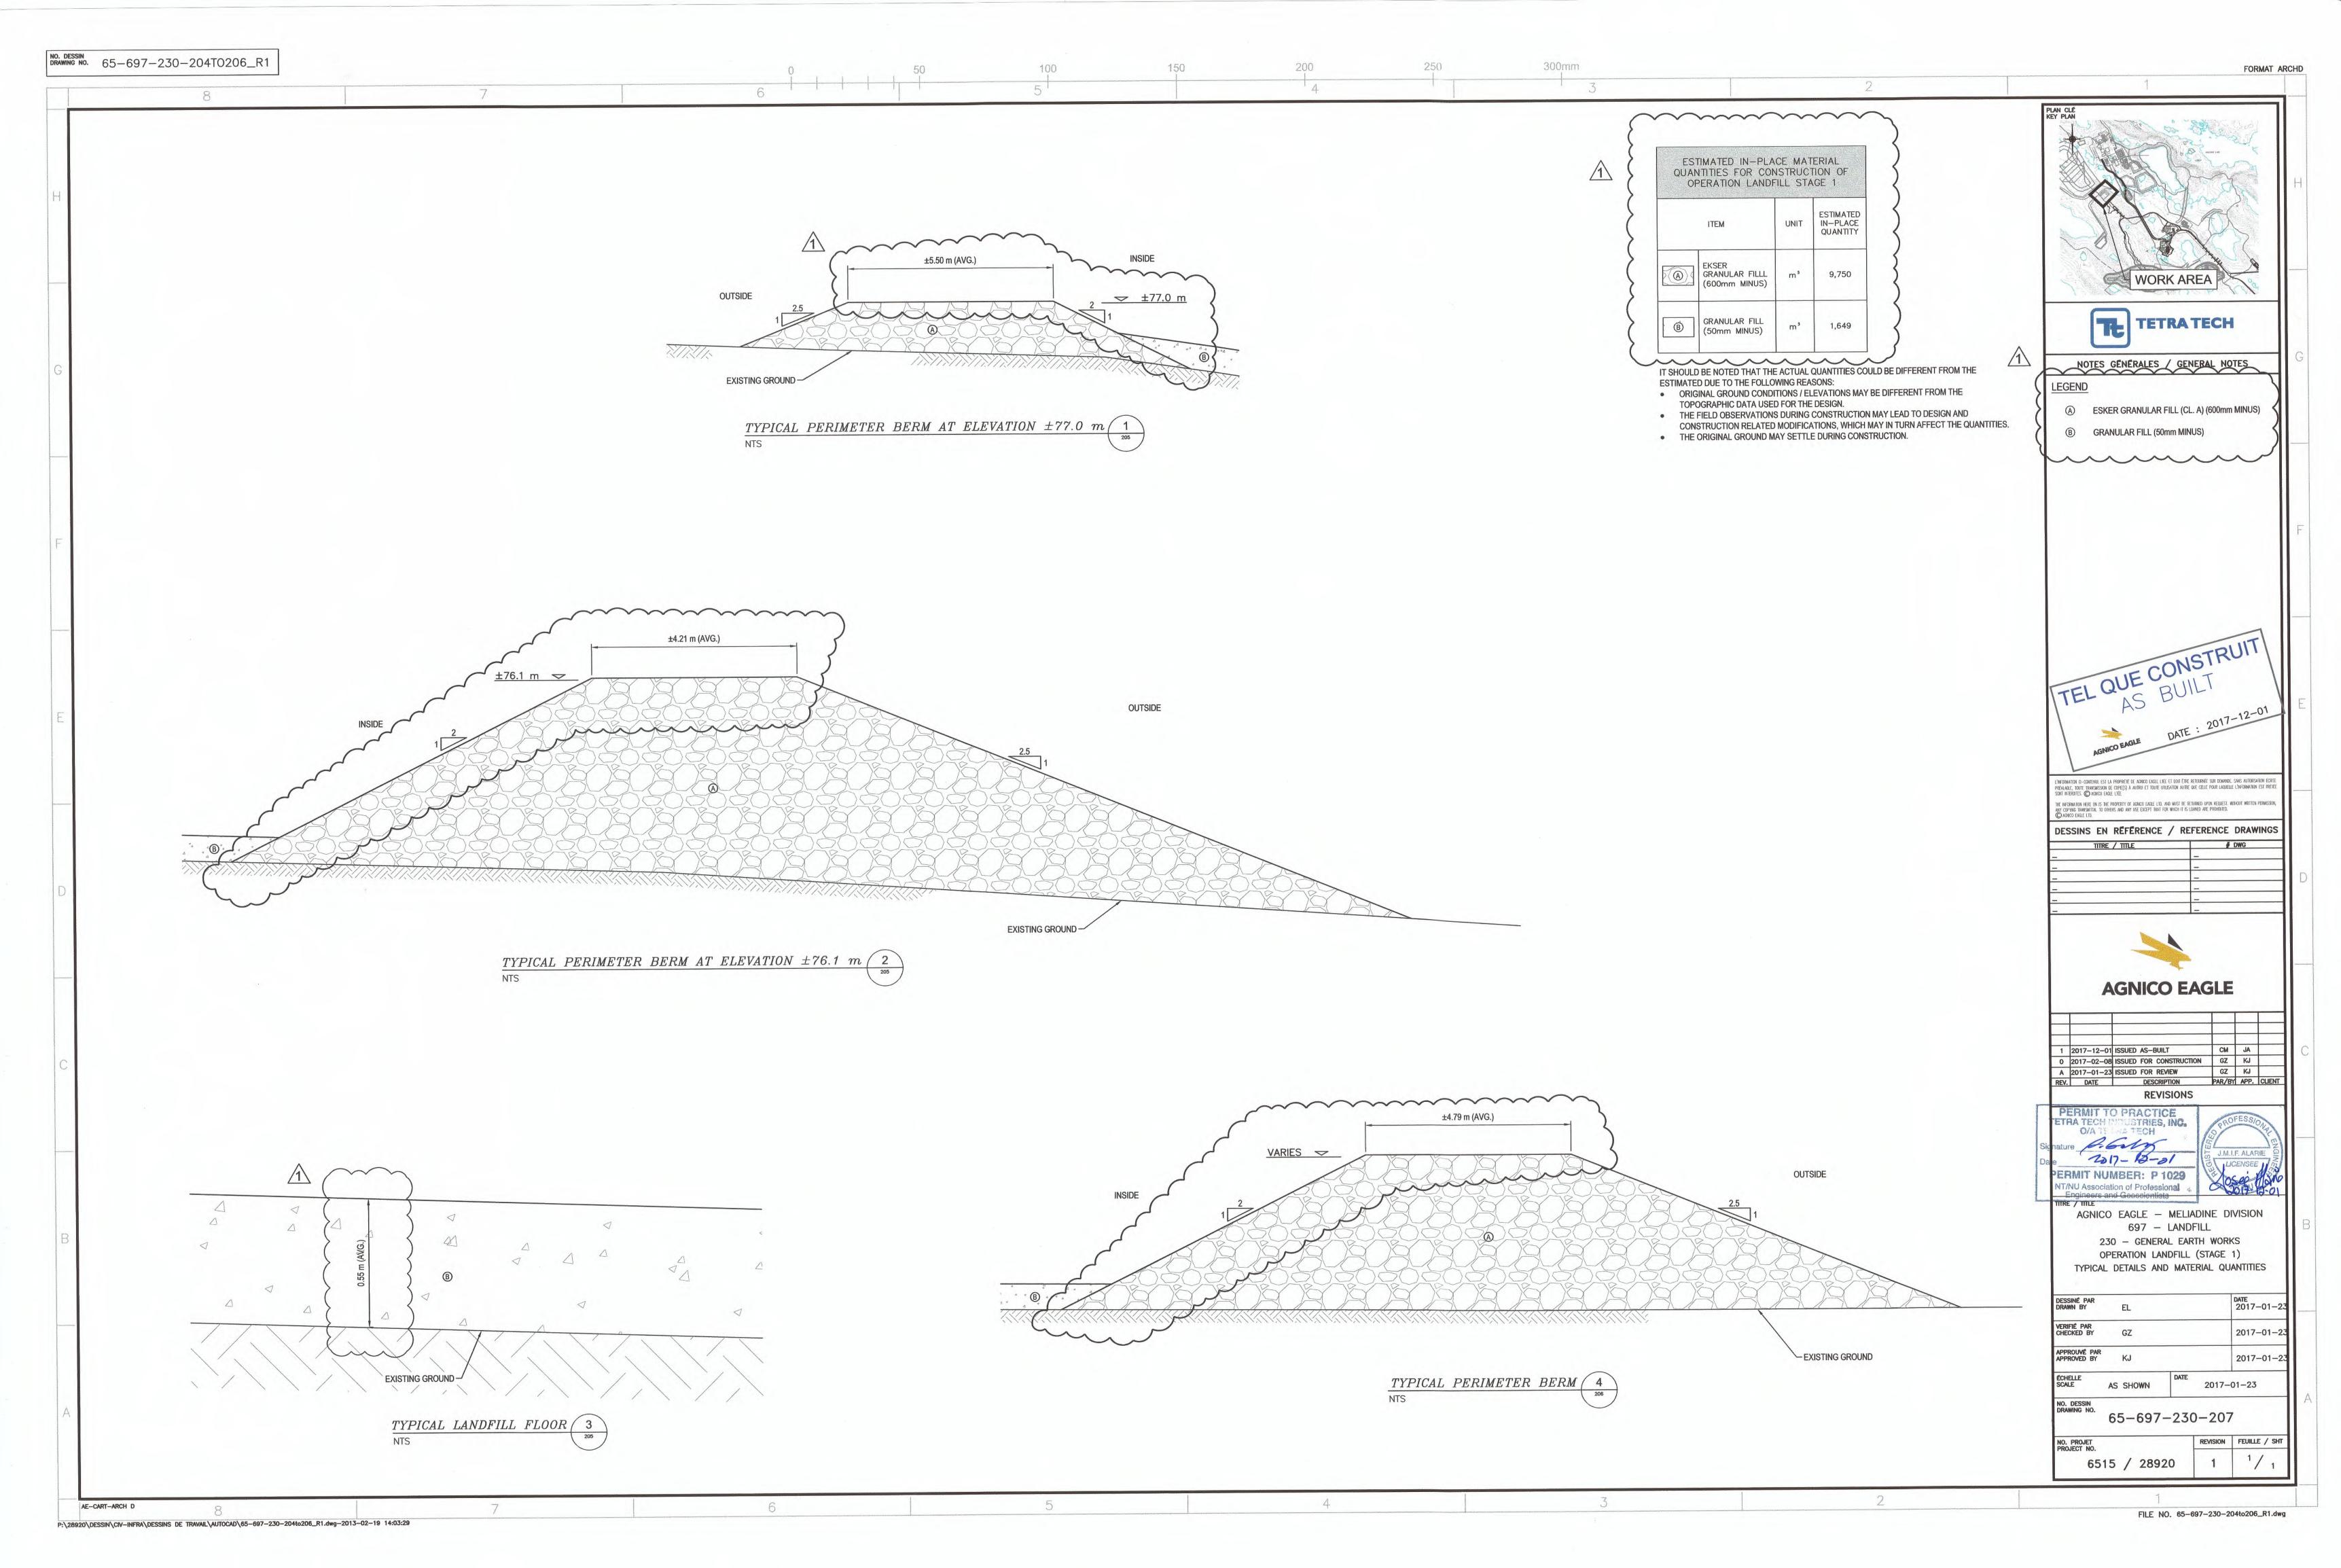
As-built drawings are presented in Appendix A.

The construction of Operation Landfill (Stage 1) is different from the original design on these following points:

- The construction work led to slight variations from the original design in the geometry of the Operation Landfill (Stage 1):
 - The exterior dimensions of the berm crest are greater by 0.23 m and 0.49 m.

- o The interior dimensions of the berm crest are smaller by 1.8 m and 0.61 m.
 - The average elevation of the berm crest was lowered by 0.26 m to an average elevation of 76.49 m.

- The average width of the berm crest is 4.79 m which is an increase of 0.79 m from the original 4m design.
- These changes in the geometry compounded into a volume capacity of 8 760 m³ calculated from the floor base to the crests of perimeter berms, which is 774 m³ lower than the designed capacity. The reduced overall volume capacity does not impact the volume of waste and intermediate soil/rockfill that can be placed in the landfill. The total storage capacity was designed to accommodate an estimated waste volume of 4 368 m³, an estimated volume of intermediate soil/rockfill cover of 3 021 m³, and a remaining capacity of 2 055 m³ for temporary storage of internal runoff and drainage. The estimated volume of runoff water during a 1 in 100 return wet spring freshet is up to 960 m³ (assuming no seepage through the berms), so the remainder is for freeboard. The reduced volume capacity would result in reducing the remaining capacity for temporary storage of the internal runoff by the same amount, which would affect the freeboard allowance but is still sufficient to store the runoff water as designed.

- An opening in the southwest side of the perimeter berm was left to allow for vehicle access/dumping. Depending on the waste disposal management plan and schedule for the landfill, the perimeter berm may need to be completed in the future to close the opening for vehicle access as the volume of waste is dumped/placed into the waste area. This is to ensure that the remaining capacity to allow for the temporary storage of the internal runoff and drainage is respected, otherwise when reaching a fill volume of 6 250 m³ there will no longer be a capacity to retain the internal runoff within the landfill, as it would flow through the opening kept in the perimeter berm.

- The average floor slope was lowered by 0.8% to a slope of 2.7% going in the designed direction of southwest to northeast, matching the natural ground slope. This slope is still adequate allowing internal runoff to gradually seep through the northeast perimeter berm and naturally flow through a chain of internal water ponds (H13 to H6) and eventually flow in a final internal water collection pond (CP1).

- The average perimeter berm side slopes both interior and exterior remained the same at 1V:2H and 1V:2.5H respectively, thus the stability of the perimeter berm should not be an issue.

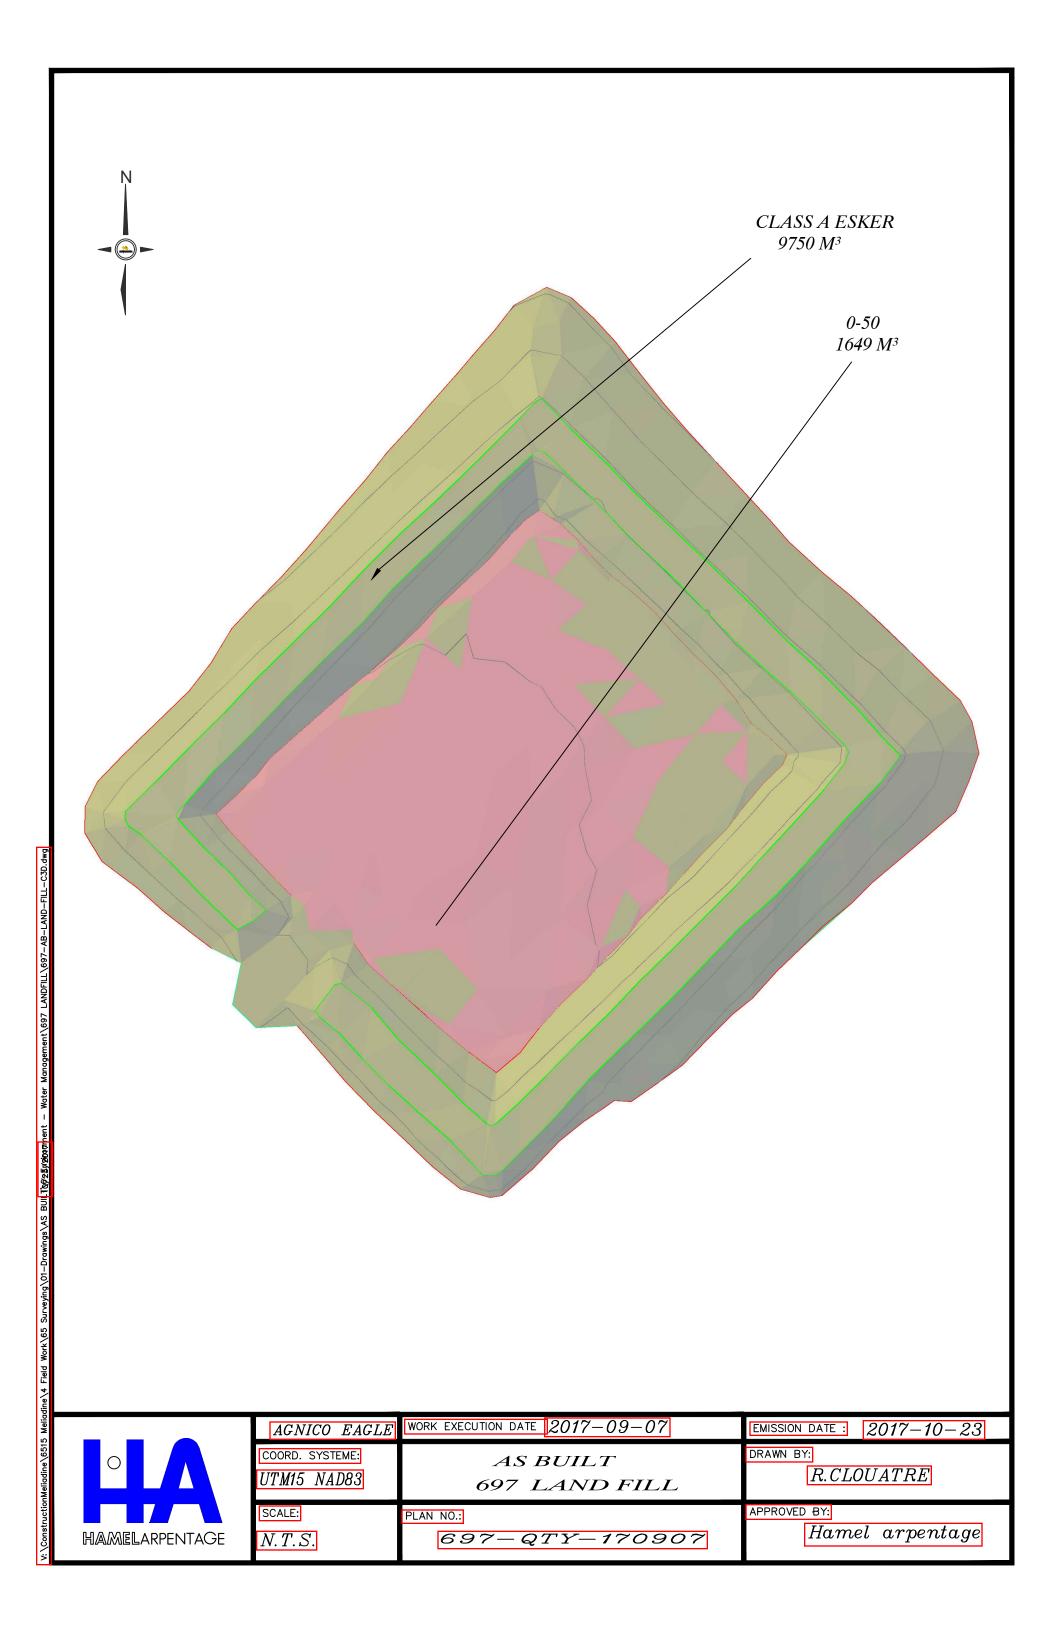
APPENDIX BSurvey drawings

A survey drawing conducted after the construction of the Operation Landfill (Stage 1) can be found in Appendix B.

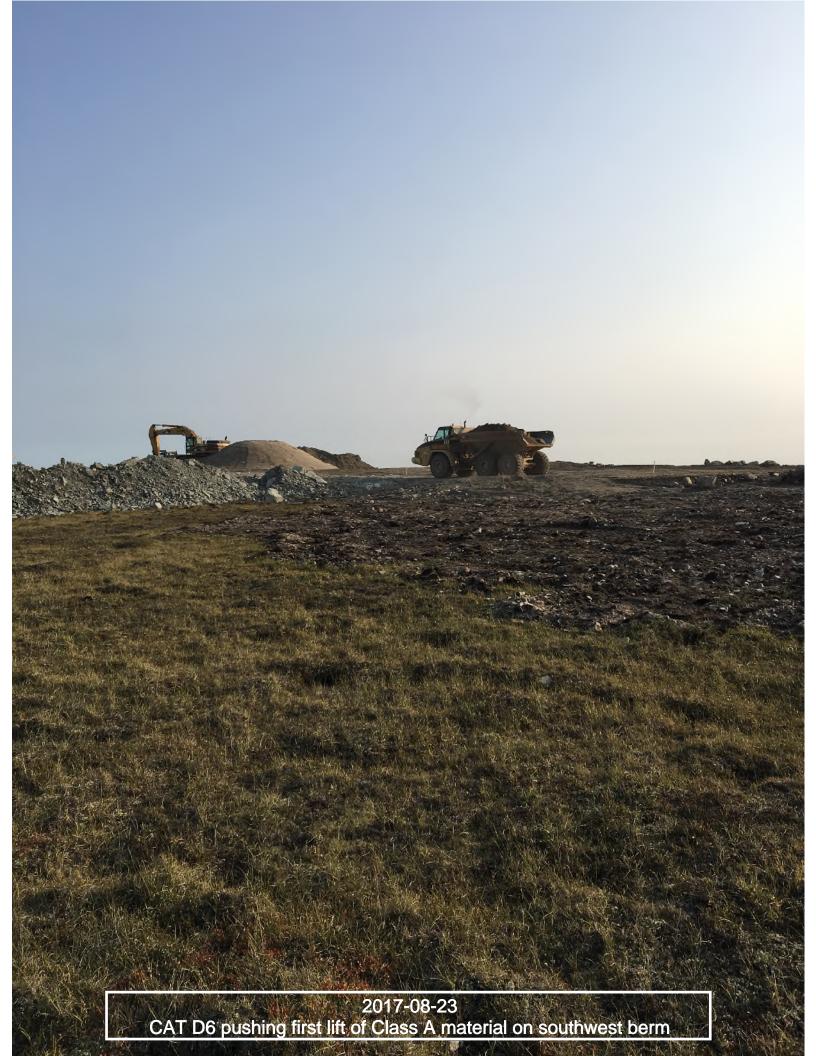
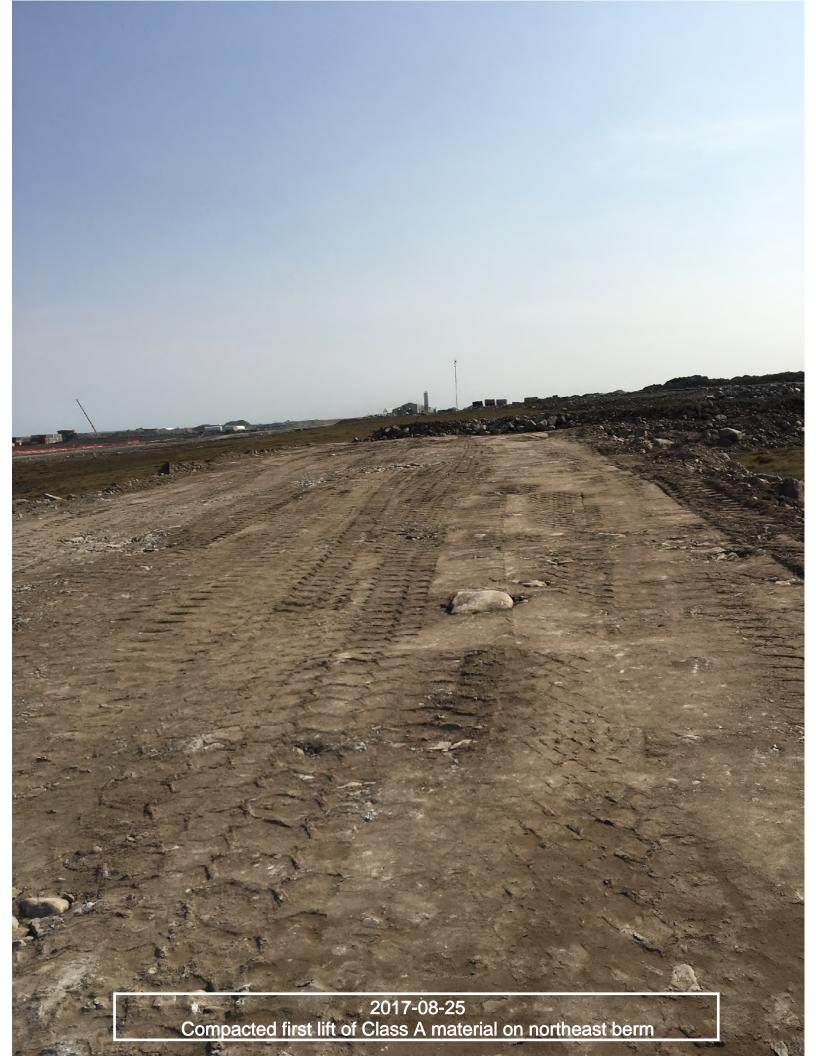
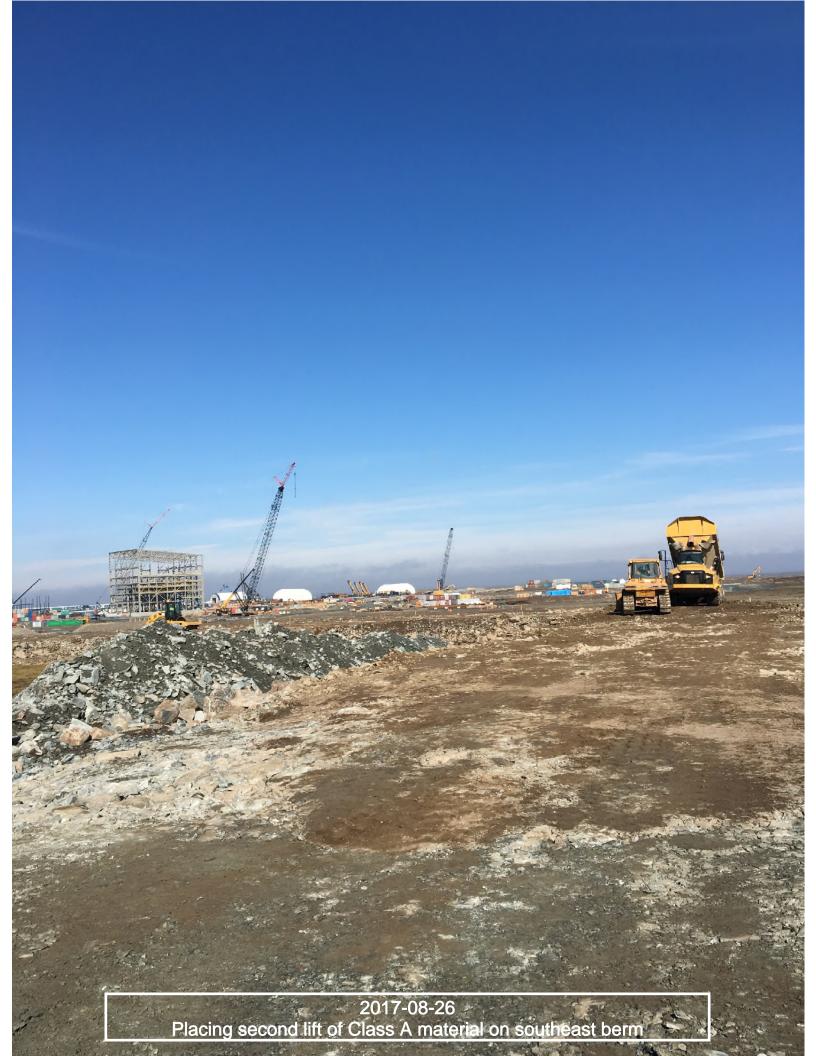
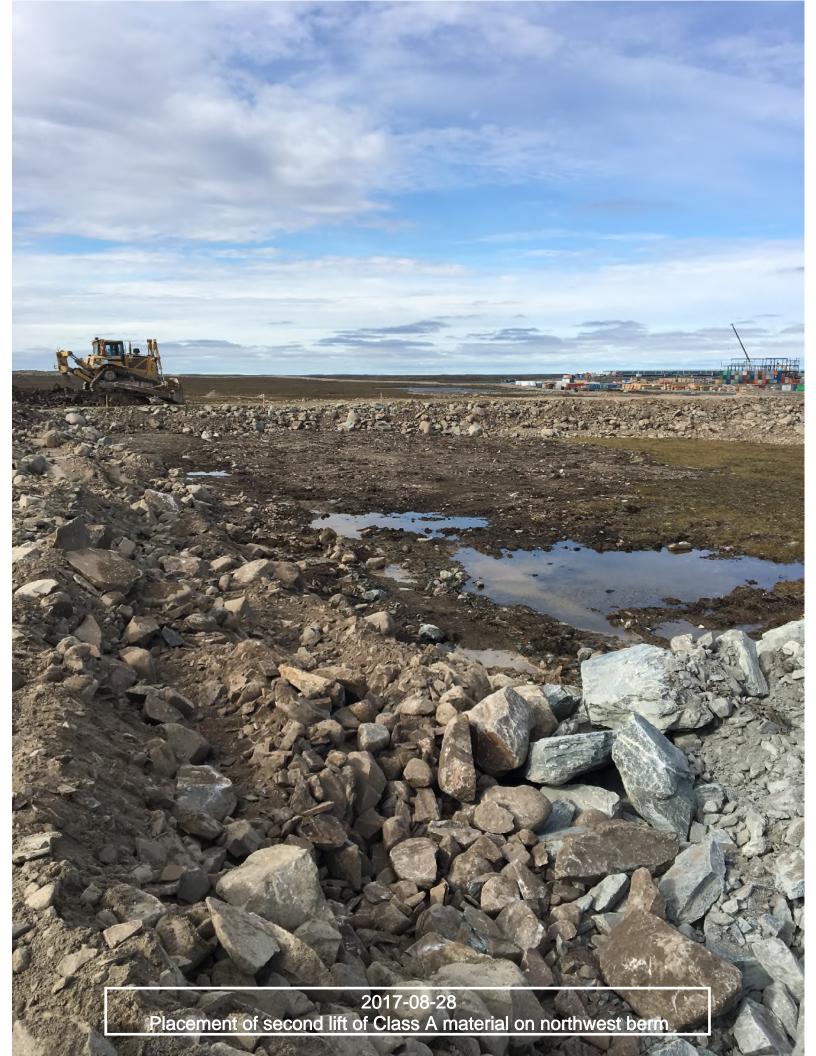
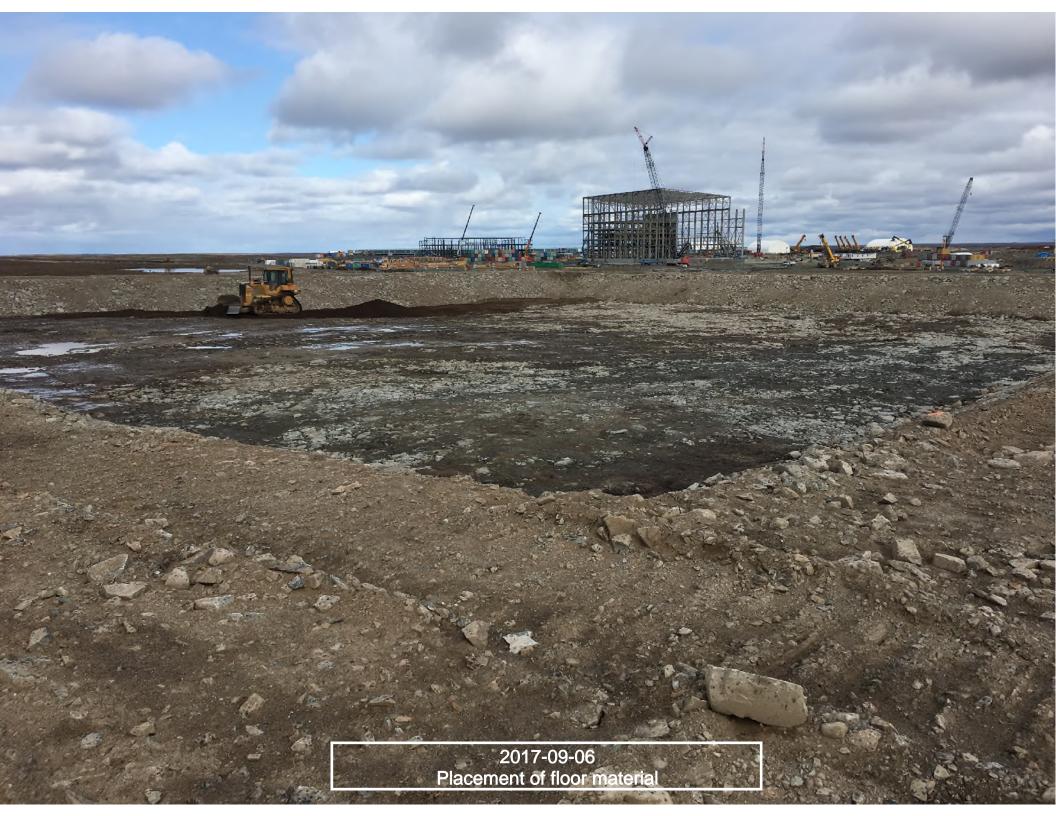
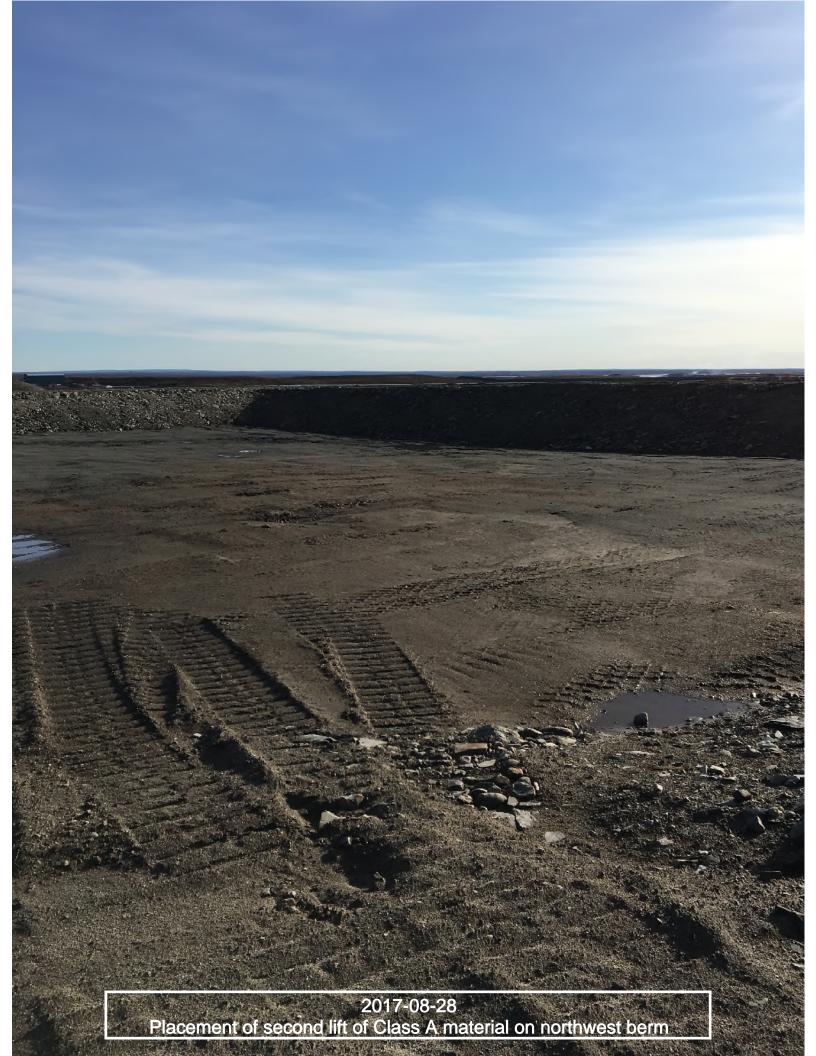
Photographs of Operation Landfill (Stage 1)

Photographs of the Operation Landfill (Stage 1) during construction is shown in Appendix C.
