## CONSTRUCTION SUMMARY (AS-BUILT) REPORT FOR BERM3 MELIADINE PROJECT, NUNAVUT

DECEMBER 2017
ISSUED FOR USE
TETRA TECH PROJECT NUMBER: 28920
AGNICO EAGLE DOCUMENT NUMBER: 6515-E-132-007-132-REP-015

Tetra Tech was retained by Agnico Eagle Mines Limited (Agnico Eagle) to prepare a construction summary (asbuilt) report for Berm3 at the Meliadine Gold Project, Nunavut. Tetra Tech previously prepared the construction drawings and specifications as well as the design report for Berm3 (AEM N° 6515-E-132-007-132-REP-005).

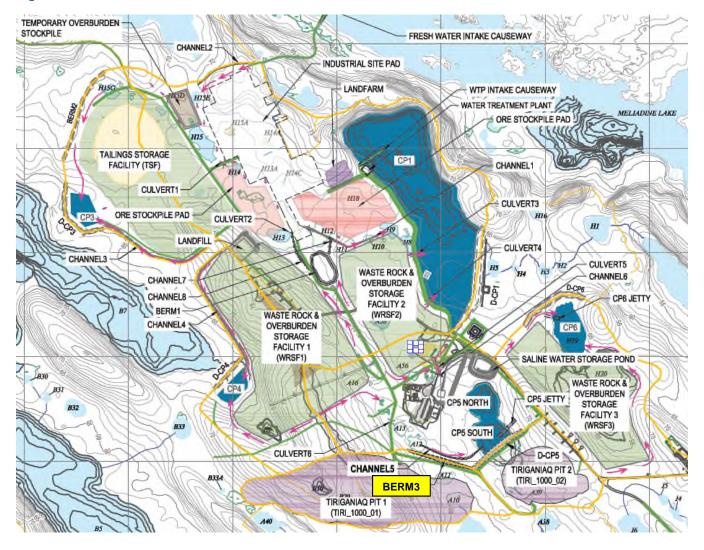
Figure 2.1: Site Location Plan

The figure below presents a site location plan for the Berm3.

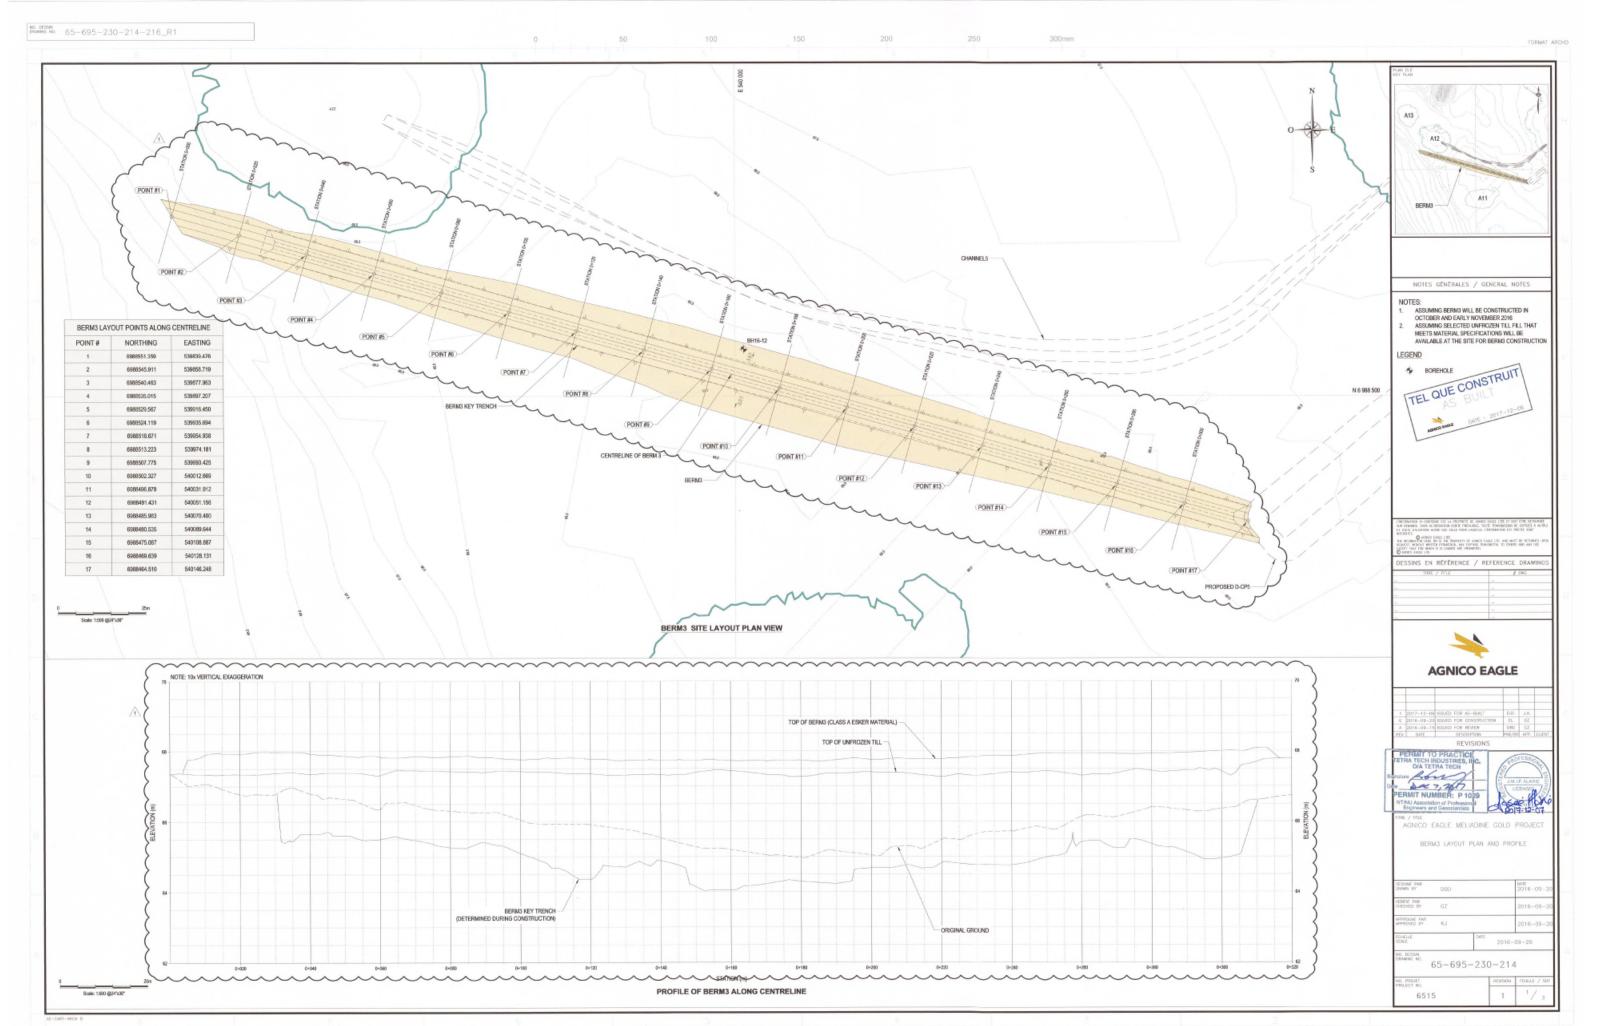
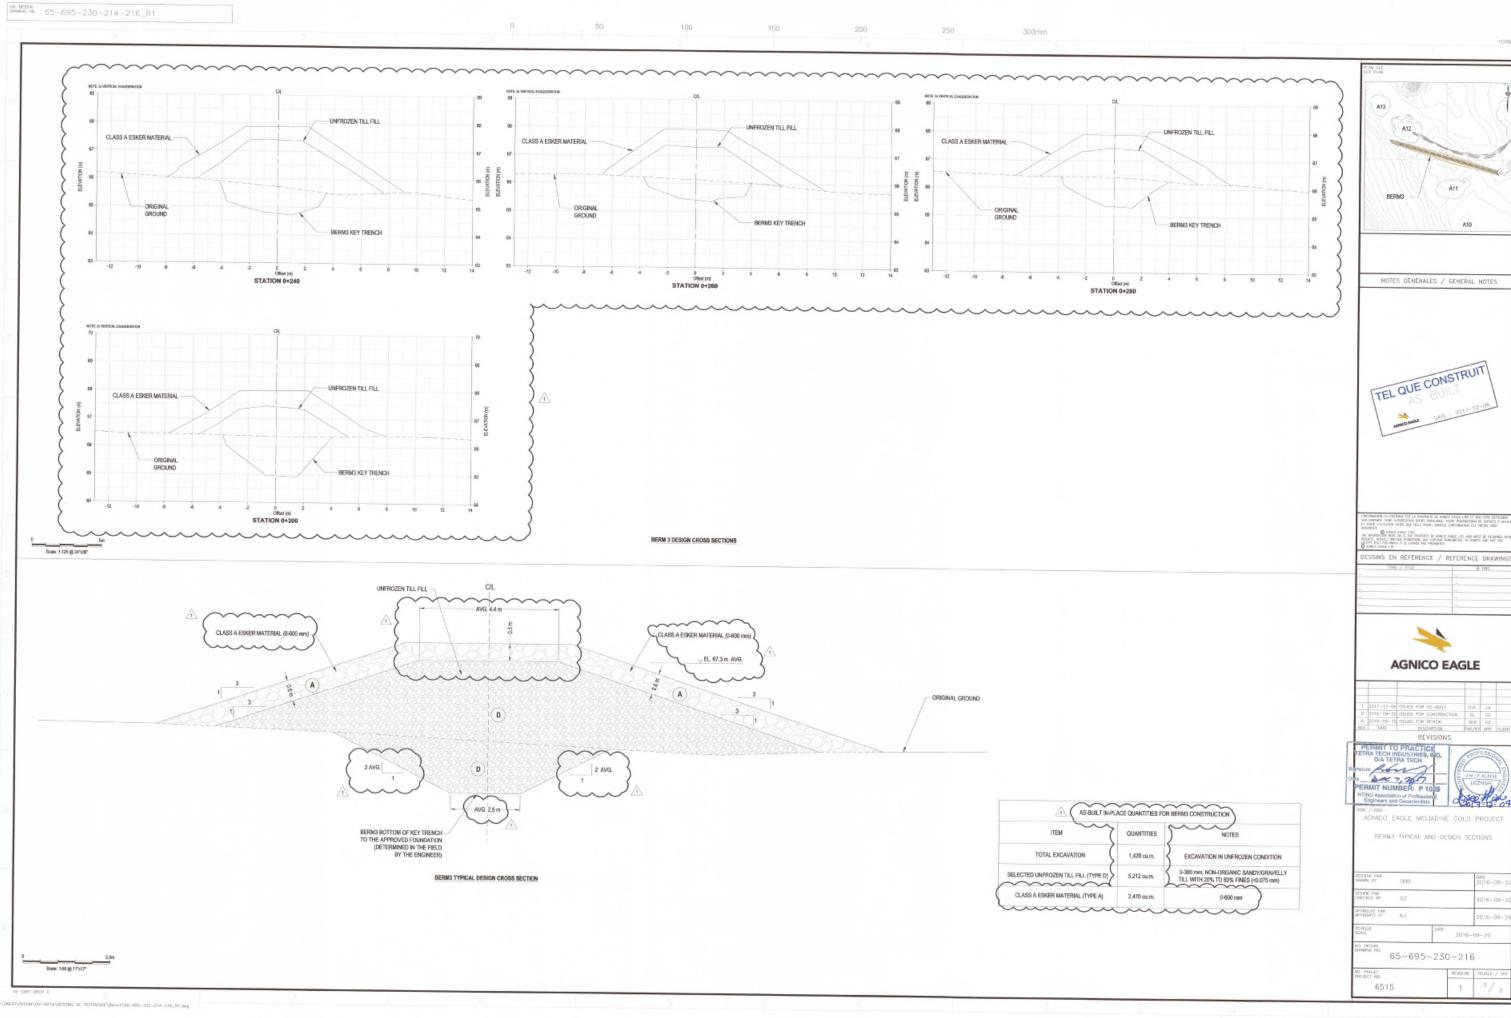
**As-Built Drawings**

As-built drawings are presented in Appendix A.

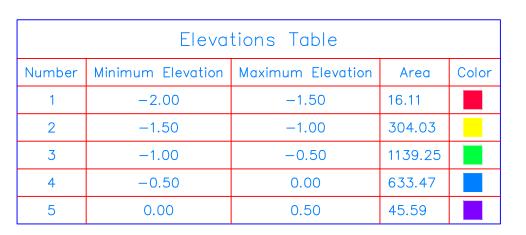
695-AB-BERM3

EXC QUANTITY BERM 3 1420 M3

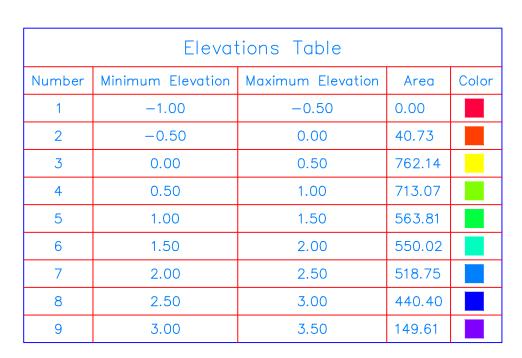
695-AB-BERM3

TILL QUANTITY BERM 3 *5212 M3*

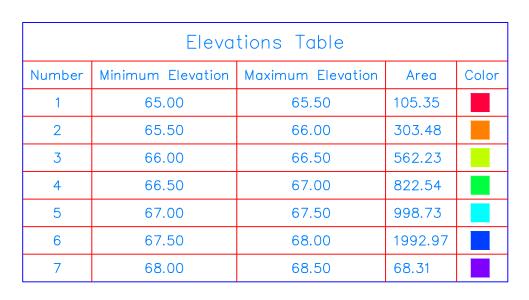
1:1000 695-AB-BERM 3 Y. HAMEL

CL/A QUANTITY BERM 3 2470 M3

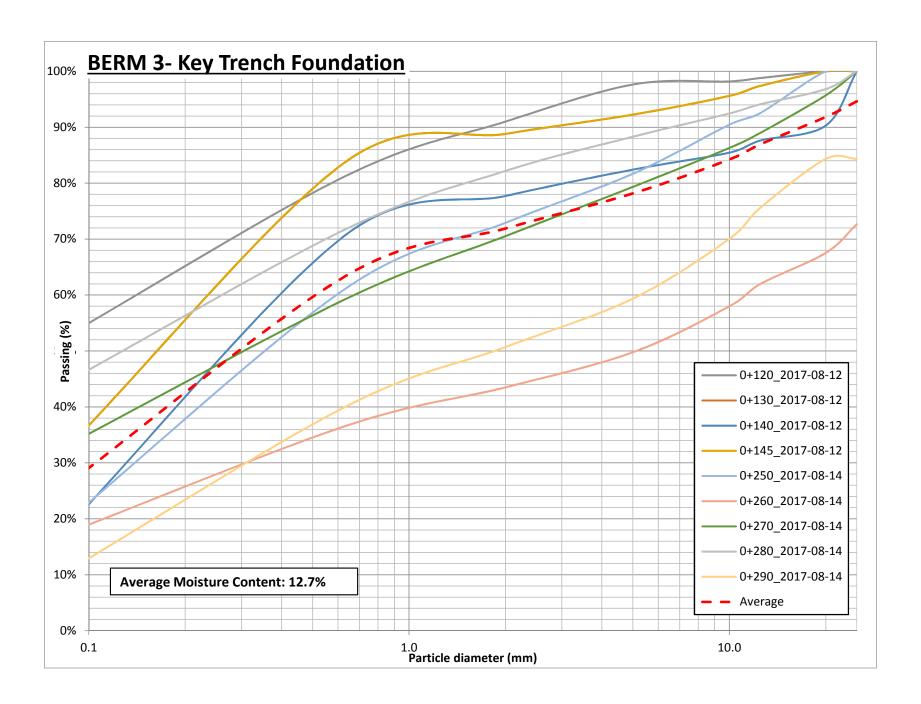
Particle Size Summary for Key Trench Foundation

Table 1: Summary of Particle Size Analysis Results - Berm 3 Key Trench Foundation

- Particle size analysis was conducted along the key trench alignment to confirm the suitability of the foundation soils
- August 12 to August 15 depth of excavation determined by sieve analysis of the foundation soils
   approximately 15% of the key trench was backfilled during this time

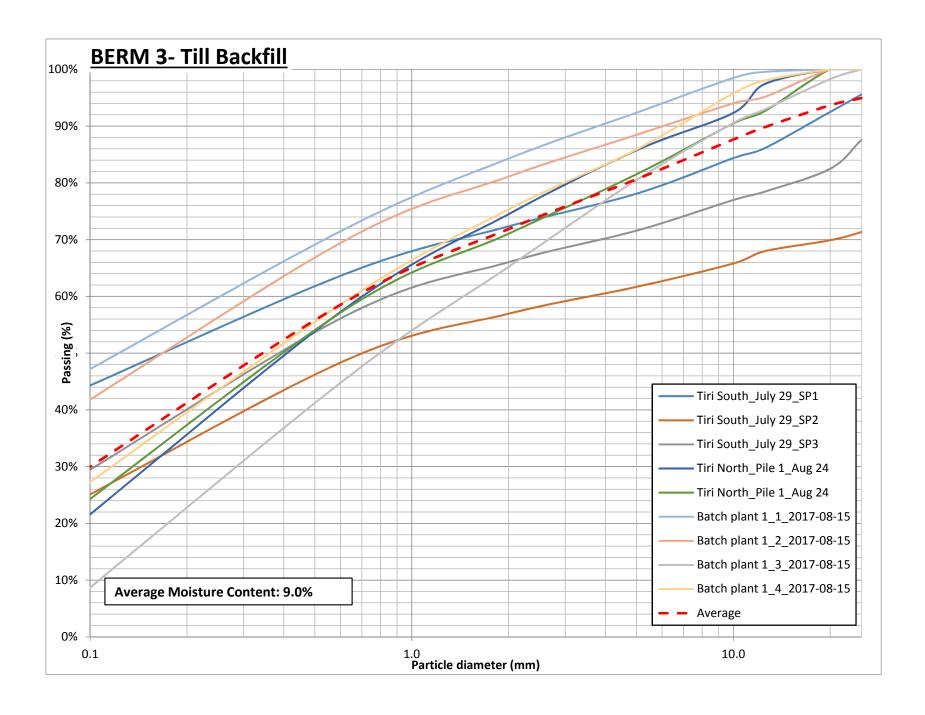
Particle Size Summary for Till Backfill Material

Table 2: Summary of Particle Size Analysis Results - Berm 3 Till Backfill

- Backfilling with approved unfrozen till (see particle size analysis) was conducted in accordance with the Technical Specifications for Civil Earthworks (6515-GNS-014). Placement occurred in controlled lifts established by survey (maximum lift height 0.5 m). Each lift was compacted with a 10 tonne vibratory drum roller prior to placement of the next lift.
