Meliadine Fresh Water Treatment Plant

Construction Summary Report (AS-Built report)

In Accordance with Water License 2AM-MEL1631 (Part D, item 3)

Agnico Eagle Mines Limited – Meliadine Division

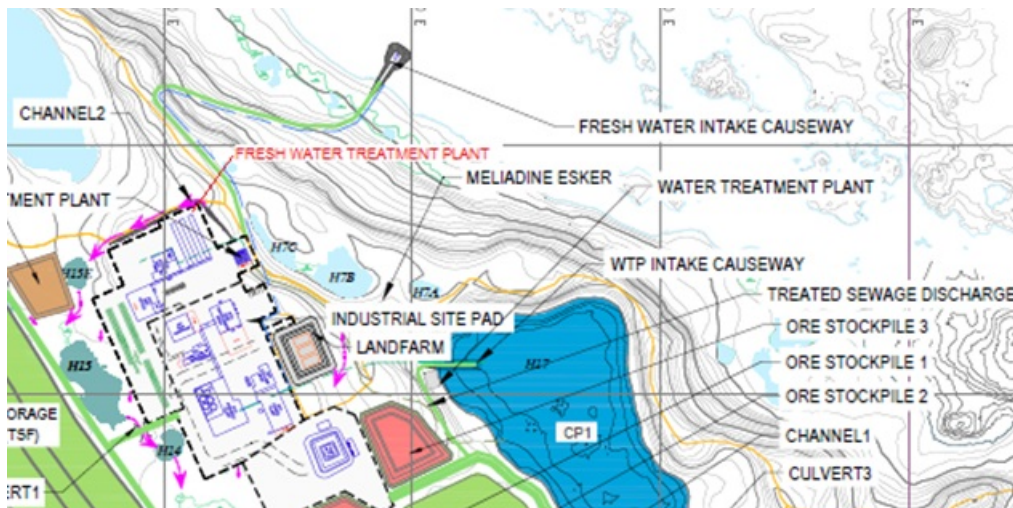
Figure 1. Plan of the site and location of the FWTP

The figure below presents a site location plan (Figure 1).

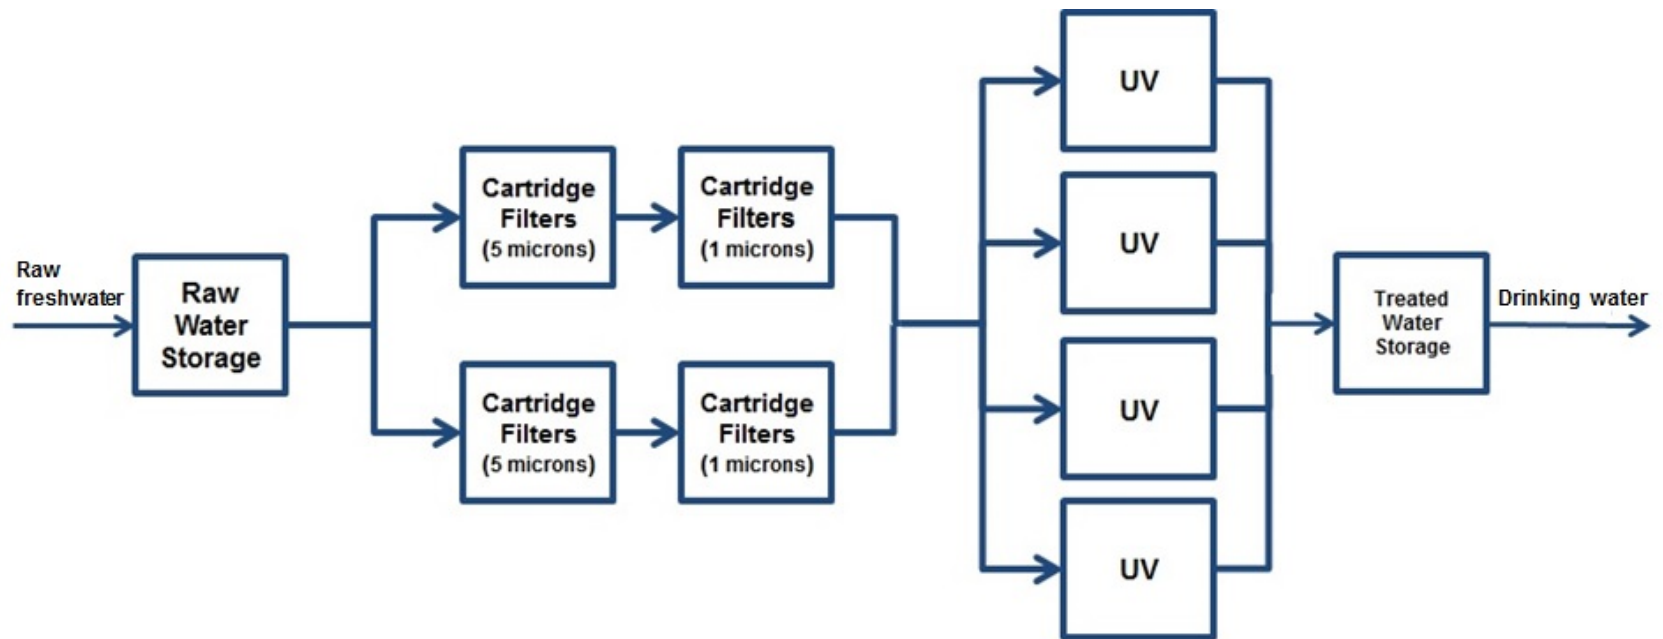
Figure 2: Process Flow Schematics

The camp and accommodations are equipped with a Freshwater Treatment Plant (FWTP) for potable (domestic) water. The design flow rate for the FWTP is 216 m3 per day. In the FWTP, the freshwater first goes through cartridge filters and then is pumped through ultraviolet units, and finally is treated with sodium hypochlorite (chlorine). The treated water is stored within a potable water tank. Potable water is monitored according to the Nunavut health regulations for total and residual chlorine and microbiological parameters. Treated potable water is piped to the camp as well as to areas in the process plant, service complex, and other facilities requiring potable water. The following sections describe in more detail each step of the treatment. The flow diagram is available in Appendix B.

Physical treatments are accomplished by withdrawing the suspended particles in raw Freshwater. This is achieved with cartridge filters which contain 4 pleated element cartridges that are able to trap debris, oils and other particles as water flows through it. The first cartridge filter will reaches 5 microns filtration and the second achieves 1 micron filtration.

The water is then disinfected by two ultraviolet reactors installed in parallel. This treatment serves as sterilization which deactivates organic contaminants, such as pathogens, bacteria, parasites or viruses.

Chemical treatments are accomplished by the injection of sodium hypochlorite (NaClO), which is often used for water purification. Hypochlorite can be used to prevent algae growth and is effective against bacteria and viruses.

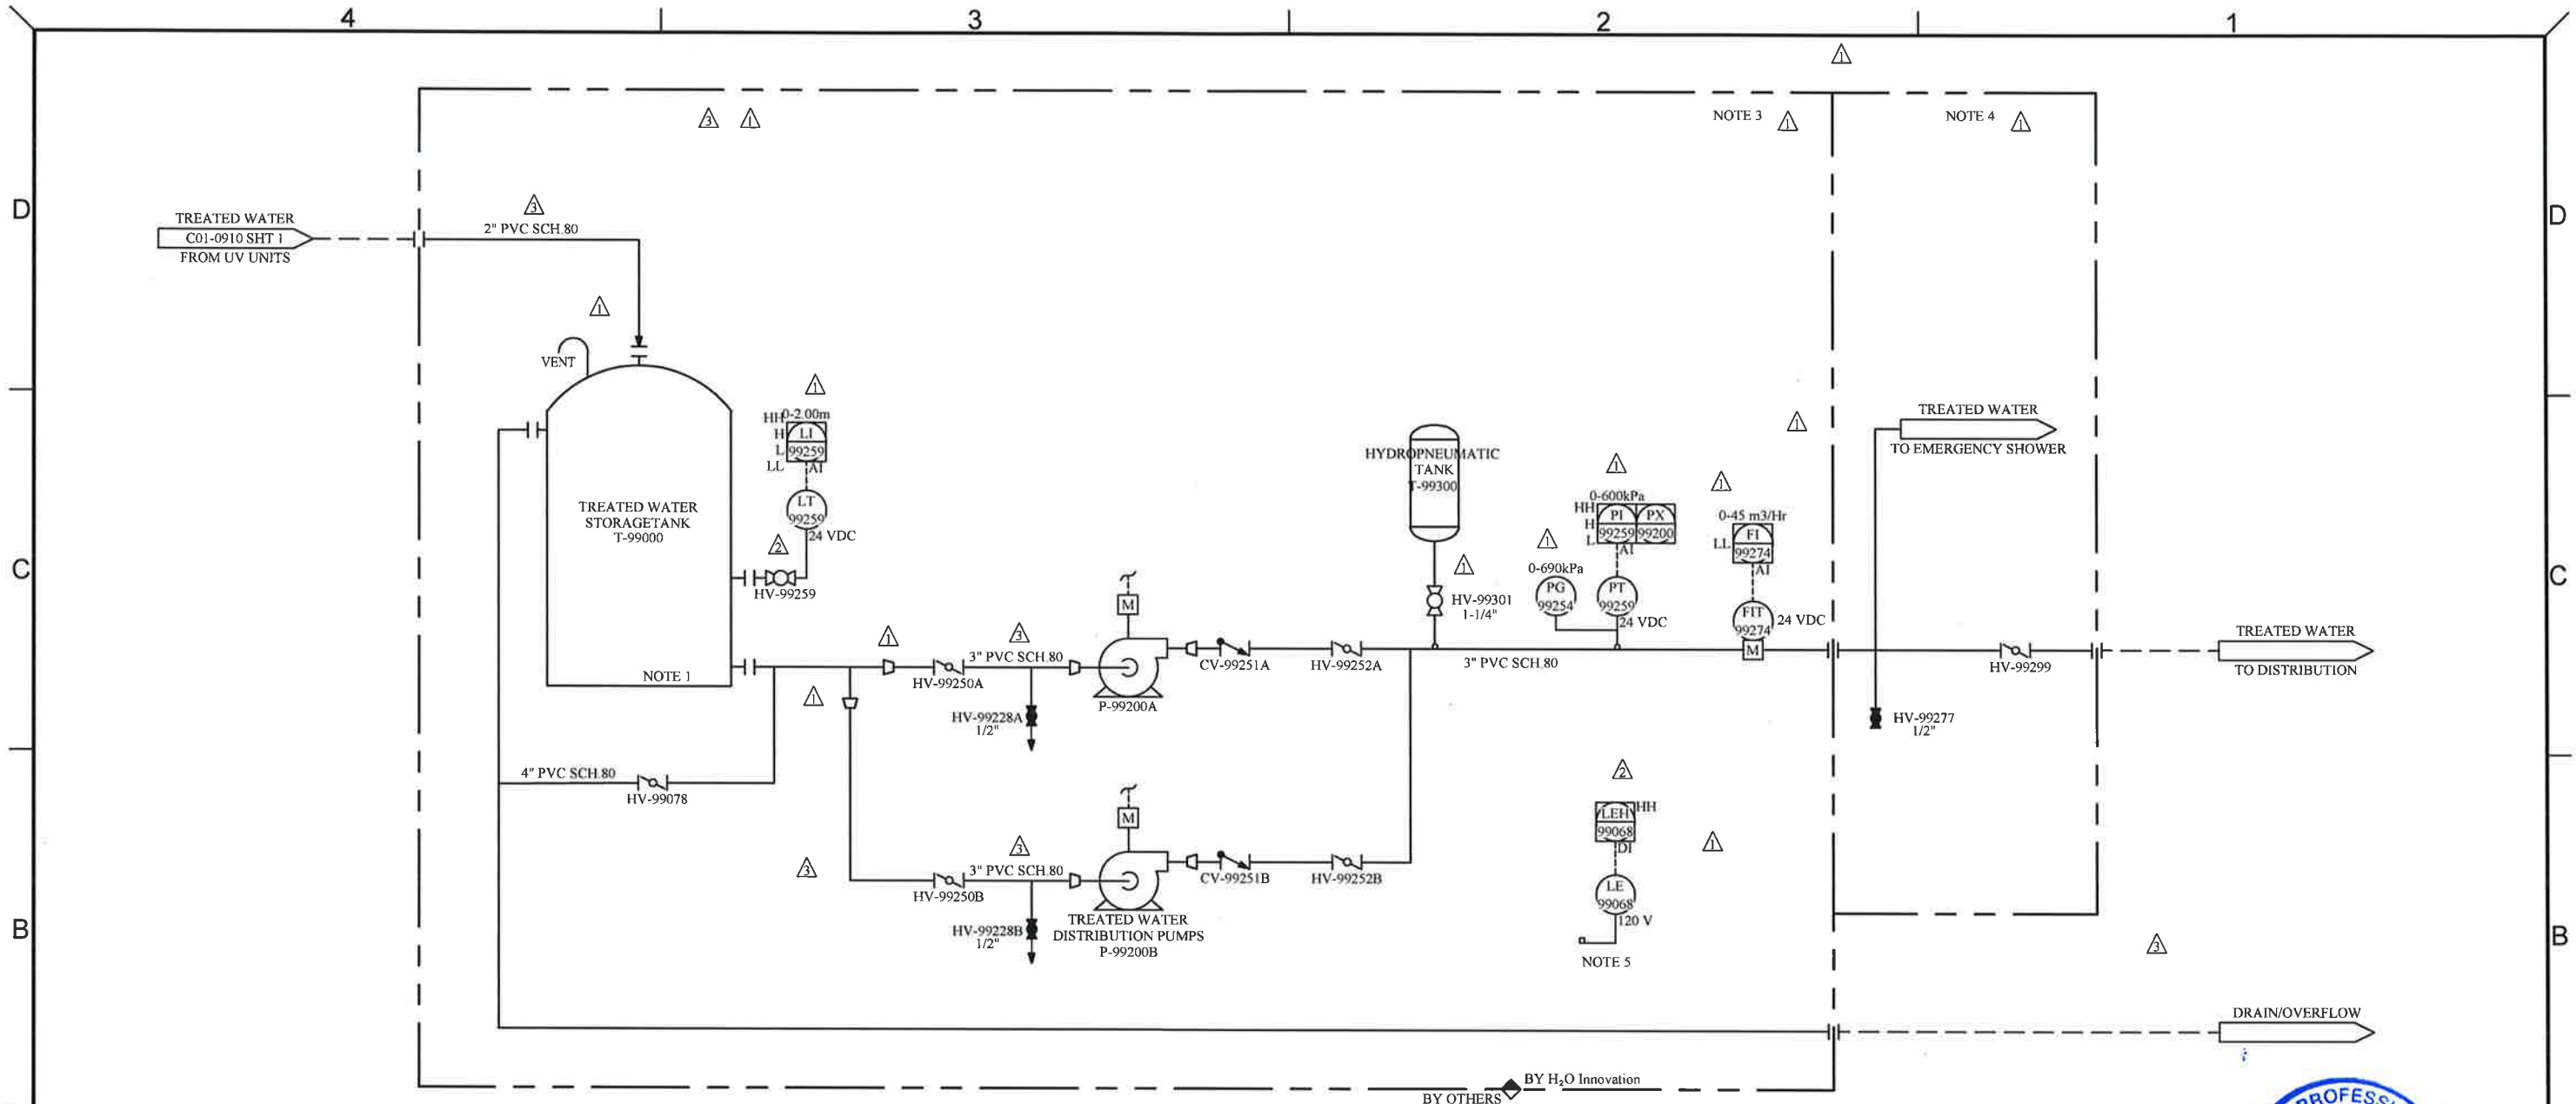
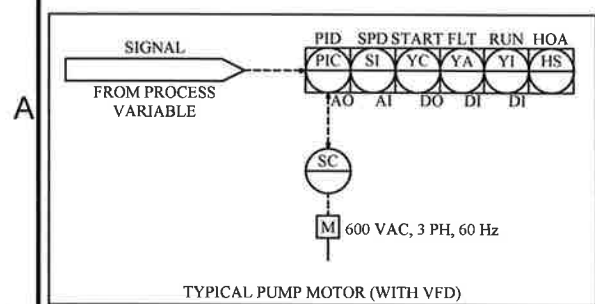
TITLE: TREATED WATER DISTRIBUTION SYSTEM PROCESS & INSTRUMENTATION DIAGRAM		
SCALE: N/A	DRAWING NUMBER: P65873-C01-0990	REVISION 04
SHEET: 1 of 1

- NOTES:
- 5 TANKS IN SERIES LINKED TOGETHER
 - ALL SIGNALS GOING INTO MCP-101.
 - EQUIPMENT TO BE PLACED IN CONTAINER #2.
 - EQUIPMENT TO BE PLACED IN CONTAINER #1.
 - WATER LEAK DETECTOR

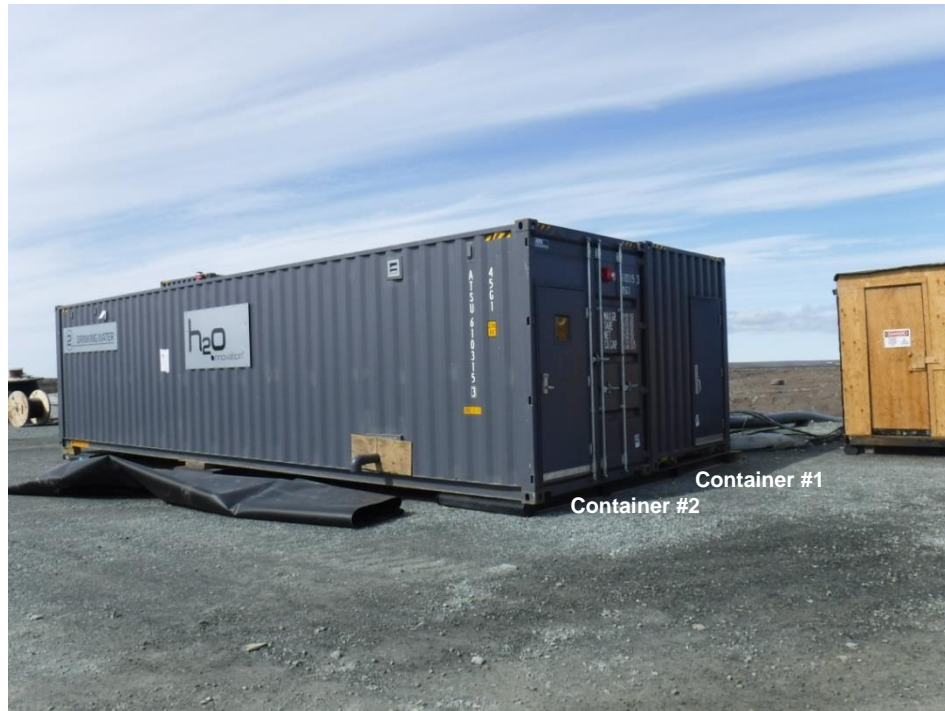
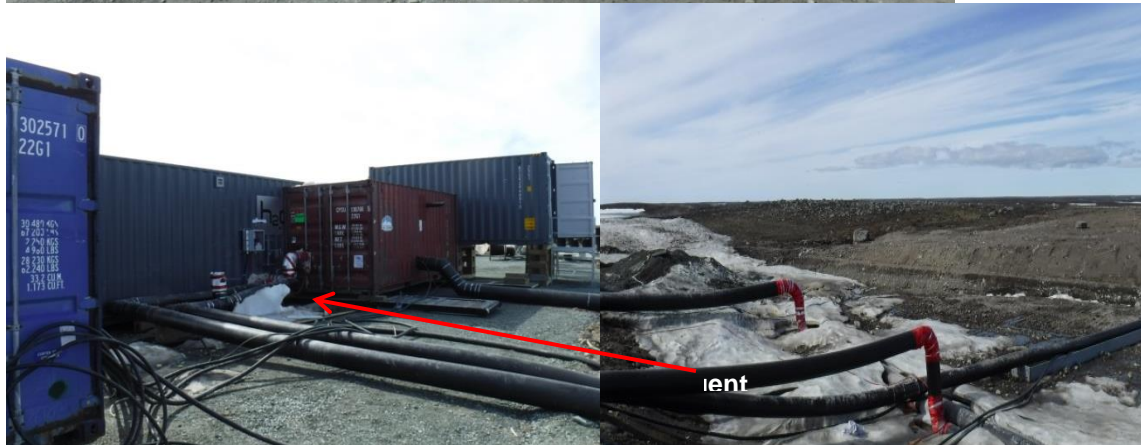
Photos of the outside view of the Freshwater Treatment Plant

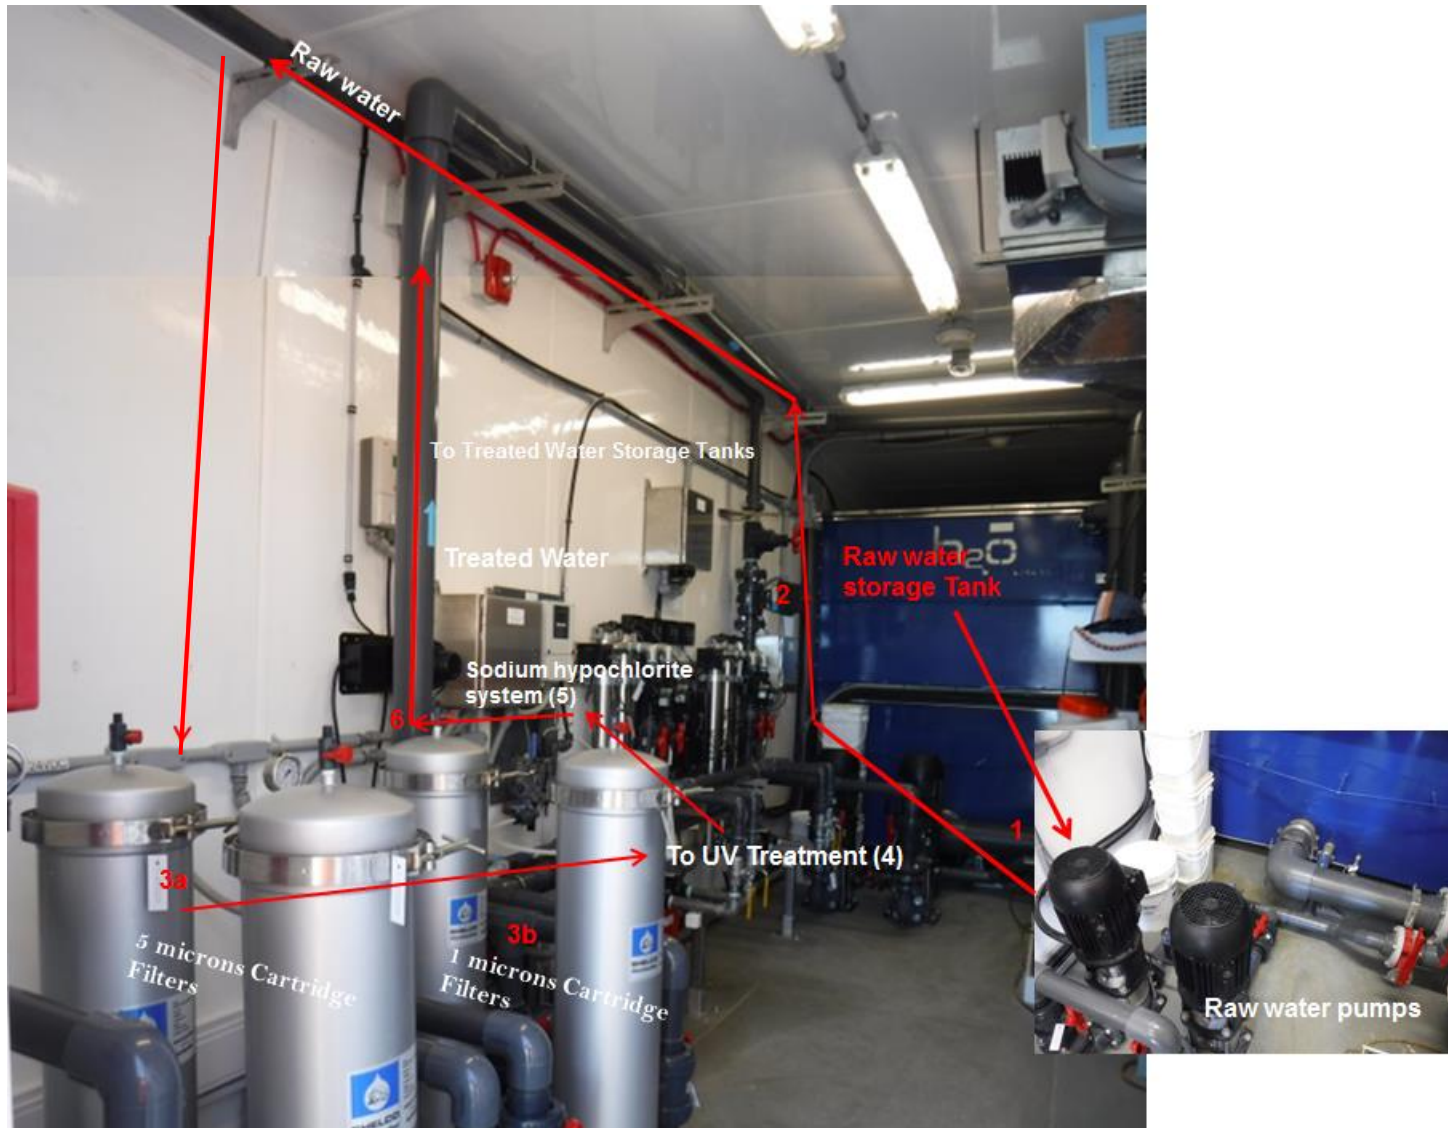
Photos of the Fresh water treatment system (Cartridge filters treatment and Chemical Treatment)

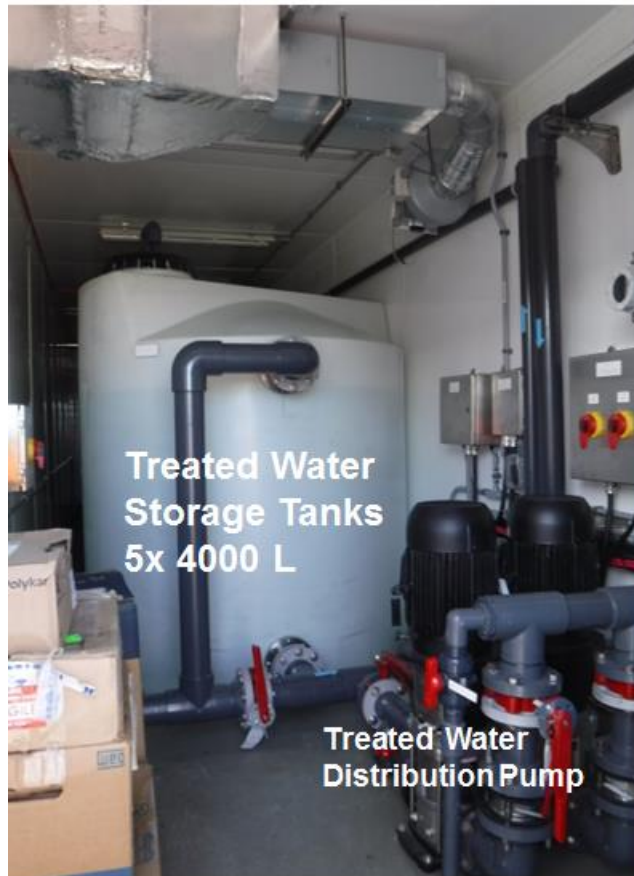
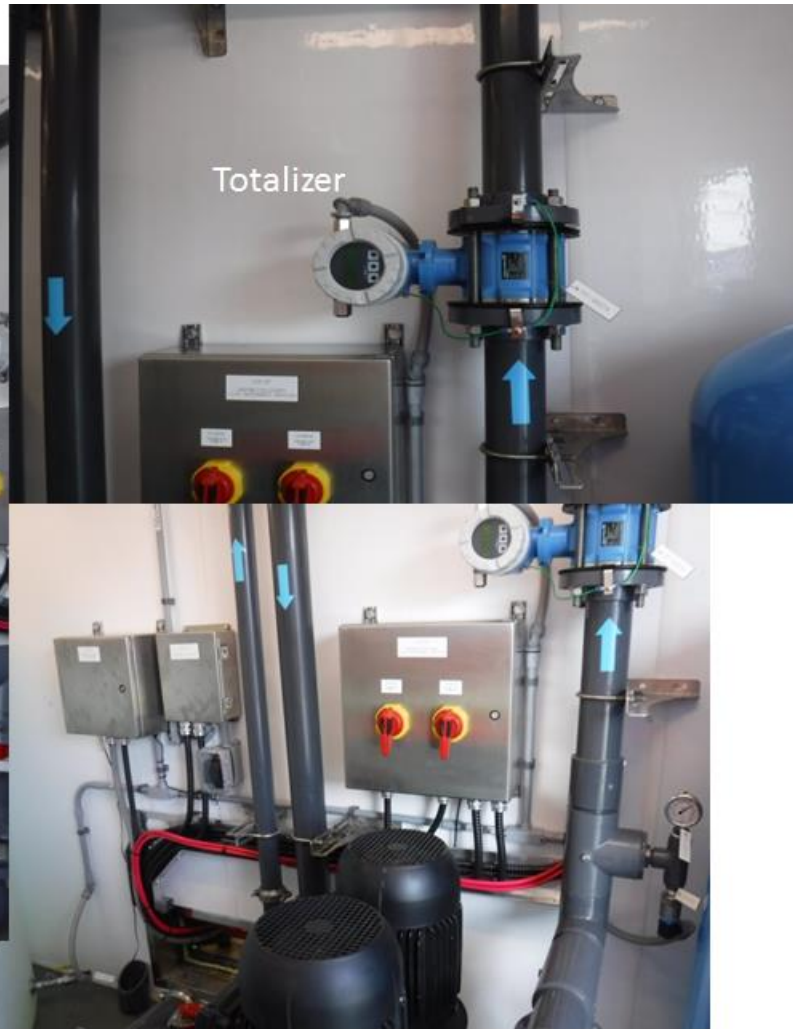
Photos of the Treated Water Storage and distribution Pump
