INTERIM REPORT

CONSTRUCTION SUMMARY (AS-BUILT) REPORT FOR RANKIN INLET ITIVIA SITE FUEL STORAGE AND CONTAINMENT FACILITIES – COMMISSIONING AND OPERATION OF TANK #2 MELIADINE PROJECT, NUNAVUT

PRESENTED TO
Agnico Eagle Mines Ltd.

MARCH 2018
ISSUED FOR USE_R1
MELIADINE PROJECT, NU | TETRA TECH PROJECT NUMBER: 28920
AGNICO EAGLE DOCUMENT NUMBER: 6515-E-132-005-132-REP-015

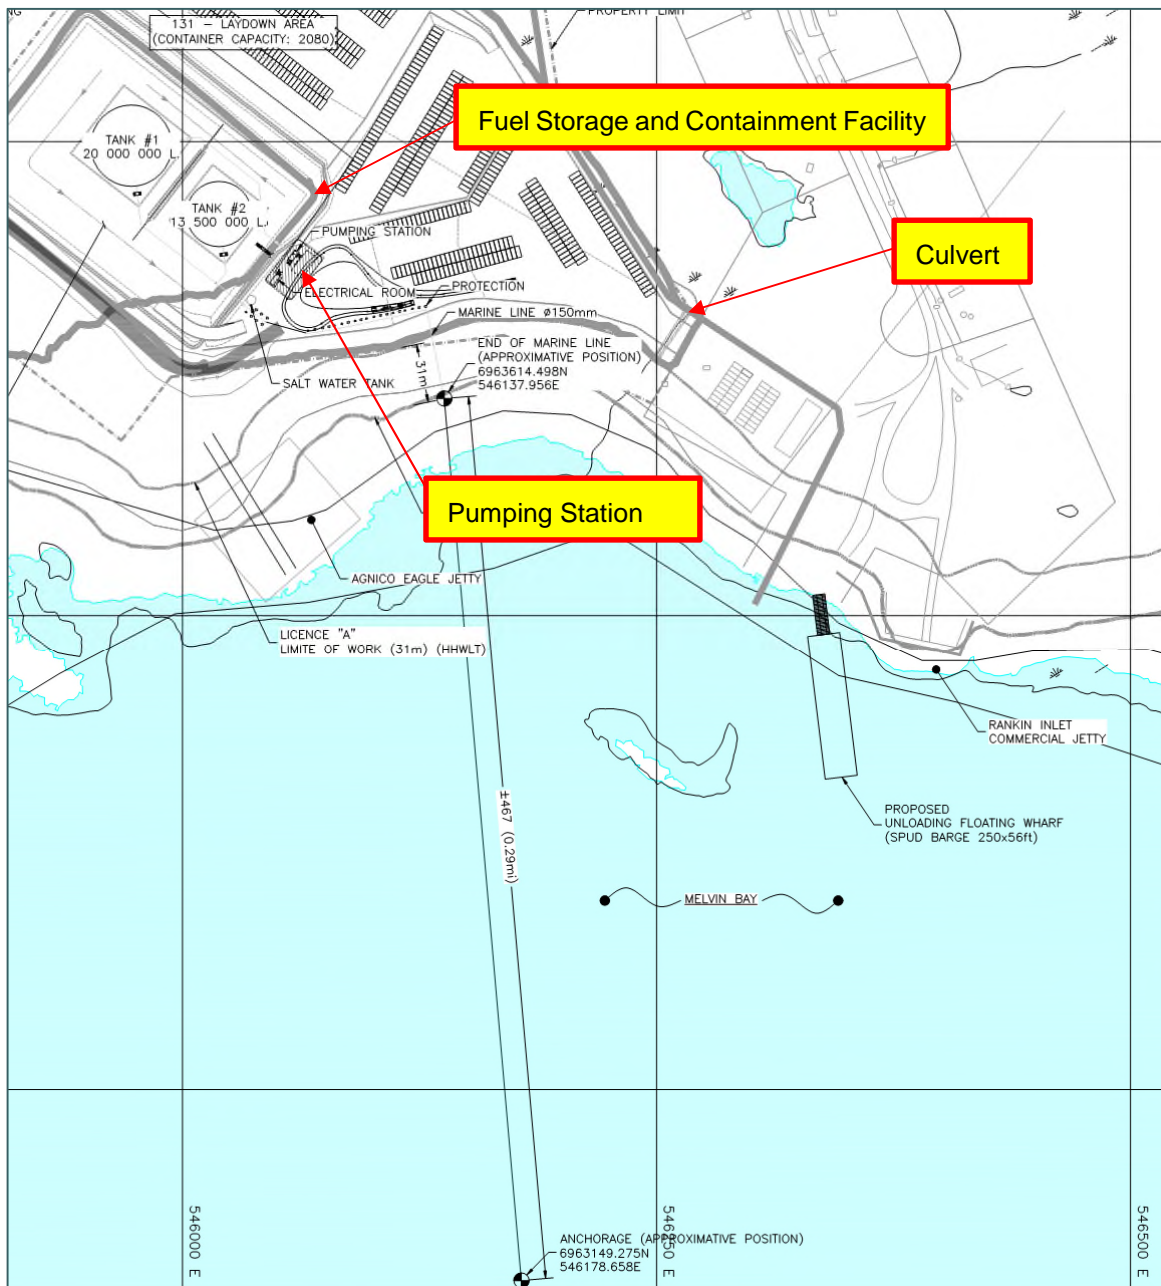
Figure 2.1: Rankin Inlet Itivia Site Location Plan

The figure below presents the site location plan for the Rankin Inlet Itivia Site Fuel Storage and Containment Facilities, pumping station, and Rankin Inlet Itivia Culvert. Tank #2 (13.5 ML) was erected, commissioned, and is now operating while Tank #1 (20 ML) will be completed in 2018. The Rankin Itivia Culvert was installed at the southwestern portion of the laydown area where the laydown connects with the existing road.

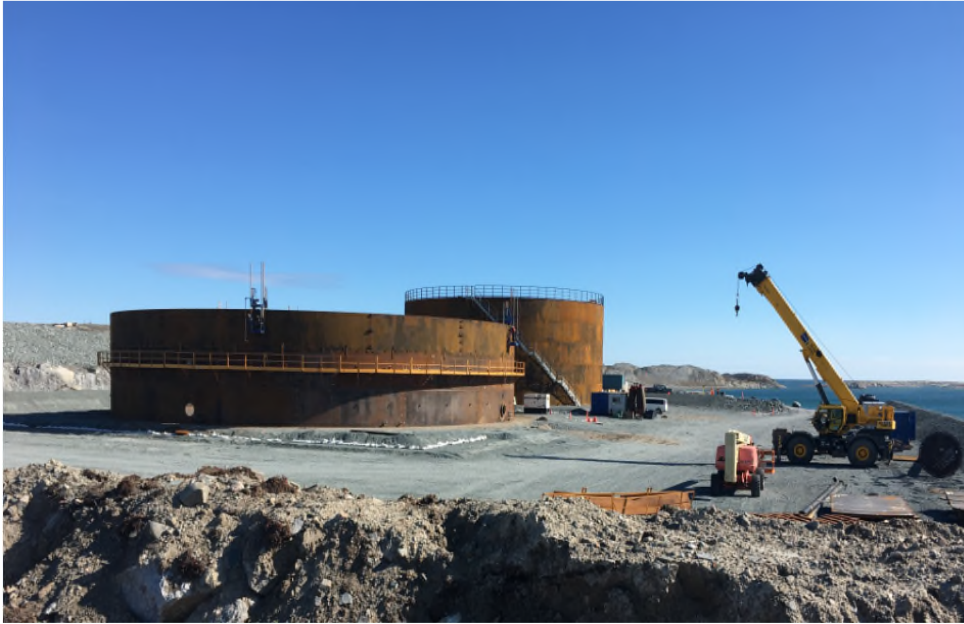
Picture 1: Construction of Rankin Inlet Itivia Site Fuel Storage and Containment Facilities
(Tank #1 is in the foreground and Tank #2 is in the background)

Construction activities at the Rankin Inlet Itivia Site Fuel Storage and Containment Facilities were conducted between March and October 2017. As shown in Picture 1 (below) taken during the construction period, both tanks were being erected but only Tank #2 was completed for service as planned. Picture 2 (below) shows the containers for the pumping and electrical stations. Construction was completed according to the milestone dates shown in Table 2.1.

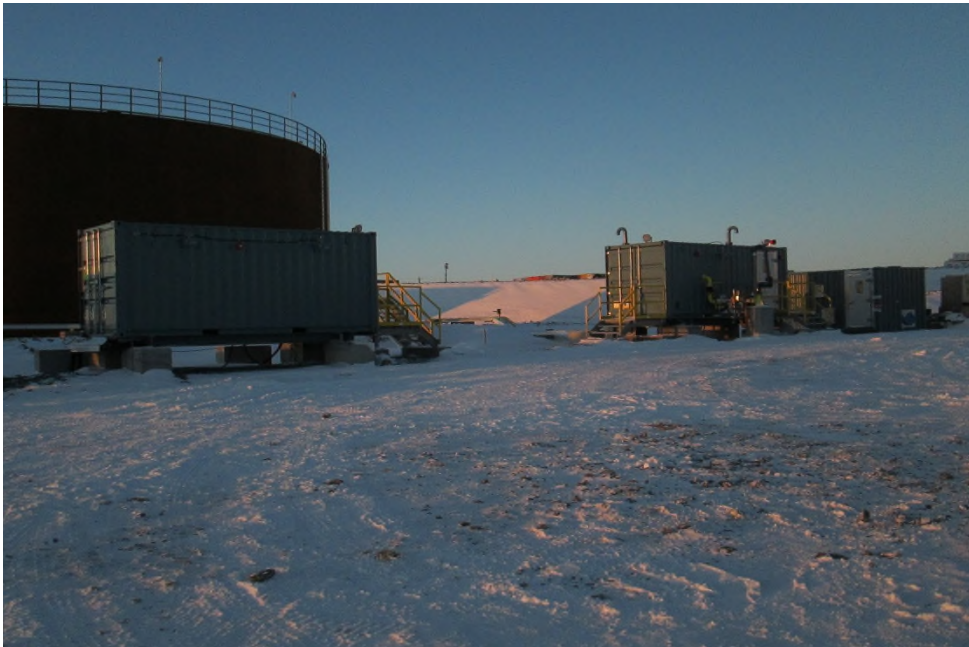
Picture 2: Pumping and Electrical Station Containers

- Tripods were replaced by cement blocks underneath the pump and electrical stations, approved by the designer.
- Structural framing was added to the pumping station to reinforce the structure beneath the motor and pump. This addition was approved by the designer.
