AGNICO-EAGLE MINES Ltd.
Inspection & Testing Report

ITR Number: AEM-EL-ITR-001
ITR Type: GENERAL
Contract No.: 6515-C-270-007

THIS REPORT IS A SUMMARY OF THE RECOMMENDATION MADE TO SUPPORT THE TANK FARM AREA FINAL WALL AS REQUESTED BY THE RANKIN CONSTRUCTION TEAM.

THIS REPORT IS A SUMMARY OF THE SECONDE INSPECTION CONDUCTED ON JUNE 22ND ONCE SCALING ACTIVITIES WERE COMPLETED IN THE TANK FARM AREA FINAL WALL AS REQUESTED BY THE RANKIN CONSTRUCTION TEAM.

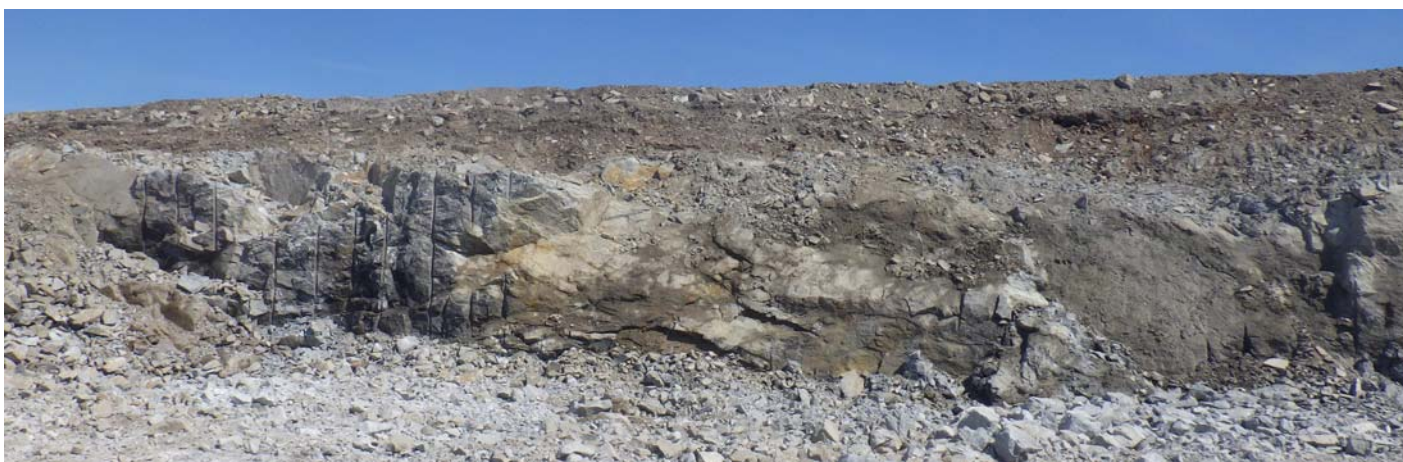
Figure 1 - Inspection area

The Rankin fuel tank farm laydown area was visited on Monday June 19, 2017 by Veronique Falmagne, Senior Mining Advisor, Vanessa Smith, Mine Engineer, and Philippe Lapointe, Engineering Superintendent. We were met on site by Stephane Gionet and inspected the northeast wall area. The northwest wall and corner were not cleaned out and were not as visible.

From what could be observed, the rock quality is good on the northwest wall except near the north corner where a fault zone can be seen. The fault zone seems to be trending Southeast-Northwest approximately parallel to the northwest wall. The corner area appears to be in bad ground and will require further assessment once the blast has been cleared out.

- Scrape and push back overburden at least 5 m from the crest then sloped to 1V:3H as indicated on the plan and covered with rock to maintain long term stability.
- The northwest corner will break back farther due to the fault zone and looks lower than the rest of the wall. In this area it will be necessary to clean out the blast and remove, then slope the broken / weak fault material. The overburden will need to be scraped back and sloped from the final crest location. Therefore it may need to be done in two passes.
- The face should be screened and bolted as a preventive measure to reduce long term deterioration from freeze/thaw action and mitigate liability of loose falling on bystanders. Regardless of the plan to fence the area, the easy accessibility of the site and location within the community puts the area at high risk of trespassing.

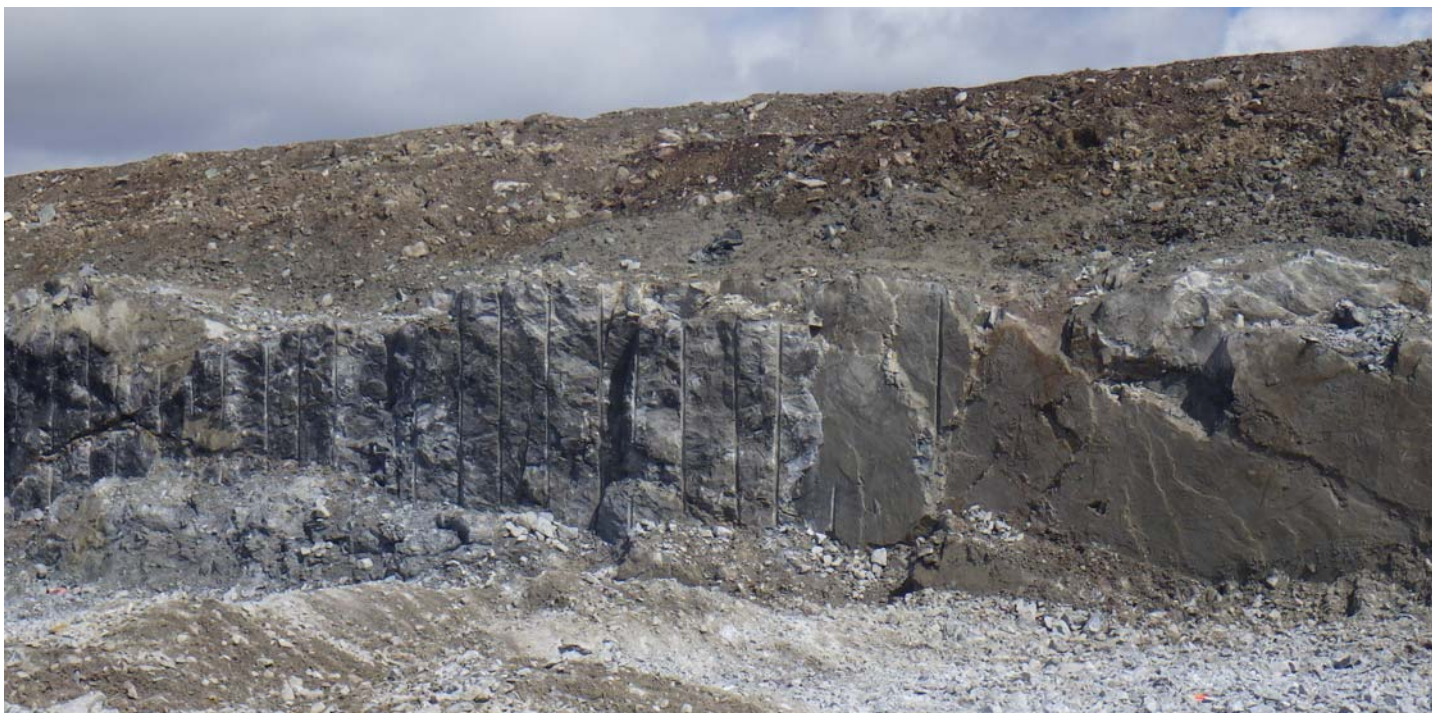
Figure 1 - Inspection area after scaling

The Rankin fuel tank farm laydown area was visited for a second inspection on Thursday June 22, 2017 following the requested scaling of the final wall area. Stephane Gionet was present for the second inspection of the northeast wall area. The northwest wall and corner were completely cleaned out and visible for this second inspection.

- Final scaling for smaller blocks remains to be done.
- Scrape and push back overburden at least 5 m from the crest then sloped to 1V:3H as indicated on the plan and covered with rock to maintain long term stability.
- Screened and bolting of the final wall area remains to the discretion of the construction department and Tetrattech. Following the removal of the larger blocks in the area the condition of the area has improved. The area which remains of concern due to deterioration from freeze/thaw action is the fault area. A proposal to create a thermal cap in this area was discussed with Tetrattech. This area would have to be cleaned of any loose/melted gauge (pressure washer or other). Then a form would be built to retain the grout within/along the fault area to act as a thermal seal and infill for the open fault.

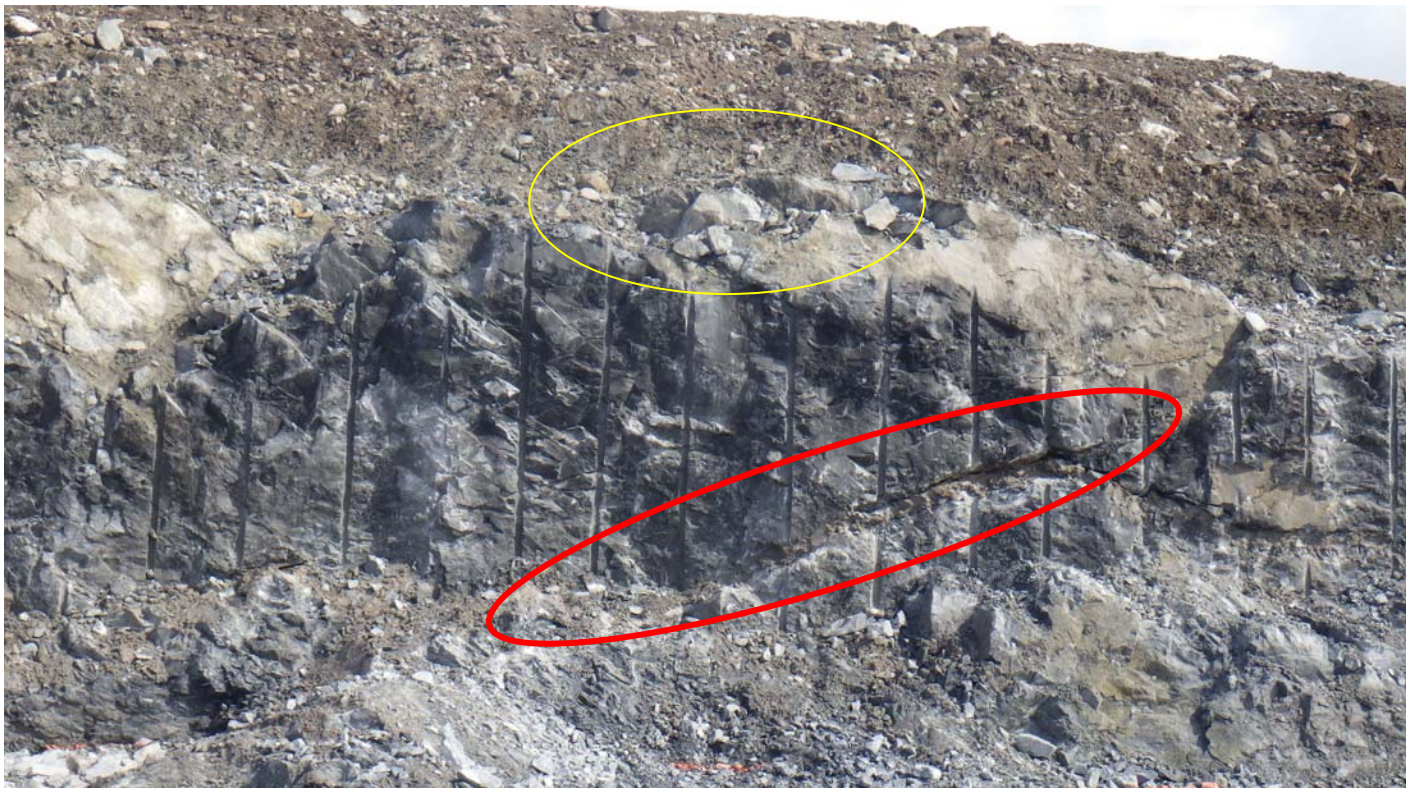
Figure 2 - Inspection area after scaling – showing fault

Figure 2 shows some smaller rocks which should be removed as part of the final scaling. The rock quality is good on the northwest wall except near the north corner where a fault zone can be seen. The fault zone seems to be trending Southeast-Northwest approximately parallel to the northwest wall. This area continues to be of concern for the long term stability of the area. This structure has up to 6-inches of frozen gauge within (Figure 3).

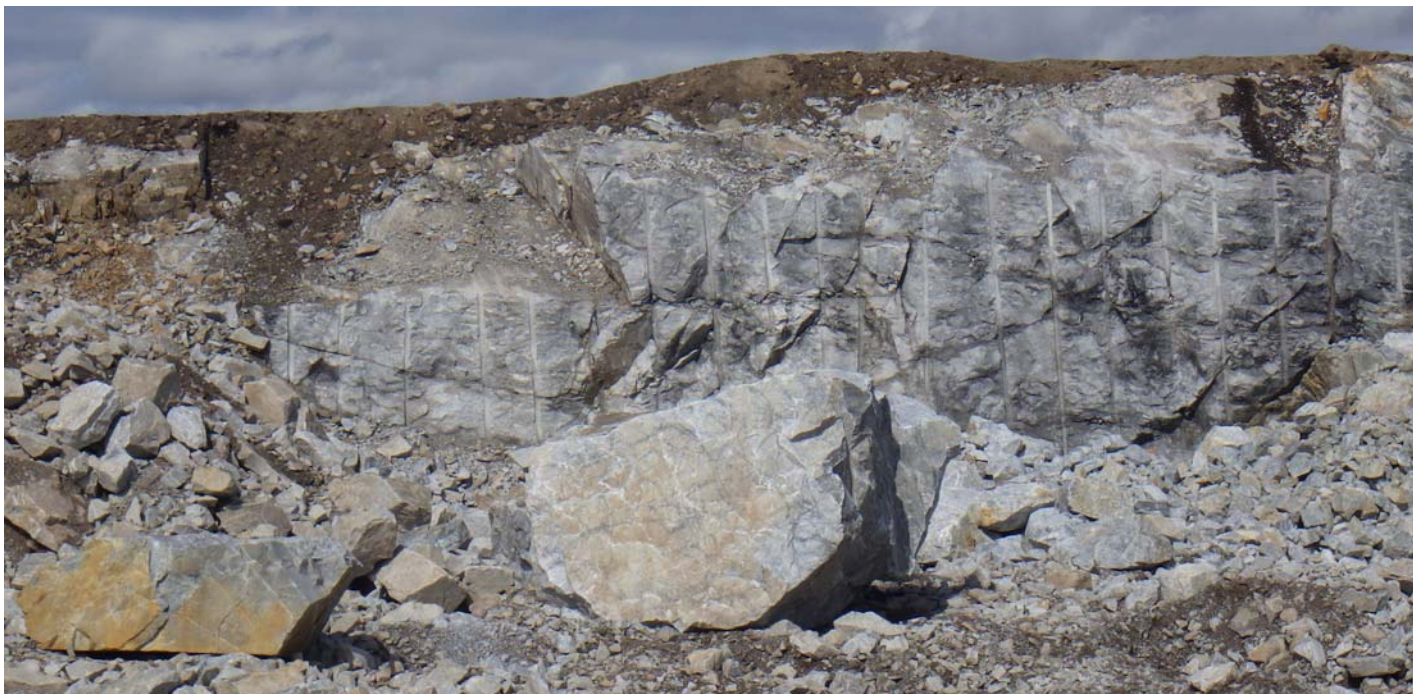
Figure 4 - Inspection area after scaling

Figure 4 shows the size of the blocks which were scaled since the previous inspection allowing for a proper inspection of the area. Figure 5 also shows the amount of scaling conducted; the drill rod was uncovered in the lasted area. The half barrels are clearly visible along the northwest wall and part of the Northeast wall that are fully exposed.
