FINAL REPORT

CONSTRUCTION SUMMARY (AS-BUILT) REPORT FOR RANKIN INLET ITIVIA SITE FUEL STORAGE AND CONTAINMENT FACILITIES MELIADINE PROJECT, NUNAVUT

FEBRUARY 2019
ISSUED FOR USE_REV 2
MELIADINE PROJECT, NU | TETRA TECH PROJECT NUMBER: 28920
AGNICO EAGLE DOCUMENT NUMBER: 6515-E-132-005-132-REP-015

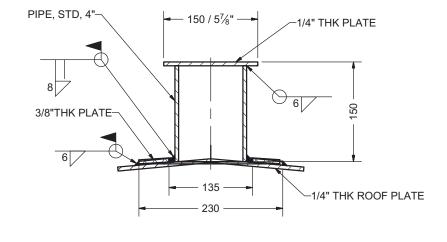
DRAWN Jacob Saunders	4/40/0047	AFMAN II II F LOU T L					
CHECKED	4/13/2017	AEM Meliadine Fuel Storage Tanks					
		TITLE					
QA							
MFG	1	M1615 - PAINTERS SCAFFOLD CABLE SUPPORT					
APPROVED		1					
		SIZE	DWG NO				REV
		A3	295-M16				3
		SCALÉ		SHEET	15	OF	22

Ø100 NS PAINTERS SCAFFOLD CABLE SUPPORT MARK: M1615

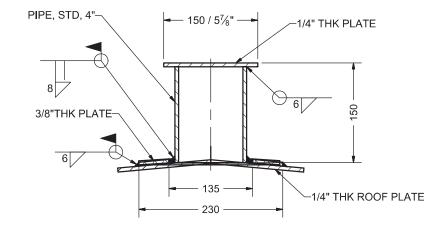
DRAWN Jacob Saunders 4/13/2017 **AEM Meliadine Fuel Storage Tanks** CHECKED TITLE QA M1615 - PAINTERS SCAFFOLD CABLE SUPPORT MFG APPROVED DWG NO REV **A3** 295-M16 3 SCALE SHEET 15 OF 22

Ø100 NS PAINTERS SCAFFOLD CABLE SUPPORT MARK: M1615
