**AMENDMENT#01 TO 6515-E-132-005-132-REP-015**

**CONSTRUCTION SUMMARY (AS-BUILT) REPORT  
FOR RANKIN INLET ITIVIA SITE FUEL STORAGE  
AND CONTAINMENT FACILITY  
MELIADINE PROJECT, NUNAVUT**

SEPTEMBER 2019  
ISSUED FOR USE  
MELIADINE PROJECT, NU | TETRA TECH PROJECT NUMBER: 28920  
AGNICO EAGLE DOCUMENT NUMBER: 6515-E-132-005-132-REP-015\_AMENDMENT01

This amendment of the as-built report summarizes the work executed at Rankin Inlet Itivia Site fuel storage and containment facility where two (2) rock check dams were installed in May 2019.

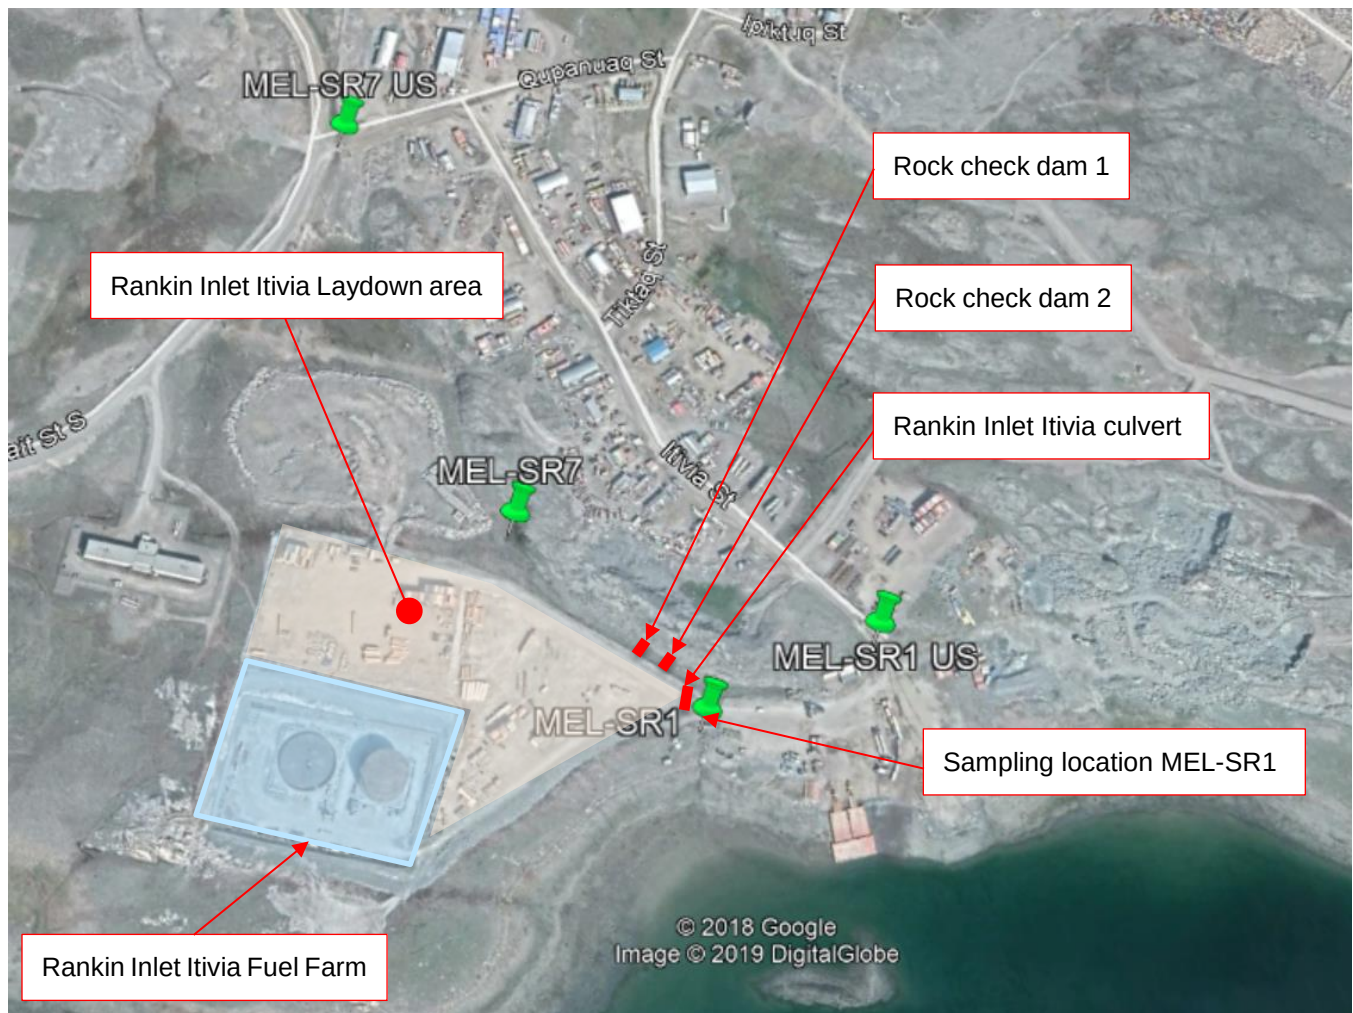
**Figure 2.1: Rankin Inlet Itivia Site Location Plan**

The figure below presents the site location plan for the two (2) Rankin Inlet Itivia Site rock check dams. The studied area for the rock check dams is located in a small drainage channel to the east of the Rankin Inlet Itivia Laydown area and upstream of Rankin Inlet Itivia culvert as well as the compliance sampling location MEL-SR1. The sample locations are also shown below in Figure 2.1.

AEM completed a field reconnaissance of the area and had initially proposed to build two (2) rock check dams immediately to the east of the Itivia Laydown Area. After discussing this location with AEM employees who have worked at the Rankin Inlet Itivia Site fuel storage and containment facilities it was decided to consider a different position for the dams as this was the same location as a snow machine trail that ran through the drainage ditch and this location would not be accepted by the residents of Rankin Inlet. This was confirmed after having communicated with the Kangiqliq Hunters and Trappers Organization (KHTO). The KHTO and AEM employees then went out to the Itivia area together and field fitted the location for two (2) rock check dams that would not impede snow machine traffic and would still remain on AEM property. The Rock Check Dams are located upstream of sampling location MEL-SR1 as previously shown on Figure 2.1.

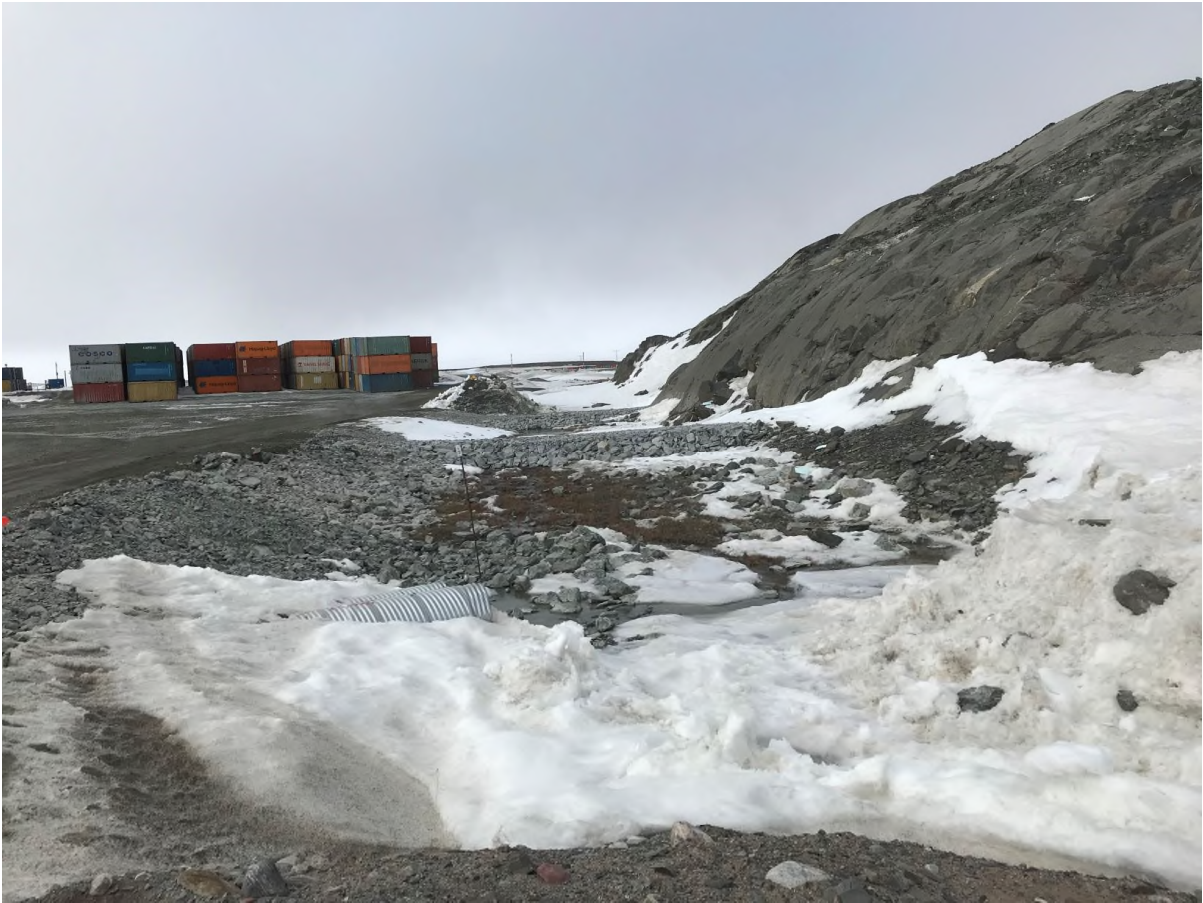
**Photo taken looking upstream from the drainage culvert**

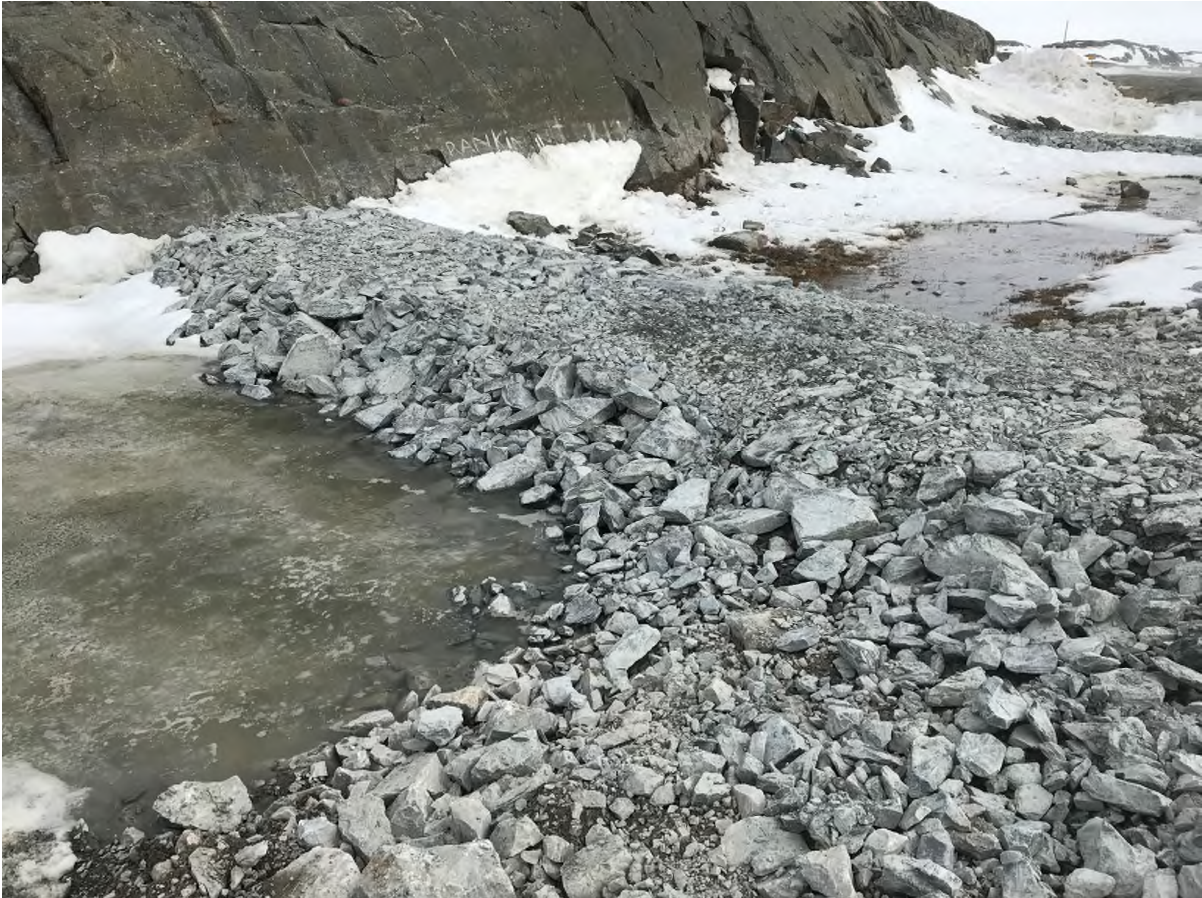
**Photo taken of the upstream Rock Check Dam Retaining some Water**

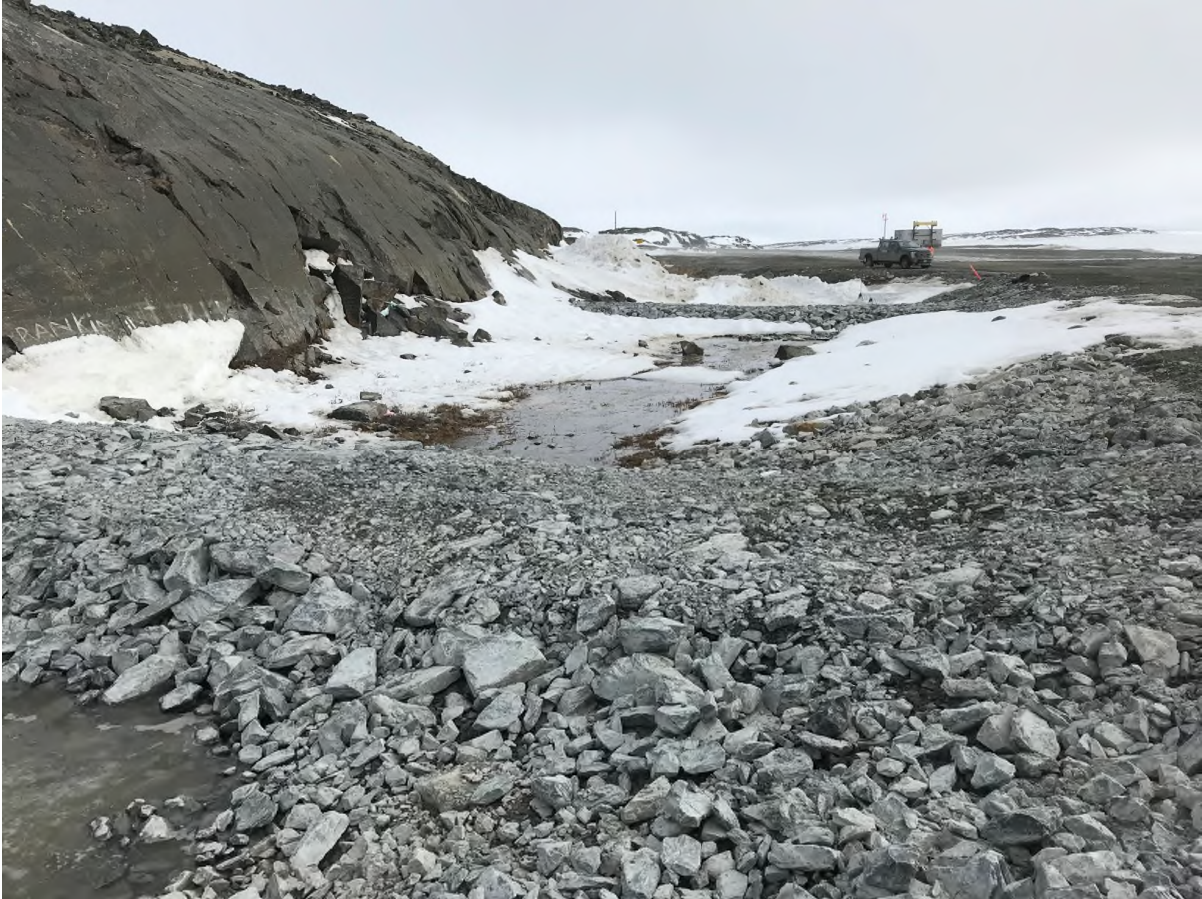
**Photo taken looking downstream from the upstream Waste Rock Check Dam**

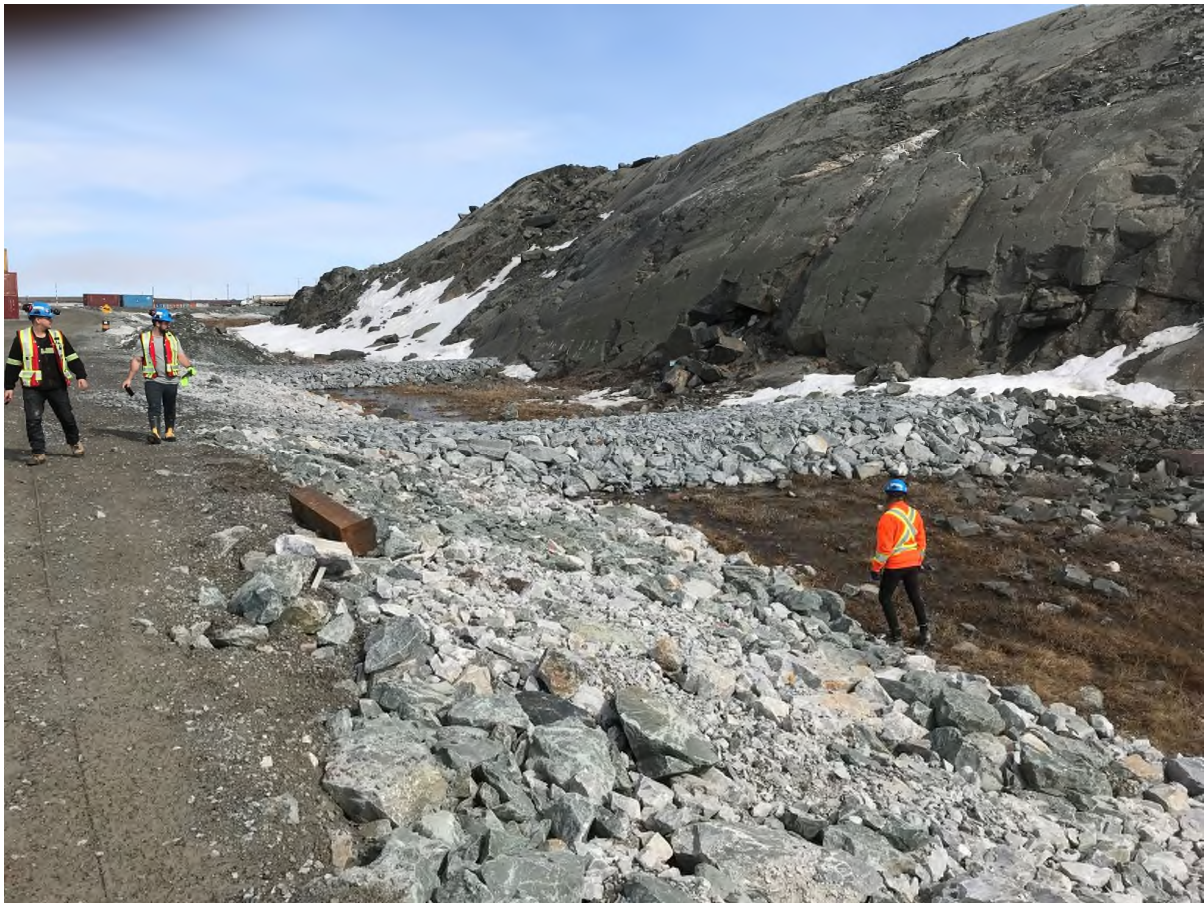
**Photo taken looking upstream at the drainage culvert**
