# AGNICO EAGLE

**MELIADINE GOLD PROJECT**

## Construction Summary (As-built) Report for Berm2, Channel3, Pond CP3, and Berm CP3

AEM Document Number 6515-695-230-REP-001

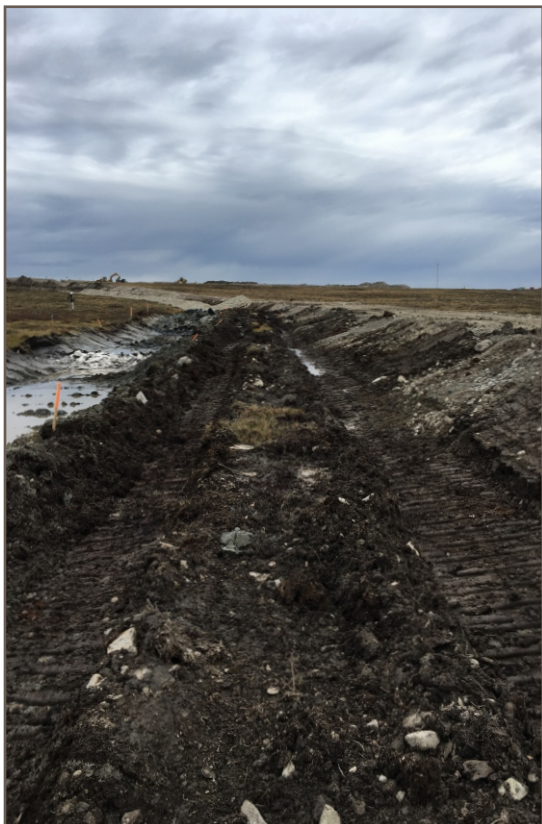
**Photo 5:** 08 29 2018 Channel3 - Mechanical excavation; Station 0+090 facing down-chainage

Mechanical excavation and geotextile and rip-rap placement was carried out from August 25, 2018 to September 6, 2018. Mechanical excavation (free-digging into the permafrost to design depth with an excavator)

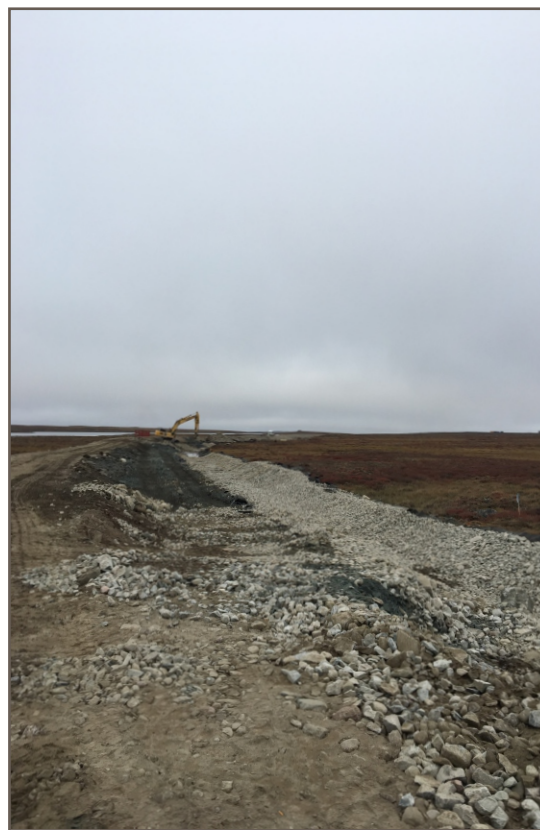
**Photo 6:** 08 29 2018 Channel3 - Poor bank conditions, ice, and bedrock; Station 1+320 facing up-chainage

Although attempts were made to effectively stage the excavation with the backfill and limit the amount of exposure, some degradation occurred to the ice-rich overburden soils. The downstream bank (against the access road) required rebuilding with a thaw-stable material (600 mm minus waste rock) between approximately Station 0+200 and Station 0+300. Overburden soils were completely removed in this section, geotextile was placed over the excavation, and 600 mm minus waste rock was placed and compacted to rebuild the bank.

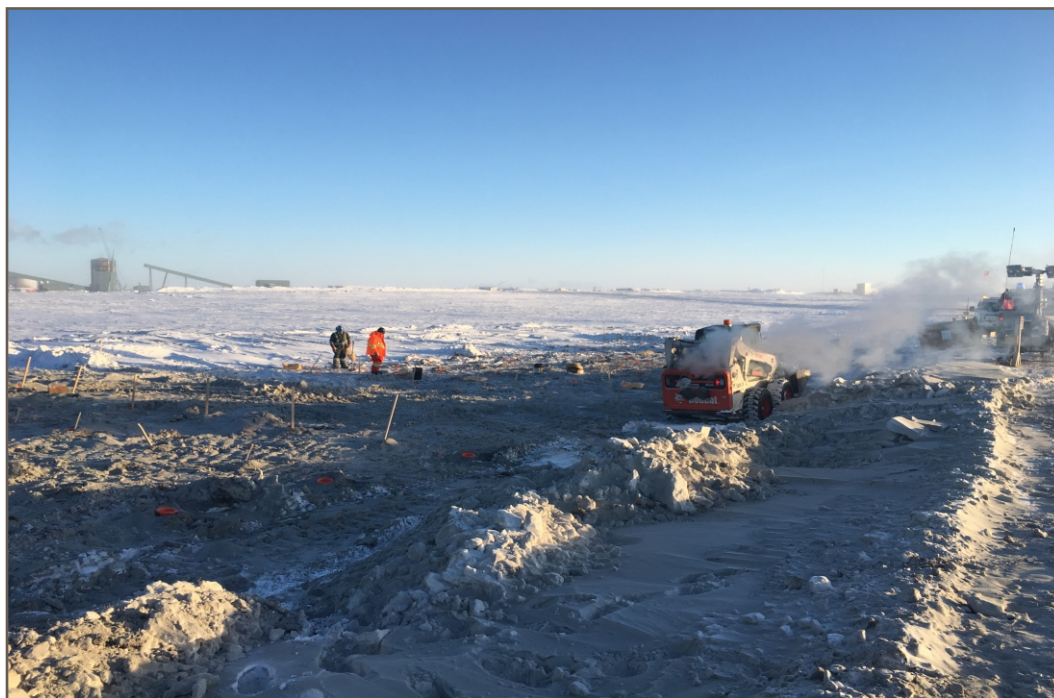
**Photo 7:** 09 03 2018 Channel3 - Rebuilt bank and channel construction; Station 1+185 facing up-chainage

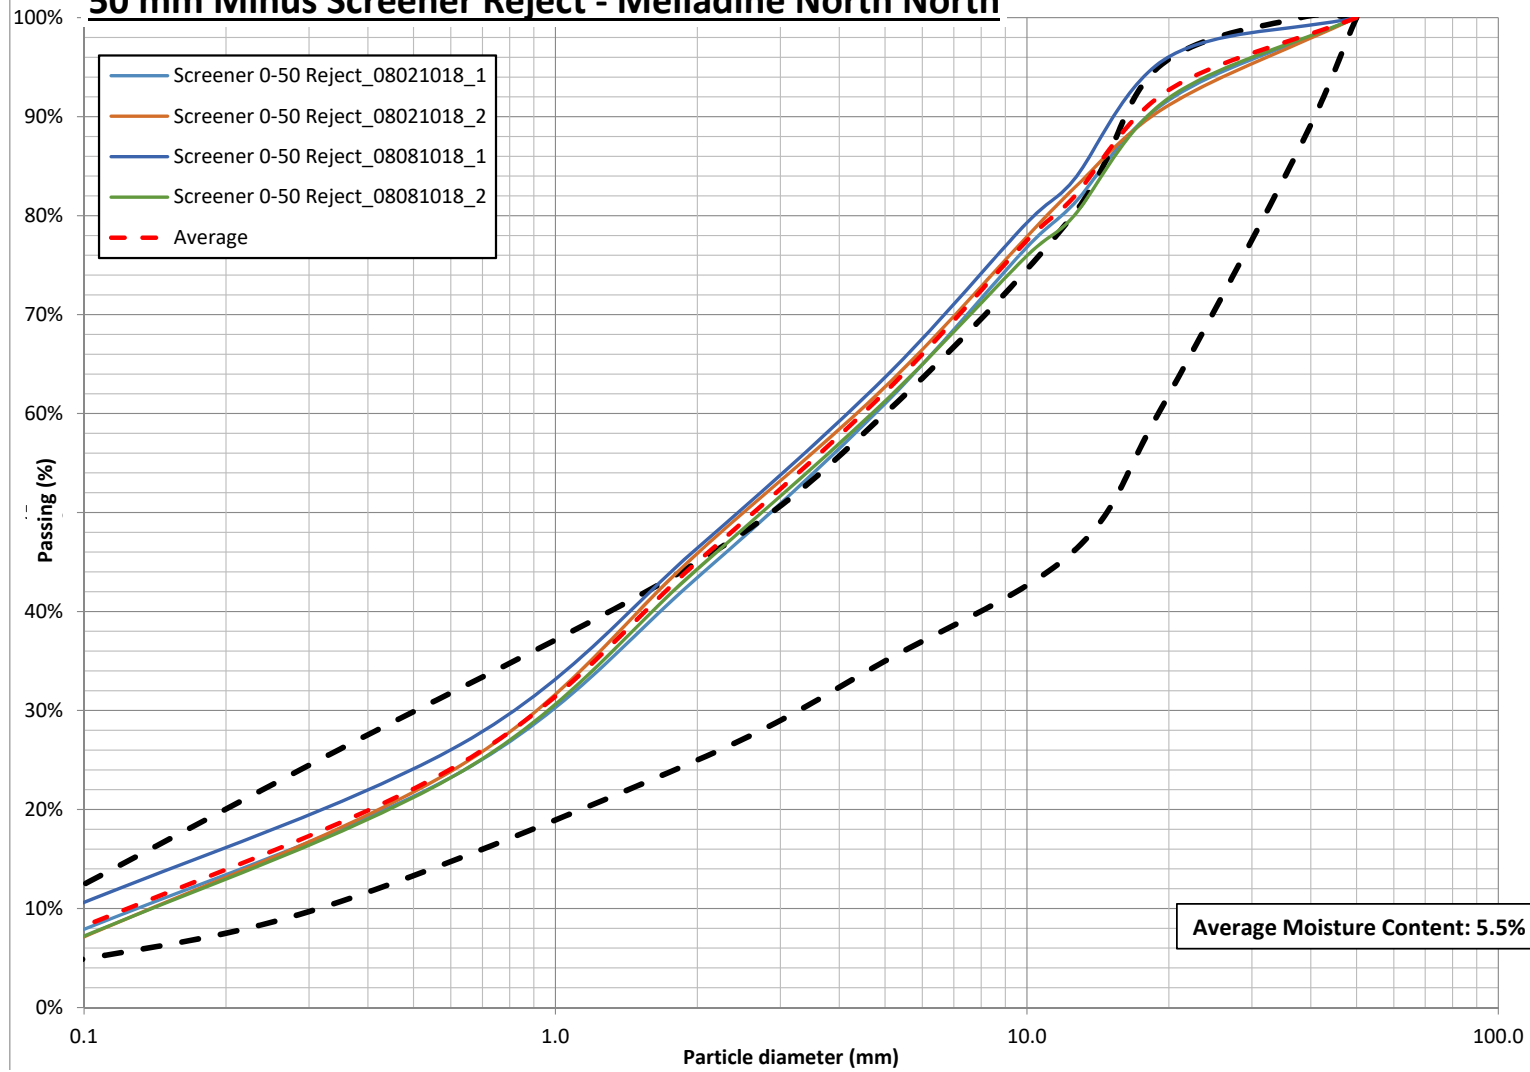
## 50 mm Minus Screener Reject - Meliadine North North

Table 1: Summary of Particle Size Analysis Results - 50 mm minus Screener Reject

Particle size analysis conducted on the 50 mm minus screened esker material (Appendix C) indicate that the material generally falls within specification for 50 mm minus granular material (AEM 2017), although slightly higher than specified proportions of particles sized between 2.00 mm and 12.5 mm were observed.

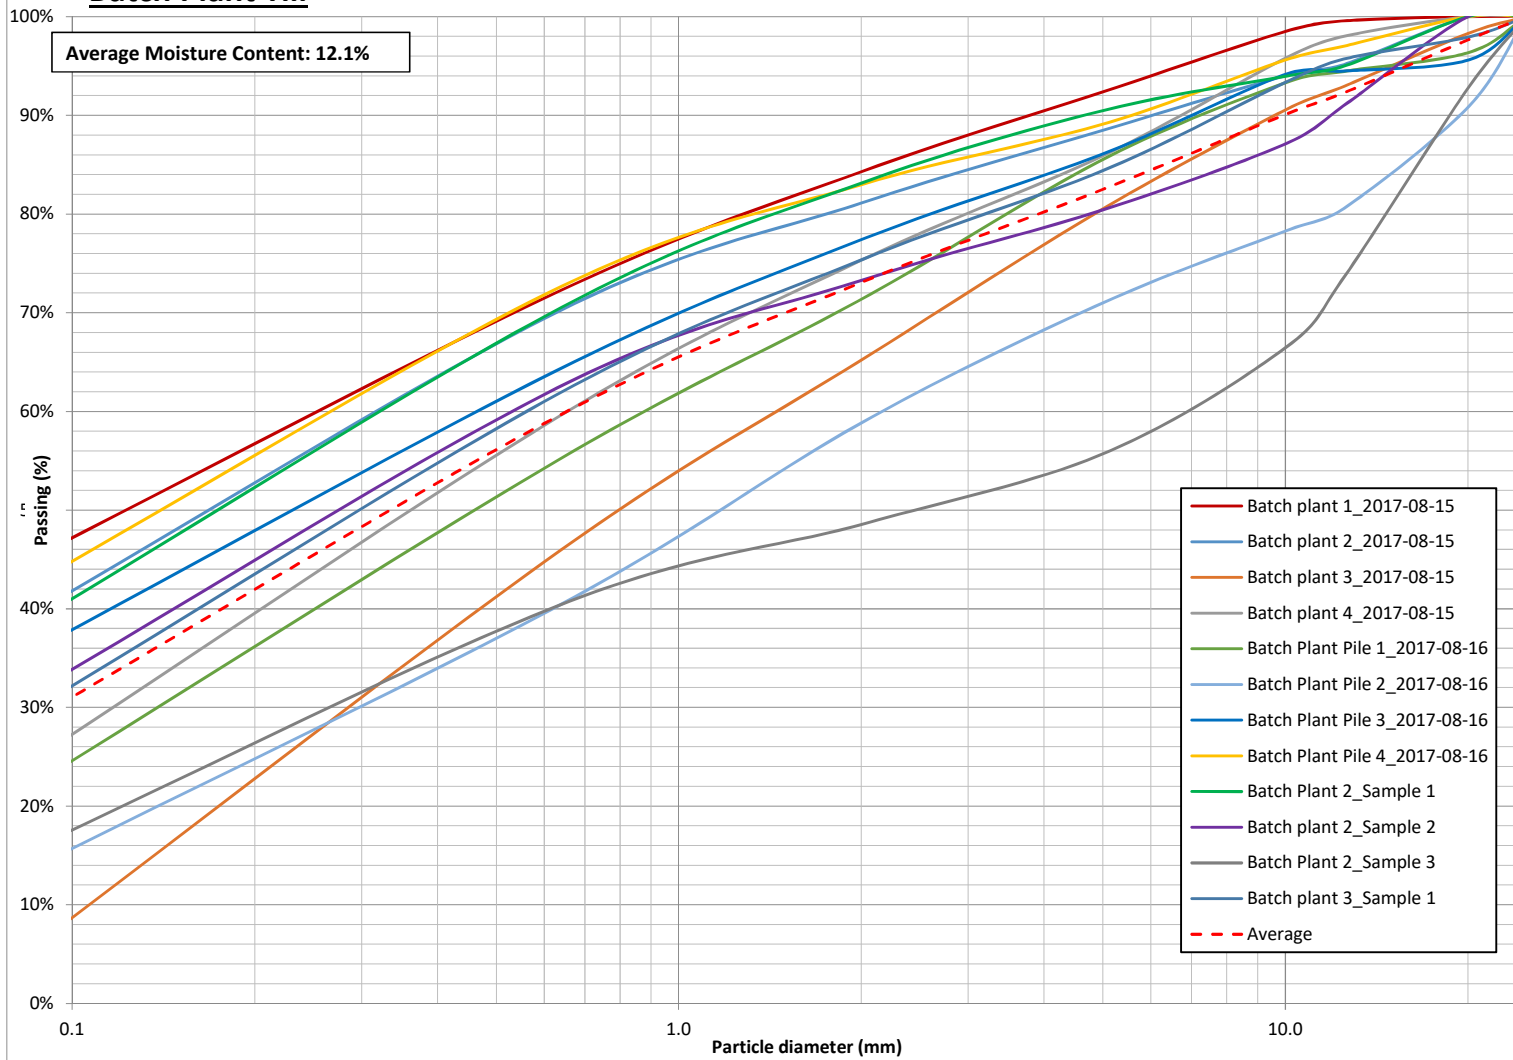
## Batch Plant Till

**Table 2: Summary of Particle Size Analysis Results - Batch Plant Till**

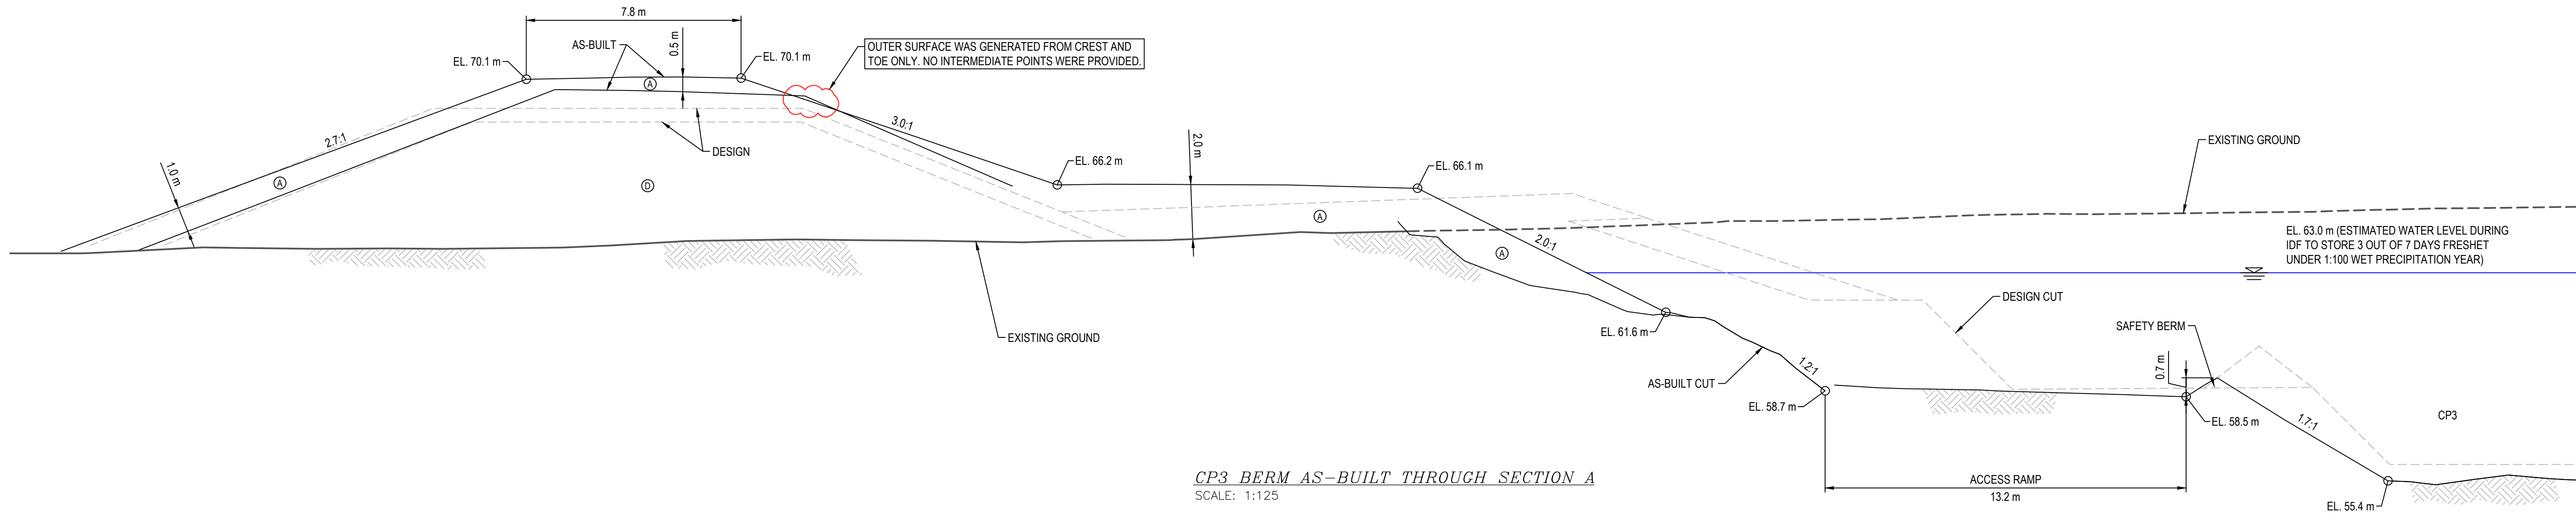
CP3 BERM AS-BUILT THROUGH SECTION A  
SCALE: 1:125

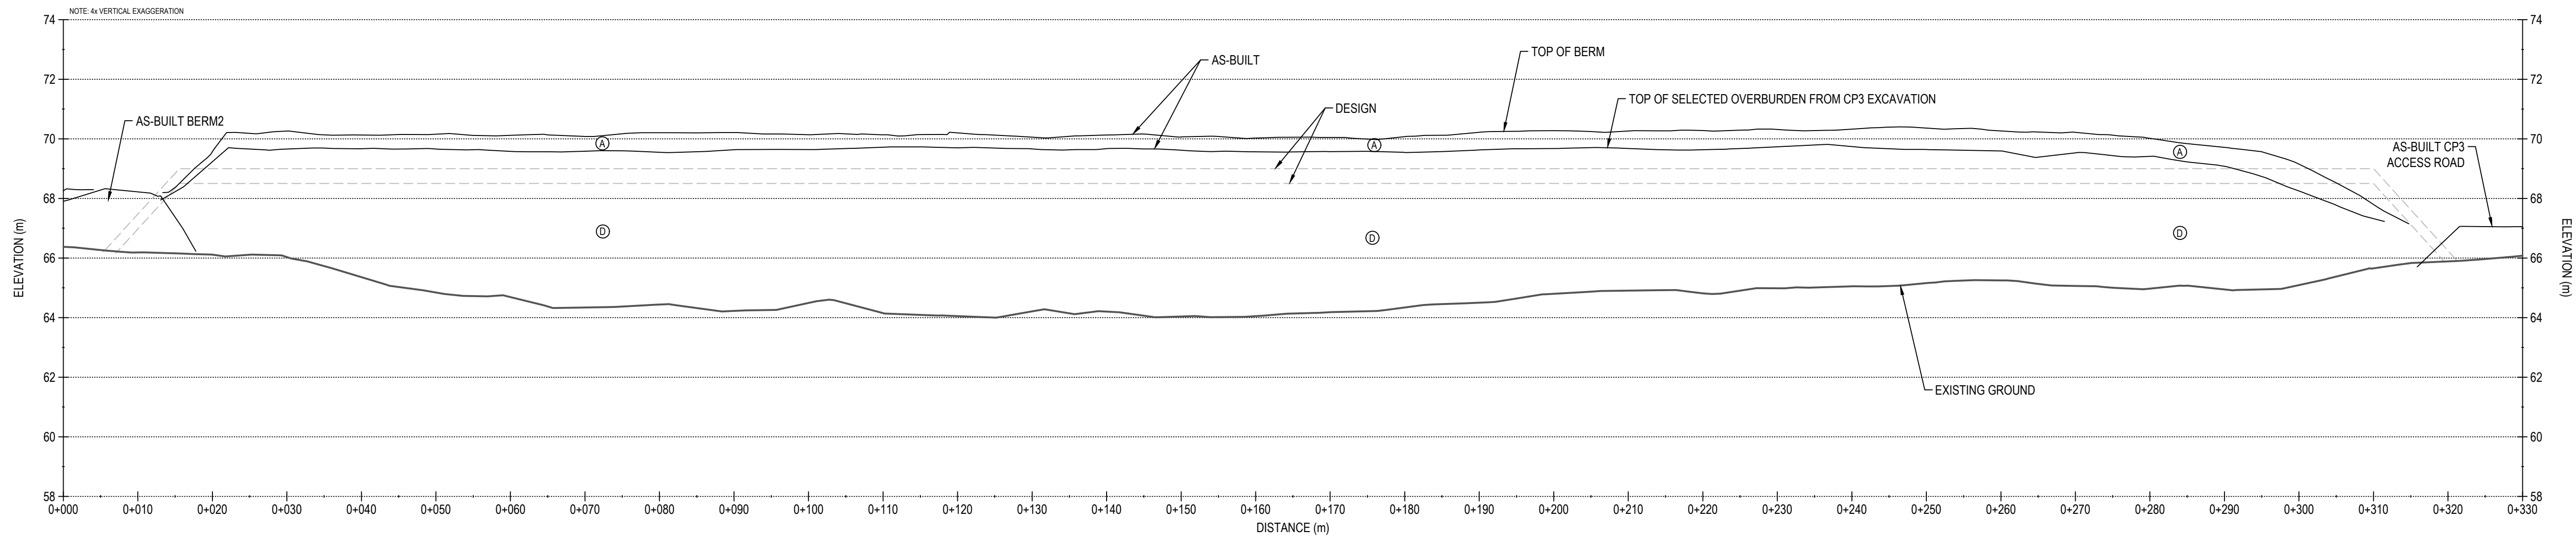
CP3 - BERM PROFILE  
SCALE: H-1:500 V-1:125

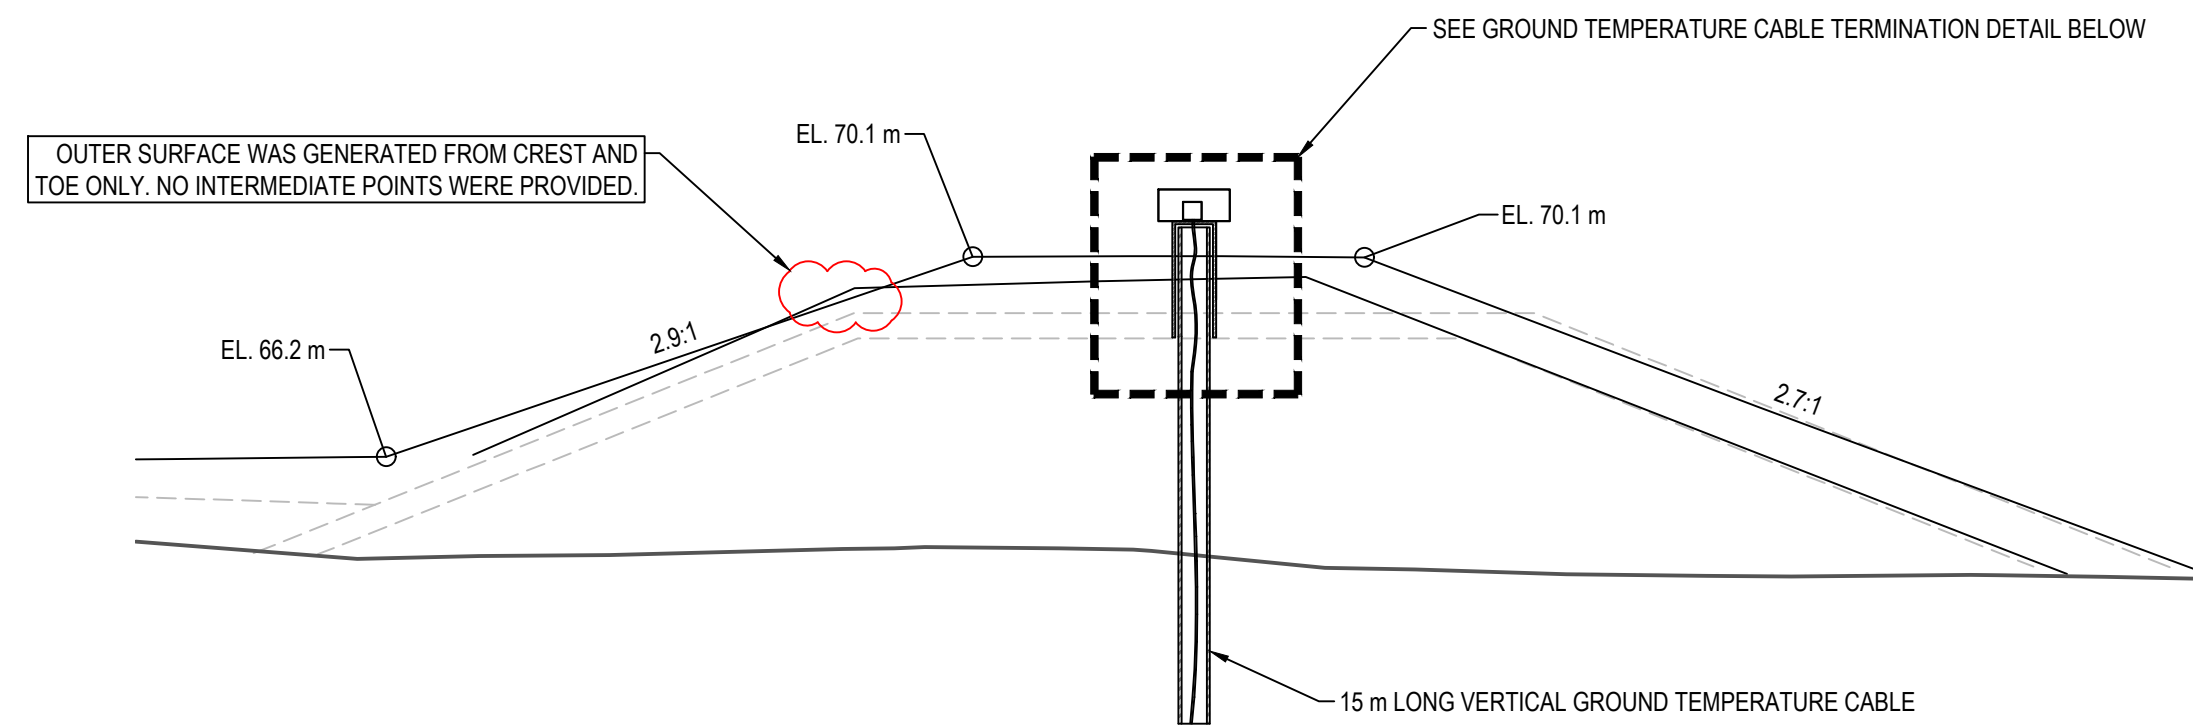
TYPICAL SECTION - CP3 BERM GROUND TEMPERATURE CABLE INSTALLATION

The GTCs installed in Berm CP3 must be read on a regular basis. Tetra Tech recommends that the cables be read once per month during the first year, and then on a yearly basis during operation. The measured readings analyzed and reported in the annual inspection report. The reading frequency can be adjusted as required.

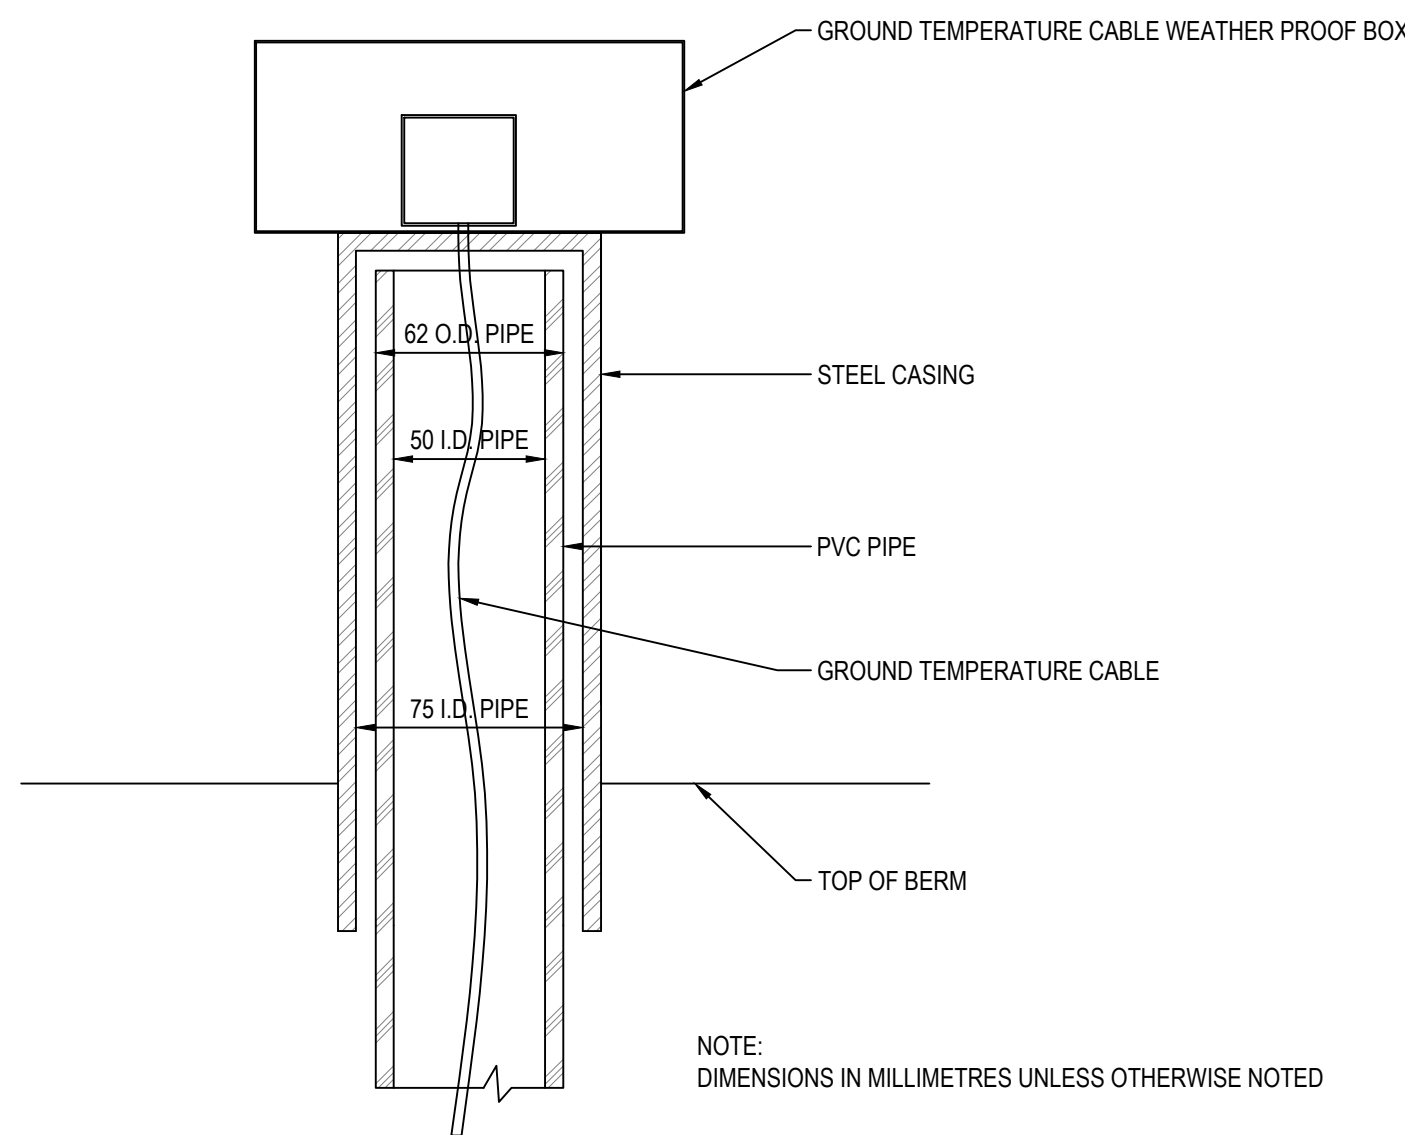
DETAIL - GROUND TEMPERATURE CABLE TERMINATION

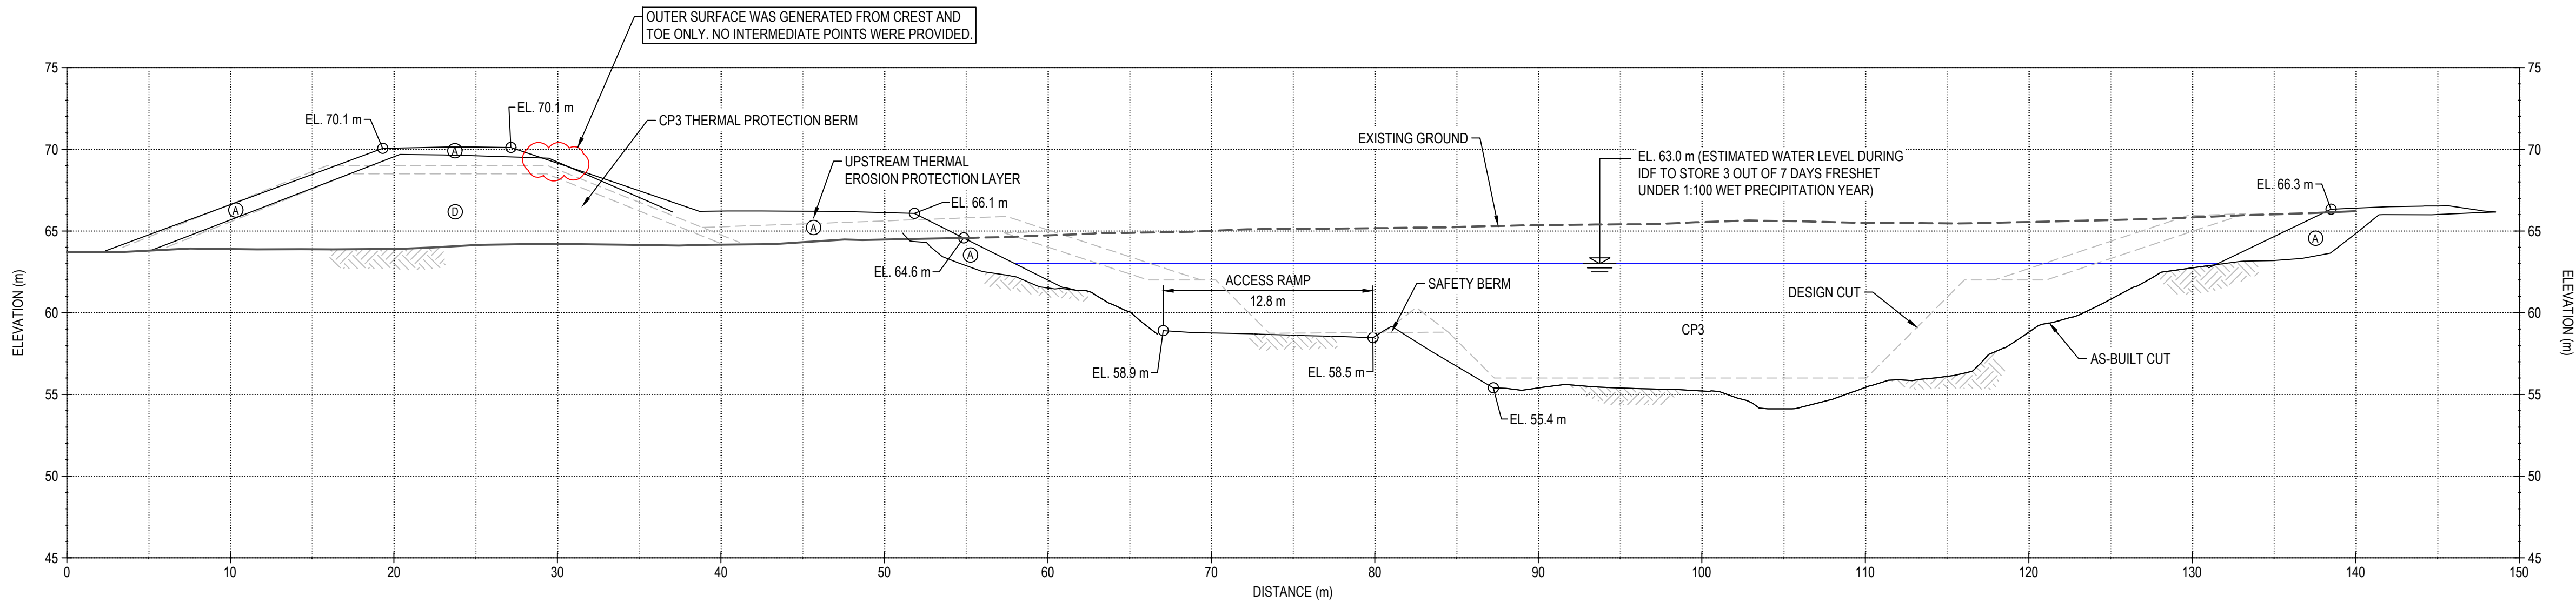
SECTION A  
SCALE: 1:250

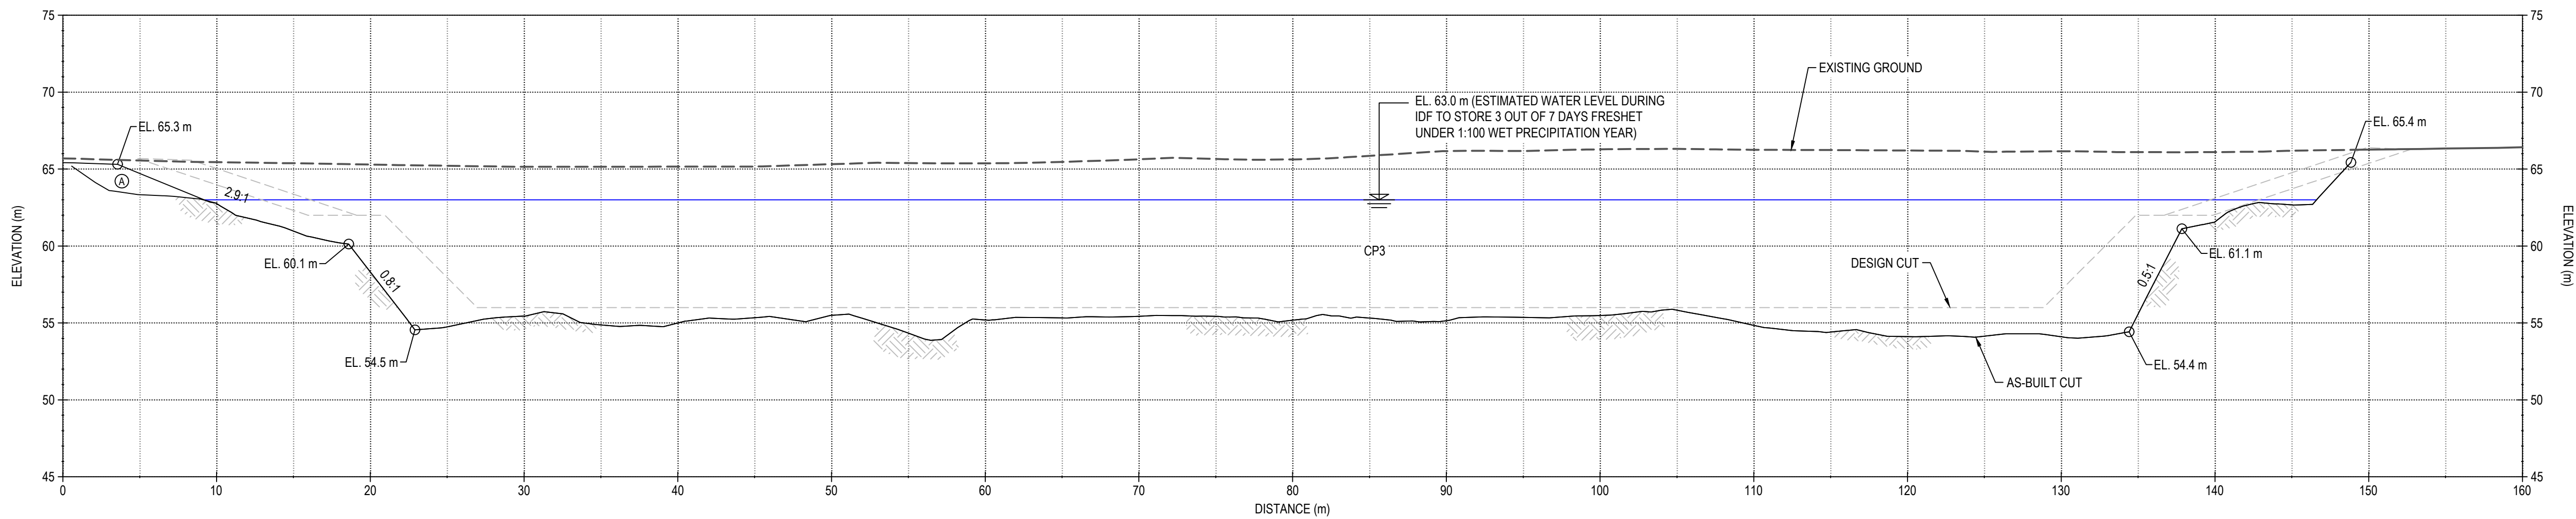
SECTION B  
SCALE: 1:250

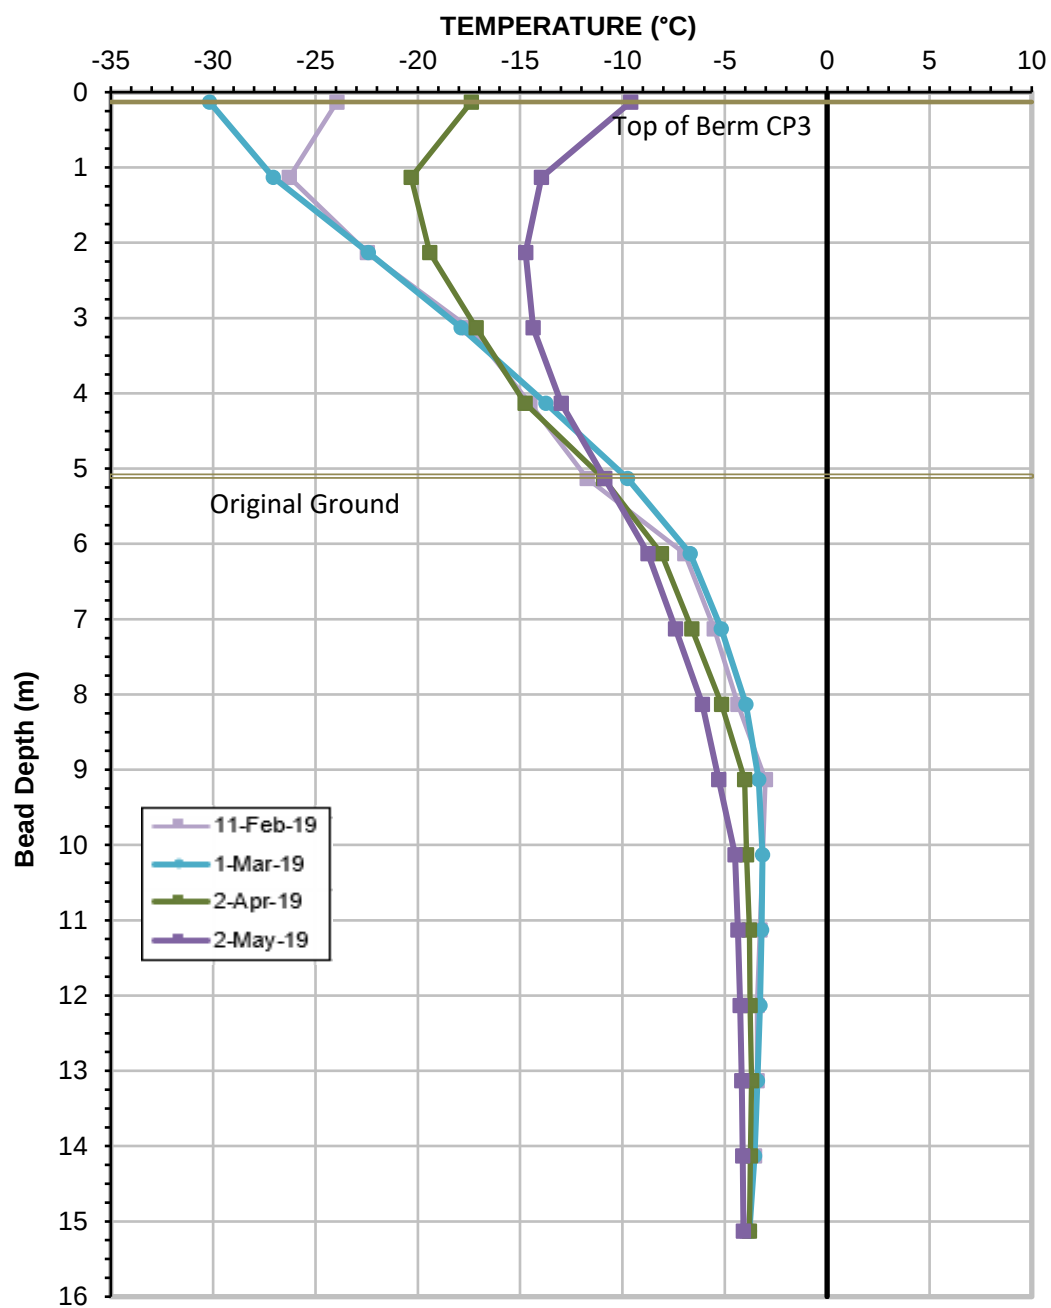
Serial No.: 2644  
Date Installed: February 11, 2019

Ground Temperature Profile for Cable GTC-01  
Berm CP3

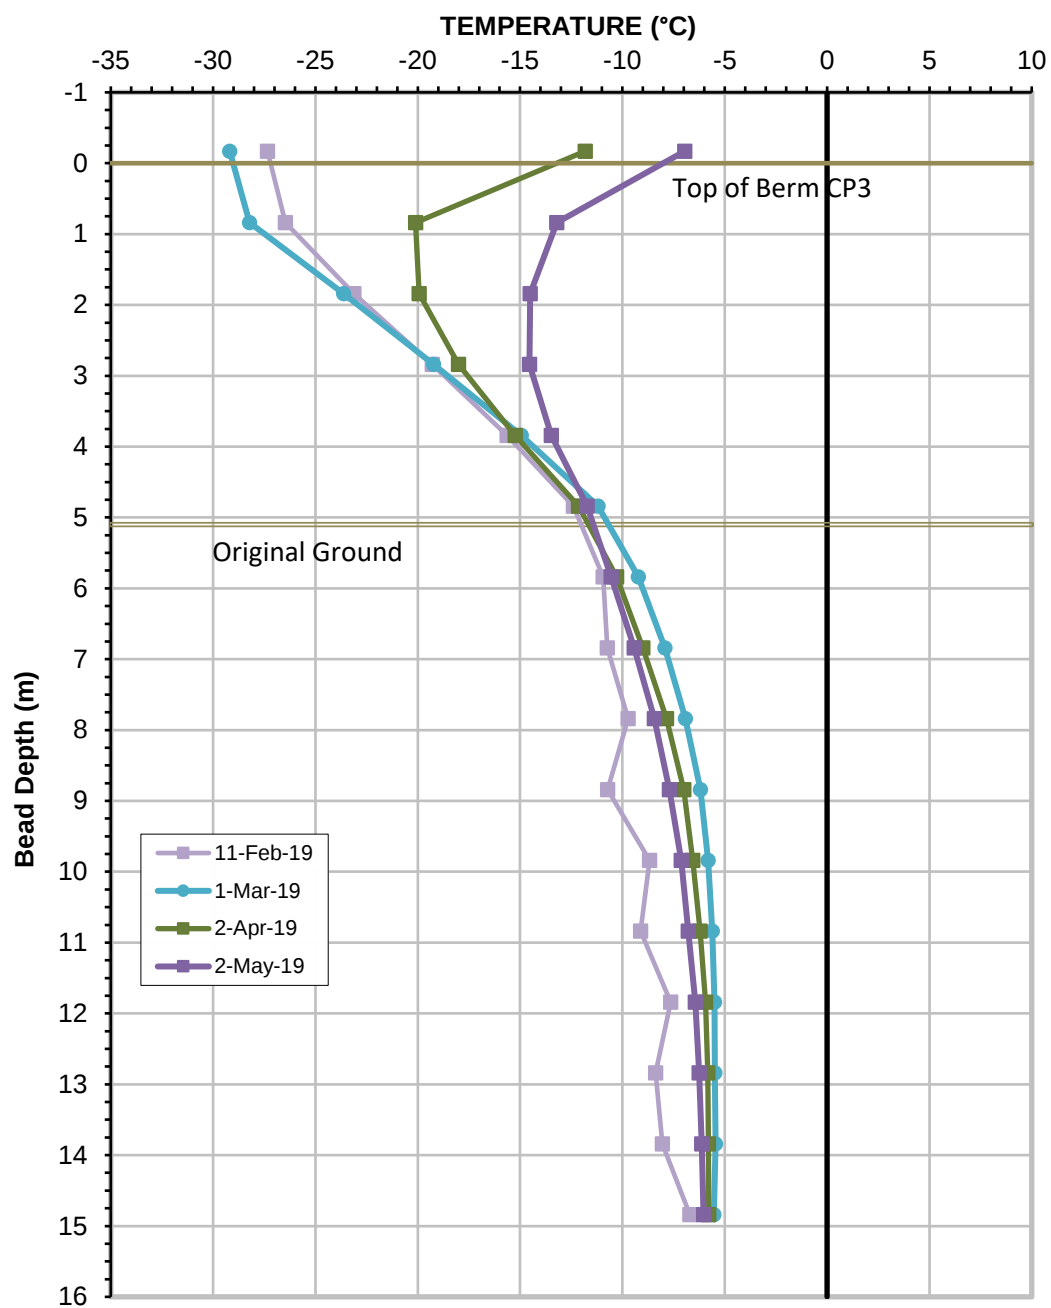
Serial No.: 2689  
Date Installed: February 11, 2019

Ground Temperature Profile for Cable GTC-03  
Berm CP3
