**MELIADINE GOLD PROJECT**

## Construction Summary (As-built) Report for Collection Pond 6 (CP6) and Berm CP6

AEM Document Number 6526-695-230-REP-002

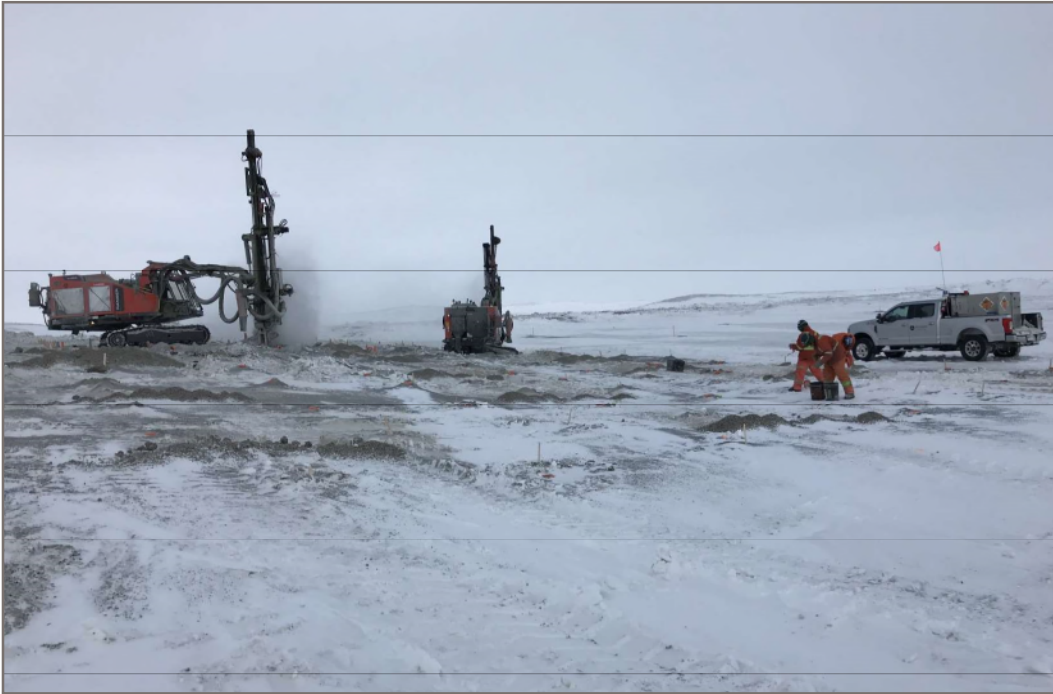
**Photo 1:** 2020-03-05 Pond CP6—Drilling first blast pattern; view facing east

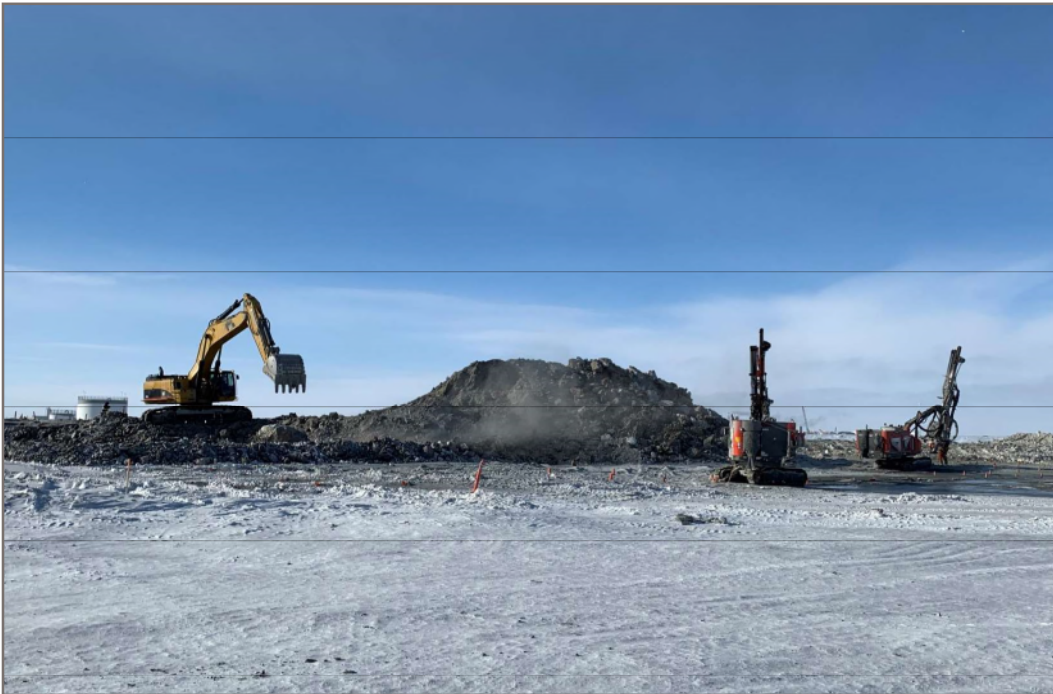
**Photo 2:** 2020-03-10 Pond CP6 - Mucking first blast; view facing north

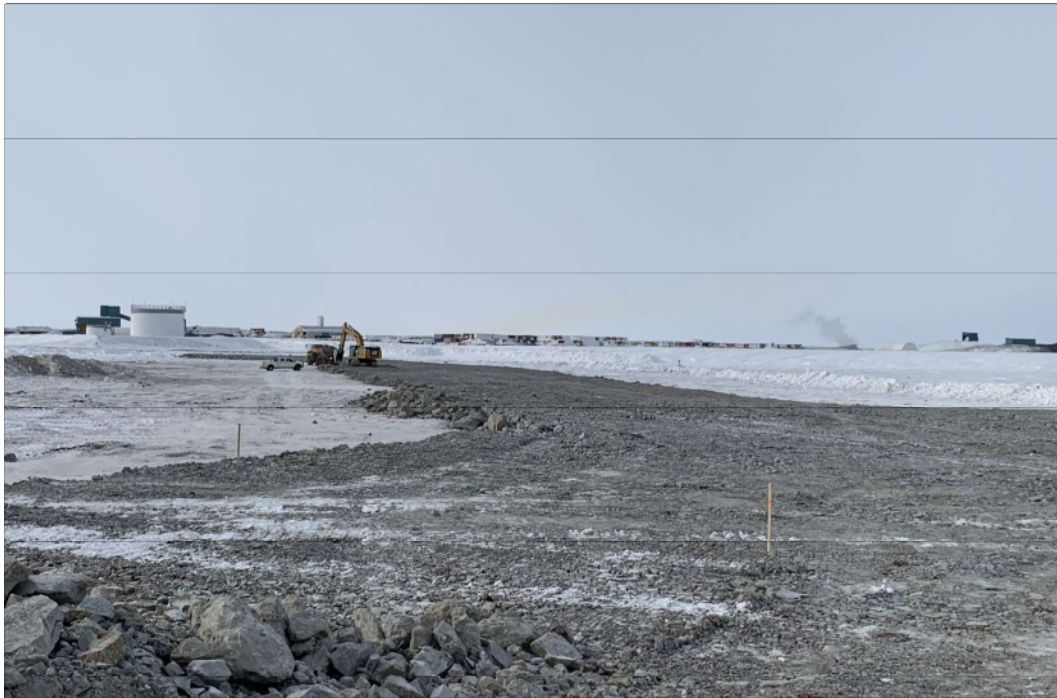
**Photo 3:** 2020-03-12 Berm CP6 - First lift overburden on Berm CP6; view facing southwest

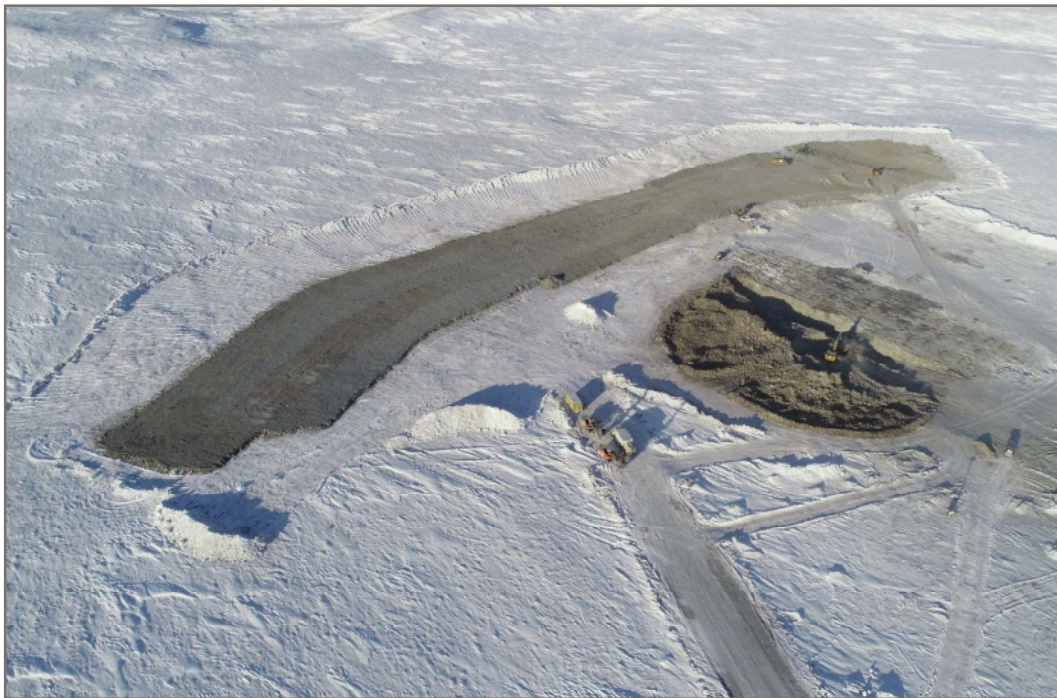
**Photo 4:** 2020-03-13 - Drone view of Pond CP6 and Berm CP6

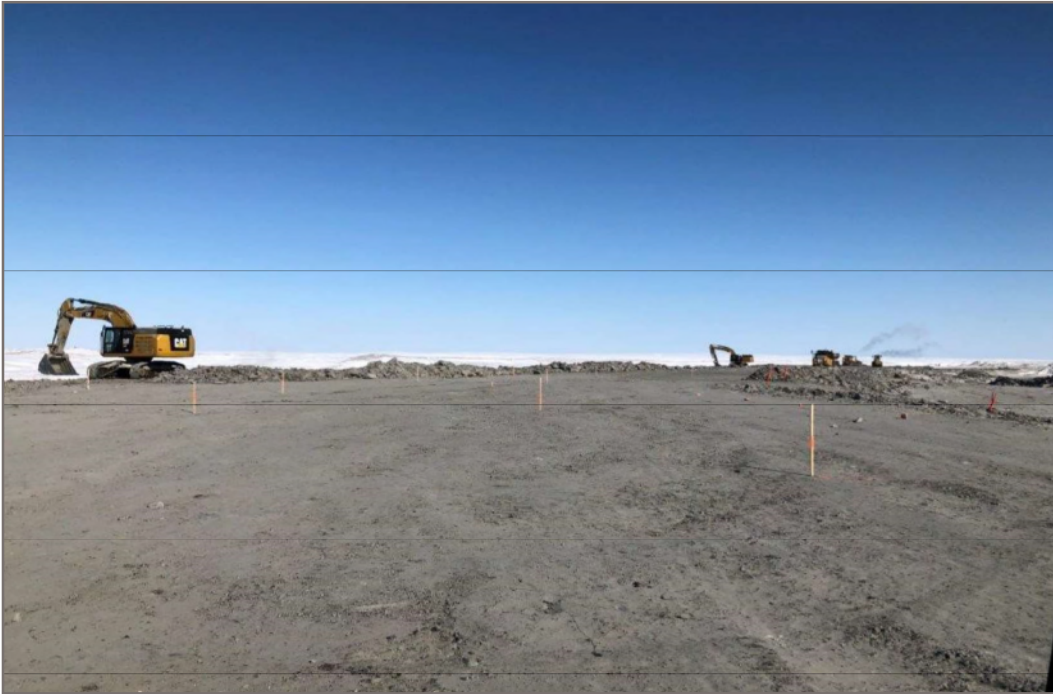
**Photo 5:** 2020-03-21 Berm CP6 - Sloping and building Berm CP6; view facing east

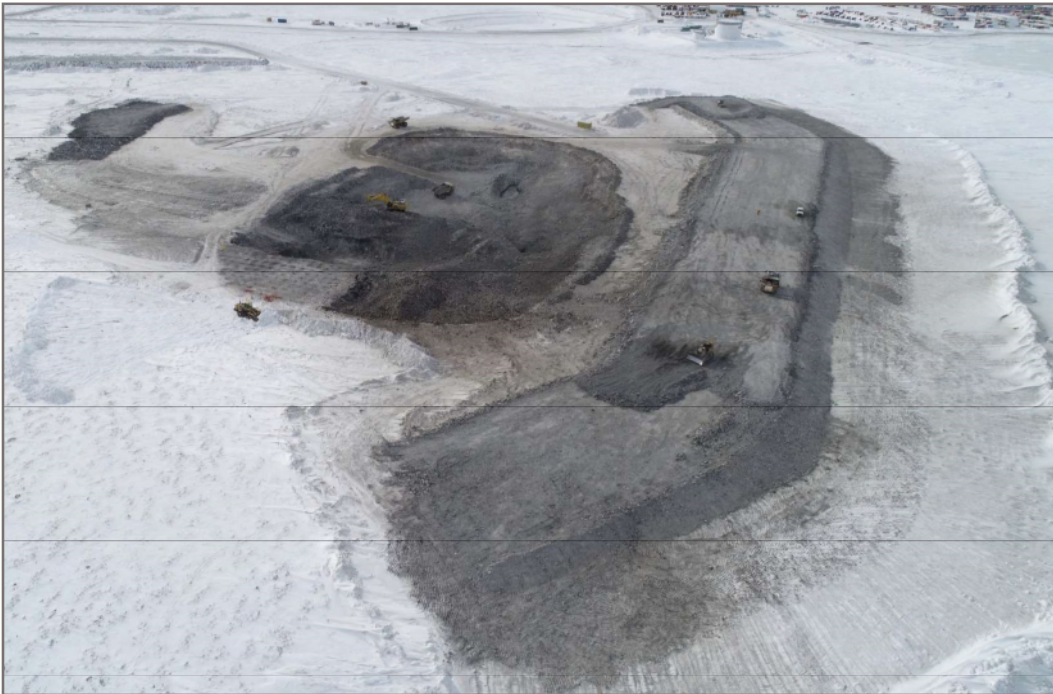
**Photo 6:** 2020-03-22 - Drone view of Pond CP6 and Berm CP6

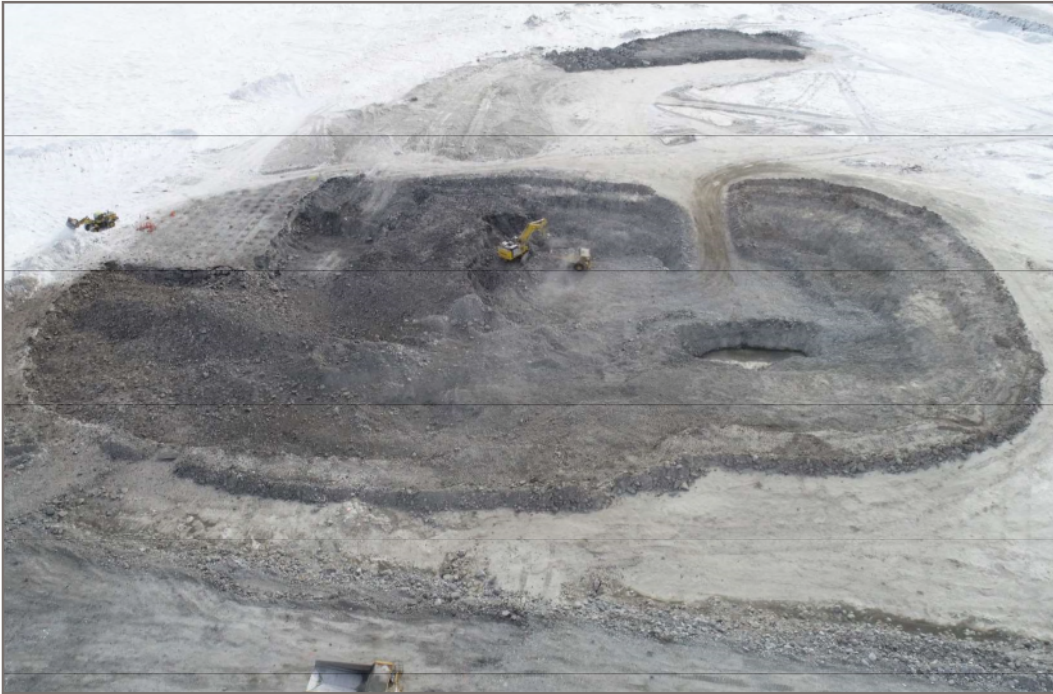
**Photo 7:** 2020-03-22 - Drone view of Pond CP6 and Berm CP6

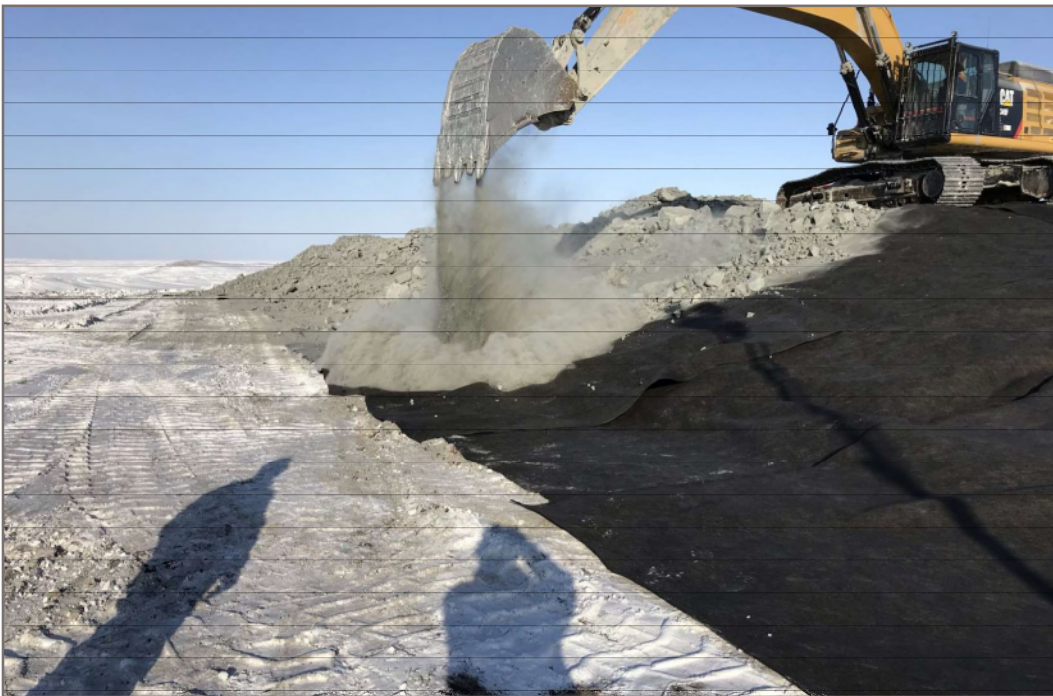
**Photo 8:** 2020-03-30 Berm CP6 - Placing erosion protection over geotextile on Berm CP6;; view facing northeast

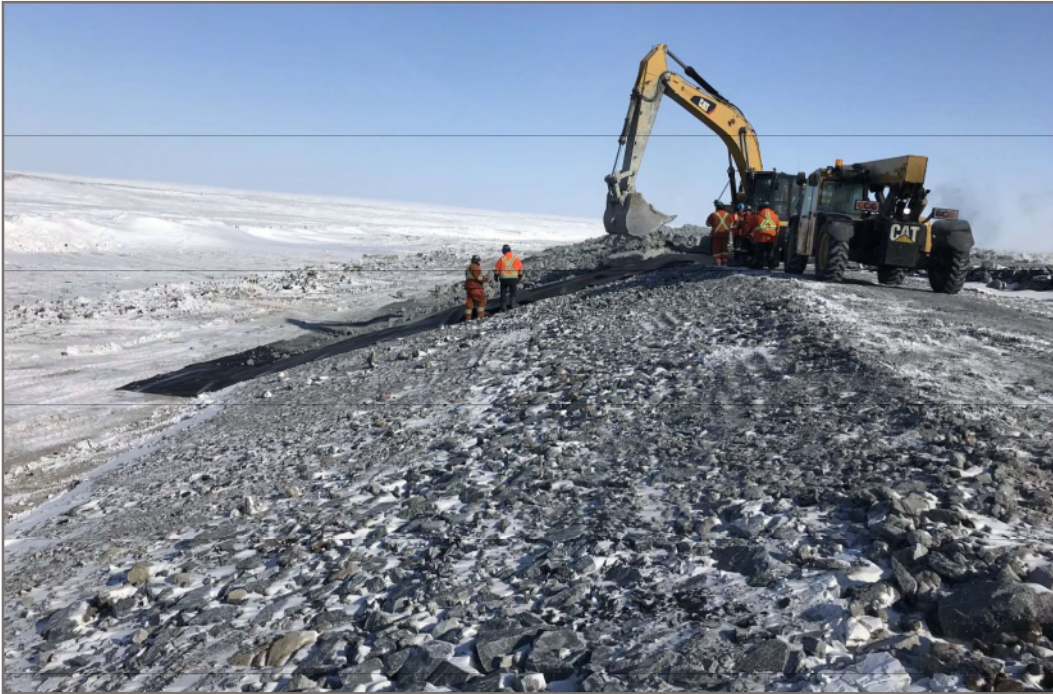
**Photo 9:** 2020-03-30 Berm CP6 - Placing geotextile on upstream slope on Berm CP6; view facing northeast

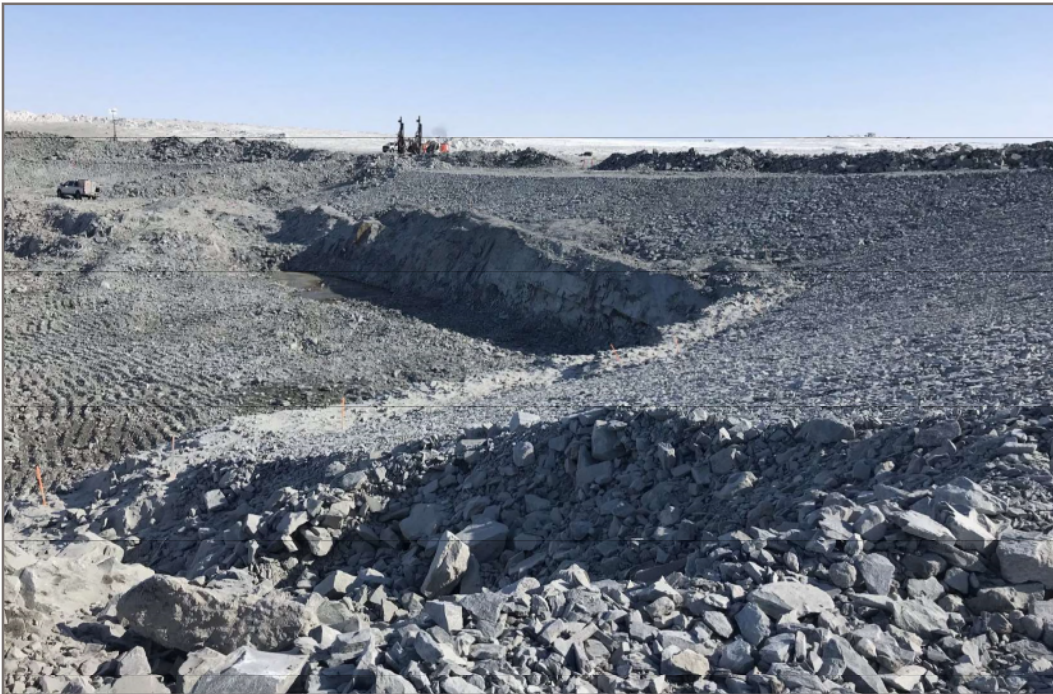
**Photo 10:** 2020-03-30 Berm CP6 - Placement of thermal protection on Berm CP6; view facing northeast

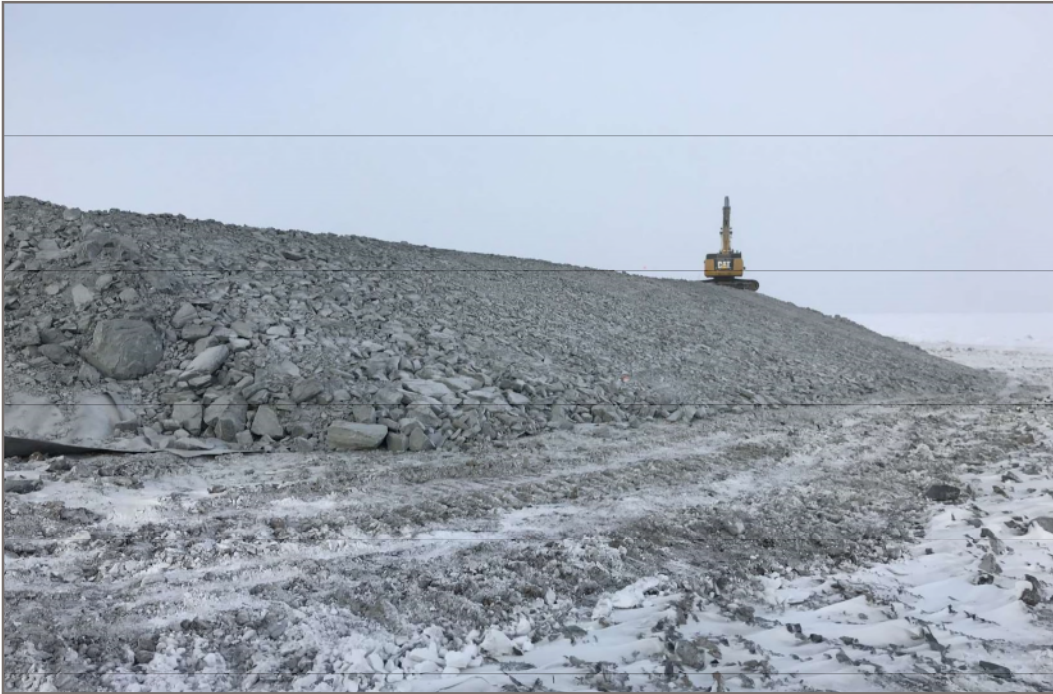
**Photo 11:** 2020-04-01 Berm CP6 - Sloping final erosion cover on Berm CP6; view facing southwest.

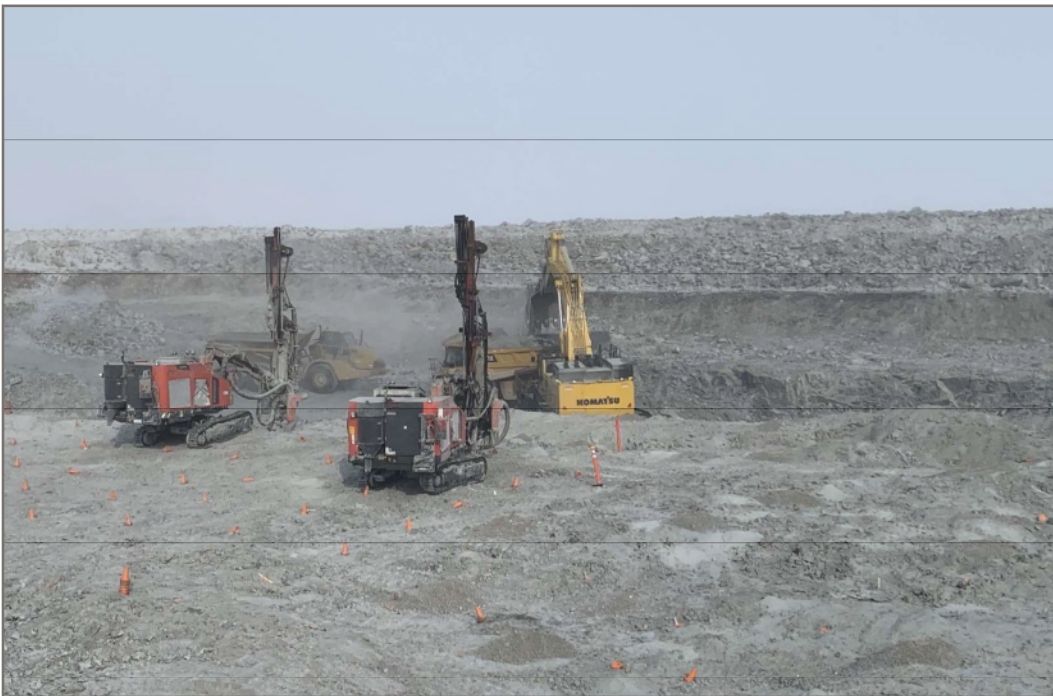
**Photo 12:** 2020-04-01 Berm CP6 - Drilling and mucking rock bench on Berm CP6; view facing north

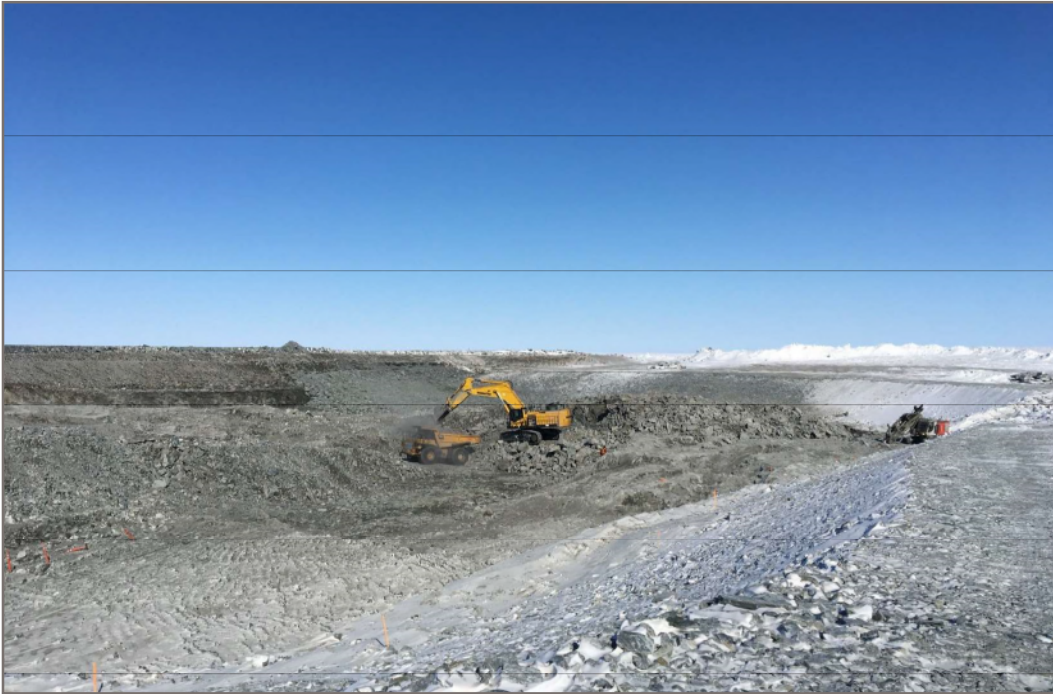
**Photo 13:** 2020-04-04 Pond CP6 - Mucking blast rock from Pond CP6; view facing northeast

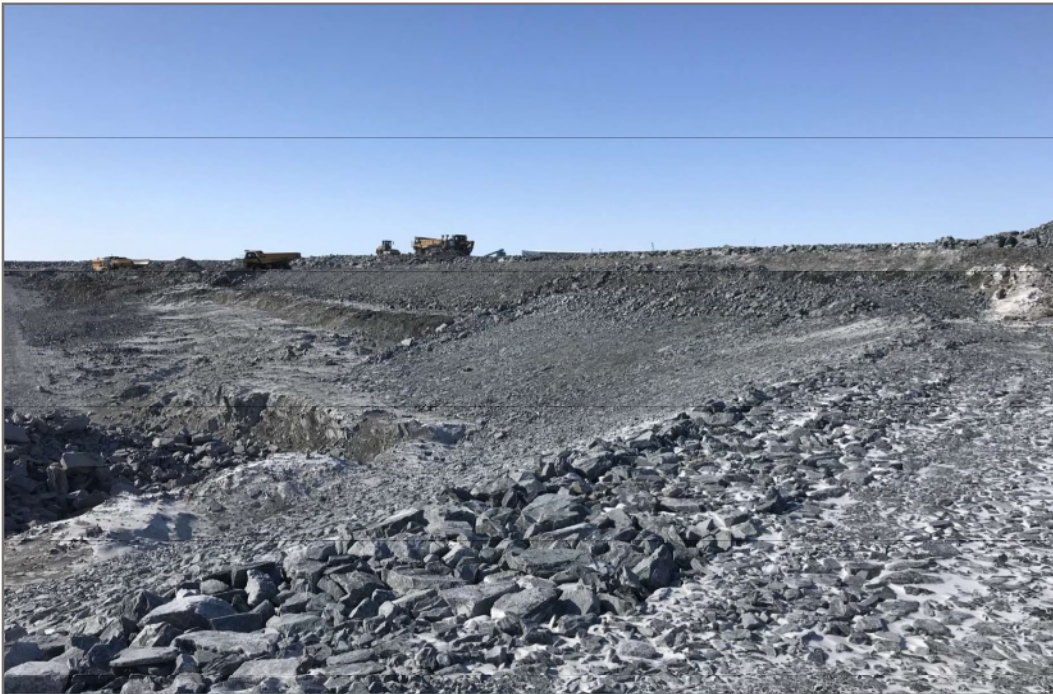
**Photo 14:** 2020-04-04 Berm CP6 - Placement of thermal protection on Berm CP6; view facing southwest

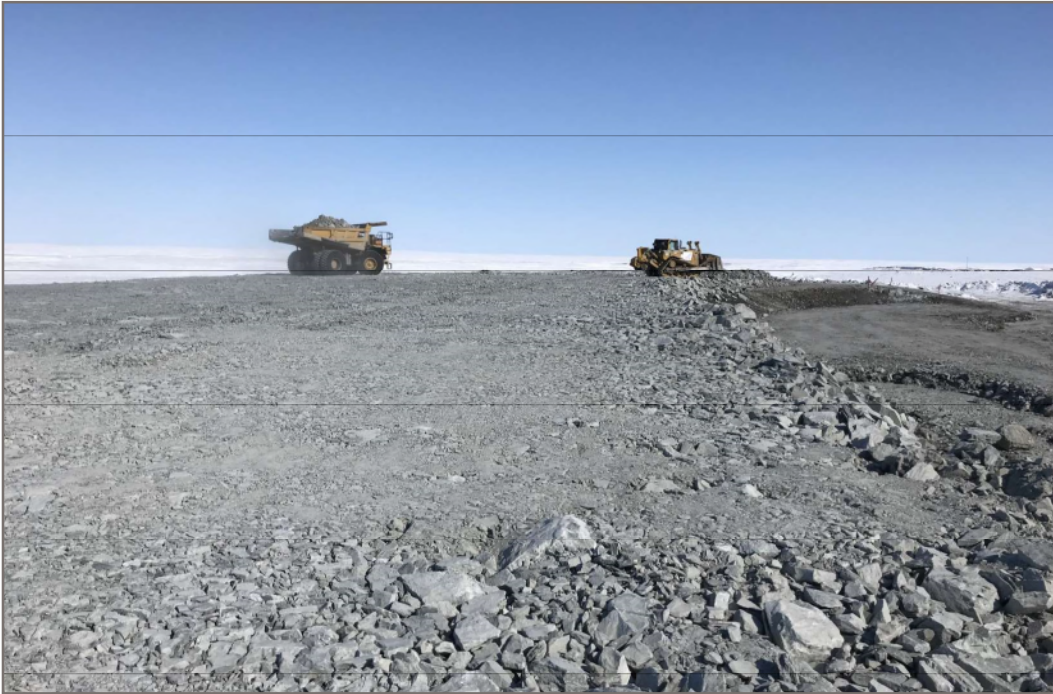
**Photo 15:** 2020-04-05 Berm CP6 - Placement of final erosion cover on Berm CP6; view facing northeast.

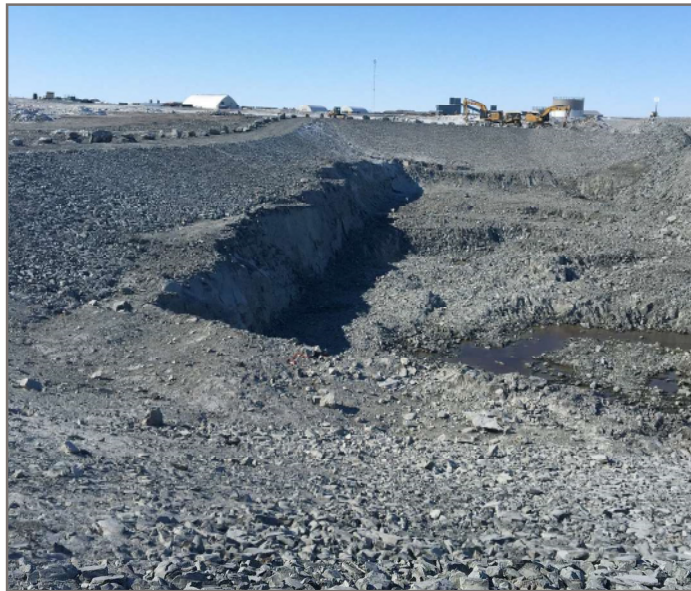
**Photo 16:** 2020-04-08 Pond CP6 - Final interior view of Pond CP6; view facing southwest

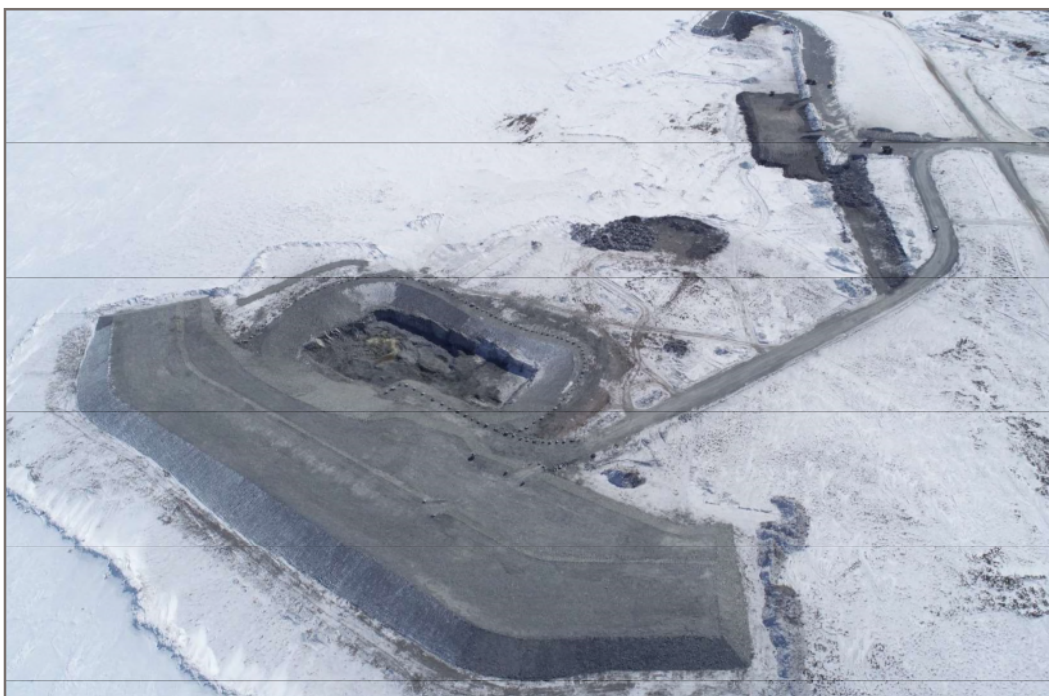
**Photo 17:** 2020-04-11 - Drone view of Pond CP6 and Berm CP6

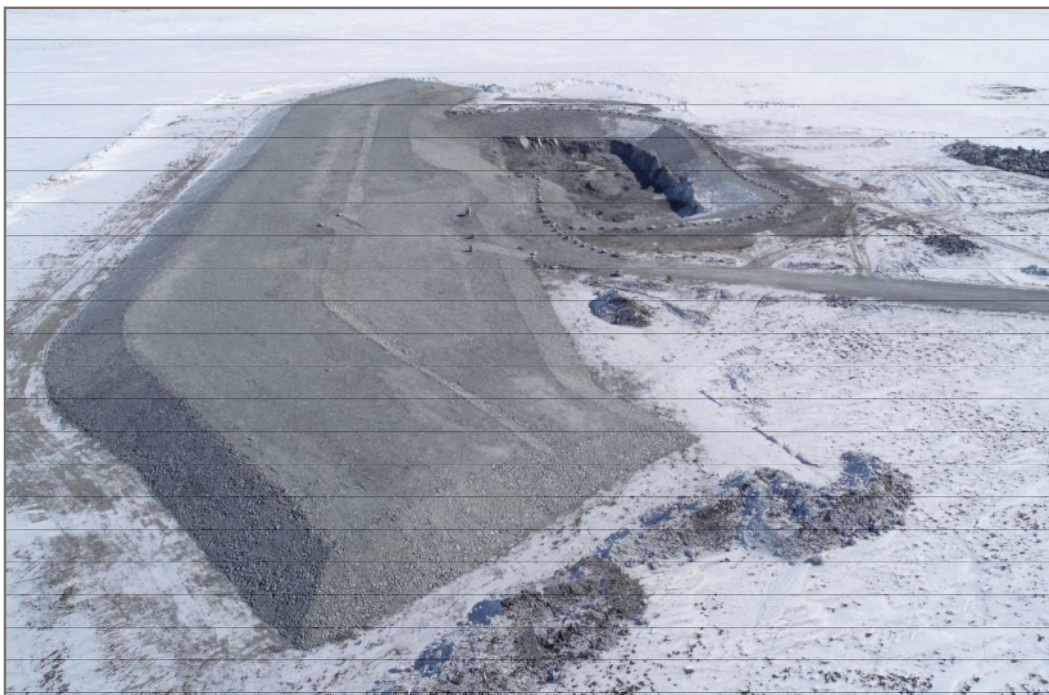
**Photo 18:** 2020-04-11 - Drone view of Pond CP6 and Berm CP6

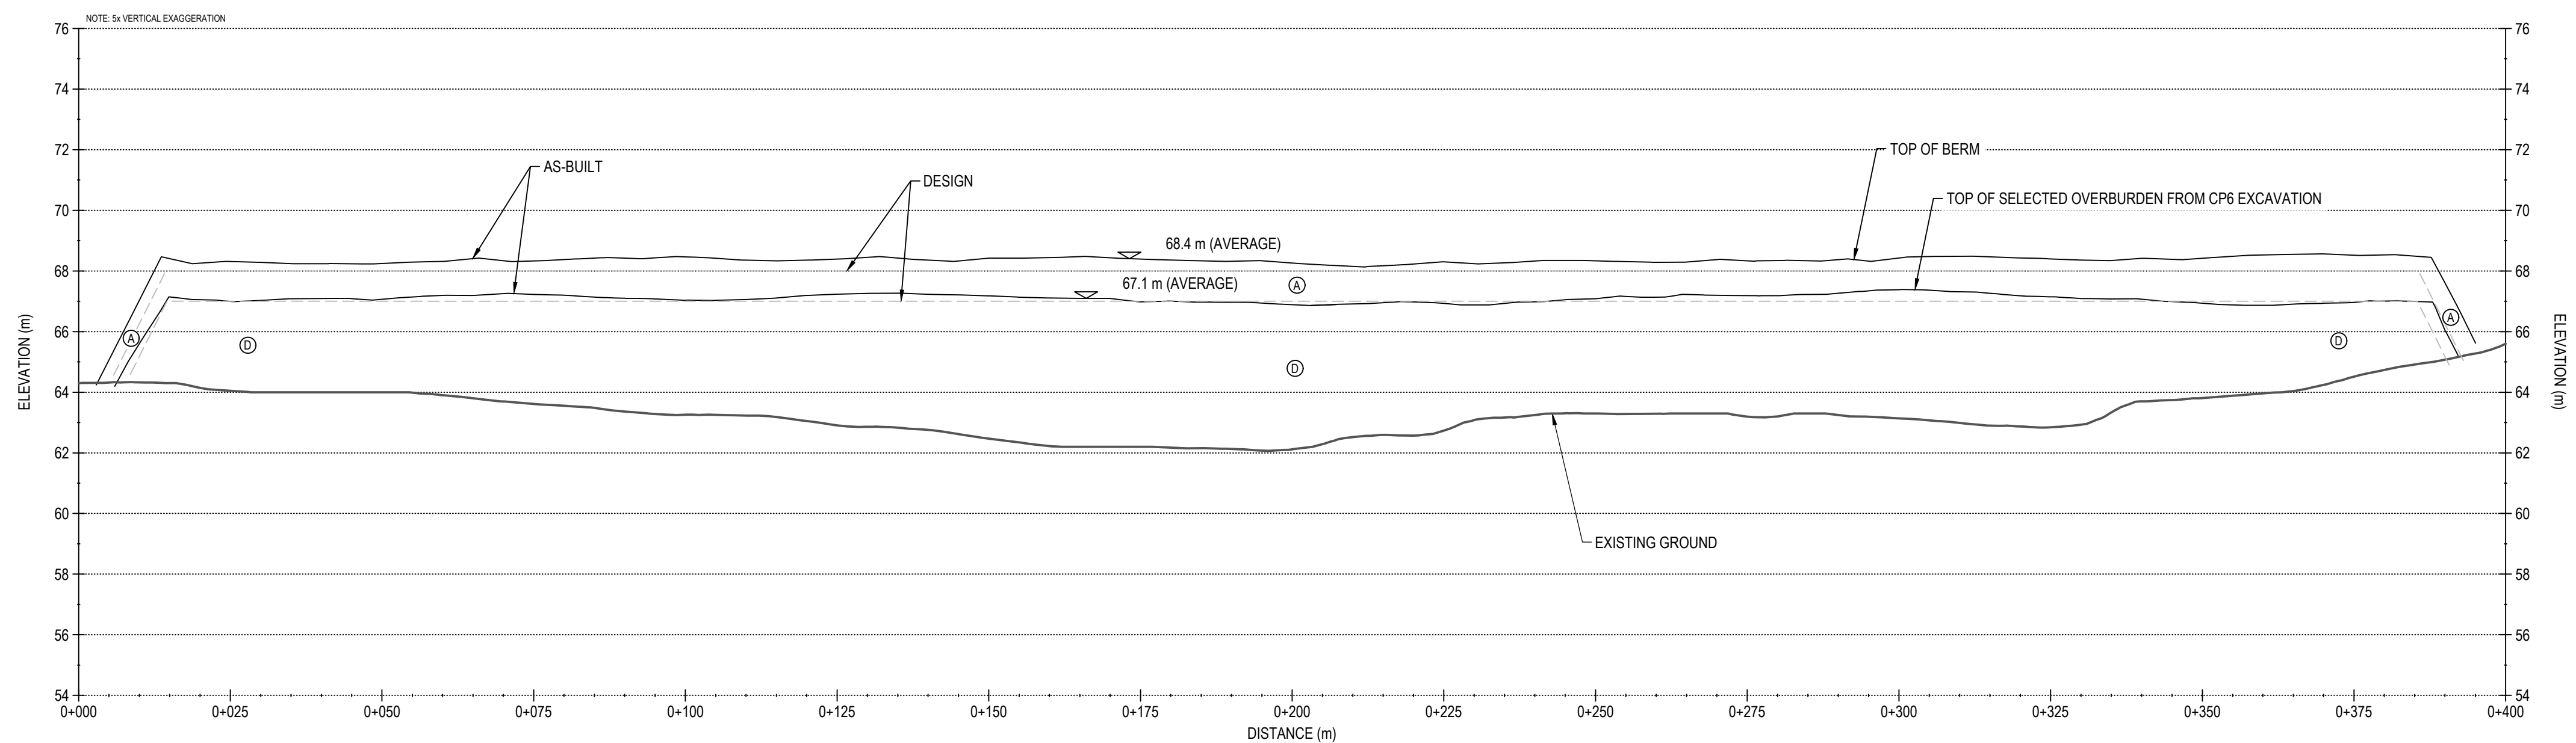
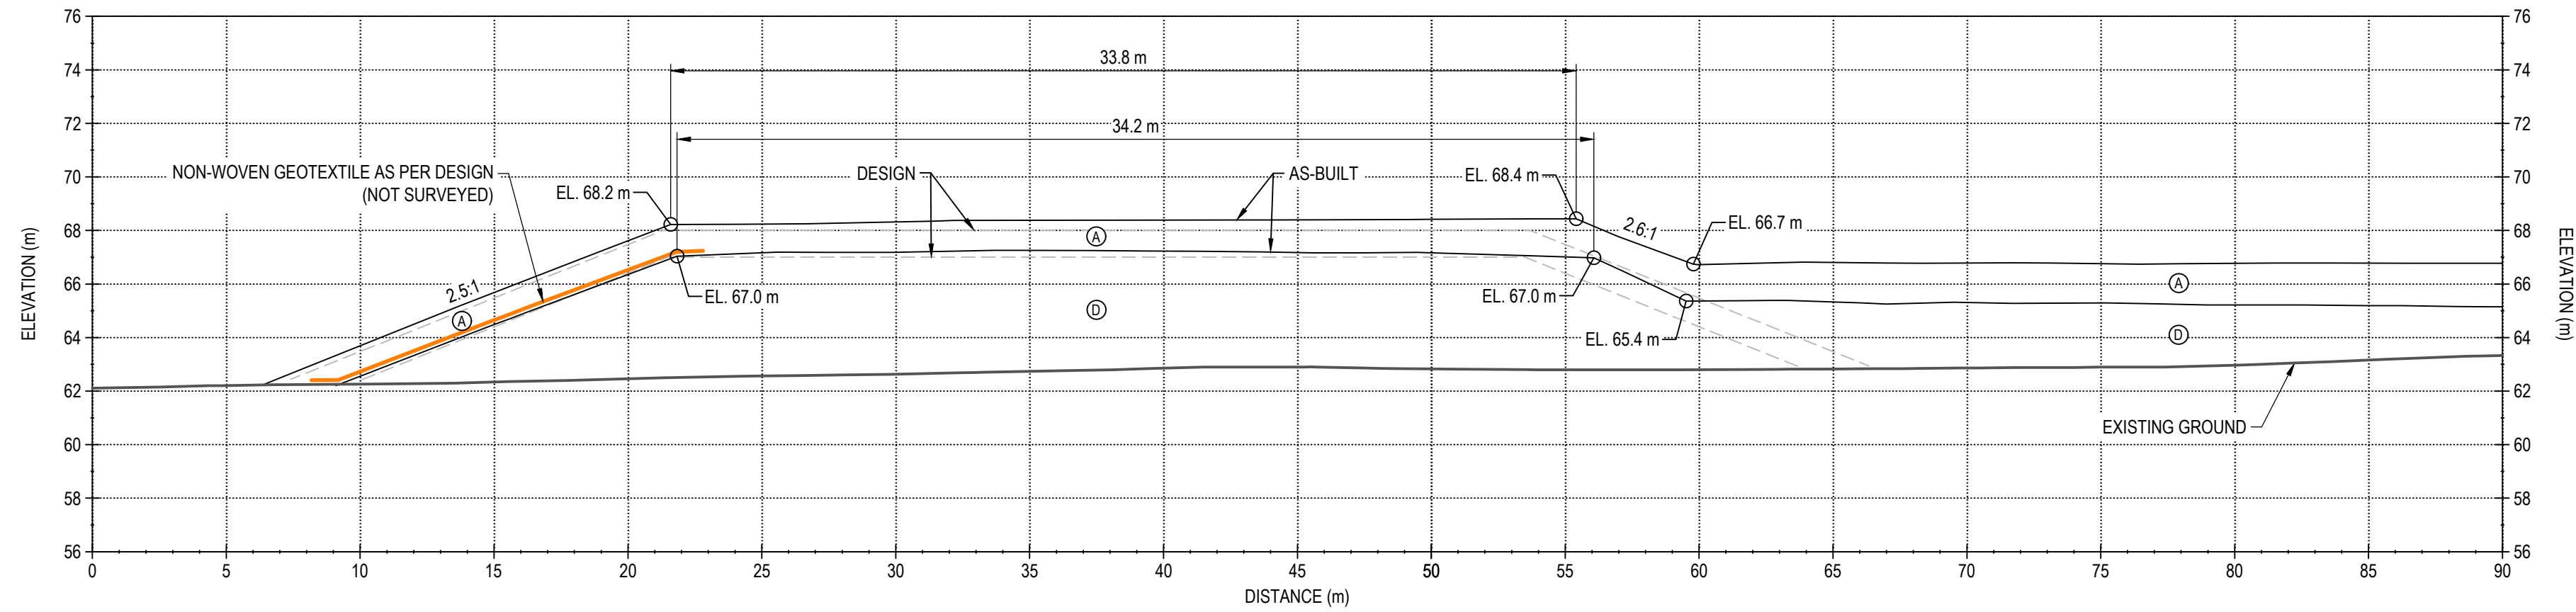
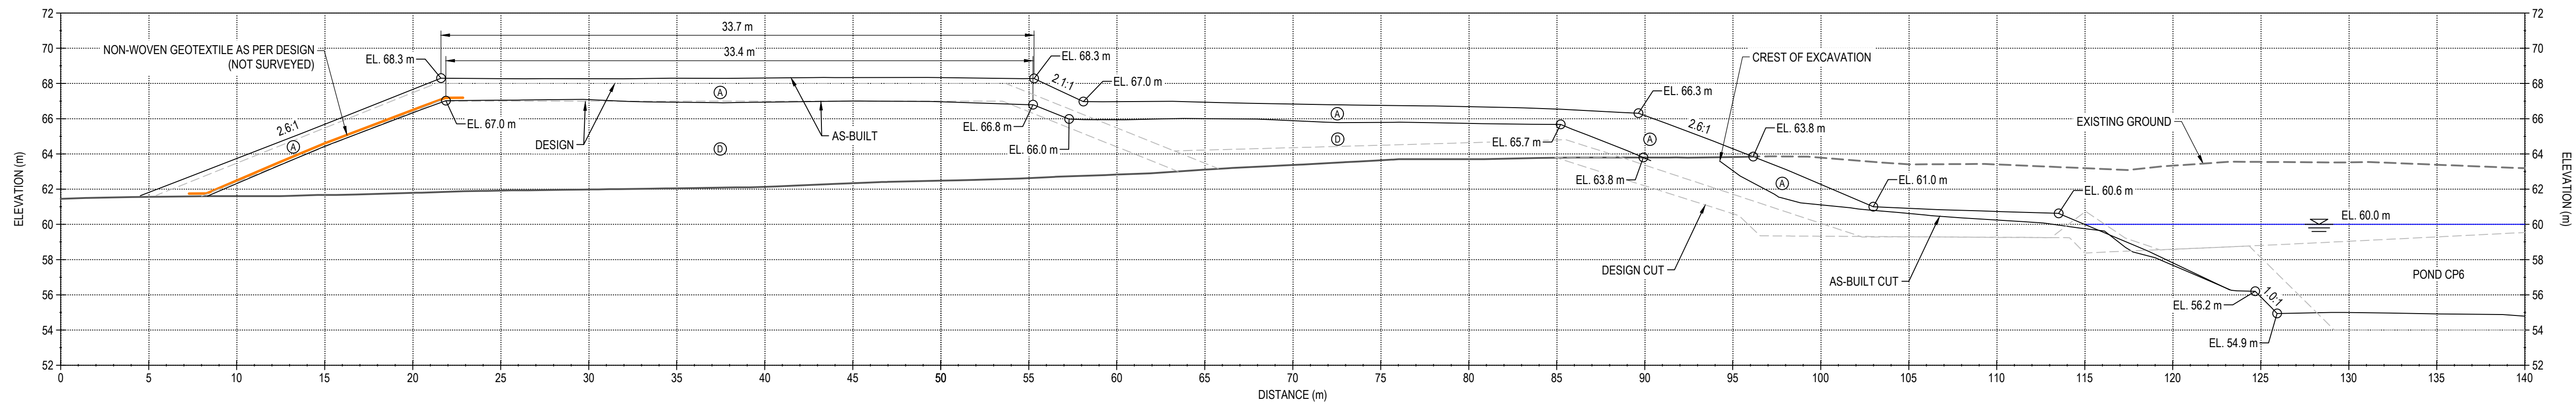
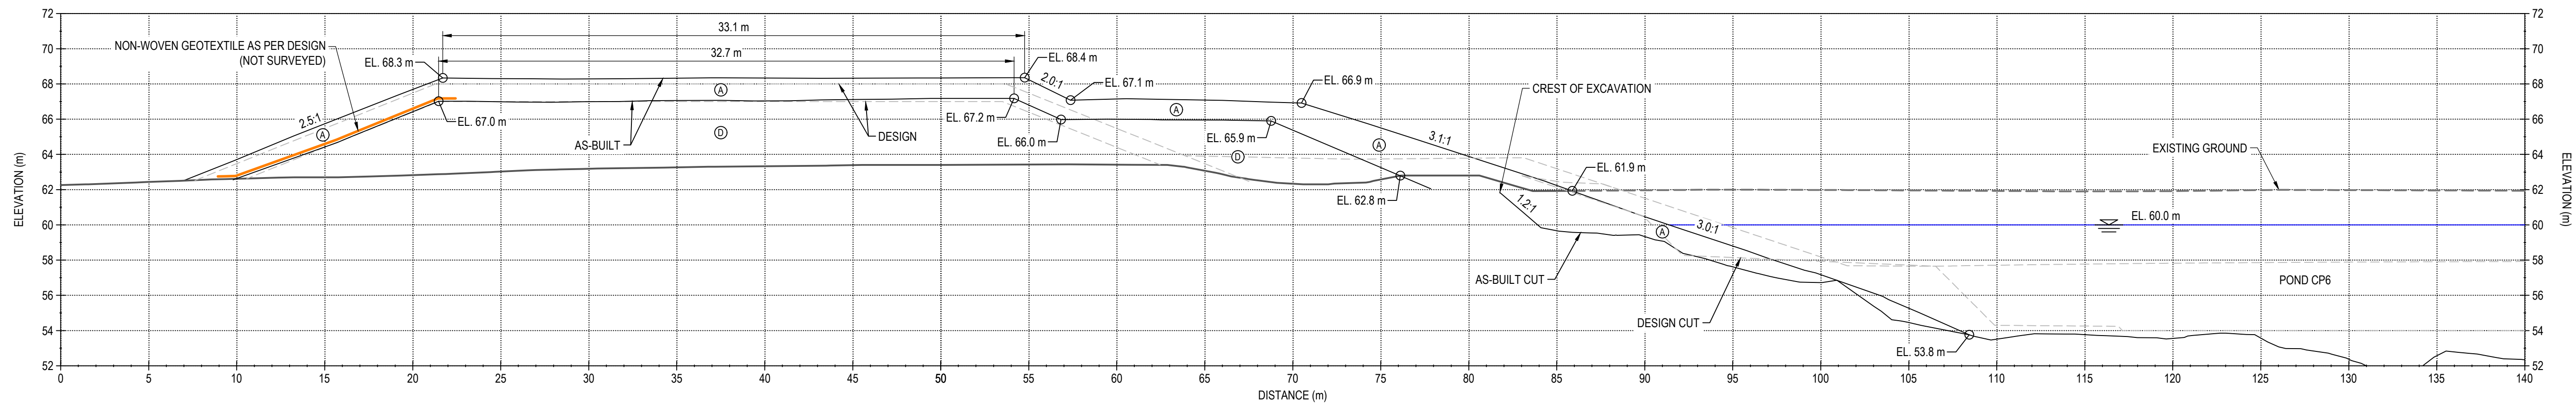
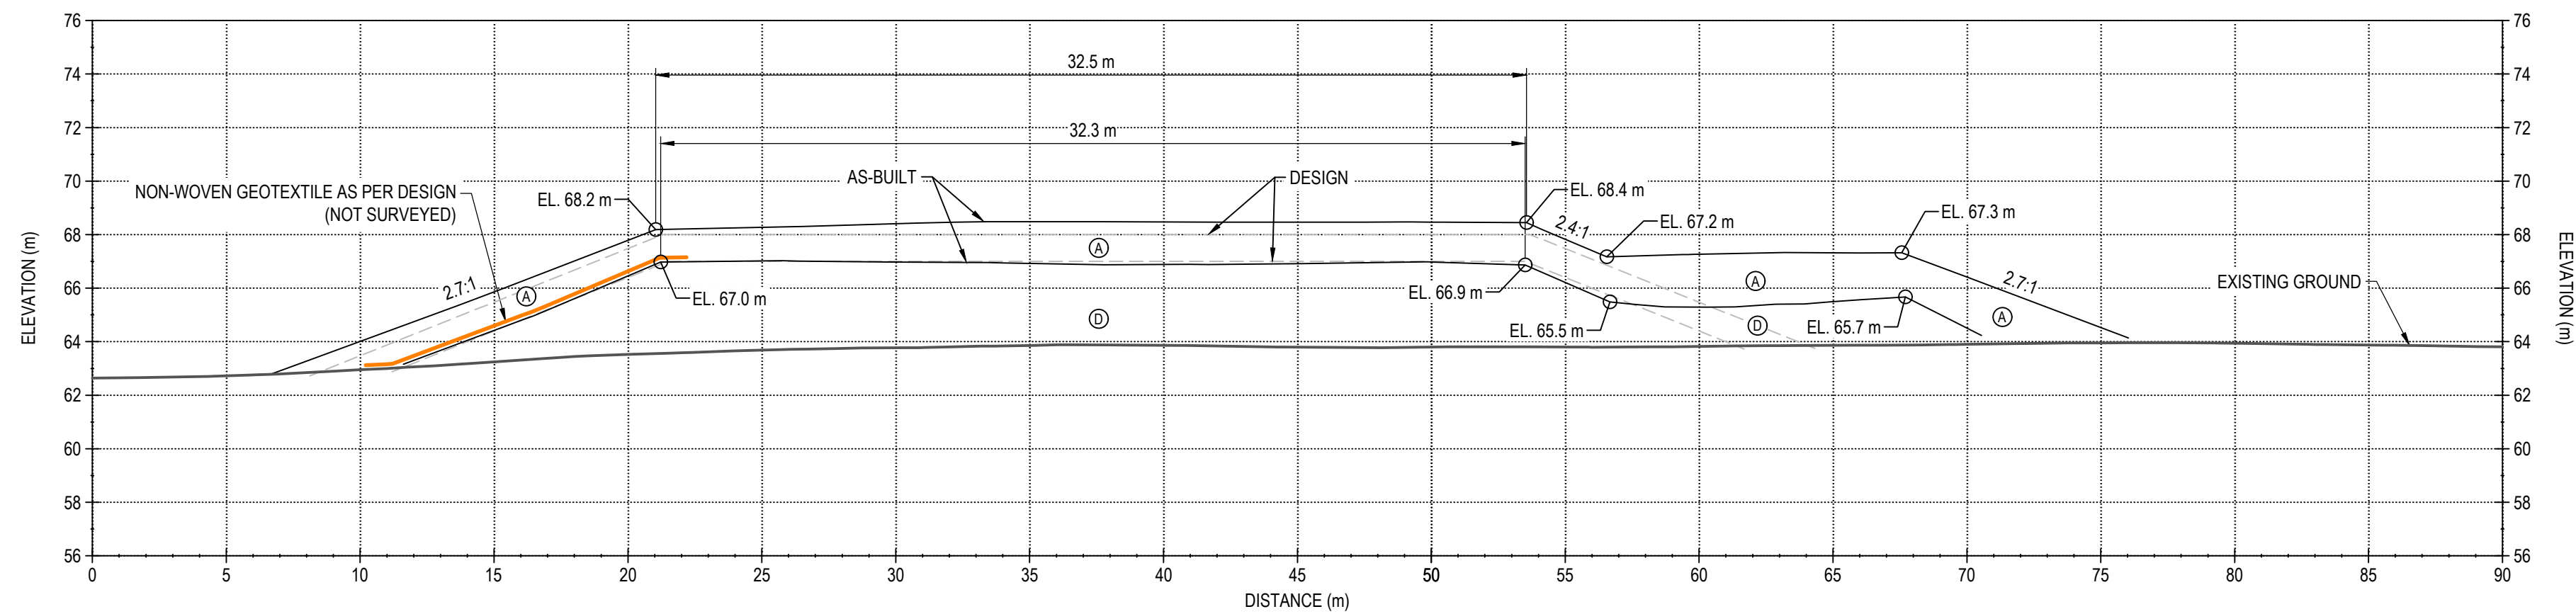
## BERM CP6 - PROFILE

- (A) CLEAN ROCKFILL FROM EXCAVATION (600 mm MINUS)
- (D) OVERBURDEN FROM EXCAVATION (300 mm MINUS)

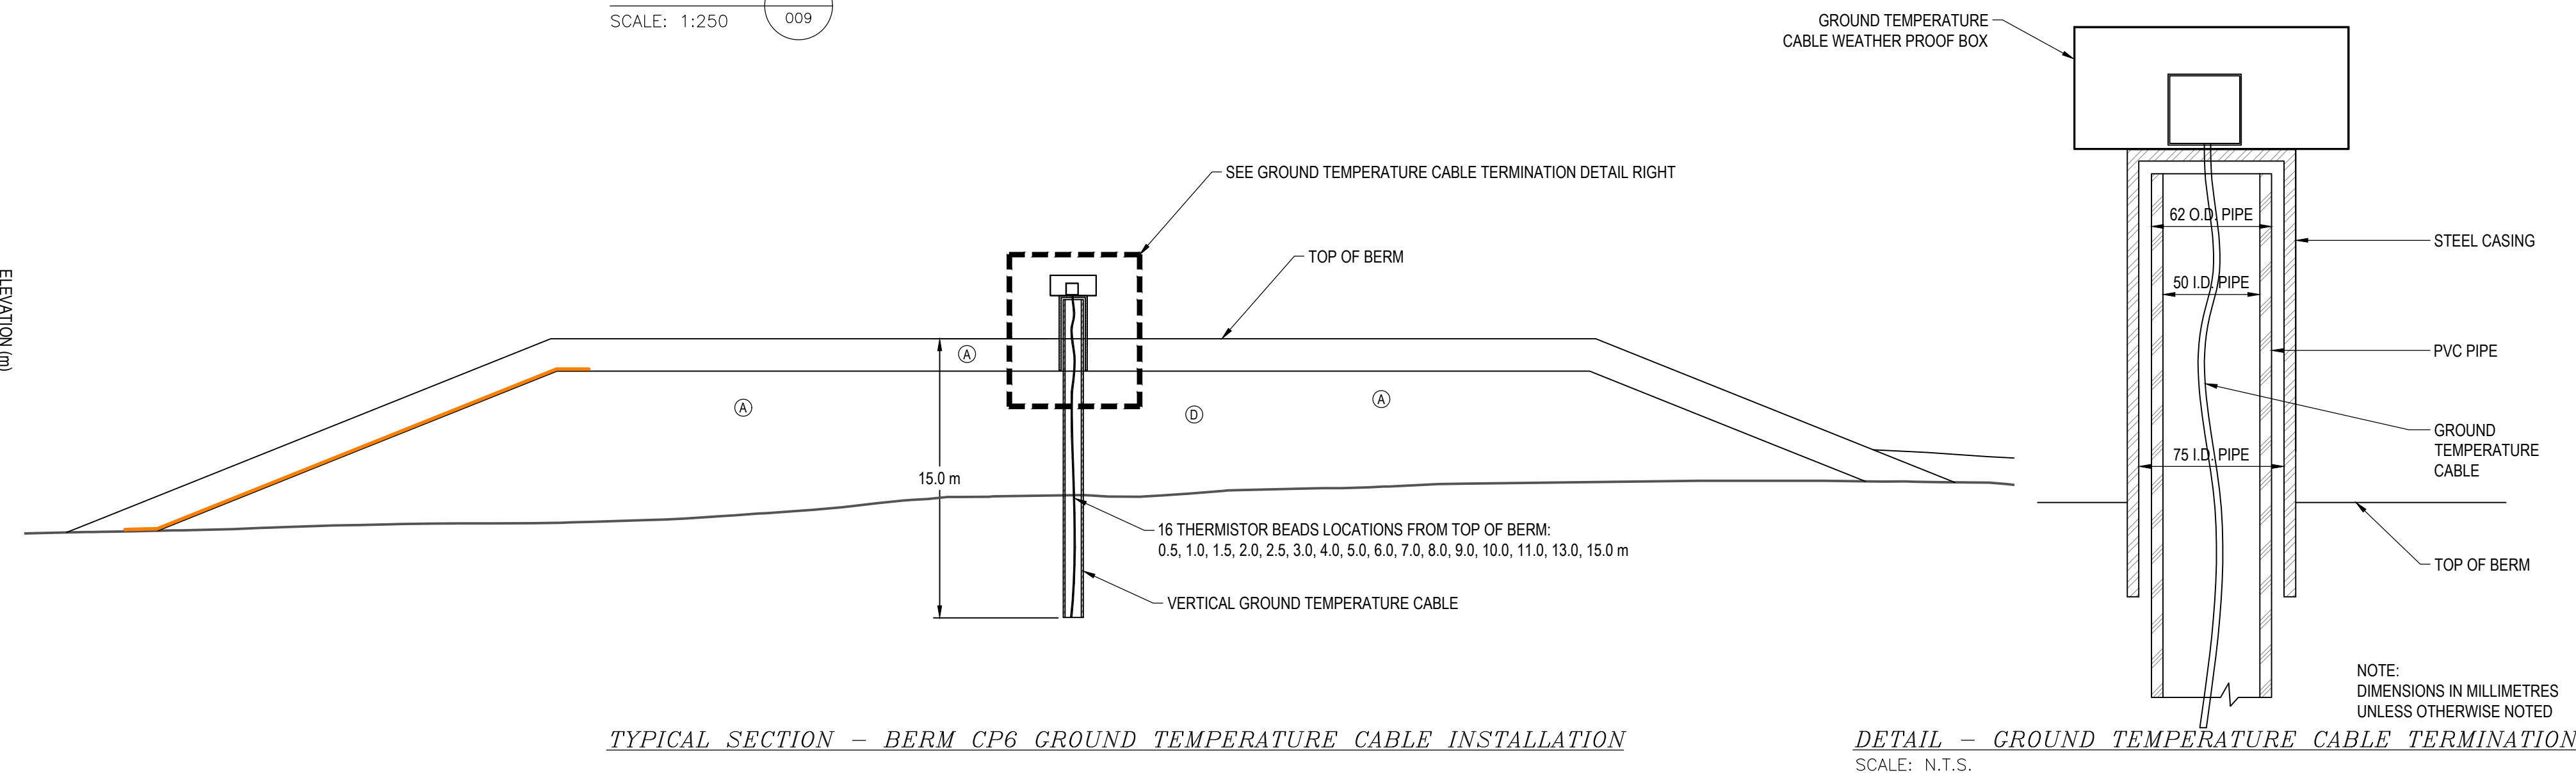
TYPICAL SECTION - BERM CP6 GROUND TEMPERATURE CABLE INSTALLATION

UNLESS OTHERWISE NOTED  
DETAIL - GROUND TEMPERATURE CABLE TERMINATION  
SCALE: N.T.S.
