CONSTRUCTION SUMMARY (AS-BUILT) REPORT FOR CP2 POND, CP2 BERM, CHANNEL9, AND CHANNEL10

Agnico Eagle Mines Limited

OCTOBER 14, 2022 ISSUED FOR USE

AGNICO EAGLE DOCUMENT NUMBER: 6537-695-230-REP-002

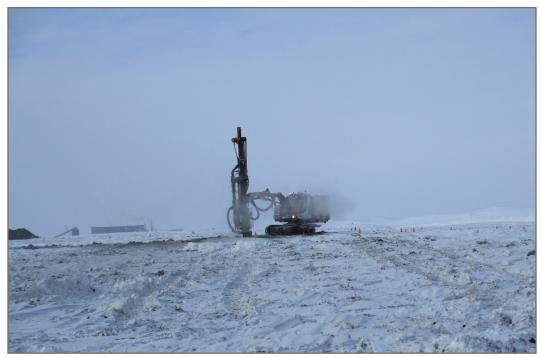
Photo 1: 2022-02-25 Pond CP2—Drilling first blast pattern; view facing north

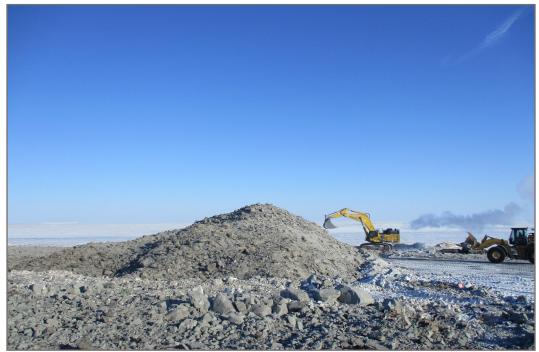
Photo 3: 2022-02-28 Pond CP2—Overburden being excavated from first blast; view facing east

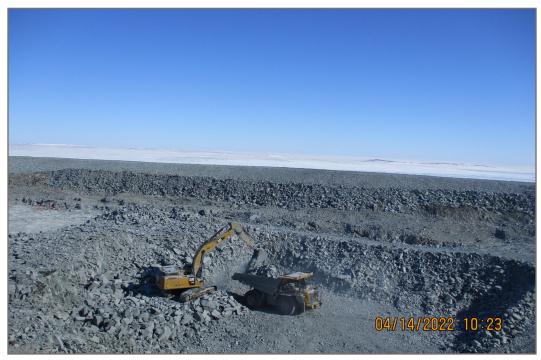
Photo 4: 2022-04-14 Pond CP2—Progress of excavating Pond CP2; view facing east

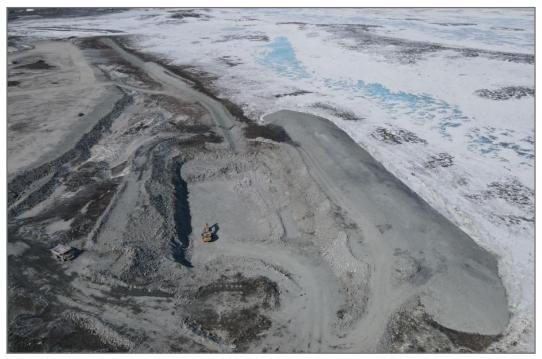
Photo 5: 2022-04-28 Pond CP2—Overview of CP2 pond, berm, and channel9

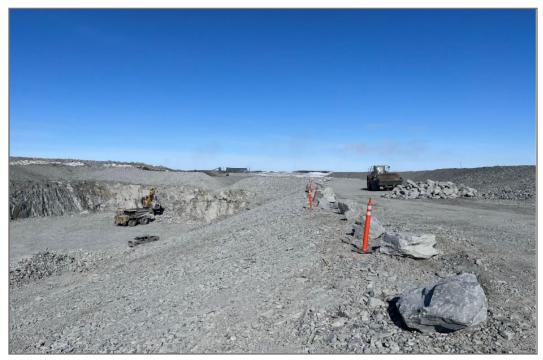
Photo 6: 2022-04-29 Pond CP2—Sloped rockfill for thermal protection; view facing north

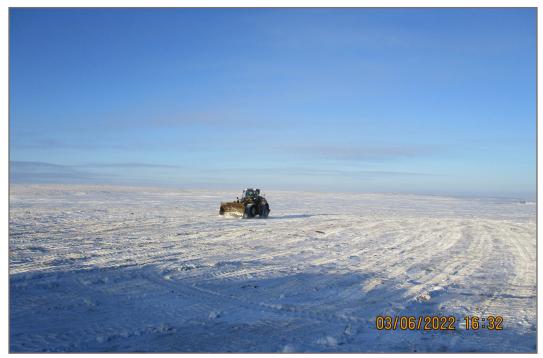
Photo 7: 2022-03-06 Berm CP2—Foundation preparation for berm; view facing northeast

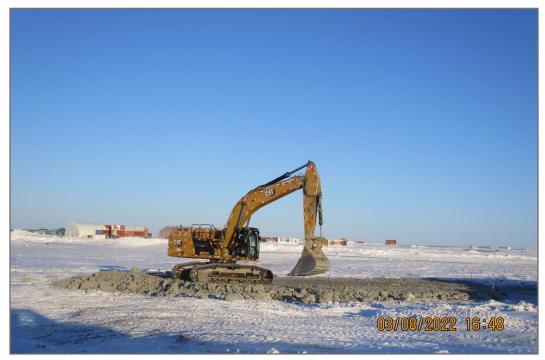
Photo 8: 2022-03-08 Berm CP2—First lift of overburden till; view facing southeast

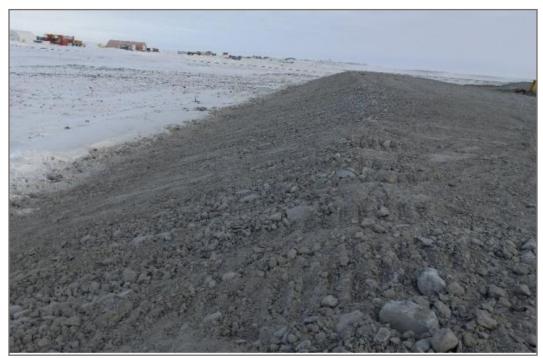
Photo 9: 2022-03-19 Berm CP2—View of overburden till downstream slopes; view facing south

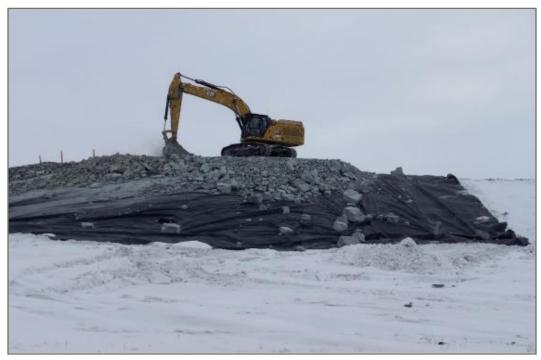
Photo 10: 2022-03-23 Berm CP2—Placing of geotextile and rockfill; view facing west

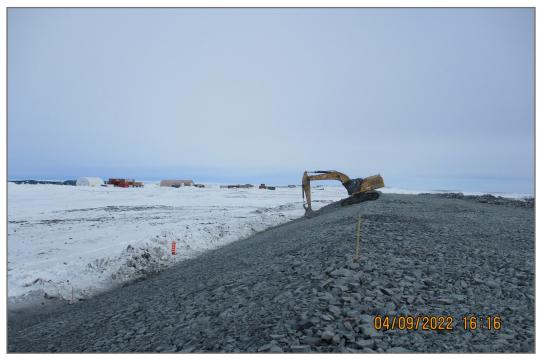
Photo 11: 2022-04-09 Berm CP2—Sloping of rockfill on berm; view facing south

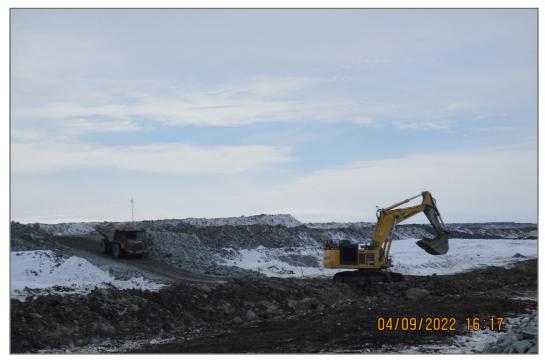
Photo 12: 2022-04-09 Channel9—Excavating of channel9; view facing northwest

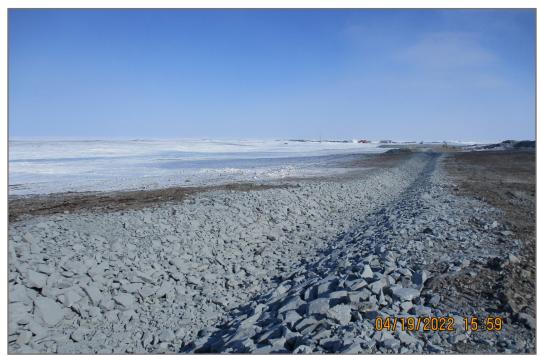
Photo 13: 2022-04-19 Channel9—Placement of rockfill before geotextile and riprap; view facing southeast

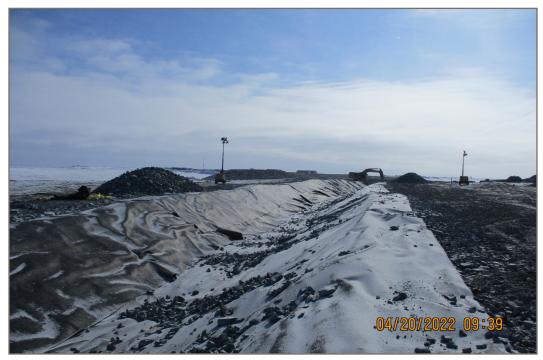
Photo 14: 2022-04-20 Channel9—Placement of geotextile; view facing south

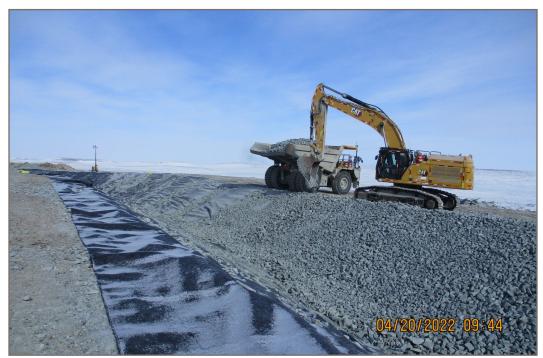
Photo 15: 2022-04-20 Channel9—Placing and sloping of riprap on geotextile; view facing northeast

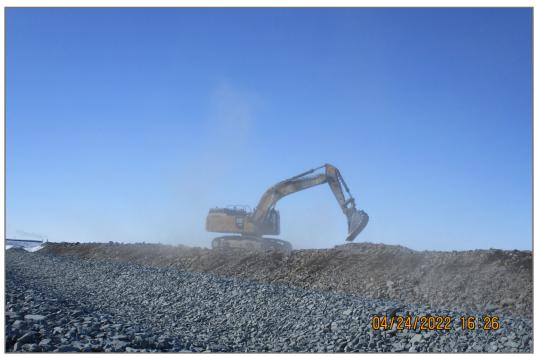
Photo 16: 2022-04-24 Channel9—Overburden fill placement of channel9 berm; view facing northeast

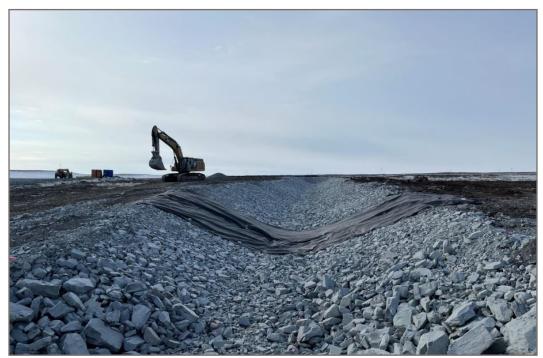
Photo 17: 2022-04-29 Channel10—Placing geotextile on channel10 after rockfill; view facing south

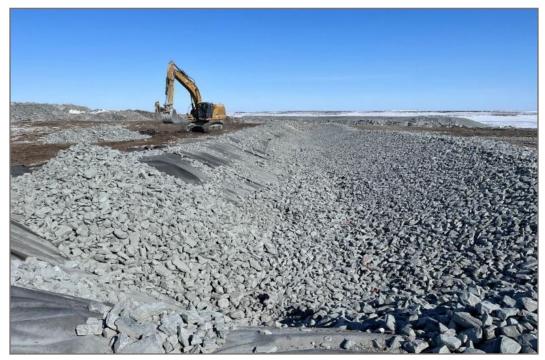
Photo 18: 2022-04-30 Channel10— Placing riprap on channel10; view facing north

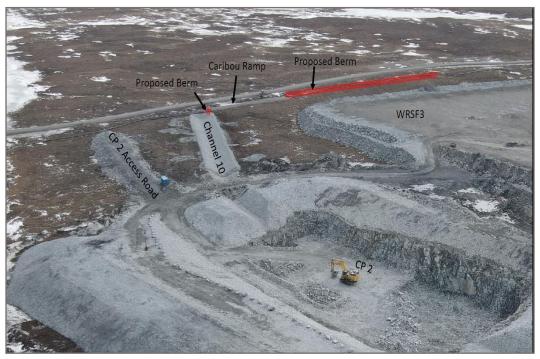
Photo 19: 2022-05-07 Channel10— Overview of proposed berm configuration for channel10

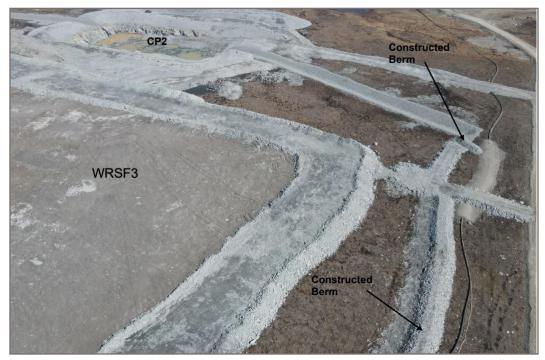
Photo 20: 2022-05-09 Channel10— Overview of constructed berms for channel10

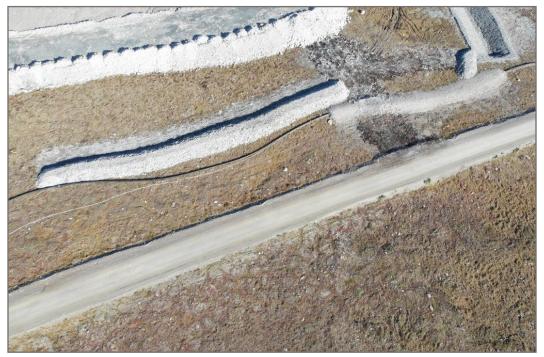
Photo 21: 2022-09-04 Channel10— Overview of constructed berms for channel10 with access road removed
