## **CONSTRUCTION SUMMARY (AS-BUILT) REPORT FOR CHANNEL 11, CP9 THERMAL BERM, AND BERM 4, MELIADINE GOLD MINE, NU**

PRESENTED TO  
**Agnico Eagle Mines Limited**

AUGUST 5, 2025  
ISSUED FOR USE  
FILE: 704-ENG.EARC03247-12  
AGNICO EAGLE DOCUMENT NUMBER: 65-695-230-TCR-001

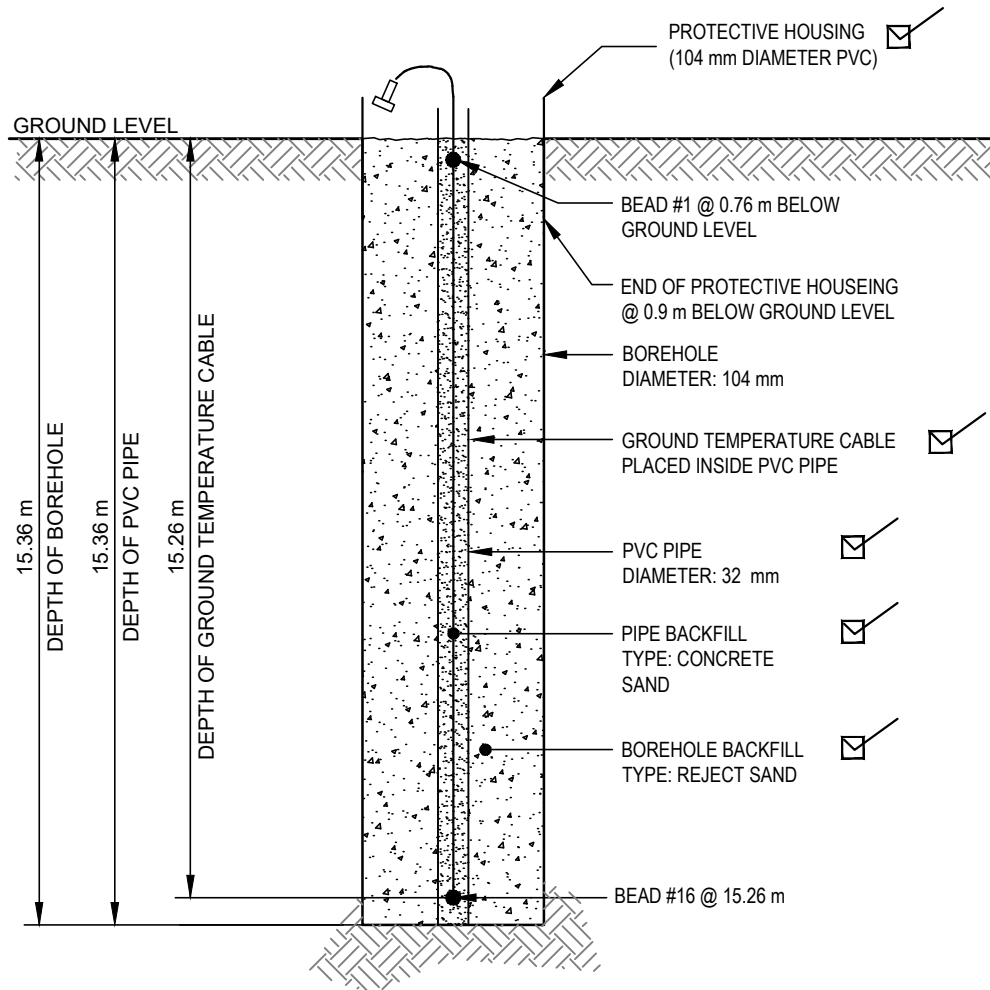
SITE: MELIADINE MINE, NU  
LOCATION: GTC25-01  
COORDINATES: NORTHING: 6 986 811  
EASTING: 539 181  
GROUND ELEVATION: 63.03 m  
1ST BEAD ELEVATION: 62.27 m  
NUMBER OF BEADS: 16

CABLE INSTALLATION NO.:  
CABLE SERIAL NO.: 2871  
DRILLING DATE: 2025-04-14  
INSTALLATION DATE: 2025-04-14  
CABLE LENGTH: 15.0 m  
LEAD LENGTH: 60.0 m  
HOLE DEPTH: 15.36 m

BEAD NO.	DEPTH BELOW OG (m)
1	0.76
2	1.26
3	1.76
4	2.26
5	2.76
6	3.26
7	4.26
8	5.26
9	6.26
10	7.26
11	8.26
12	9.26
13	10.26
14	11.26
15	13.26
16	15.26

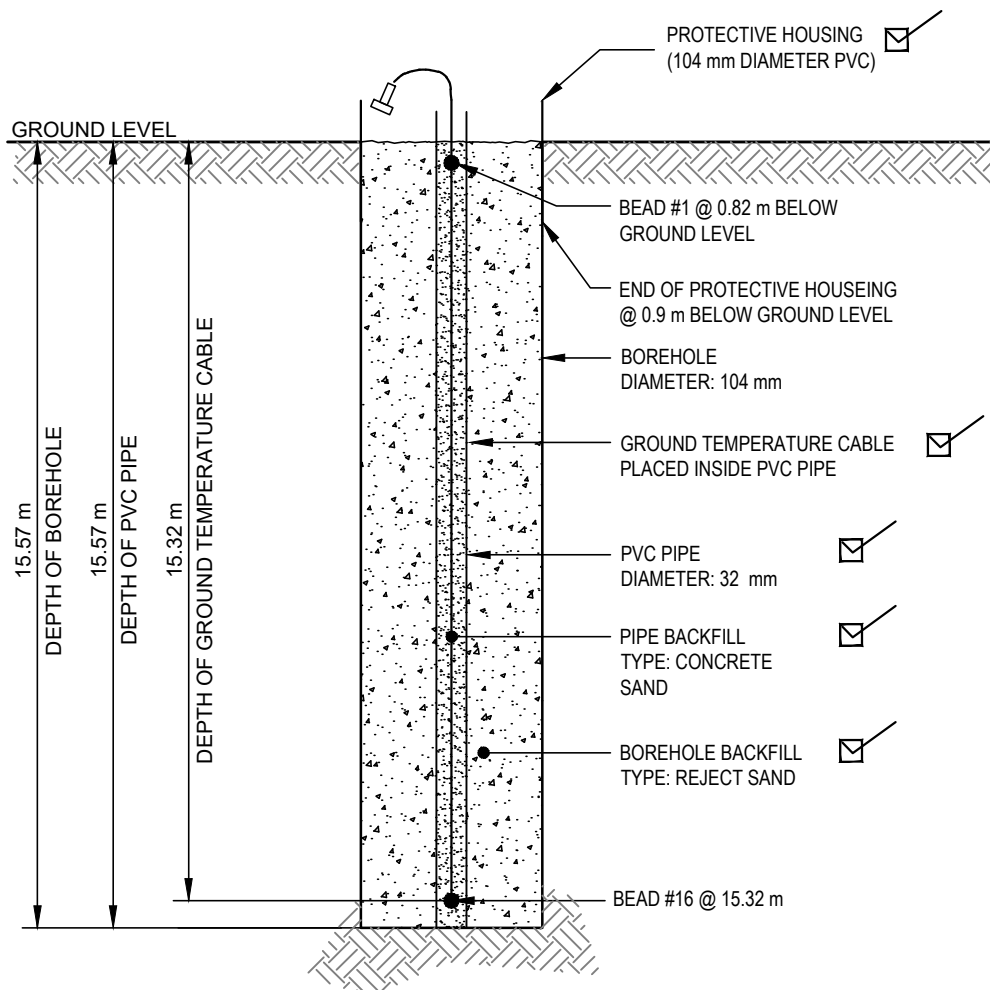
SITE: MELIADINE MINE, NU  
LOCATION: GTC25-02  
COORDINATES: NORTHING: 6 986 860  
EASTING: 539 170  
GROUND ELEVATION: 63.02 m  
1ST BEAD ELEVATION: 62.20 m  
NUMBER OF BEADS: 16

CABLE INSTALLATION NO.:  
CABLE SERIAL NO.: 2872  
DRILLING DATE: 2025-04-14  
INSTALLATION DATE: 2025-04-14  
CABLE LENGTH: 15.0 m  
LEAD LENGTH: 3.0 m  
HOLE DEPTH: 15.57 m

BEAD NO.	DEPTH BELOW OG (m)
1	0.82
2	1.32
3	1.82
4	2.32
5	2.82
6	3.32
7	4.32
8	5.32
9	6.32
10	7.32
11	8.32
12	9.32
13	10.32
14	11.32
15	13.32
16	15.32

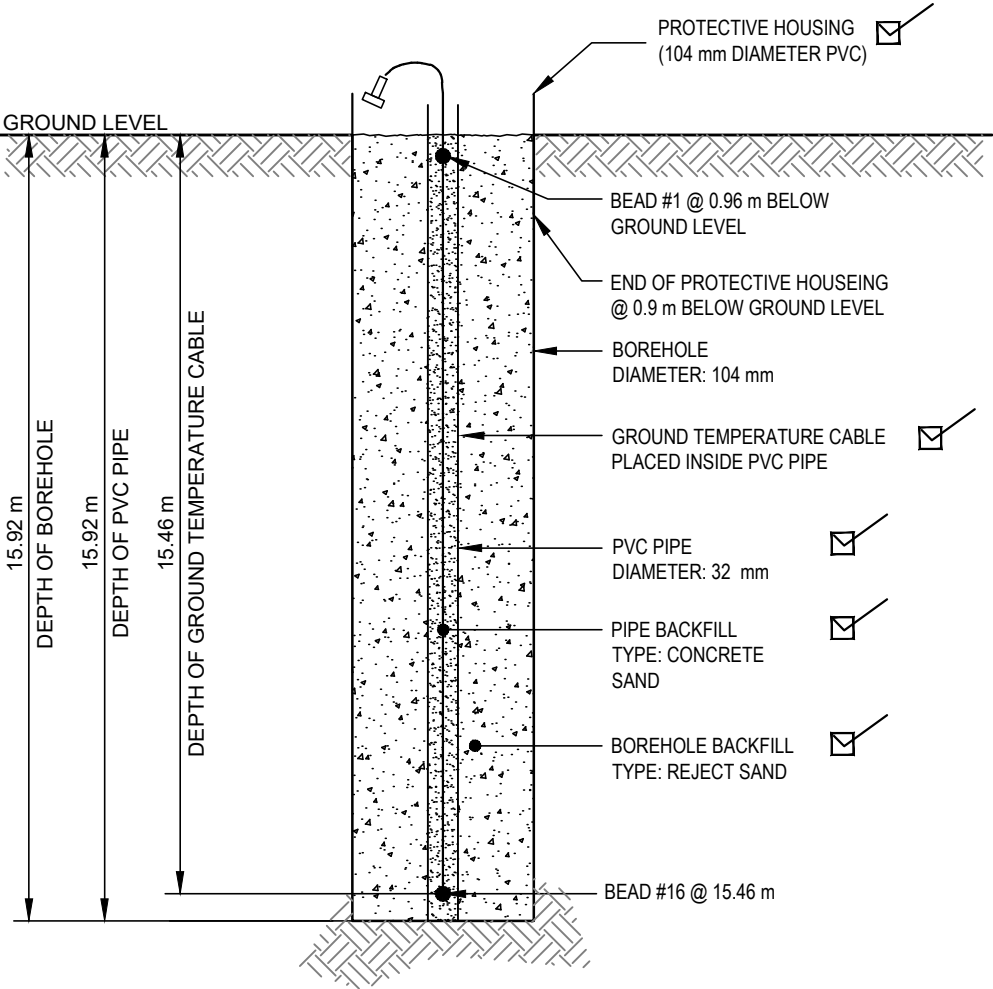
SITE: MELIADINE MINE, NU  
LOCATION: GTC25-03  
COORDINATES: NORTHING: 6 989 909  
EASTING: 539 160  
GROUND ELEVATION: 63.129 m  
1ST BEAD ELEVATION: 62.17 m  
NUMBER OF BEADS: 16

CABLE INSTALLATION NO.:  
CABLE SERIAL NO.: 2873  
DRILLING DATE: 2025-04-14  
INSTALLATION DATE: 2025-04-14  
CABLE LENGTH: 15  
LEAD LENGTH: 60  
HOLE DEPTH: 15.92

BEAD NO.	DEPTH BELOW OG (m)
1	0.96
2	1.46
3	1.96
4	2.46
5	2.96
6	3.46
7	3.96
8	4.46
9	4.96
10	5.96
11	6.96
12	7.96
13	9.46
14	10.96
15	12.96
16	15.46

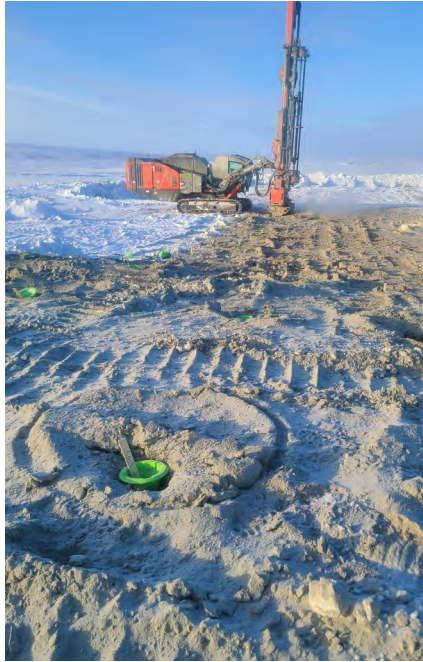
**Photo 1:** 2025-02-05 Channel11 —  
Drilling Blast Pattern;  
Facing Northwest

Due to the time of year, mechanical excavation (free digging into the permafrost) was not feasible, as a result, drill and blast operations were used to complete the entire excavation. A total of seven blasts were conducted at the channel between February 6, 2025 and March 26, 2025. Following each blasting, the material was excavated, and a rock hammer was used to lower any areas that exceeded the design grade. Because of the drill/blast excavation technique, the excavated channel surface required the placement of clean rockfill to achieve the design grade before geotextile installation. All overburden till material removed from the channel was either used for the construction of CP9 Thermal Berm, Berm4, or placed at WRSF6. Selected clean rockfill (typically 300 mm minus) from the PUMP 01 open pit excavation was placed over the excavated surface to form the design slopes/grades of the channel. Placement was performed using excavators, and bucket packed to compact the material.

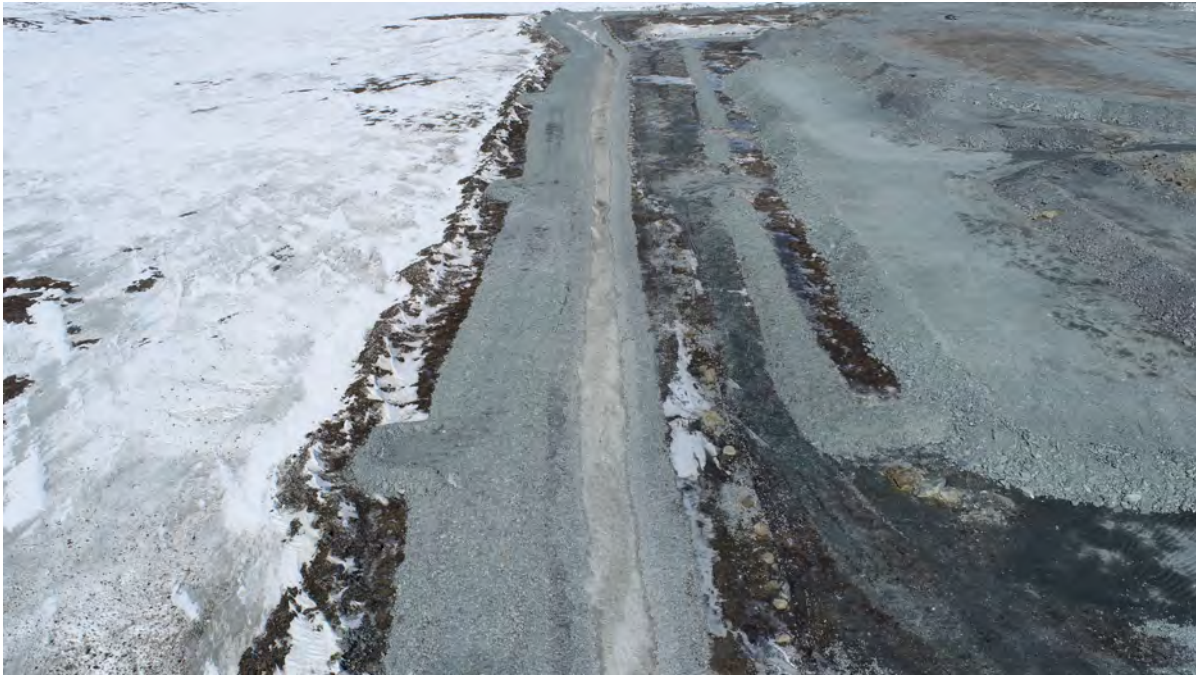
**Photo 7:** 2025-05-14 Channel11 — Channel11 Overview; Station 0+000 Facing North

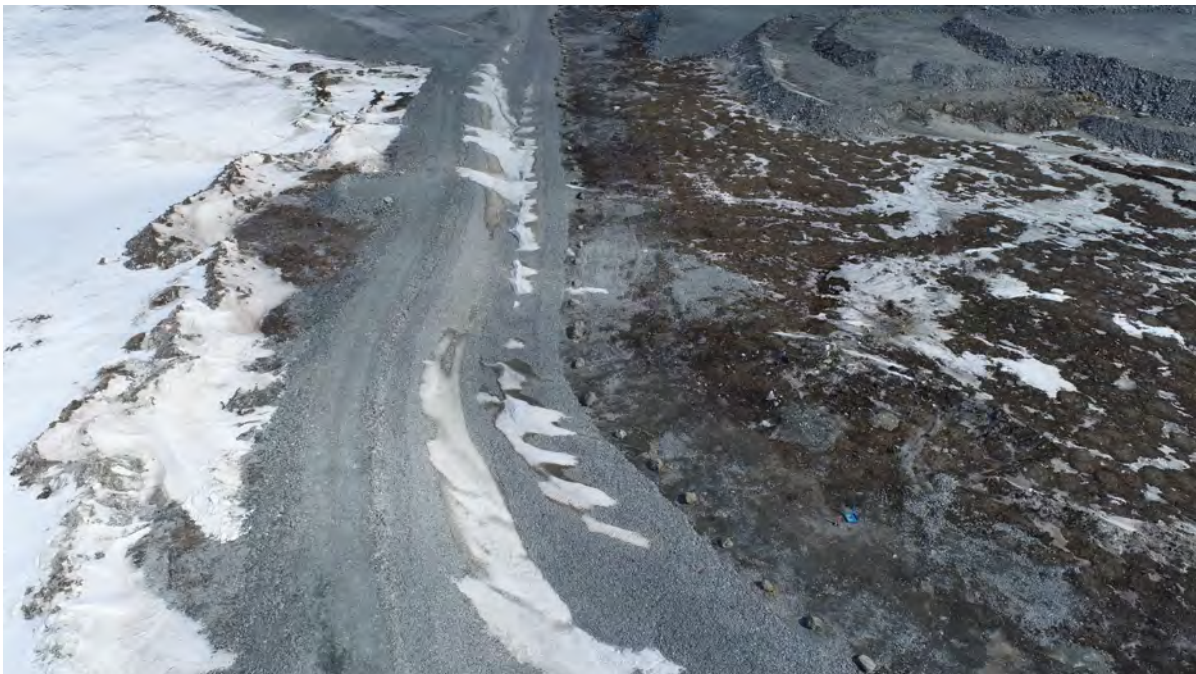
**Photo 8:** 2025-05-14 Channel11 — Channel11 Overview; Station 0+550 Facing East

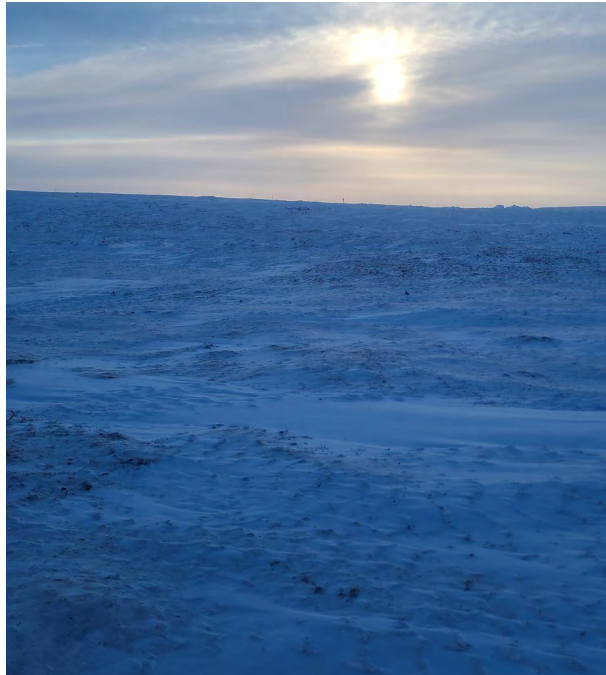
**Photo 9:** 2025-02-07 CP9 Thermal Berm —  
Foundation Preparation; Facing West

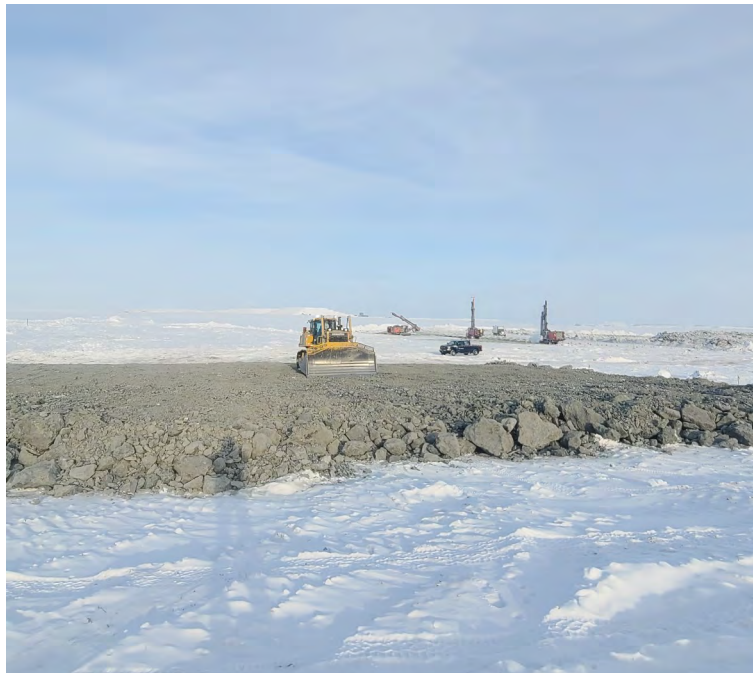
**Photo 10:** 2025-02-08 CP9 Thermal Berm — First Lift of  
Overburden Till; Facing North

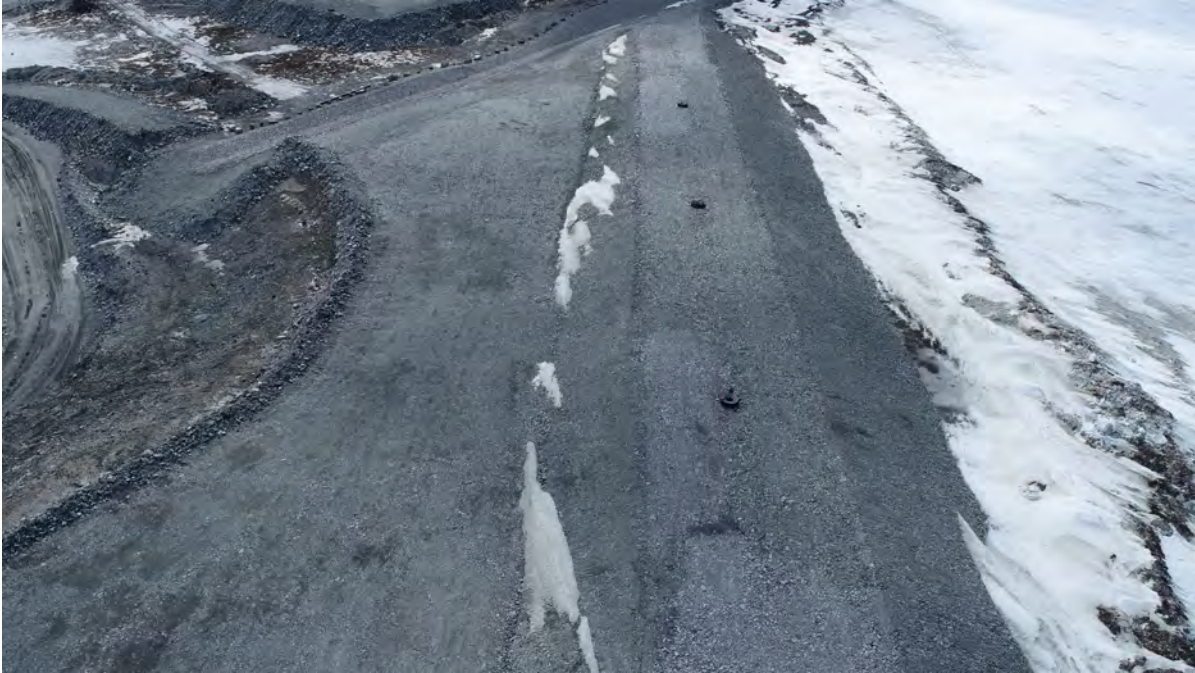
**Photo 15:** 2025-05-14 CP9 Thermal Berm — CP9 Thermal Berm Overview; Station 0+250 Facing Southeast

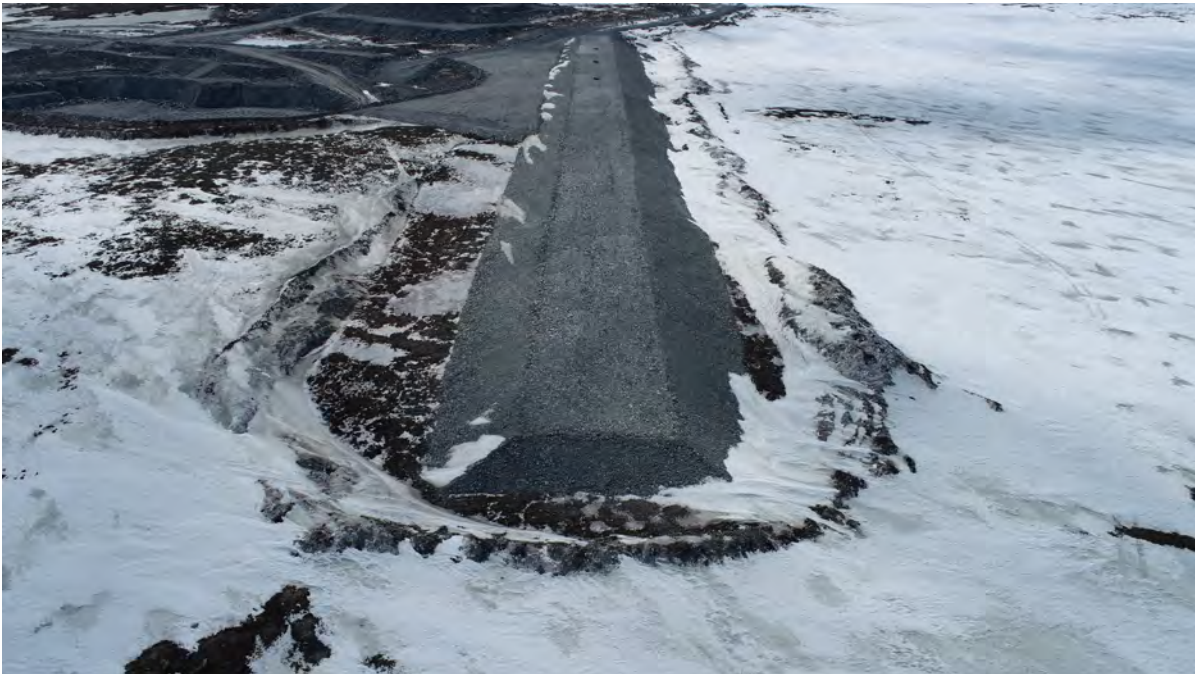
**Photo 16:** 2025-05-14 CP9 Thermal Berm — CP9 Thermal Berm Overview; Station 0+500 Facing Southeast

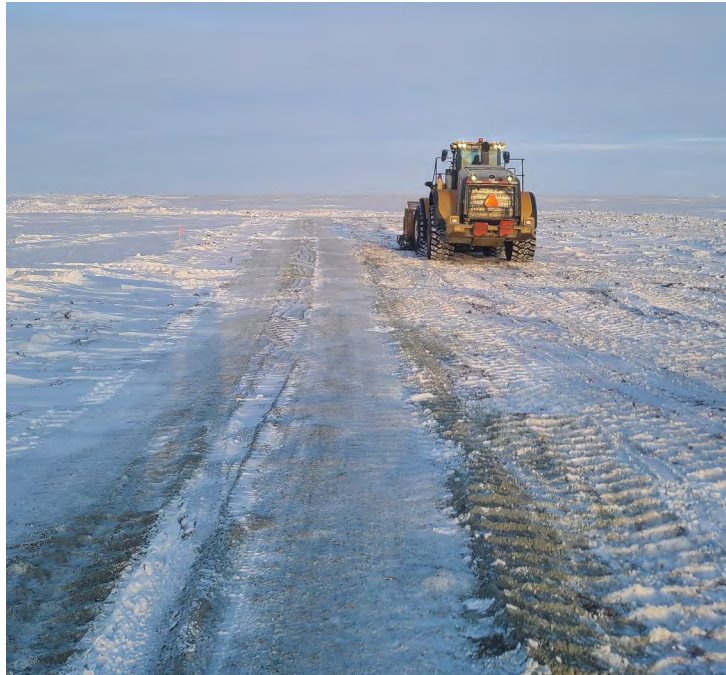
**Photo 17:** 2025-02-05 Berm4 — Foundation Preparation; Facing Northeast

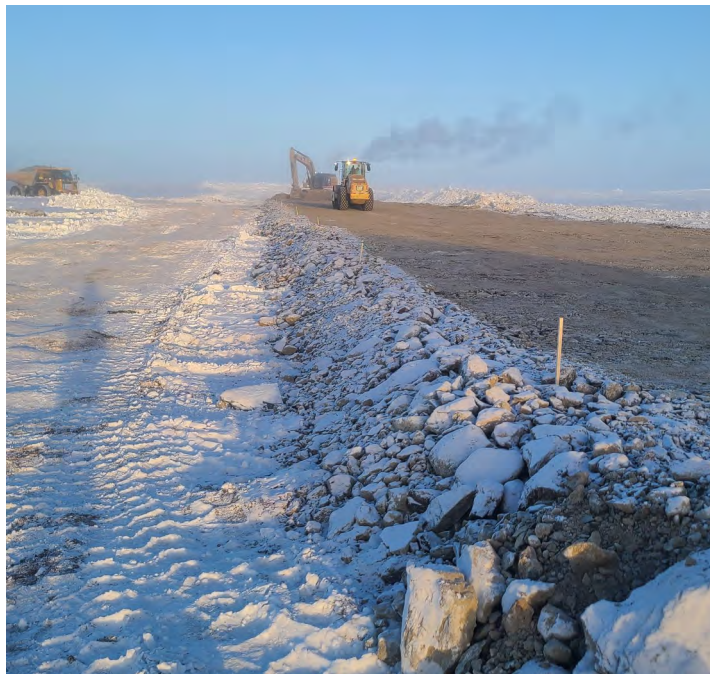
**Photo 18:** 2025-02-06 Berm4 — First Lift of Overburden Till; Facing East

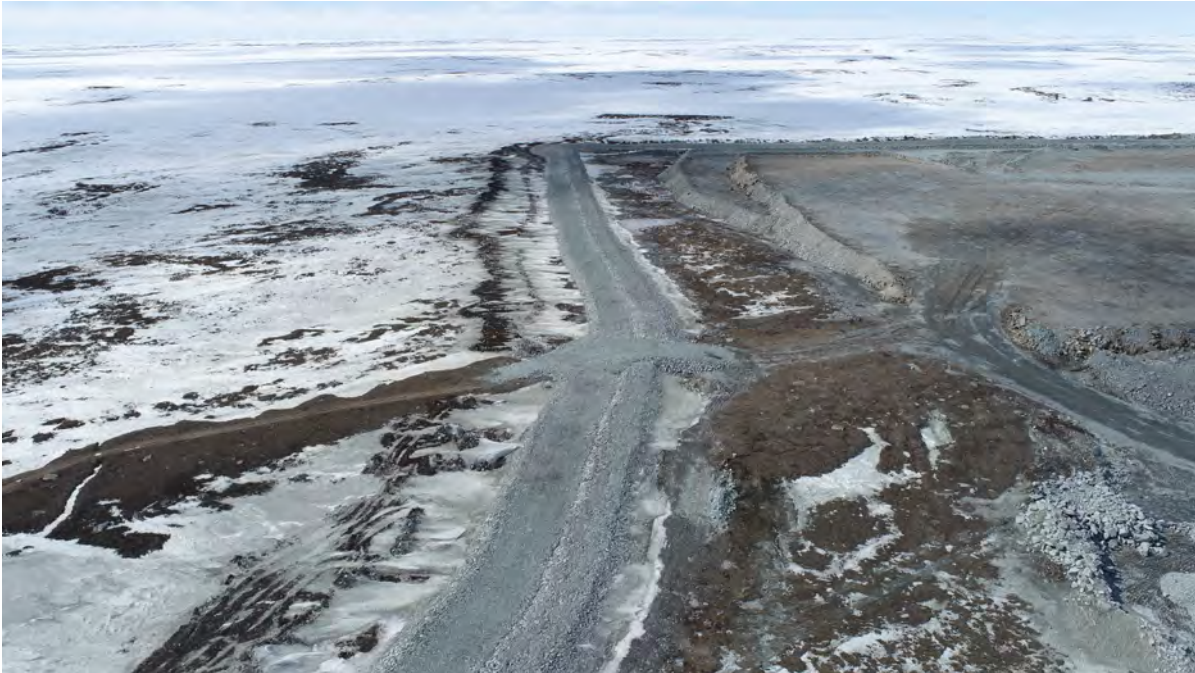
**Photo 21:** 2025-05-14 Berm4 — Overview of Berm4; Station 0+500 Facing Southwest

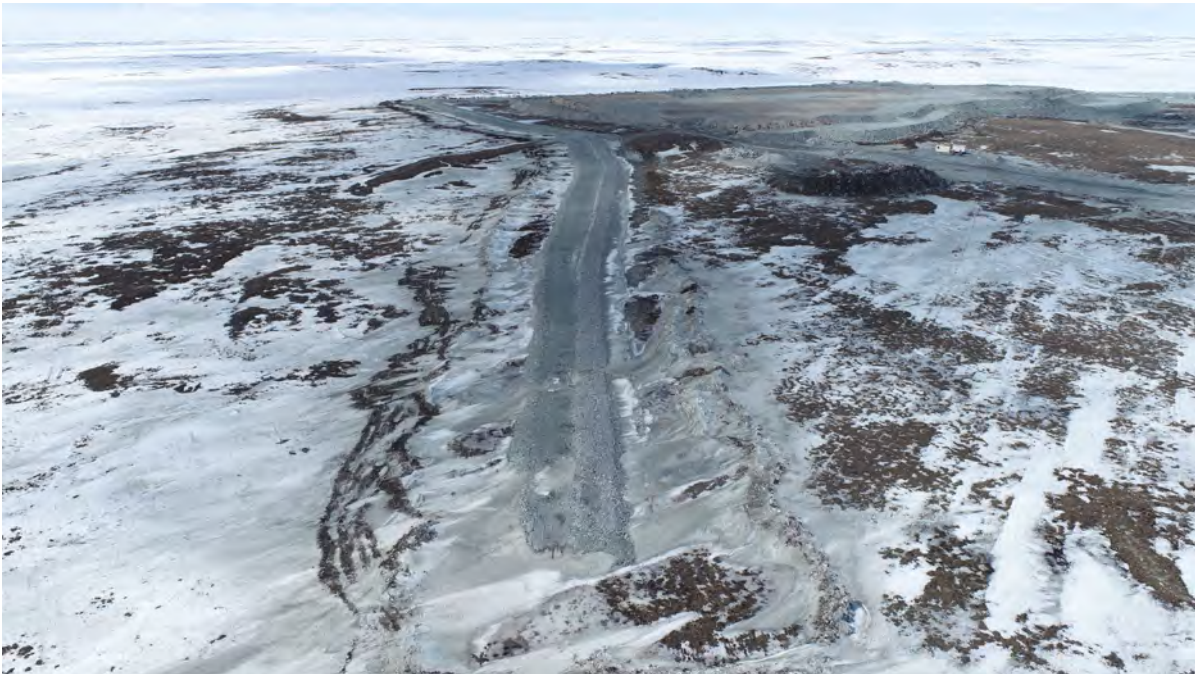
**Photo 22:** 2025-05-14 Berm4 — Overview of Berm4; Station 0+700 Facing West

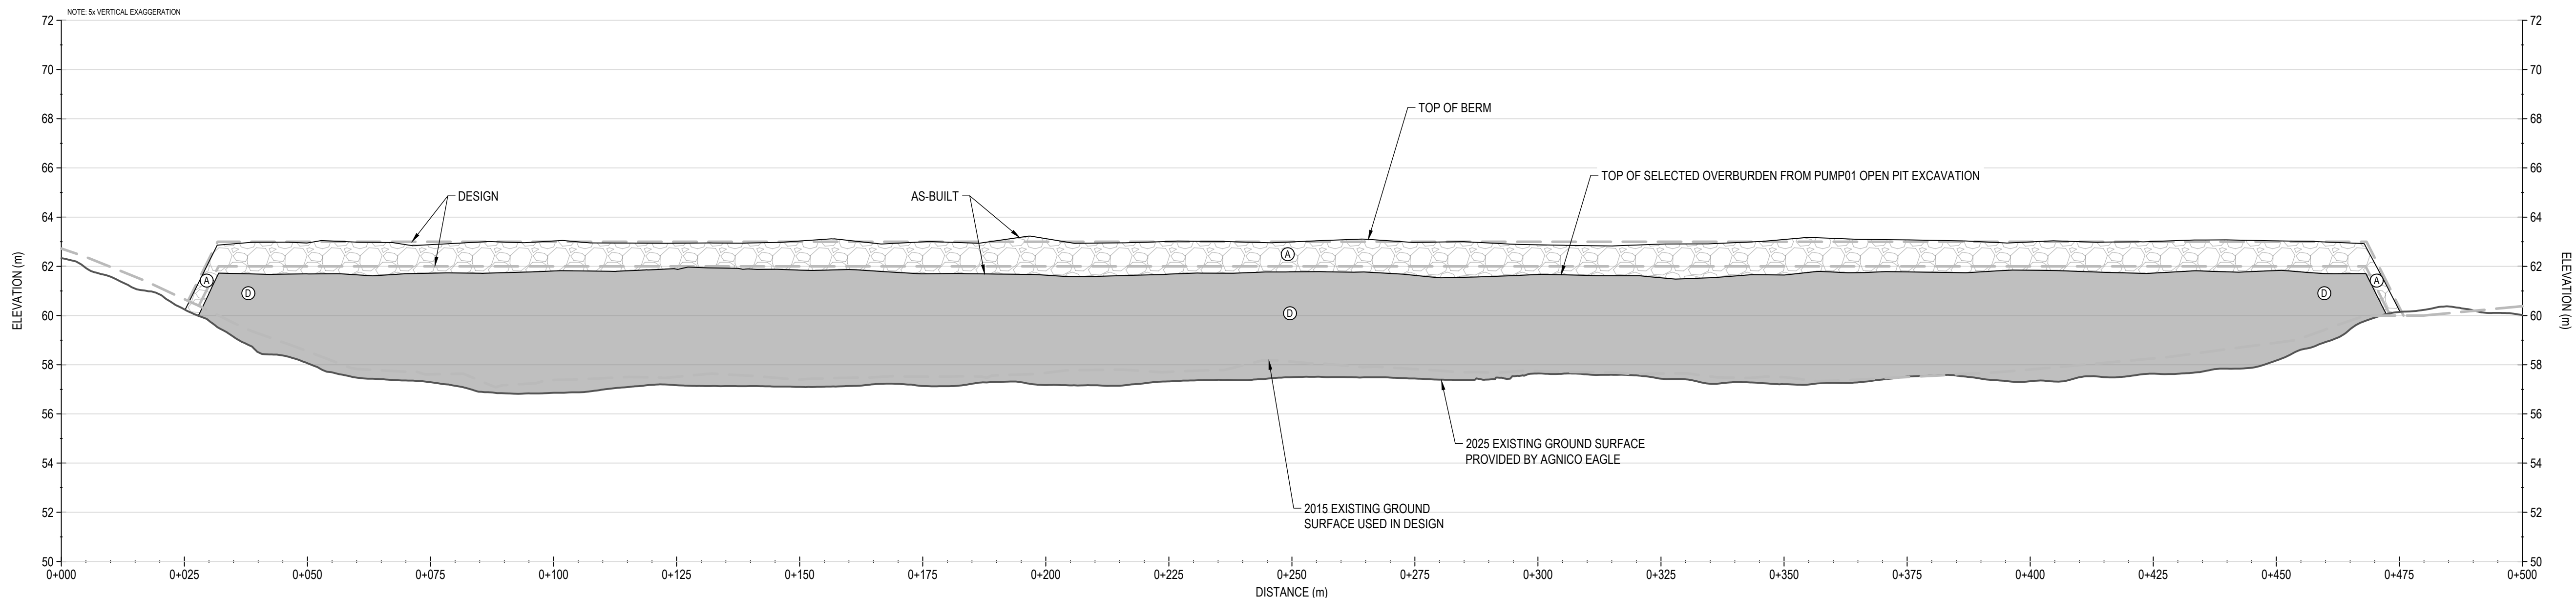
CP9 THERMAL BERM PROFILE  
SCALE: H-1:750 V-1:150

- The as-built berm crest ranged from 18.8 m to 19.9 m with an average width of 19.5 m, which is slightly narrower than design width of 20.4 m.
- The top elevation of the as-built overburden ranged from 61.4 m to 61.8 m with an average of 61.6 m, which is approximately 0.4 m below the design elevation.
- The as-built thickness of the rockfill apron ranged from 0.6 m to 1.3 m with an average of 0.9 m, which is thicker than the design of 0.5 m.

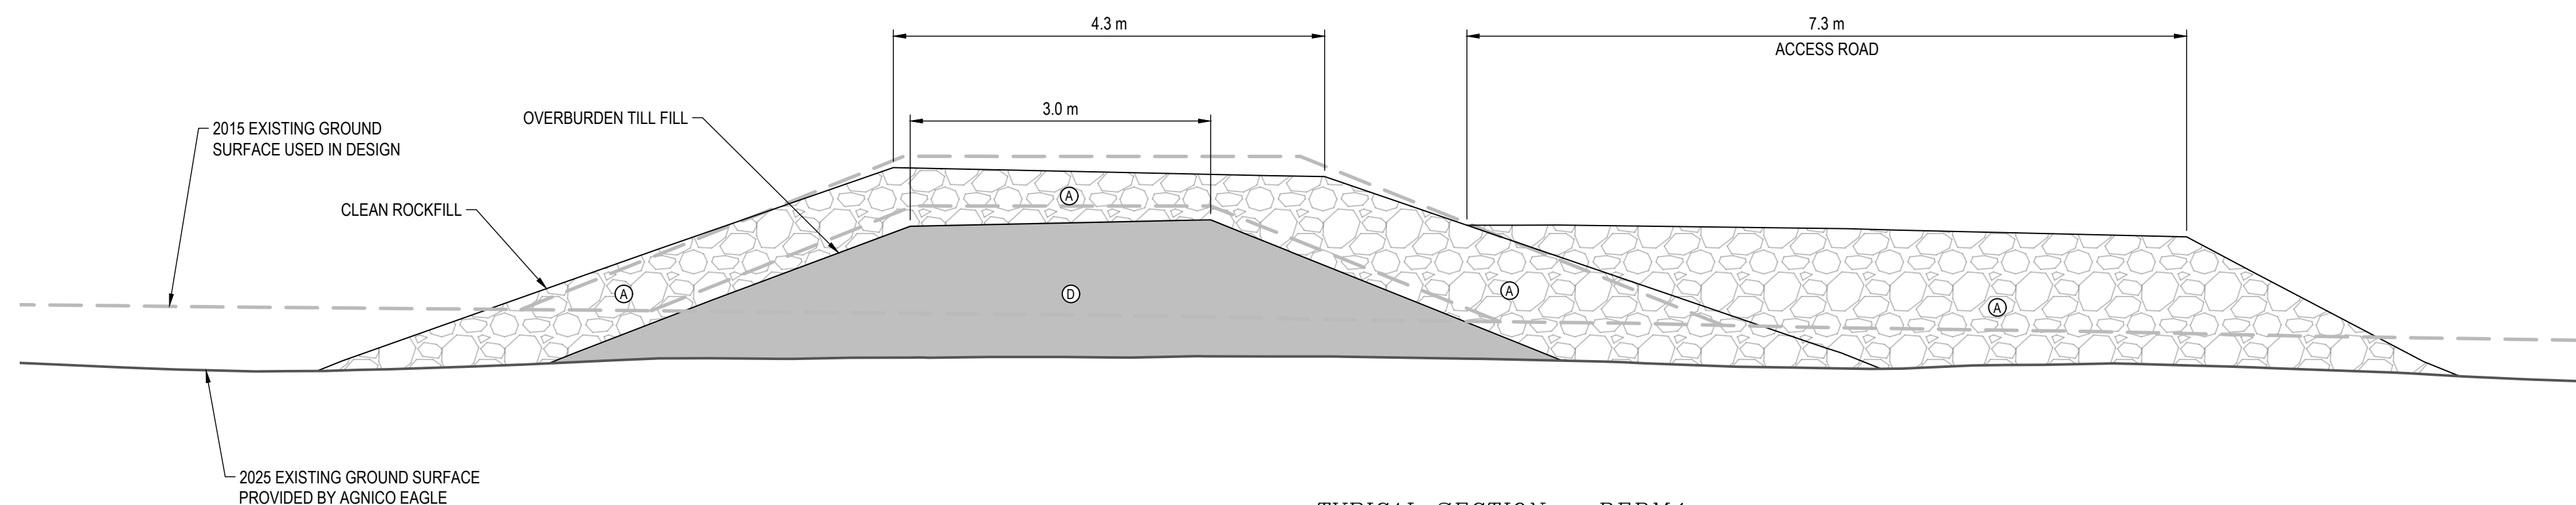
TYPICAL SECTION - BERM4  
SCALE: 1:50

ITEM		UNITS	ESTIMATED AS-BUILT QUANTITY
④	CLEAN ROCKFILL	m³	5,805
⑤	OVERBURDEN TILL FILL	m³	5,560

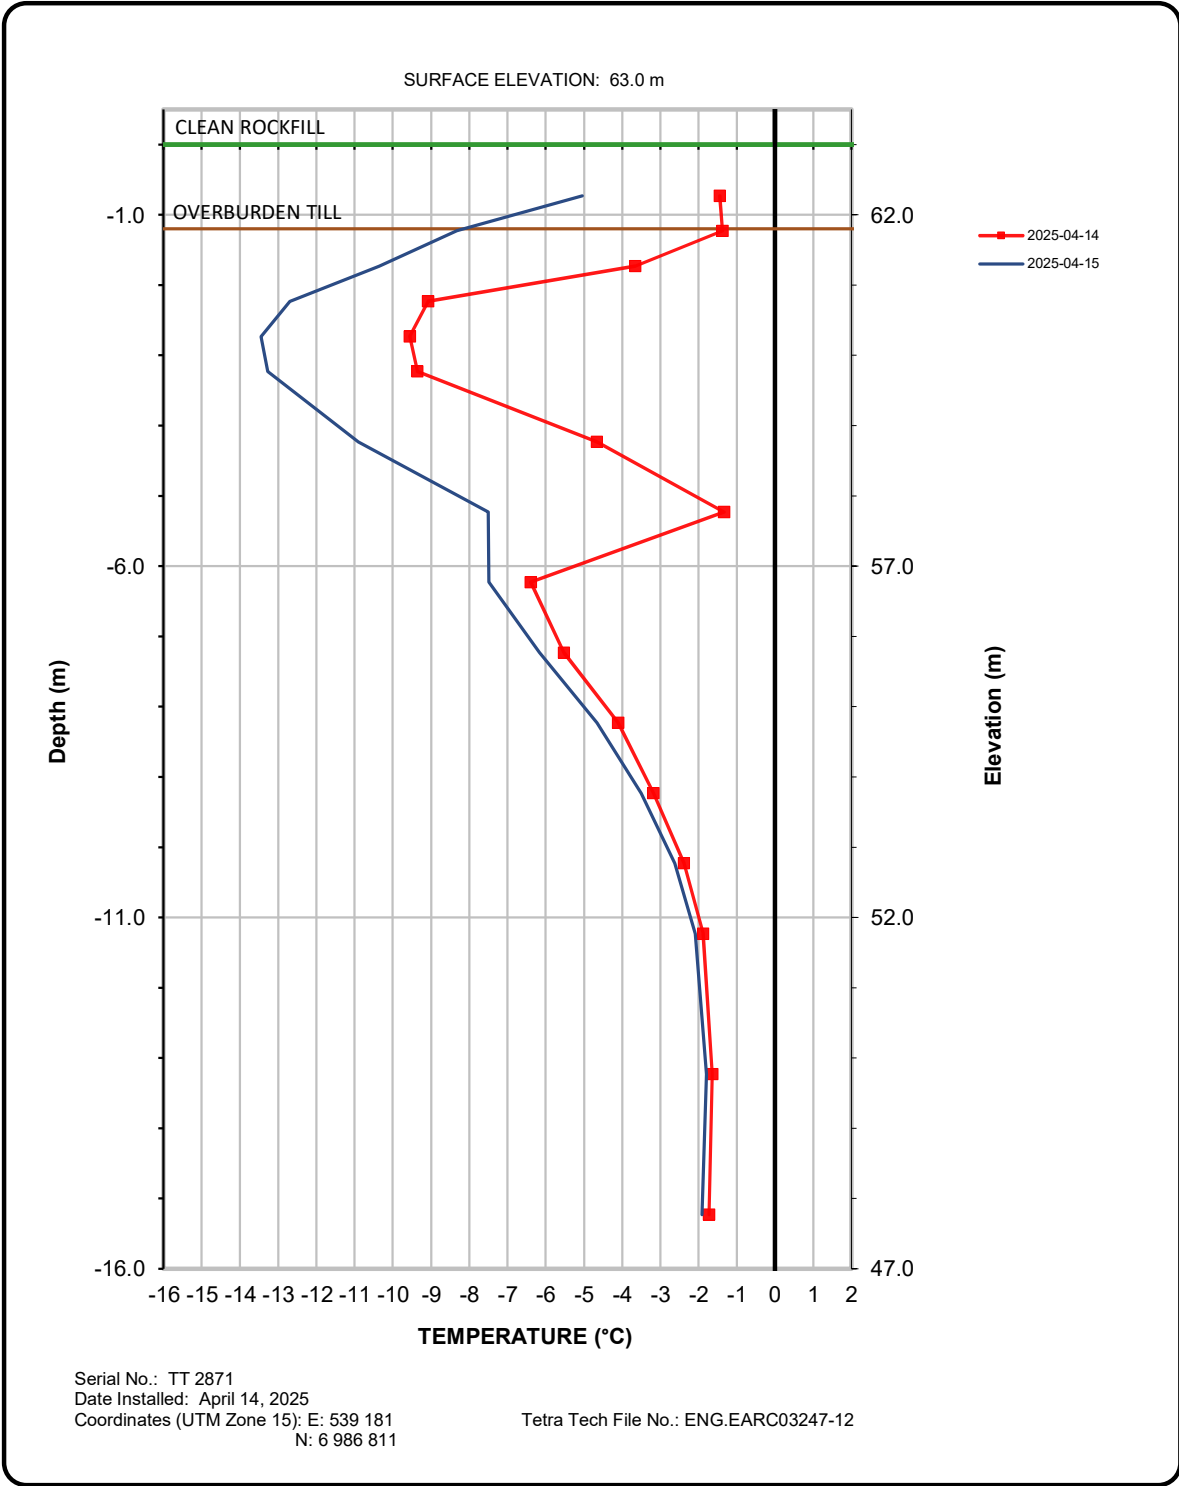
**Ground Temperature Profile**  
**Borehole GTC25-01**  
**Elevation: 63.0 m**

Permafrost is expected to exist beneath the footprint of the PUMP 01 open pit and CP9 Thermal Berm, and the design intent is to maintain the original permafrost foundation over the life of the berm. The GTCs installed in CP9 Thermal Berm should be read on a regular basis. Tetra Tech recommends that the cables be read once per month during the first year, and then on a yearly basis during operation. The measured readings should be analyzed and reported in the annual geotechnical inspection report. The reading frequency can be adjusted as required.

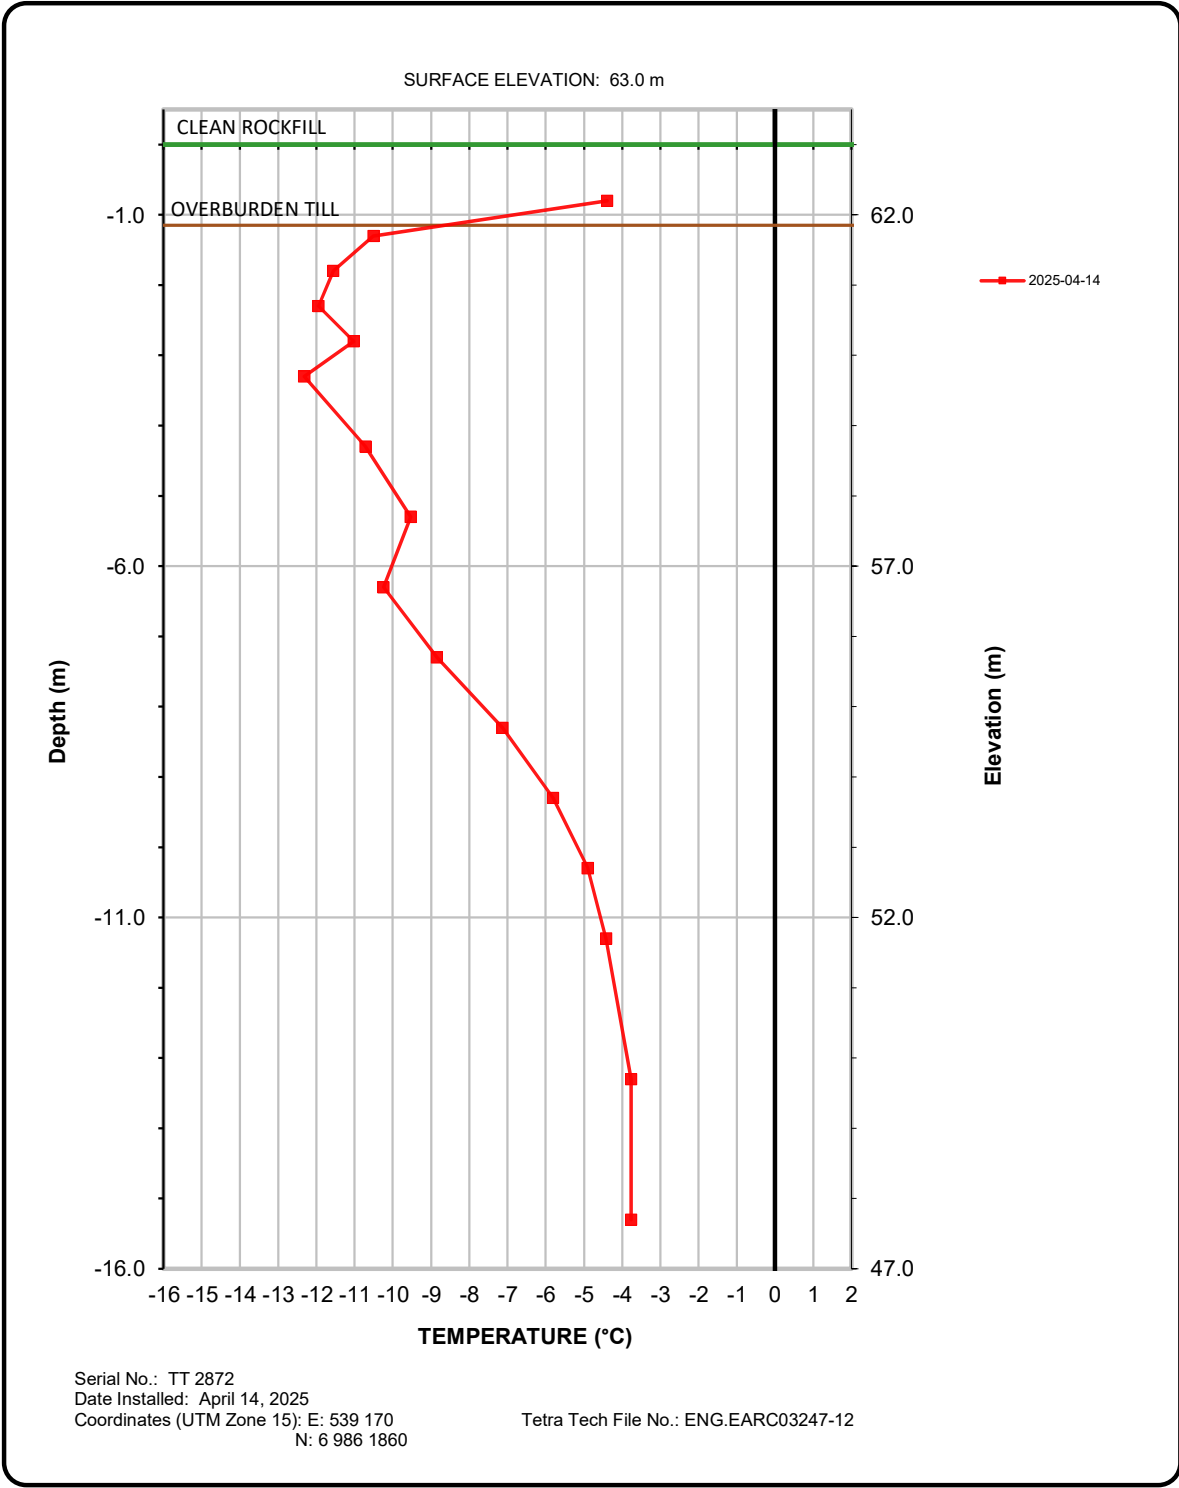
**Ground Temperature Profile**  
**Borehole GTC25-02**  
**Elevation: 63.0 m**

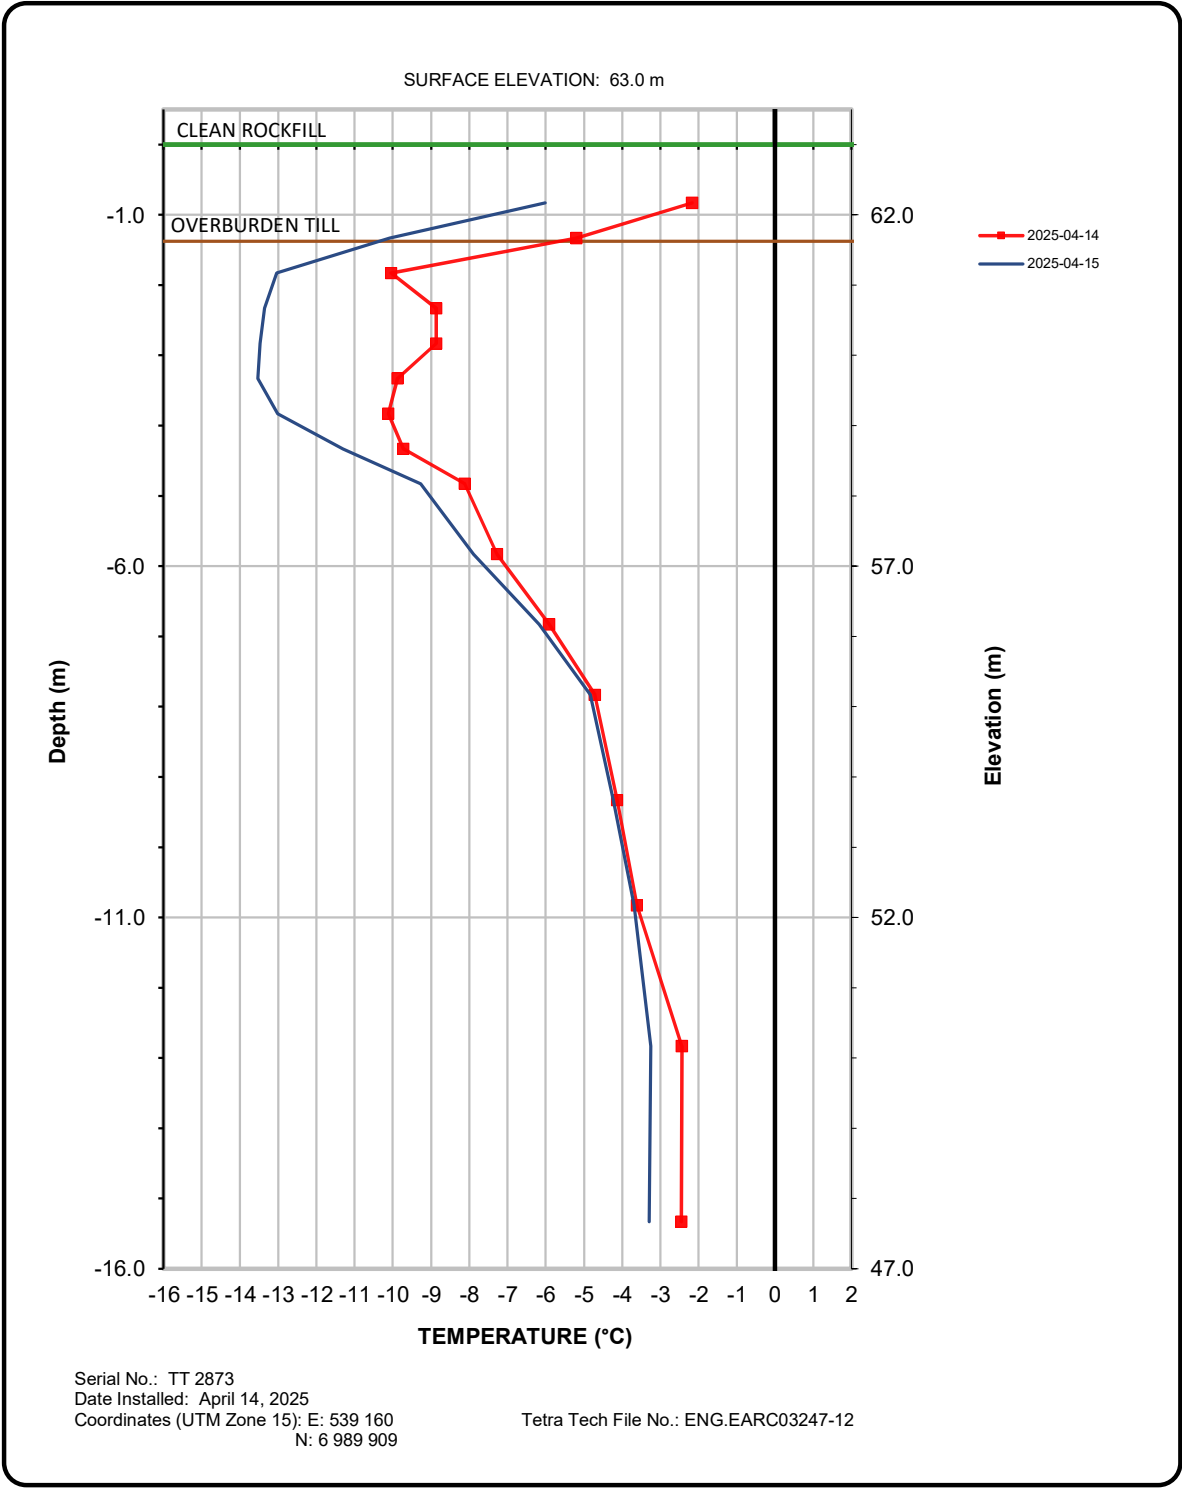
Ground Temperature Profile  
Borehole GTC25-03  
Elevation: 63.0 m
