TSF WEEKLY INSPECTION FORM

Date: November 23, 2019	Time: 8:30
Weather: -21.9C; 18 km/h N; mainly sunny	Inspected by: Vanessa Gagnon
Present: Alexandre Plasse

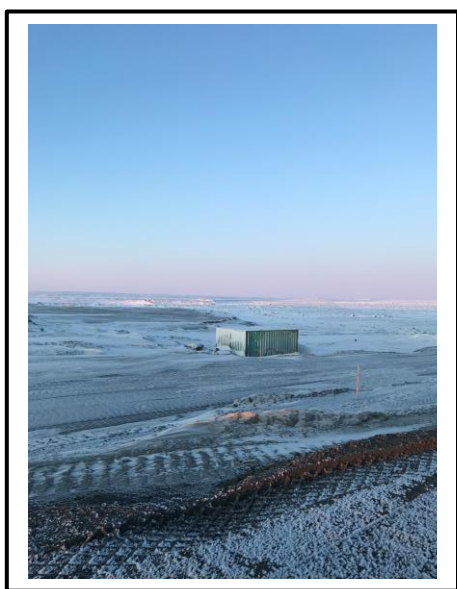
- Two sea cans with unplaced filter cloths are still located in sub-cell 6 where snow is accumulating and tailing cannot be placed. Filter cloths pallets are also accumulating at the end of sub-cell 3.

Photo 1: Sea cans causing snow to build up and restricting placement area in sub-cell 6; view facing northwest

- Filter cloths should be placed as soon as possible** to avoid additional work to separate the cloths prior to placement if they are all frozen together.

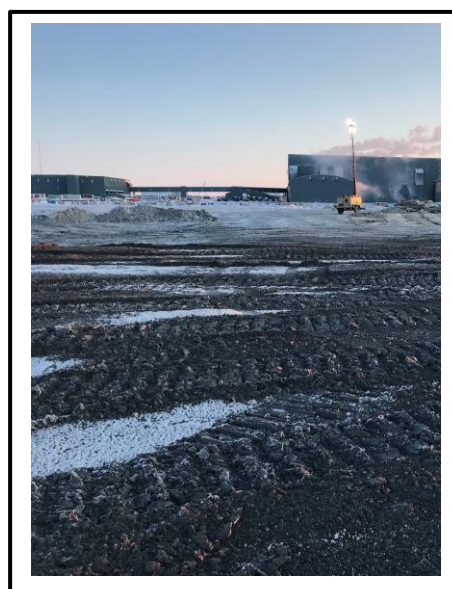
- It was observed that an area has not been compacted in the center cell. As soon as the wind picks up, this will result in dusty condition if the surface is not sealed.

Photo 2: Uncompacted surface in the center cell; view facing east

- Compaction of tailings should also occur immediately following placement.** If compacted while unfrozen, the same number of passes (3 slow passes on high vibrate) applies. If frozen tailings material has to be placed, Engineering must be notified so that the least harmful placement location and compaction specifications can be chosen.

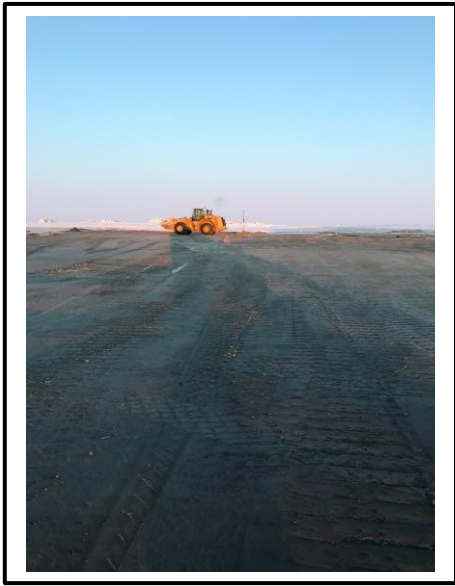
- Vehicle tracks were observed on sealed surfaces. Main access to center cell seems to be through sub-cell 2 and sub-cell 2 is being used to park equipment between shifts.

Photo 3: Track marks and tire tracks on the sealed surface in the center cell; view facing north

- There should be no vehicle traffic on the finished tailings surface.** Flash freezing of the surface will occur and erosion/dust generation will be at its peak. Traffic over snow will grind/compress the snow into the tailings surface and will make snow removal in these areas more difficult.

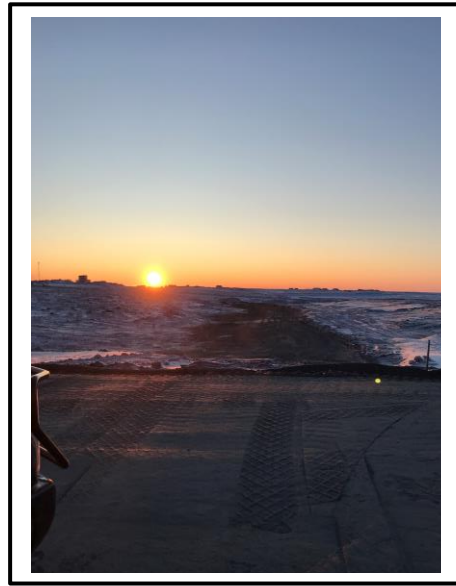
- Snow removal was occurring from accumulation in center cell. A loader was cleaning the piles made with a shovel earlier and loading trucks to send the snow to the TSF snow dump. Snow is still left to be removed in the sub-cell 6 and in the south part of the center cell.

Photo 4: Snow to be removed in the southern part of the center cell before future placement; view facing south

- Placement should continue to focus on "filling in the holes" as issues regarding snow collection and removal will occur in these areas over the winter. These locations are the center cell, sub-cell 1 and between sub-cells 4/5. **Any excess snow/ice must be removed from trenches or the tailings/ground surface prior to placement.** No additional lifts are to be placed on sub-cells 2, 3, 4 or 5 at this time.

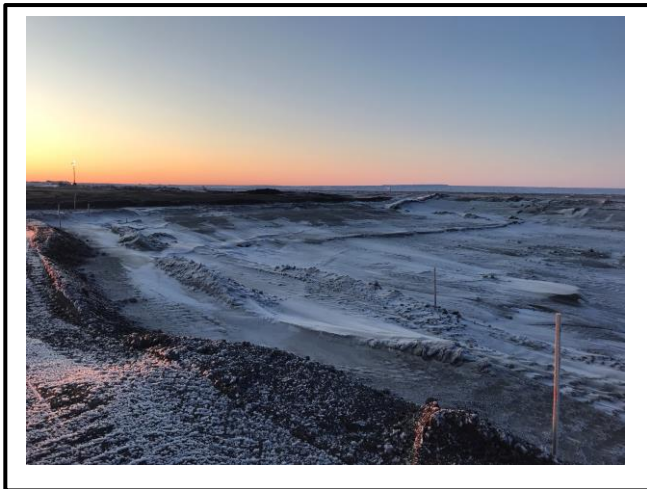
Photo 5: Snow to be removed between sub-cell 4/5 before future placement; view facing south
