Follow Up Report: #18-455

November 17, 2018 Retention Tank Overflow

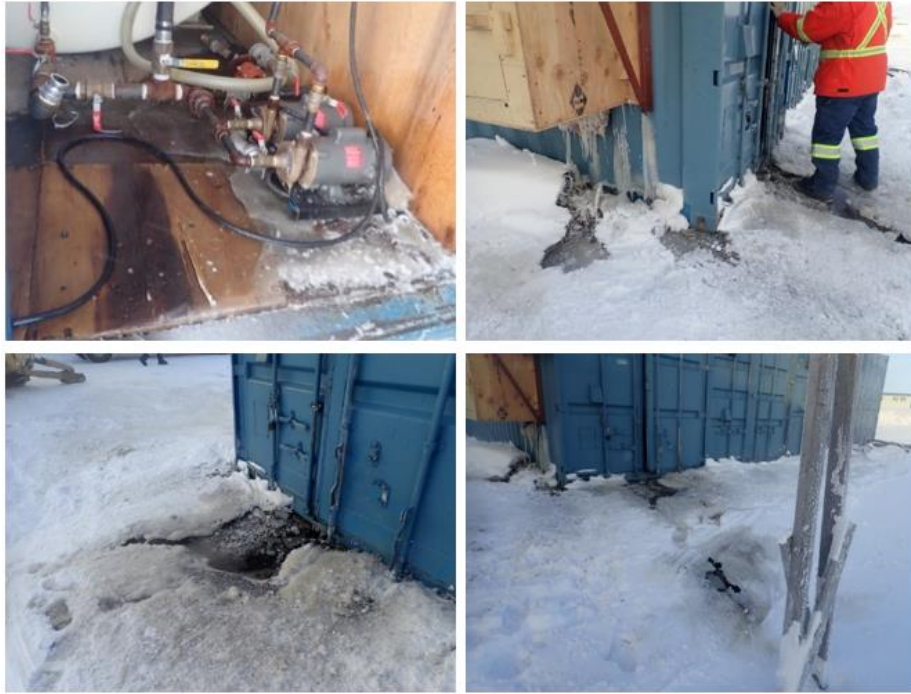
Due to freezing of an outlet hose and valve at the Exploration Camp Sewage Treatment Plant retention tank, the retention tank could not be emptied. The tank overflowed treated sewage effluent within the Sea-can housing and made contact with the ground via a hole in the door. The flow extended less than 5m from the spill source and the nearest water body, Meliadine Lake is approximately 78m from the source.

Figure 1: 2018-11-17 – The day of spill, before clean up.

Following the overflow, water to the Exploration Camp was temporarily shut down, the hose and valve was thawed and the retention tank was emptied. Treated effluent was frozen in place beneath the Mel-7 pipeline. The material was removed with ice picks and transported to CP1.

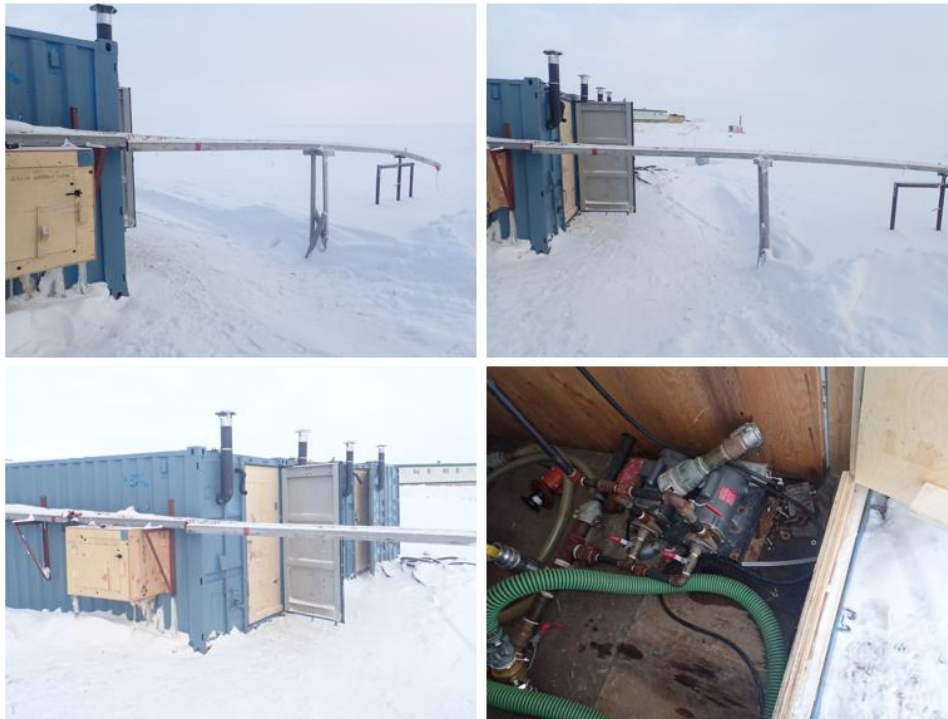
Figure 2: 2018-11-30 – After clean up with new door installed.

The Sea-Can containing the retention tank had shifted in such a way that the door was not able to be closed completely, and had been left slightly ajar. Although a heater runs inside the Sea-Can, the outside temperature was less than -30°C, which led to the freezing of the hose and valve. As a preventative measure, an insulated plywood door was installed on the Sea-Can so that it can be closed completely and prevent freezing in the future.
