Follow Up Report: #20-310

August 9th 2020, 1 m³ Saline Water Spill

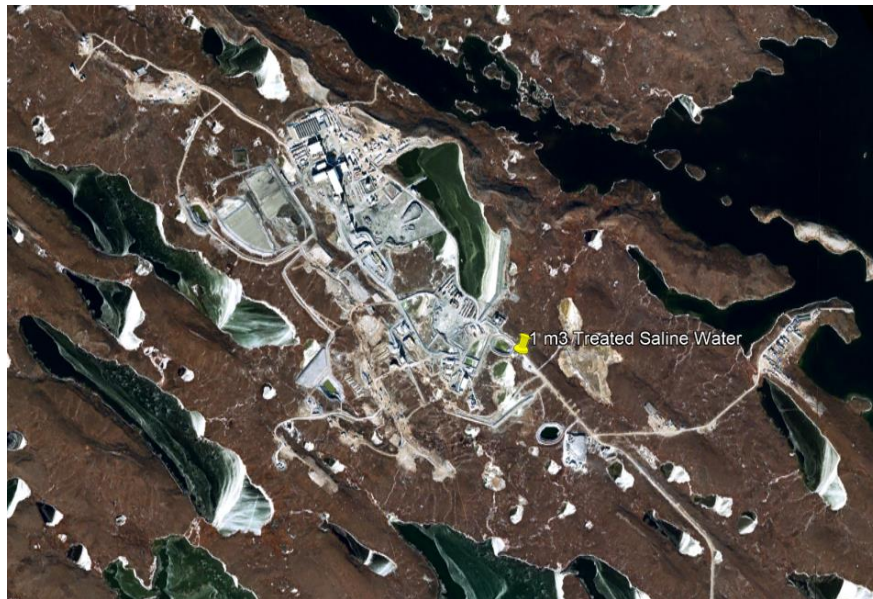
On August 9th, at approximately 3:00 pm, an estimated 1 m³ of treated saline water was spilled as water was being conveyed via a waterline from Saline Pond 3 (SP3) to the truck loading station. An accidental release occurred from a recently commissioned waterline, resulting in water spilling to the ground and flowing towards Containment Pond 5 (CP5). No water migrated off-site. The closest water body is approximately 925 m away. The coordinates of the spill are 63° 1'36.00"N, 92°12'10.00"W (Figure 1).

Figure 1: Location of spill 1 m³ treated saline water spill in CP5 catchment, adjacent to loading station.

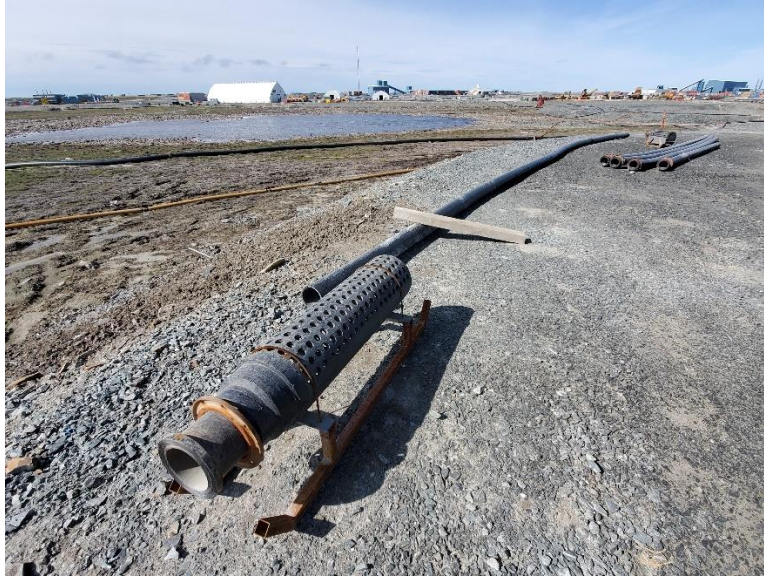
Figure 2: Piping removed from SP3 to loading station.

The Energy and Infrastructure (E&I) department replaced the piping August 10th and inspected the line before resuming operations. When the line was brought back into service, E&I personnel remained at the point of the spill to ensure that the replaced piping was operating correctly. No issues were observed.

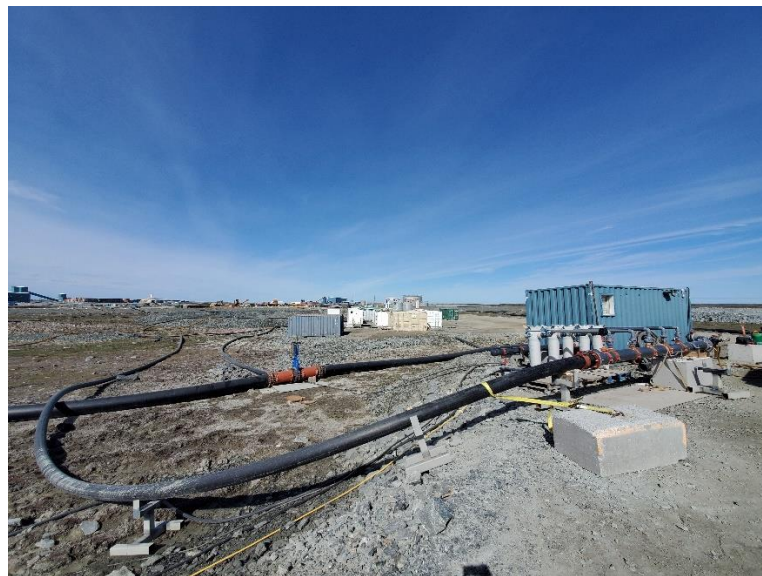
Figure 3: Piping replaced from SP3 to loading station.
