## Follow Up Report: #20-463 December 15, 2020 – Haul Truck Hydraulic Spill

The following information refers to an incident reported by Agnico Eagle Mines Ltd. December 15, 2020, and is being provided in accordance with:

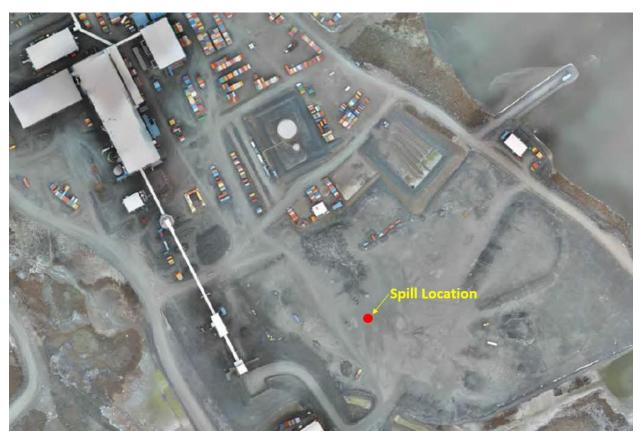
At approximately 00:30 on November 15, 2020, a 50 ton haul truck working on the Ore Pad 2 (OP2) experienced a hydraulic hose failure. The operator lost hydraulic power and noticed the oil draining onto the pad. Workers used absorbents to contain and absorb as much oil as they could, but were unable to actually stop the hydraulic tank from draining out. Approximately 280L was released onto the ore pad.

The coordinates of this spill are 63° 2'4.41"N, 92°13'16.04"W. No water bodies were impacted by this spill.

Figure 1: Location of the spill on OP2.

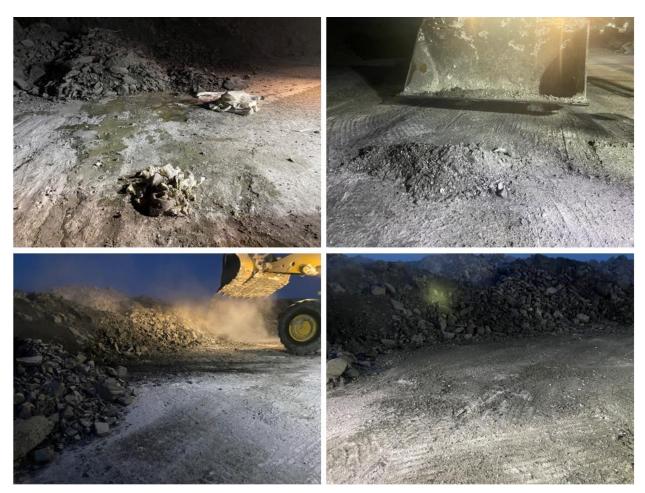
Figure 2: Process photos of the clean up of the contaminated ore.

Operators used absorbent pads to absorb as much of the oil as possible. The spill occurred adjacent to an ore pile and some of the oil made its way under the ore. The ore pile was pushed aside with a loader, and the affected ore was processed through the mill. The pad material below was scraped up with a loader, and approximately one cubic meter of pad gravel was removed and brought to the Landfarm A for future remediation.
